# INITIAL STRUCTURAL INTEGRITY ASSESSMENT REPORT (SIAR)

Factory Name: **ADURY APPARELS LTD**  
Address: **Karardi, Shibpur, Narsingdi, Narsingdi Dhaka  
Bangladesh**  
Assessor: **Bureau Veritas**  
Date: **10 May 2013**

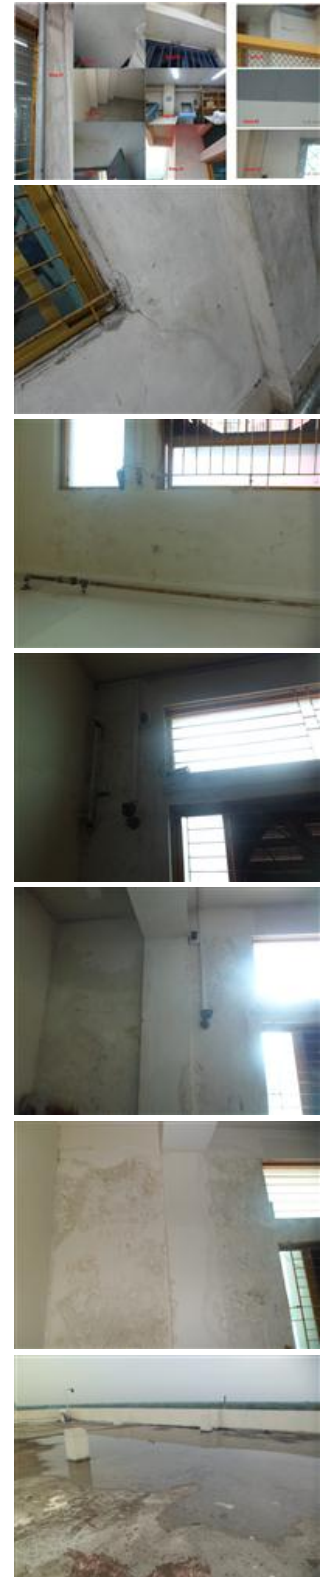
Question:	Have all areas of needed maintenance, including areas with efflorescence, dampness, standing water on rooftops, and corrosion been addressed.
Priority Level:	Medium
Non-Compliance Level:	2
Description:	1) Six story RCC building (Building 01): Dampness have been found on the Ground, 2nd, 3rd, 4th and 5th floor. Water ponding has been observed on roof of the building. 2) Five story RCC building (Building 04): Water ponding has been observed on roof of the building. 3) Three story RCC building (Building 06): Standing water has been observed on roof of the building 4) Two story Steel building (Building 02) Dampness have been found on Ground and 1st floor. 5) Single story prefab shed 02: Corrosion have been found on steel column.
Source of Findings:	Visual Assessment: Confirmed visually.
Suggested Plan of Action:	Under the guidance from a qualified structural engineer, address all areas of needed maintenance by corresponding the identified issues.

Suggested Deadline Date:	31 Jul 2014
Standard:	Alliance Standard Part 8 Section 8.26 Durability and Maintenance

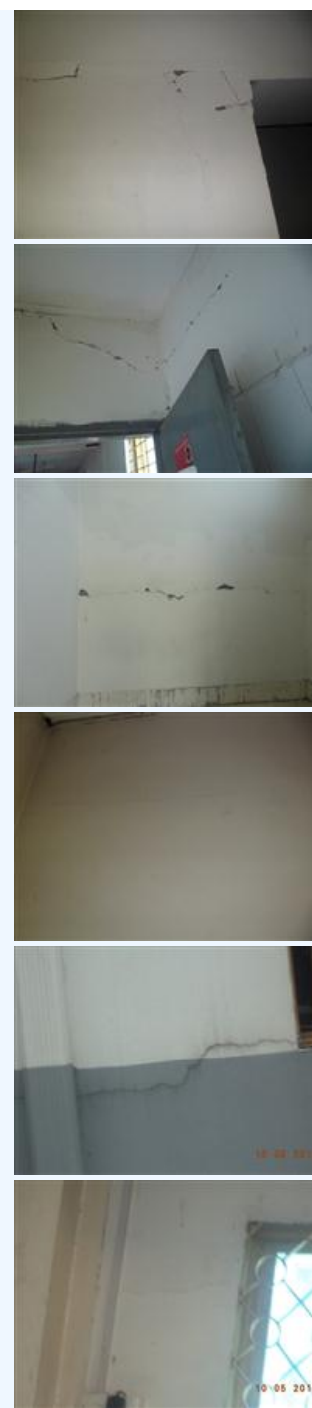
Question:	Is the structural system free of distress, settlement, shifting, or cracking in columns or walls?	
Priority Level:	High	
Non-Compliance Level:	1	
Description:	1) Six story RCC building (Building 01): Hair cracks have been noticed on Ground, 2nd, 3rd, and 5th floor. 2) Five story RCC building (Building 04): Masonry cracks have been noticed on 5th floor. 3) Three story RCC building (Building 06): Masonry cracks have been noticed on 1st floor. 4) Two story Steel building (Building 02): Masonry cracks have been noticed on 1st floor. 5) Single story prefab shed 01: Some masonry cracks found on external wall of the shed. 6) Single story prefab shed 07: Few masonry cracks have been found on window of the shed.	
Source of Findings:	Visual Assessment: Visually confirmed.	
Suggested Plan of Action:	Qualified structural engineer should be provided for further testing and analysis of distress, settlement, shifting, or cracking in columns or walls.

Suggested Deadline Date:	31 Oct 2014
