# Blue Planet Knit Composite Ltd.

Barotopa, Rathura, Mawna, Sreepur, Gazipur

5<sup>th</sup> July and 28<sup>th</sup> August 2022

# Observations

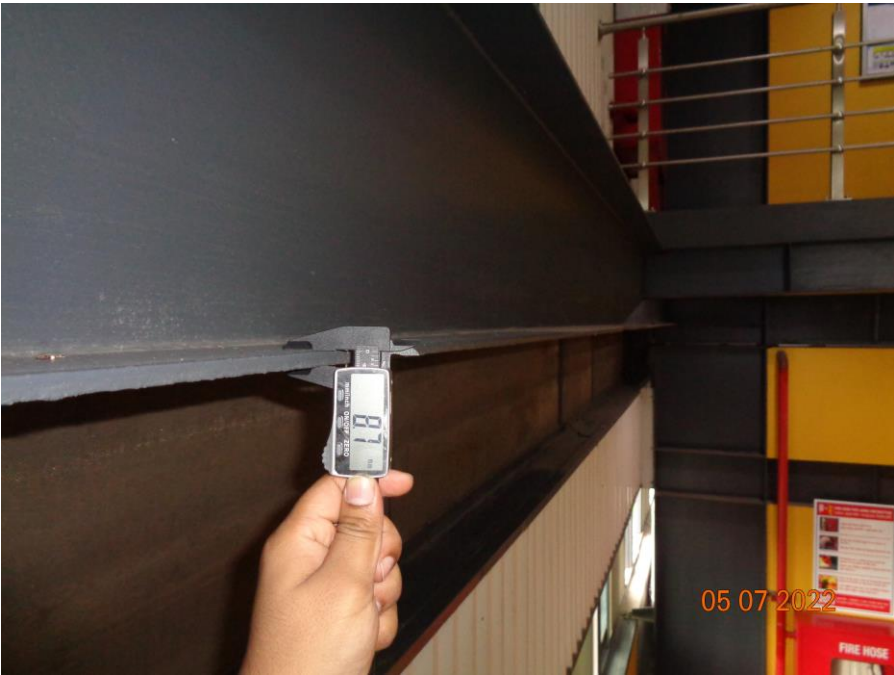
Thickness of flange shown as 10mm for Beam B7

Flange thickness was measured 8mm

Thickness of the flange measured as 8mm instead of 10mm for beam B7. Building engineer is required to re-survey the whole structure and update the as-built drawing to as-built condition as well as revise the design documents for all steel members.

| Item No. | Observation | Recommended Action Plan | Recommended Timeline |
|---|---|---|---|
| 01 | Discrepancy in as-built drawing (Building 1 (Dyehouse Shed Building)) | Building Engineer is required to update the as-built drawings. | 6-weeks |
| 02 | Discrepancy in as-built drawing (Building 1 (Dyehouse Shed Building)) | Building Engineer to update the design document including a design report, and a set of structural drawings in compliance with section 1.9.1.1 and section 1.9.1.2 of BNBC (part-6). | 6-weeks |

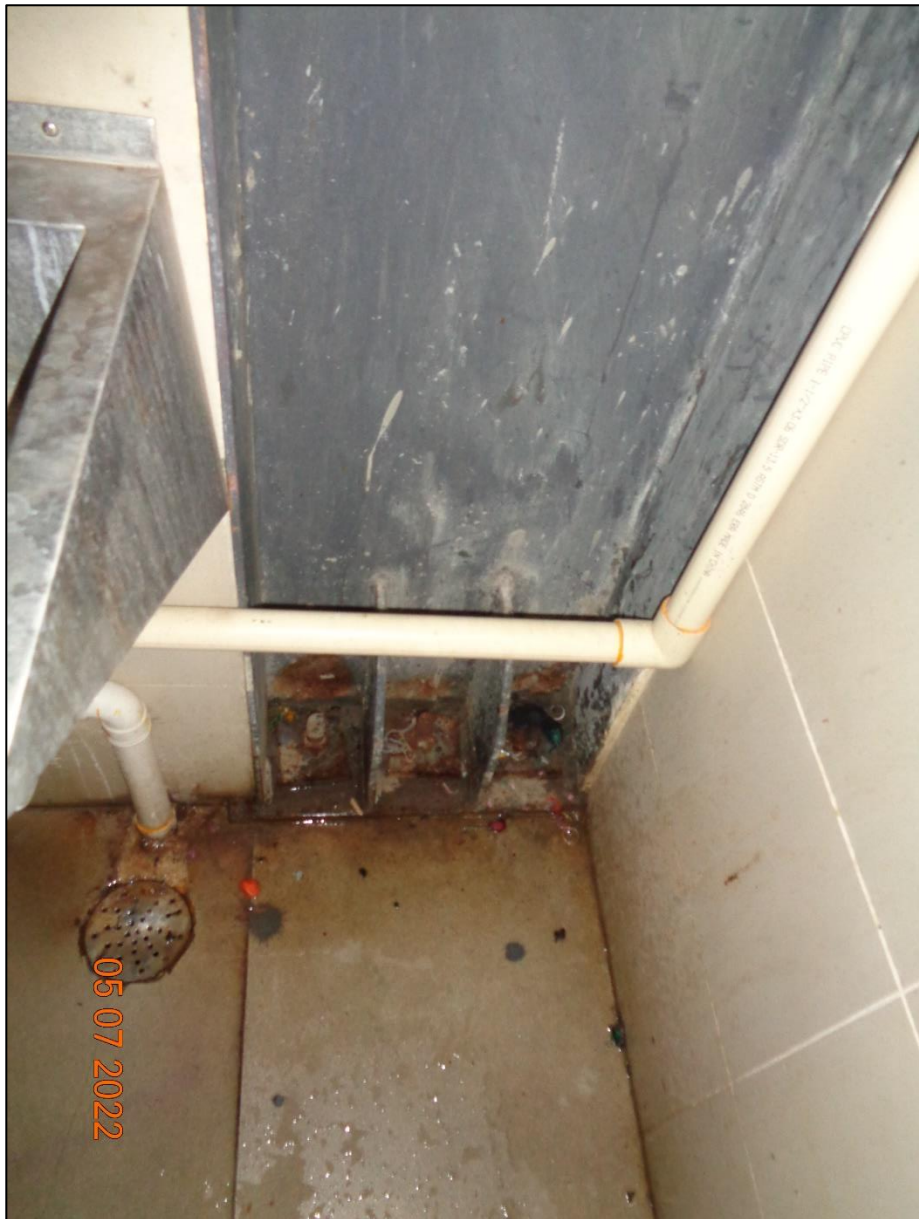
Corrosion was found in the baseplate of steel column. Factory is required to remove corrosion and apply rust proofing on the corroded areas to protect the steel members from corrosion.

Corrosion in steel column

| Item No. | Observation | Recommended Action Plan | Recommended Timeline |
|---|---|---|---|
| 04 | Corrosion in steel column (Building 1 (Dyehouse Shed Building)) | Factory is required to remove the corrosion and provide rust proof paint on all steel members to protect from further corrosion. | 6-weeks |

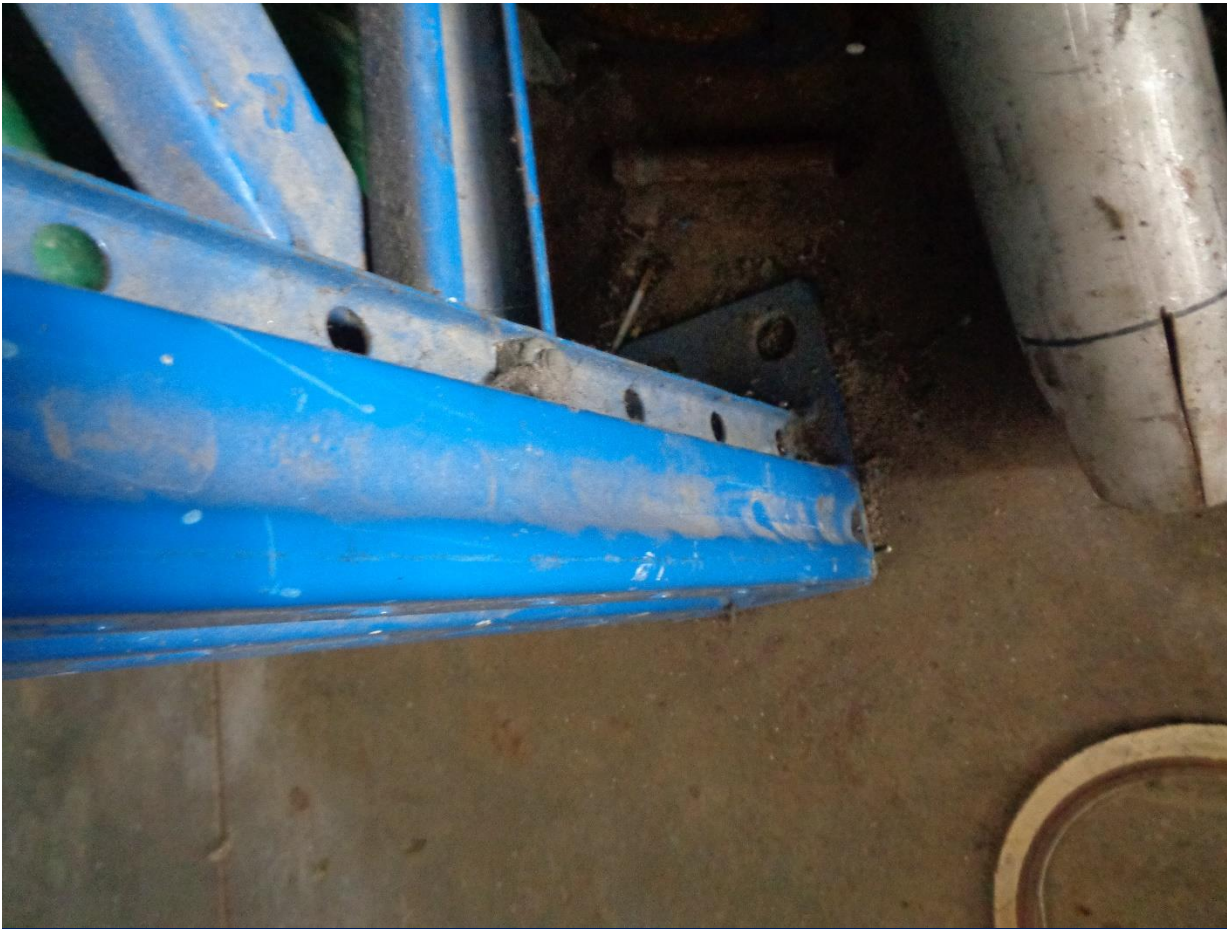
Storage rack found within the building without braced/anchored

Factory is required to brace/anchor all non structural elements.

| Item No. | Observation | Recommended Action Plan | Recommended Timeline |
|---|---|---|---|
| 07 | Non-structural elements found unbraced/not anchored (Building 2 (Utility Shed)) | Factory is required to brace/anchor all non-structural elements. | 6-weeks |

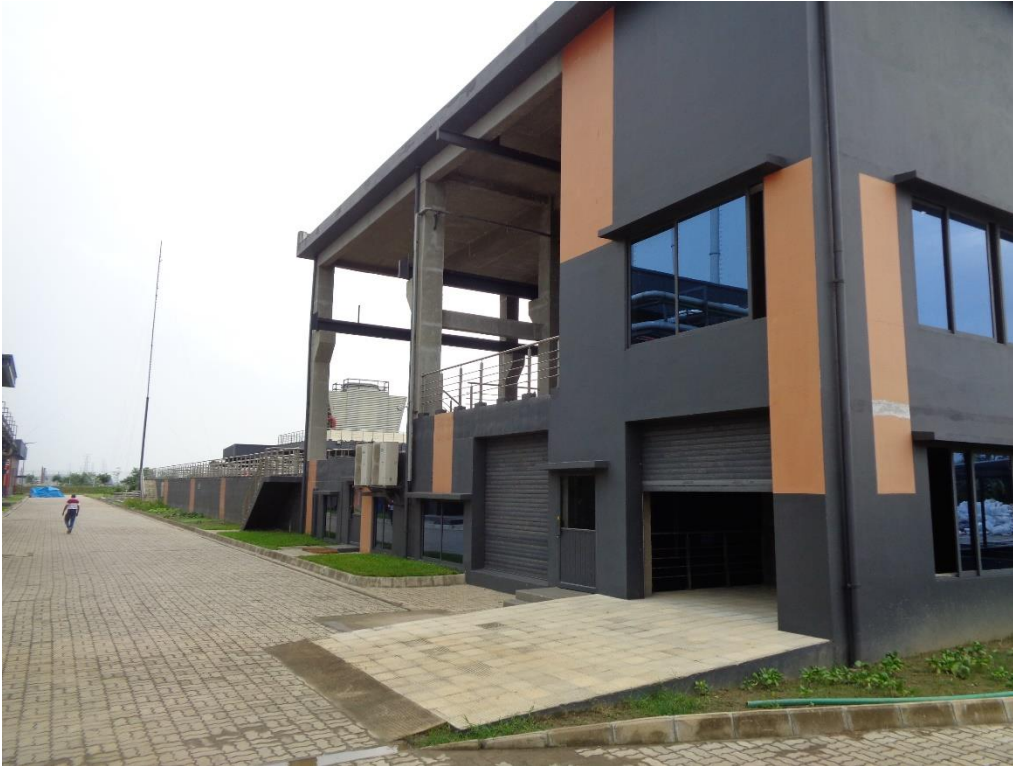
ETP Building

As per BNBC, every building or structure designed shall have its design documents prepared in accordance with the provision of Section 1.9.1. The design document shall include a design report, and a set of structural drawings, which shall be prepared in compliance with section 1.9.1.1 and section 1.9.1.2 of BNBC (part-6). At the time of inspection, design report was not available which is required to be prepared in compliance with section 1.9.1 of BNBC (part-6).

| Item No. | Observation | Recommended Action Plan | Recommended Timeline |
|---|---|---|---|
| 08 | Absence of design documents (Building 3 (ETP Building)) | Building Engineer is required to prepare a design report in compliance with section 1.9.1 of BNBC (part-6). | 6-weeks |

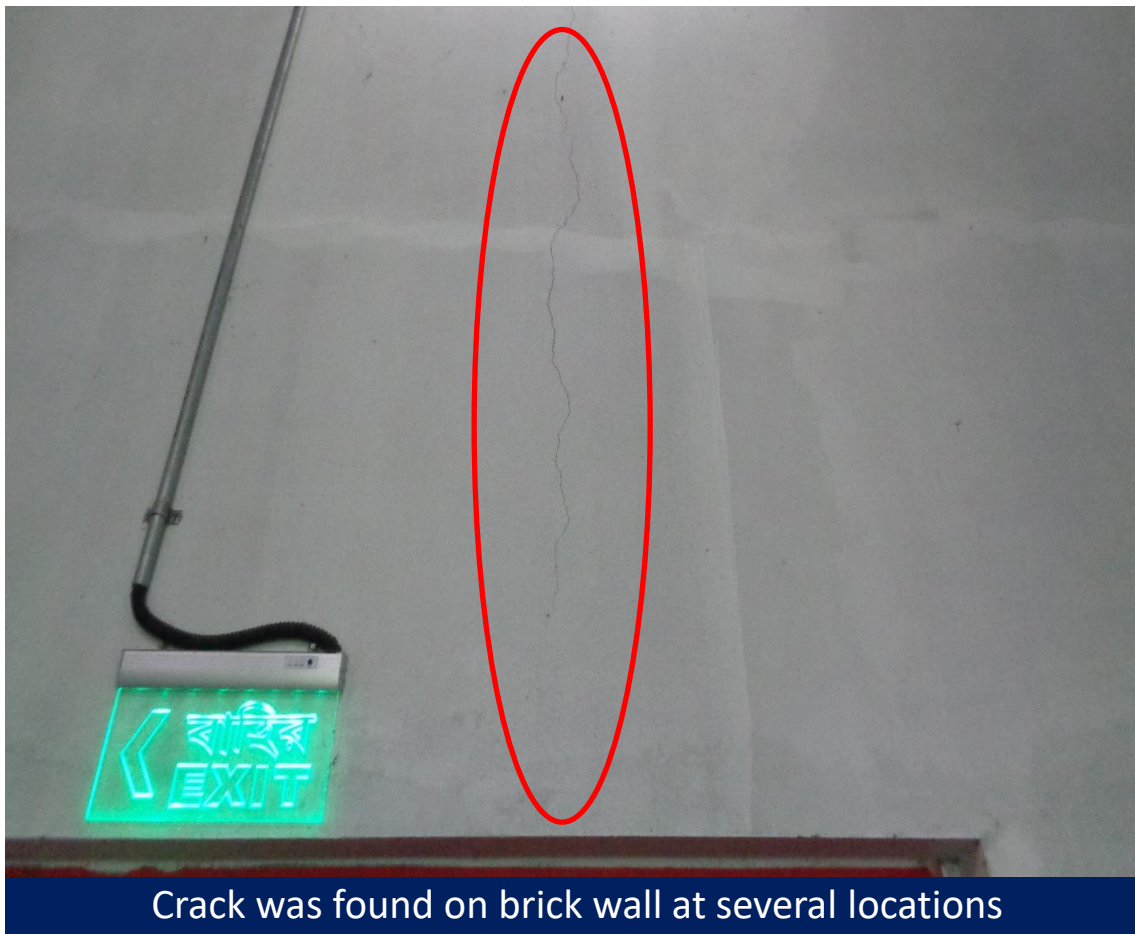
Crack was found on brick wall at several locations

Building engineer is required to investigate the cause of crack and repair with a suitable method.

| Item No. | Observation | Recommended Action Plan | Recommended Timeline |
|---|---|---|---|
| 10 | Crack on brick wall (Building 3 (ETP Building)) | Building Engineer is required to investigate the cause of crack and repair with a suitable method. | 6-weeks |

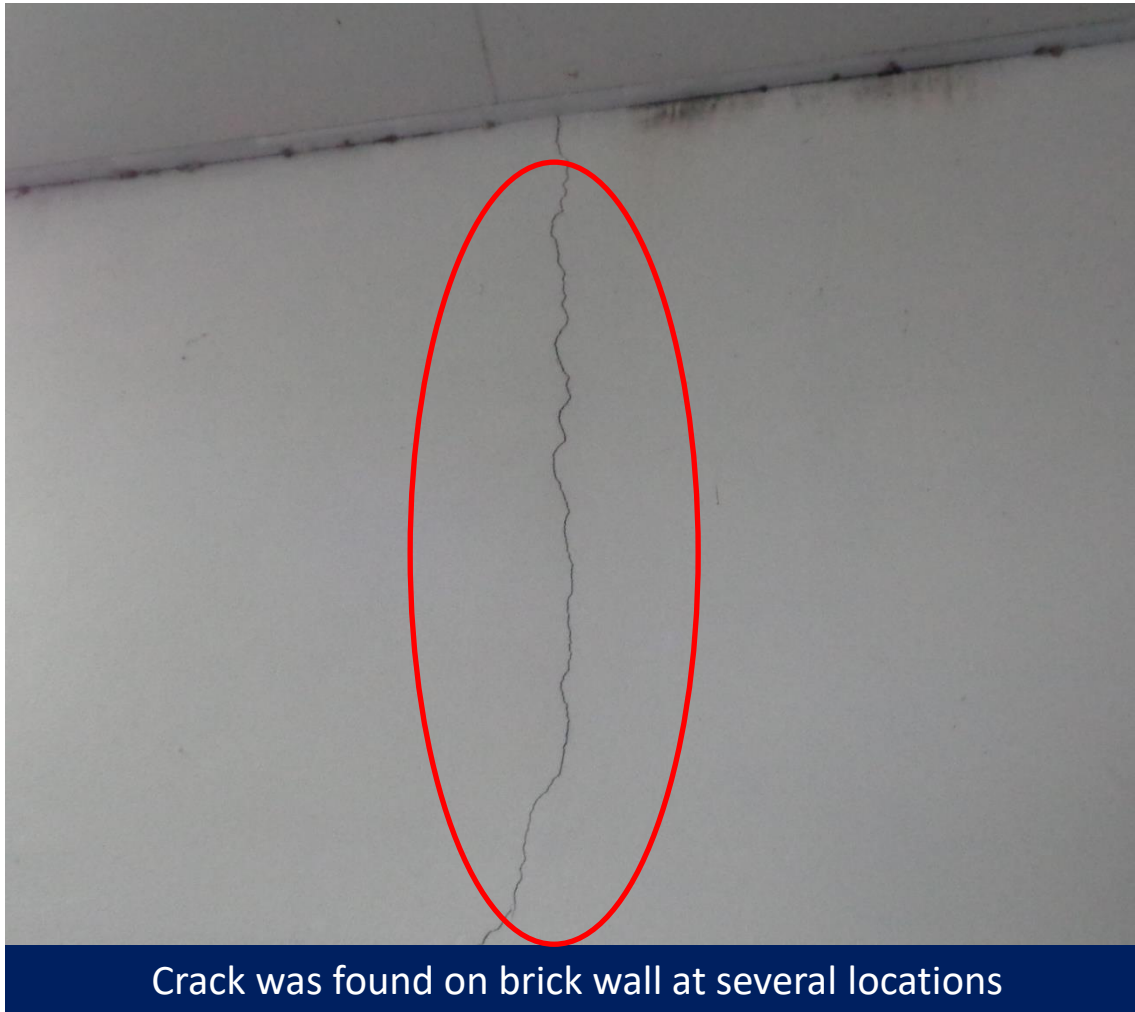
Crack was found on brick wall at several locations

Building engineer is required to investigate the cause of crack and repair with a suitable method.

| Item No. | Observation | Recommended Action Plan | Recommended Timeline |
|---|---|---|---|
| 13 | Crack on brick wall (Building 5 (Bonded Warehouse Shed)) | Building Engineer is required to investigate the cause of crack and repair with a suitable method. | 6-weeks |

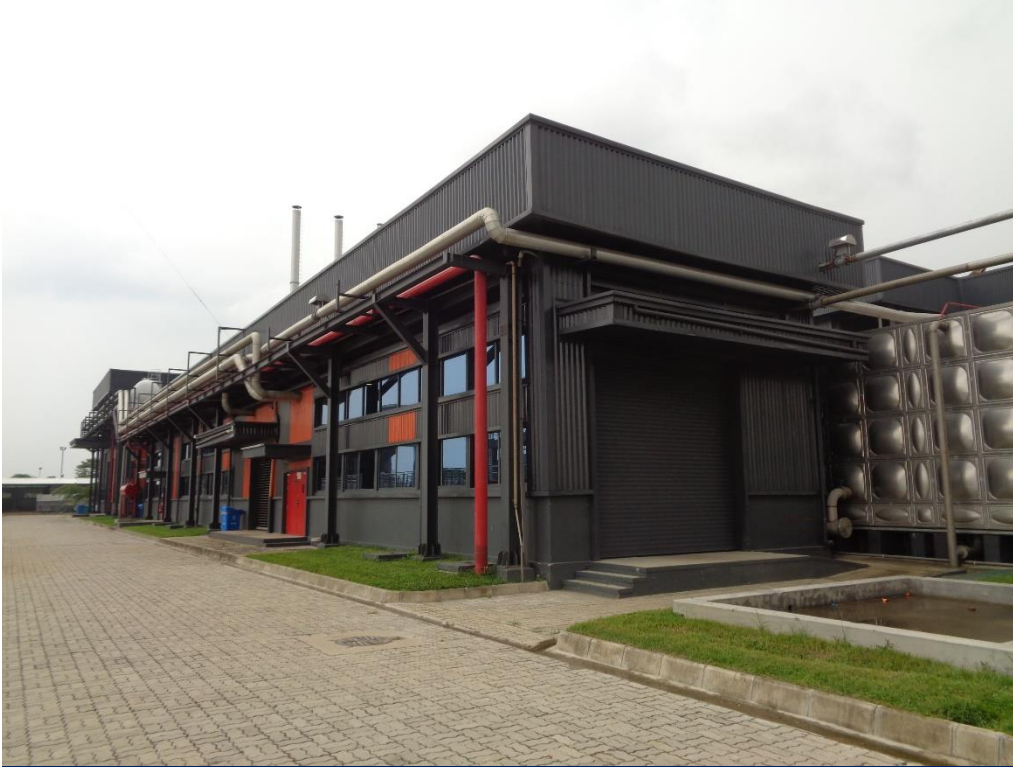
WTP & Pump House

As per BNBC, every building or structure designed shall have its design documents prepared in accordance with the provision of Section 1.9.1. The design document shall include a design report, and a set of structural drawings, which shall be prepared in compliance with section 1.9.1.1 and section 1.9.1.2 of BNBC (part-6). At the time of inspection, design report was not available which is required to be prepared in compliance with section 1.9.1 of BNBC (part-6).

| Item No. | Observation | Recommended Action Plan | Recommended Timeline |
|---|---|---|---|
| 14 | Absence of design documents (Building 6 (WTP & Pump House)) | Building Engineer is required to prepare a design report in compliance with section 1.9.1 of BNBC (part-6). | 6-weeks |

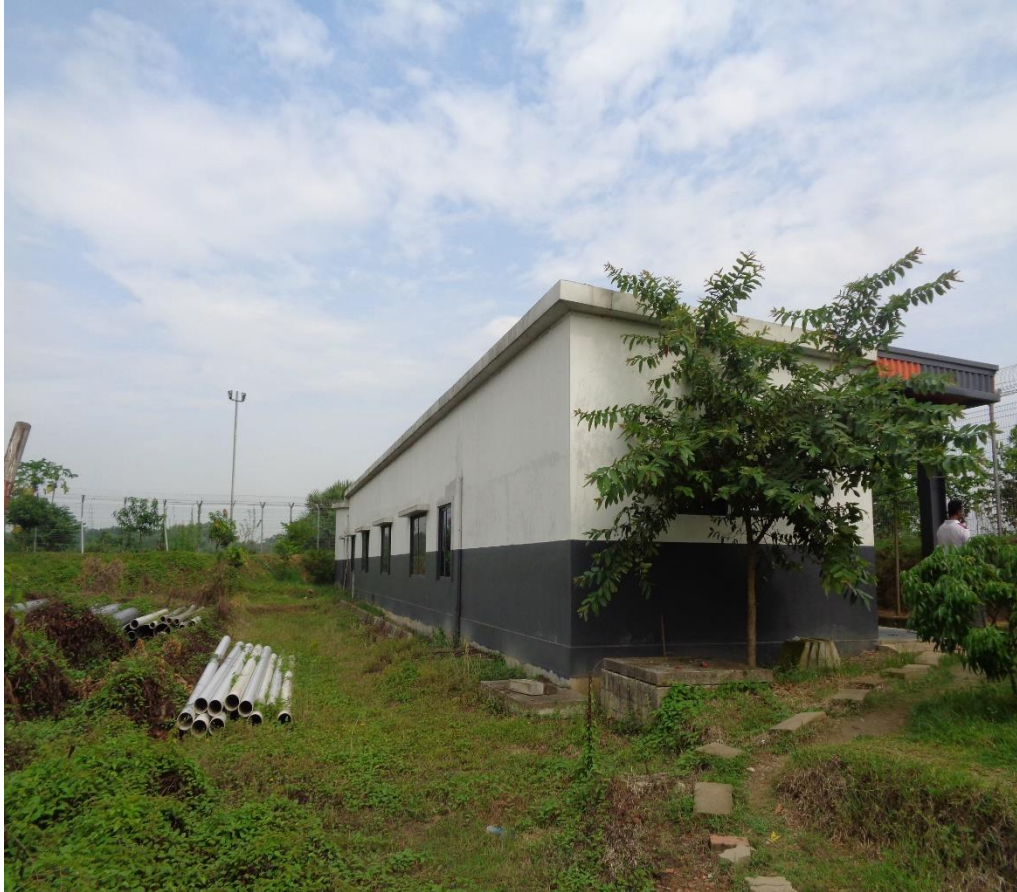
Security Dormitory Shed

As per BNBC, every building or structure designed shall have its design documents prepared in accordance with the provision of Section 1.9.1. The design document shall include a design report, and a set of structural drawings, which shall be prepared in compliance with section 1.9.1.1 and section 1.9.1.2 of BNBC (part-6). At the time of inspection, design report was not available which is required to be prepared in compliance with section 1.9.1 of BNBC (part-6).

| Item No. | Observation | Recommended Action Plan | Recommended Timeline |
|---|---|---|---|
| 16 | Absence of design documents (Building 8 (Security Dormitory Shed)) | Building Engineer is required to prepare a design report in compliance with section 1.9.1 of BNBC (part-6). | 6-weeks |

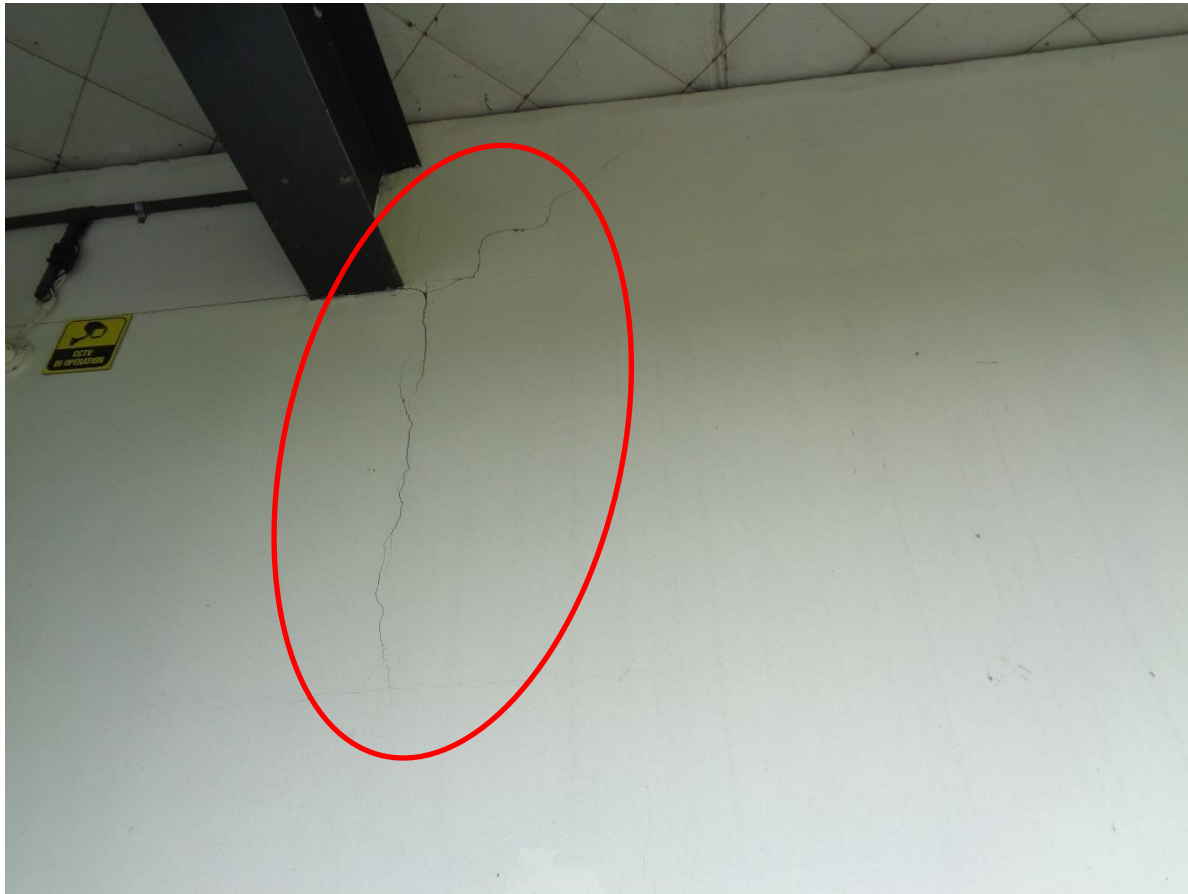
Crack was found on brick wall at several locations

Building engineer is required to investigate the cause of crack and repair with a suitable method.

| Item No. | Observation | Recommended Action Plan | Recommended Timeline |
|---|---|---|---|
| 18 | Crack on brick wall (Building 8 (Security Dormitory Shed)) | Building Engineer is required to investigate the cause of crack and repair with a suitable method. | 6-weeks |

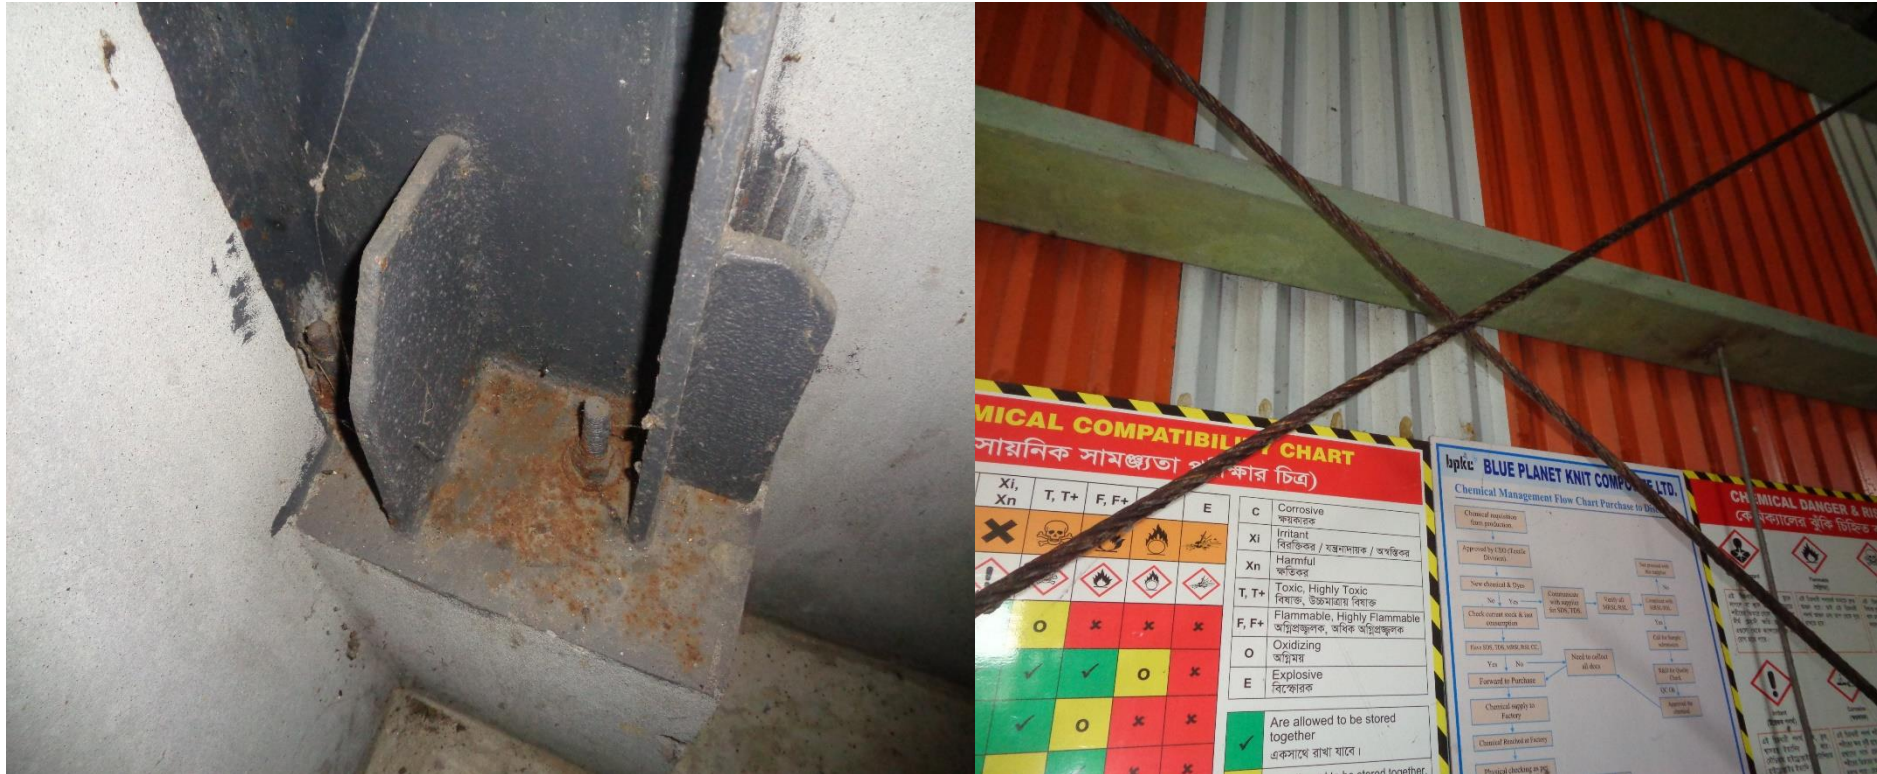
Corrosion on steel member and cable bracing

Corrosion was observed on steel members and cable bracing. Factory is required to remove the corrosion and provide rust proof paint on all steel members to protect from corrosion.

| Item No. | Observation | Recommended Action Plan | Recommended Timeline |
|---|---|---|---|
| 19 | Corrosion on steel members (Building 9 (ETP Chemical Shed)) | Factory is required to provide rust proof paint on all steel members to protect from corrosion. | 6-weeks |

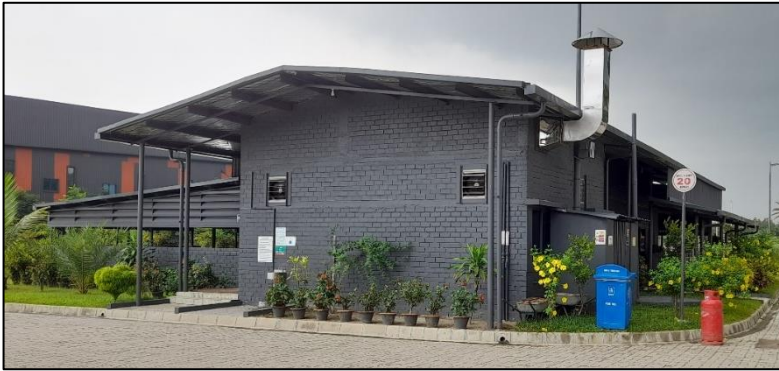
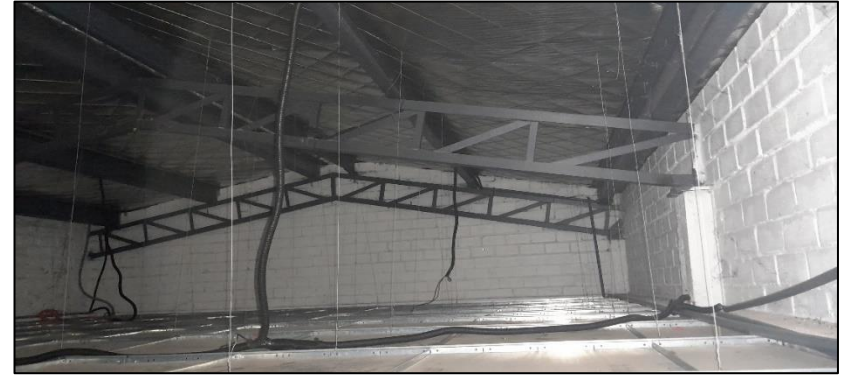
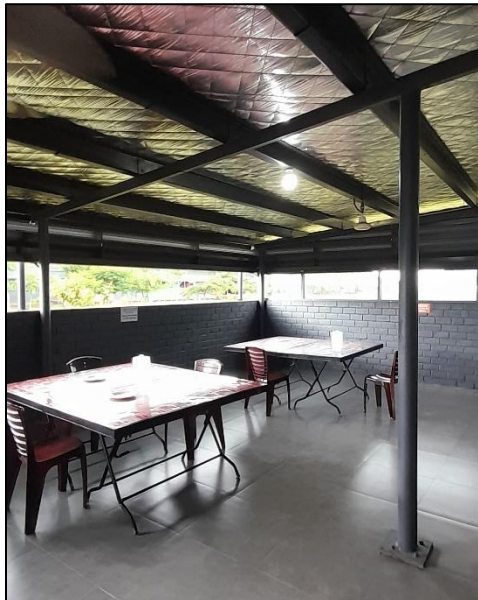
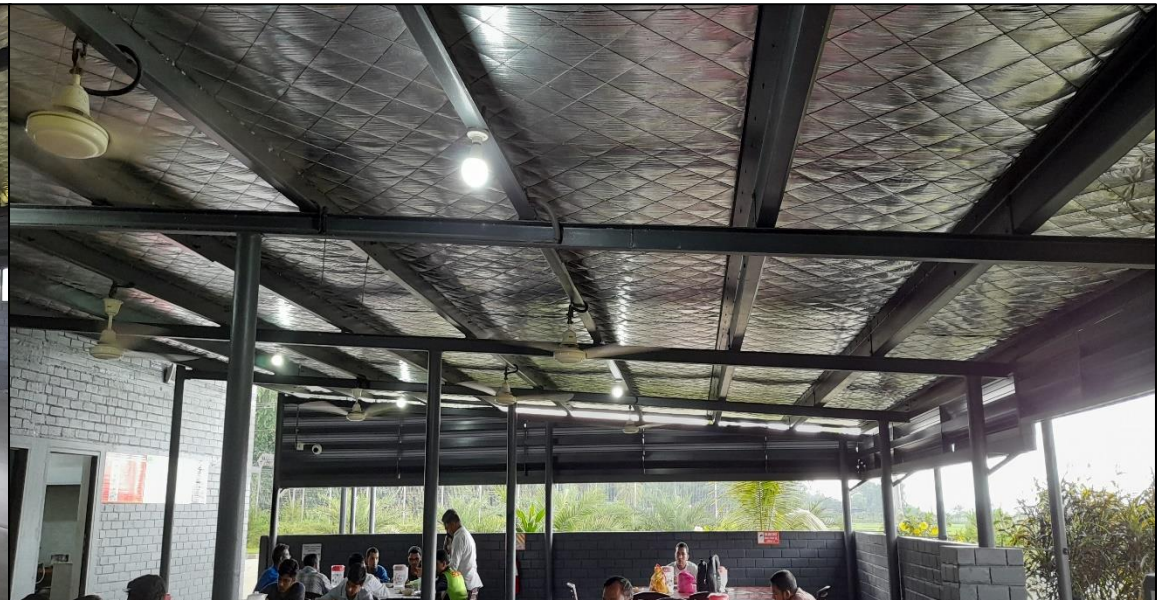
No lateral load transfer media provided

No lateral load transfer media provided from frame to frame to transfer the lateral load therefore lateral stability system of the shed is apparently incomplete.  
Building engineer is required to check the lateral stability of the structure.

| Item No. | Observation | Recommended Action Plan | Recommended Timeline |
|---|---|---|---|
| 20 | Apparently incomplete lateral stability system (Building-10 (Staff Canteen)) | As part of Engineering Assessment (EA), the building engineer is required to check the lateral stability of the structure. | 6-weeks |

| Item No. | Observation | Recommended Action Plan | Recommended Timeline |
|---|---|---|---|
| 21 | Apparently incomplete lateral stability system (Building-10 (Staff Canteen)) | Carry out remedial works as per EA recommendations. | 6-months |

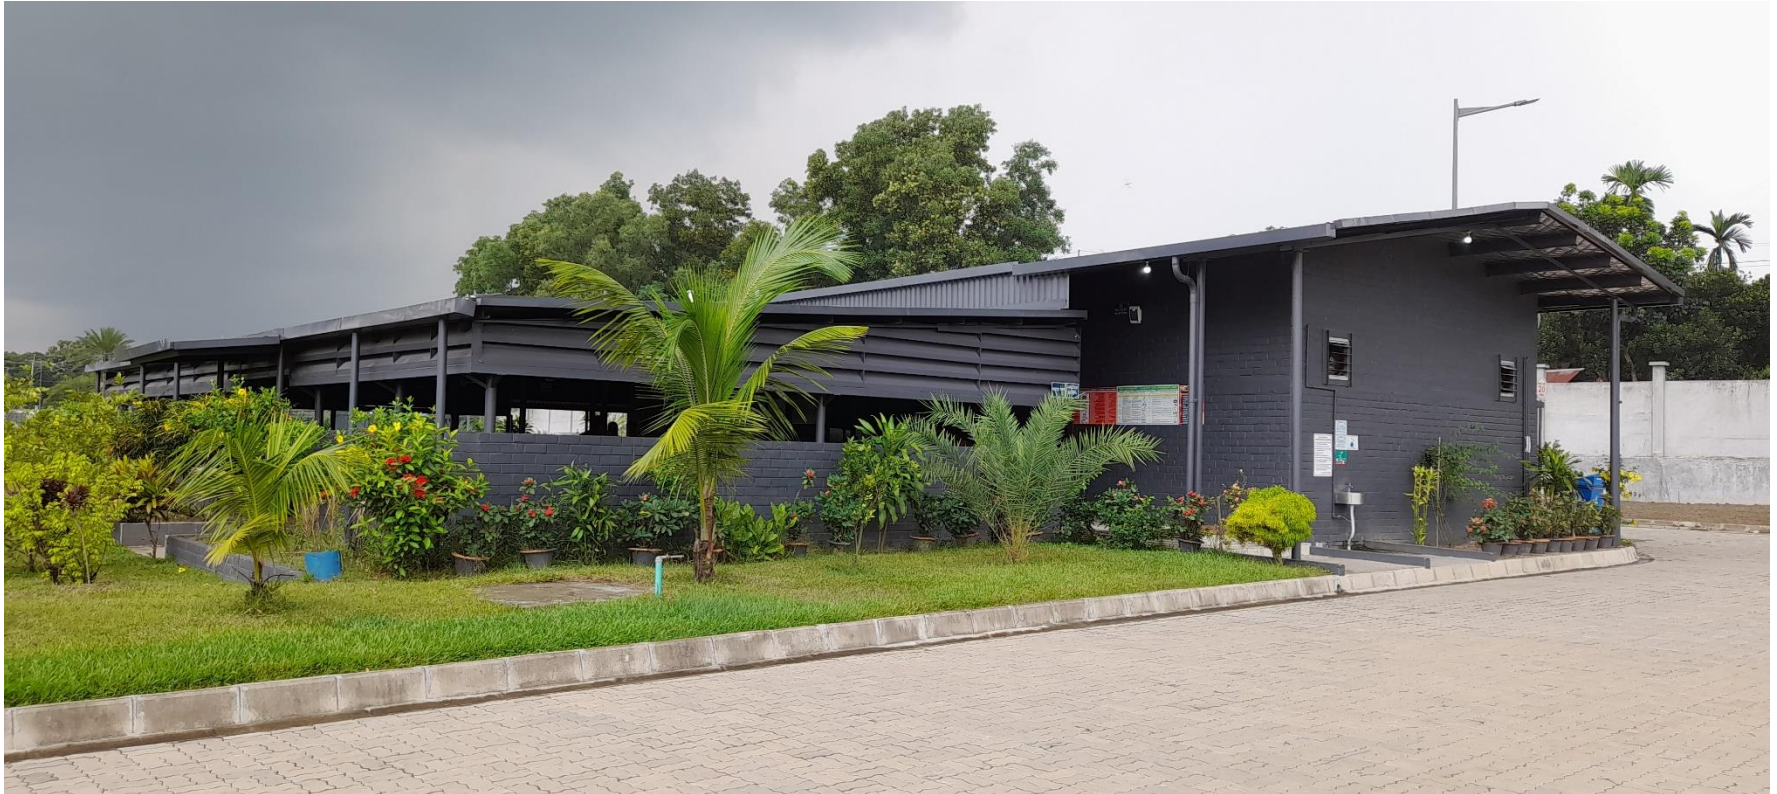
Staff Canteen

As-built structural drawing was not available for Canteen Shed. Building engineer is required to produce full set of as-built drawing with connection details for the structure.

| Item No. | Observation | Recommended Action Plan | Recommended Timeline |
|---|---|---|---|
| 22 | Lack of structural drawing (Building-10 (Staff Canteen)) | Building Engineer is required to produce as-built drawing for both toilet blocks. | 6-weeks |

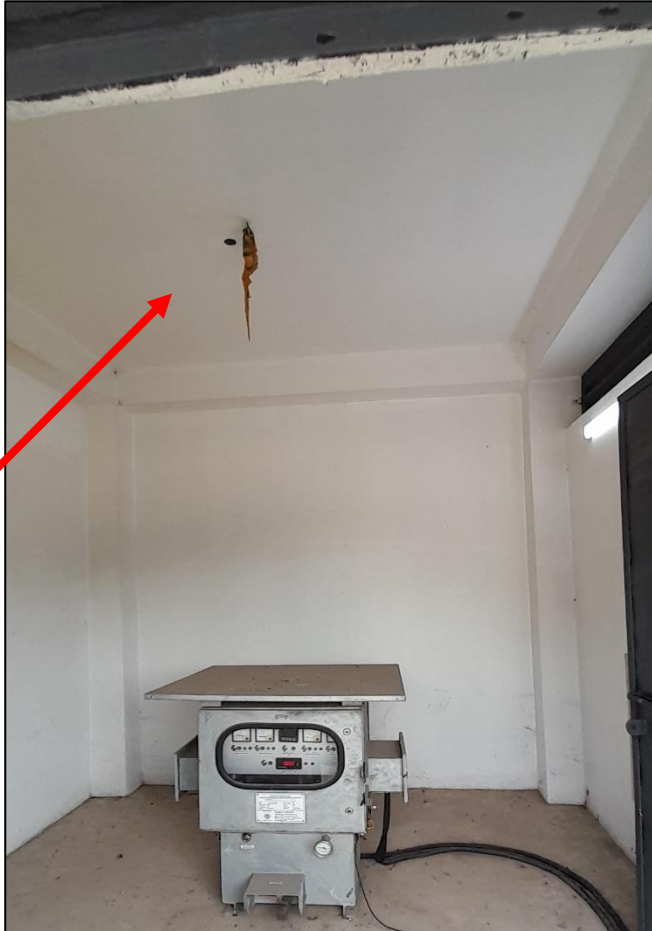
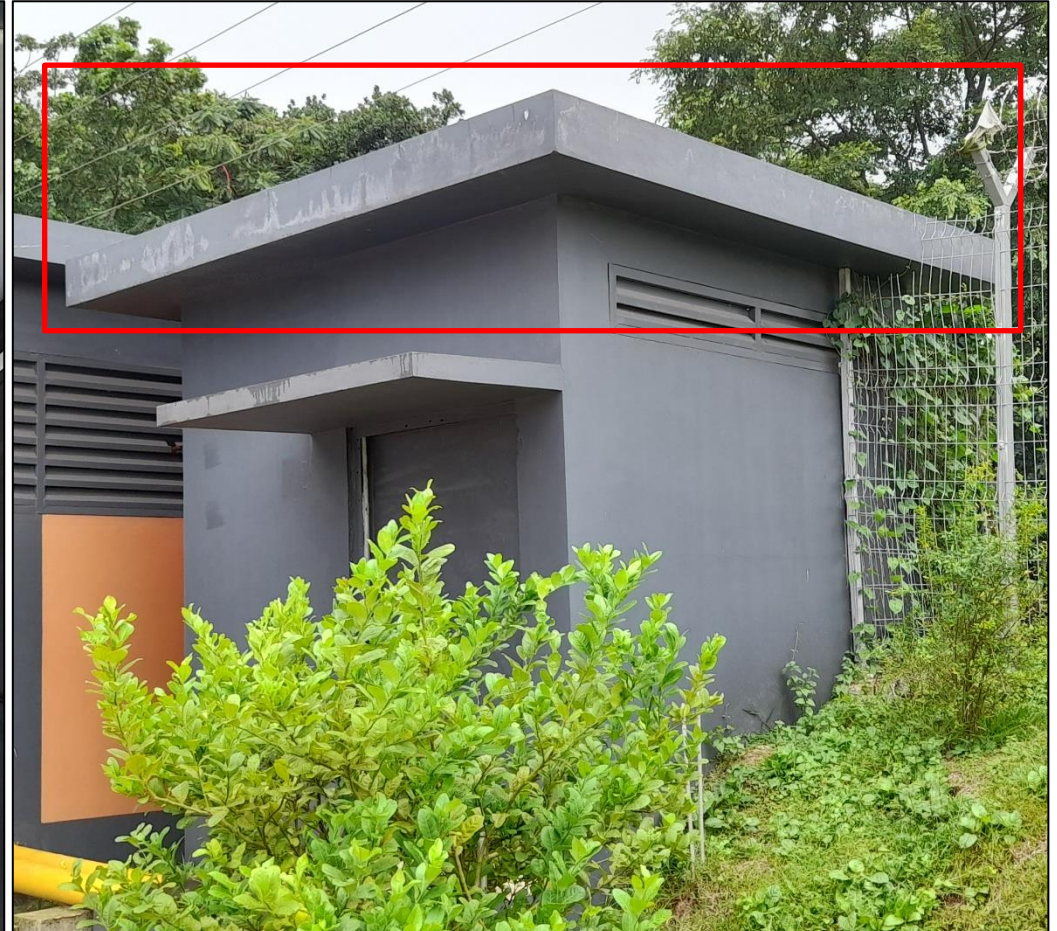
CP Building

As-built drawing was available for the CP Building, but for slab has been included in as-built structural drawing. Building engineer is required to produce accurate as-built drawing for structure.

| Item No. | Observation | Recommended Action Plan | Recommended Timeline |
|---|---|---|---|
| 23 | Lack of information in as-built drawing (Building 12) | Building Engineer is required to produce as-built drawing for both toilet blocks. | 6-weeks |
