# KDS Washing Plant

251-252, Nasirabad I/A, Baizid Bostami Road, Chattogram, Bangladesh  
(22.392529, 91.819859)  
15 September 2022

# Buildings Information

1. Block-B Building seven (G+6) reinforced concrete building.

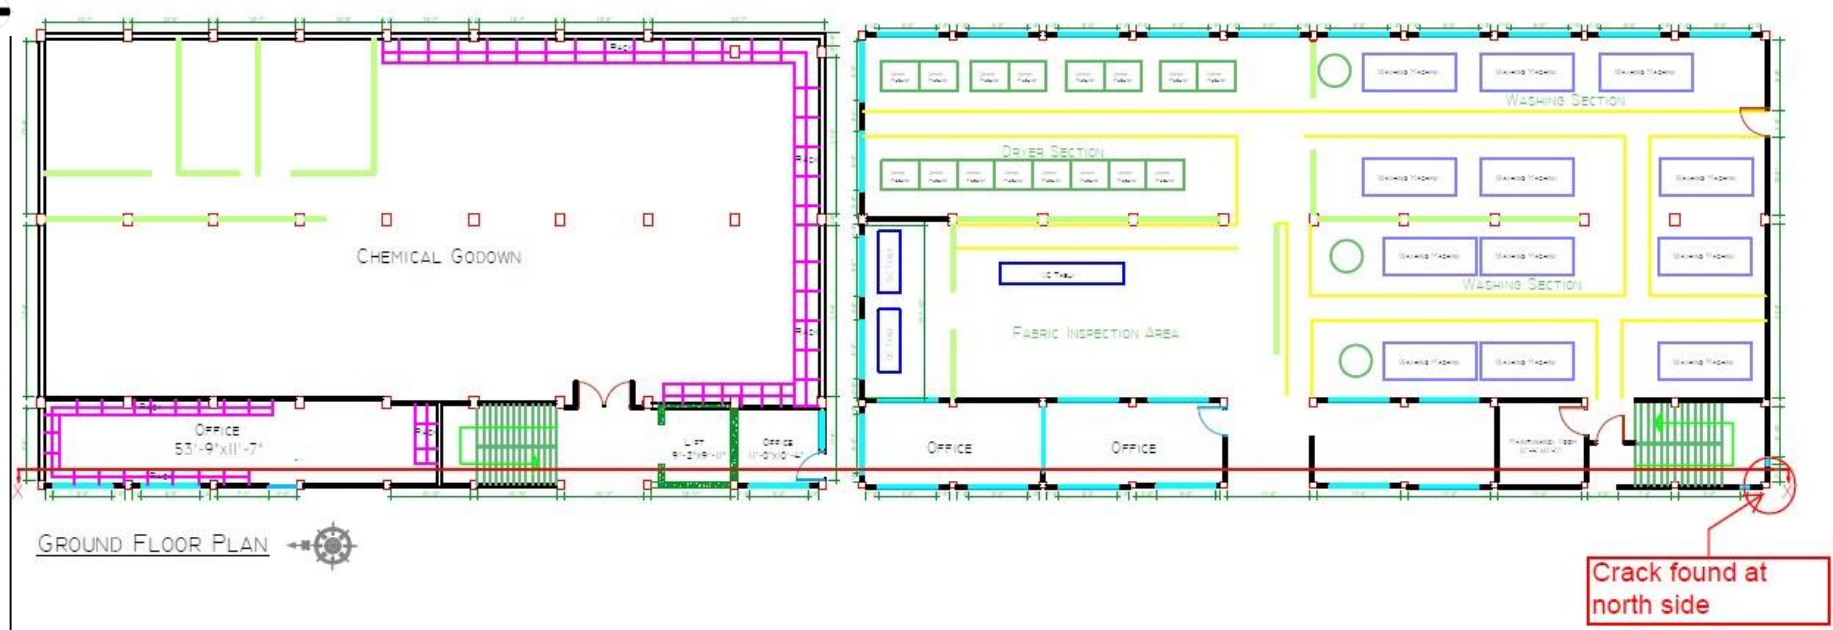
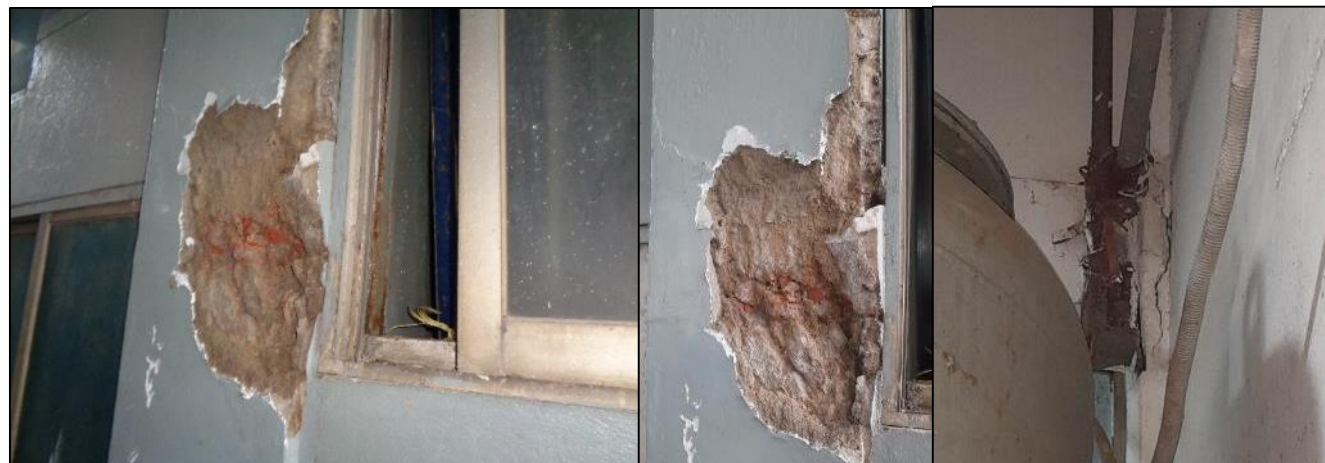
Damaged Column

Damaged column was found on the south-west corner of the ground floor at the stair area (Marked in Figure-1) of the 7-storied factory Building (Block-B).

The factory must immediately engage a consultant to investigate the damaged column. Any safety measures, if required as suggested by the consultant must be taken immediately to ensure safety.

| Item No. | Observation | Recommended Action Plan | Recommended Timeline |
|---|---|---|---|
| 01 | Damaged column found at Factory Building. (Block-B) | Factory is required to engage a qualified engineer to investigate the damaged column. | (Immediate - Now) |
| 02 | Damaged column found at Factory Building. (Block-B) | Factory engineer is required to investigate the adequacy of damaged column suggest for props if required. | (Immediate - Now) |
| 03 | Damaged column found at Factory Building. (Block-B) | Factory is required to provide props as per recommendation of investigation report. | (Immediate - Now) |
| 04 | Damaged column found at Factory Building. (Block-B) | Factory engineer is required to investigation the damage column including reason of damage, extend of damage and suggest proper remedial action. | 6-weeks |
| 05 | Damaged column found at Factory Building. (Block-B) | Remediation work must be completed as per the recommendation of investigation report. | 6-months |

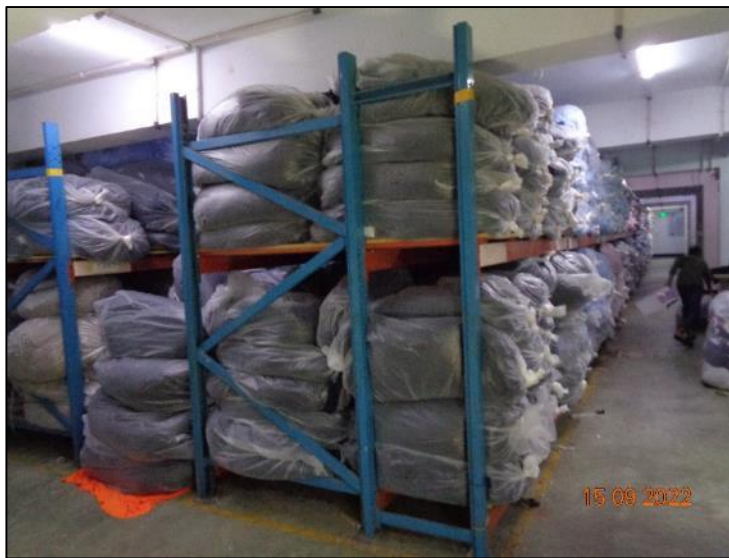
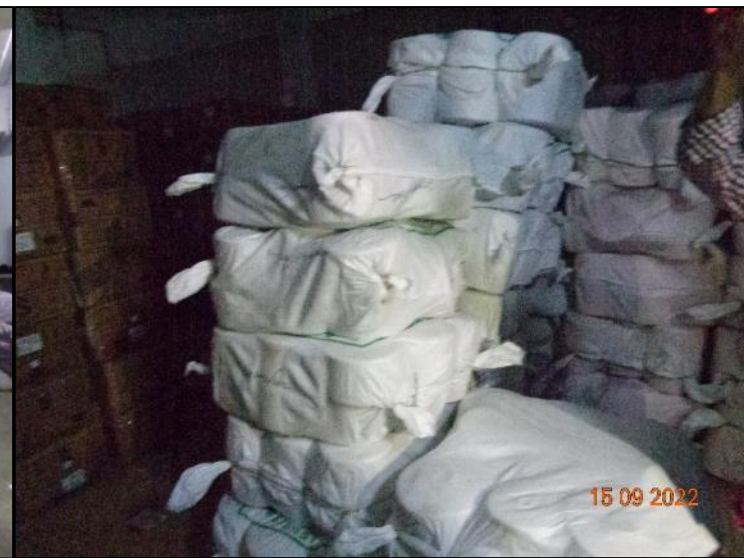
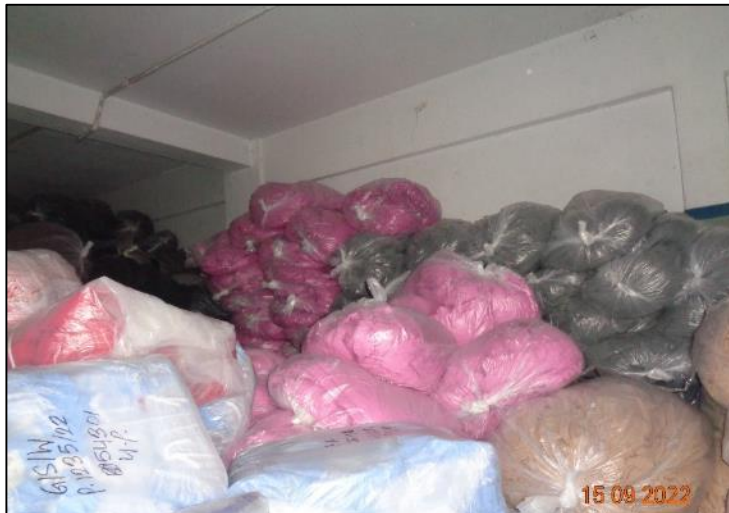
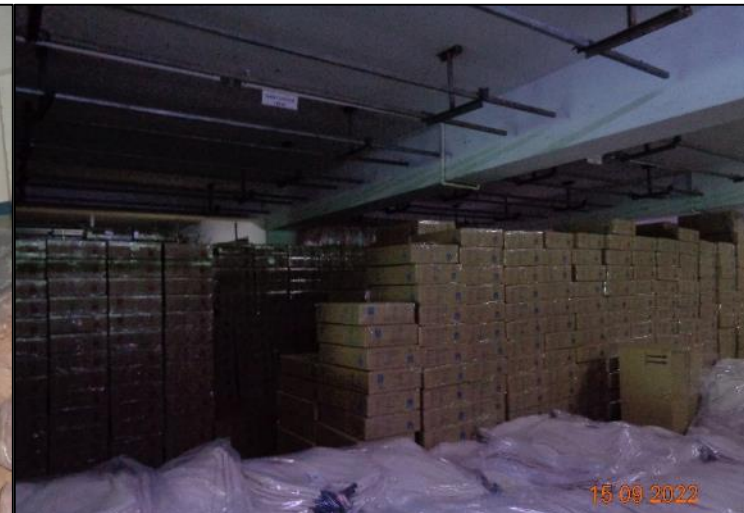
Storage loading

The floor load plan was accepted by Alliance as part of DEA. Factory completed the required retrofitting works. But load plan was not found posted in each floor. Factory engineer is required to post final load plan in each floor and maintain the floor loading accordingly.

| Item No. | Observation | Recommended Action Plan | Recommended Timeline |
|---|---|---|---|
| 06 | Load plan not posted in floor (Block-B). | Post the floor live load plan in each of the floors and Implement the load management programs effectively. | 6-weeks |

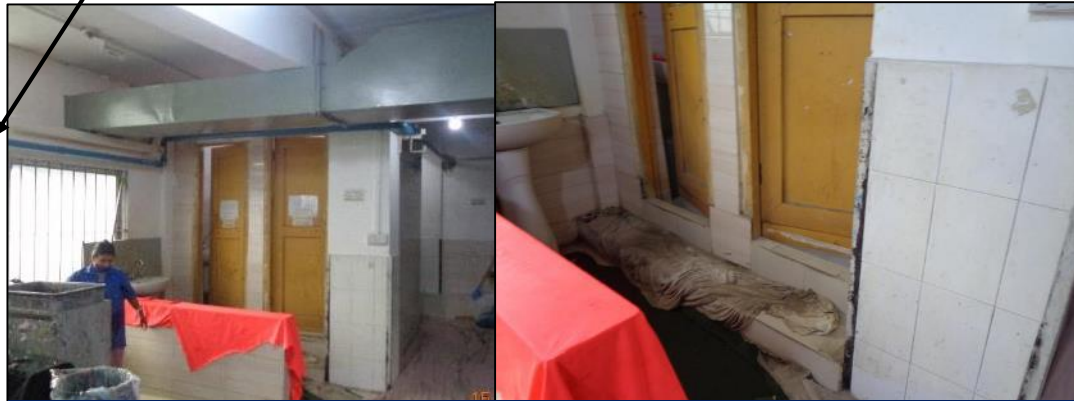
Additional room in front of stair

Undocumented toilet block was found at marked location. The toilet block was found with 225mm build up supported by cantilever beam. Factory engineer is required to update the as-built drawing and provide the adequacy of the cantilever beam and slab against the super imposed load from toiler block.

| Item No. | Observation | Recommended Action Plan | Recommended Timeline |
|---|---|---|---|
| 07 | Mismatch in as-built drawings (Block-B) | Building engineer is required to prepare accurate as-built drawing in compliance with section 1.9.1.2 (part-6, BNBC). | 6-weeks |

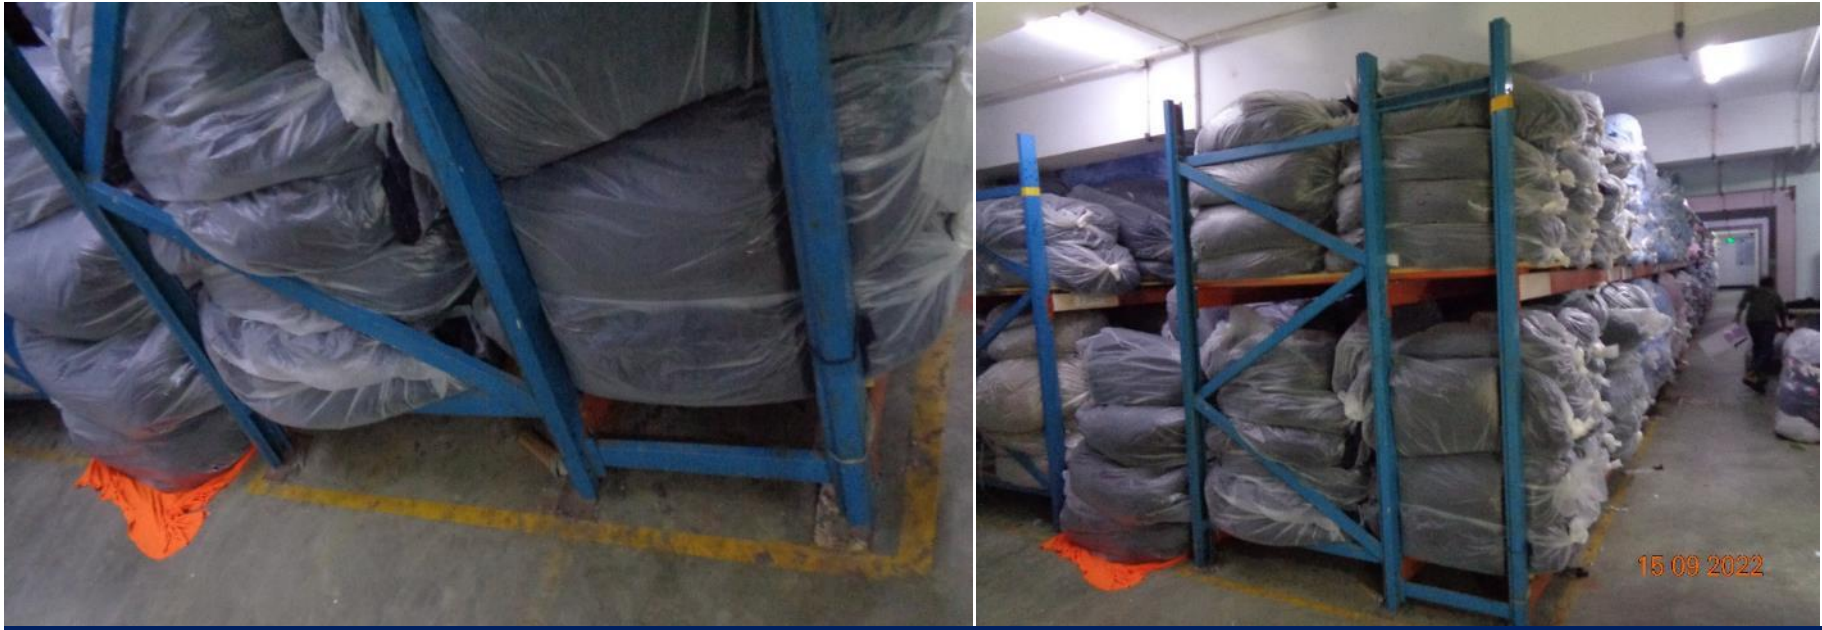
Rack on floor level

Racks on different floors are not adequately anchored or braced to resist lateral (earthquake) forces. Adequately anchor and brace all non-structural elements (all buildings) to resist earthquake forces to comply with the BNBC.

| Item No. | Observation | Recommended Action Plan | Recommended Timeline |
|---|---|---|---|
| 08 | Non-structural elements not anchored or braced (Block-B) | Adequately anchor and brace all non-structural elements (all buildings) to resist earthquake forces to comply with the BNBC. | 6-weeks |

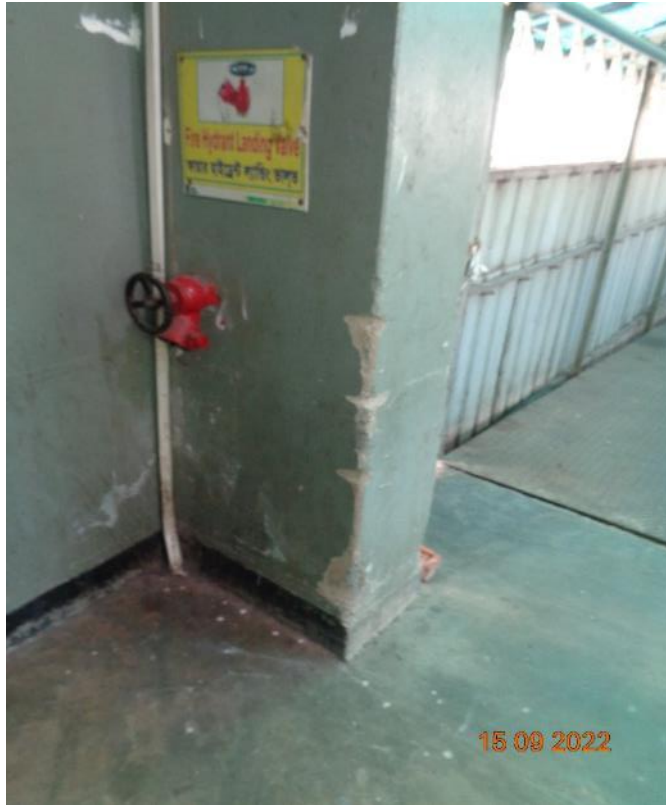
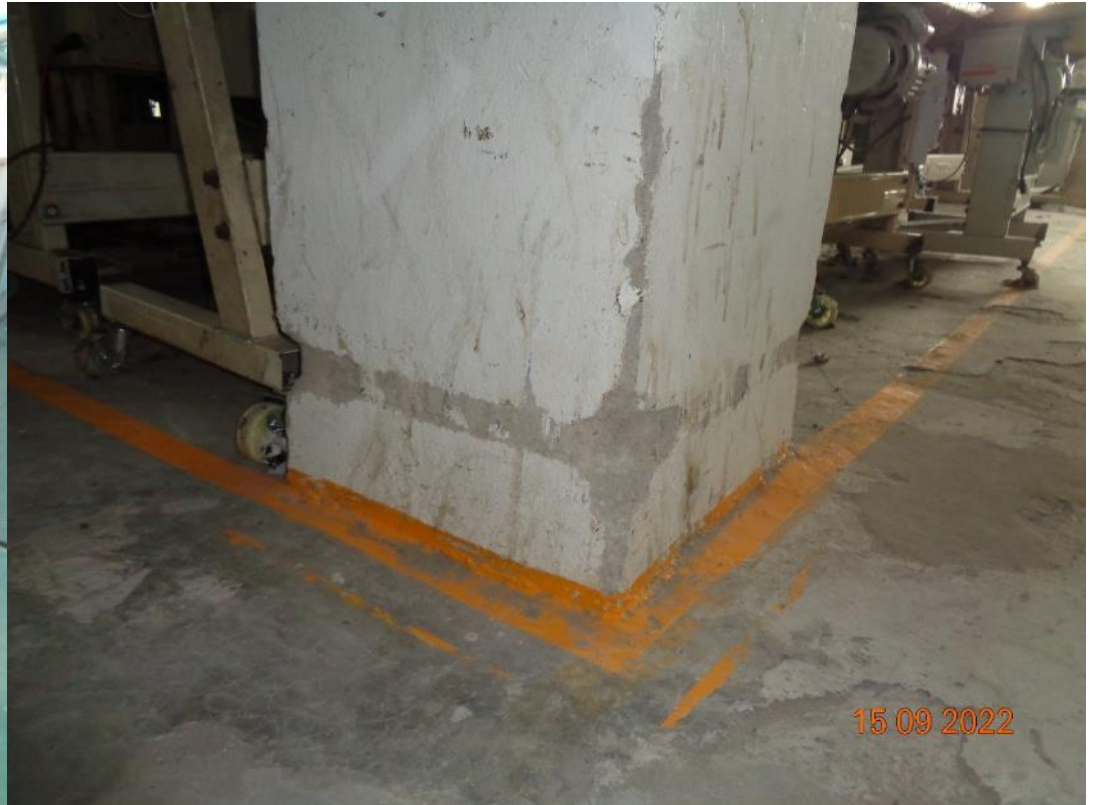
RC Column was found damaged due to the impact with trolley. Factory engineer is required to investigate the damage and suggest a remedial action as well as provide suggestion to prevent such damages in future. Factory is required to follow the suggestion of the engineer for remedial actions.

| Item No. | Observation | Recommended Action Plan | Recommended Timeline |
|---|---|---|---|
| 09 | Trolley impact on Column. (Block-B) | Factory engineer is required to investigate the damage and suggest a remedial action as well as provide suggestion to prevent such damages in future. | 6-weeks |
| 10 | Trolley impact on Column. (Block-B) | Carry out remedial works as per recommendation | 6-months |

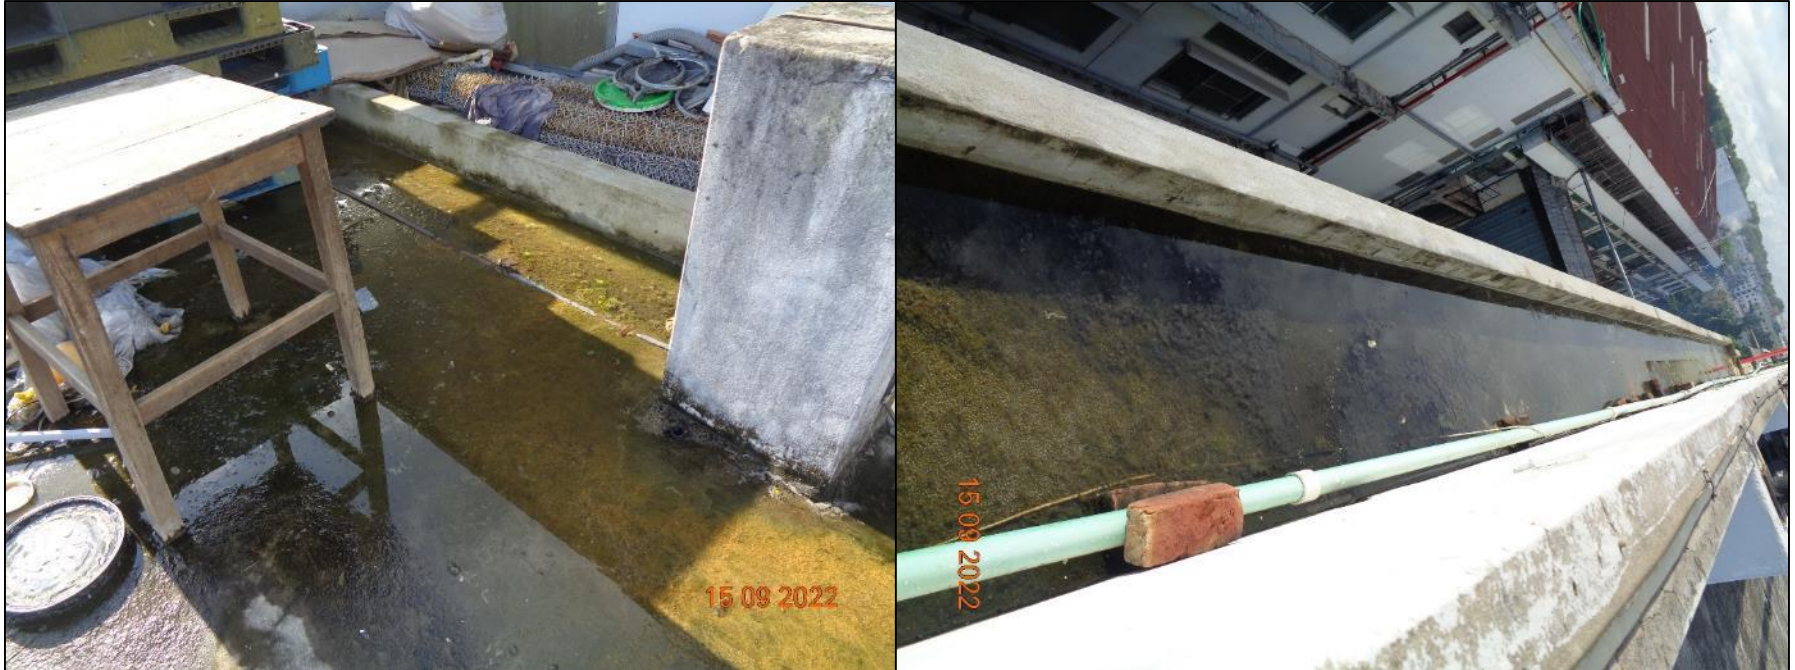
Water ponding at Roof

Water ponding was found on the roof slab due to inadequate slope. The factory is required to develop proper drainage system with adequate slope and water outlet on the roof.

| Item No. | Observation | Recommended Action Plan | Recommended Timeline |
|---|---|---|---|
| 11 | Water ponding at roof. (Block- B) | The factory engineer to develop proper drainage system with adequate slope to resist water ponding on the roof. | 6-months |

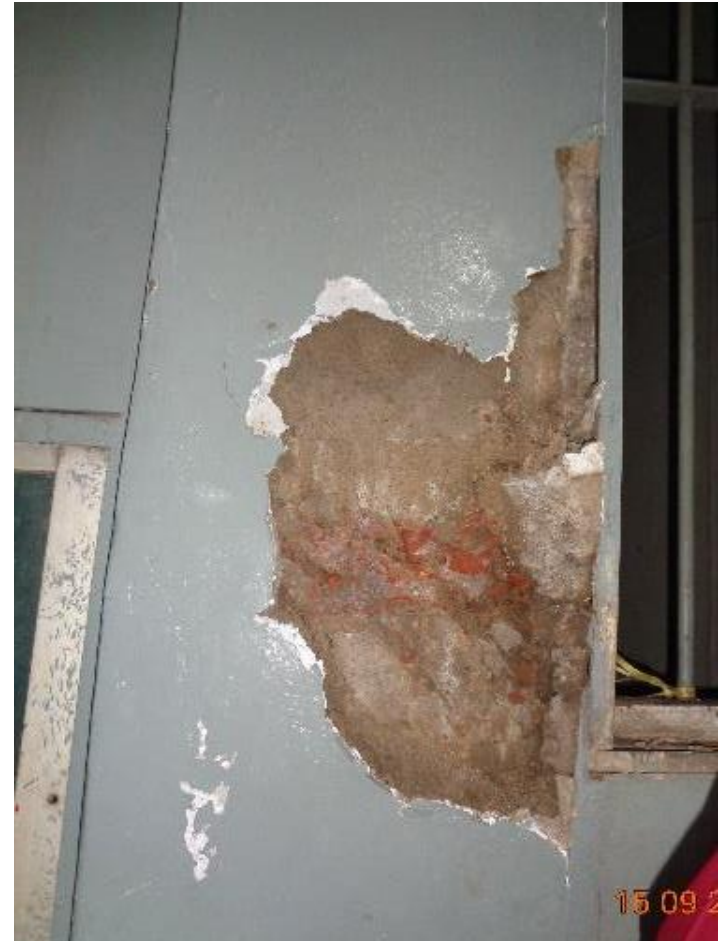
Brick chips at column (Block-B)
