# KDS Textile Mills Ltd

251-252, Nasirabad I/A, Baizid Bostami Road, Chattogram, Bangladesh  
(22.392529, 91.819859)  
15 September 2022

# Observations

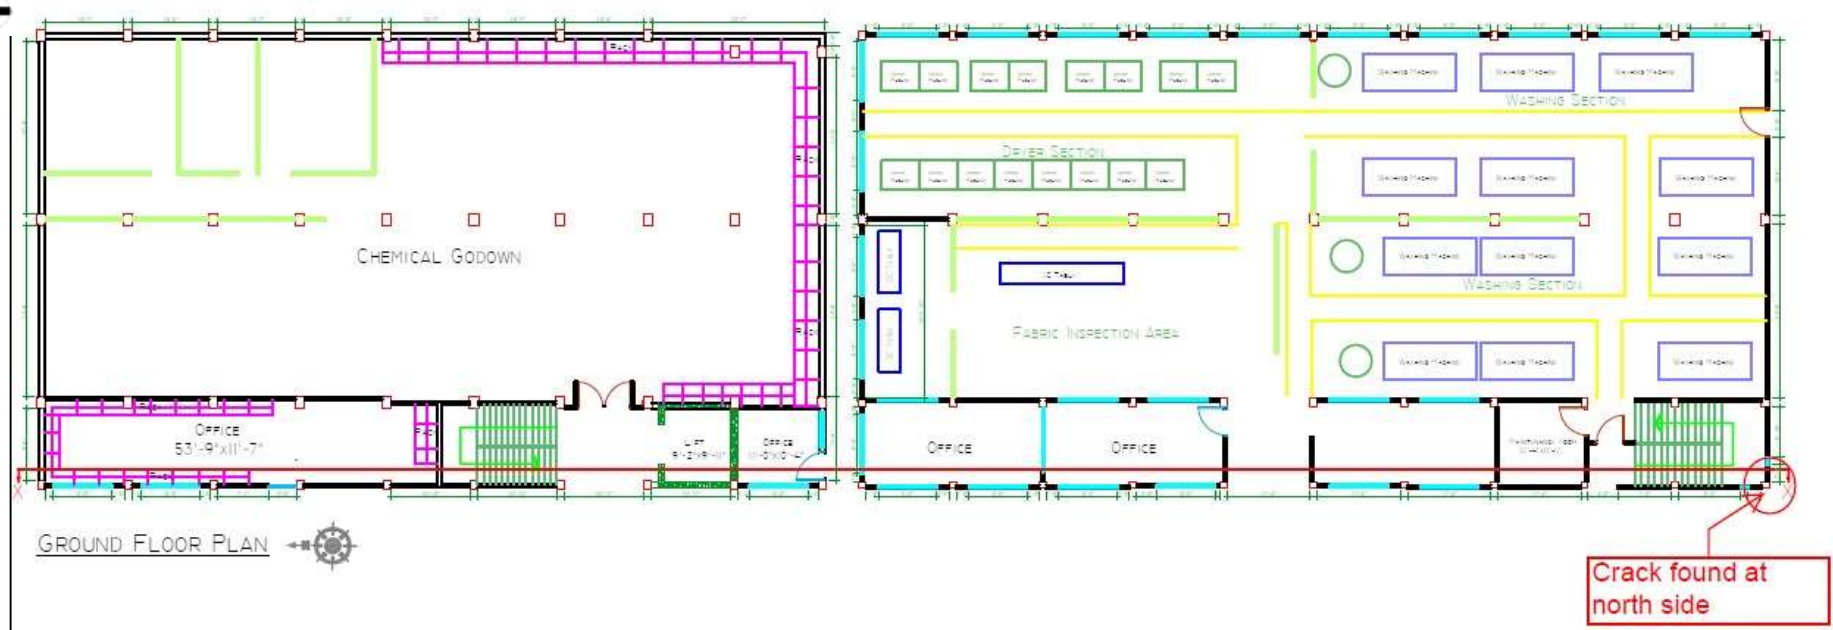
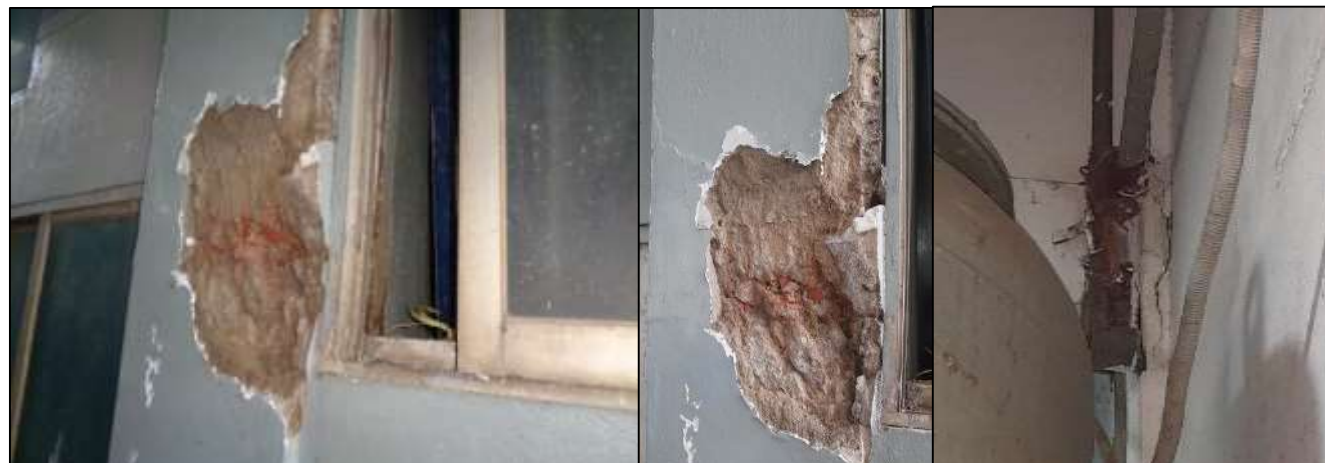
Damaged Column

Damaged column was found on the south-west corner of the ground floor at the stair area (Marked in Figure-1) of the 7-storied factory Building (Block-B).

The factory must immediately engage a consultant to investigate the damaged column. Any safety measures, if required as suggested by the consultant must be taken immediately to ensure safety.

| Item No. | Observation | Recommended Action Plan | Recommended Timeline |
|---|---|---|---|
| 01 | Damaged column found at Factory Building. (Block-B) | Factory is required to engage a qualified engineer to investigate the damaged column. | (Immediate - Now) |
| 02 | Damaged column found at Factory Building. (Block-B) | Factory engineer is required to investigate the adequacy of damaged column suggest for props if required. | (Immediate - Now) |
| 03 | Damaged column found at Factory Building. (Block-B) | Factory is required to provide props as per recommendation of investigation report. | (Immediate - Now) |
| 04 | Damaged column found at Factory Building. (Block-B) | Factory engineer is required to investigation the damage column including reason of damage, extend of damage and suggest proper remedial action. | 6-weeks |
| 05 | Damaged column found at Factory Building. (Block-B) | Remediation work must be completed as per the recommendation of investigation report. | 6-months |

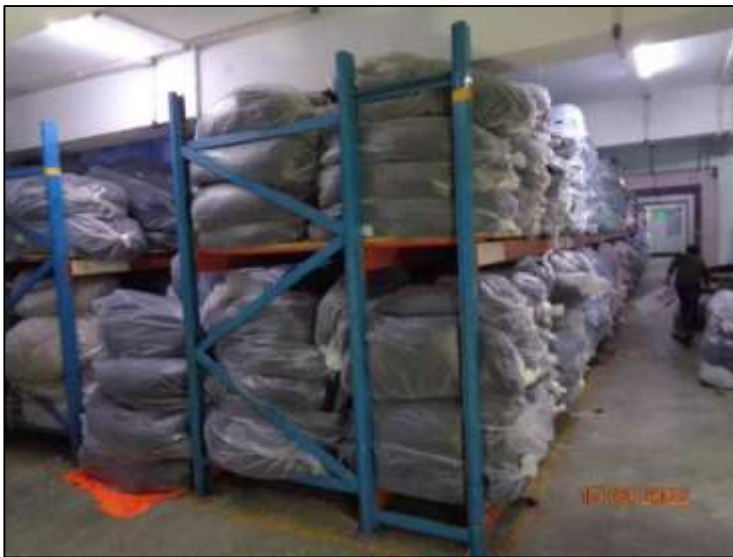
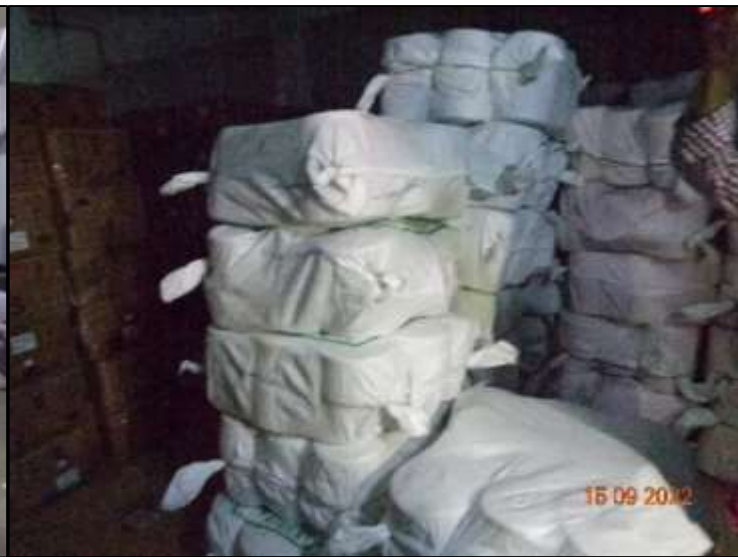
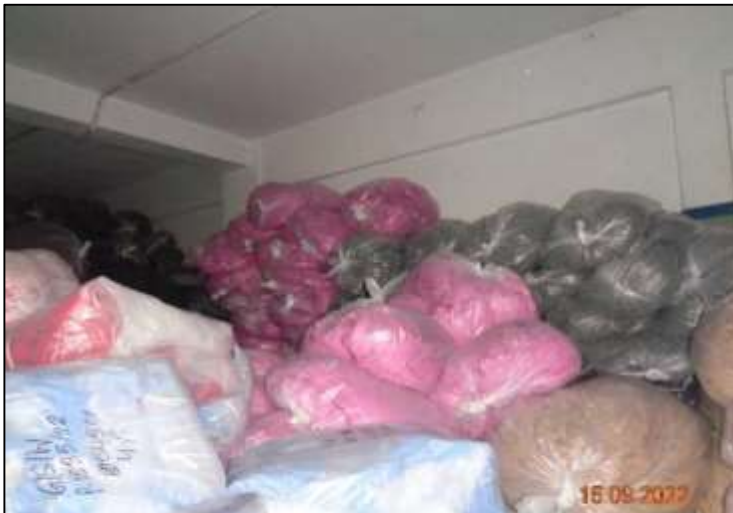
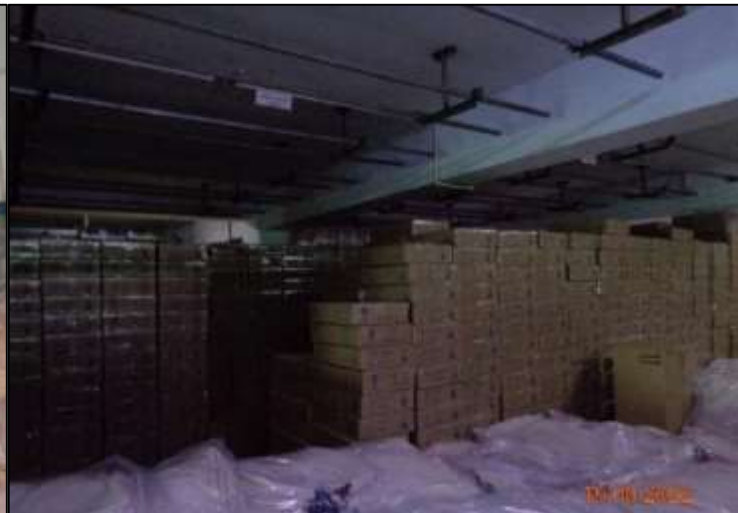
Storage loading

The floor load plan was accepted by Alliance as part of DEA. Factory completed the required retrofitting works. But load plan was not found posted in each floor. Factory engineer is required to post final load plan in each floor and maintain the floor loading accordingly.

| Item No. | Observation | Recommended Action Plan | Recommended Timeline |
|---|---|---|---|
| 06 | Load plan not posted in floor (Block-B). | Post the floor live load plan in each of the floors and Implement the load management programs effectively. | 6-weeks |

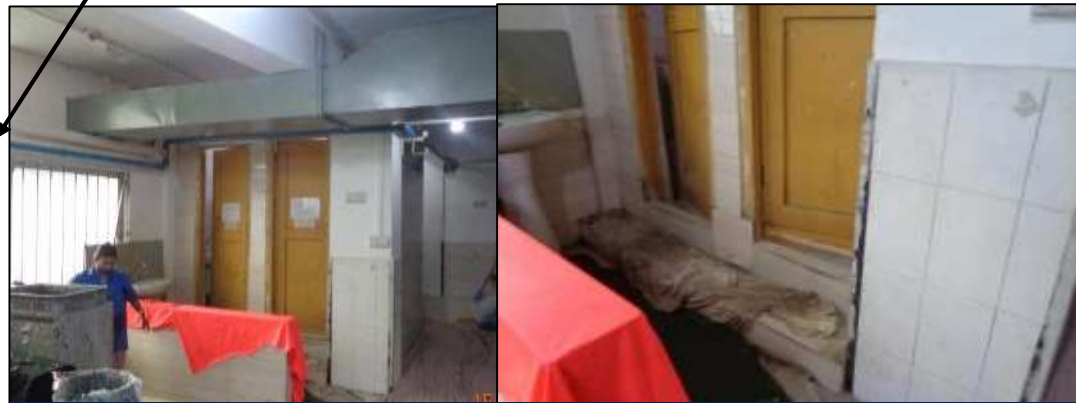
Additional room in front of stair

Undocumented toilet block was found at marked location. The toilet block was found with 225mm build up supported by cantilever beam. Factory engineer is required to update the as-built drawing and provide the adequacy of the cantilever beam and slab against the super imposed load from toiler block.

| Item No. | Observation | Recommended Action Plan | Recommended Timeline |
|---|---|---|---|
| 07 | Mismatch in as-built drawings (Block-B) | Building engineer is required to prepare accurate as-built drawing in compliance with section 1.9.1.2 (part-6, BNBC). | 6-weeks |

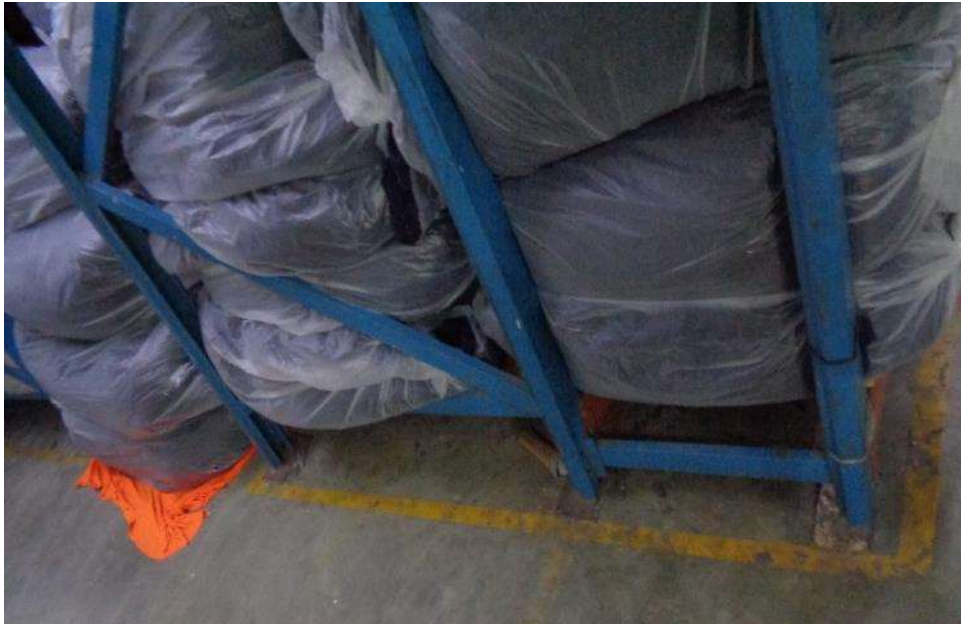
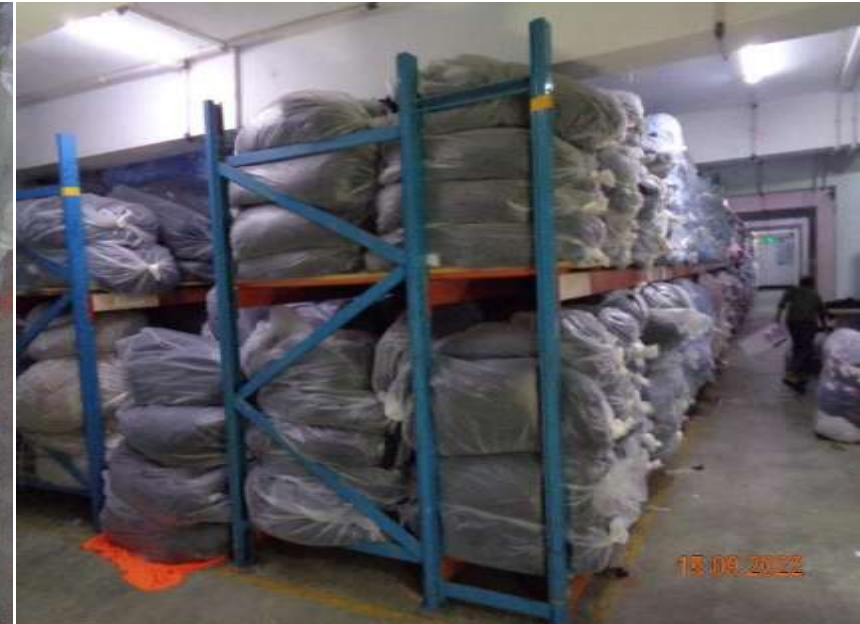
Rack on floor level

Racks on different floors are not adequately anchored or braced to resist lateral (earthquake) forces. Adequately anchor and brace all non-structural elements (all buildings) to resist earthquake forces to comply with the BNBC.

| Item No. | Observation | Recommended Action Plan | Recommended Timeline |
|---|---|---|---|
| 08 | Non-structural elements not anchored or braced (Block-B) | Adequately anchor and brace all non-structural elements (all buildings) to resist earthquake forces to comply with the BNBC. | 6-weeks |

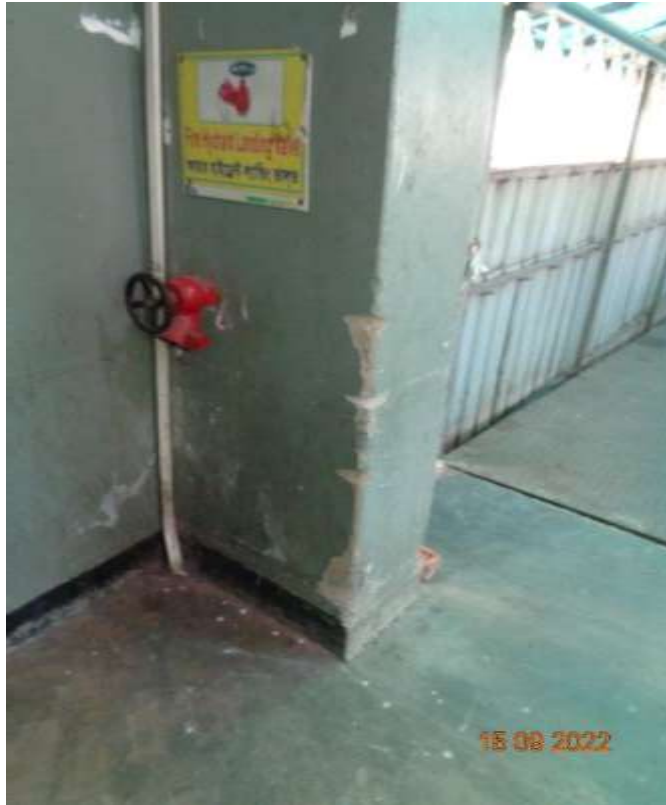
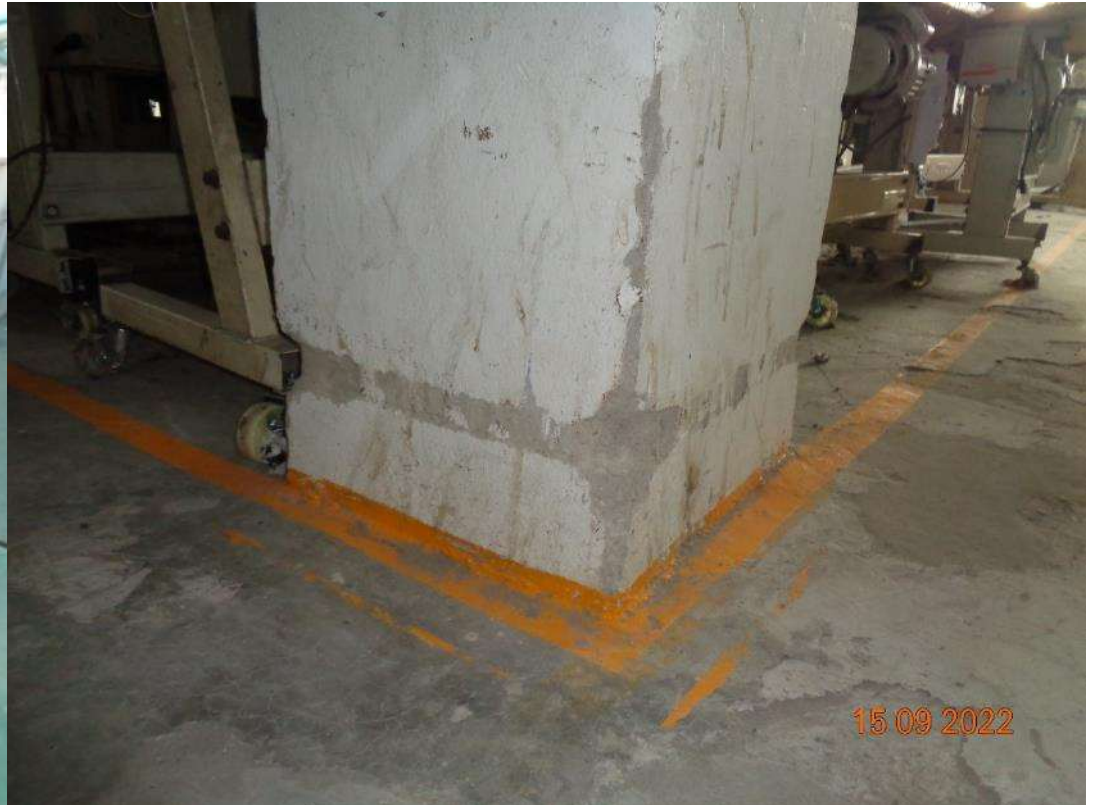
RC Column was found damaged due to the impact with trolley. Factory engineer is required to investigate the damage and suggest a remedial action as well as provide suggestion to prevent such damages in future. Factory is required to follow the suggestion of the engineer for remedial actions.

| Item No. | Observation | Recommended Action Plan | Recommended Timeline |
|---|---|---|---|
| 09 | Trolley impact on Column. (Block-B) | Factory engineer is required to investigate the damage and suggest a remedial action as well as provide suggestion to prevent such damages in future. | 6-weeks |
| 10 | Trolley impact on Column. (Block-B) | Carry out remedial works as per recommendation | 6-months |

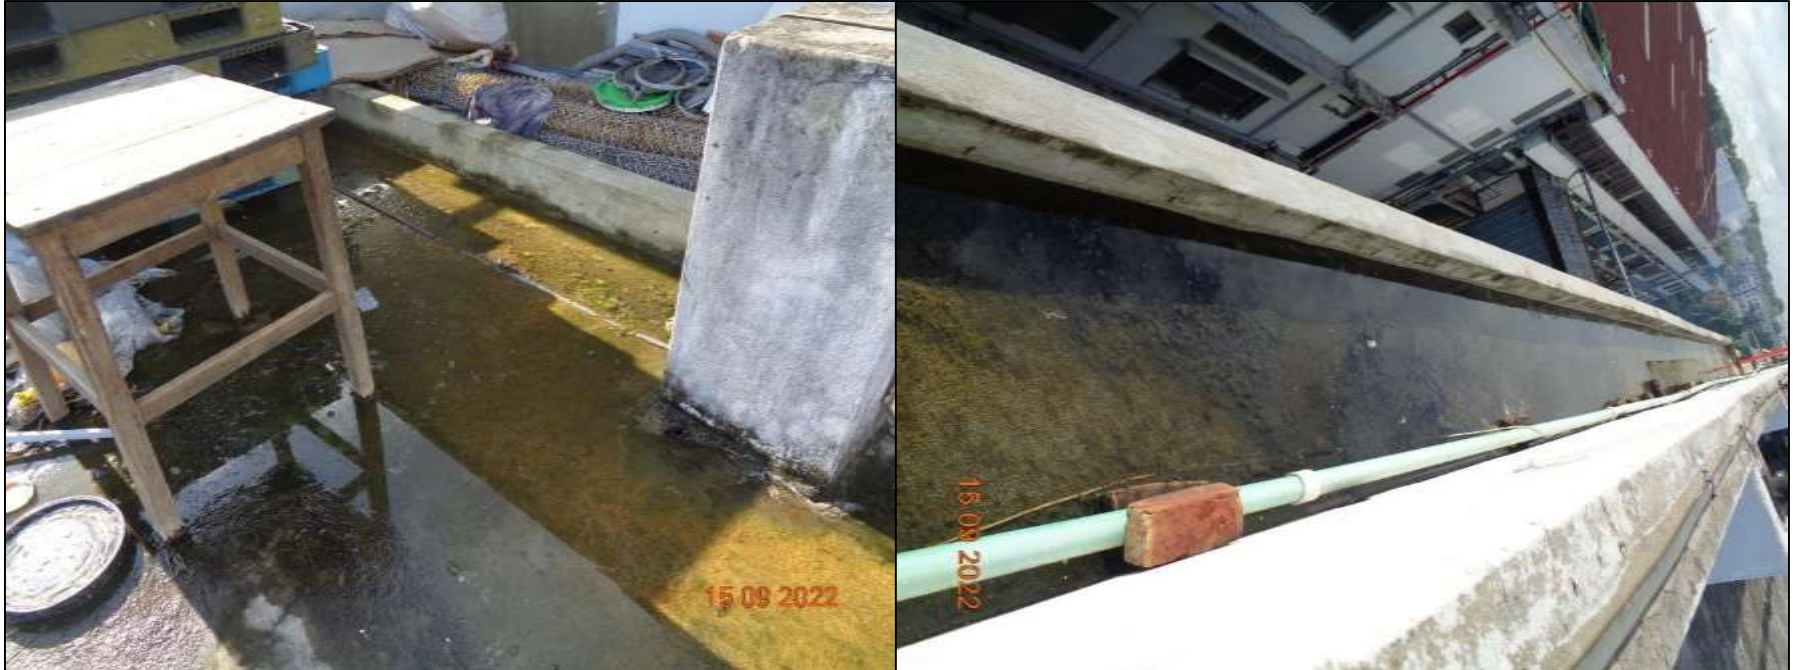
Water ponding at Roof

Water ponding was found on the roof slab due to inadequate slope. The factory is required to develop proper drainage system with adequate slope and water outlet on the roof.

| Item No. | Observation | Recommended Action Plan | Recommended Timeline |
|---|---|---|---|
| 11 | Water ponding at roof. (Block- B) | The factory engineer to develop proper drainage system with adequate slope to resist water ponding on the roof. | 6-months |

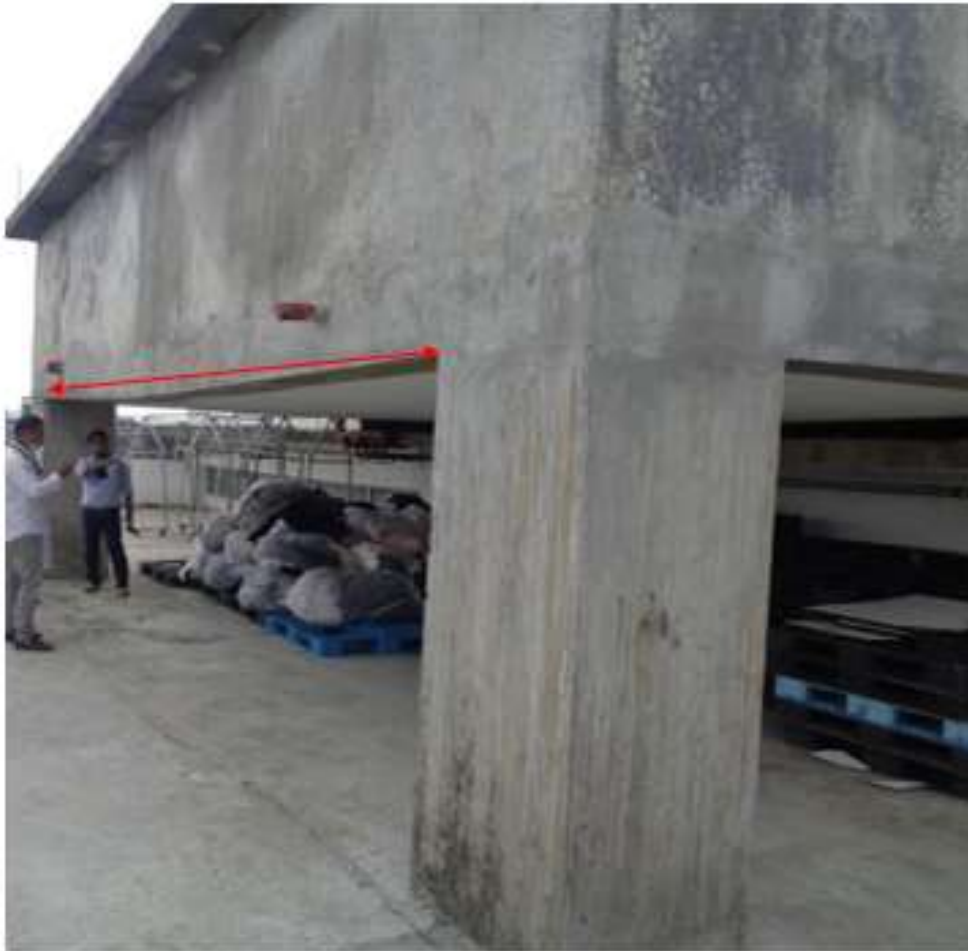
Deflection at Inverted beam of OHWT

Deflection at Inverted slab of OHWT was observed. Building engineer is required to check whether the deflection cross the normal design limit or not and take necessary action as per engineer's guideline.

| Item No. | Observation | Recommended Action Plan | Recommended Timeline |
|---|---|---|---|
| 12 | Deflected of slab under the overhead water tank. [Block-C (RC part)] | Building engineer is required to check the adequacy of OHWT slab to confirm deflection is within the allowable limit. | 6-weeks |
| 13 | Deflected of slab under the overhead water tank. [Block-C (RC part)] | Produce and actively manage a loading plan for the OHWT and maintain accordingly. | 6-weeks |
| 14 | Deflected of slab under the overhead water tank. [Block-C (RC part)] | Carry out remedial works if required. | 6-months |
| 15 | Deflected of slab under the overhead water tank. [Block-C (RC part)] | Continue to implement the load management plan. | 6-months |

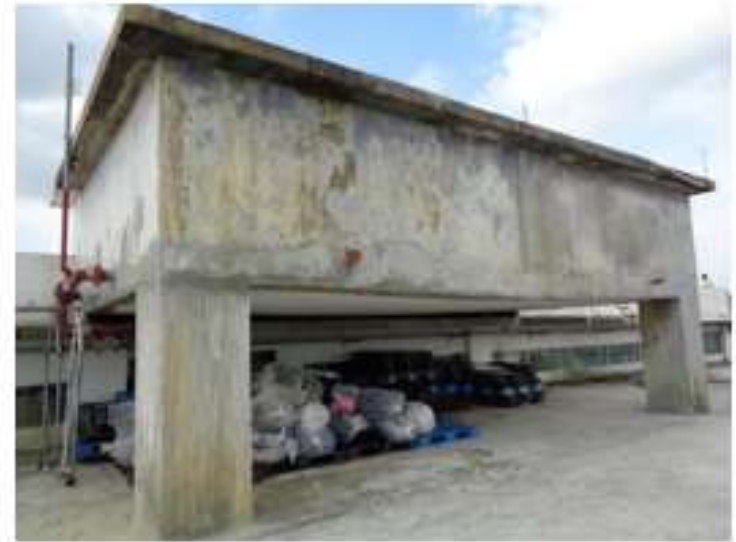
Deflection at slab

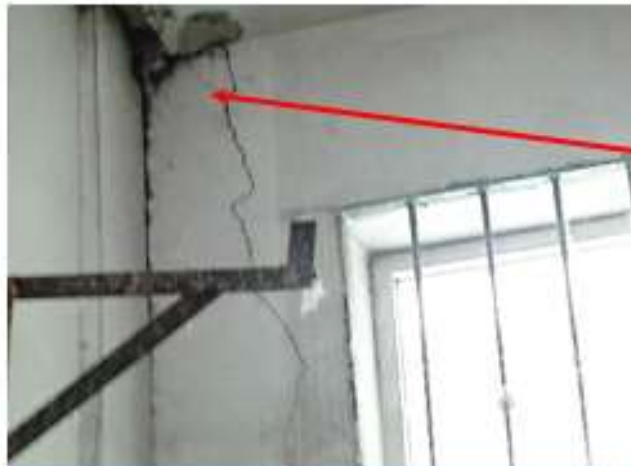
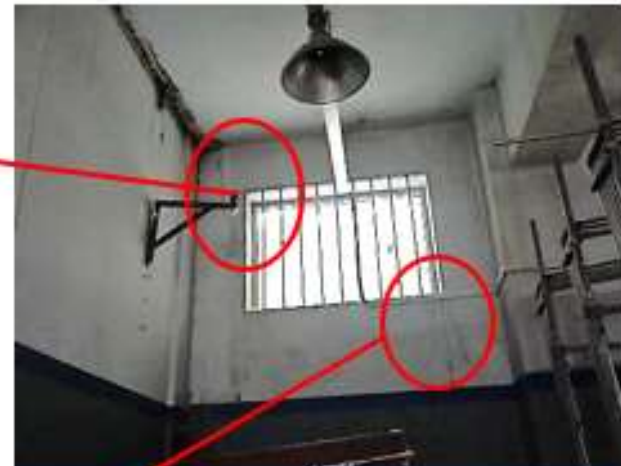
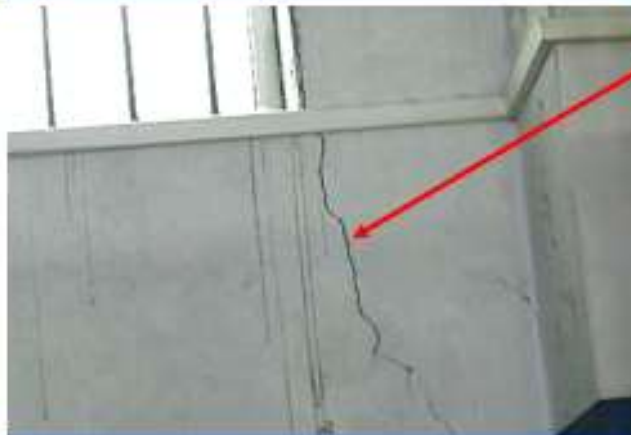
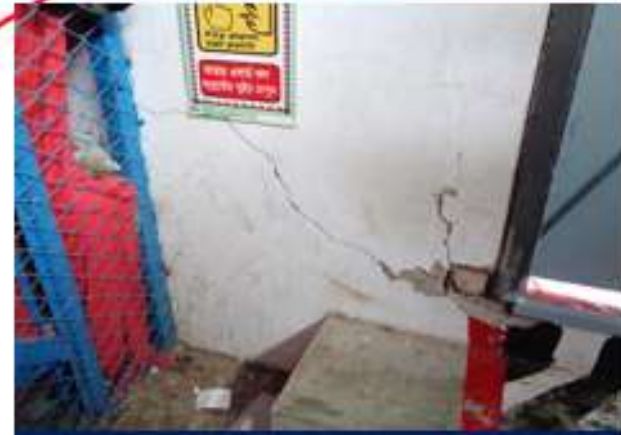
Zoom view of crack

Cracks on wall

Crack was observed at brick wall. Building engineer is required to check the intensity of crack and suggest proper repair methodology.

| Item No. | Observation | Recommended Action Plan | Recommended Timeline |
|---|---|---|---|
| 16 | Crack on brick wall. [Block-C (RC part)] | Building engineer is required to check the extent of crack and suggest proper repair methodology. | 6-weeks |
| 17 | Crack on brick wall. [Block-C (RC part)] | Carry out remedial works. | 6-months |

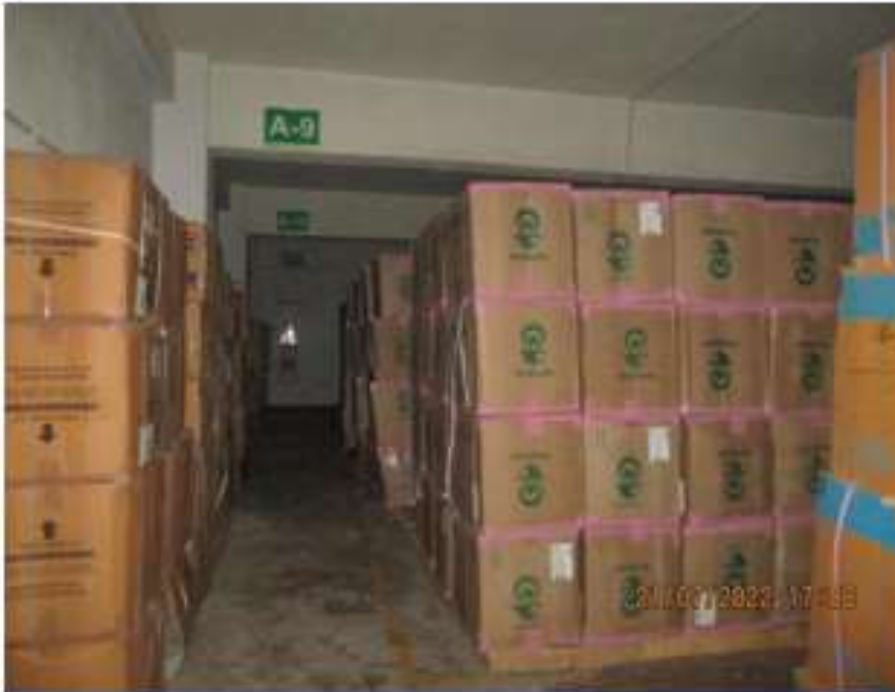
Yarn store (2<sup>nd</sup> Floor), RC part

As per prepared load plan, allowable live load limit of 2<sup>nd</sup> floor (Yarn store) is 7.5 kPa. But, at the time of inspection calculated localize loading was found more than 7.5 kPa.

| Item No. | Observation | Recommended Action Plan | Recommended Timeline |
|---|---|---|---|
| 18 | Localized high loading on 2nd floor. [Block-C] | Factory engineer to investigate the floor loading arising from storage and advise on any necessary alterations taking account of floor capacity and column capacity. | 6-weeks |

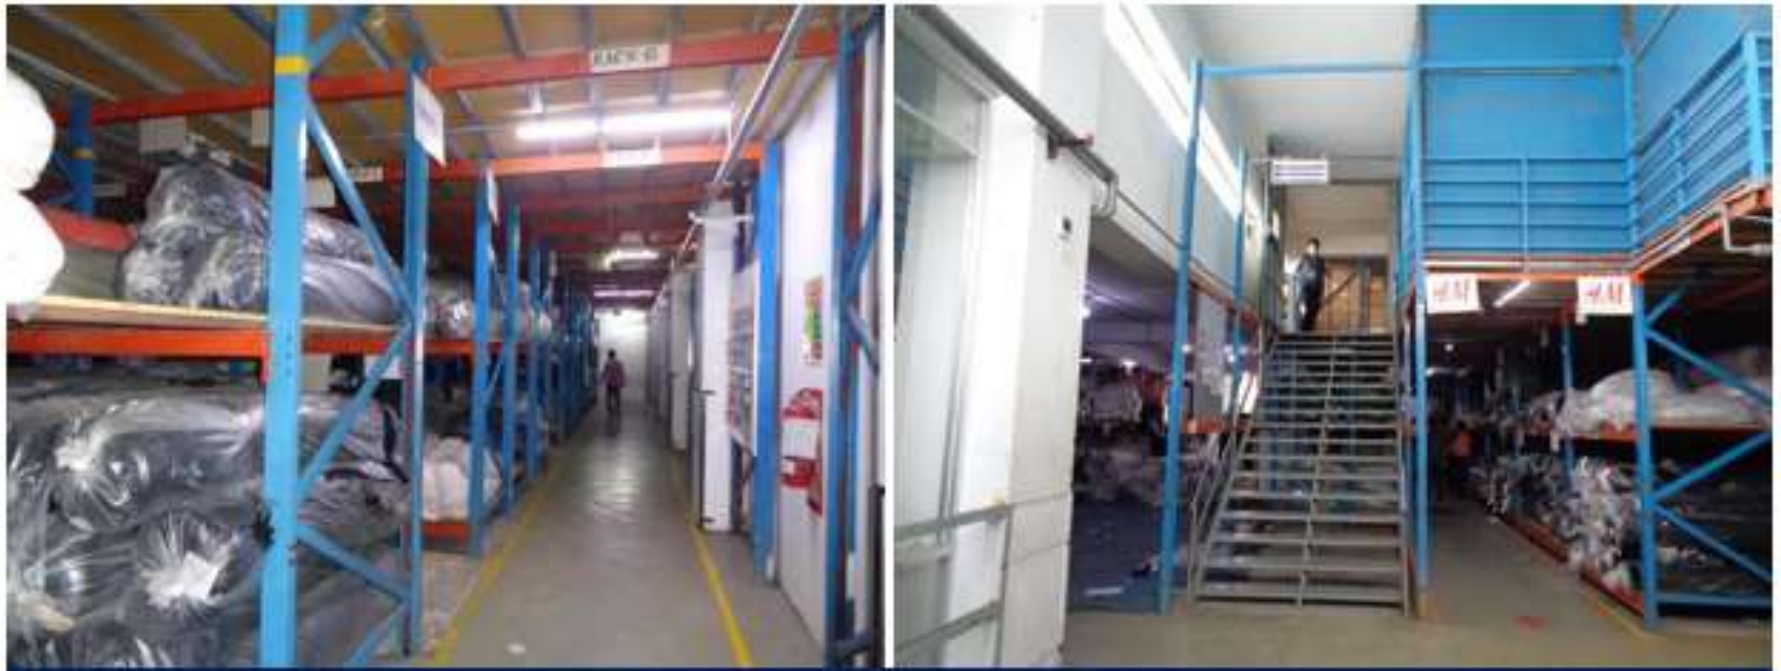
Storage rack (5<sup>th</sup> Floor), RC part

Storage rack has no allowable loading limit. Also, the rack has no adequate anchorage.

| Item No. | Observation | Recommended Action Plan | Recommended Timeline |
|---|---|---|---|
| 20 | Localized high loading on 2nd floor. [Block-C] | Adequately anchor and brace all non-structural elements to resist earthquake forces to comply with the BNBC. | 6-weeks |

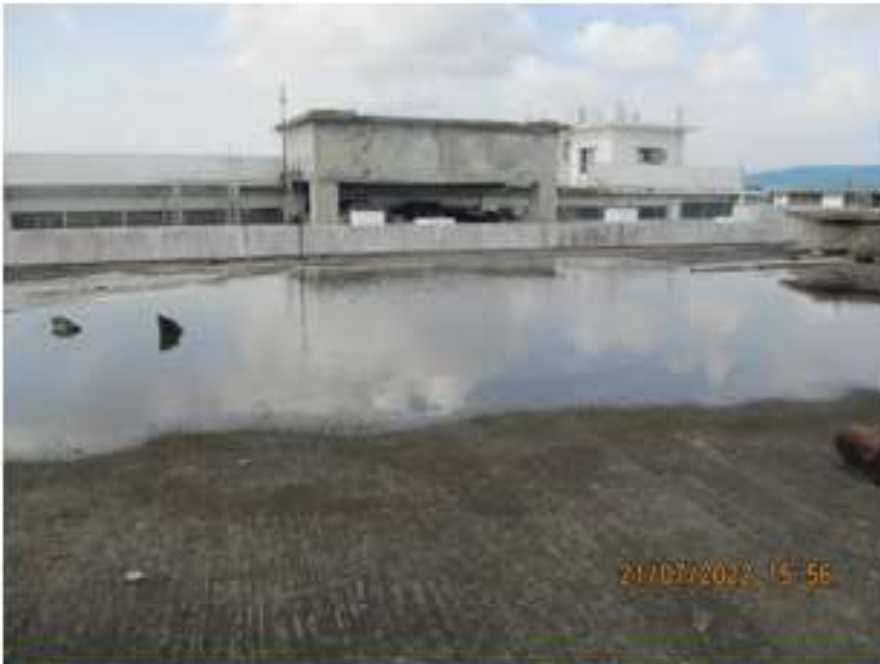
Standing water on the roof of RO plant

Standing water & growth of algae/ vegetation on roof floor due to improper drainage system. Factory engineer is required to provide adequate slope to wash out the water.

| Item No. | Observation | Recommended Action Plan | Recommended Timeline |
|---|---|---|---|
| 25 | Standing water on the roof and floor of RO plant. [Block-C (Steel part)] | Factory engineer is required to develop roof drainage system with adequate slope and outlets. | 6-weeks |

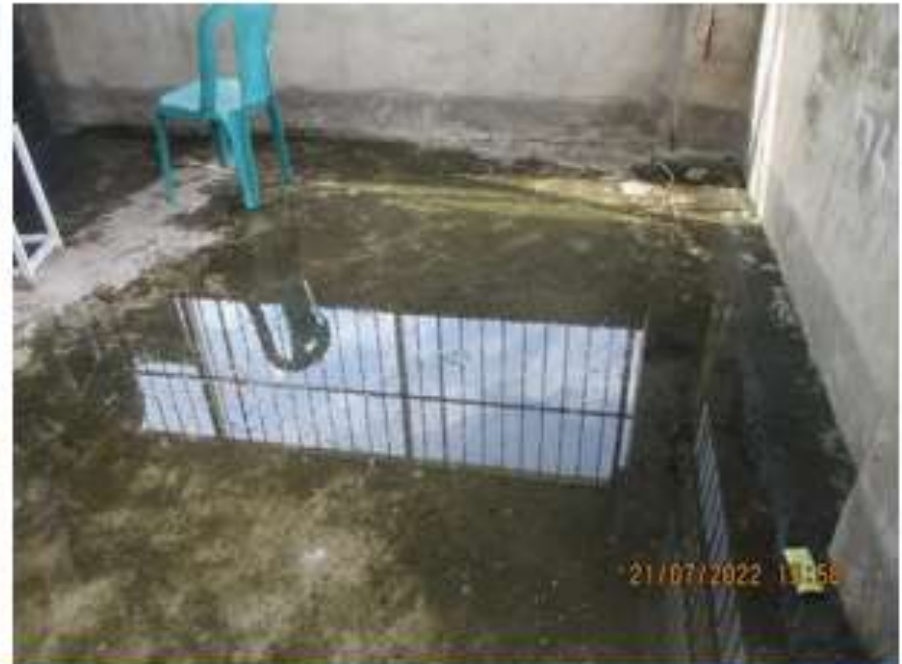
Standing water on the floor of RO plant

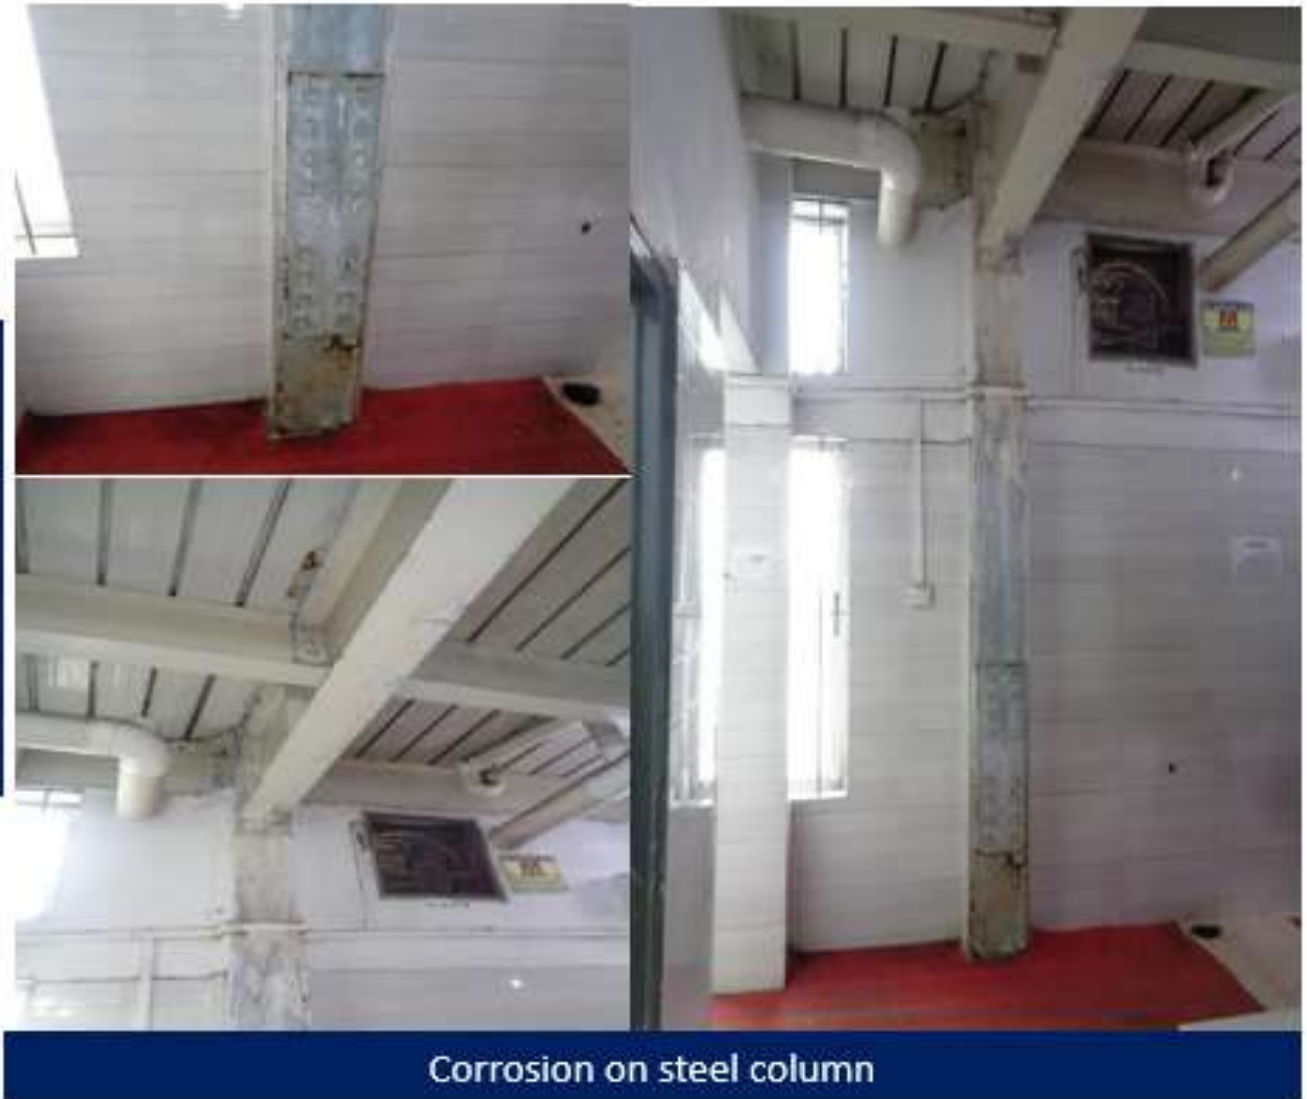
Corrosion was found on steel column at toilet zone. The building engineer to investigate the reason of corrosion and suggest proper remedial measure accordingly.

Corrosion on steel column

| Item No. | Observation | Recommended Action Plan | Recommended Timeline |
|---|---|---|---|
| 26 | Corrosion on steel column at toilet zone. [Block-C (Steel part)] | The building engineer to investigate the reason of corrosion and suggest proper remedial measure accordingly. | 6-weeks |
| 27 | Corrosion on steel column at toilet zone. [Block-C (Steel part)] | Remove rust from affected steel member and apply corrosion resistance coating to the steel member. | 6-weeks |

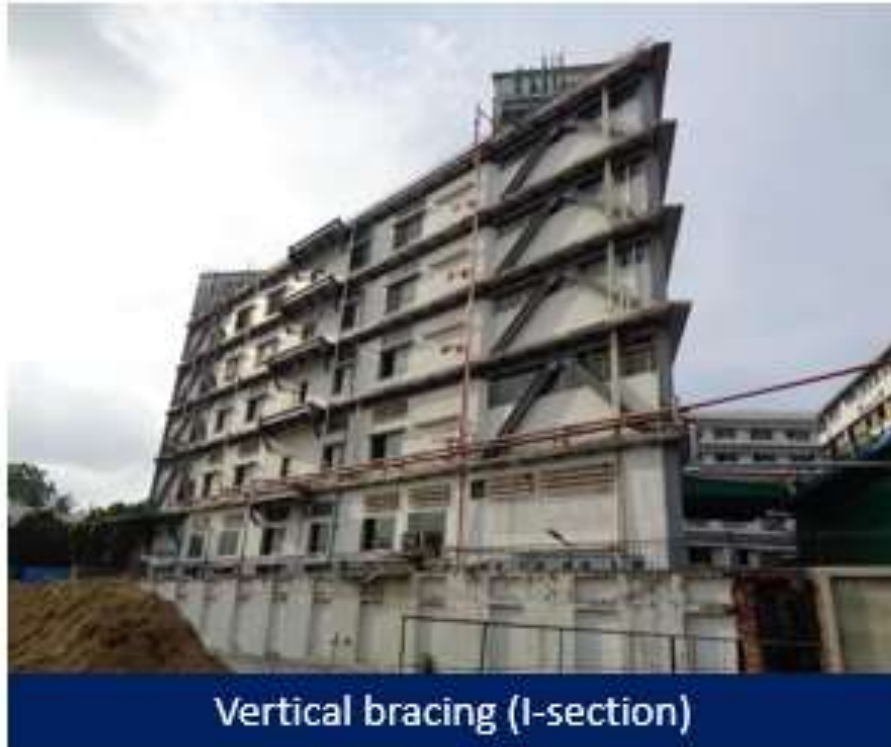
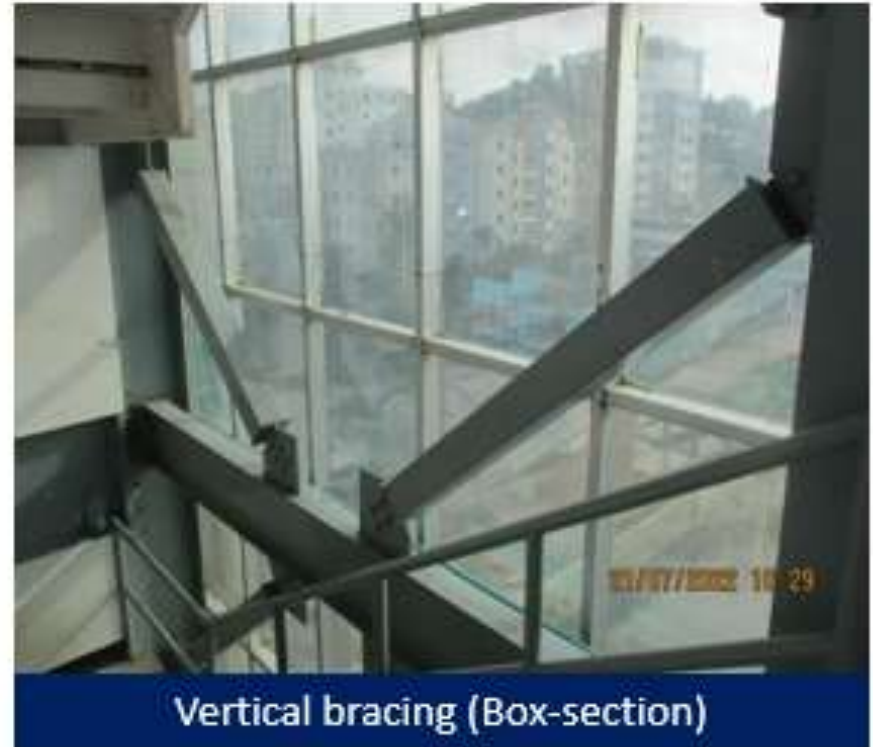
Vertical bracing (I-section)

Vertical bracing (Box-section)

No information related to vertical bracing details in the as built drawing of Block-C (Steel Part).

| Item No. | Observation | Recommended Action Plan | Recommended Timeline |
|---|---|---|---|
| 28 | Lack of information in as-built drawing. [Block-C (Steel part)] | Building engineer is survey the whole structure and prepare accurate as-built drawings with structural details. | 6-weeks |

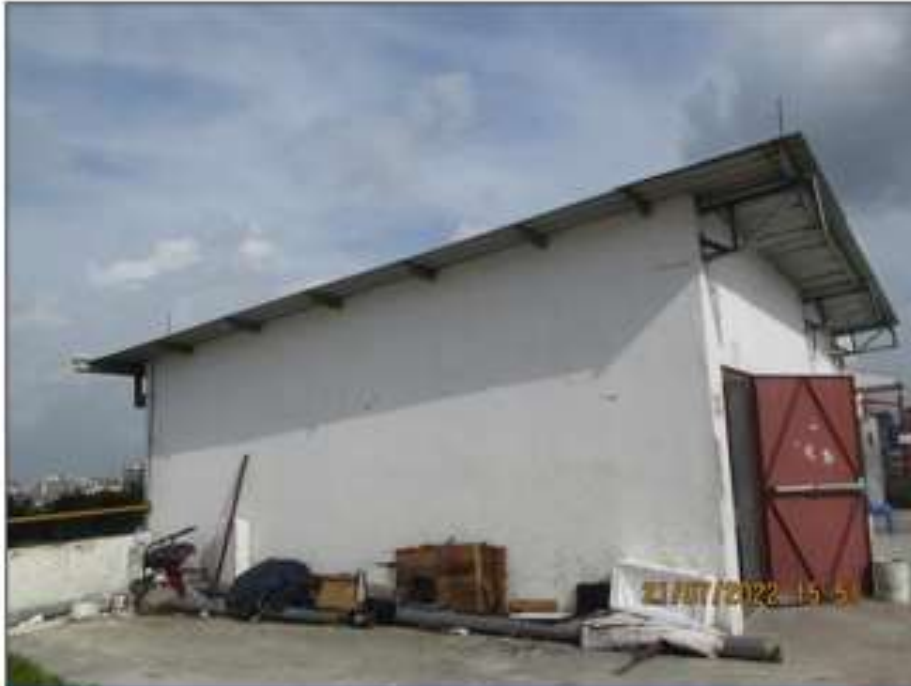
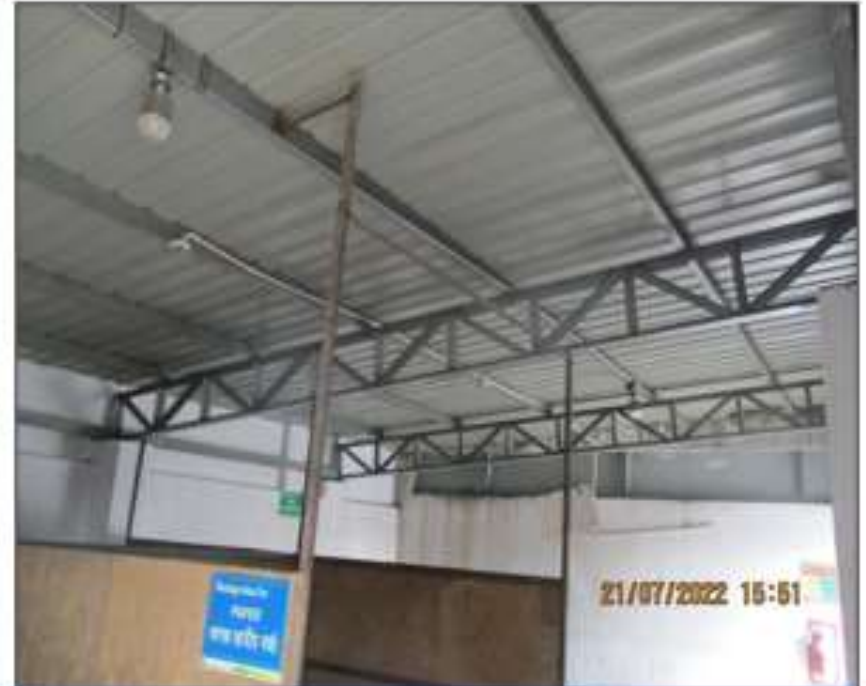
Wastage storage area

No information related to wastage storage area in the as built drawing of Block-C (Steel Part). Factory engineer is required to survey the whole structure and to prepare accurate as-built drawing. Also, check the connection adequacy for uplift forces.

| Item No. | Observation | Recommended Action Plan | Recommended Timeline |
|---|---|---|---|
| 29 | Lack of information in as-built drawing. [Block-C (Steel part)] | Check for the connection adequacy of truss support for uplift forces and suggest proper remedial actions accordingly. | 6-weeks |
| 30 | Lack of information in as-built drawing. [Block-C (Steel part)] | Carry out suggested remedial works if required. | 6-months |

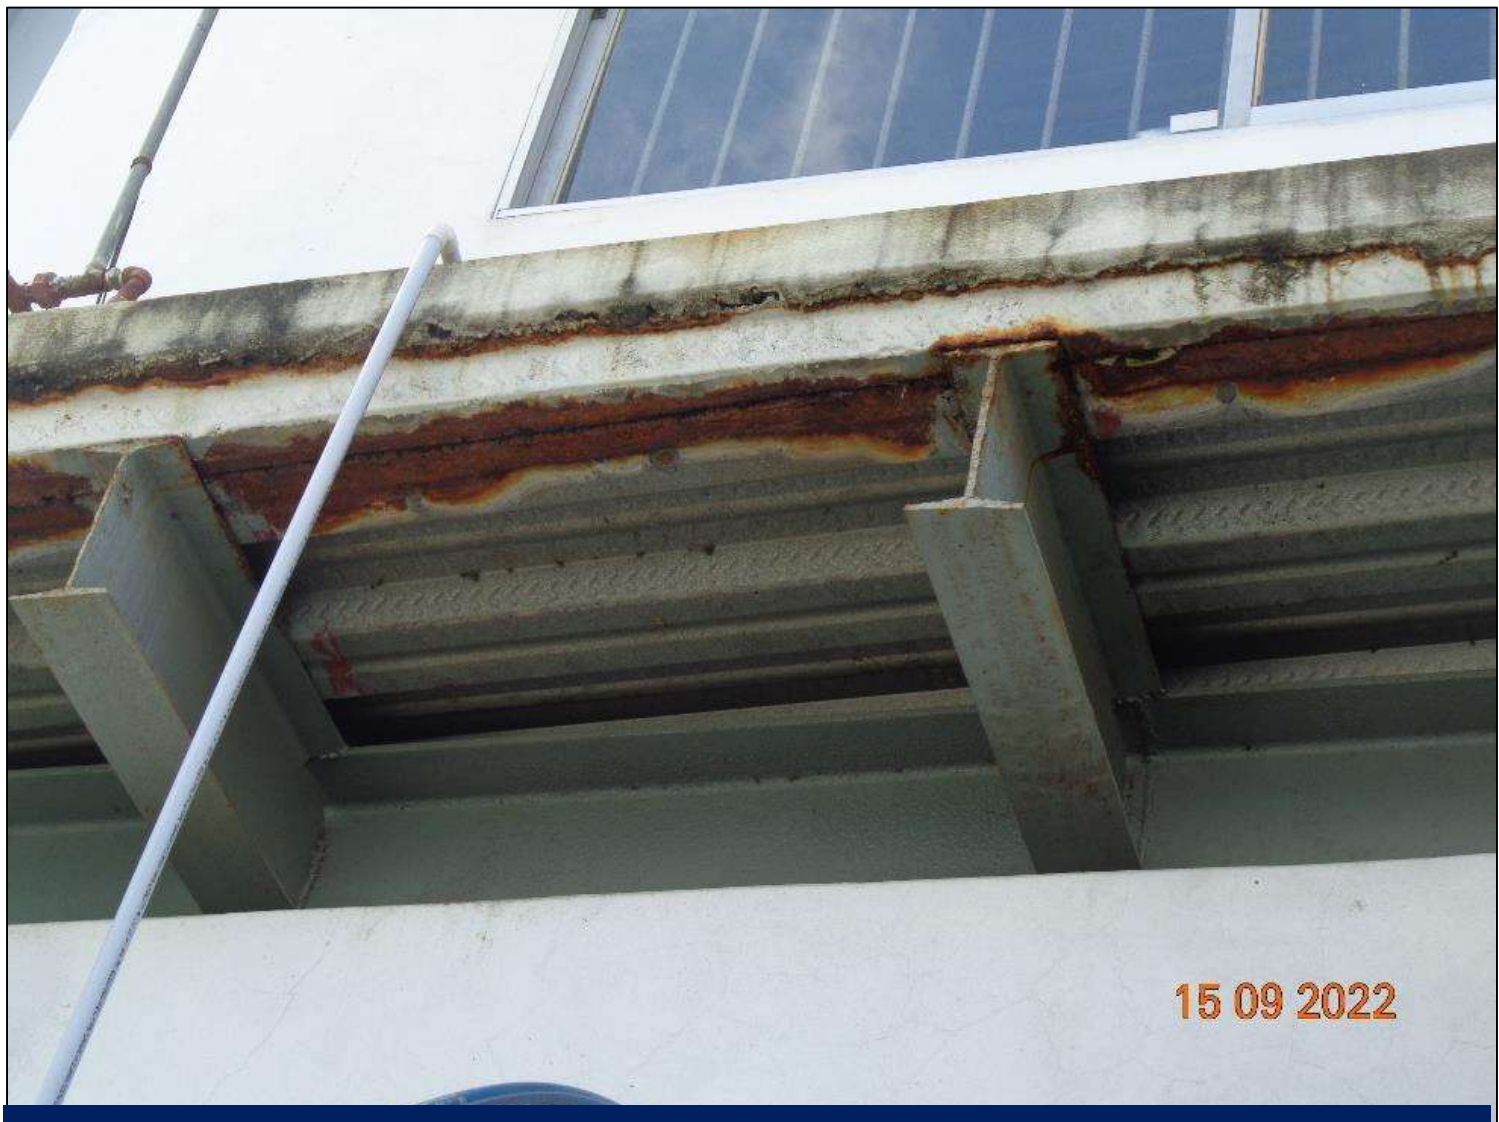
Corrosion on steel elements of deck slab and steel beam. Factory is required to investigate the reason of corrosion and provide remedial measure to remove corrosion.

| Item No. | Observation | Recommended Action Plan | Recommended Timeline |
|---|---|---|---|
| 31 | Corrosion in steel elements( BETP building) | Factory is required to investigate the reason of corrosion and provide remedial measure to remove corrosion. | 6-months |

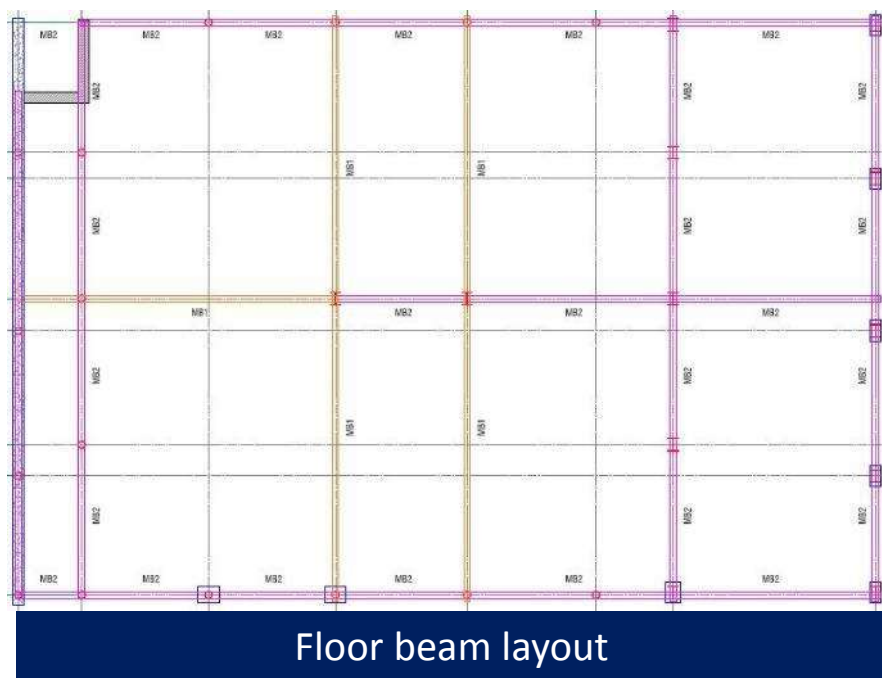
MB2 beam section

During inspection all MB2 floor beam size found W-300(6)mm X 100(8)mm instead of W-300(6)mm X 150(8)mm. The building is required to survey the structure and prepare accurate as-built drawings.

| Item No. | Observation | Recommended Action Plan | Recommended Timeline |
|---|---|---|---|
| 32 | Mismatch between drawing & as-built condition( Boiler Building) | The building engineer is required to survey the whole structure and prepare accurate as-built drawings with structural details. | 6-weeks |
| 33 | Mismatch between drawing & as-built condition( Boiler Building) | The building engineer is required to revise the design report of the building in compliance with section 1.9.1 of BNBC (part-6).. | 6-weeks |
| 34 | Mismatch between drawing & as-built condition( Boiler Building) | Carry out suggested remedial works where required. | 6-months |

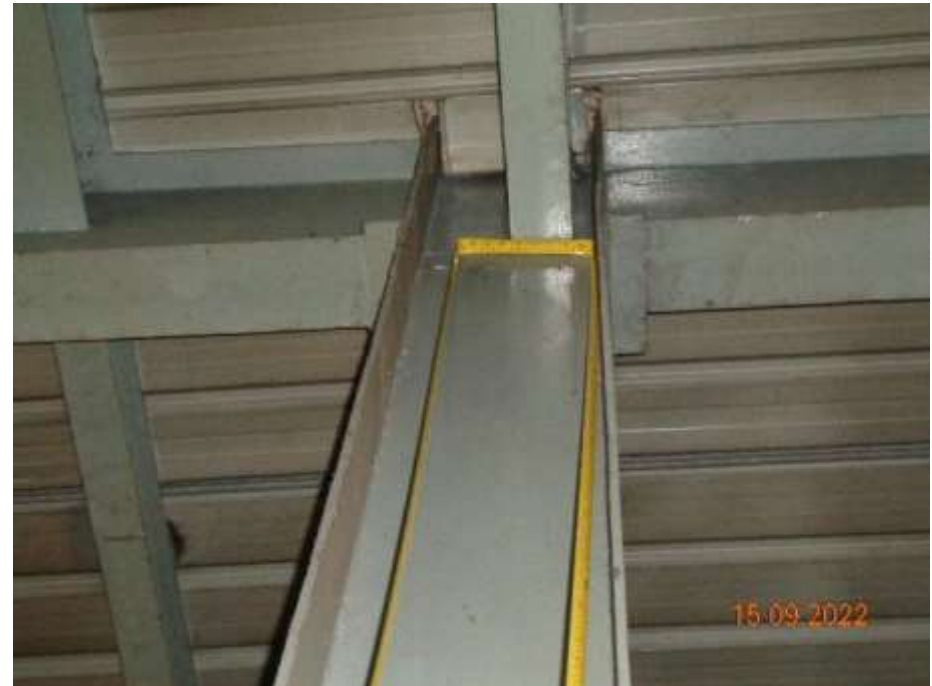
Onsite MB2 beam condition.
