# KDS Textile Mills Ltd

251-252, Nasirabad I/A, Baizid Bostami Road, Chattogram, Bangladesh  
(22.392529, 91.819859)  
15 September 2022

# Observations

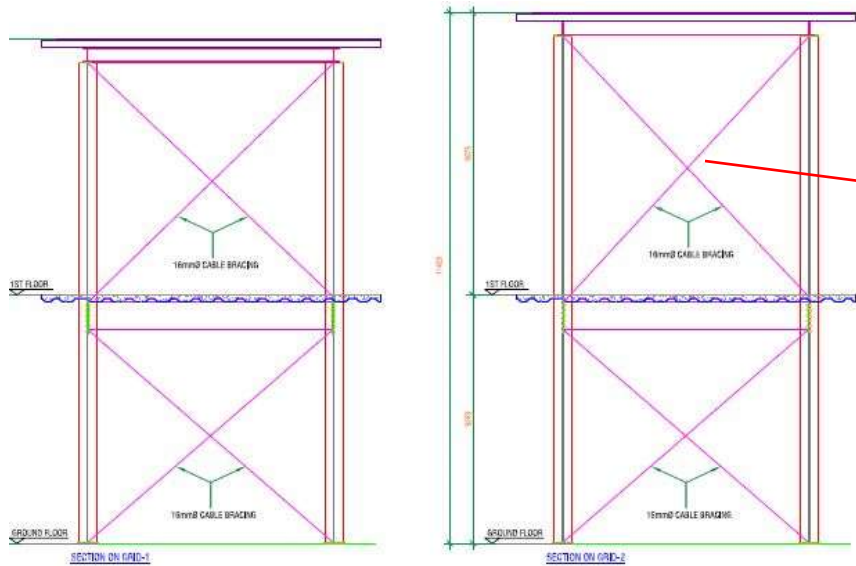
Bracing section.

During inspection, no cable bracing was found at any floor, but in as built drawing 16mm cable bracing has been shown.

| Item No. | Observation | Recommended Action Plan | Recommended Timeline |
|---|---|---|---|
| 35 | Mismatch between drawing & as-built condition( EGB Building) | The building engineer is required to survey the whole structure and prepare accurate as-built drawings with structural details. | 6-weeks |

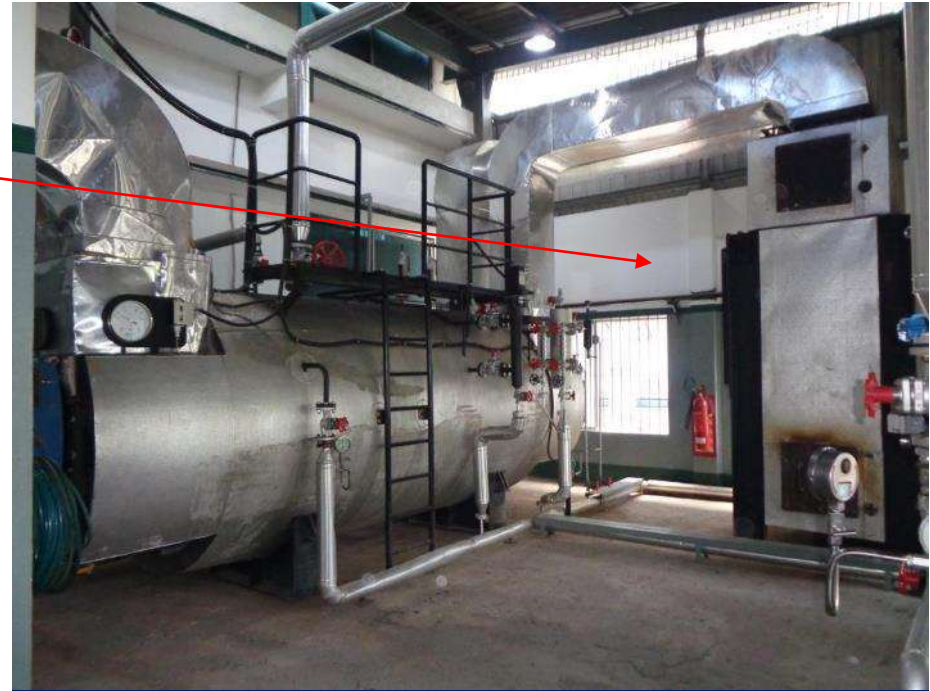
Onsite bracing condition

| Item No. | Observation | Recommended Action Plan | Recommended Timeline |
| 36 | Mismatch between drawing & as-built condition( EGB Building) | The building engineer is required to revise the design report of the building in compliance with section 1.9.1 of BNBC (part-6). | 6-weeks |

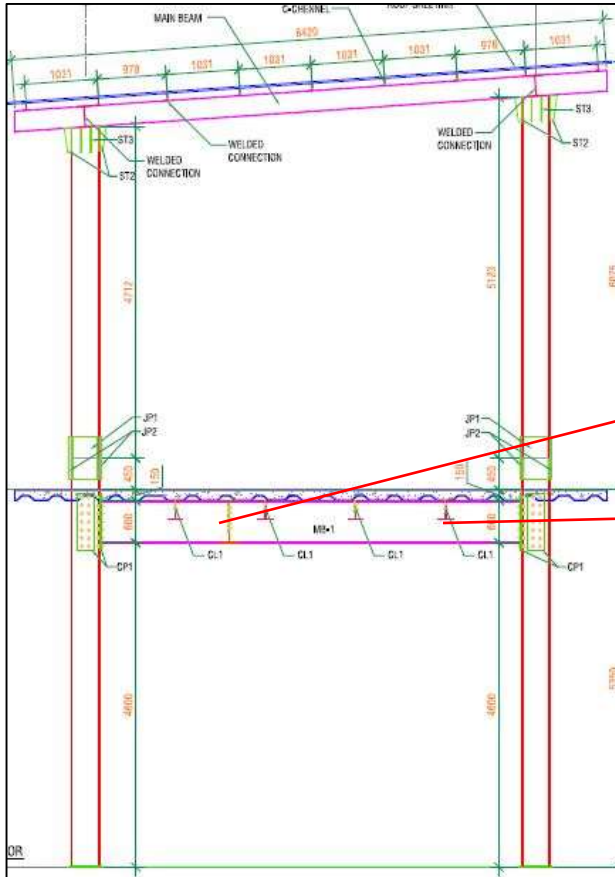
section.

In as built drawing there is no clear dimension has been provided for 1<sup>st</sup> floor MB1 and SB1. The building is required to survey the structure and prepare accurate as-built drawings

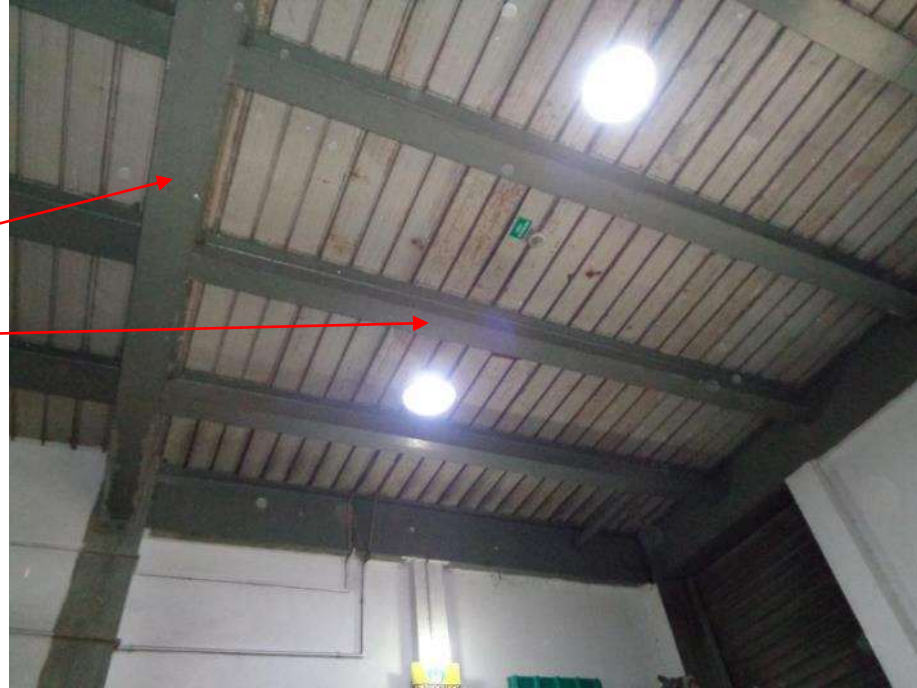
Onsite condition of 1<sup>st</sup> floor steel beam
