# Ahsan Knitting Ltd.

Siddhirgonj Pool, Siddhirgonj Narayangonj.

04<sup>th</sup> October 2022

Ahsan Knitting Building (G+5)

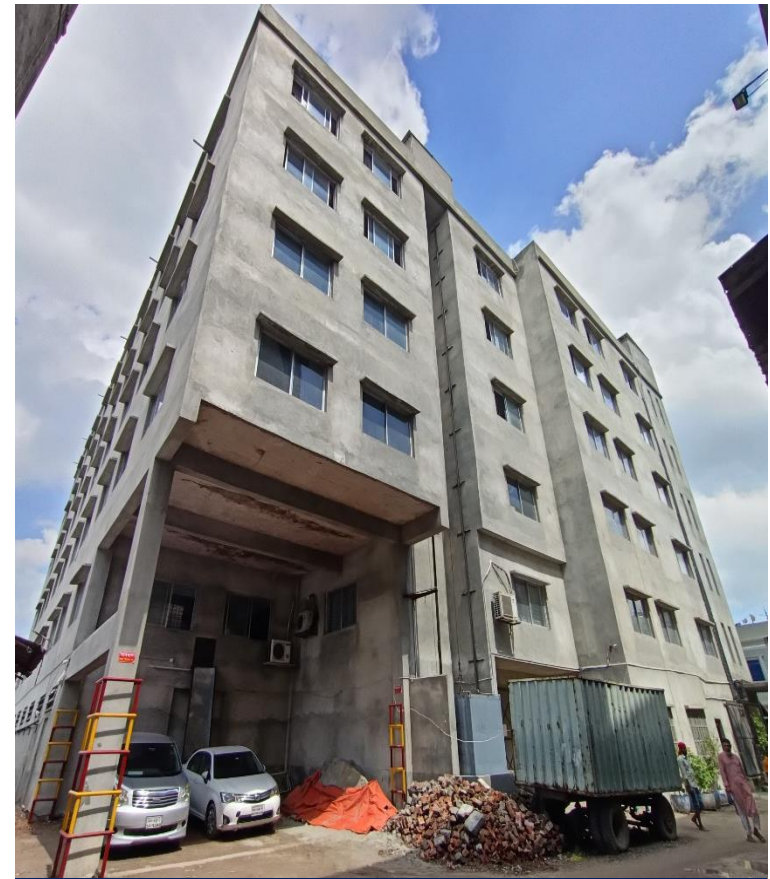
Geotechnical certificate

Incomplete geotechnical investigation report was found for the six storied factory building. Only a geotechnical certificate was available on site which shows allowable bearing capacity 4.5 ksf without having any bore log data. Thus, complete geotechnical investigation report for the building is required be prepared to confirm the foundation adequacy.

| Item No. | Observation | Recommended Action Plan | Recommended Timeline |
|---|---|---|---|
| 01 | Incomplete geotechnical investigation report | The factory is required to provide credible geotechnical investigation report with all bore log data. | 6-weeks |
| 02 | Incomplete geotechnical investigation report | Verify the foundation adequacy of the building. | 6-weeks |
| 03 | Incomplete geotechnical investigation report | Implement remedial actions if necessary. | 6-months |

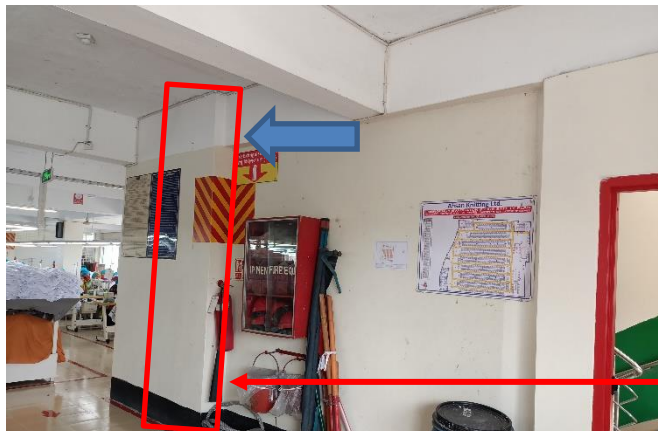
Column found offset from beam-column joint

| Item No. | Observation | Recommended Action Plan | Recommended Timeline |
|---|---|---|---|
| 04 | Discrepancies in as built drawings | Building engineer is required to survey the structure and prepare accurate as-built drawing in compliance with section 1.9.1.2 (part-6, BNBC). | 6-weeks |

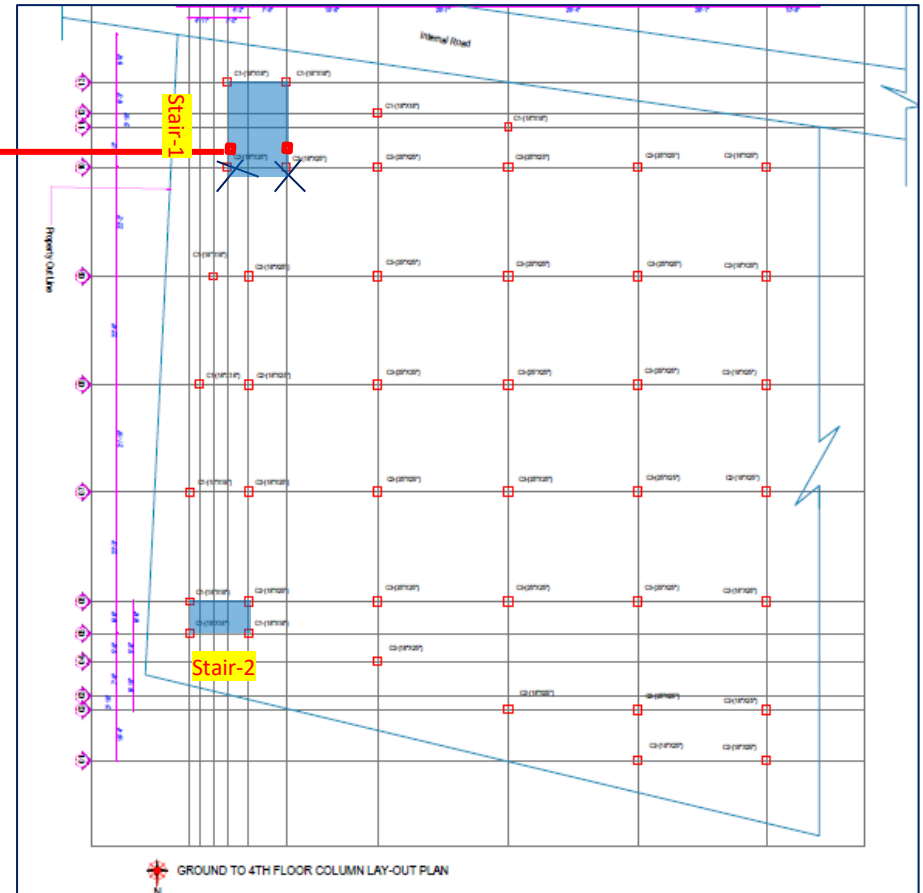
Column Layout

Column and beam layout were not fully matched with drawings near stair-1. Mismatches are shown in the figure.

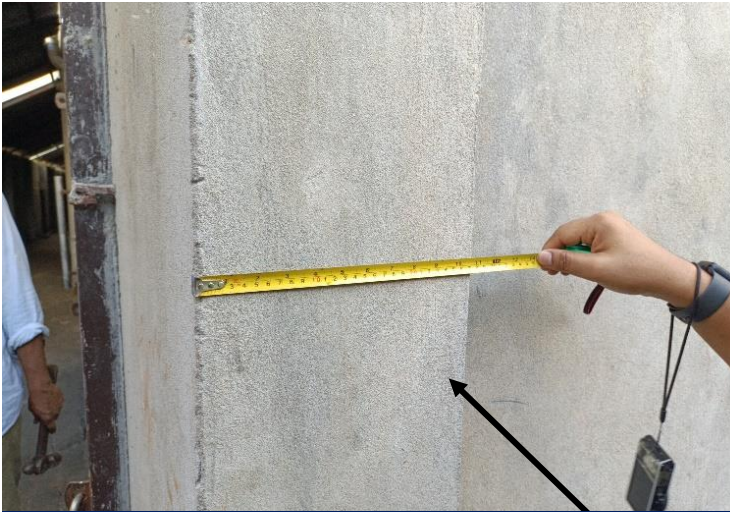
Stair column

Size of corner column of stair-2 did match with column schedule. 15 X 10 inches were measured instead of 18 X 18 inches.

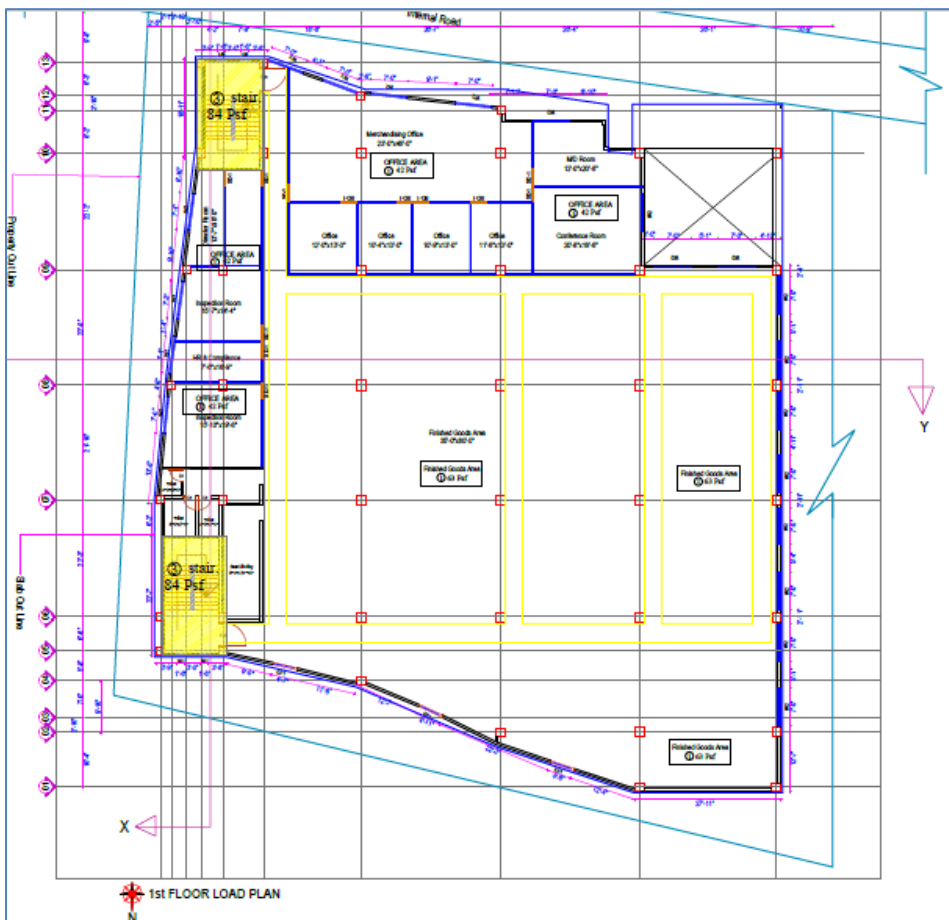
load plan with 3 kN/m<sup>2</sup> (63 psf ) loading limit

As per BNBC, the minimum floor live load for light storage is 6 kN/m<sup>2</sup> (125 psf). But, floor load plan for storage areas was found considering 3 kN/m<sup>2</sup>. The building engineer is required to revise the live load plan as per BNBC requirement and prepare the design documents accordingly.

| Item No. | Observation | Recommended Action Plan | Recommended Timeline |
|---|---|---|---|
| 05 | Prepared load plan do not comply with BNBC and lack of design report | The building engineer is required to revise the live load plan as per BNBC requirement. | 6-weeks |
| 08 | Prepared load plan do not comply with BNBC and lack of design report | Implement floor load plan. | 6-months |

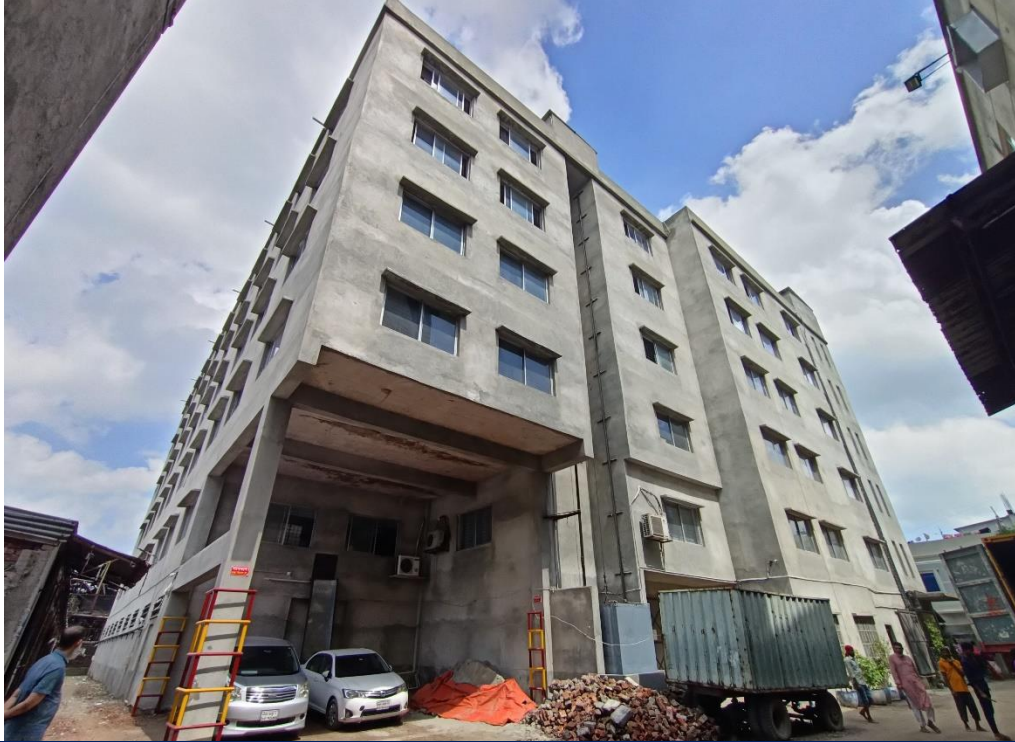
Factory Building

As per BNBC, every building or structure designed shall have its design documents prepared in accordance with the provision of Section 1.9.1. The design document shall include a design report, and a set of structural drawings, which shall be prepared in compliance with section 1.9.1.1 and section 1.9.1.2 as per BNBC. At the time of inspection, design report was not available which is required to be prepared in compliance with section 1.9.1.1 (part-6, BNBC).

| Item No. | Observation | Recommended Action Plan | Recommended Timeline |
|---|---|---|---|
| 06 | Prepared load plan do not comply with BNBC and lack of design report | Prepare the design report in compliance of section 1.9.1 of BNBC (part-6). | 6-weeks |
| 07 | Prepared load plan do not comply with BNBC and lack of design report | Implement the recommendations of design report. | 6-months |

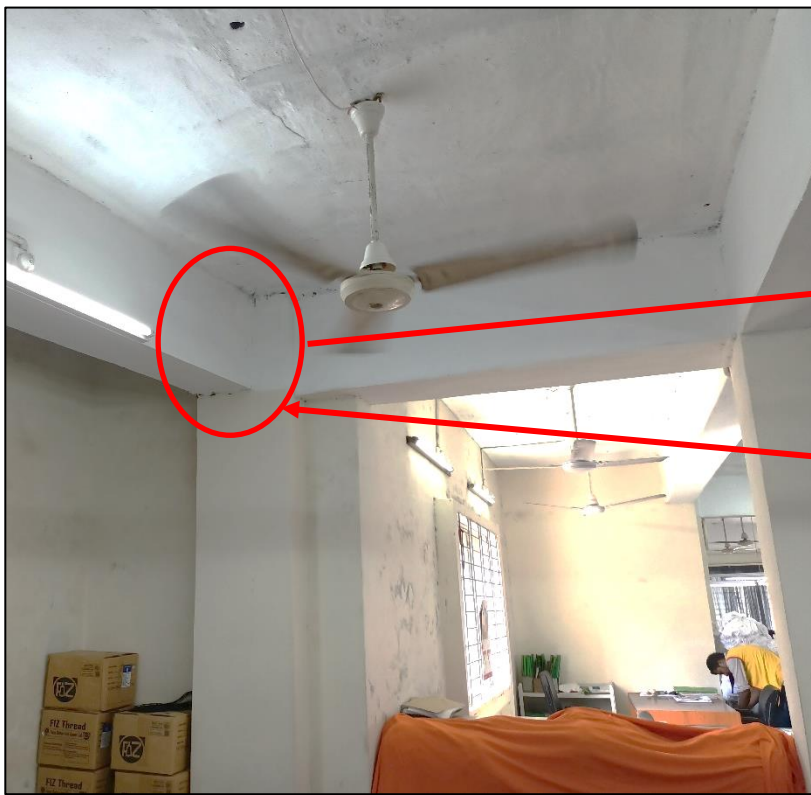
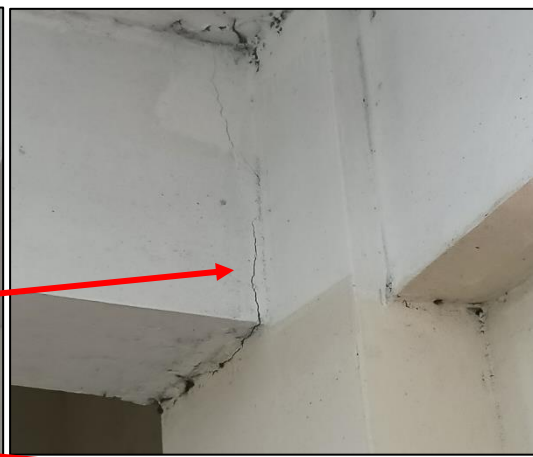
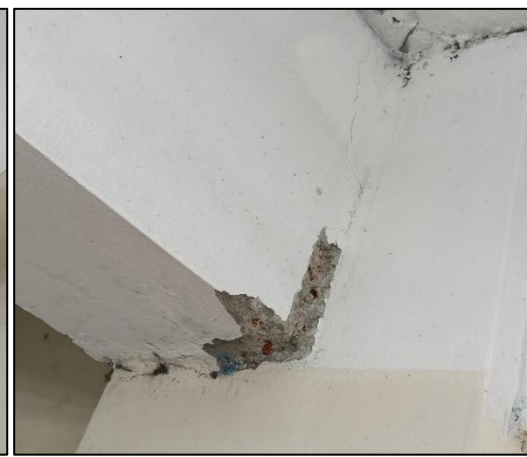
Crack found in Beam-Column Joint

Crack found in beam-column joint (4<sup>th</sup> floor level) at south side of the building may caused due to poor workmanship. The factory engineer is required to investigate the causes of crack and repair with a suitable method.

| Item No. | Observation | Recommended Action Plan | Recommended Timeline |
|---|---|---|---|
| 09 | Crack in beam-column joint | The building engineer is required to investigate the causes of crack and suggest a suitable remedial method. | 6-weeks |
| 10 | Crack in beam-column joint | Carry out suggested remedial works. | 6-months |

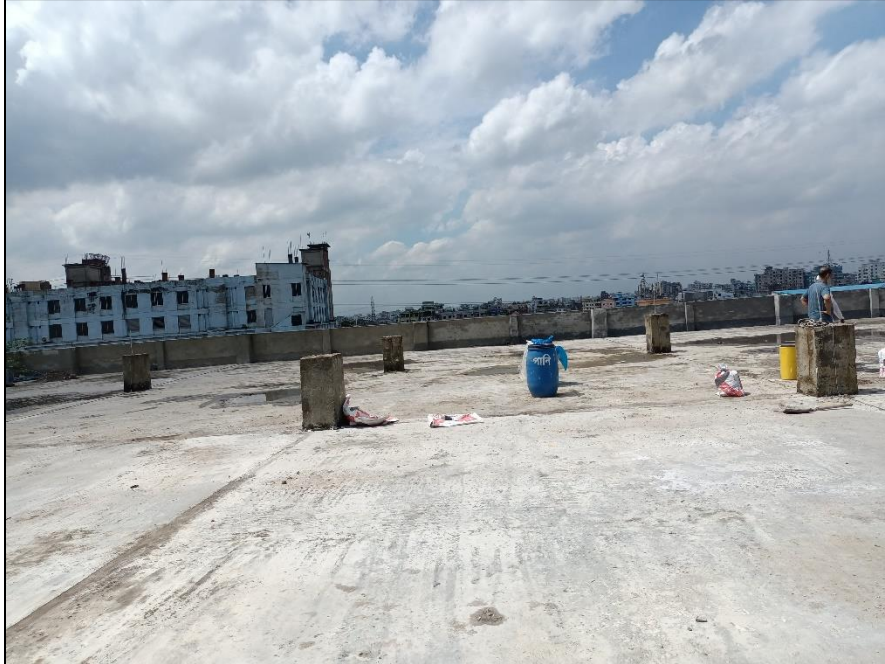
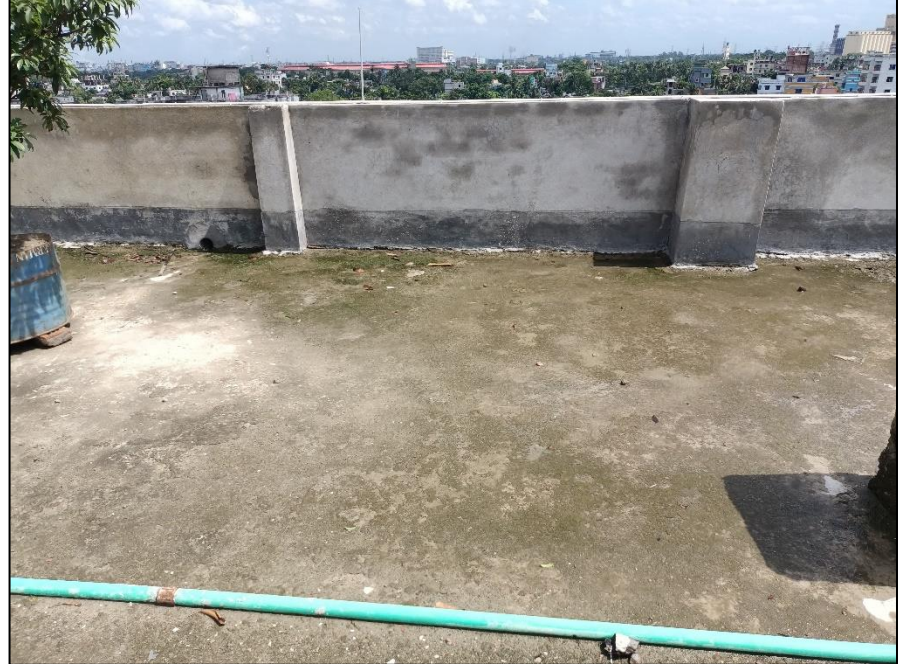
The roof slab is made of brick chips aggregate. Water proofing layer has not been applied yet. The factory is required provide water proofing layer with adequate sloping on the roof.

| Item No. | Observation | Recommended Action Plan | Recommended Timeline |
|---|---|---|---|
| 11 | Water proofing layer not found | The factory is required provide water proofing layer with adequate sloping on the roof. | 6-months |

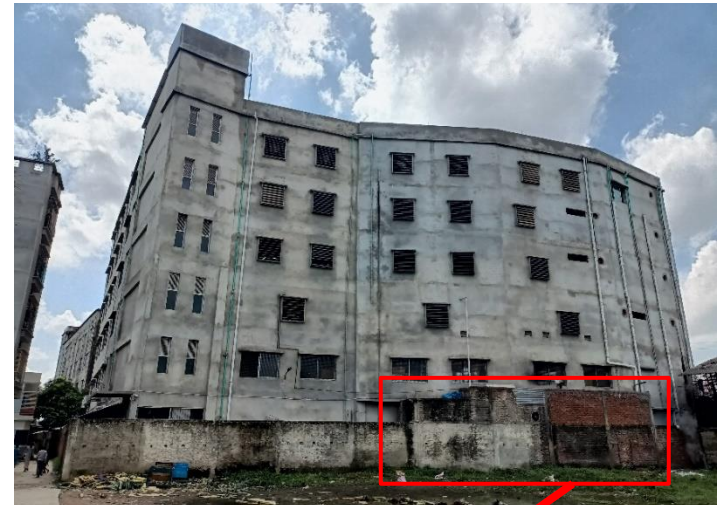
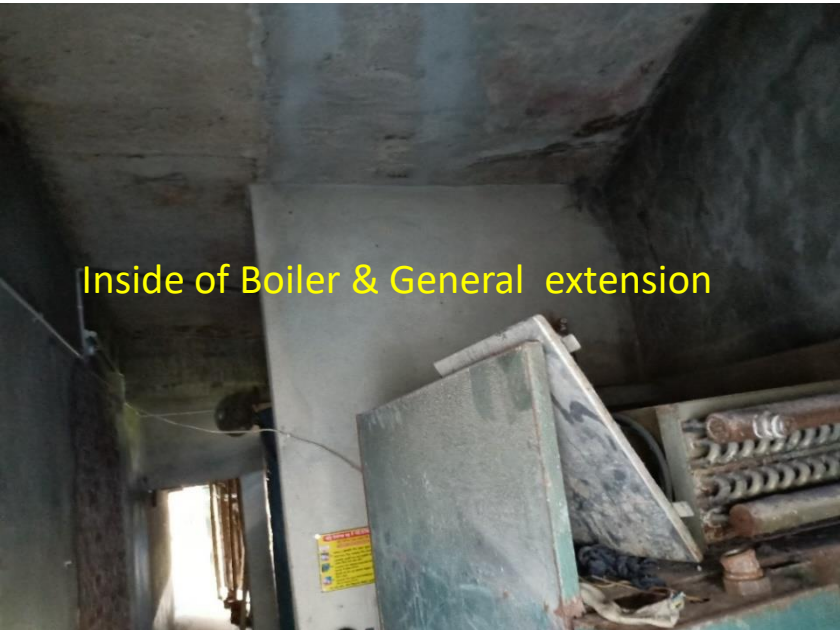
Undocumented single storied Boiler & Generator room was found at North side on ground floor level adjacent to the Ahsan Knitting Building. The roof of the boiler & generator room is supported by the cantilever portion of the Ahsan Knitting Building and boundary wall.

Inside of Boiler & General extension

Building engineer is required to prepare as built drawings for the Boiler & Generator room and check the adequacy of the cantilever slab of Ahsan knitting building that supports the roof of the Boiler & Generator room.

| Item No. | Observation | Recommended Action Plan | Recommended Timeline |
|---|---|---|---|
| 12 | Undocumented Boiler and Generator Room | Building engineer is required to survey the structure and prepare accurate as-built drawing in compliance with section 1.9.1.2 (part-6, BNBC). | 6-weeks |
| 13 | Undocumented Boiler and Generator Room | Building Engineer is required to check the capacity of cantilever slab. | 6-weeks |

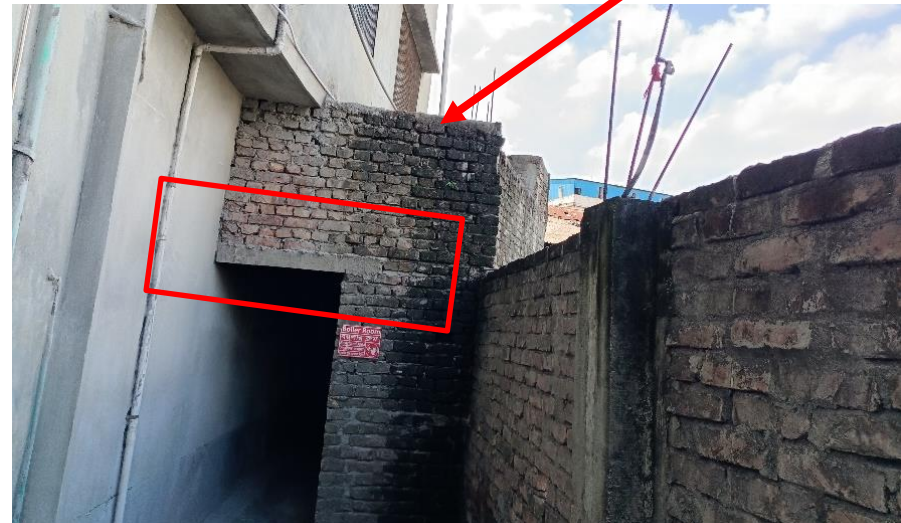
Unsupported Lintel in Boiler & Generator Room

The Building engineer is required to check the capacity of unsupported lintel and suggest proper remedial actions.

| Item No. | Observation | Recommended Action Plan | Recommended Timeline |
|---|---|---|---|
| 14 | Undocumented Boiler and Generator Room | The factory engineer is required to check the capacity of unsupported lintel. | 6-weeks |
