# Zaheen Knitwears Limited

(Shed - 3, 4, 5, 10, 11, 12, 13) &  
(Building - Security, ETP and Fire Pump)

Keodala, Madanpur, Bandar, Narayangonj

19 September 2022

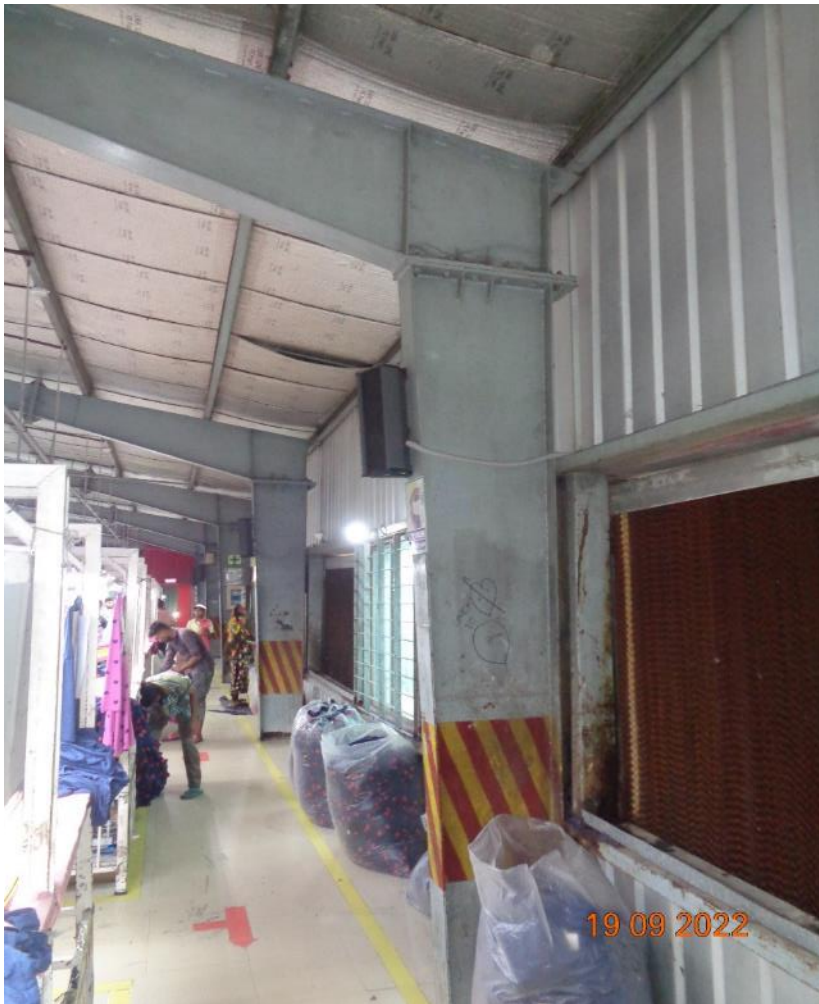
Load transfer media is not provided at first floor along long direction.

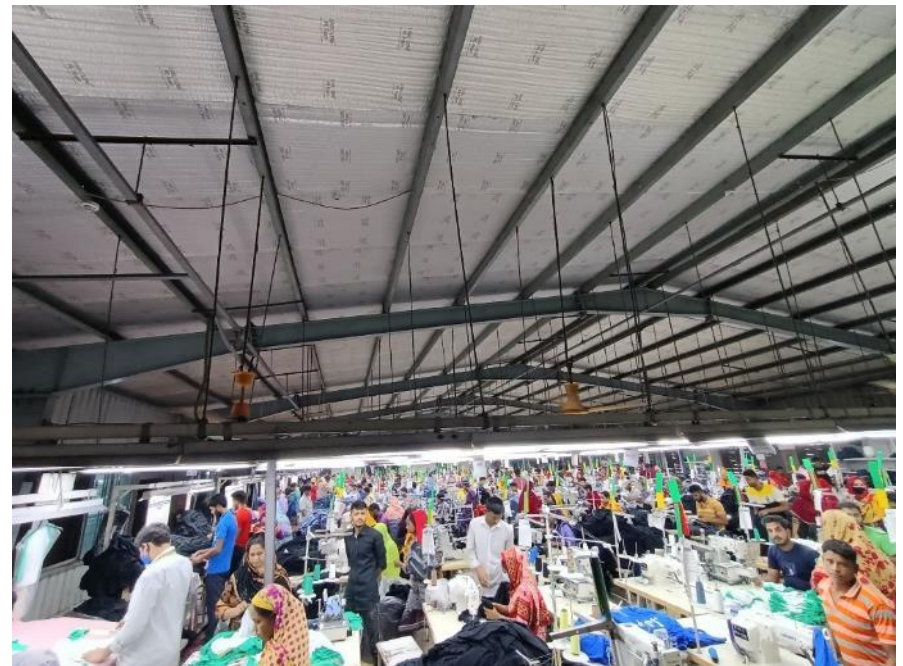
Load transfer media is missing at first floor along long direction

Lateral stability system of the shed has been checked by the building engineer. Retrofitting work is proposed. The factory has not implemented the retrofitting works yet.

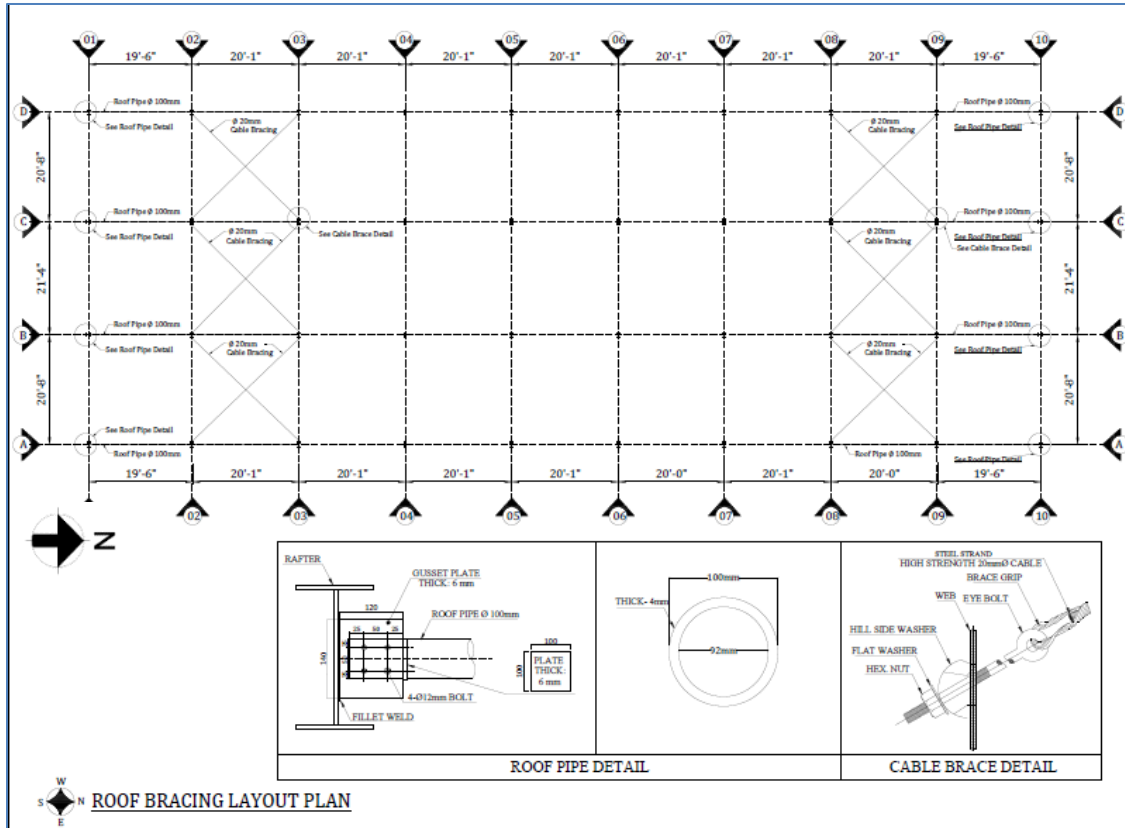
Strut pipe and cable bracing are proposed in retrofitting drawing.

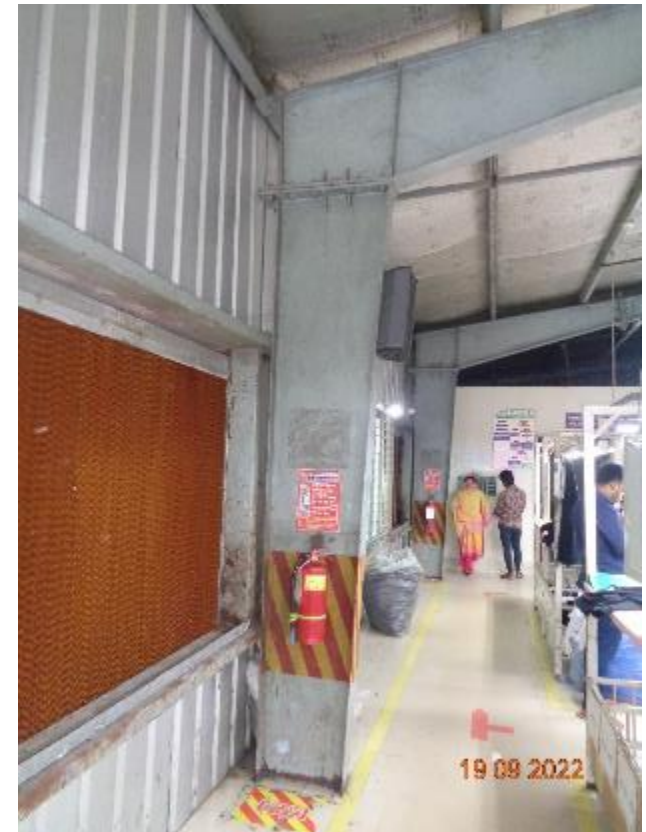
Retrofitting work is not implemented

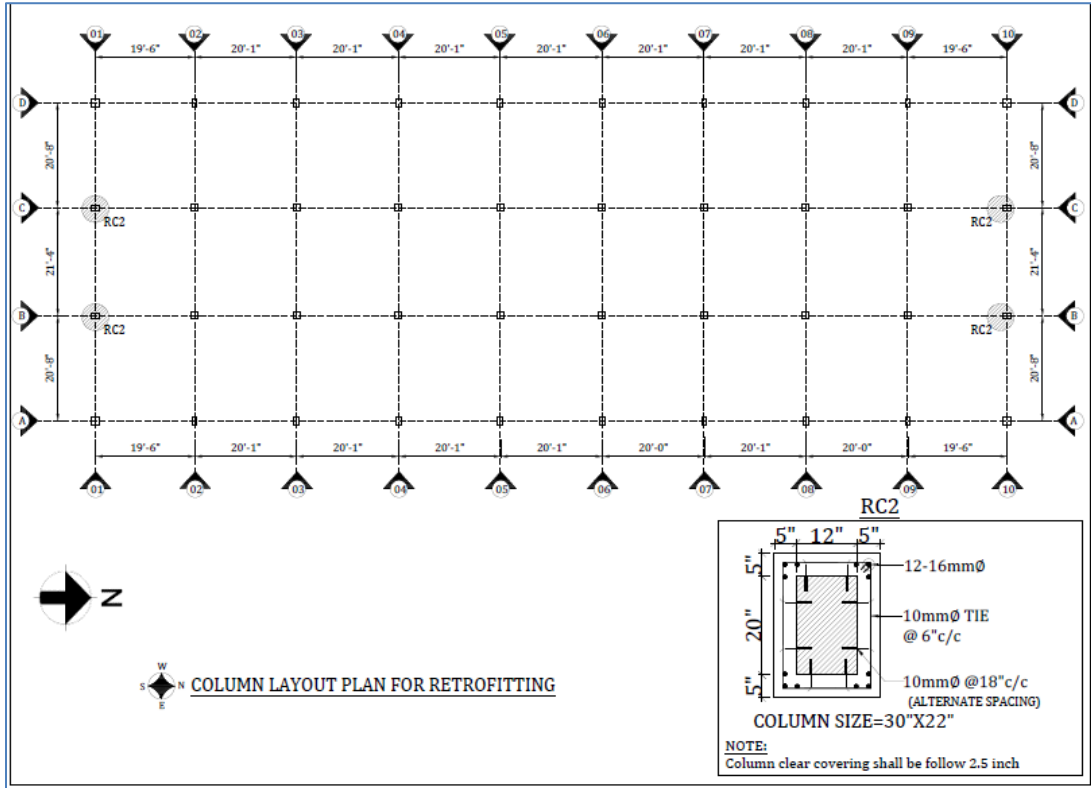
Retrofitting is proposed for RC pedestal column

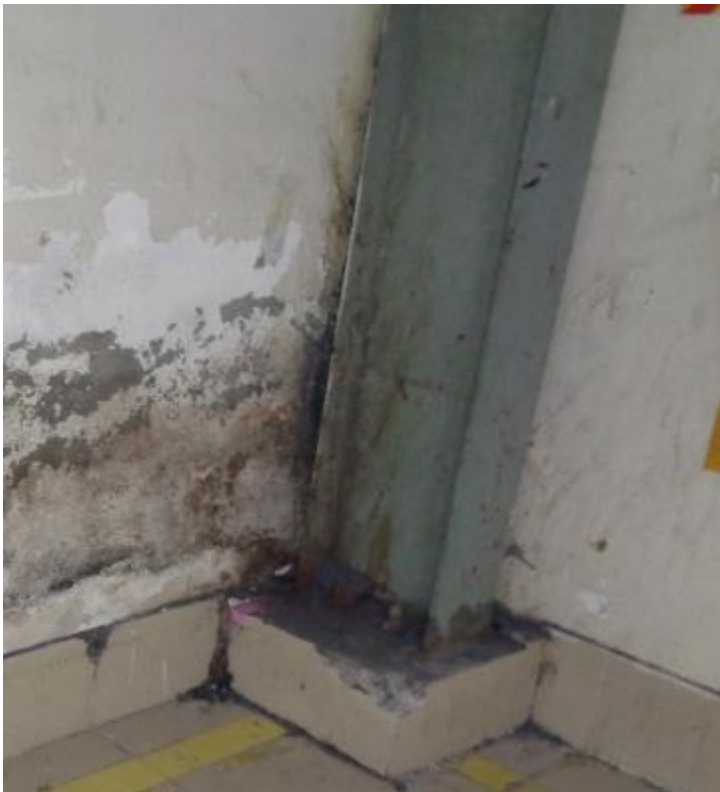
Retrofitting work is not implemented

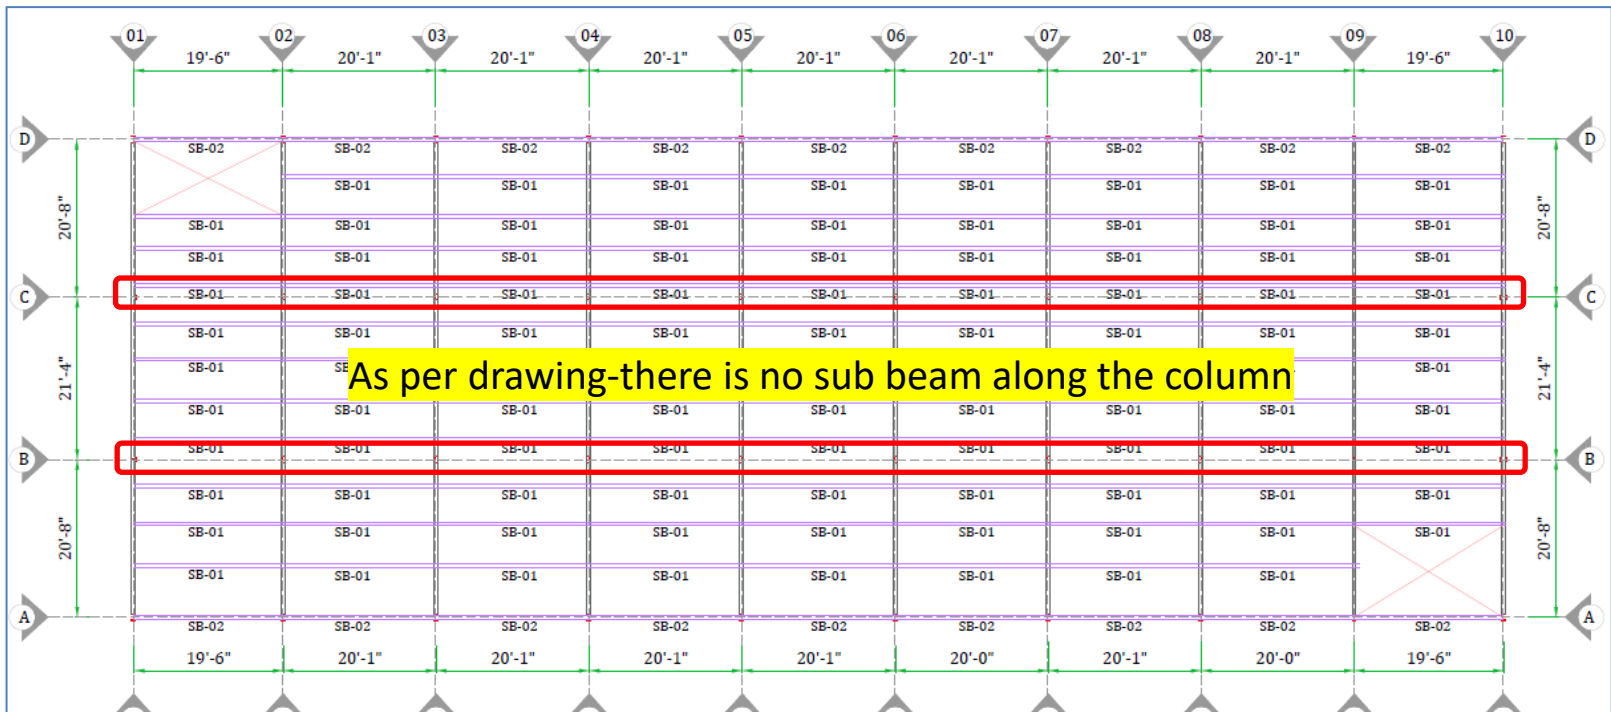
Sub beam layout

As per as built drawing sub-beams are not connected with the column. But on-site condition (marked grid) sub-beams are connected with columns. Building engineer is required to survey the whole structure and produce accurate as-built drawings.

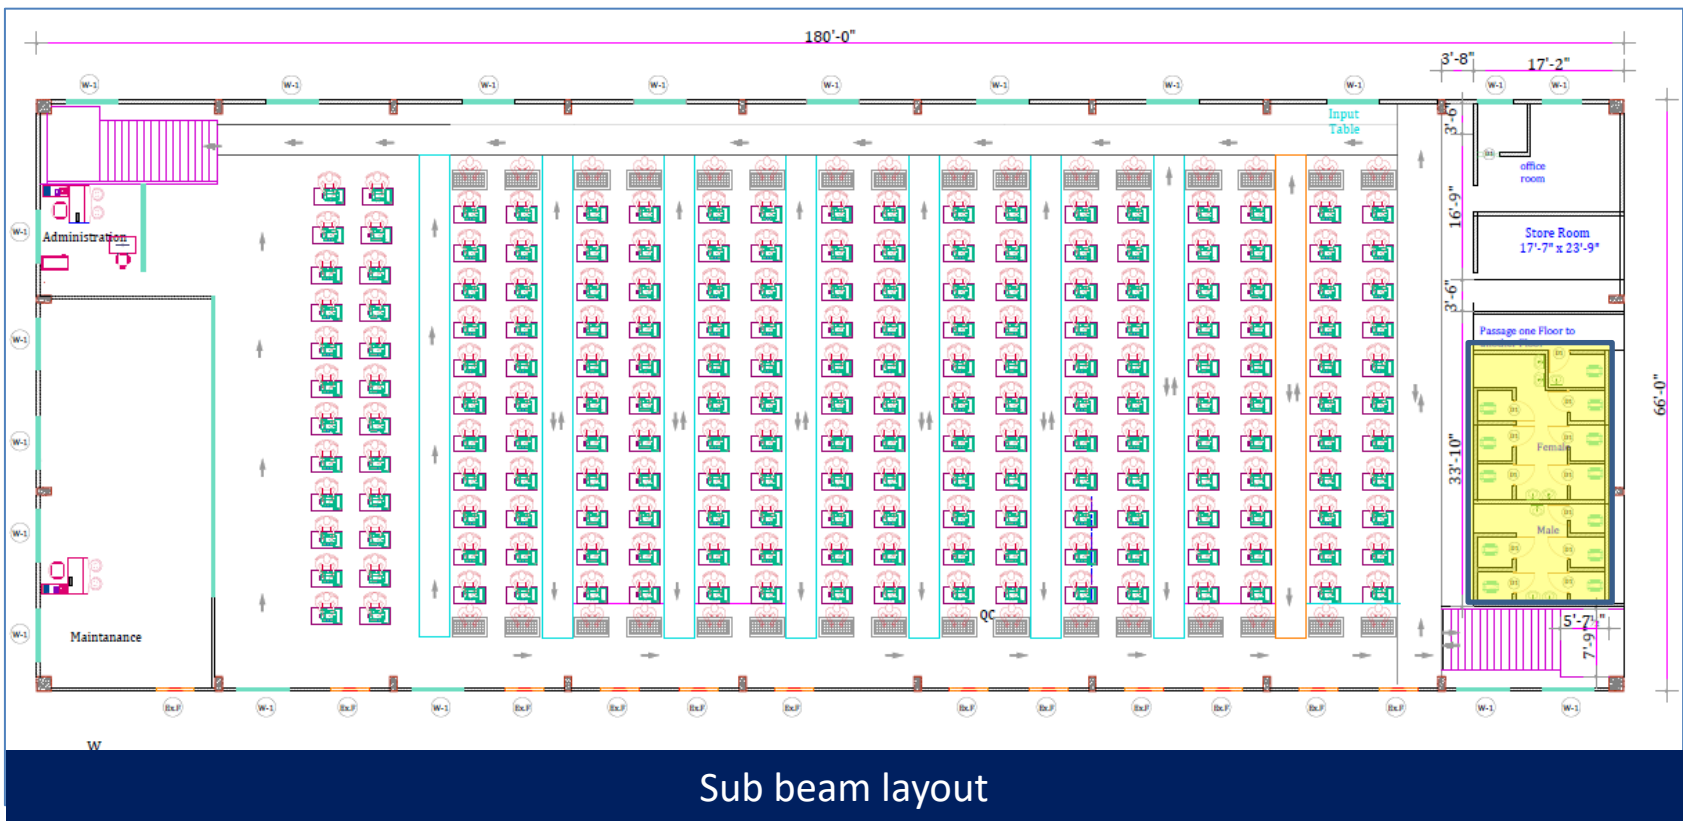
Toilet build up at 1<sup>st</sup> floor are not shown in architectural drawing. Building engineer is required to survey the whole structure and produce accurate as-built drawing.

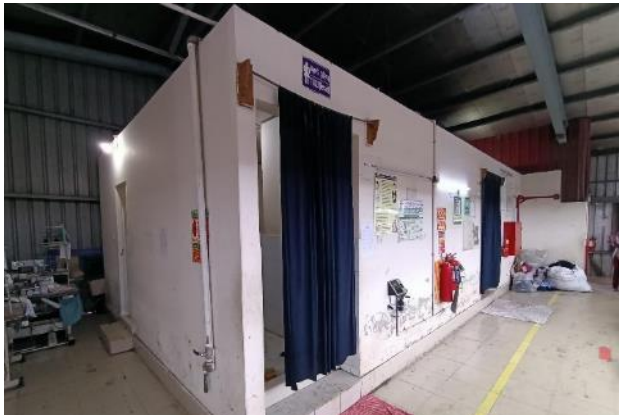
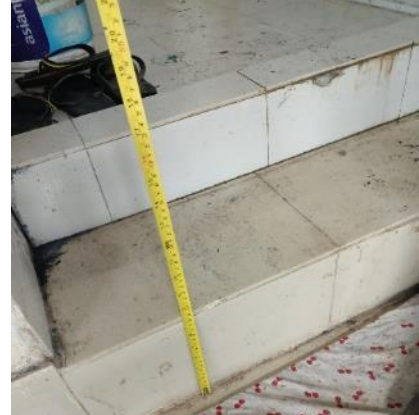
Toilet Build up (230 mm)

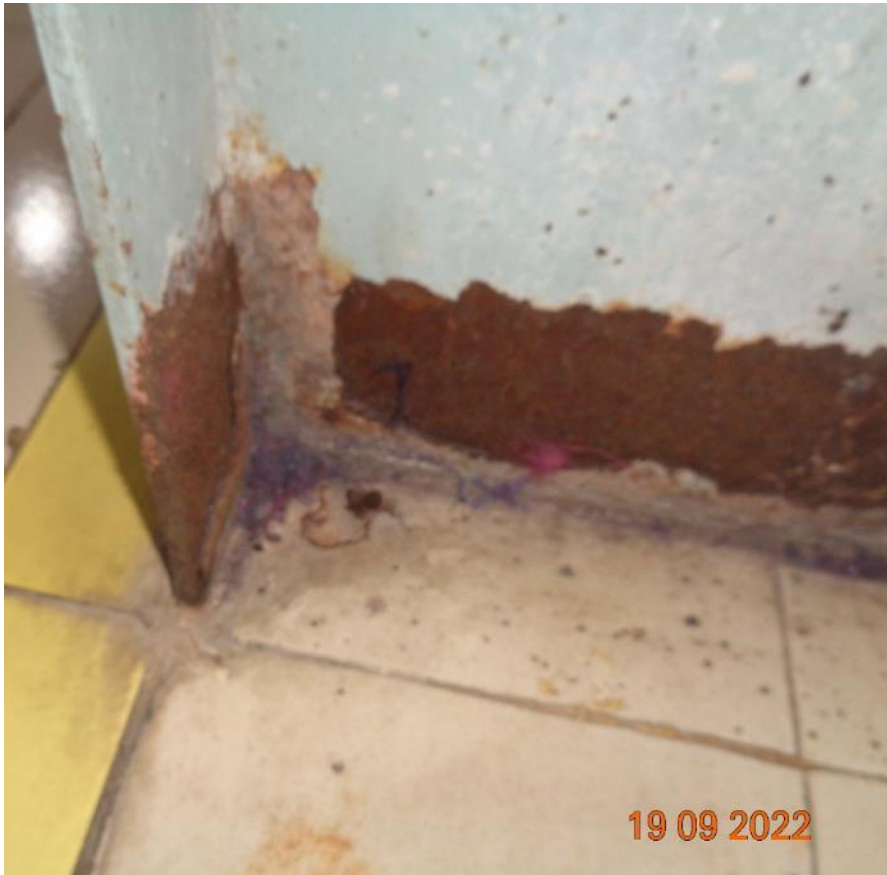
Corrosion on steel members

Corrosion was observed on steel members at several locations. Building engineer is required to provide rust proof paint on all steel members to protect from corrosion.

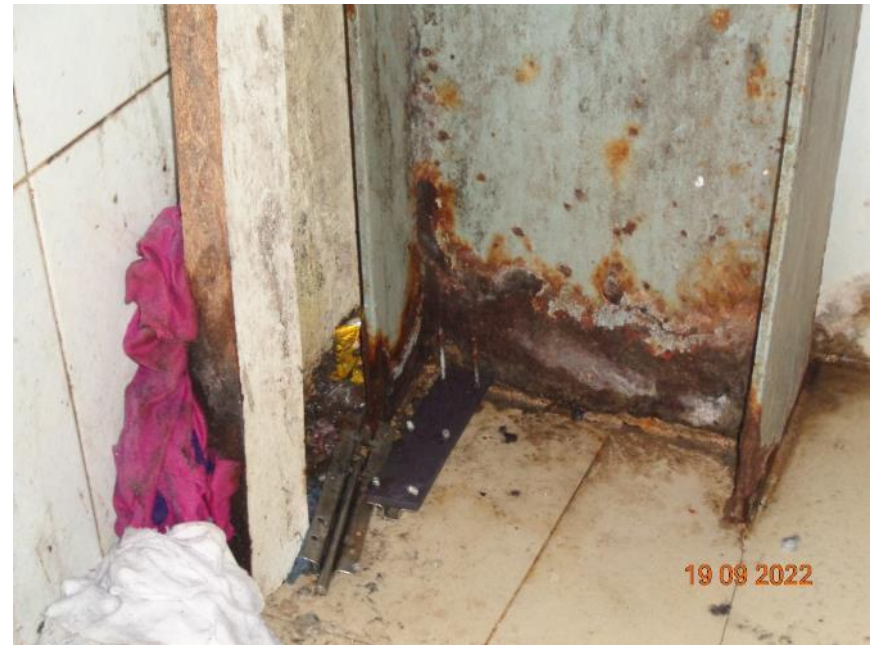
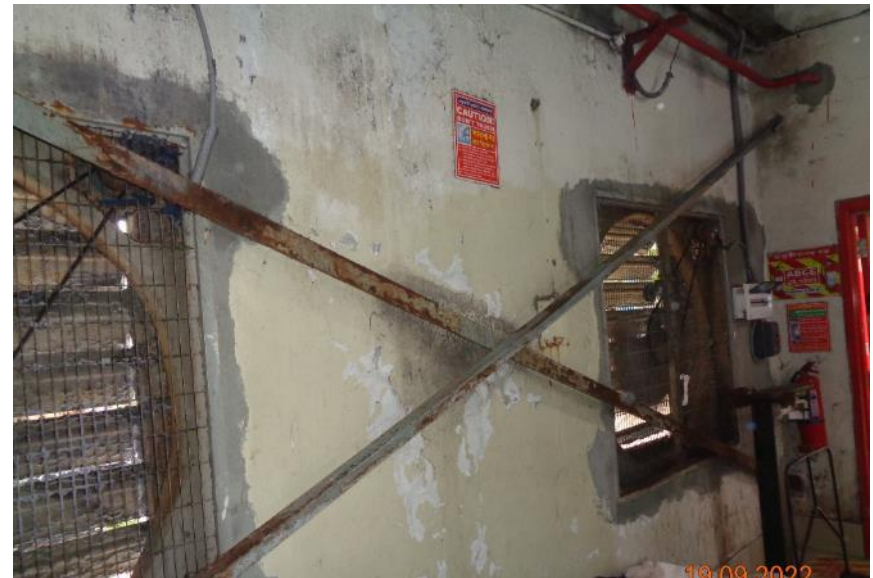
Corrosion on steel members

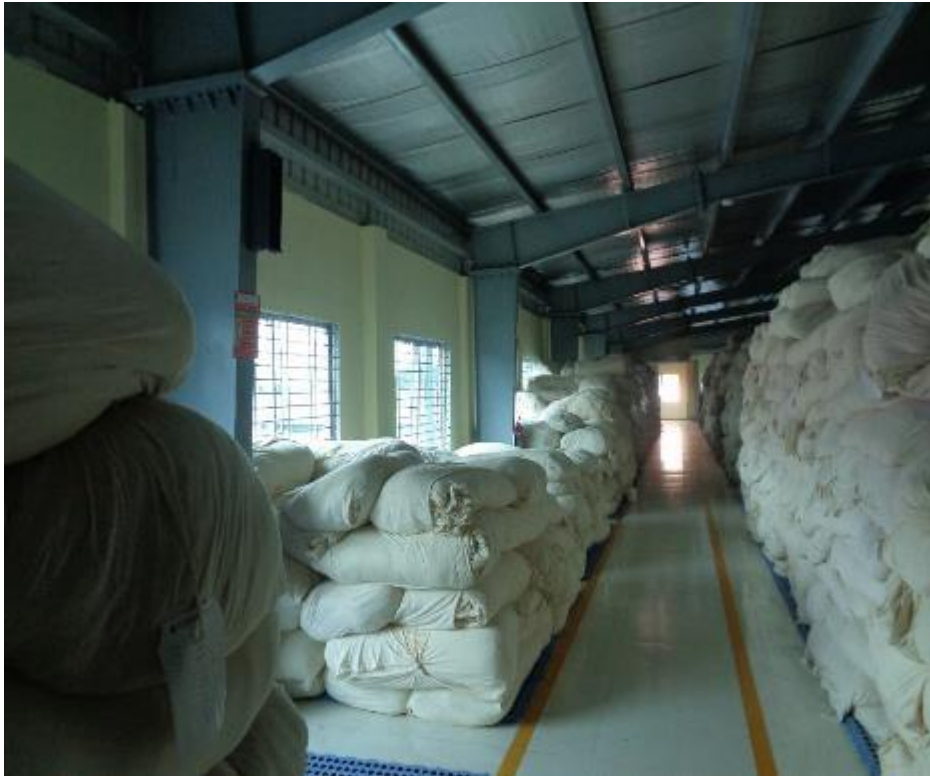
Load transfer media is missing at most of the location along long direction

Roof and wall bracing are provided. Load transfer media is provided at some locations but load transfer media is missing at most of the location along long direction. Therefore, lateral stability system of the shed is apparently incomplete. Building engineer is required to check the lateral stability of the structure.

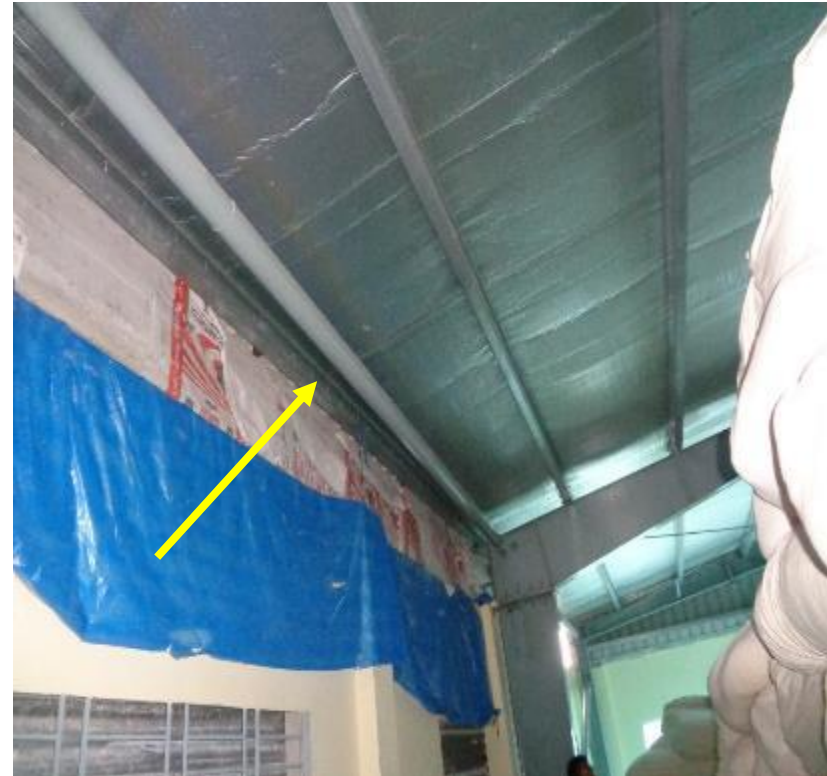
Load transfer media is provided at some locations along long direction

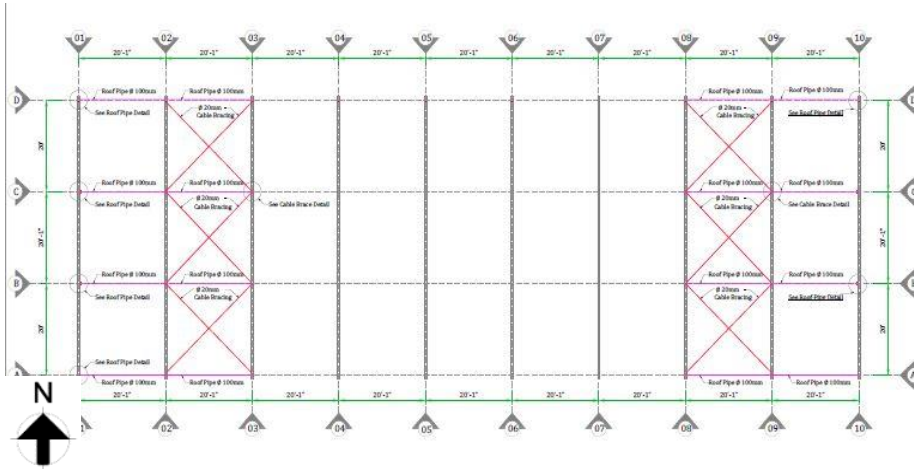
Bracing location shown in layout

Roof and wall bracing are found at different location of bracing layout plan shown in drawing. Building engineer is required to update the as-built drawing and check the lateral stability of the structure.

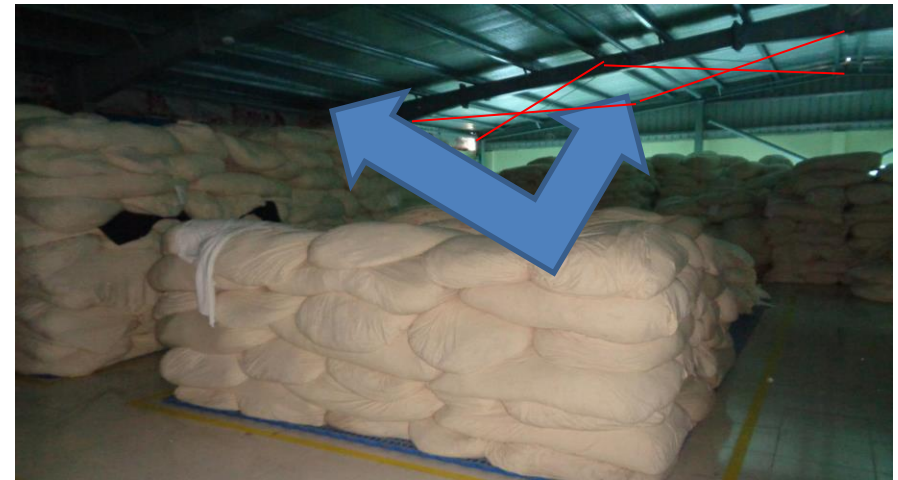
Bracing location shifted

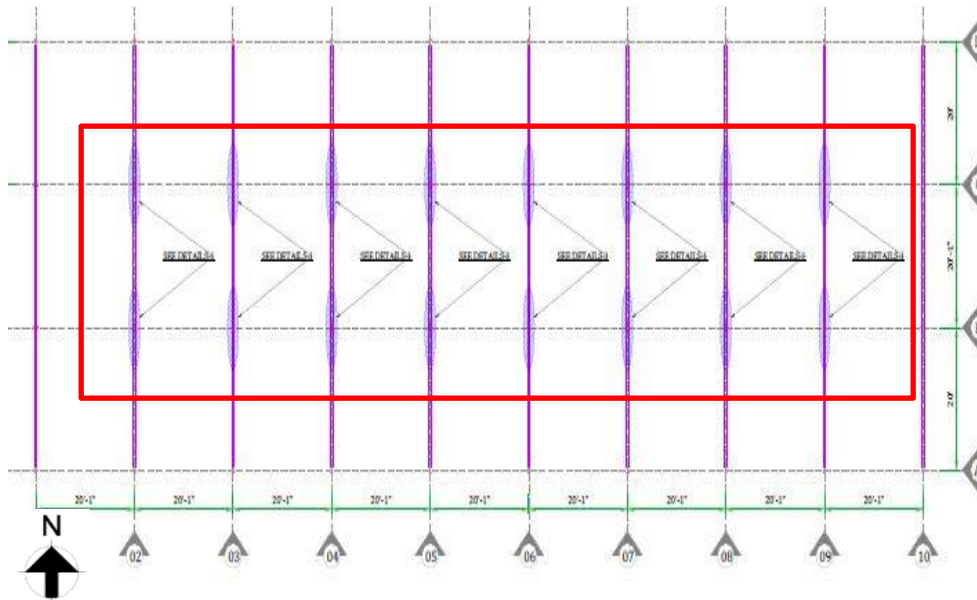
Lateral stability system and member adequacy of the shed has been checked by the building engineer. Retrofitting work is proposed. The factory has not implemented the retrofitting works yet.

Retrofitting (additional plate installation) is proposed for steel beam

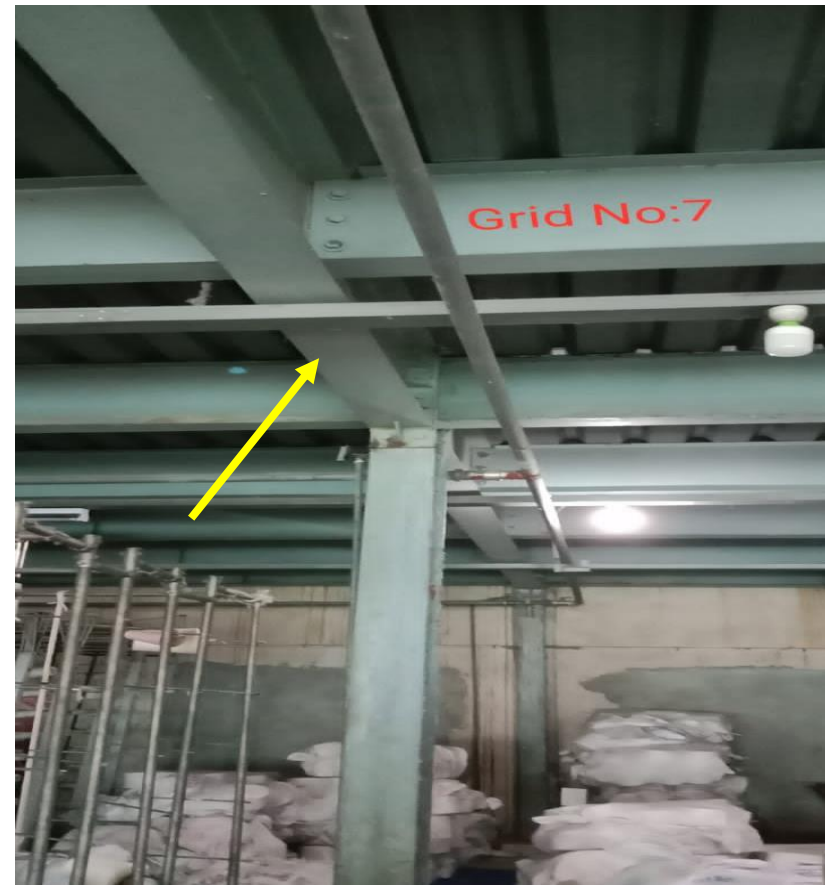
Retrofitting work is not implemented

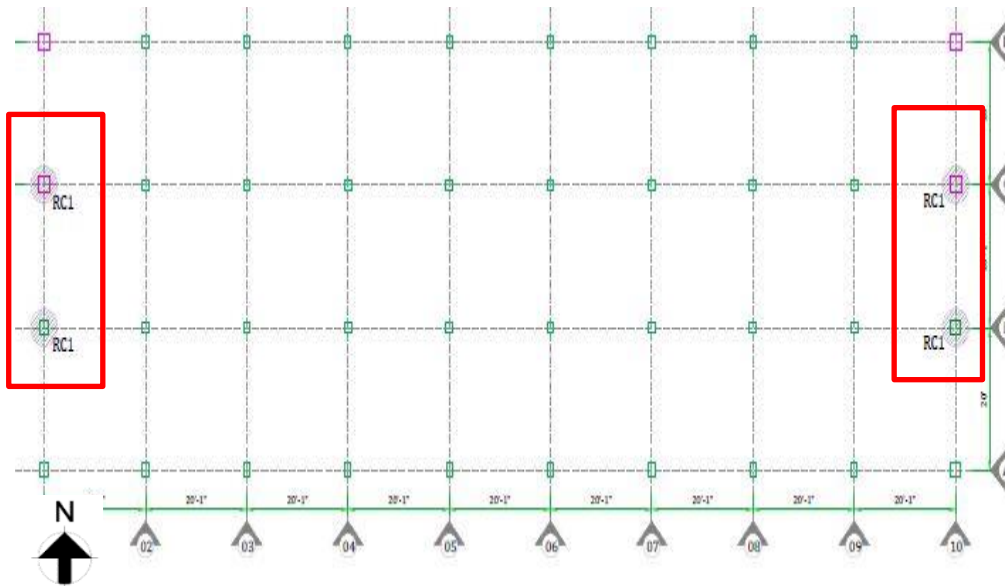
Retrofitting is proposed for RC pedestal column

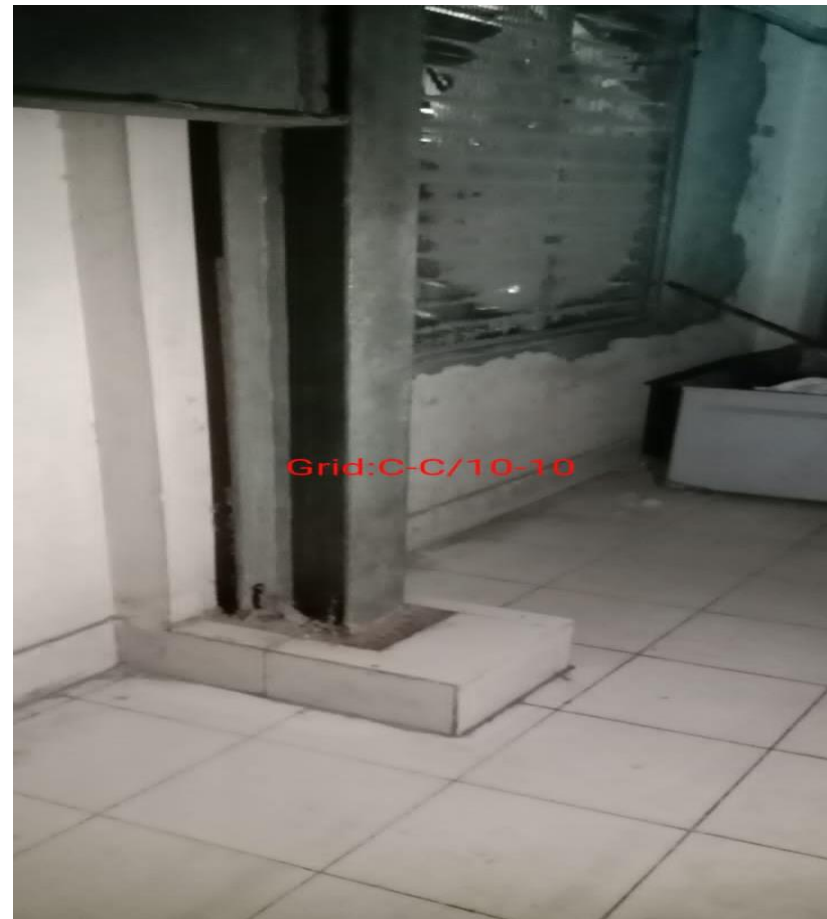
Retrofitting work is not implemented

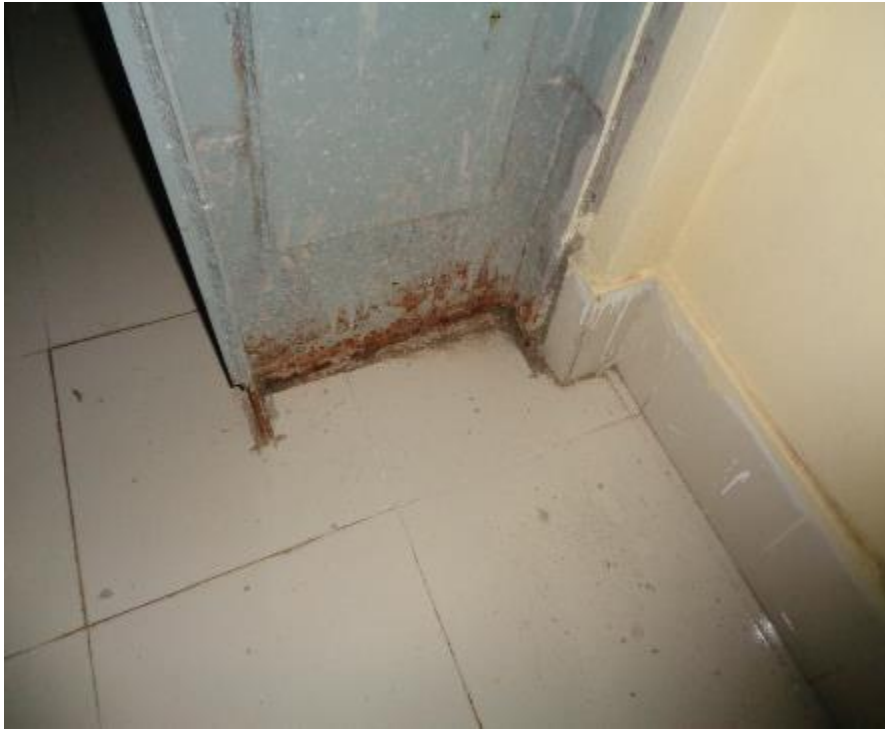
Corrosion on steel members

Corrosion was observed on steel members at several locations. Building engineer is required to provide rust proof paint on all steel members to protect from corrosion.

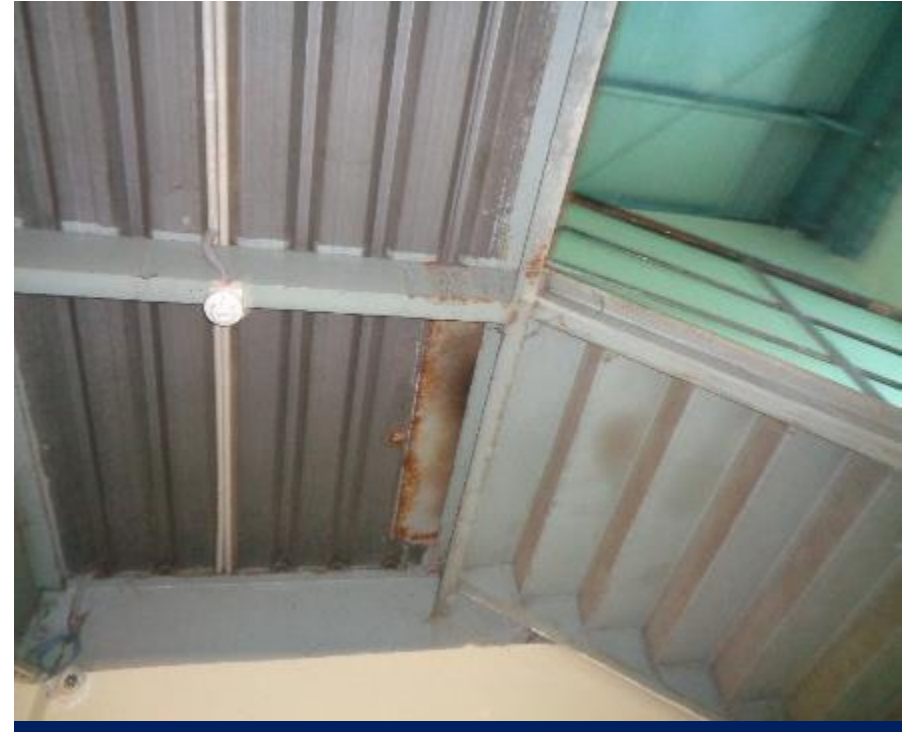
Corrosion on steel members

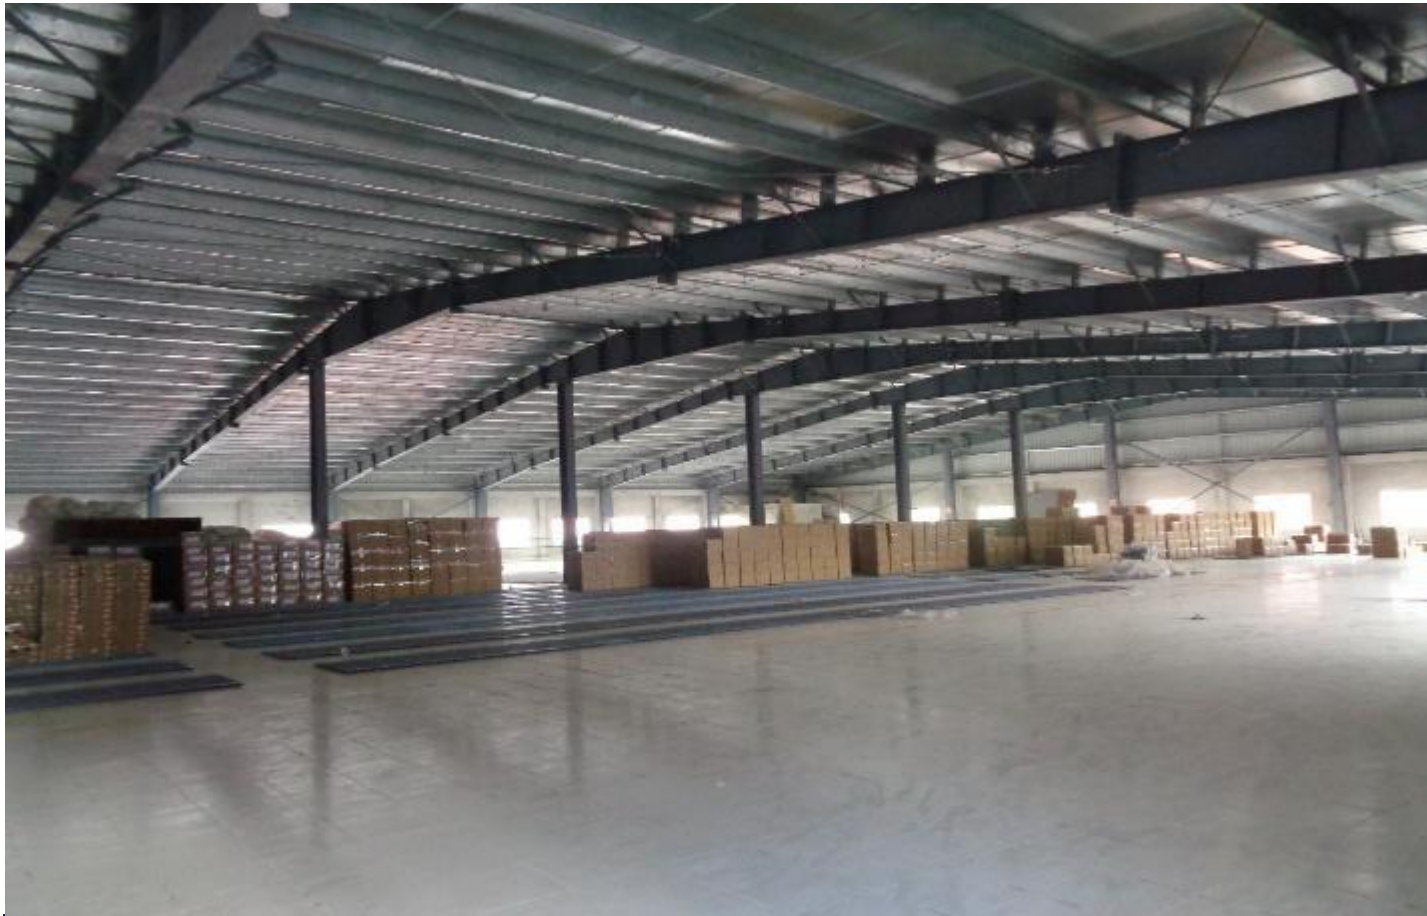
No load transfer media is provided along long direction

Roof and wall bracing are provided but load transfer media is not provided along long direction for this shed. Therefore, lateral stability system of the shed is apparently incomplete. Factory engineer is required to check the lateral stability of the structure.

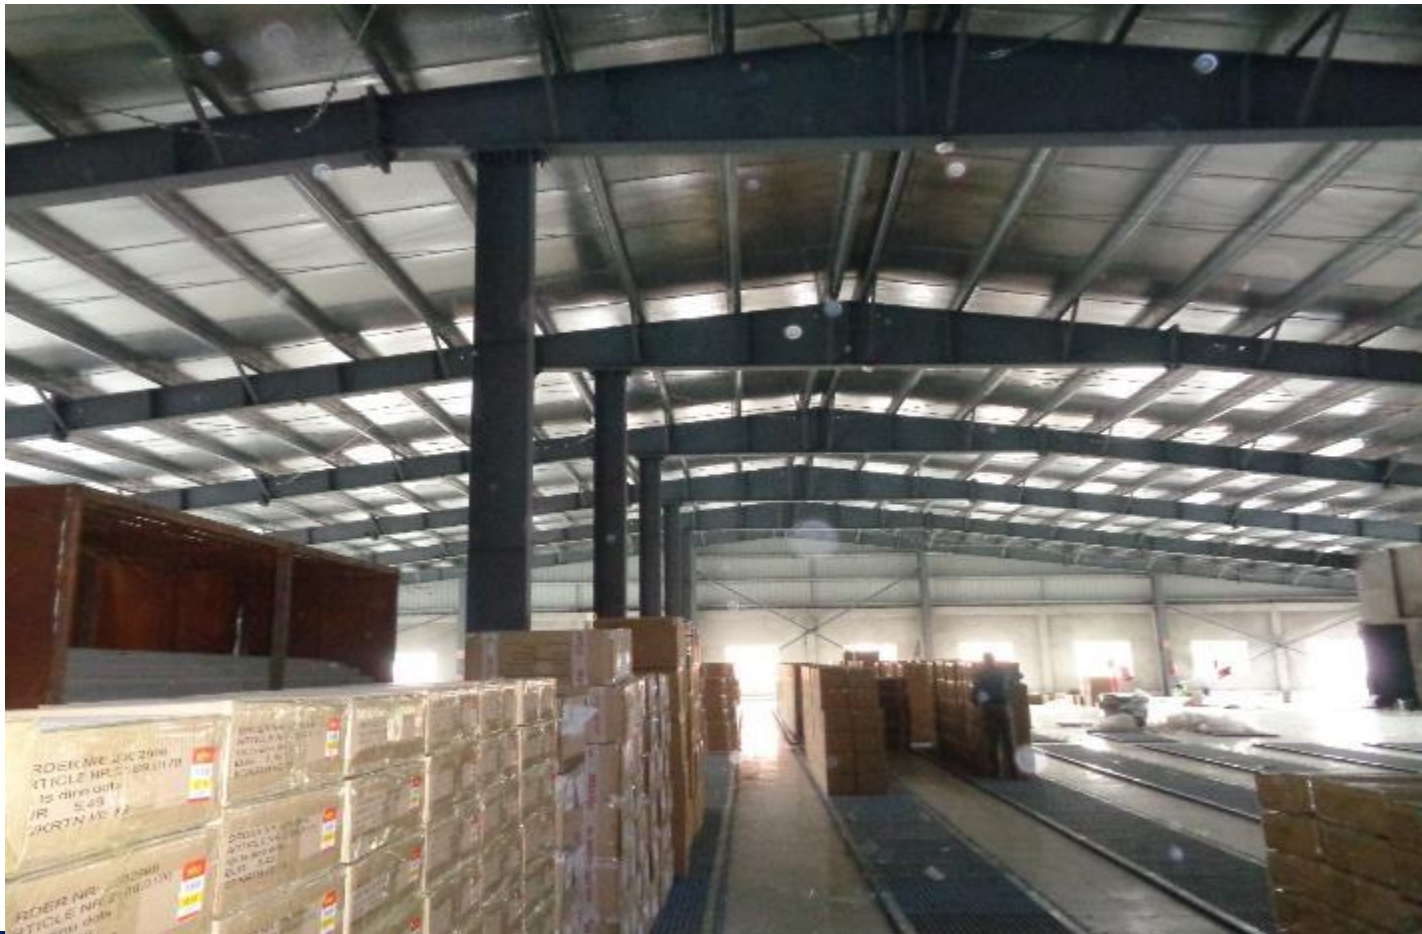
Column not placed along ridge

Internal columns are not placed along the ridge and placed at one side which indicates the irregularities in the load transfer system. A building engineer is required to check the load path and suggest any remediation work if required.

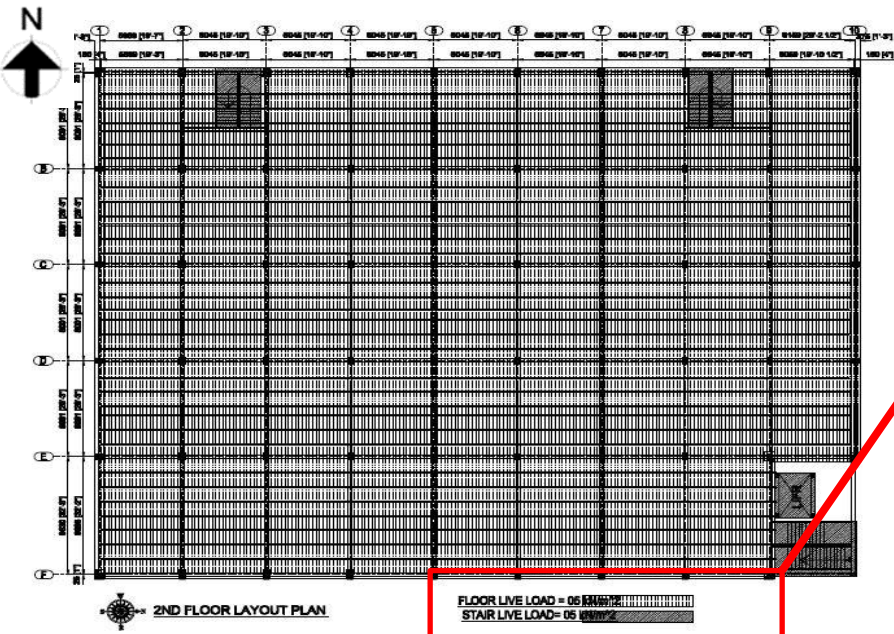
Live load plan- 1<sup>st</sup> floor

Live load considered as 5 KPa for typical floor

Live load on typical floor is considered as 5 kPa in prepared load plan. As per BNBC- Part 6, live load for light storage areas is required to be considered minimum 6 kPa. However, the building engineer is required to revise the load plan as per BNBC requirement and check the design accordingly.

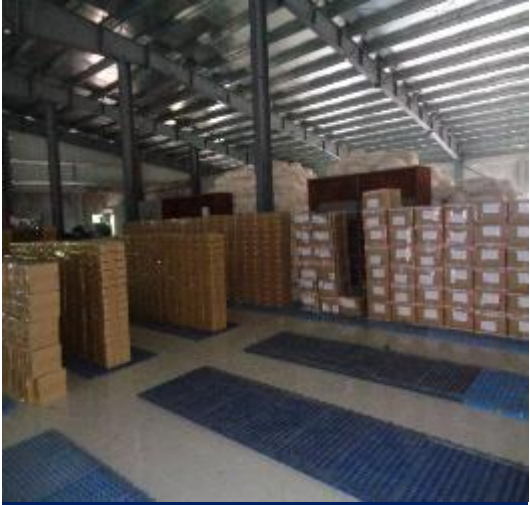
Storage on 1<sup>st</sup> floor

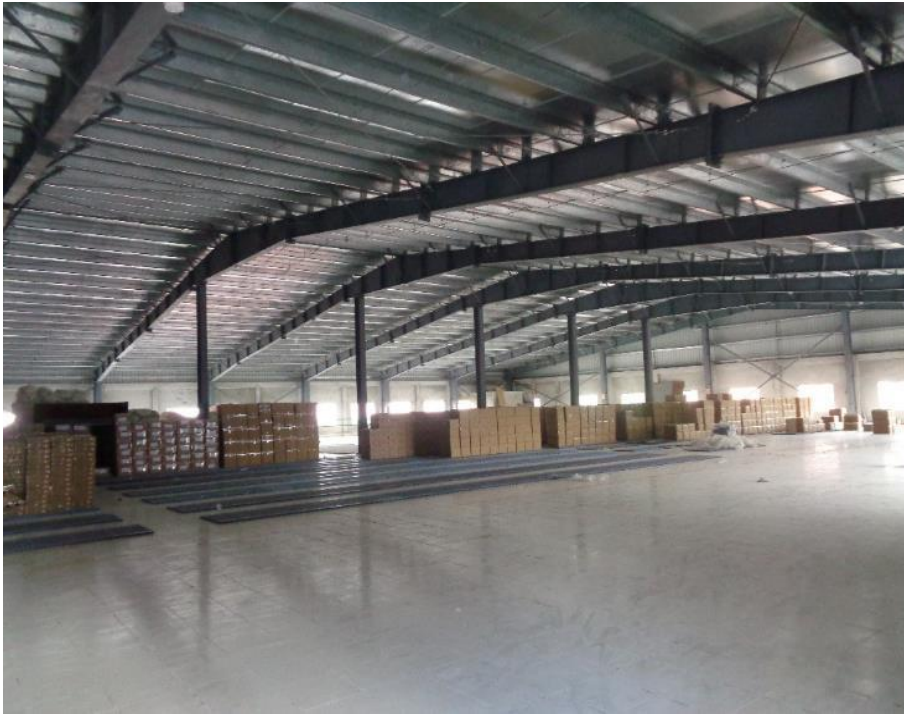
One internal column found at every grid along ridge at first floor

One internal column found at every grid along ridge at first floor. Marked column shown in drawing but not found on site from grid 2 to grid 9. Building engineer is required to survey the whole structure and produce accurate as-built drawing.

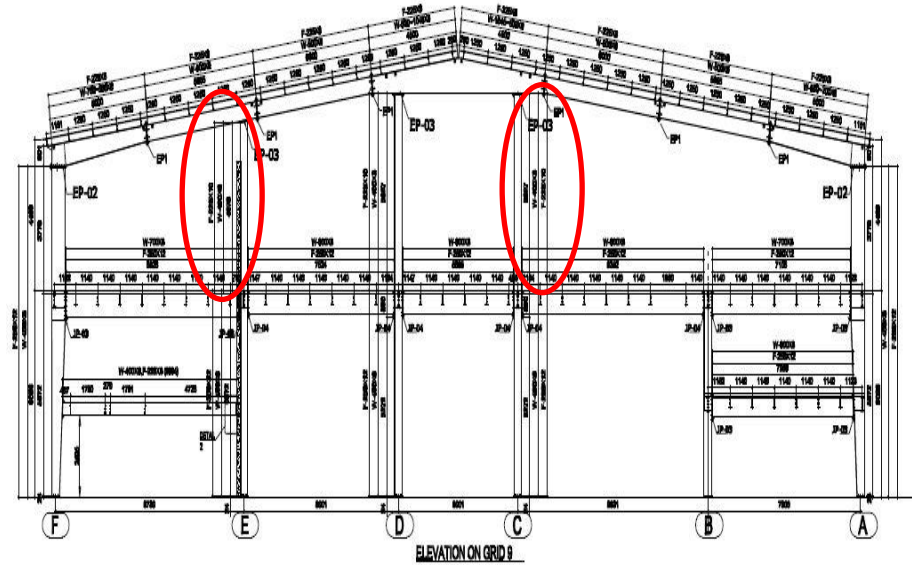
Marked column shown in drawing but not found on site from grid 2 to grid 9

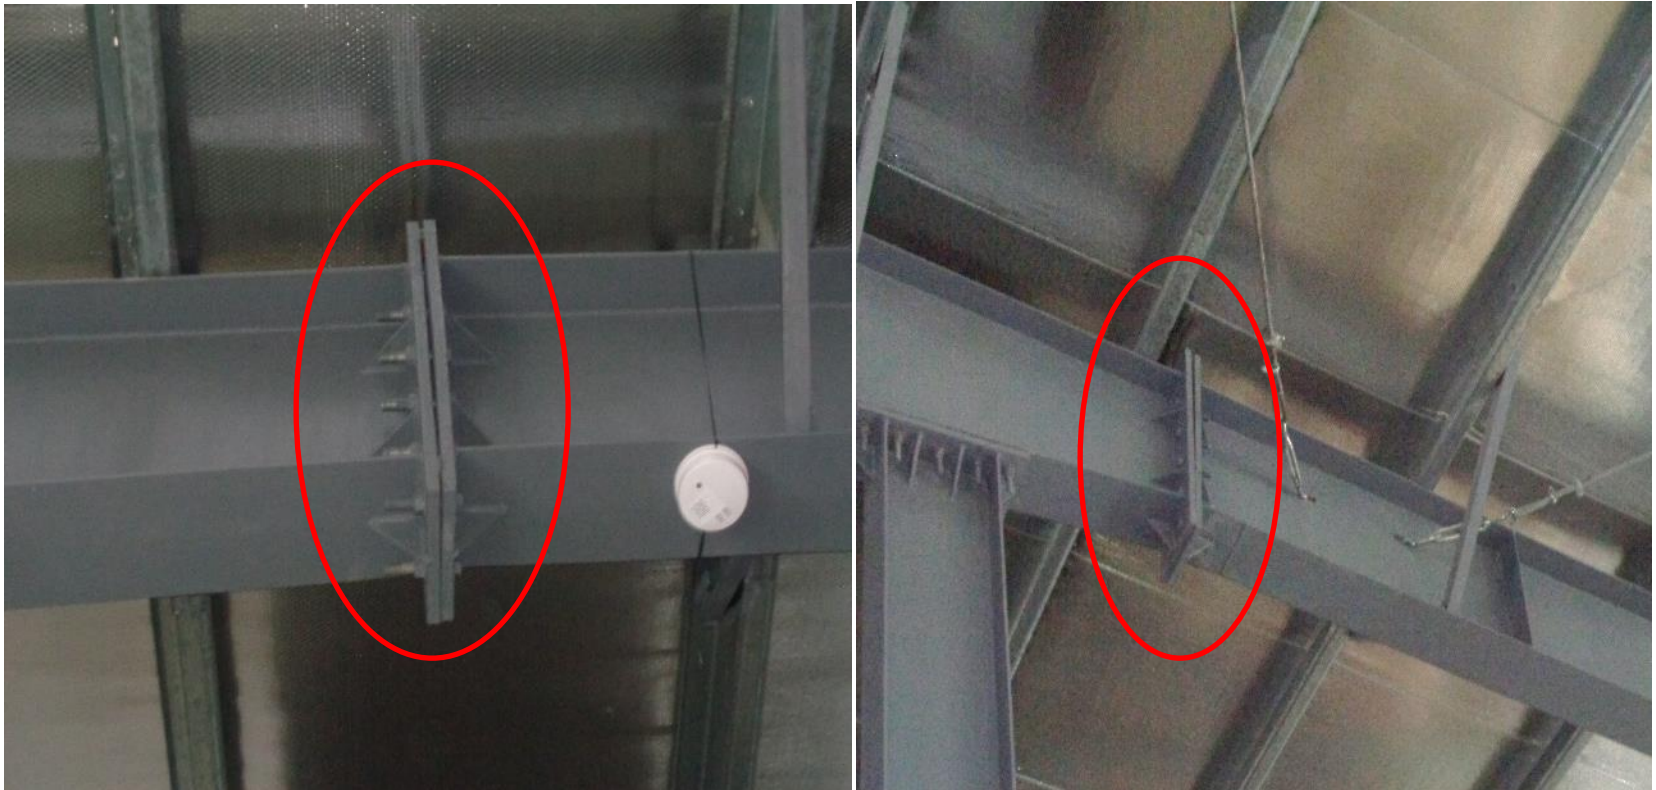
Gap was observed in connection

Gap was observed in connection of steel members. Building engineer is required to repair the connections with suitable method suggested by building engineer.
