# Zaheen Knitwears Limited

(Shed - 3, 4, 5, 10, 11, 12, 13) &  
(Building - Security, ETP and Fire Pump)

Keodala, Madanpur, Bandar, Narayangonj

19 September 2022

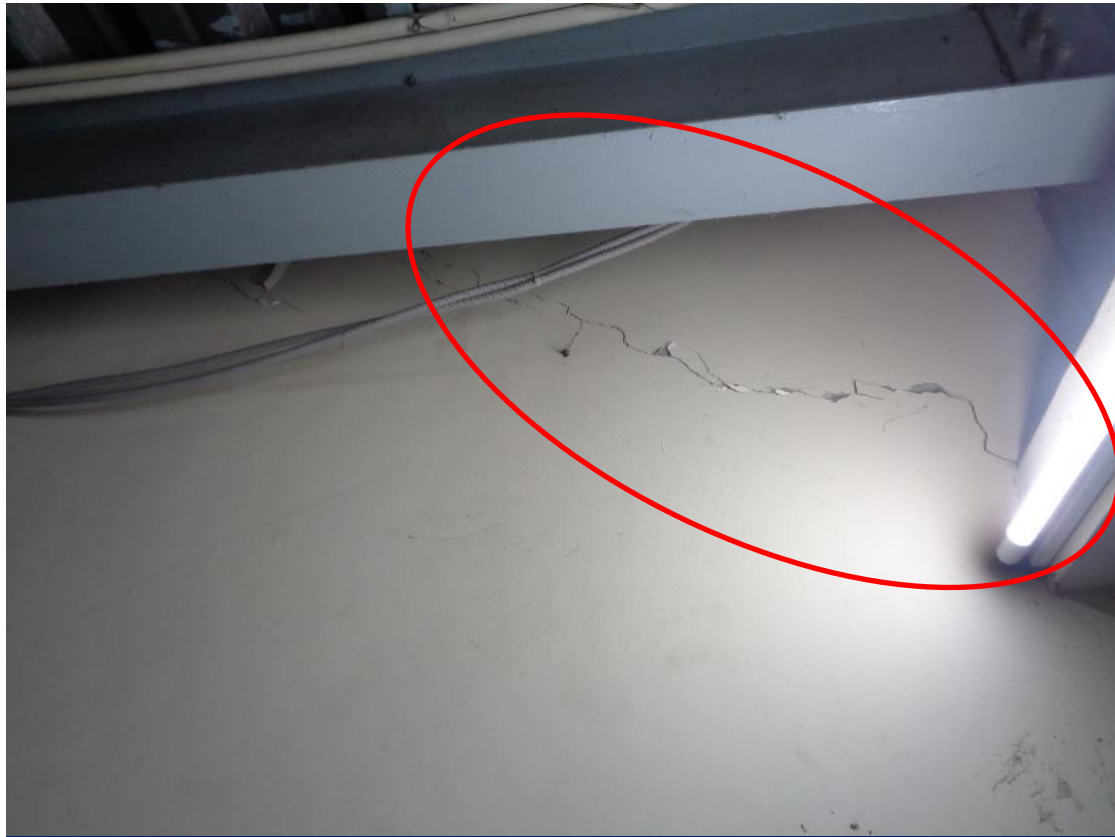
Crack observed on brick wall at several locations

Crack observed on brick wall at several locations. Building engineer is required to instigate the reason of the crack and repair with a suitable method.

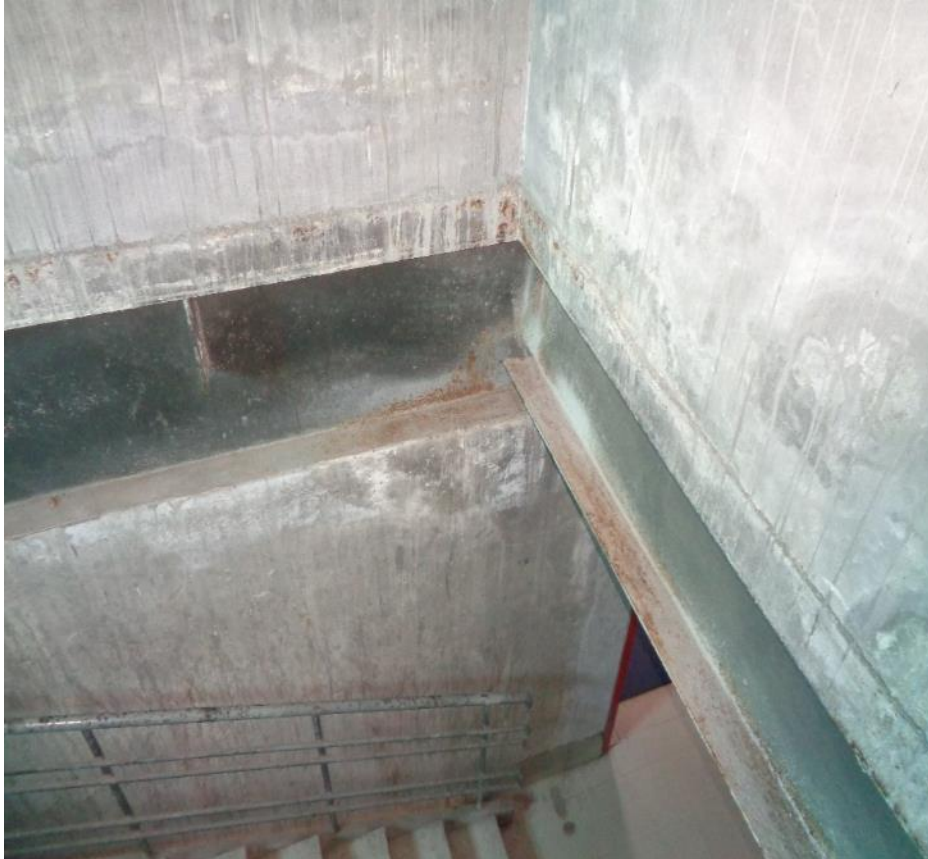
Corrosion on steel members

Corrosion was observed on steel members at several locations. Factory is required to provide rust proof paint on all steel members to protect from corrosion.

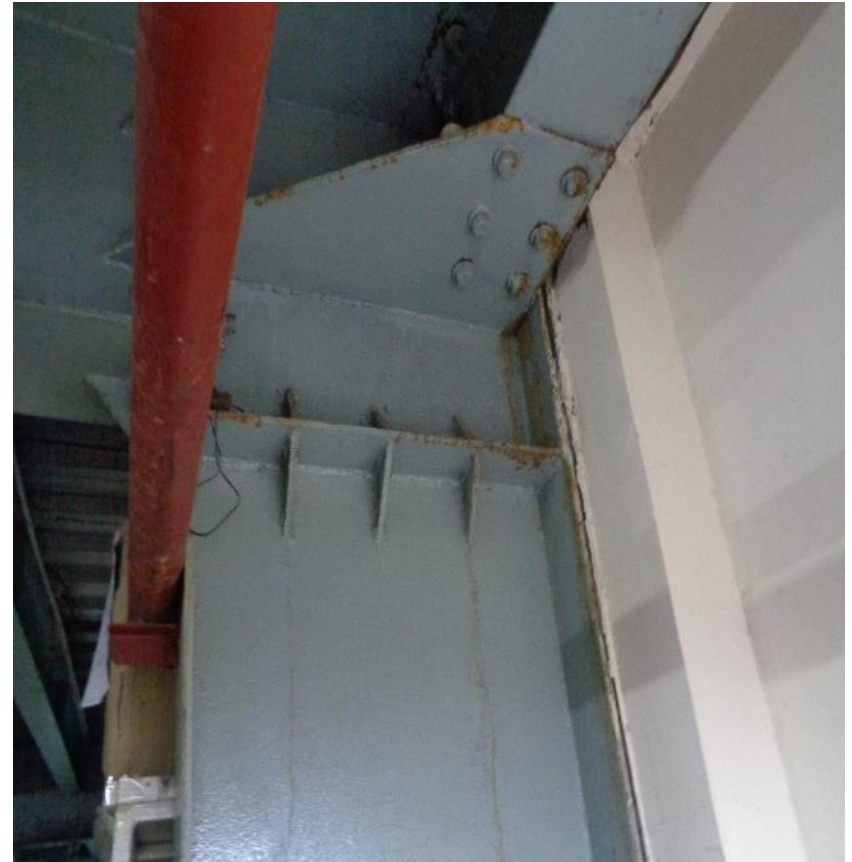
Corrosion on steel members

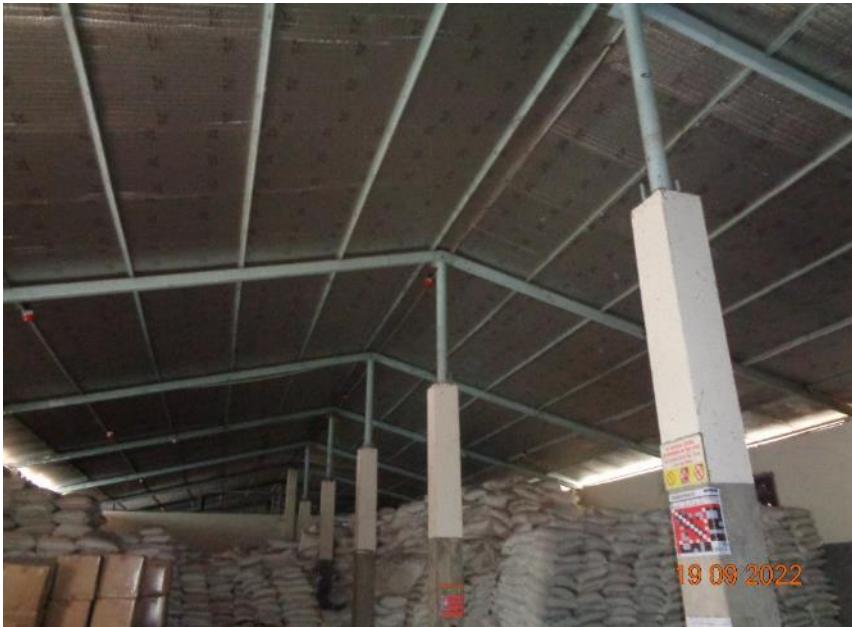
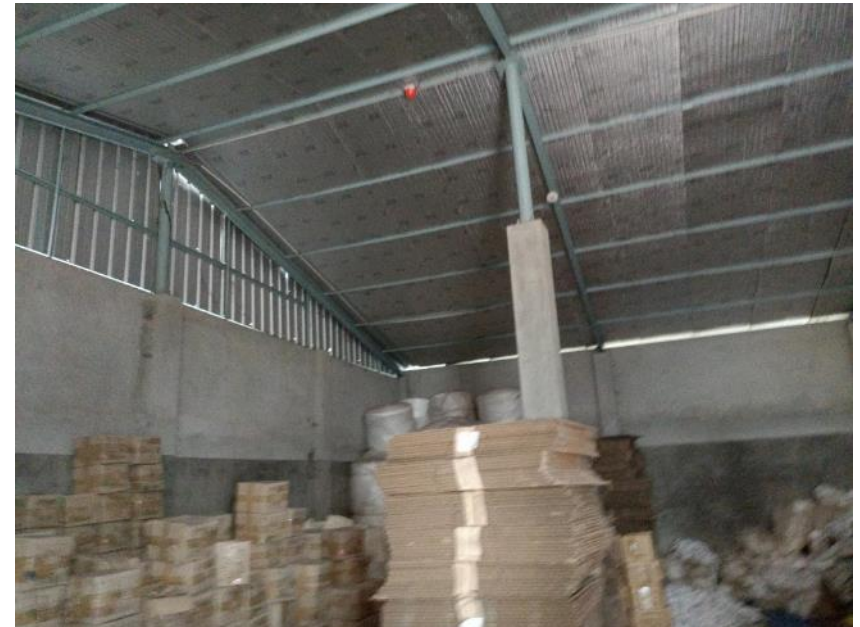
Load transfer media (Bracing, Compression Strut) is not provided. Therefore, lateral stability system of the shed is apparently incomplete. Also, apparently the members are inadequate to resist vertical and lateral loading. Building engineer is required to check the lateral stability of the structure.

Load transfer media is missing at along long direction

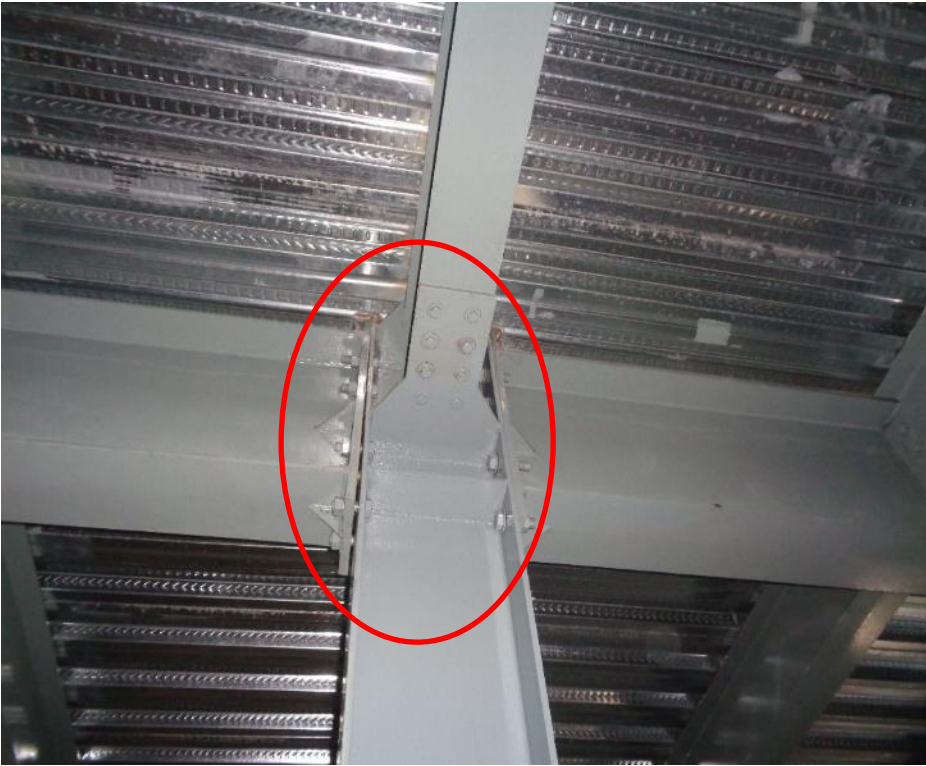
Gap was observed in connection

Gap and warping were observed in connection of steel members. Factory is required to repair the connections with suitable method suggested by building engineer.

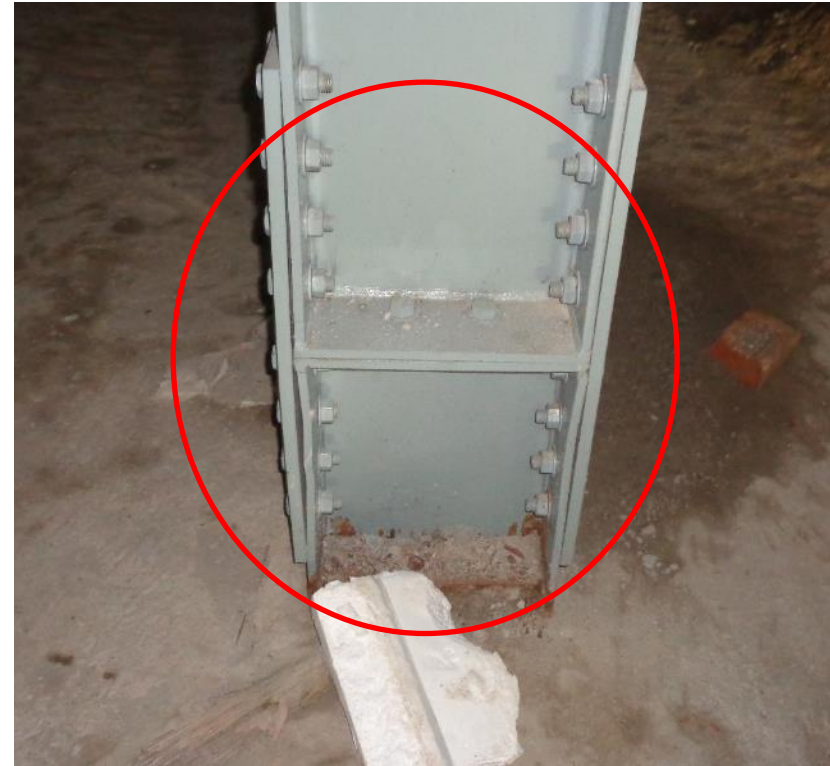
Warping in connection

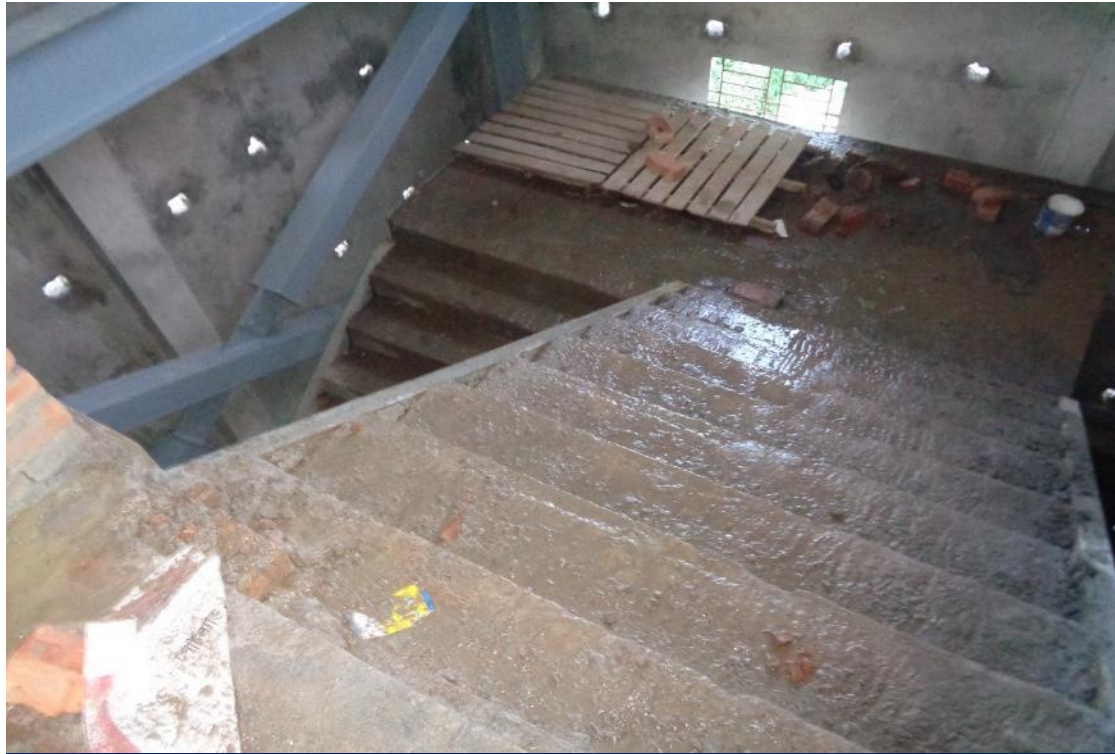
Railing was missing at several location at staircase

Building engineer is required to provide railing at all locations of staircase to prevent possible falling hazard.

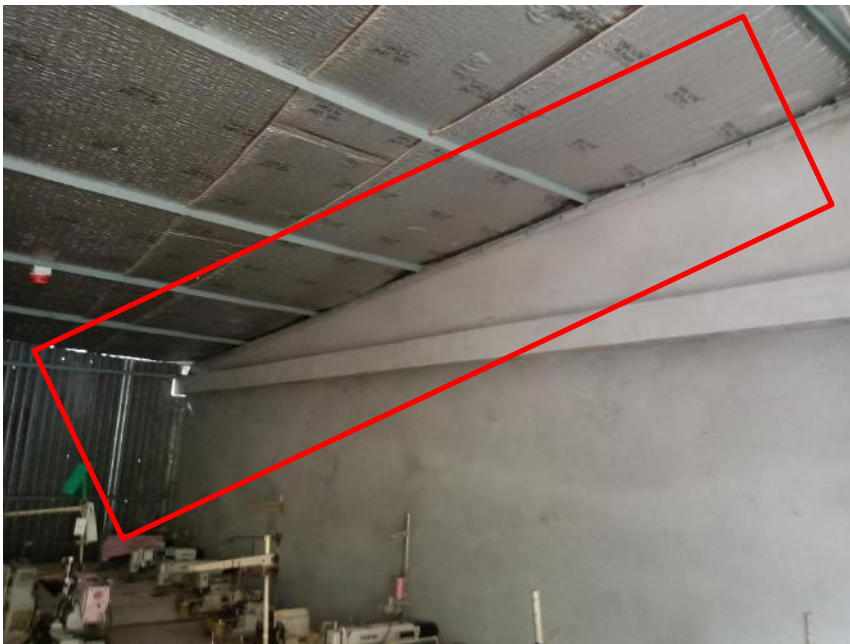
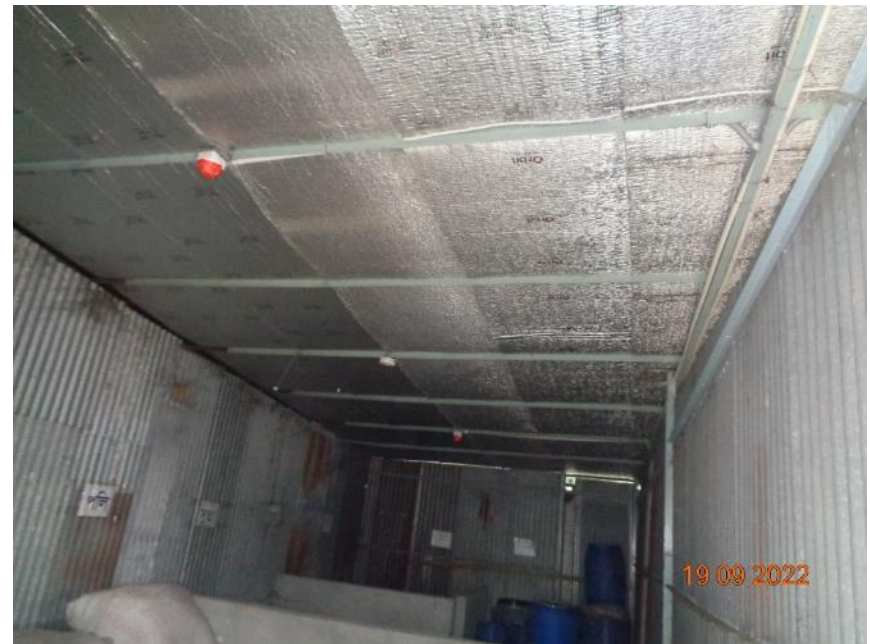
Apparently Inadequate structural member, poor connection details were found. Building engineer is required to check the adequacy of the steel members & connection for uplift and lateral forces otherwise replace with engineered structure.

Apparently inadequate connection

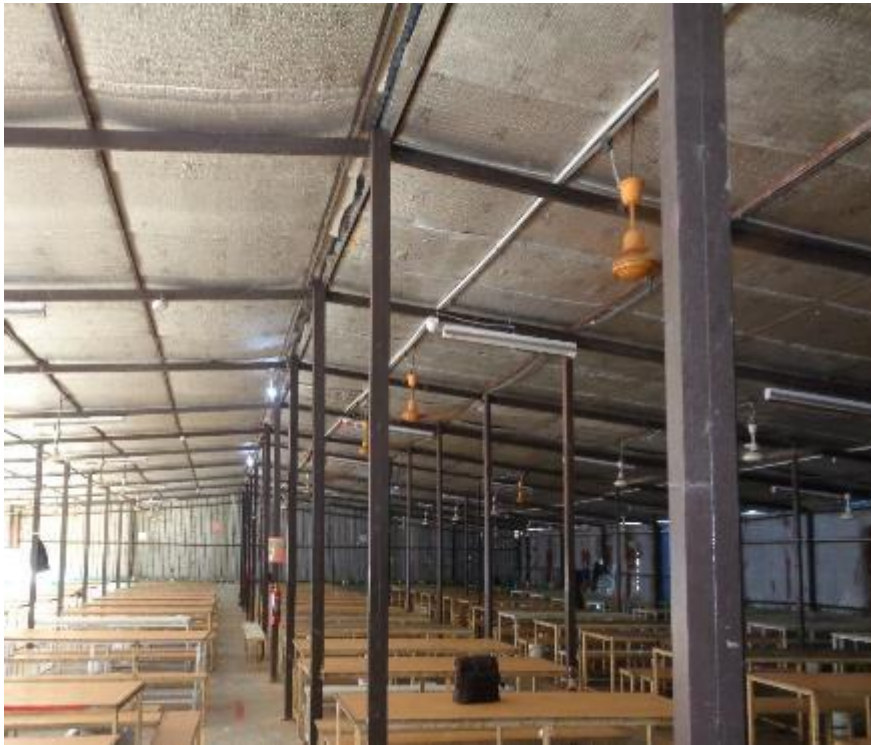
No obvious stability system

Shed -13 (Worker dining Shed) was appeared to be non engineered due to lack of apparent load path, poor connection and apparently inadequate member size. Building engineer is required to check the connection adequacy for uplift forces as part of EA otherwise replace with well designed structure.

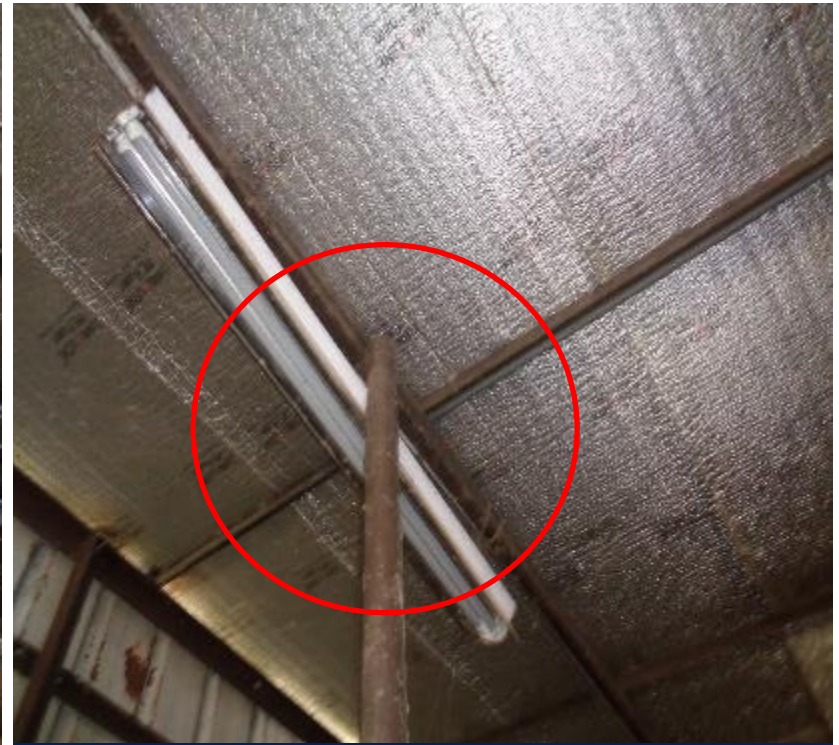
Poor connection

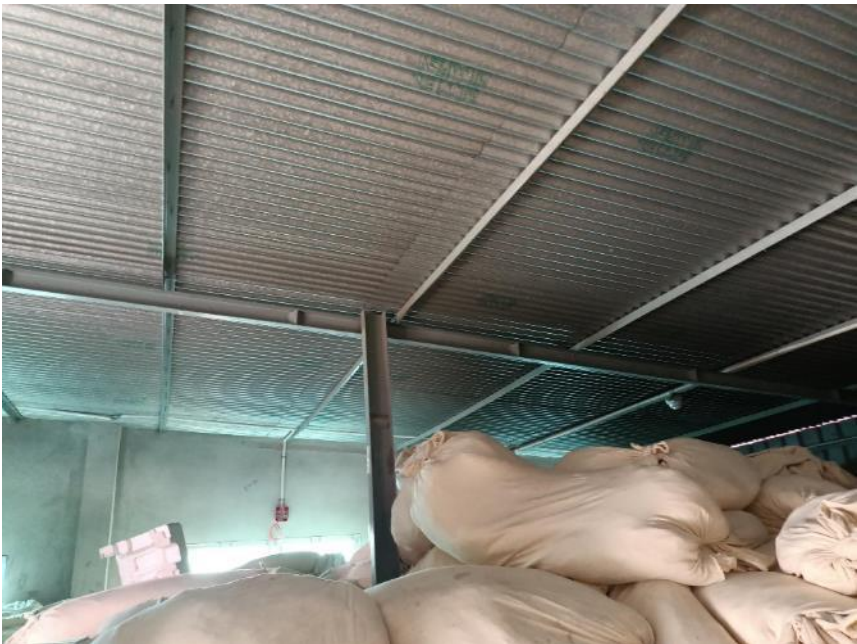
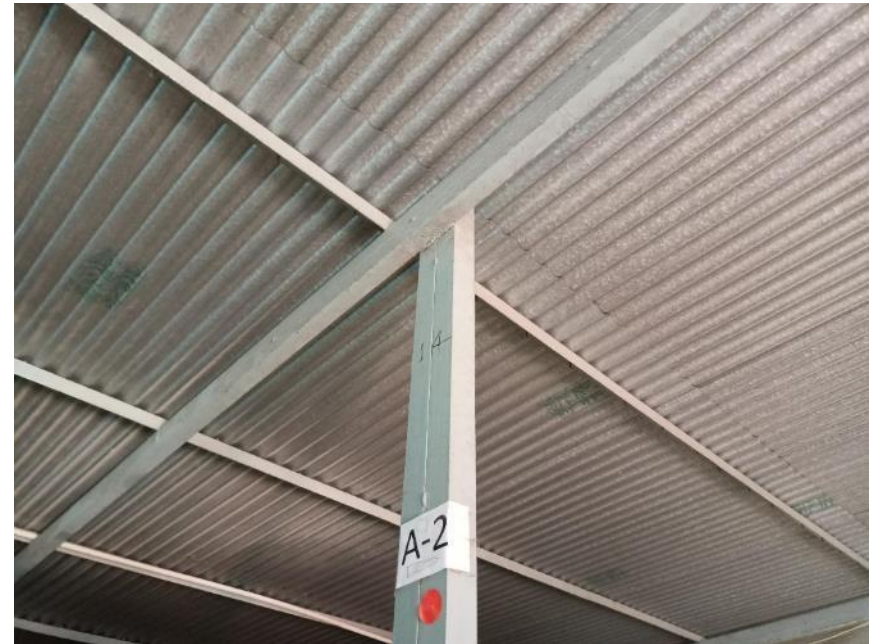
Apparently Inadequate structural member, poor connection details were found. Building engineer is required to check the adequacy of the steel members & connection for uplift and lateral forces otherwise replace with engineered structure.

Apparently inadequate connection

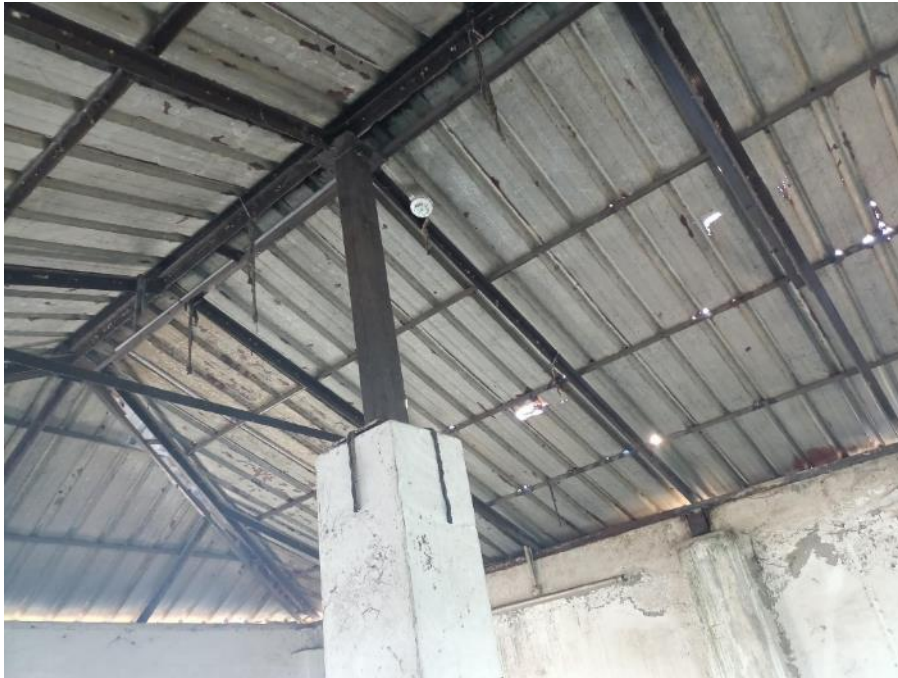
Roof shed of ETP Building

As-built structural drawing and architectural drawings were not available for ETP building. Building engineer is required to survey the whole structure and produce accurate as-built drawing.

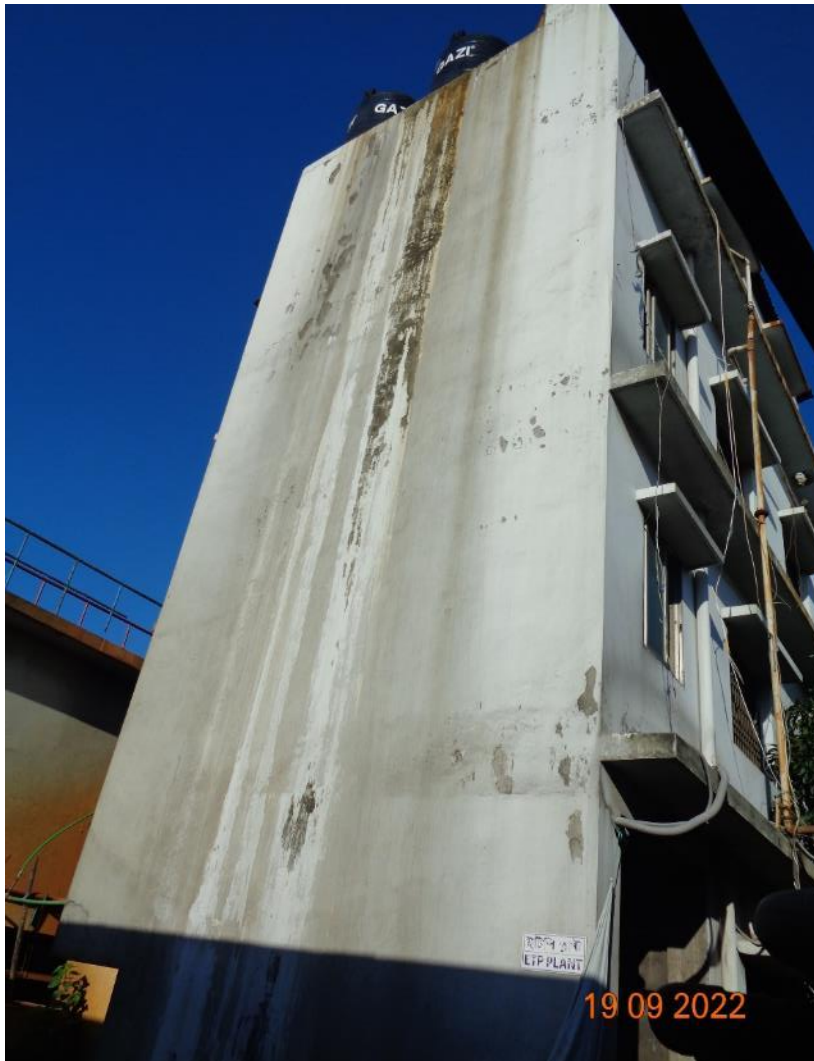
ETP Building

Geotechnical investigation report was not available for this structure. On the other hand, foundation details were unavailable.

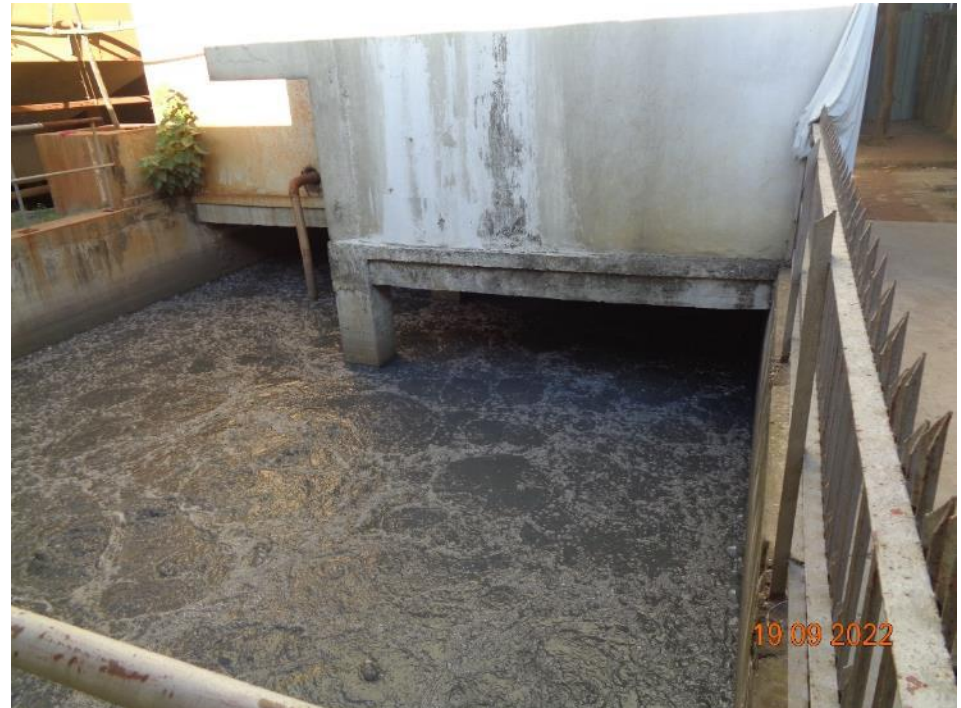
Foundation drawing was not available for ETP Building. Building engineer is required to investigate foundation details and check the foundation capacity accordingly.

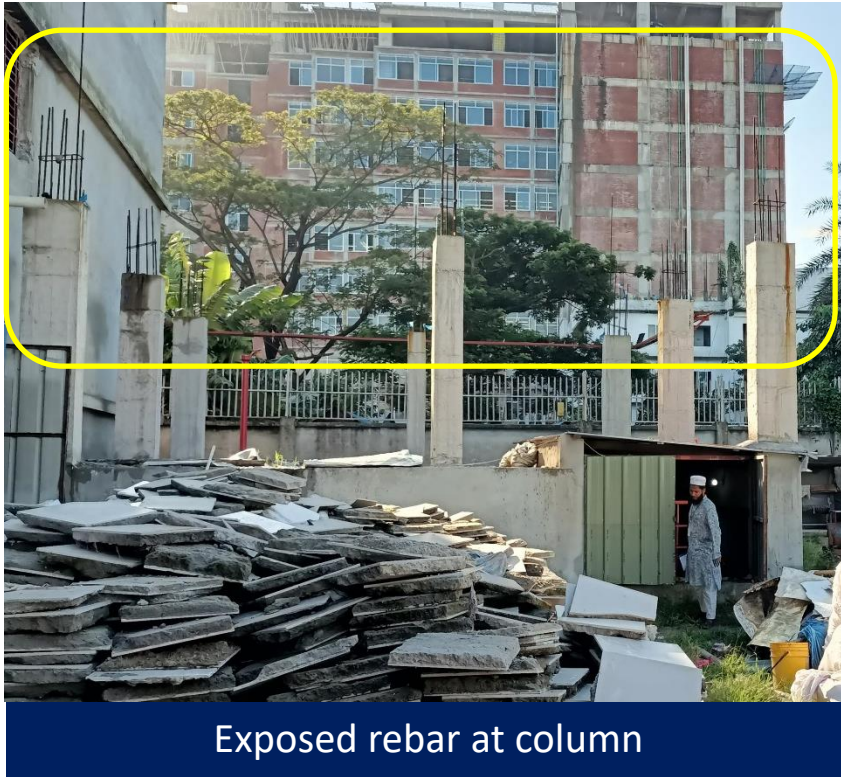
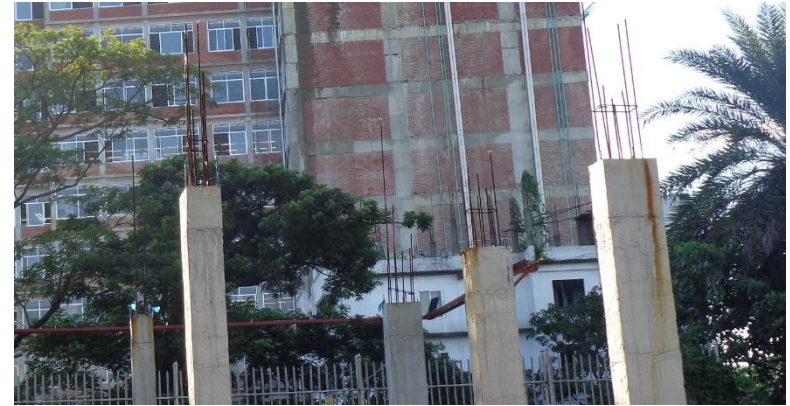
Exposed reinforcement was found at column which is susceptible to corrosion that may be the cause of deterioration for concrete. Building engineer is required to take necessary measures to prevent the corrosion in exposed rebar.
