# Tanima Knit Composite Ltd. (Extension)

10/20, SOUTH DARIAPUR, SAVAR, DHAKA-1340  
(23.833847, 90.254812)  
10 October 2022

# Buildings Information

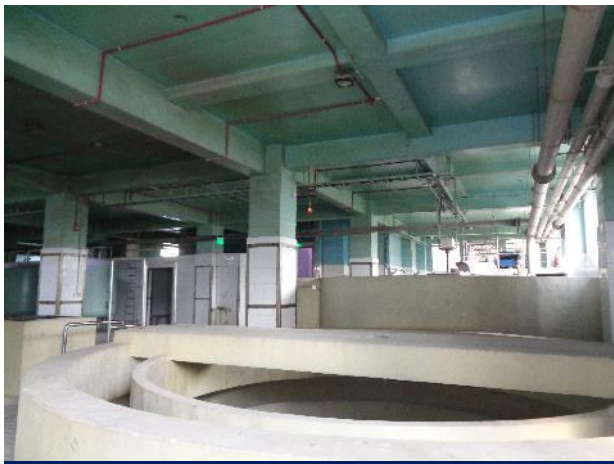
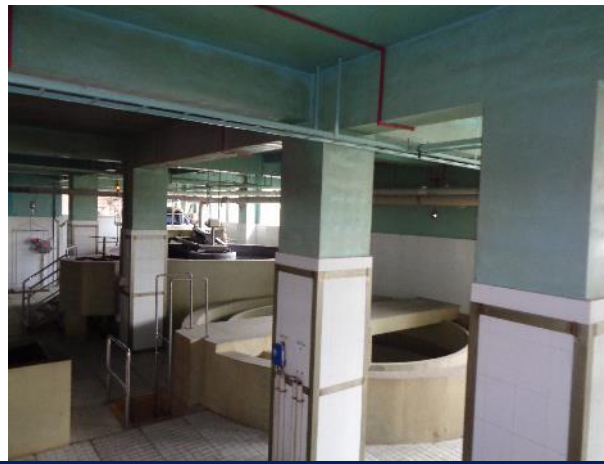
Marked columns were not found at ground floor to 1<sup>st</sup> floor level.

The building engineer is required to survey the structure and prepare accurate as-built drawings. Also, revise the structural analysis and EA report accordingly.

| Item No. | Observation | Recommended Action Plan | Recommended Timeline |
|---|---|---|---|
| 01 | Mismatch between drawing & as-built condition. (ETP Building) | The building engineer is required to survey the whole structure and prepare accurate as-built drawings with structural details. | 6-weeks |
| 02 | Mismatch between drawing & as-built condition. (ETP Building) | Revise the structural analysis and Engineering Assessment (EA) report based on updated as-built drawings and submit EA documents to the RSC for review. | 6-weeks |

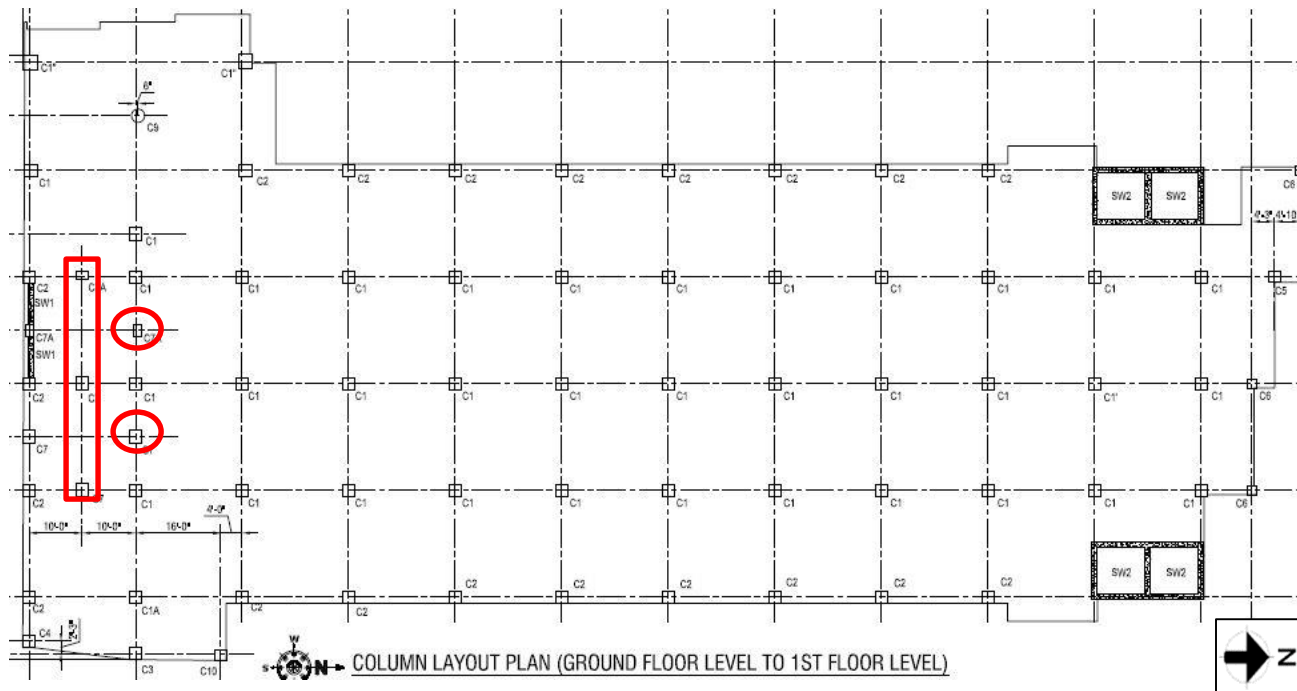
Column Layout plan for ground floor to 1<sup>st</sup> floor

Missing columns locations

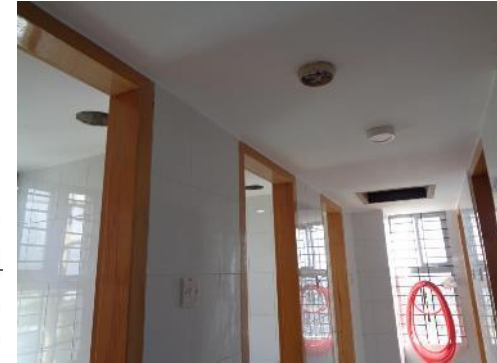
Toilet false slab and built-ups was not shown in drawings.

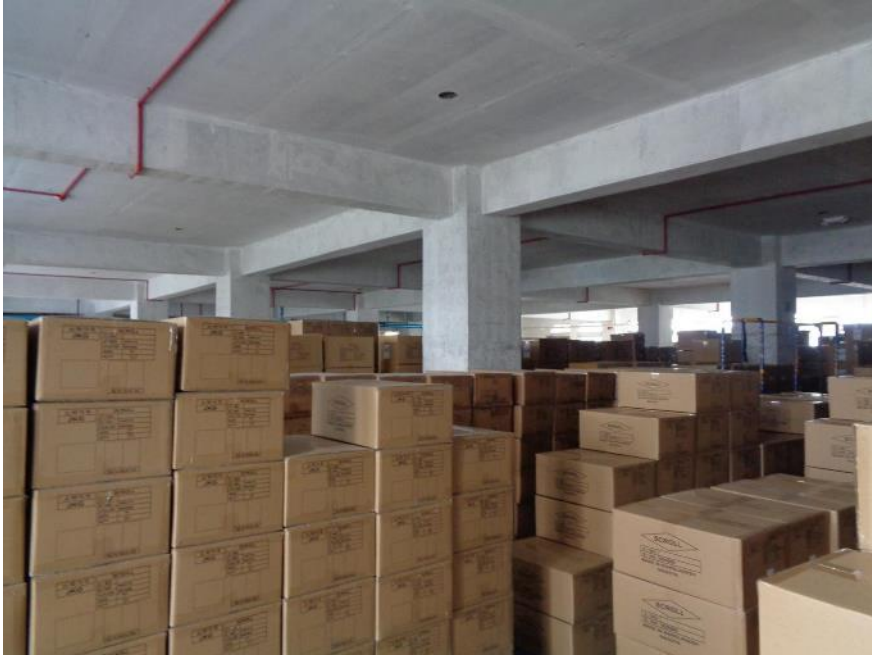
No load height marking on 2<sup>nd</sup> floor storage area

The factory is required to implement floor load management program and maintain floor loading accordingly.

| Item No. | Observation | Recommended Action Plan | Recommended Timeline |
|---|---|---|---|
| 04 | Lack of floor load management. (ETP Building) | Remove the storage from cutting areas and provide signage and height marking in the storage areas. | 6-weeks |

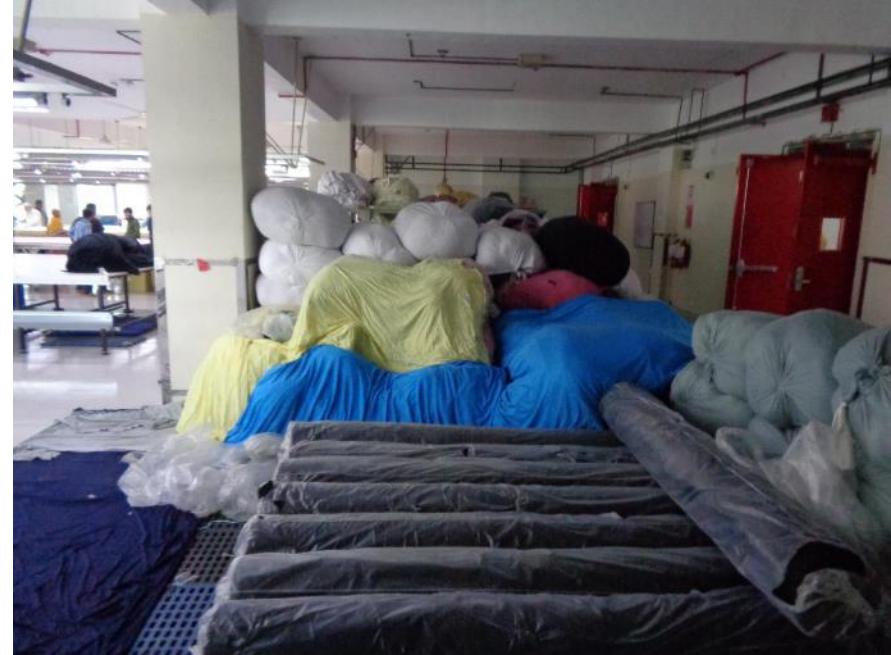
Storage in cutting table areas on 1<sup>st</sup> floor

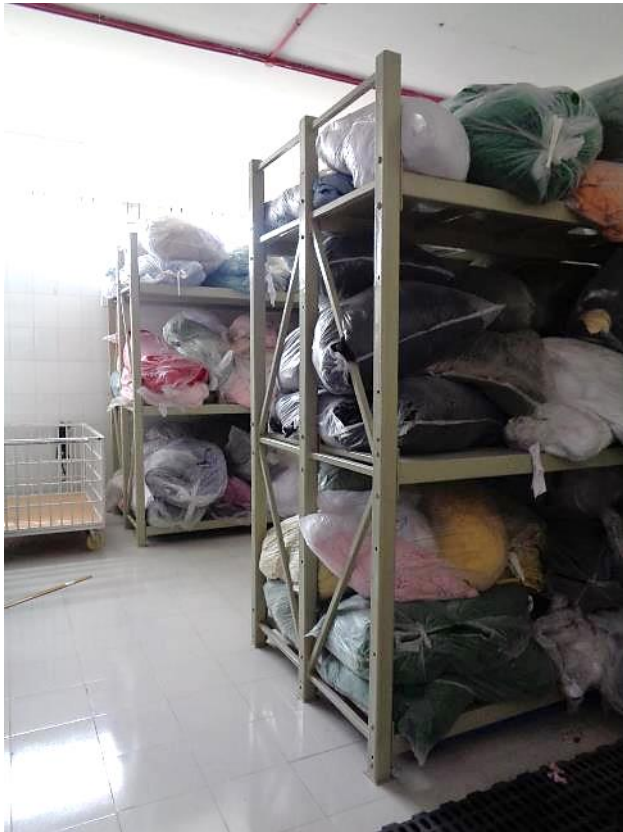
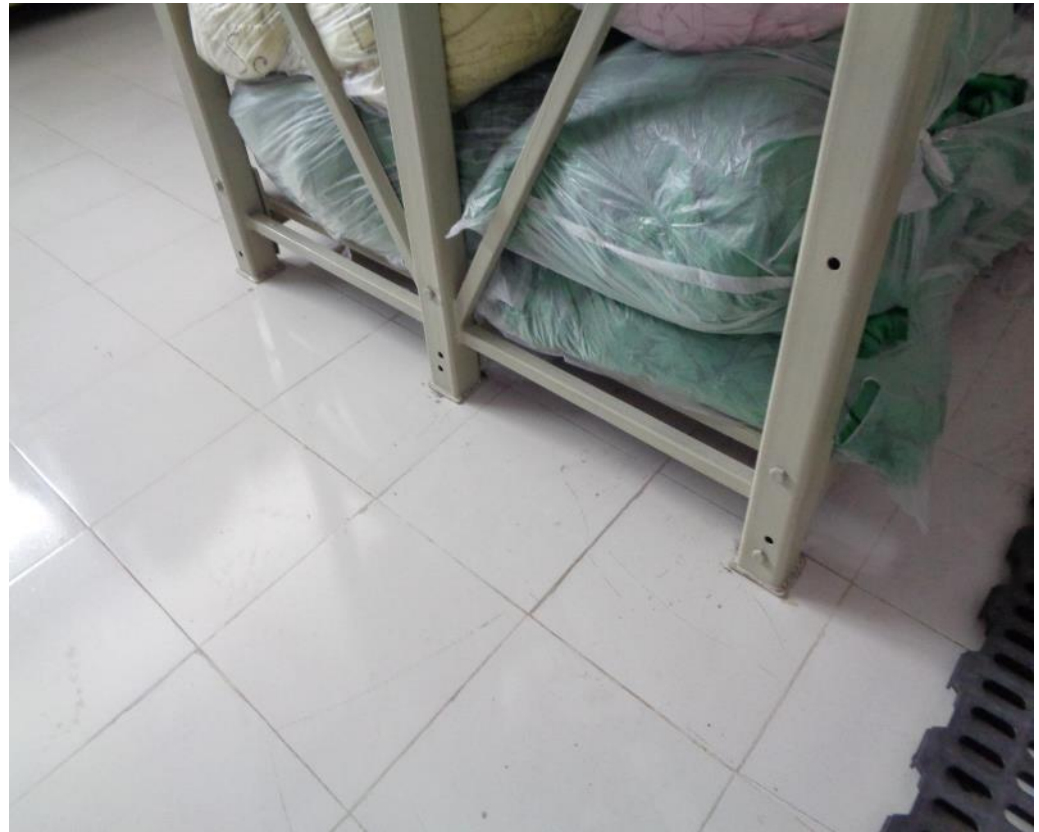
Rack without lateral bracing or anchorage

Provide lateral bracing or anchorage to all non-structural elements of the building.

| Item No. | Observation | Recommended Action Plan | Recommended Timeline |
|---|---|---|---|
| 06 | Anchorage to the storage racks. (ETP Building) | Provide lateral bracing or anchorage to all non-structural elements of the building. | 6-months |

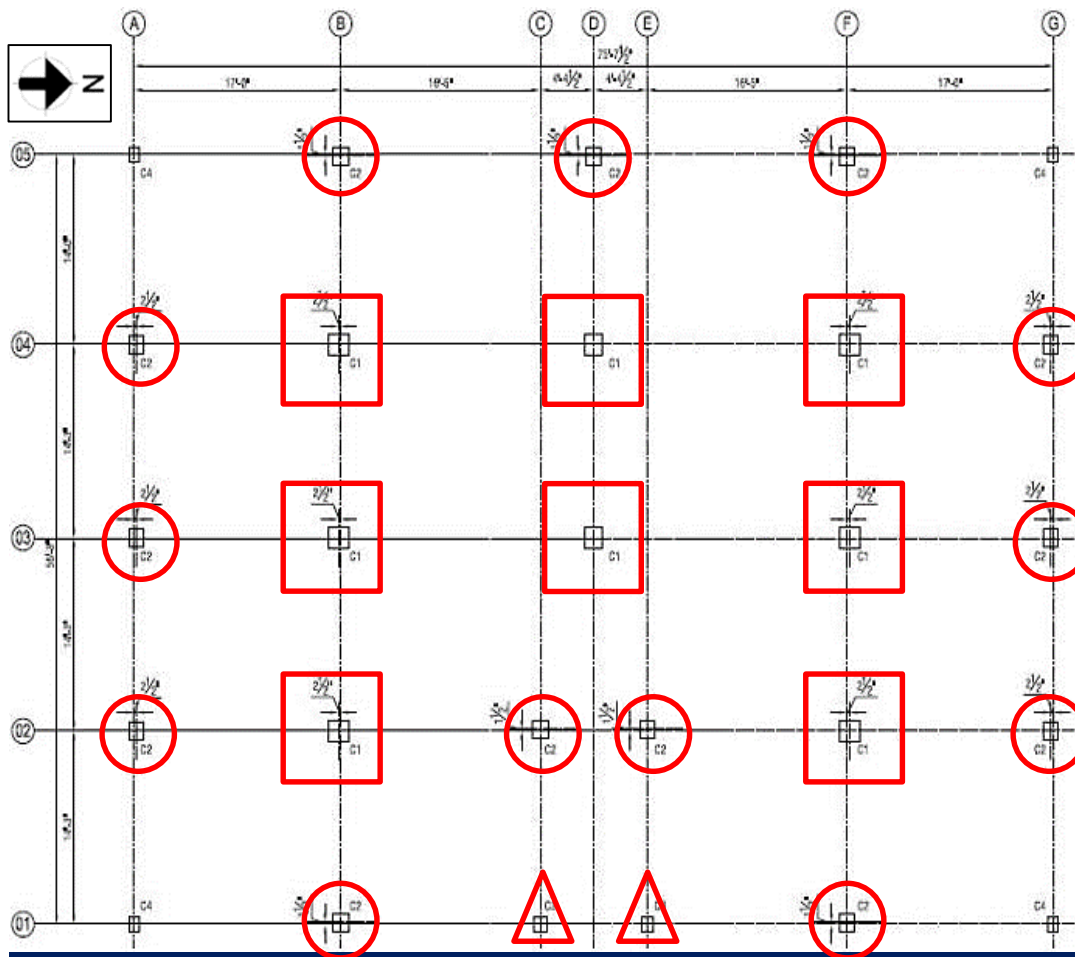
Column Layout plan for Basement to GF

C1 column was found 800 mm X 800mm instead of 575mm X 525mm.

C2 column was found 700 mm X 700mm instead of 450mm X 450mm.

C3 column was found 600 mm X 600mm instead of 300mm X 300mm.

The building is required to survey the structure and prepare accurate as-built structural drawings.

| Item No. | Observation | Recommended Action Plan | Recommended Timeline |
|---|---|---|---|
| 07 | Mismatch between drawing & as-built condition. (Store Building) | The building engineer is required to survey the whole structure and prepare accurate as-built drawings with structural details. | 6-weeks |

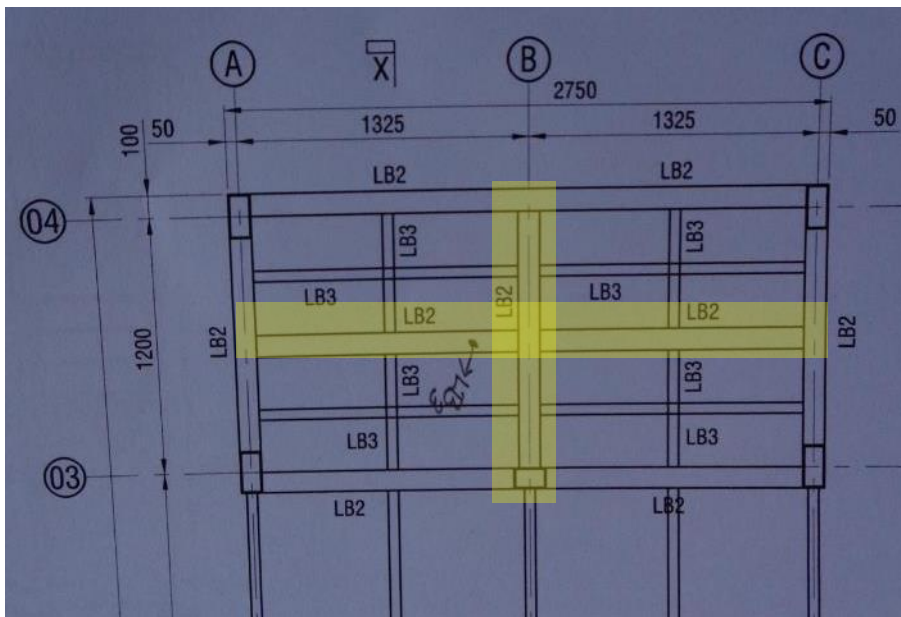
Steel landing beam layout (Middle beams are LB2)

The middle beams of steel stair landing was mentioned as LB2 (100x100 mm box) but onsite the beam size was measured as 50x50 mm box (LB3).

The building is required to survey the structure and prepare accurate as-built structural drawings.

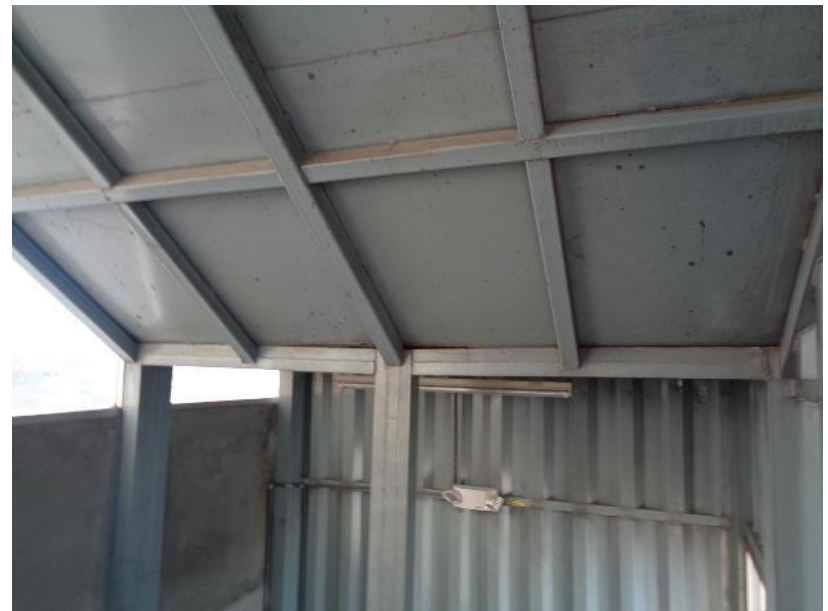
Onsite condition (Middle beams are LB3)

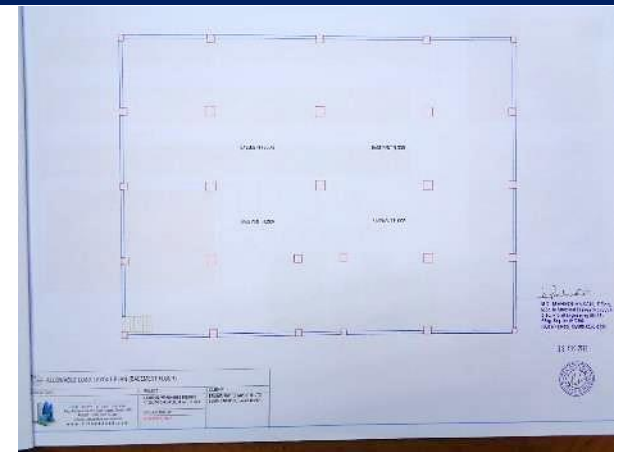
Basement floor load plan.

There are some mismatch between building information and onsite conditions. The flat plate framing system, basement floor and MAT foundation are not mentioned in the building information. Furthermore, construction year is mentioned as 2021 instead of 2006. Basement floor loading limit was not mentioned in the floor load plan.

The building engineer is required to revise the EA report of both RC building and adjacent steel stair, and submit the revised EA to RSC for further review.

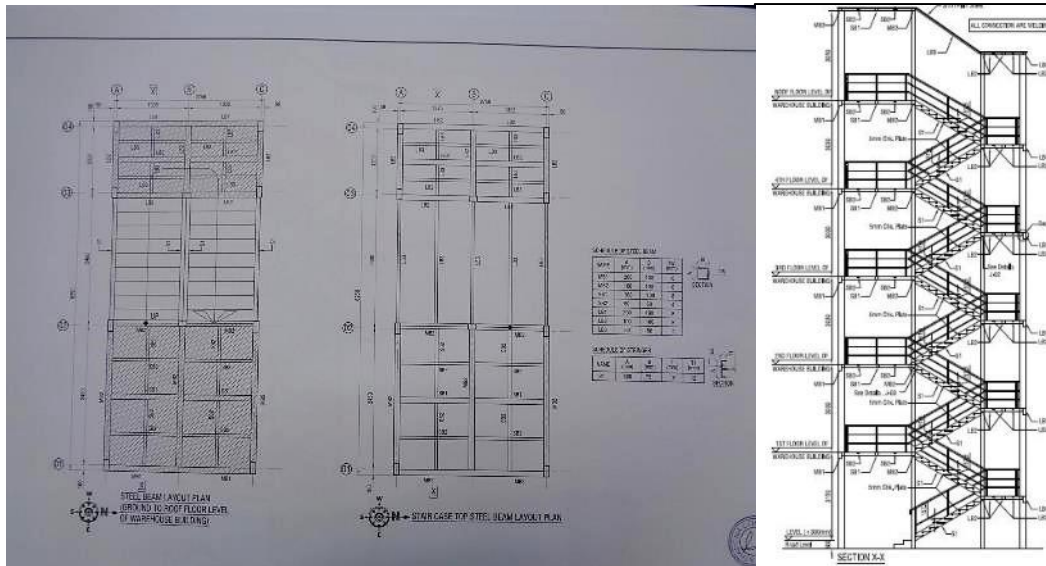
As-built structural drawing of steel stair.

Retrofitting of steel stair was suggested in the EA report which has not been implemented yet. During inspection lateral support between RC building and steel stair was observed. The building engineer is required to investigate the support connections and revise connection details.

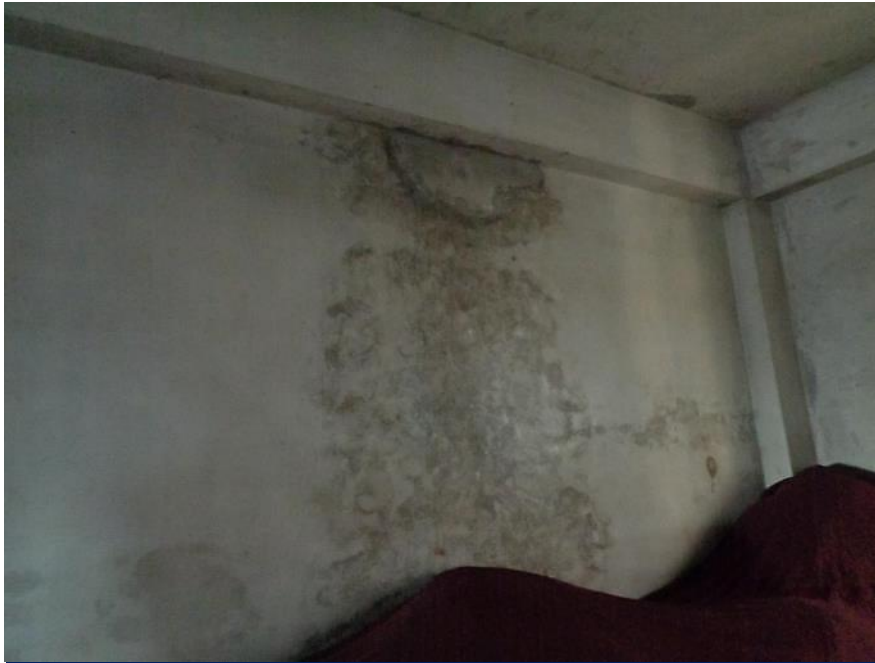
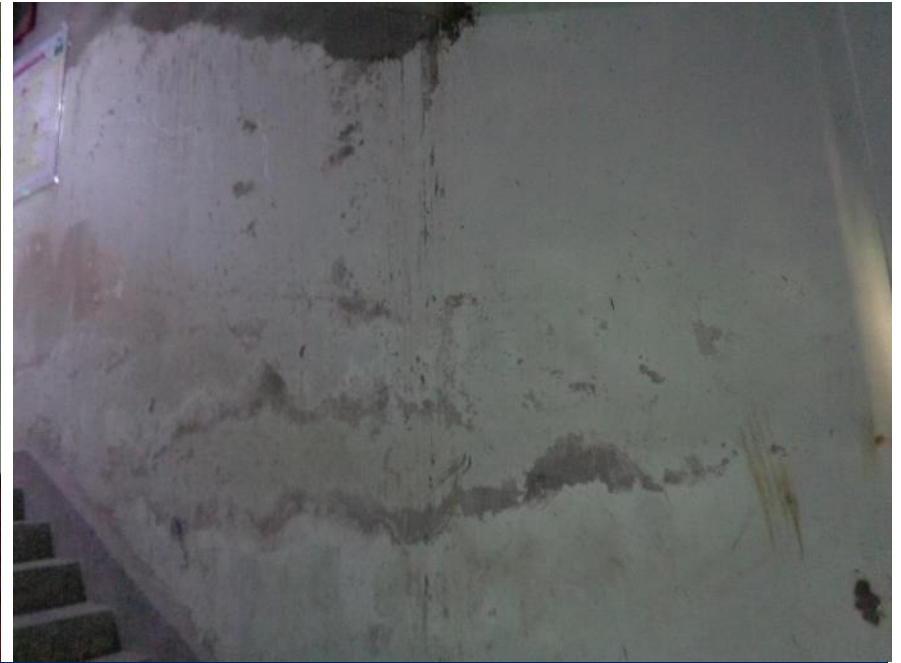
Dampness on wall of RC stair zone

Dampness observed on the brick wall in several locations of RC stair zone. The factory is required to identify the reason of dampness and repair the damp areas with suitable repair method.

| Item No. | Observation | Recommended Action Plan | Recommended Timeline |
|---|---|---|---|
| 11 | Dampness on brick walls. (Store Building) | The factory is required to identify the reason of dampness and repair the damp areas with suitable method. | 6-months |
