# PNG (BD) LTD. (NEW SHED)

Karerhat, Sattaroa, Jorarganj, Mirsharai, Chattogram  
(22.9414841, 91.5560009)

17 August 2022

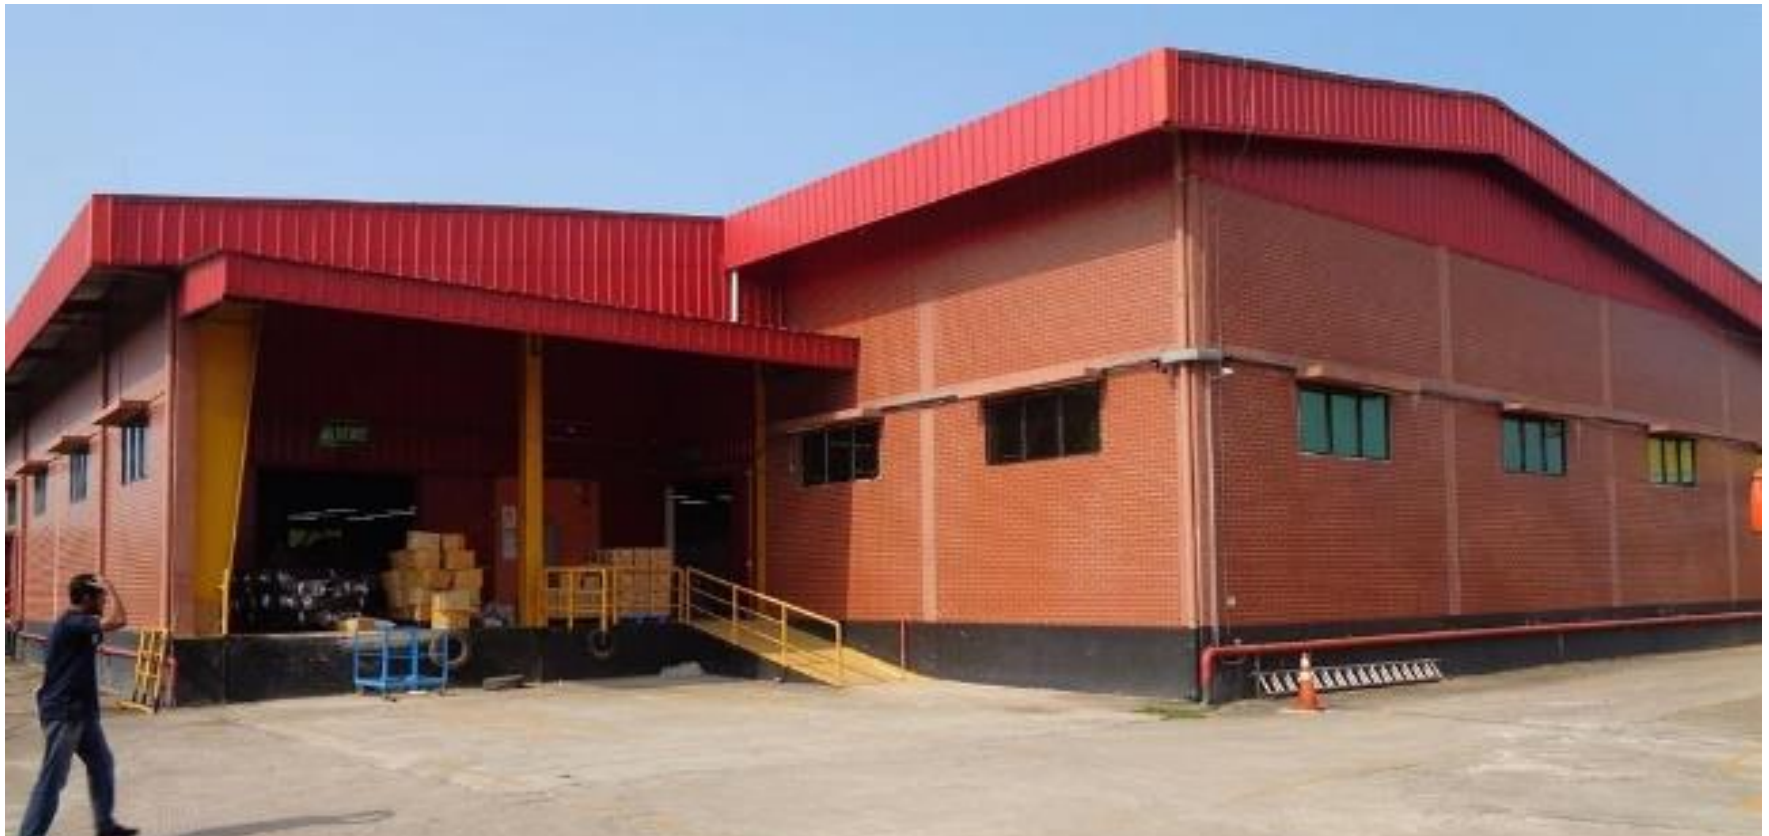
Store Shed

At the time of inspection, the design report was not available which is required to be prepared in compliance with section 1.9.1.1 and section 1.9.1.2 of BNBC (part-6).

| Item No. | Observation | Recommended Action Plan | Recommended Timeline |
|---|---|---|---|
| 01 | Design report not available. | Building engineer is required to prepare design report in compliance with section 1.9.1 of BNBC (part-6). | 6-weeks |

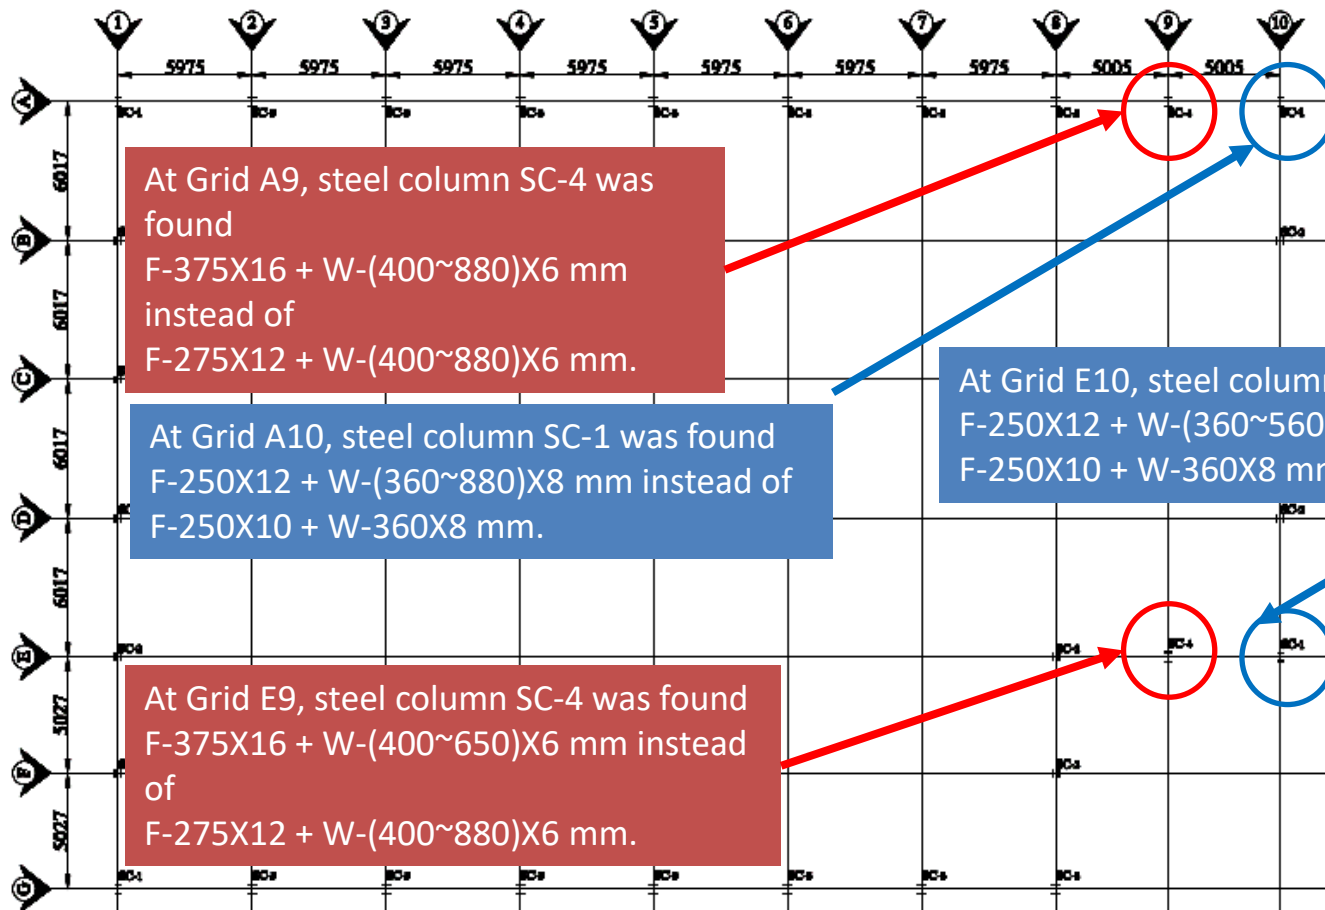
Steel Column Layout

Steel column schedule according to provided as-built drawing

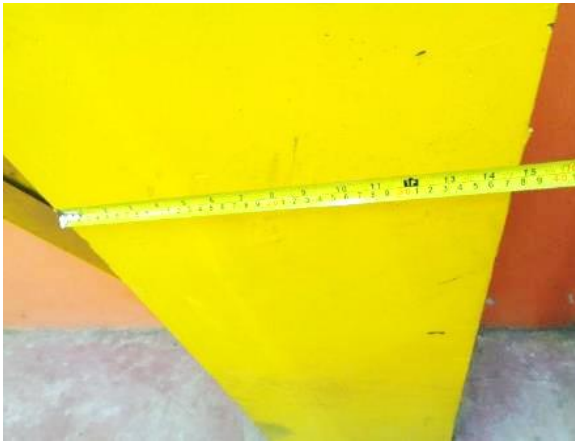
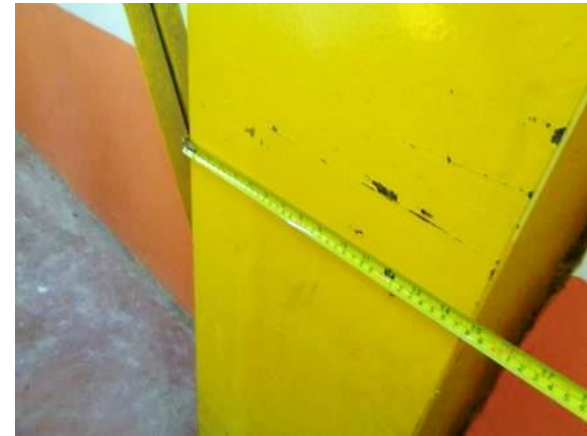
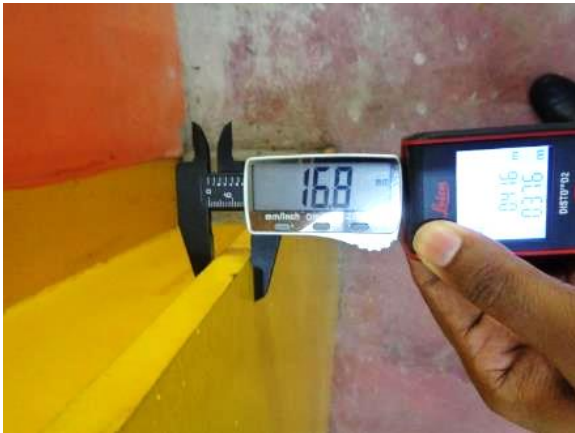
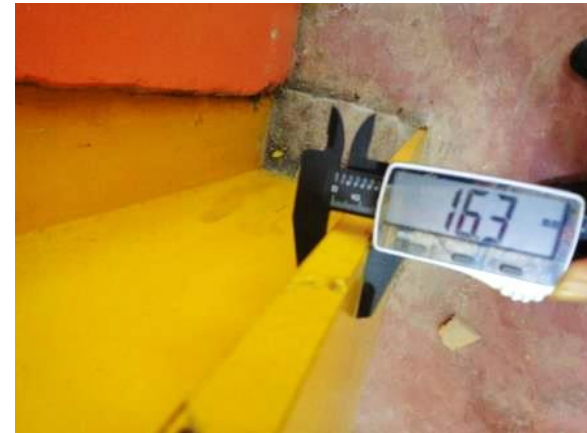
At Grid A9, steel column was found F-375X16 + W-(400~880)X6 mm instead of F-275X12 + W-(400~880)X6 mm.

At Grid E9, steel column was found F-375X16 + W-(400~650)X6 mm instead of F-275X12 + W-(400~880)X6 mm.

Building Engineer is required to survey the whole structure and to prepare accurate as-built drawing.

| Item No. | Observation | Recommended Action Plan | Recommended Timeline |
|---|---|---|---|
| 03 | Discrepancy in as-built drawing. | Building engineer is required to survey the structure & prepare accurate as-built drawings with structural details. | 6-weeks |

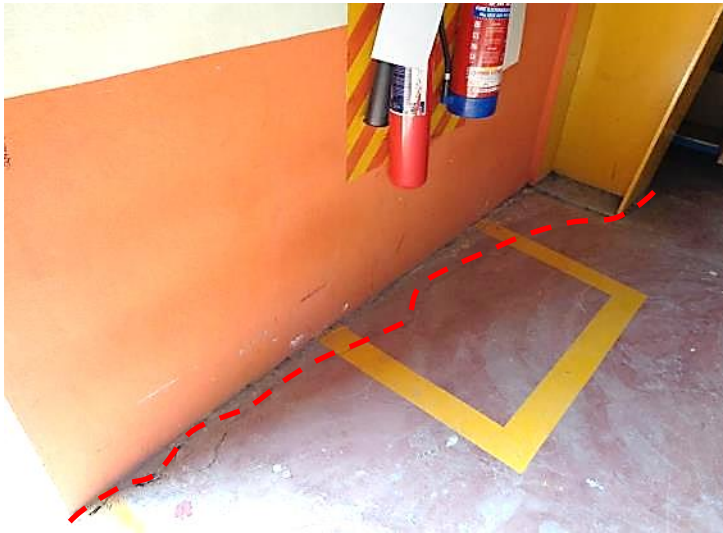
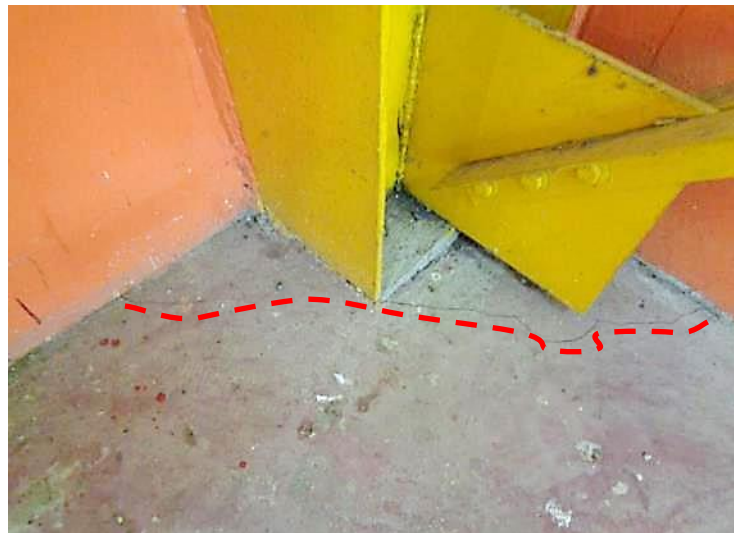
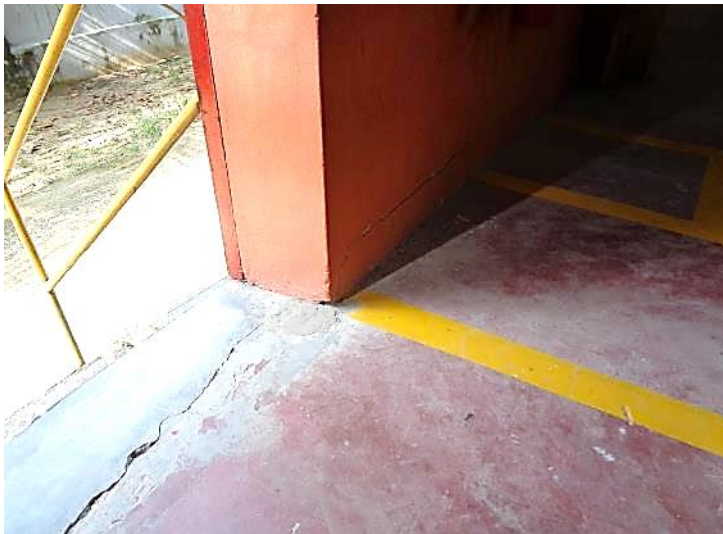
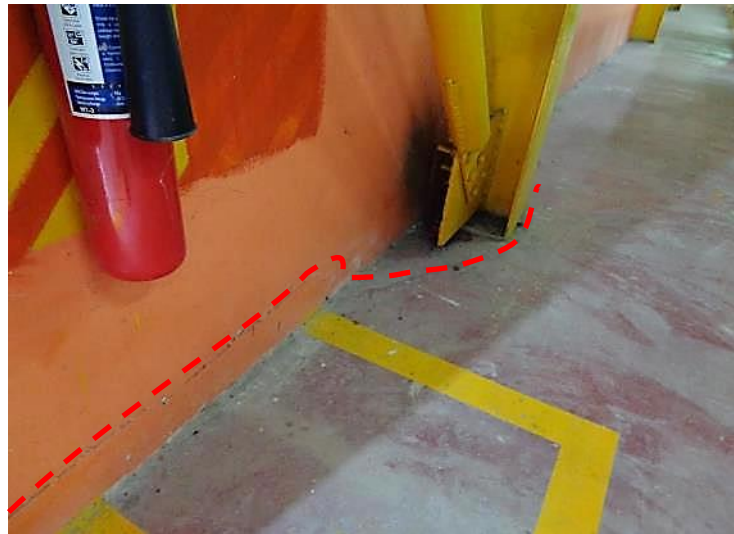
Crack was observed on the ground slab and walls. Building Engineer is required to investigate the reason of the crack and suggest remedial action.

| Item No. | Observation | Recommended Action Plan | Recommended Timeline |
|---|---|---|---|
| 04 | Crack observed on the ground slab & wall | Building engineer is required to investigate the reason of the crack and prepare an investigation with required remedial action. | 6-weeks |
| 05 | Crack observed on the ground slab & wall | Carry out remedial work where required. | 6-months |
