# Designer Fashion Ltd. (Warehouse)

Gohailbari, Shimulia, Ashulia, Savar, Dhaka-1345

8 August 2022

1. Warehouse (Building No-2) (G+1)

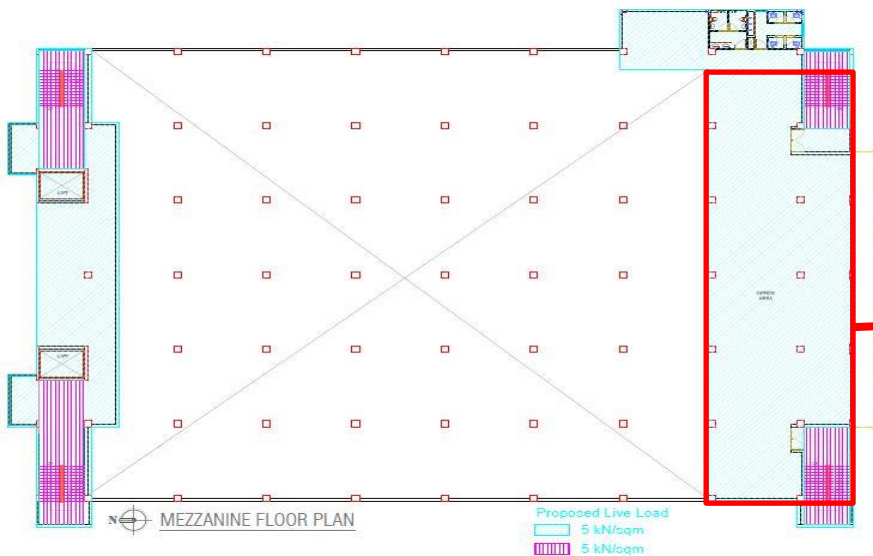
Live load plan- Mezzanine floor (above ground)

Live load on mezzanine floor above ground is considered as 5 kPa in prepared load plan and occupancy type shown as office but storage was observed on that area. As per BNBC- Part 6, live load for light storage areas is required to be considered minimum 6 kPa. However, the building engineer is required to revise the live load plan as per BNBC requirement and check the design accordingly.

| Item No. | Observation | Recommended Action Plan | Recommended Timeline |
|---|---|---|---|
| 01 | Prepared load plan to be revised (Warehouse: Building No-2) | The building engineer is required to revise the load plan as per BNBC requirement and check the design accordingly. | 6-weeks |
| 02 | Prepared load plan to be revised (Warehouse: Building No-2) | Implement remediation work from design check if required. | 6-months |

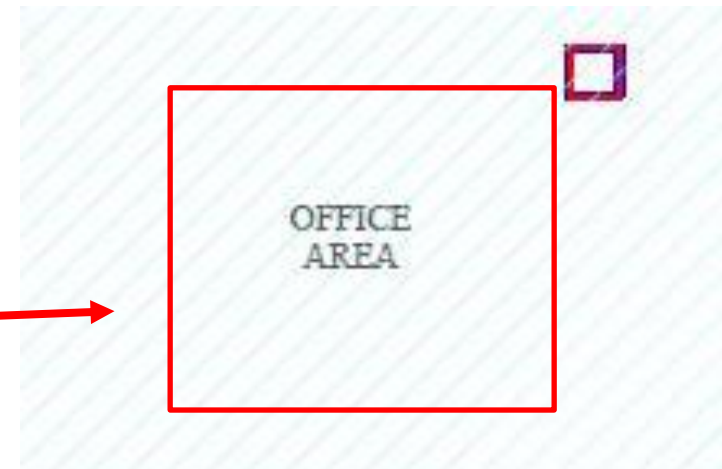
Office area mentioned in the load plan with live load limit of 5 kPa.

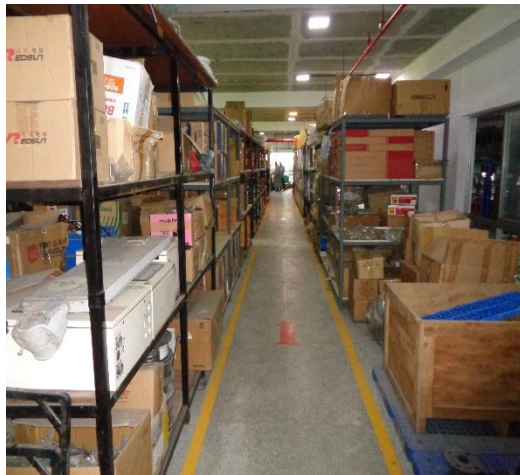
Storage on Mezzanine above ground floor.

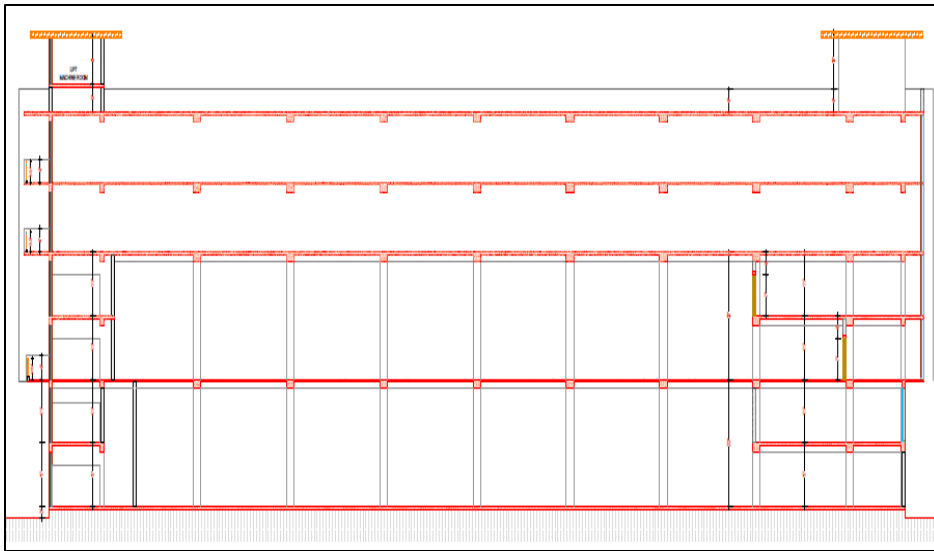
Building is permitted for 4 storied (as per approval drawing from local authority)

For proposed 4 storied building, the cursory calculation indicates that factor of safety (FoS) of internal pile foundations is below the allowable limit. The building engineer is required to carryout a Detail Engineering Assessment (DEA) and submit to the RSC prior for review prior to conduct any further extension above existing 2 storied building.

| Item No. | Observation | Recommended Action Plan | Recommended Timeline |
|---|---|---|---|
| 03 | Foundation stress exceeds normal design limit for proposed 4 storied building (Warehouse: Building No-2) | The building engineer is required to carryout a Detail Engineering Assessment (DEA) and submit to the RSC prior for review prior to conduct any further extension above existing 2 storied building. | 6-weeks |
| 04 | Foundation stress exceeds normal design limit for proposed 4 storied building (Warehouse: Building No-2) | Implement remediation work prior any extension if required. | 6-months |

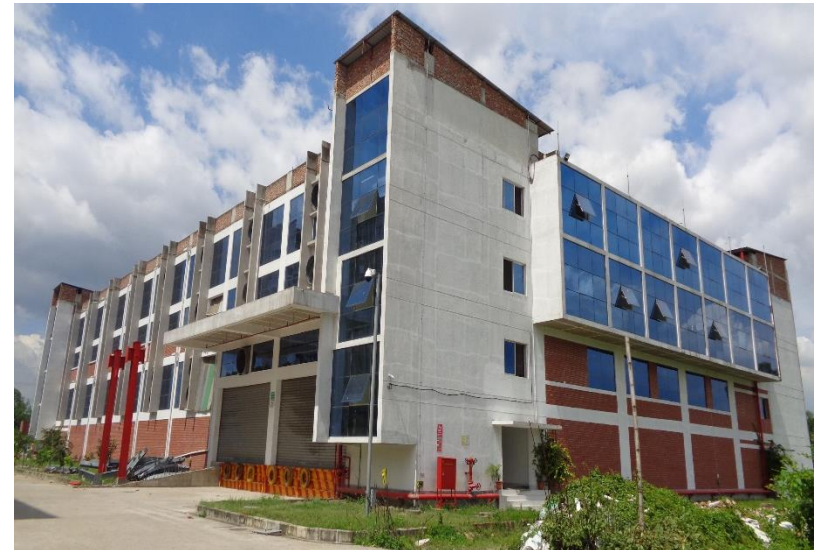
Building is currently 2 storied

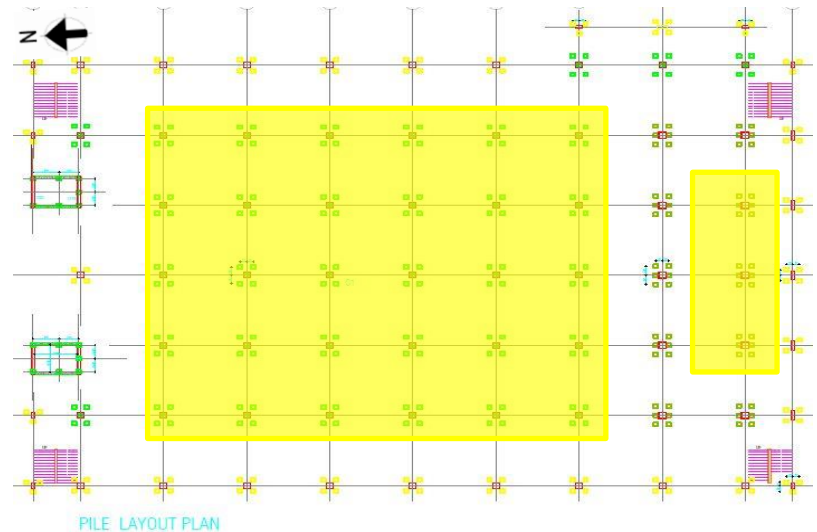
Stressed foundation in layout (yellow mark)

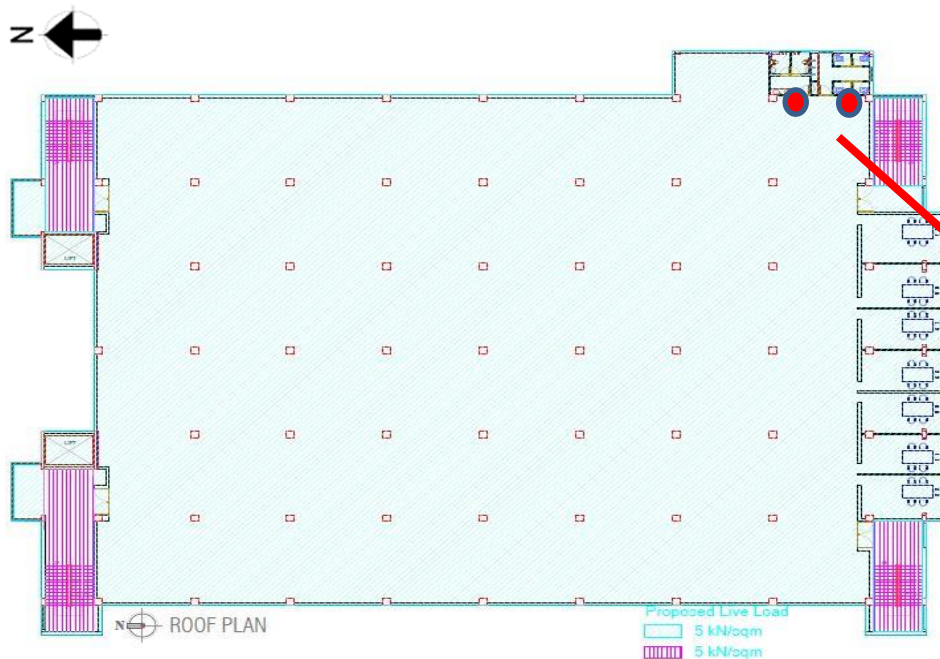
Present roof layout

Two plastic water tanks (capacity- 2000 litre each) found on roof slab which were not shown in roof layout. The building engineer is required to update the current roof layout plan.

| Item No. | Observation | Recommended Action Plan | Recommended Timeline |
|---|---|---|---|
| 05 | Discrepancy in as-built drawings (Warehouse: Building No-2) | The building engineer is required to survey the structure and update the as-built drawings to the as-constructed status. | 6-weeks |

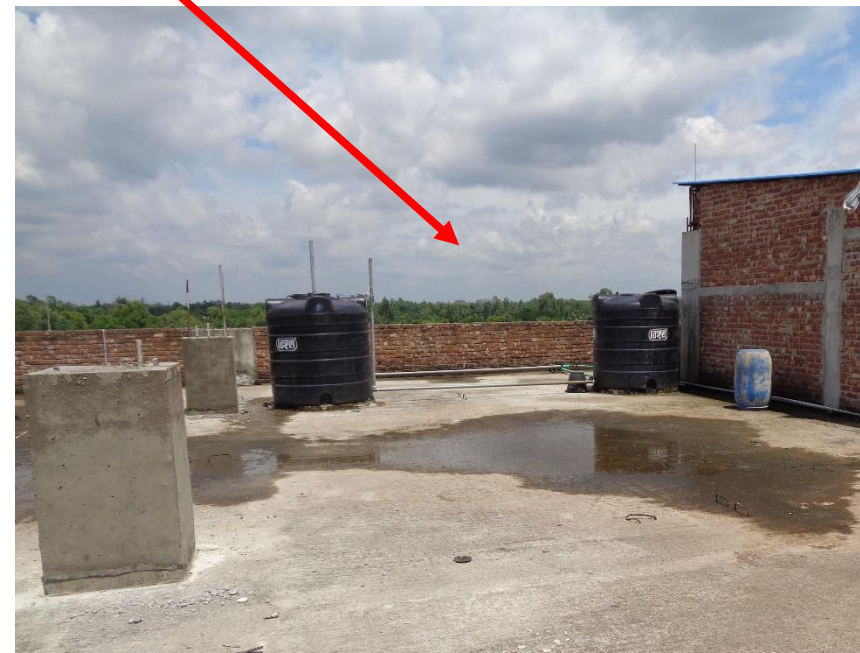
Plastic water tanks (2000 liter each)

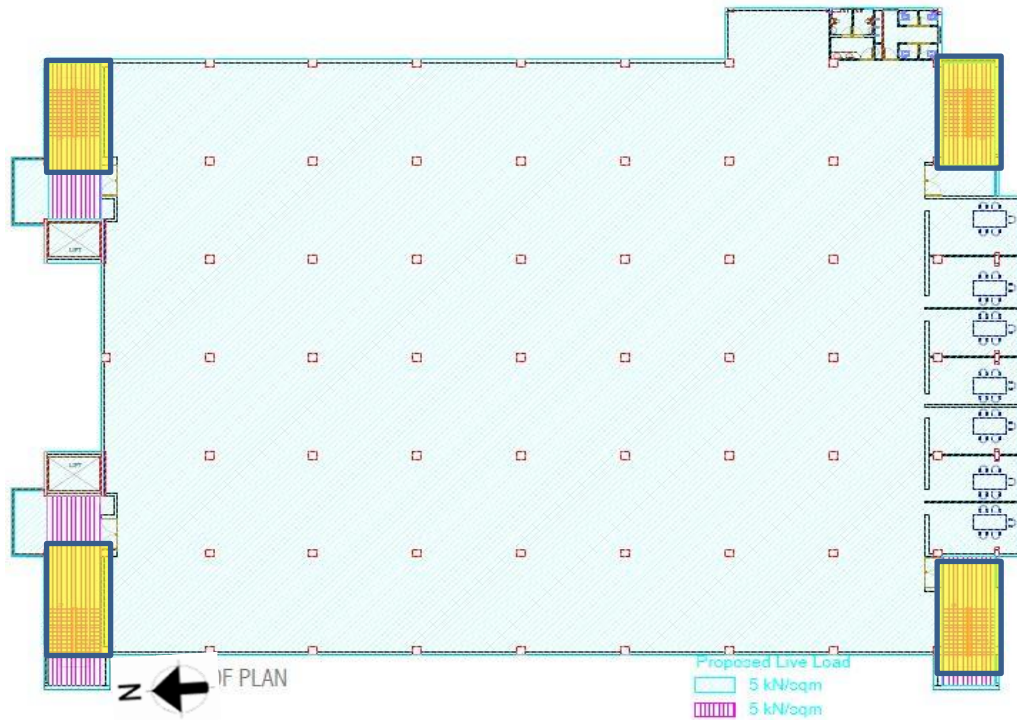
Layout of steel roofing on staircases

Connections of truss to RC column at roof of staircases were appeared to be inadequate for uplift forces. The building engineer is required to check the connections for uplift forces and suggest proper remedial actions accordingly.

| Item No. | Observation | Recommended Action Plan | Recommended Timeline |
|---|---|---|---|
| 06 | Apparently inadequate connection (Warehouse: Building No-2) | The building engineer is required to check the connection adequacy for uplift forces and suggest necessary remedial actions. | 6-weeks |
| 07 | Apparently inadequate connection (Warehouse: Building No-2) | Implement suggested remediation work. | 6-months |

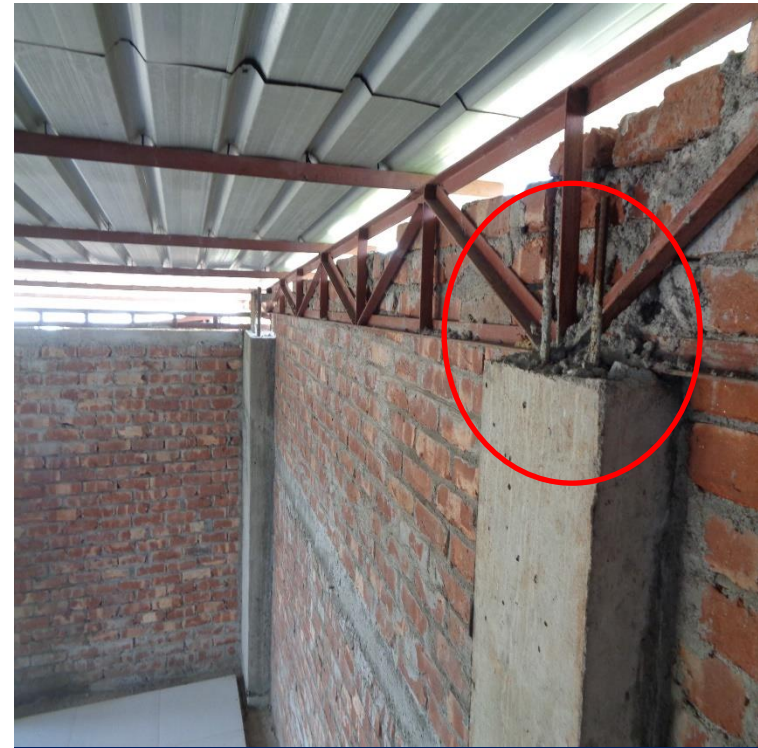
Roof truss not anchored with the rebar of RC column

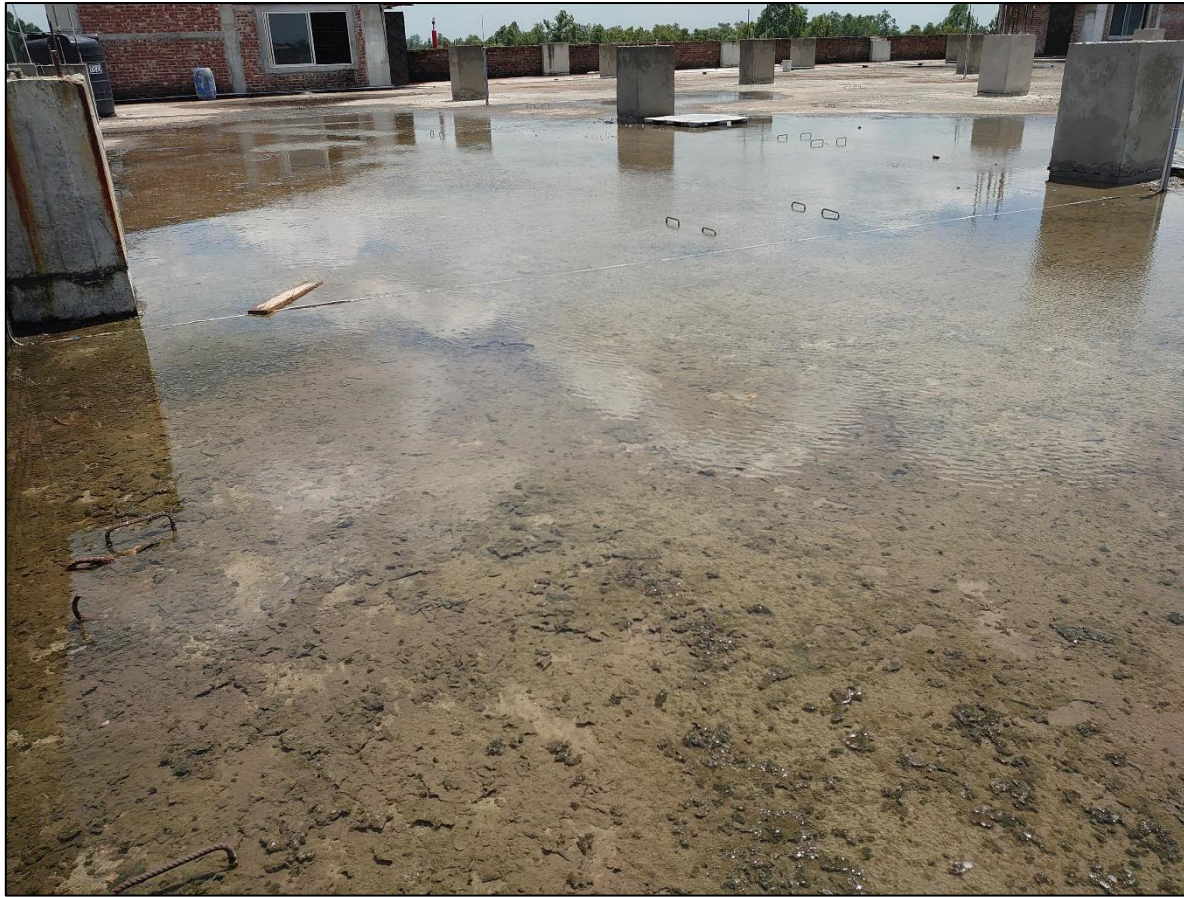
Water ponding on the roof slab

Water ponding on the roof was observed due to poor drainage system. The factory is required to improve the roof drainage system with adequate slope.

| Item No. | Observation | Recommended Action Plan | Recommended Timeline |
|---|---|---|---|
| 08 | Water ponding on the roof slab (Warehouse: Building No-2) | The factory is required to improve the roof drainage system with adequate slope. | 6-months |

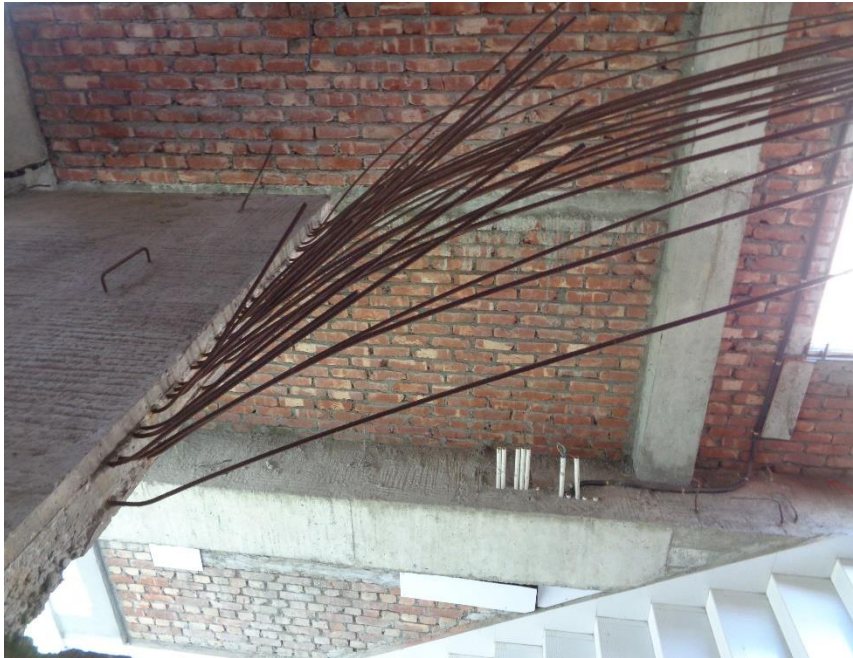
Exposed reinforcement left at Staircase

Exposed reinforcement is left at roof level & staircases which was prone to corrosion. The factory is required to provide rust proof paint on exposed reinforcement to protect from corrosion.

| Item No. | Observation | Recommended Action Plan | Recommended Timeline |
|---|---|---|---|
| 09 | Exposed reinforcement left at roof level (Warehouse: Building No-2) | Factory is required to provide rust proof paint on exposed reinforcement to protect from corrosion. | 6-months |

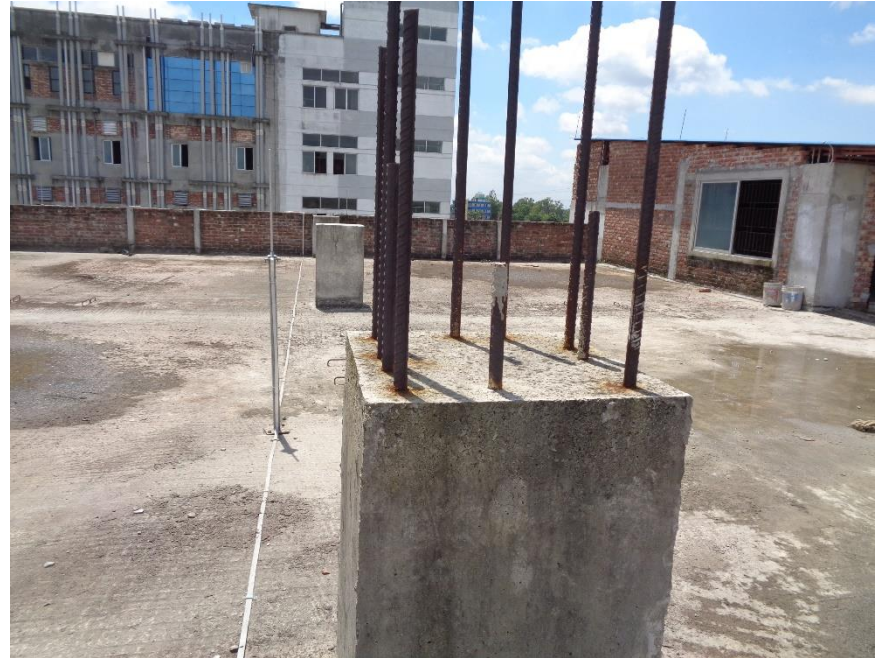
Exposed reinforcement left in column at roof
