# Nofs Garments Ltd

Plot no. 01/04, Road no. 01, Doyal Housing Ltd., Bosila, Mohammadpur, Dhaka-1207.

14 August 2022

# Building Information

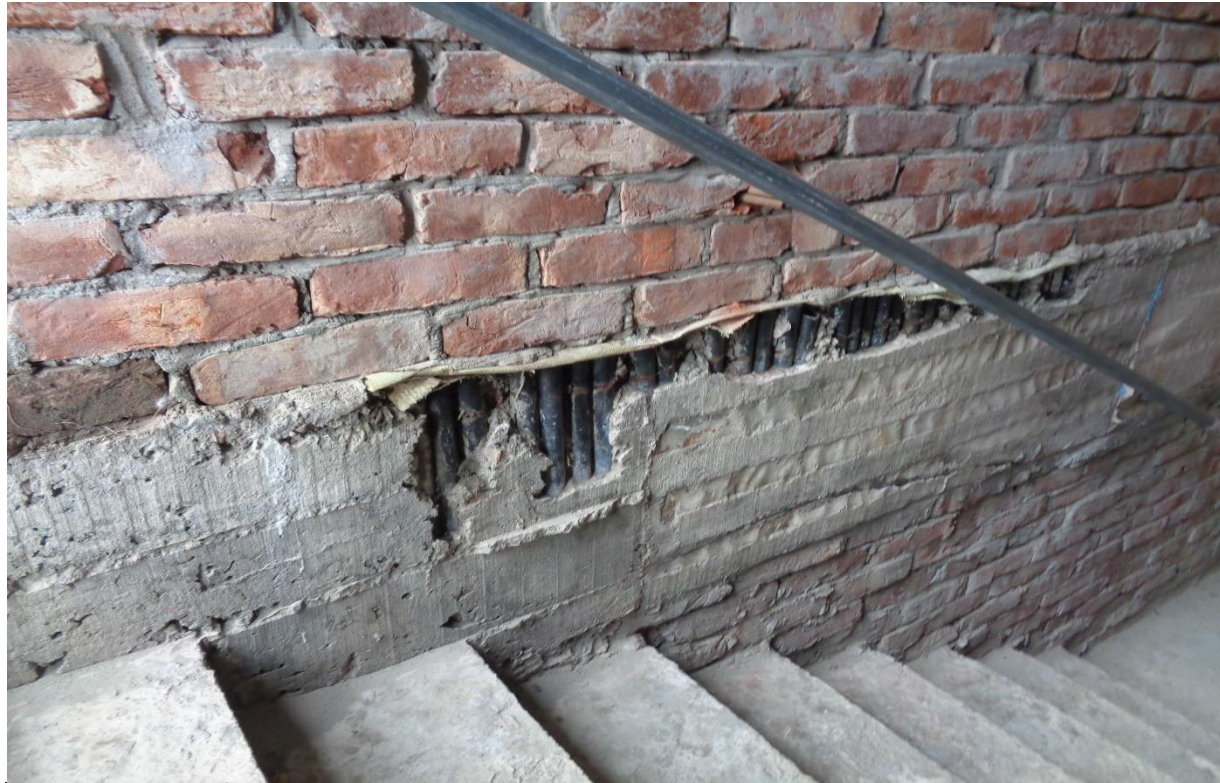
Ducting in beam at staircase area

Ducting in beam observed at staircase area (roof level-west side). Services pipes have been placed within reinforced concrete beams. Building engineer is required to assess whether the structural strength of the beam has been compromised.

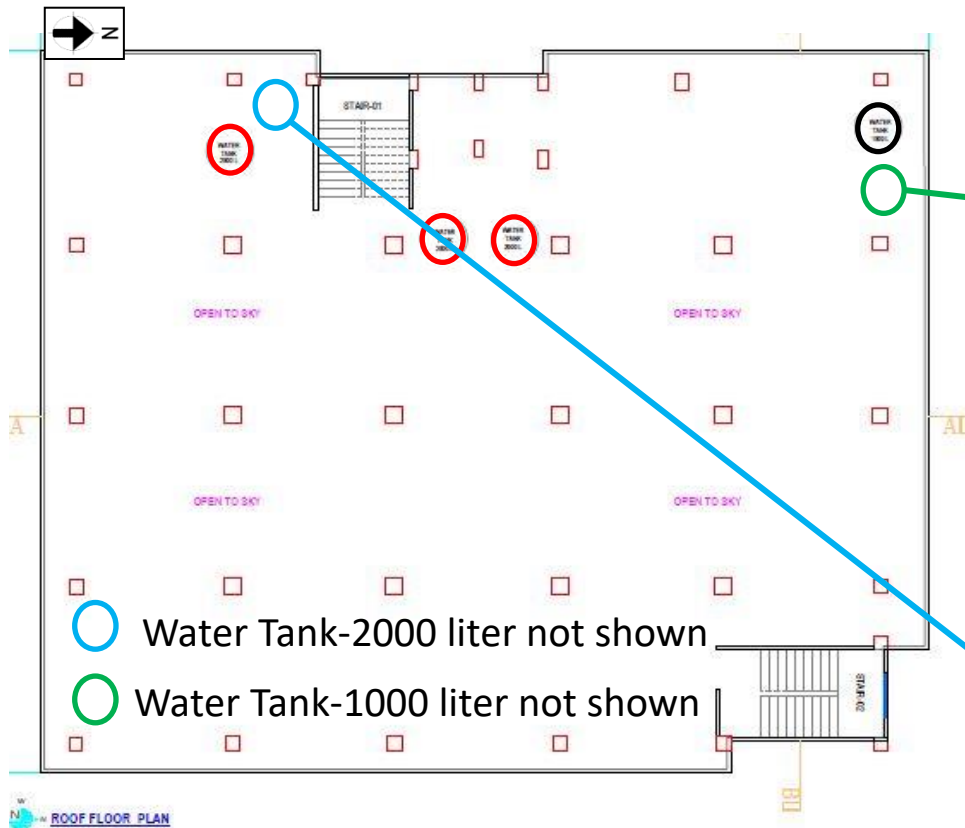
Roof layout

One plastic water tank of 2000 litre capacity and one plastic water tank of 1000 litre capacity were not shown in roof layout but found onsite. Building engineer is required to update the as-built drawing.

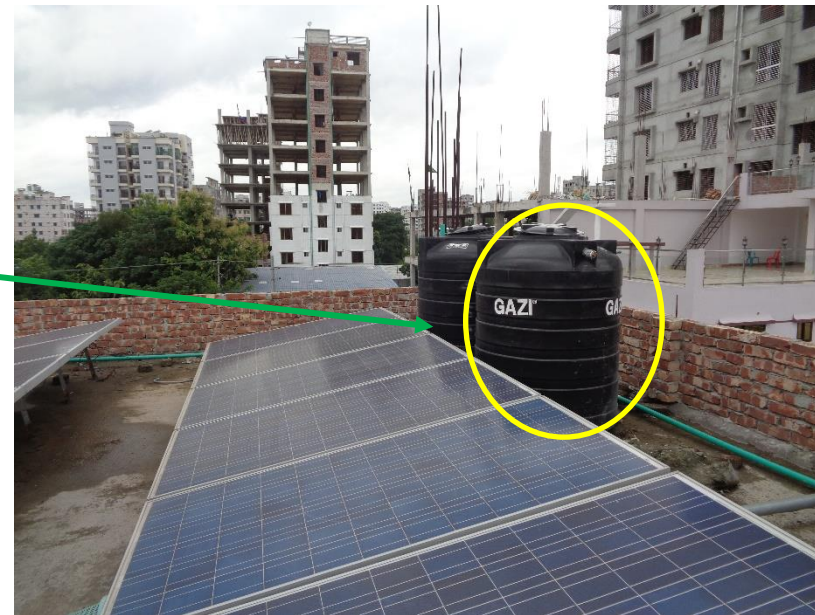
Water tank (1000 liter) not shown

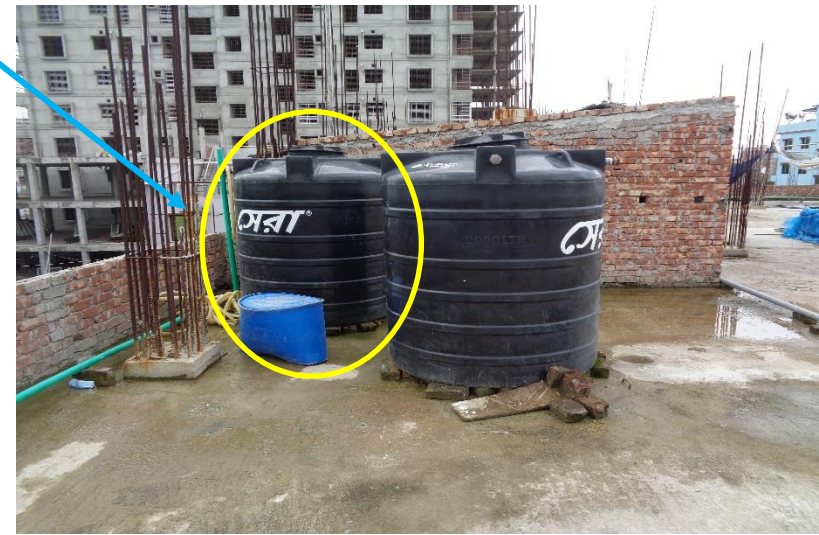
Water tank (2000 liter) not shown

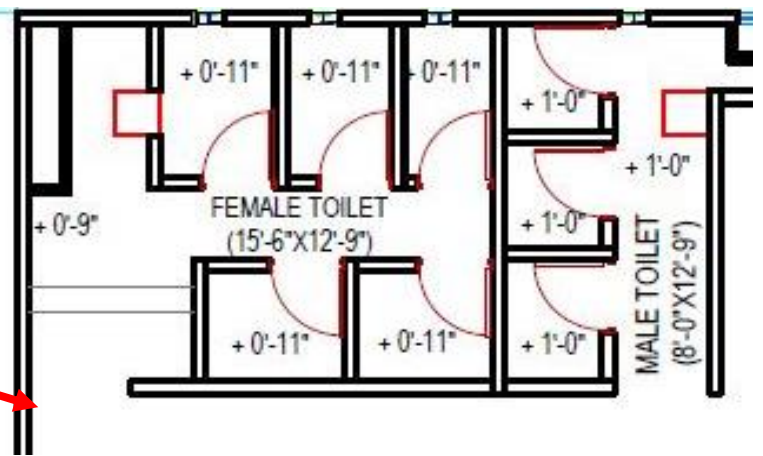
Dimension of internal toilet wall not shown in as-built drawing

Dimension of internal brick partition wall at toilet areas is not shown in as-built architectural drawing. Factory engineer is required to update the as-built drawing showing dimension of all toilet partition wall.

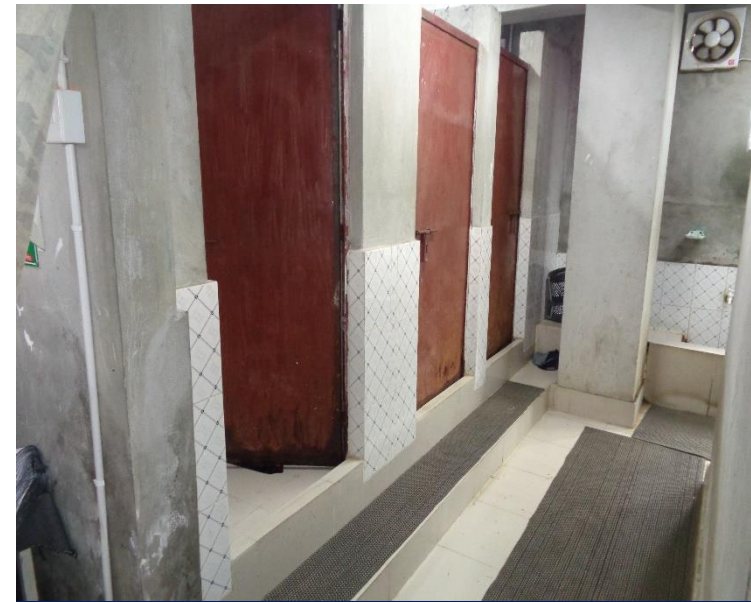
Brick partition wall at toilet area

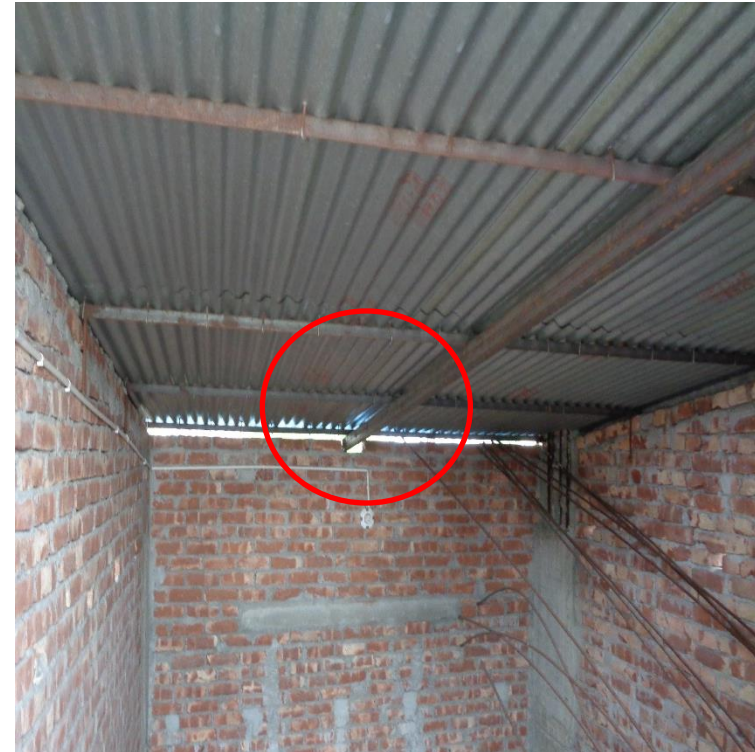
Apparently inadequate connection

At stair roof, rafters were observed as inadequately anchored with brick wall which were appeared to be inadequate for uplift forces. Building engineer is required to check the connection adequacy for uplift forces as part of EA.

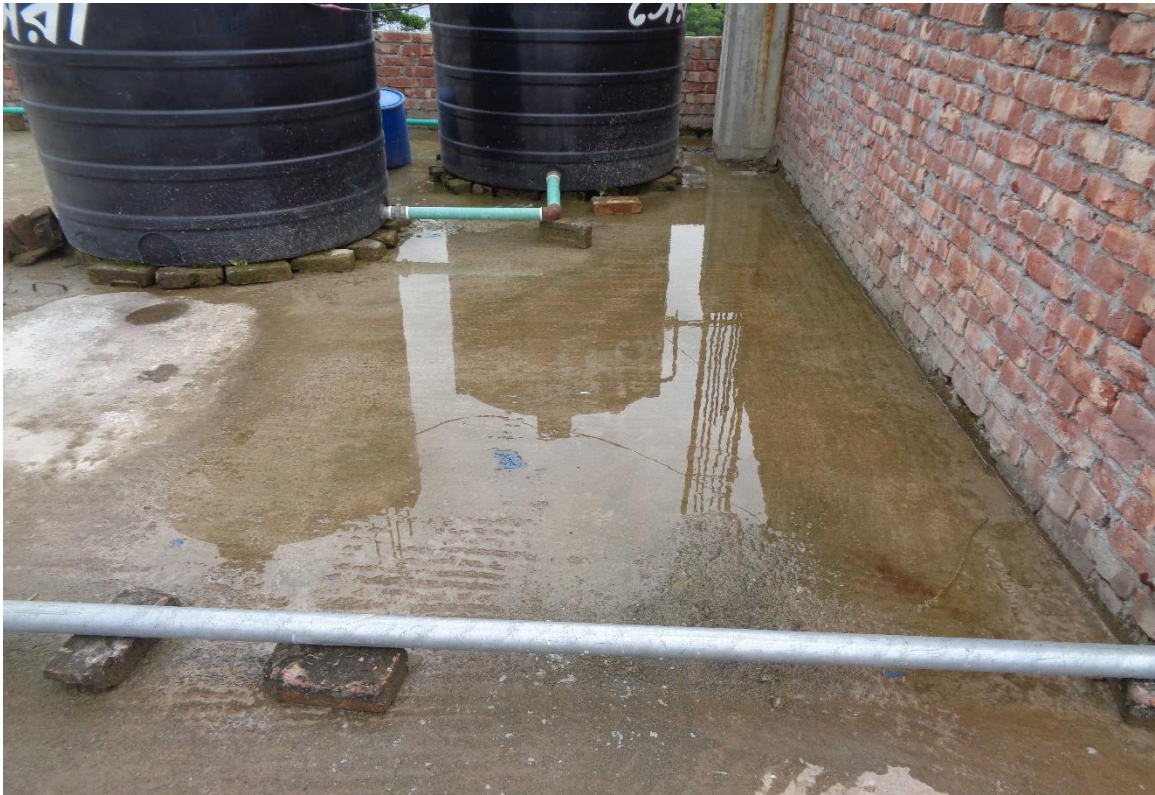
Water ponding on roof slab

Water ponding on roof slab due to improper drainage system. Factory is required to improve drainage system with adequate slope on roof slab.

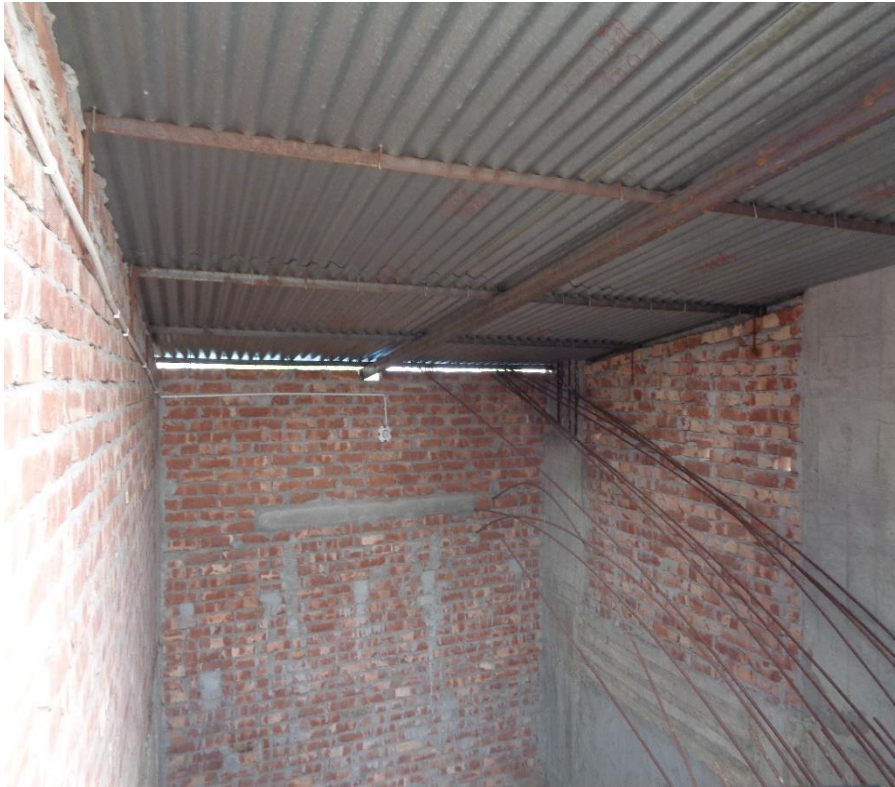
Exposed reinforcement left at Staircase

Exposed reinforcement is left at roof level and staircase which was prone to corrosion. Factory is required to provide rust proof paint on exposed reinforcement to protect from corrosion.

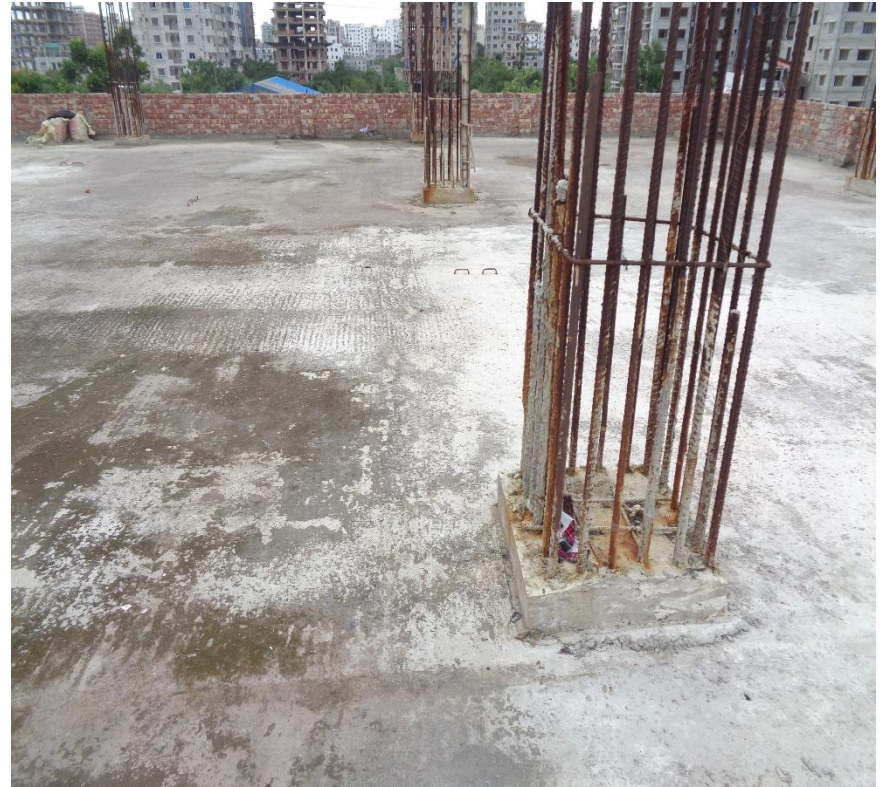
Exposed reinforcement left at roof
