# Brandix Apparel Bangladesh Ltd.

Plot 39-43, 46-49, EPZ Cumilla  
(23.446381, 91.188181)

03 August 2022

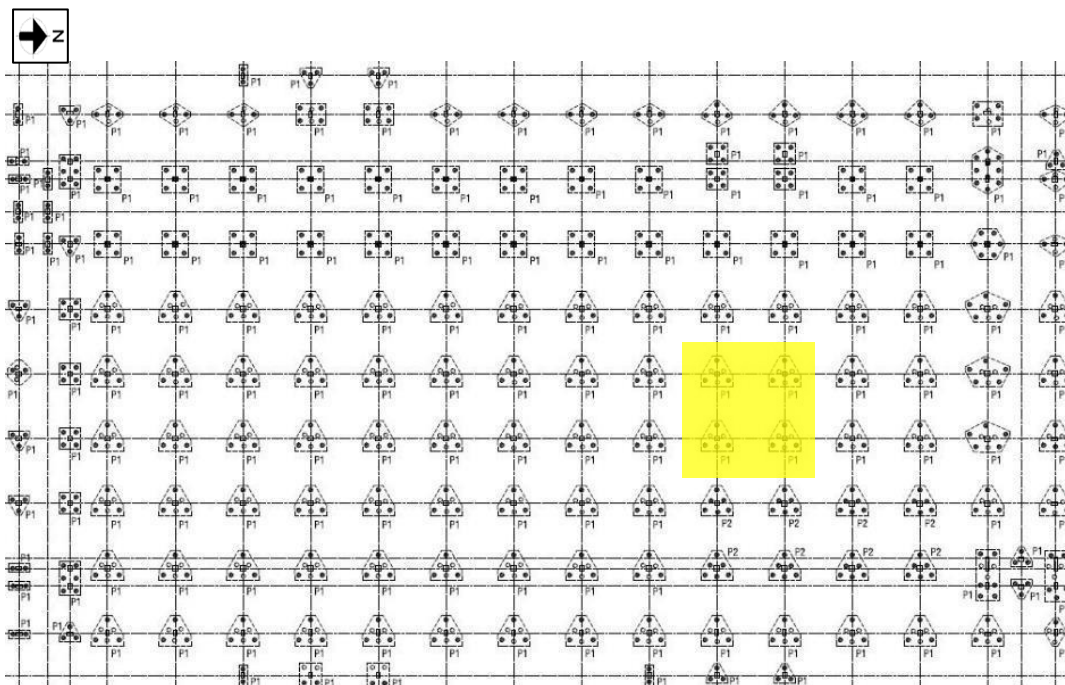
Pile Layout plan

**Factor of Safety of several pile foundations are  
below the allowable limit**

Cursory calculation indicates that factor of safety (FoS) of some pile foundations is below the allowable limit at marked locations considering the floor live load 5 kPa for typical floor, 1.5 kPa for roof, super imposed load from overhead water tank and ultimate pile capacity 106 Ton from pile load test data. Building engineer to required to review the design, loads and foundation stresses and prepare a remediation plan.

| Item No. | Observation | Recommended Action Plan | Recommended Timeline |
|---|---|---|---|
| 01 | Factor of Safety of several pile foundations are below the allowable limit (Building 1: Production Building) | Building engineer is required to review the design, loads and foundation stresses for the marked area. | 6-weeks |
| 02 | Factor of Safety of several pile foundations are below the allowable limit (Building 1: Production Building) | Actively manage floor loading plan. | 6-weeks |
| 03 | Factor of Safety of several pile foundations are below the allowable limit (Building 1: Production Building) | Implement remediation work where required. | 6-months |
| 04 | Factor of Safety of several pile foundations are below the allowable limit (Building 1: Production Building) | Implement load plan. | 6-months |

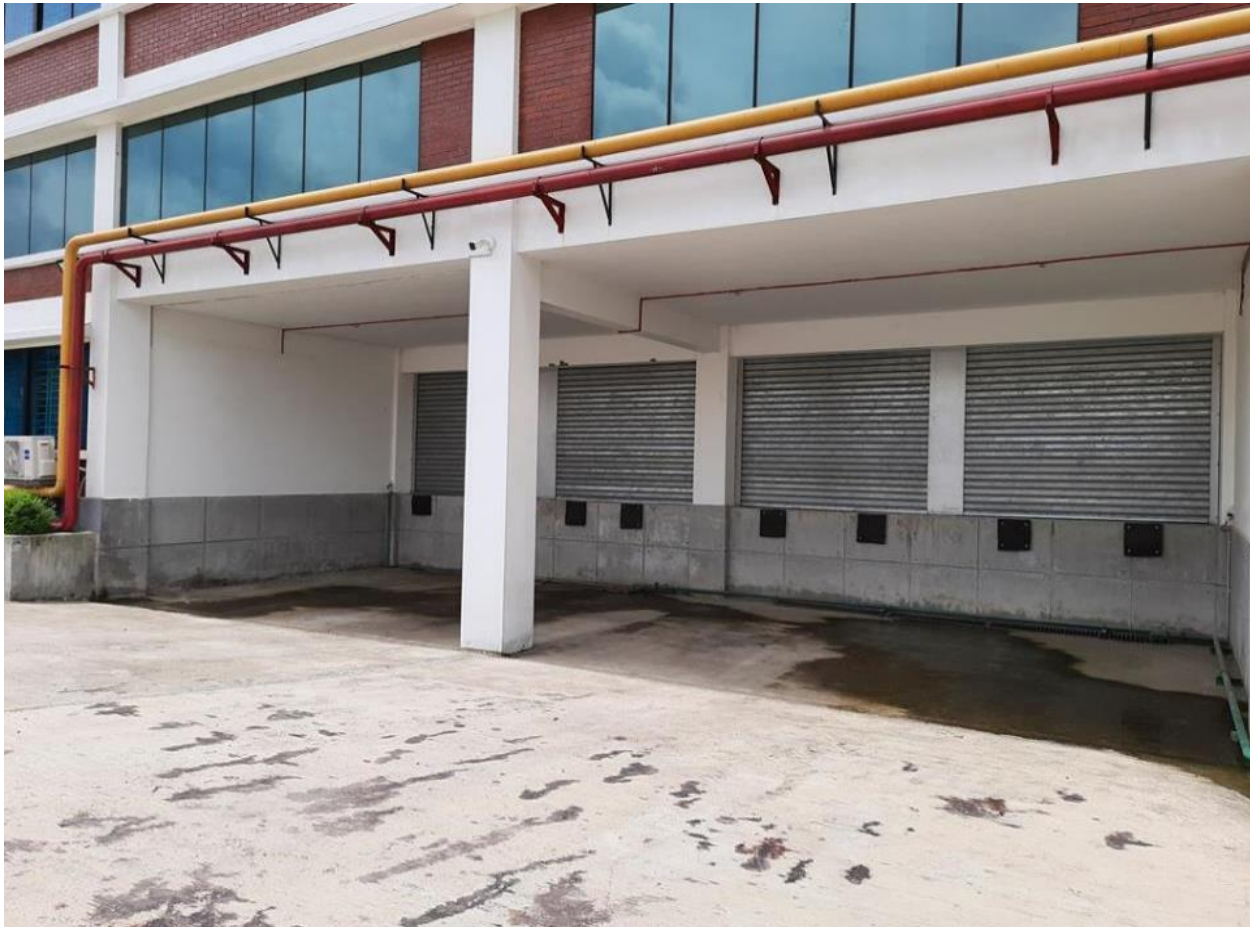
No barrier provided for the exposed columns and beams at ground floor

Columns and beams at ground floor are prone to possible vehicle impact. Building engineer is required to provide barrier for all exposed columns & beams at ground floor to prevent from possible vehicle impact.

| Item No. | Observation | Recommended Action Plan | Recommended Timeline |
|---|---|---|---|
| 05 | Possible vehicle impact for column & beam (Building 1: Production Building) | Building engineer is required to provide barrier for all exposed columns & beams at ground floor to prevent from possible vehicle impact. | 6-weeks |

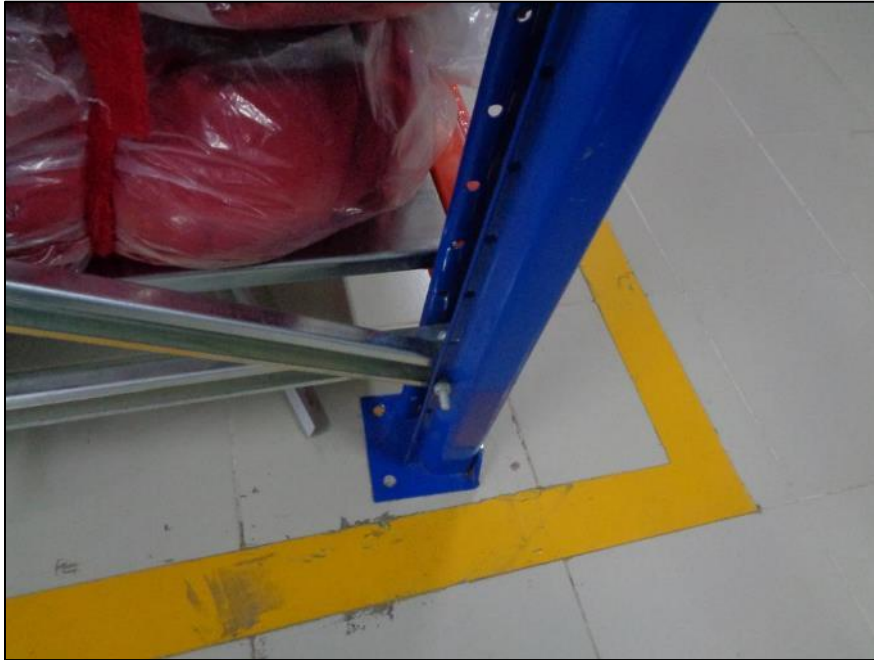
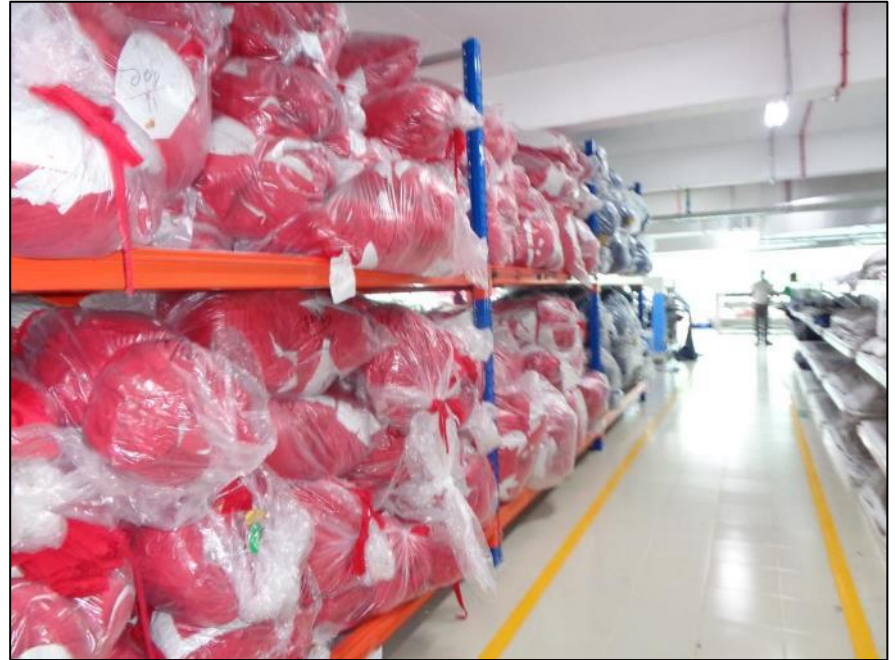
Storage rack found within the building without braced/anchored

Building engineer is required to brace/anchor all non structural elements.

| Item No. | Observation | Recommended Action Plan | Recommended Timeline |
|---|---|---|---|
| 06 | Non-structural elements found unbraced/not anchored (Building 1: Production Building) | Building engineer is required to brace/anchor all non-structural elements. | 6-weeks |

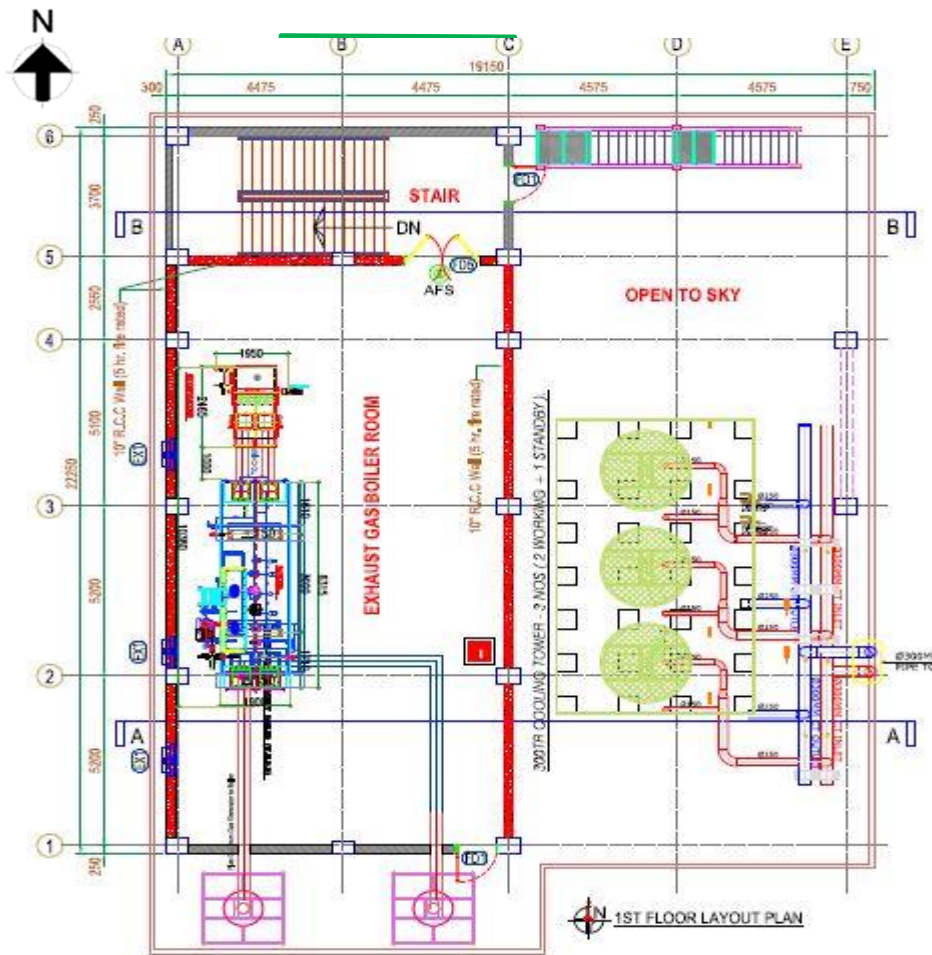
First floor layout plan

Significant vibration was felt on the first floor due to operation of heavy machineries. Building engineer is required to investigate the long-term effect of the vibration and suggest remediation.

| Item No. | Observation | Recommended Action Plan | Recommended Timeline |
|---|---|---|---|
| 07 | Vibration on floor due to operation of heavy machine (Building 3: Utility Building) | Building engineer is required to investigate the long-term effect of the vibration and suggest remediation. | 6-weeks |
| 08 | Vibration on floor due to operation of heavy machine (Building 3: Utility Building) | Carry out remedial works where necessary. | 6-months |

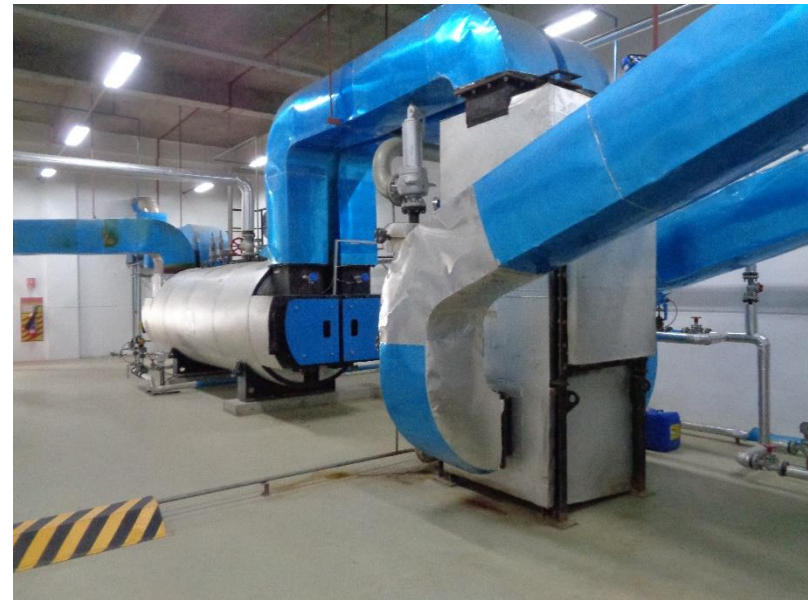
Heavy machineries

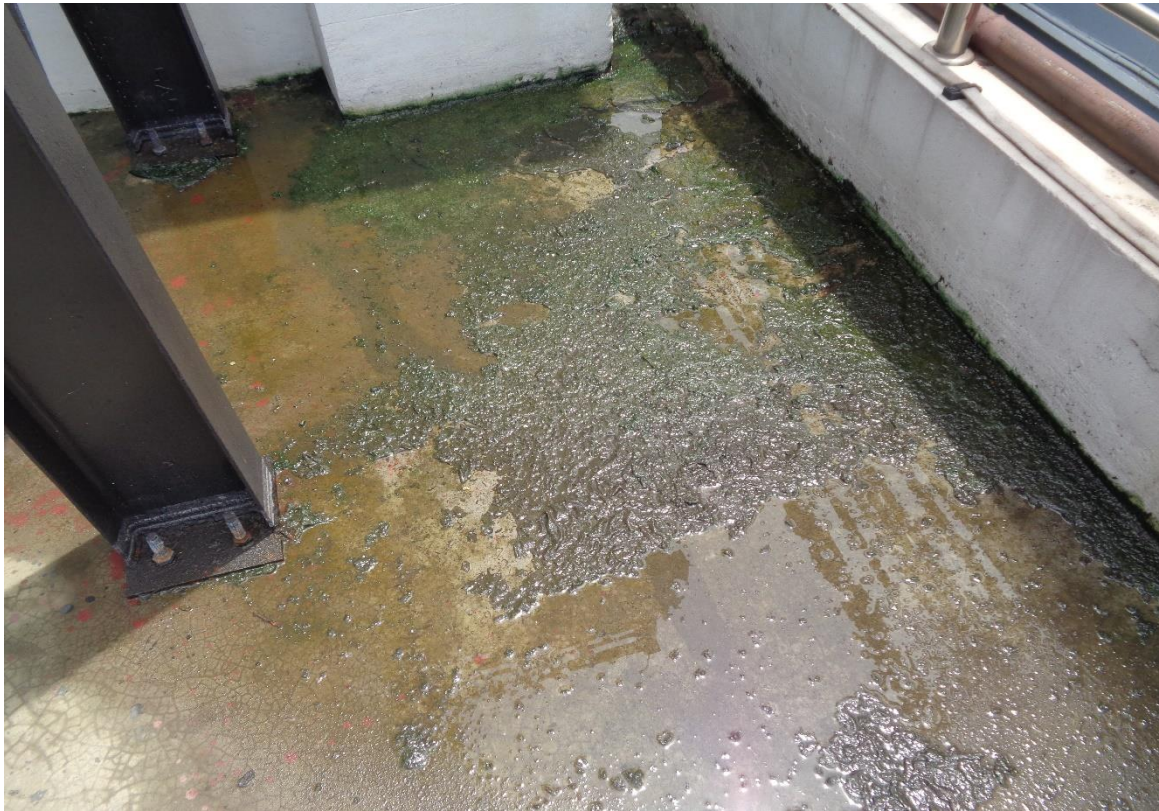
Water ponding on roof slab due to poor drainage system

Water ponding was observed on roof slab due to poor drainage system. Building engineer is required to improve drainage system.

| Item No. | Observation | Recommended Action Plan | Recommended Timeline |
|---|---|---|---|
| 09 | Water ponding on roof (Building 3: Utility Building) | Building engineer is required to improve drainage system. | 6-months |

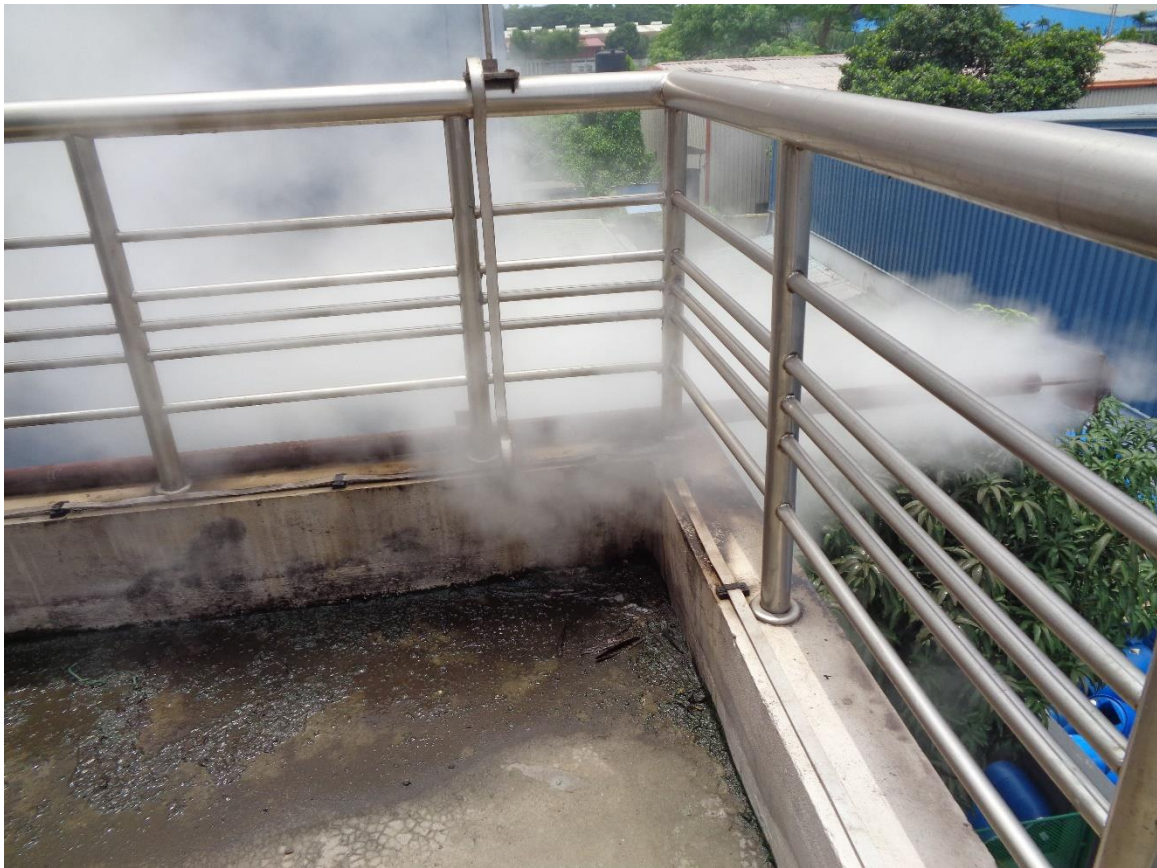
Steam flow adjacent to periphery beam

Steam flow from boiler was observed adjacent to periphery beam which may damage the beam in the long run. Building engineer is required to divert the steam flow to another direction to avoid the future damage of beam.

| Item No. | Observation | Recommended Action Plan | Recommended Timeline |
|---|---|---|---|
| 10 | Steam flow near structural element (Building-3 : Utility Building) | Building engineer is required to divert the steam flow to another direction to avoid the future damage of beam. | 6-weeks |
