# Knit Valley Fashions Limited

Kalma, Dairy Farm, Savar, Dhaka.

01 August 2022

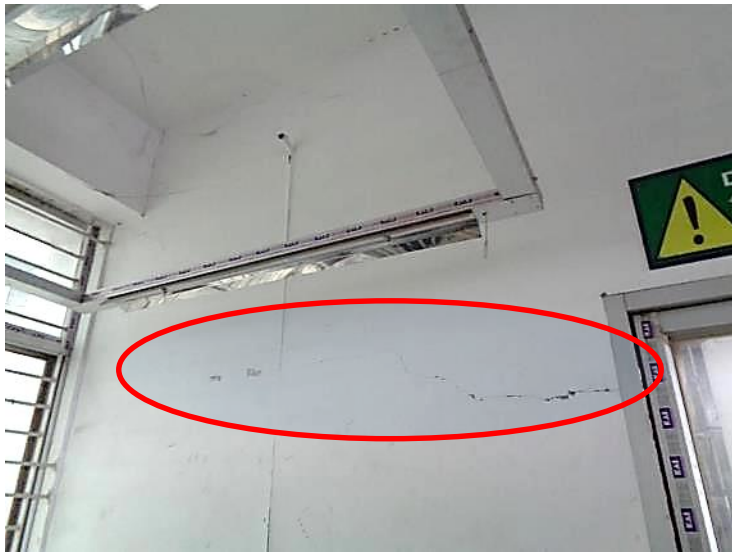
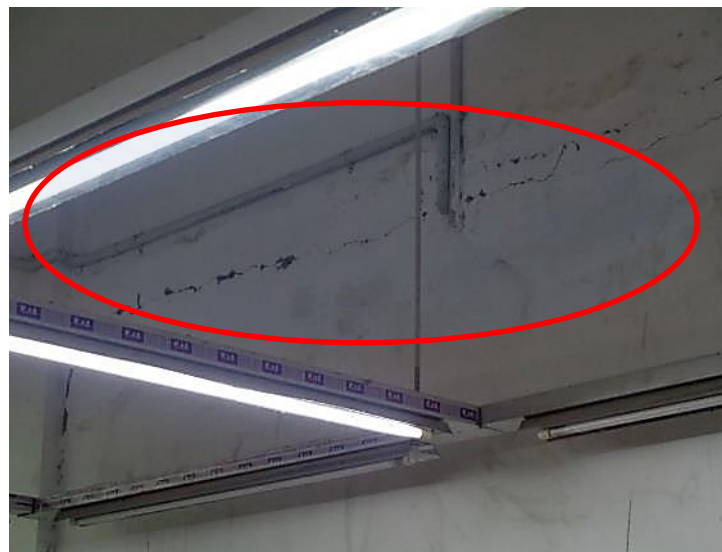
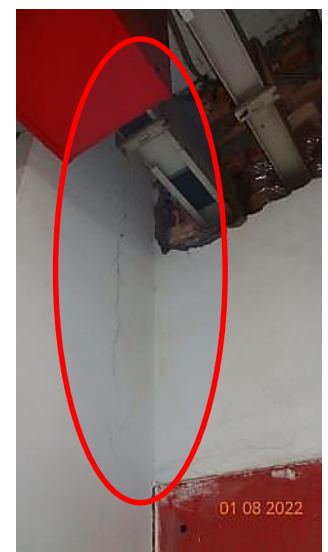
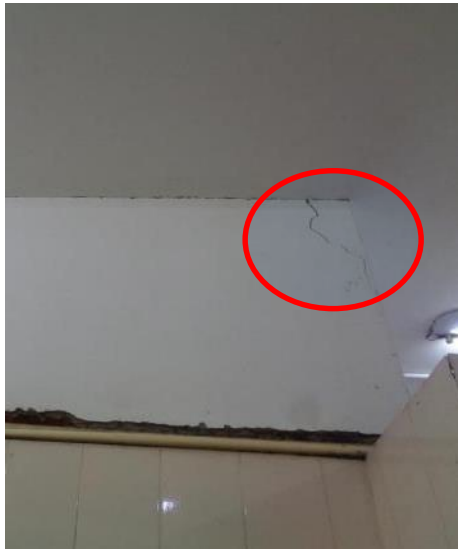
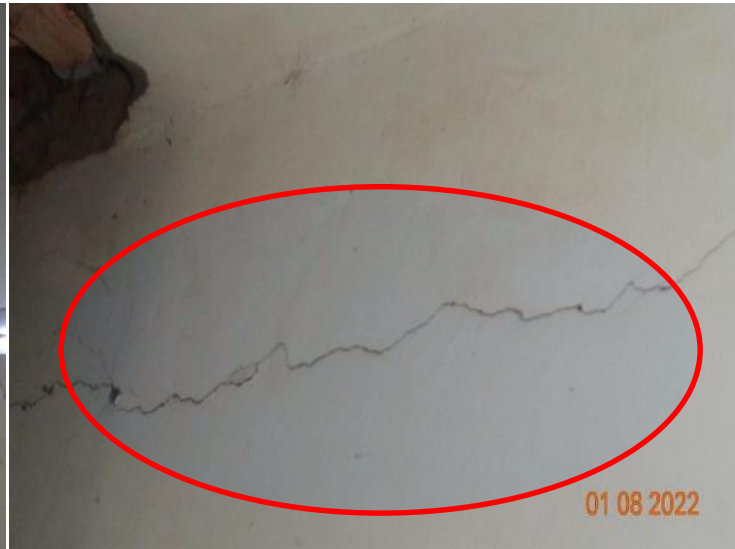
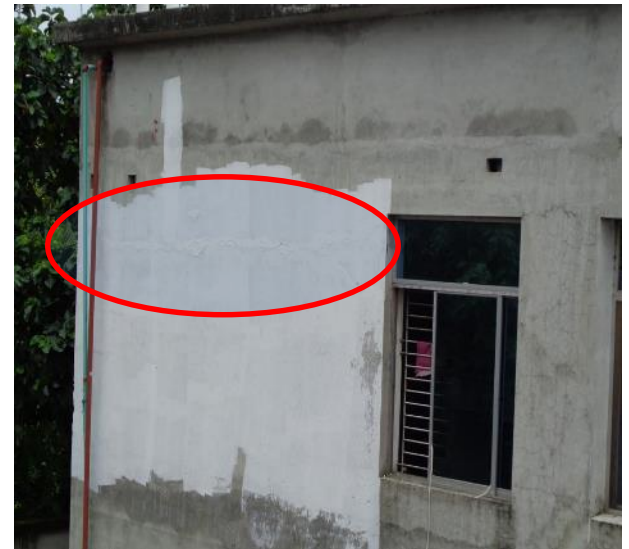
## **Cracks observed on the façade wall and brick wall**

Crack was observed at façade wall & brick wall. Building engineer is required to check the extent of crack and suggest proper repair methodology.

Item 02: Crack observed on the façade wall and brick wall.

| Item No. | Observation | Recommended Action Plan | Recommended Timeline |
|---|---|---|---|
| 03 | Crack observed on the façade wall and brick wall. (Production Building). | Building engineer is required to check the extent of the crack and suggest proper repair methodology in the investigation report. | 6-weeks |
| 04 | Crack observed on the façade wall and brick wall. (Production Building). | Carry out suggested remedial works. | 6-months |

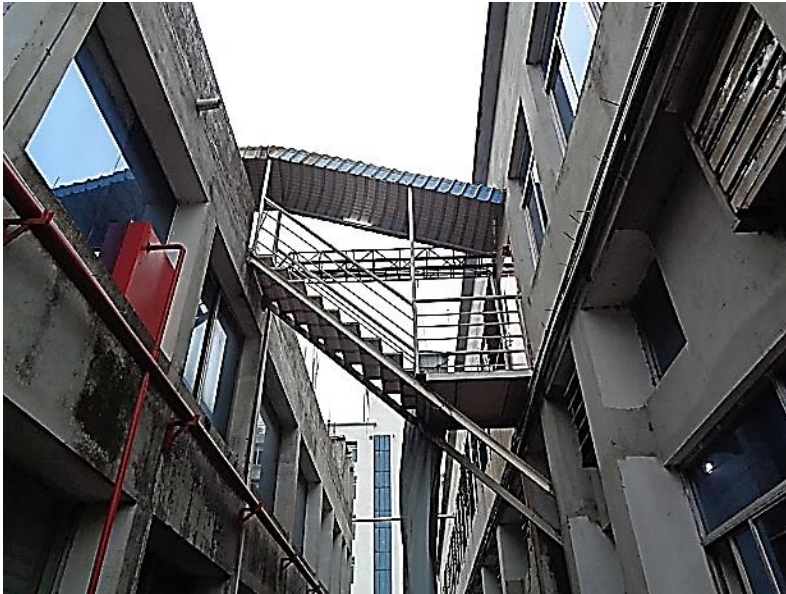
Connecting stair between the production building & head office building.

Connecting stair observed between the production building & head office building. As-built drawing was not found on-site. Moreover, the load transfer media and connection of members seemed to be inadequate. The building engineer is required to prepare accurate as-built drawings and check the adequacy of the members & connections for seismic loading.

| Item No. | Observation | Recommended Action Plan | Recommended Timeline |
|---|---|---|---|
| 05 | Connecting stair between production building & head office building. (Production Building). | Building engineer is required to prepare accurate as-built drawings, check the adequacy of the steel members, and connections, and suggest proper remedial actions. | 6-weeks |
| 06 | Connecting stair between production building & head office building. (Production Building). | Carry out suggested remedial works. | 6-months |

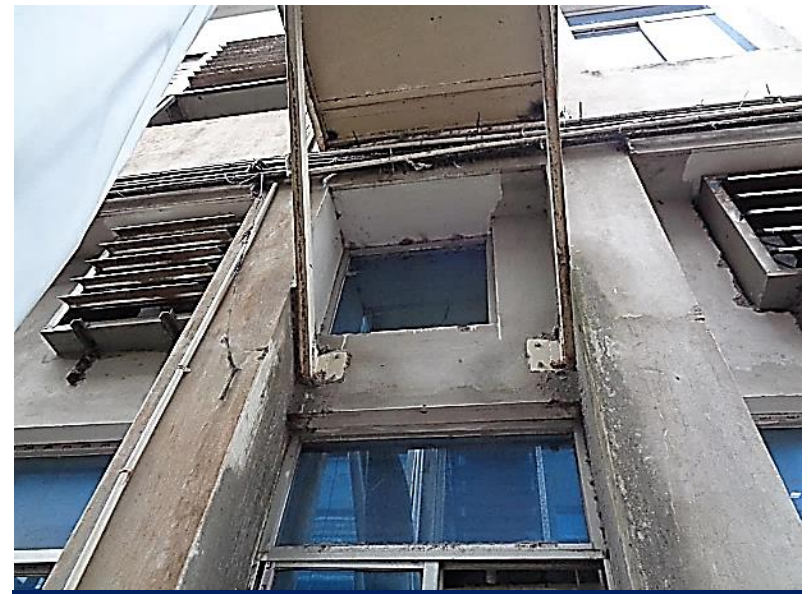
Connection joints between the steel part & RC part.

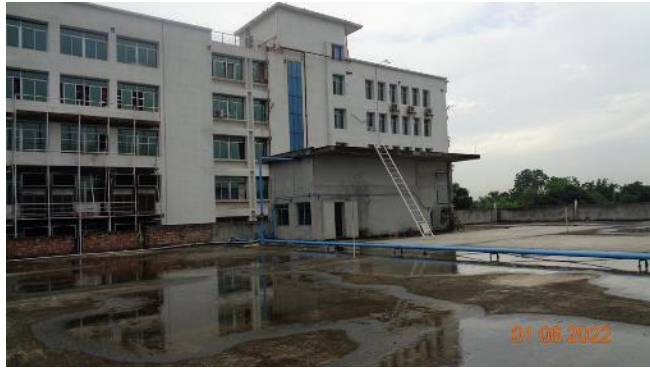
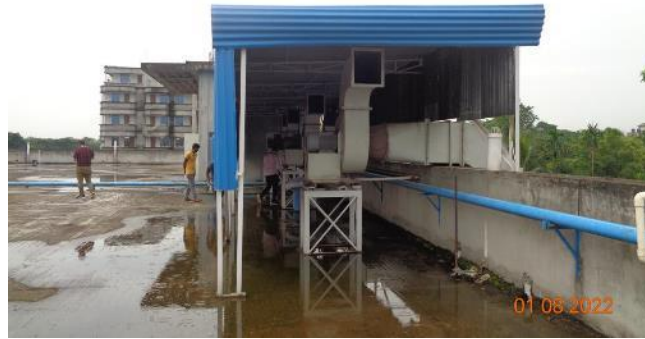
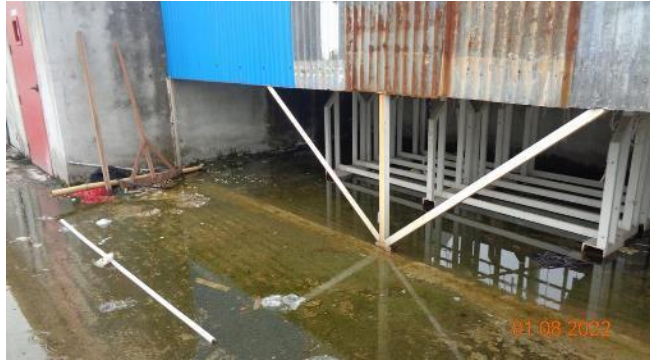
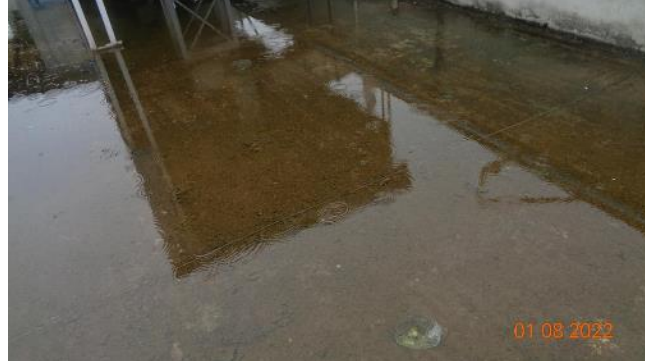
**Water stagnant on the roof**

Water clogging on roof.

Stagnant water on the roof was observed. Also, dampness observed in several places. The building engineer is required to develop proper drainage system on the roof with adequate slopping. Repair the damped area as per engineer's guideline.

| Item No. | Observation | Recommended Action Plan | Recommended Timeline |
|---|---|---|---|
| 07 | Stagnant water on the roof. (Production Building) | <ul style="list-style-type: none"> <li>Building engineer is required to develop a proper drainage system on the roof with adequate slope.</li> <li>Repair the damp area as per the engineer's suggestion.</li> </ul> | 6-weeks |

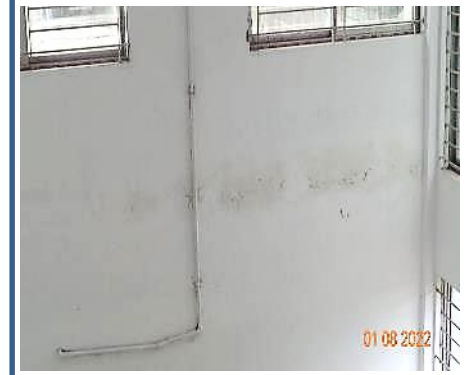
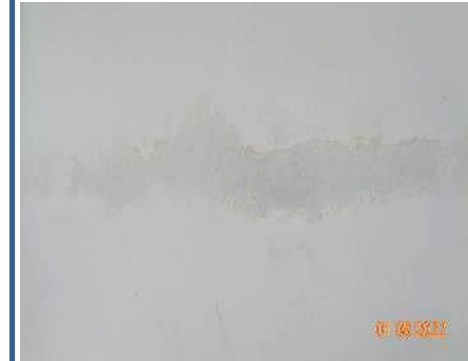
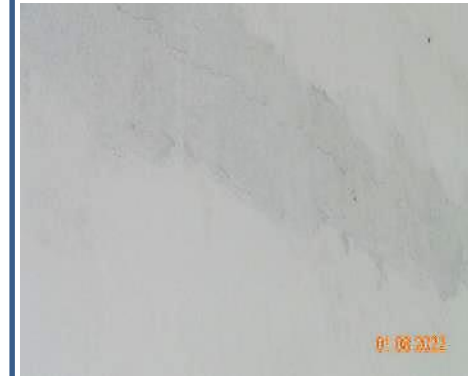
Dampness was observed in several places on the 1<sup>st</sup> floor.

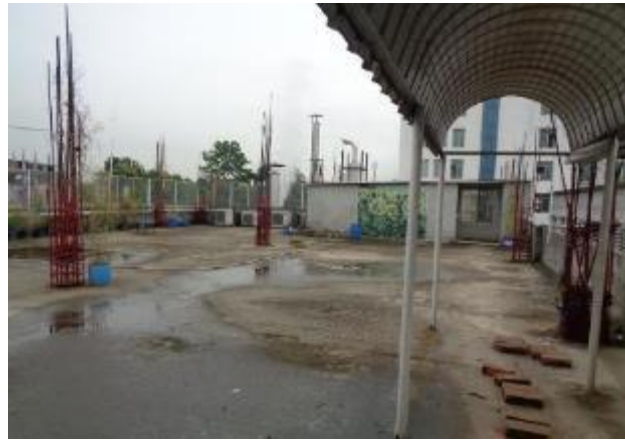
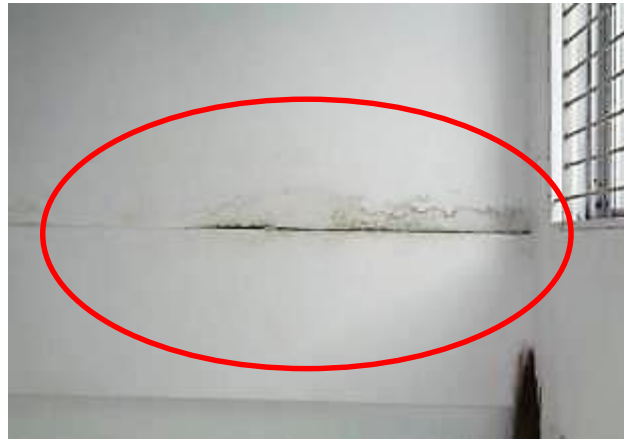
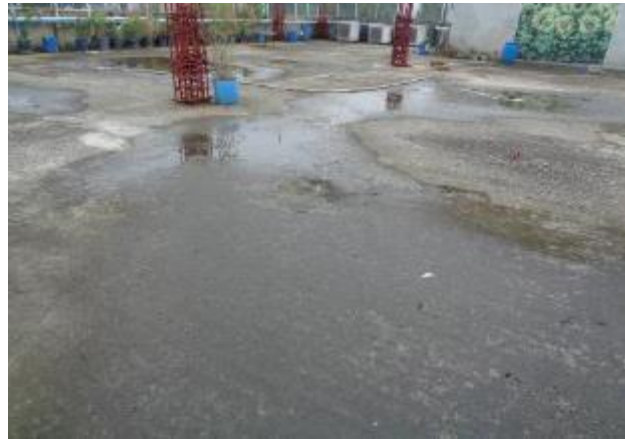
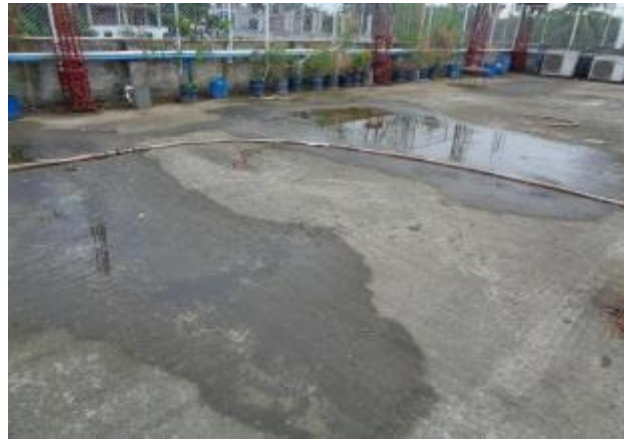
Water clogging on the roof and dampness on wall & beam

Water Clogging on the roof was observed. Also, dampness observed in several places. The building engineer is required to develop proper drainage system on the roof with adequate slopping. Repair the damped area as per engineer's guideline.

| Item No. | Observation | Recommended Action Plan | Recommended Timeline |
|---|---|---|---|
| 10 | Stagnant water on the roof. (Head Office Building) | <ul style="list-style-type: none"> <li>Building engineer is required to develop a proper drainage system on the roof with adequate slope.</li> <li>Repair the damp area as per the engineer's suggestion.</li> </ul> | 6-weeks |

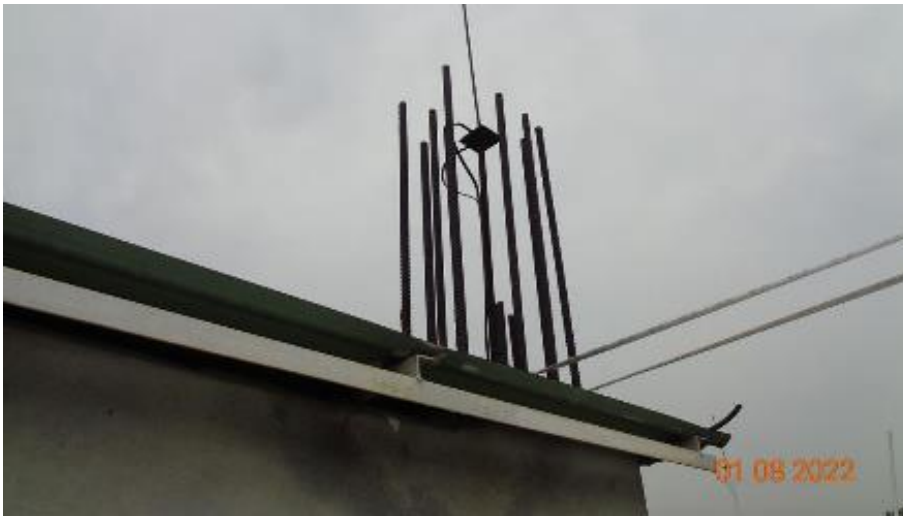
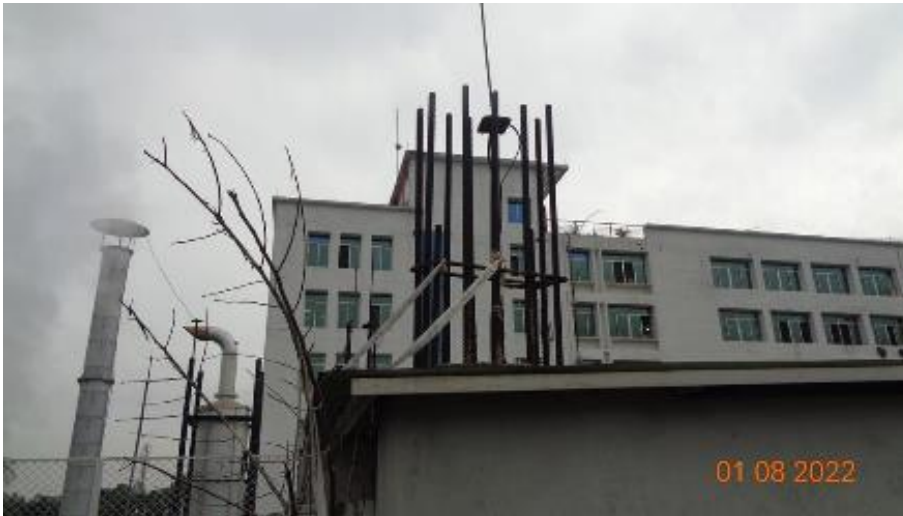
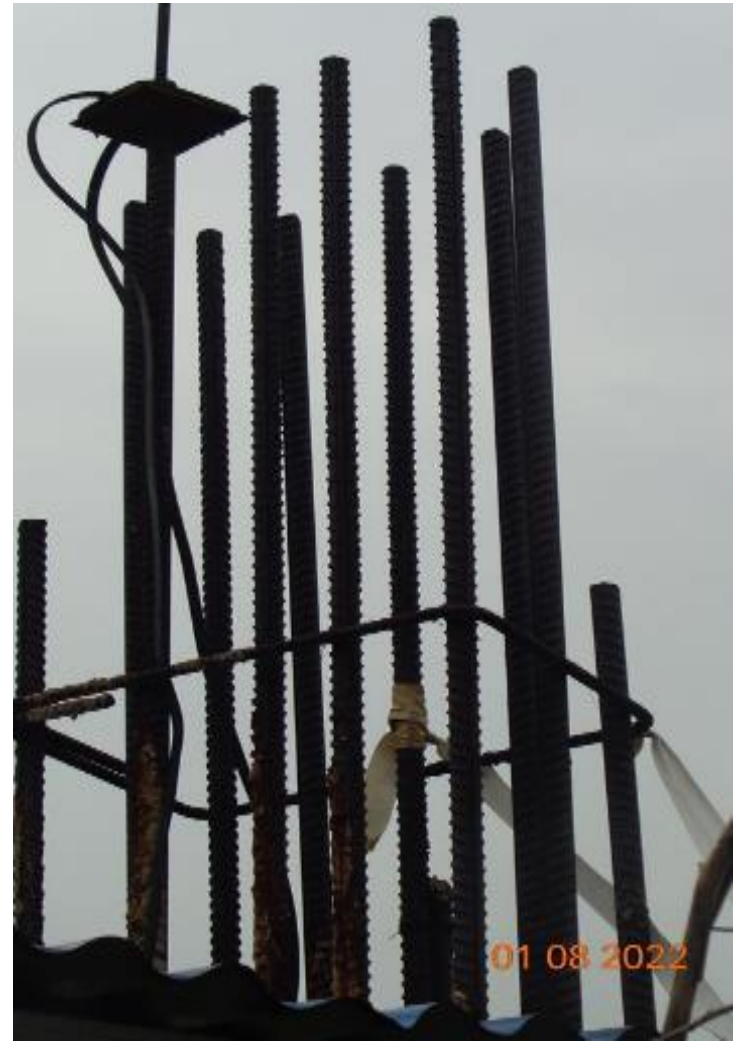
## **Exposed rebar on the roof**

Corroded rebar on roof.

Corroded rebar on the roof was observed. The building engineer is required to apply anti-corrosive paint on exposed rebar as per engineer's guideline.

| Item No. | Observation | Recommended Action Plan | Recommended Timeline |
|---|---|---|---|
| 11 | Exposed corroded rebar on the roof. (Head Office Building) | Building engineer is required to apply anti-corrosive paint on exposed rebar as per the engineer's guideline. | 6-months |

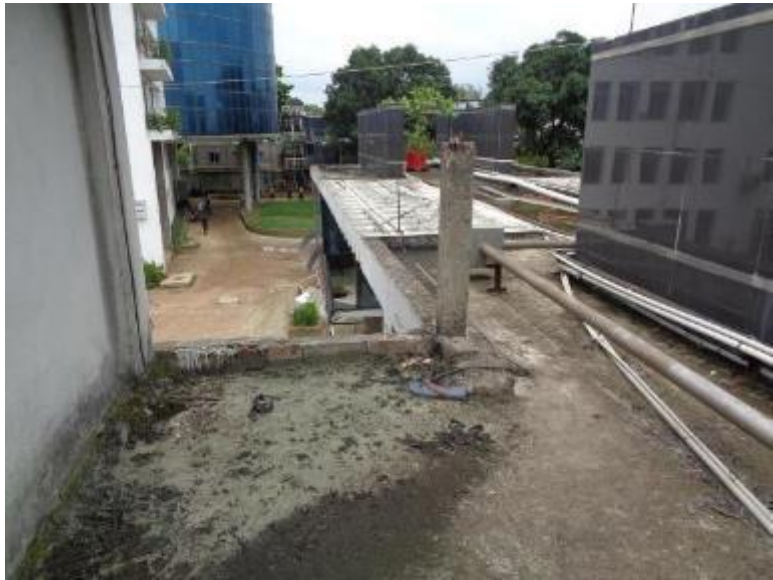
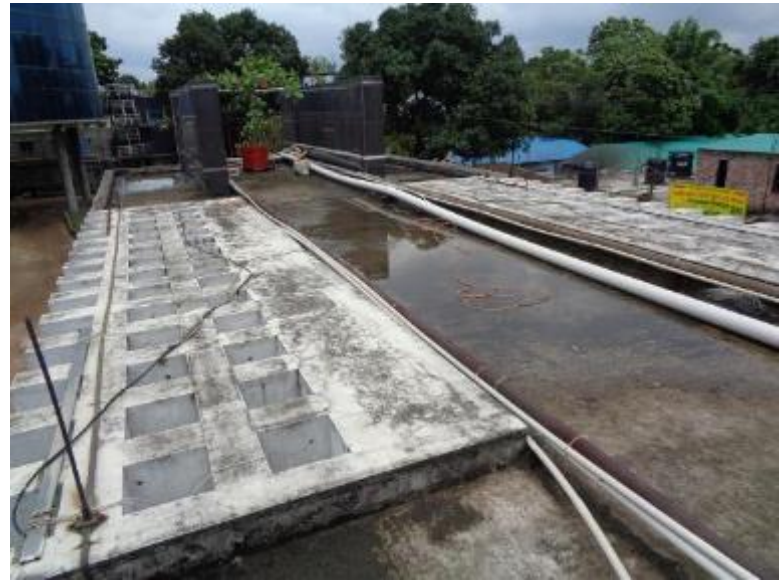
## Possible falling hazard

No parapet wall or protection provided on the roof

The building engineered is required to provide the parapet wall surrounding the roof to avoid possible falling hazards.

| Item No. | Observation | Recommended Action Plan | Recommended Timeline |
|---|---|---|---|
| 14 | Possible falling hazard. (Main Gate Building) | Building engineer is required to provide the parapet wall surrounding the roof to avoid possible falling hazards. | 6-weeks |

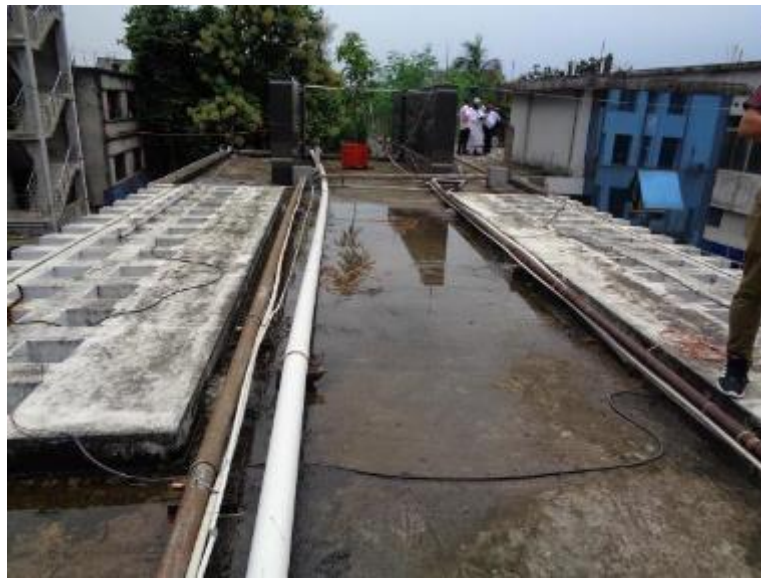
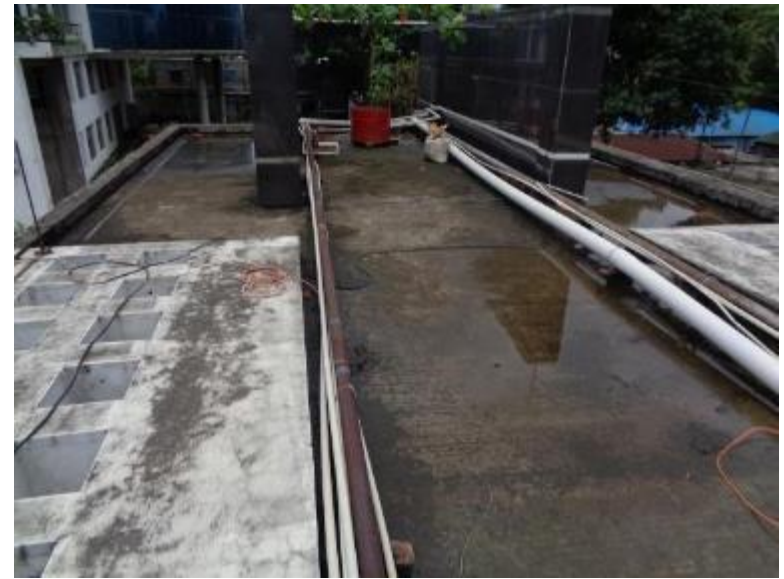
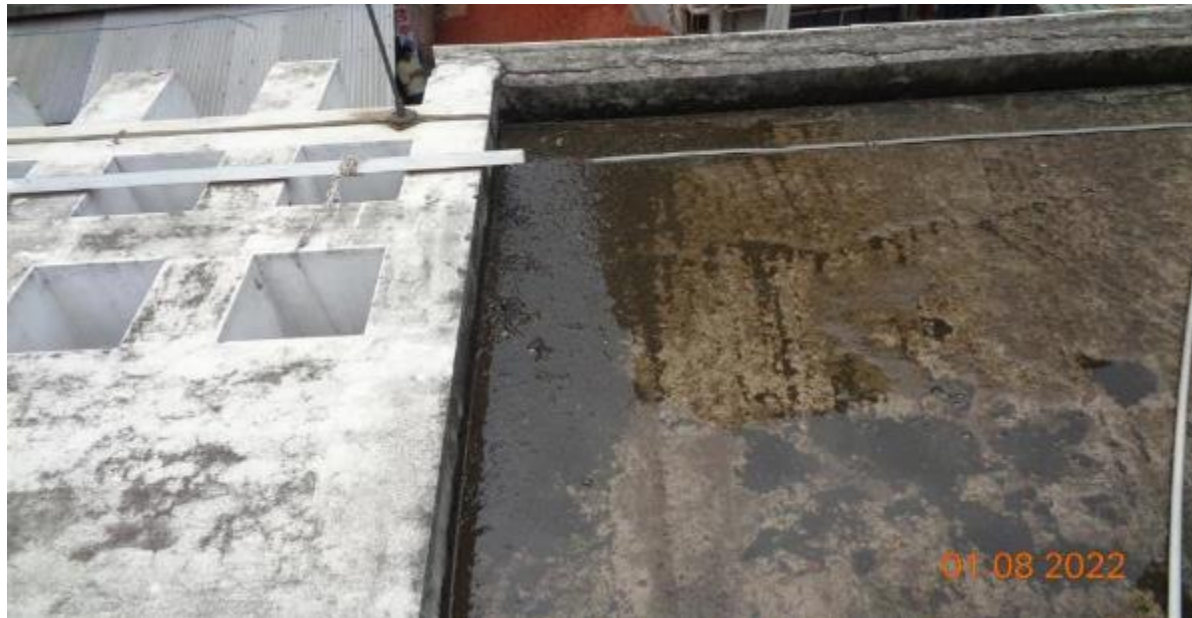
**Stagnant water on the roof**

Water clogging on roof

Stagnant water on the roof was observed on the roof. The factory is required to develop a proper drainage system on the roof with an adequate slope.

| Item No. | Observation | Recommended Action Plan | Recommended Timeline |
|---|---|---|---|
| 15 | Stagnant water on the roof. (Main Gate Building) | Building engineer is required to develop a proper drainage system on the roof with adequate slope. | 6-weeks |

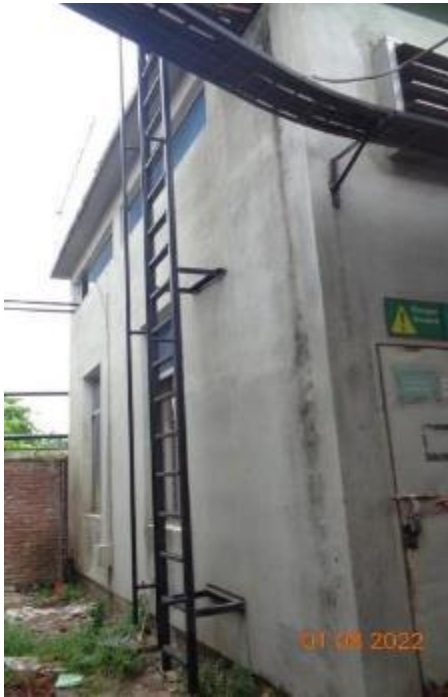
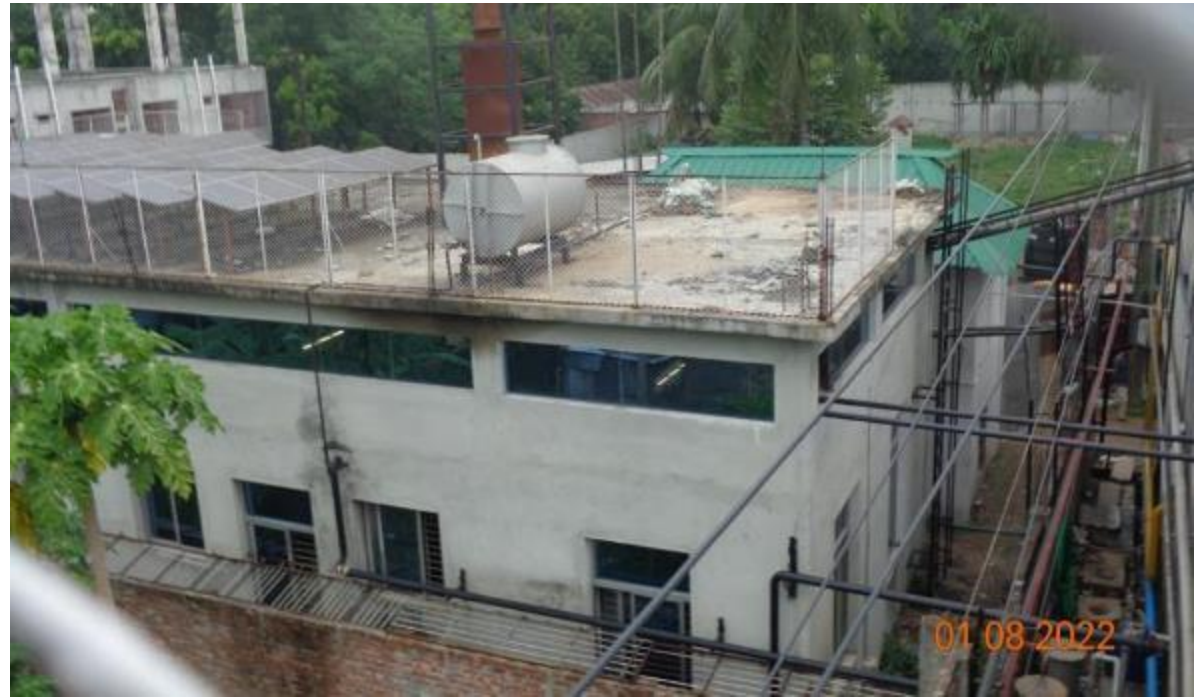
## **Lack of as-built structural drawing**

Lack of as-built structural drawing

The building engineer is required to survey the structure and to prepare the structural as-built drawing.

| Item No. | Observation | Recommended Action Plan | Recommended Timeline |
|---|---|---|---|
| 18 | Lack of as-built structural drawing. (Utility Building) | Building engineer is required to survey the structure and prepare as-built structural drawings. | 6-weeks |
