# Famkam Fashion Ltd.

Shirir Chala, Bagher Bazer, Gagipur Shadar, Gazipur

28<sup>th</sup> July 2022 & 03<sup>rd</sup> August 2022

# Executive Summary

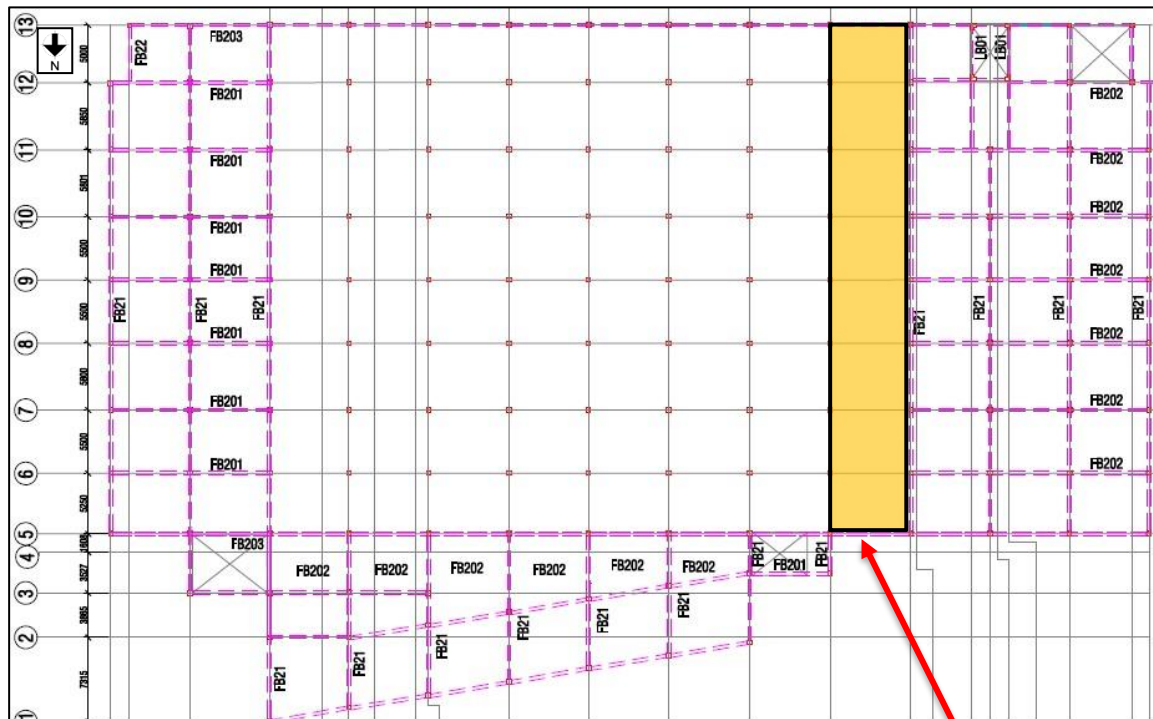
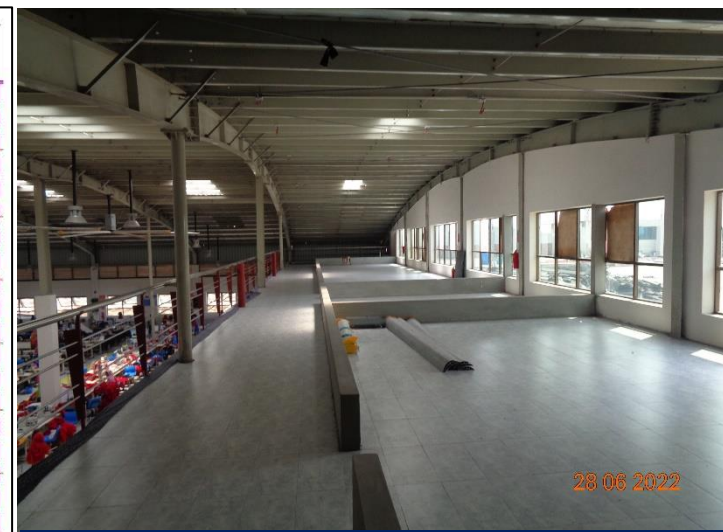
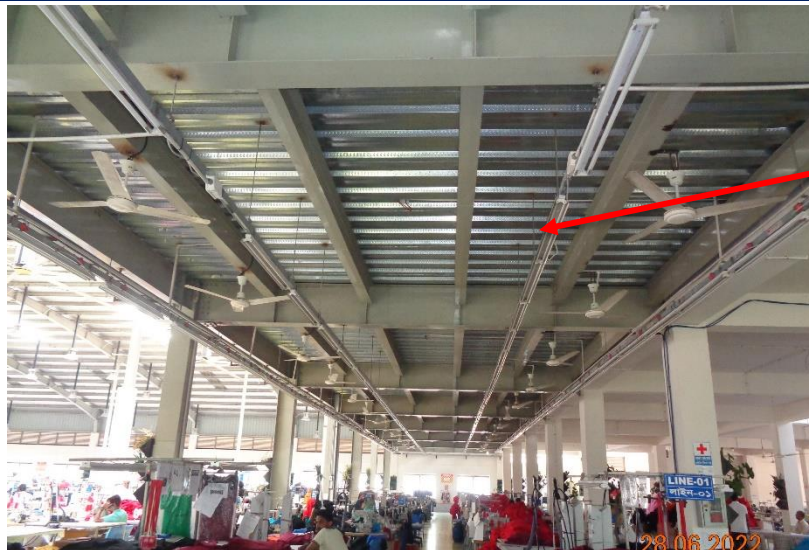
Un documented mezzanine

Mezzanine proposed for office

Mezzanine on 2<sup>nd</sup> floor

A mezzanine floor was found on 2<sup>nd</sup> floor. The mezzanine is a steel beam-column frame structure with deck slab. But in the as-built drawing, no information has been provided for the mezzanine.

The Building engineer is required to survey the whole structure and update the as-built drawing as well as design document as per site condition.

| Item No. | Observation | Recommended Action Plan | Recommended Timeline |
|---|---|---|---|
| 05 | Lack of information in as-built drawing (Fashion Building) | Building engineer to update the design document including a design report, and a set of structural drawings in compliance with section 1.9.1.1 and section 1.9.1.2 as per BNBC. | 6-weeks |

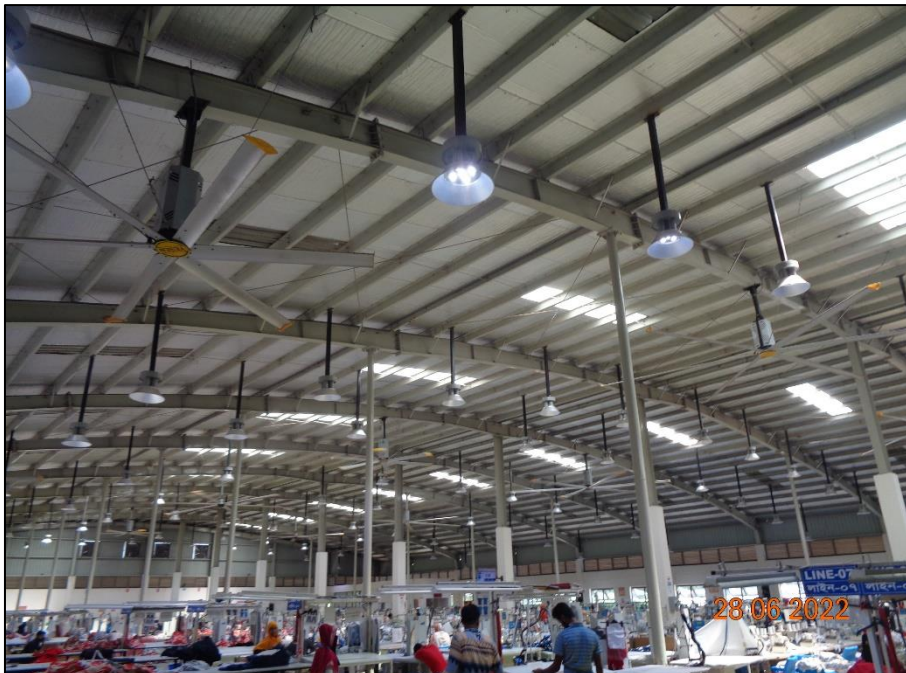
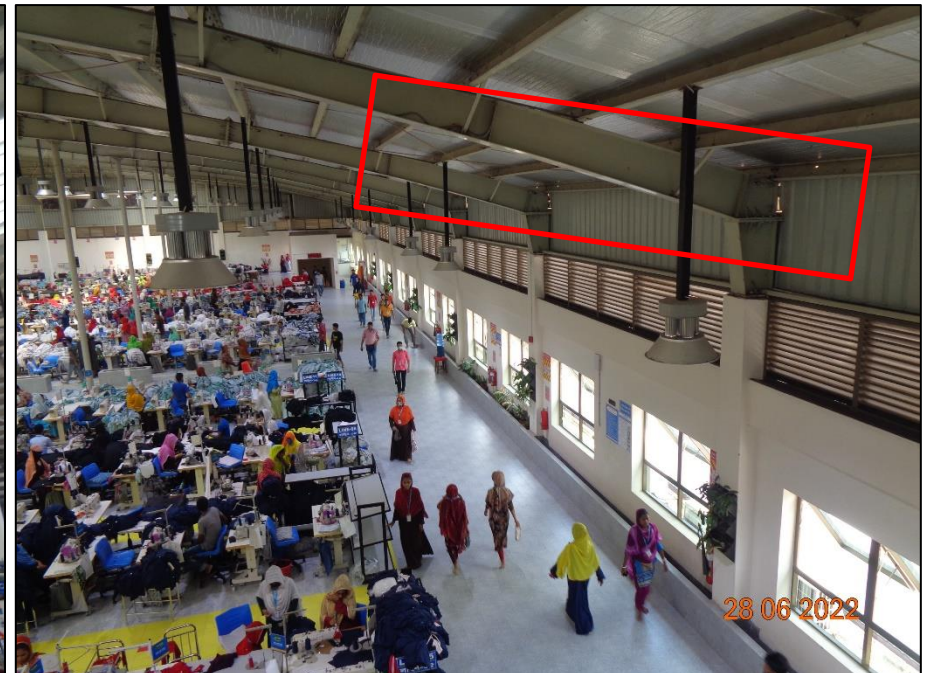
Steel roof shed - Lateral load transfer media missing at roof level

Lateral load transfer media (compression strut) along the ridge and eave is missing. The building engineer to check the lateral load path and review the stability of the structure accordingly.

| Item No. | Observation | Recommended Action Plan | Recommended Timeline |
|---|---|---|---|
| 07 | Lack of lateral stability of roof shed (Fashion Building) | Building Engineer is required to confirm the lateral load path & verify the lateral stability of the steel shed. | 6-weeks |

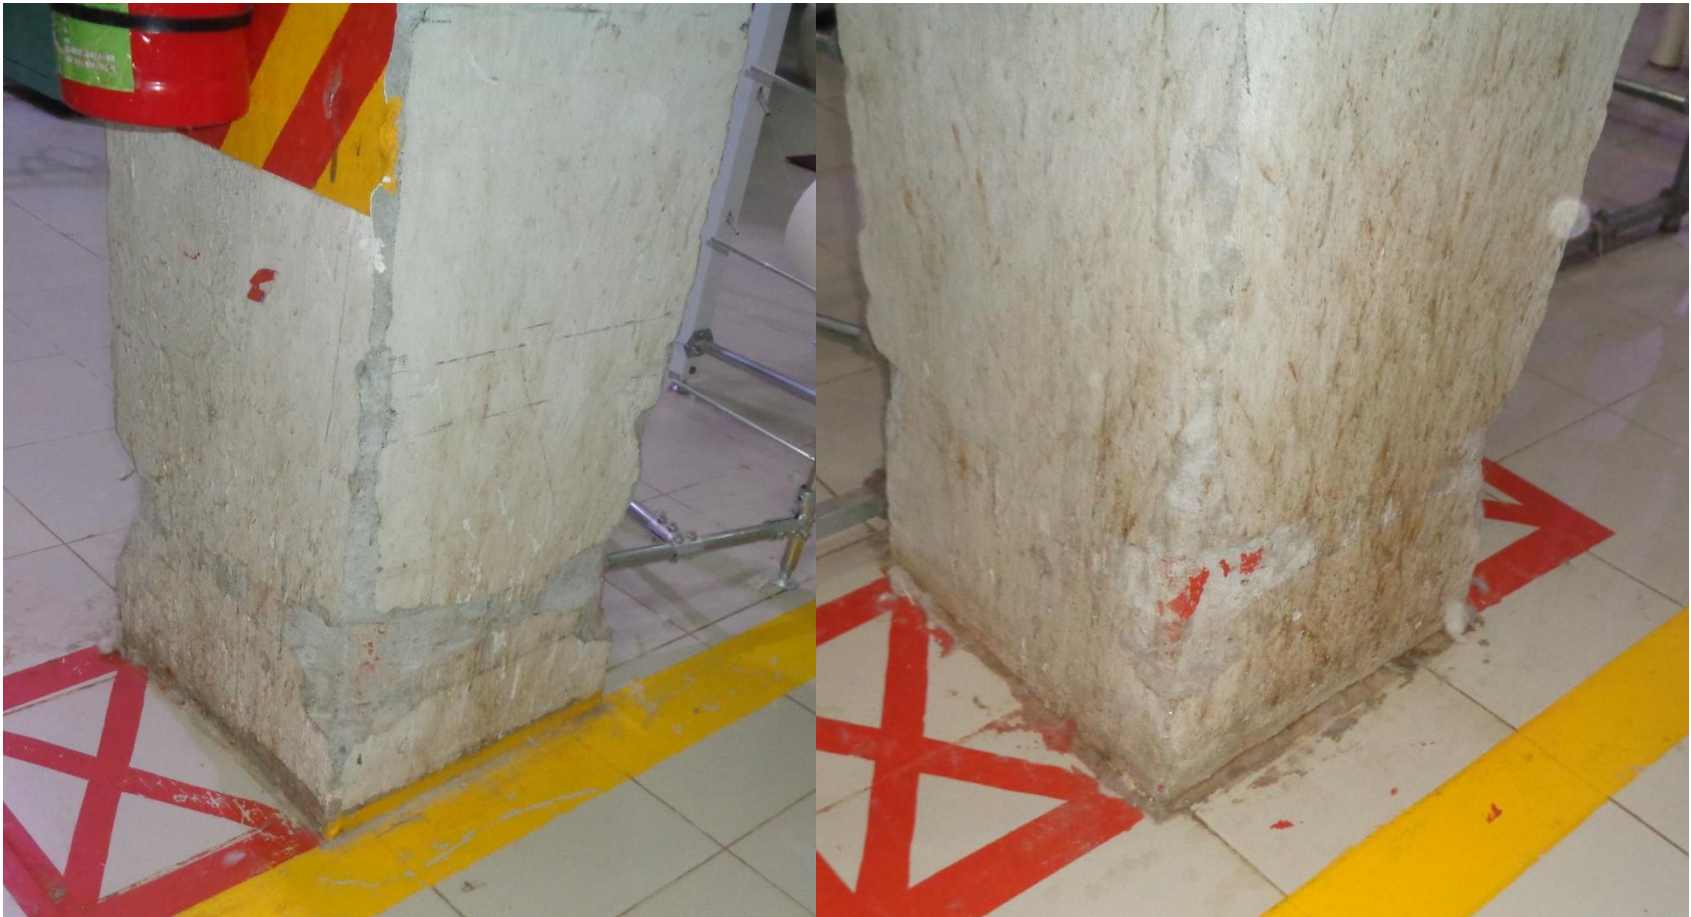
RC Column was found damaged due to the trolley impact. The building engineer is required to investigate the damage and suggest remedial action as well as provide suggestions to prevent such damages in the future. The factory is required to implement the suggested actions.

| Item No. | Observation | Recommended Action Plan | Recommended Timeline |
|---|---|---|---|
| 09 | Trolley impact on Column (Fashion Building) | Factory engineer is required to investigate the damage and suggest a remedial action as well as provide suggestion to prevent such damages in future. | 6-weeks |

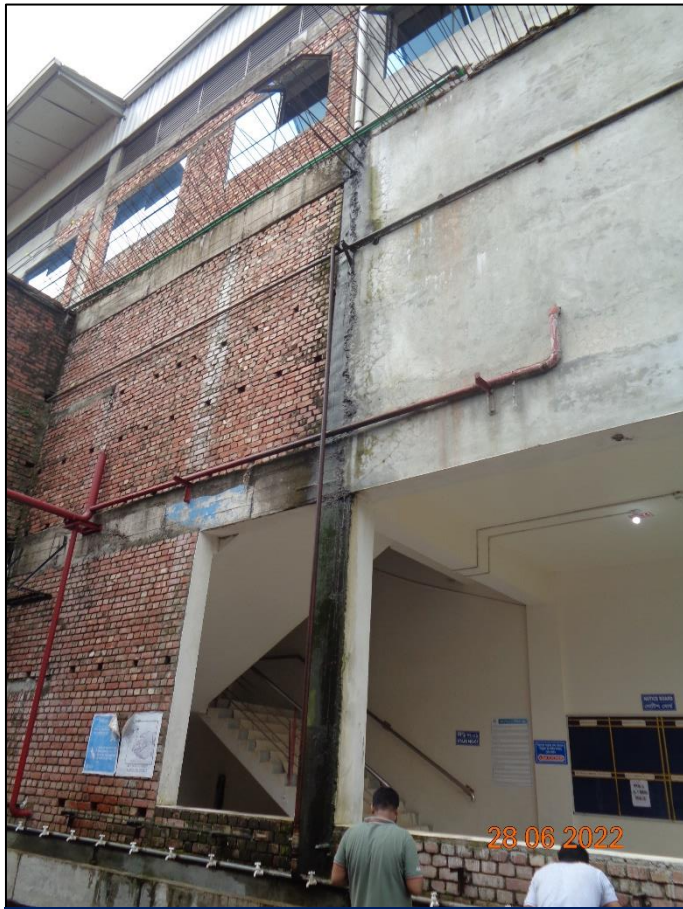
Dampness in RC Column

Due to water absorption, dampness was found in the brick wall & RC Column. The building engineer is required to take necessary measures to prevent dampness in the brick wall & RC beam.

| Item No. | Observation | Recommended Action Plan | Recommended Timeline |
|---|---|---|---|
| 11 | Dampness on brick wall & Column (Fashion Building) | Building engineer is required to investigate the damp area to verify if any damaged occurred due to the presence of the moisture and repair accordingly. | 6-weeks |

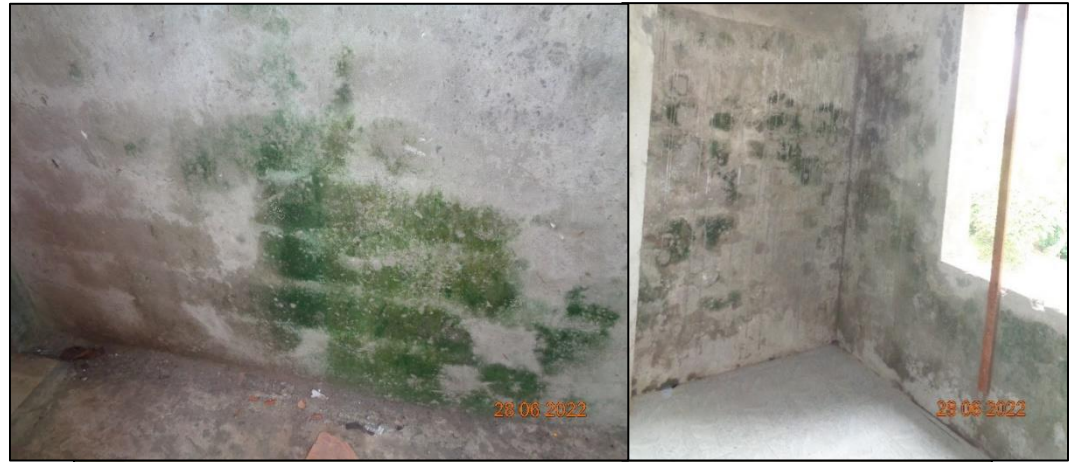
Dampness in Brick wall

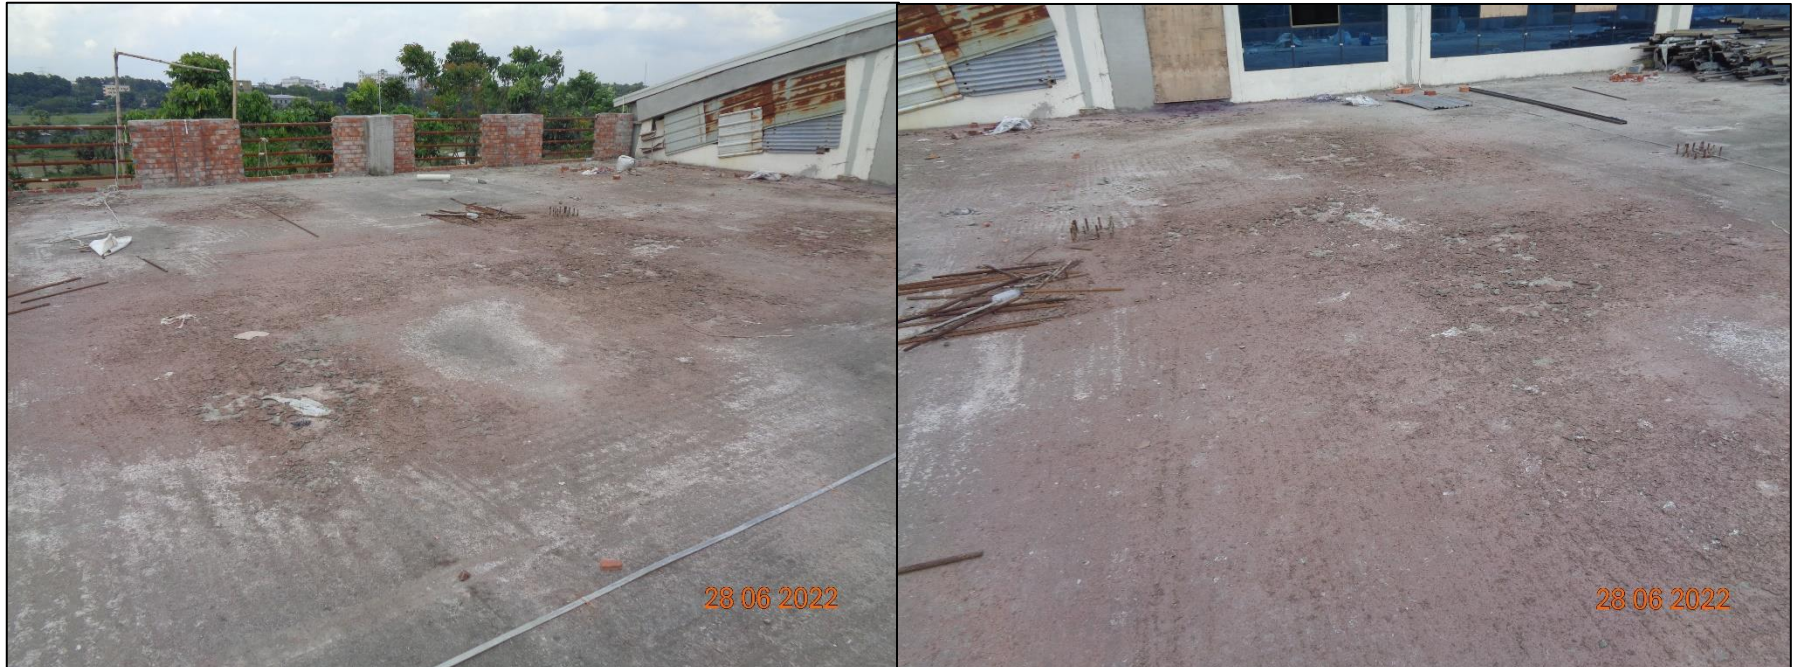
Lack of water proofing on roof slab

The roof of the building is made of MCAC but no protective coating is provided to prevent water ingress into the slab. Also, signage of water ponding was found. The factory is required to provide a protective coating with 2% slope on the exposed surface to prevent the accumulation of water.

| Item No. | Observation | Recommended Action Plan | Recommended Timeline |
|---|---|---|---|
| 12 | Lack of water proofing on roof slab (Fashion Building) | Apply water proofing at the roof top and improve the drainage system. | 6-weeks |

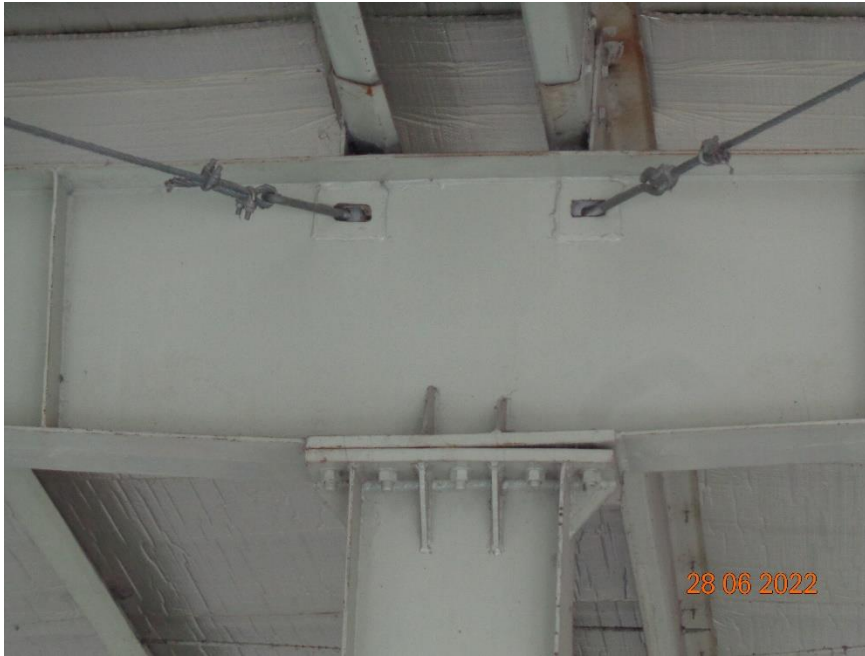
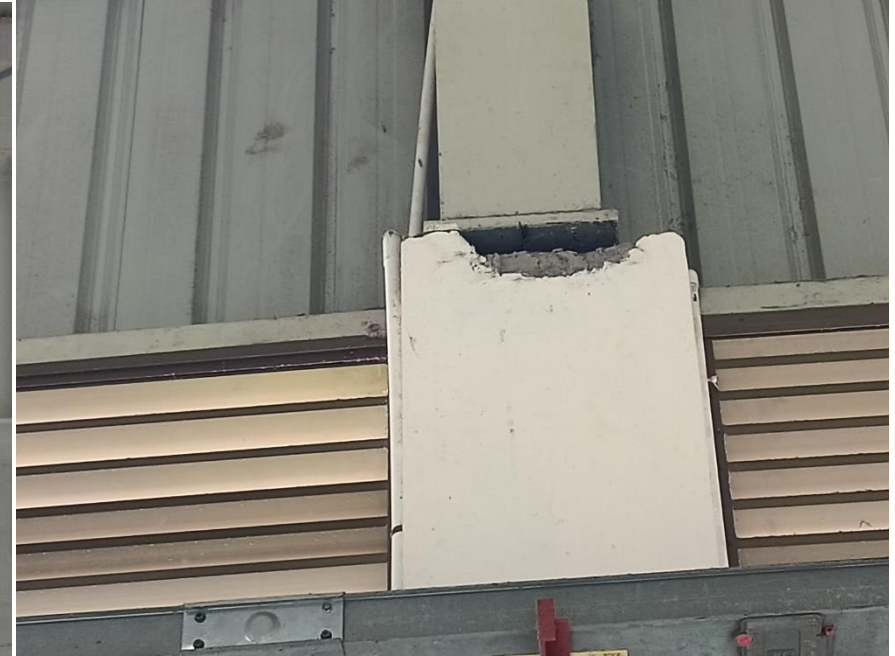
Connection gap was found in rafter-column and RC column-Steel column connection

Connection gaps were observed at joints of several locations. The building engineer is required to identify the locations and carry out suitable remedial works.

| Item No. | Observation | Recommended Action Plan | Recommended Timeline |
|---|---|---|---|
| 13 | Connection gap at several locations (Fashion Building) | Identify the locations and carryout suitable repair works where necessary. | 6-weeks |

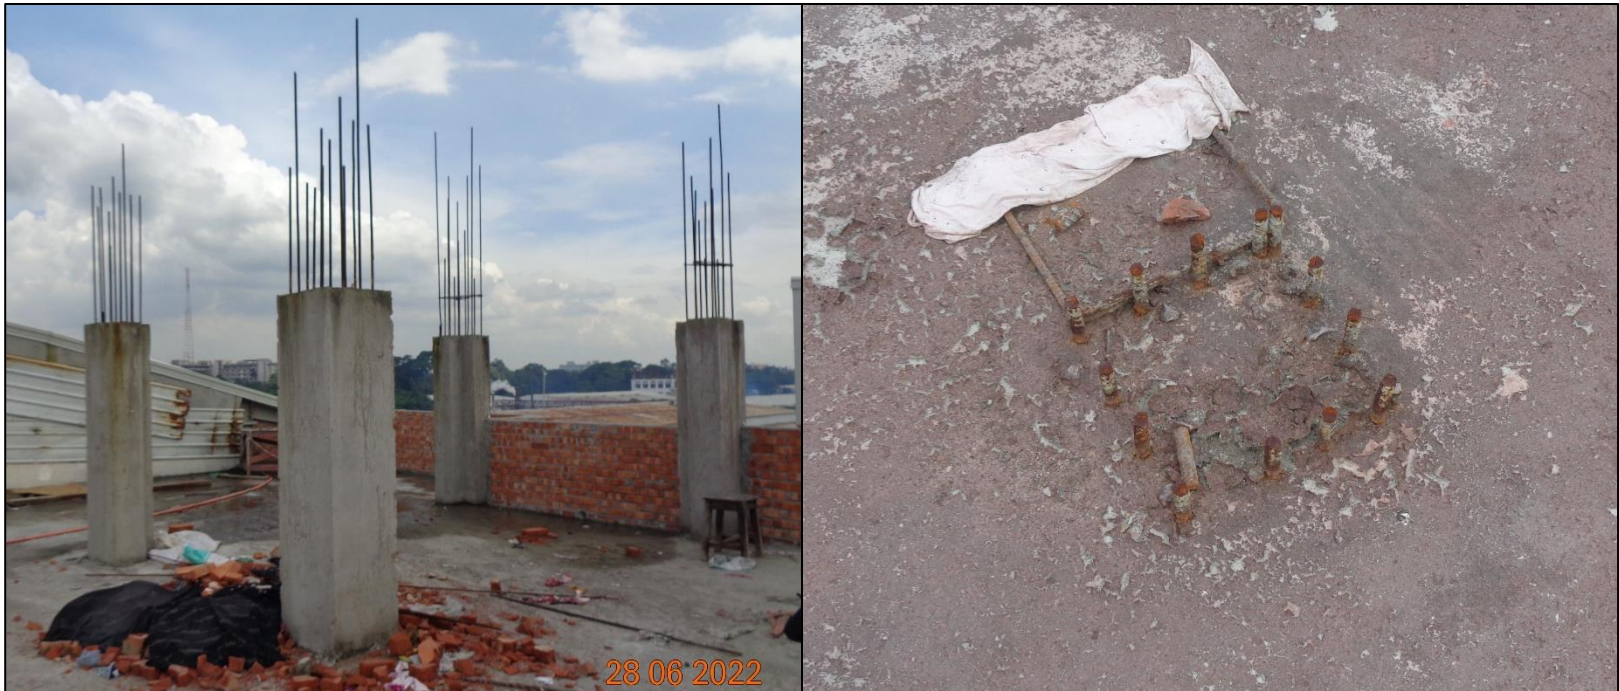
Exposed rebar at roof

Exposed reinforcement was found on the roof which is susceptible to corrosion that may cause deterioration of concrete. The building engineer is required to take necessary measures to prevent corrosion in the exposed rebar.

| Item No. | Observation | Recommended Action Plan | Recommended Timeline |
|---|---|---|---|
| 14 | Exposed rebar at roof level (Fashion Building) | All exposed reinforcement is to be protected from corrosion which may cause degradation of the concrete. | 6-weeks |

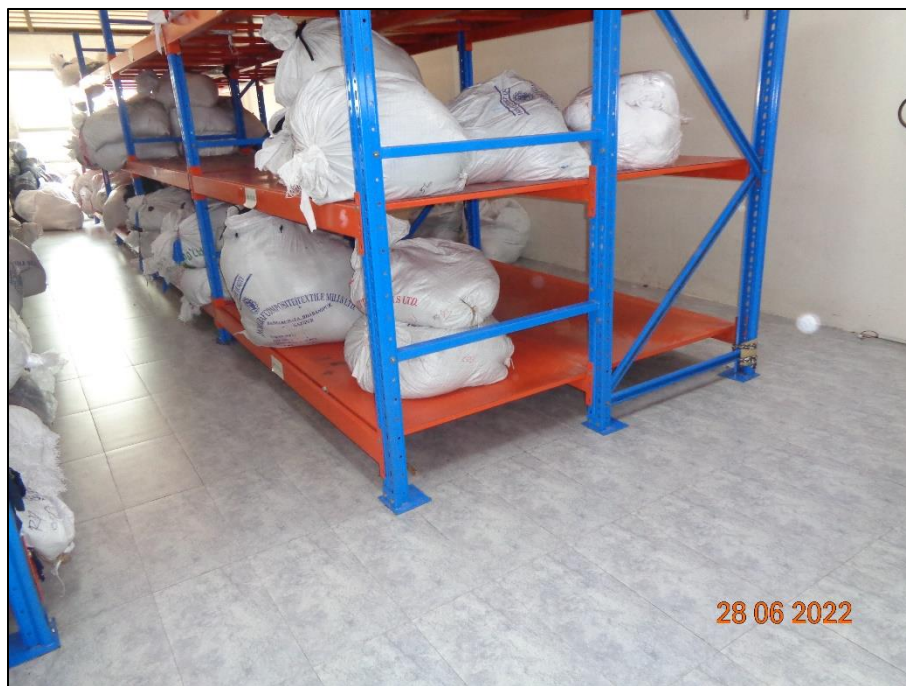
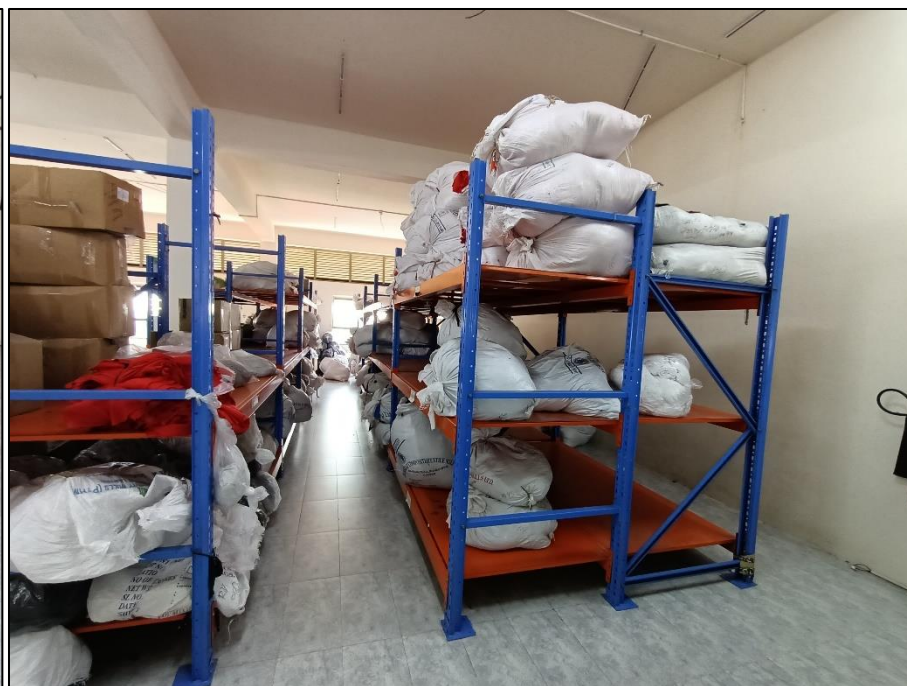
Rack on floor level

Racks on different floors are not adequately anchored or braced to resist lateral (earthquake) forces.  
Adequately anchor and brace all non-structural elements to resist earthquake forces.

| Item No. | Observation | Recommended Action Plan | Recommended Timeline |
|---|---|---|---|
| 15 | Non-structural elements not anchored or braced (Fashion Building) | Adequately anchor and brace all non-structural elements to resist earthquake forces. | 6-weeks |

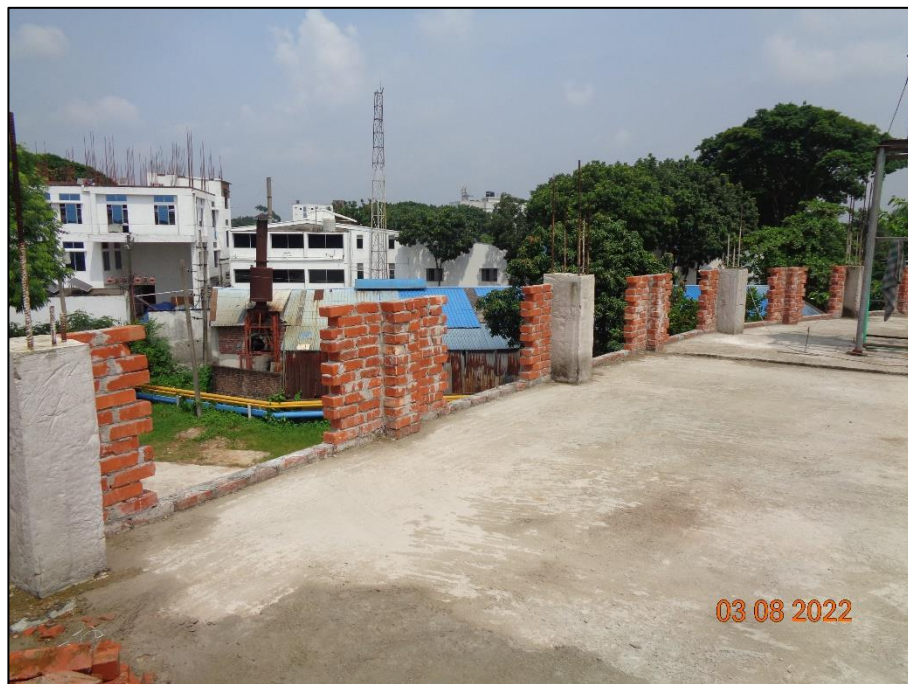
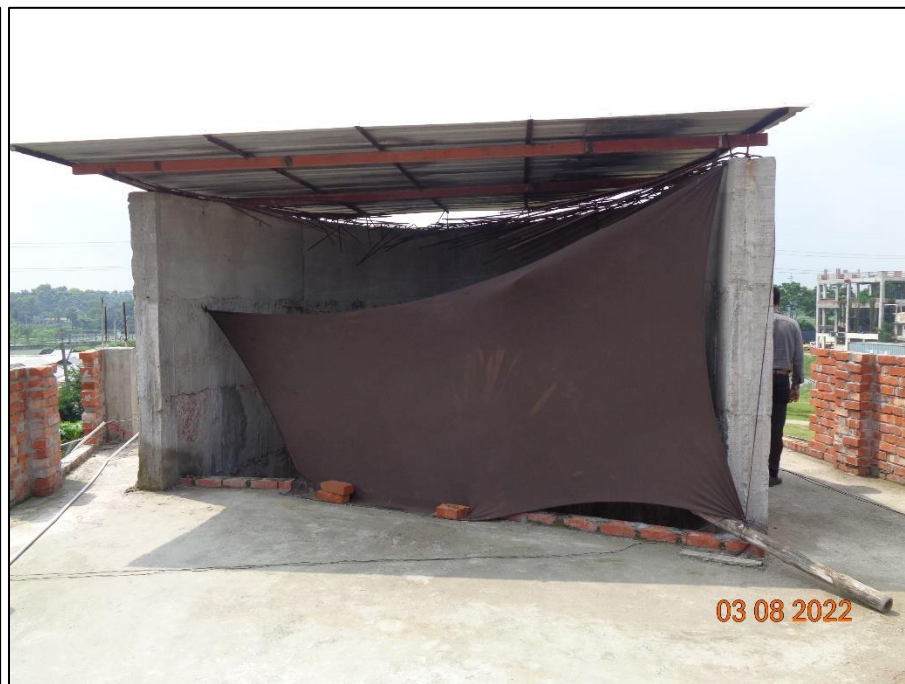
Parapet wall missing at roof

During the inspection, Edge protection (Parapet wall/Railing) was not observed on the roof and stairs. The factory is required to provide edge protection to avoid falling hazard.

| Item No. | Observation | Recommended Action Plan | Recommended Timeline |
|---|---|---|---|
| 18 | Lack of edge protection (Admin Building) | Factory is required to provide edge protection on roof and stair to avoid falling hazard. | 6-weeks |

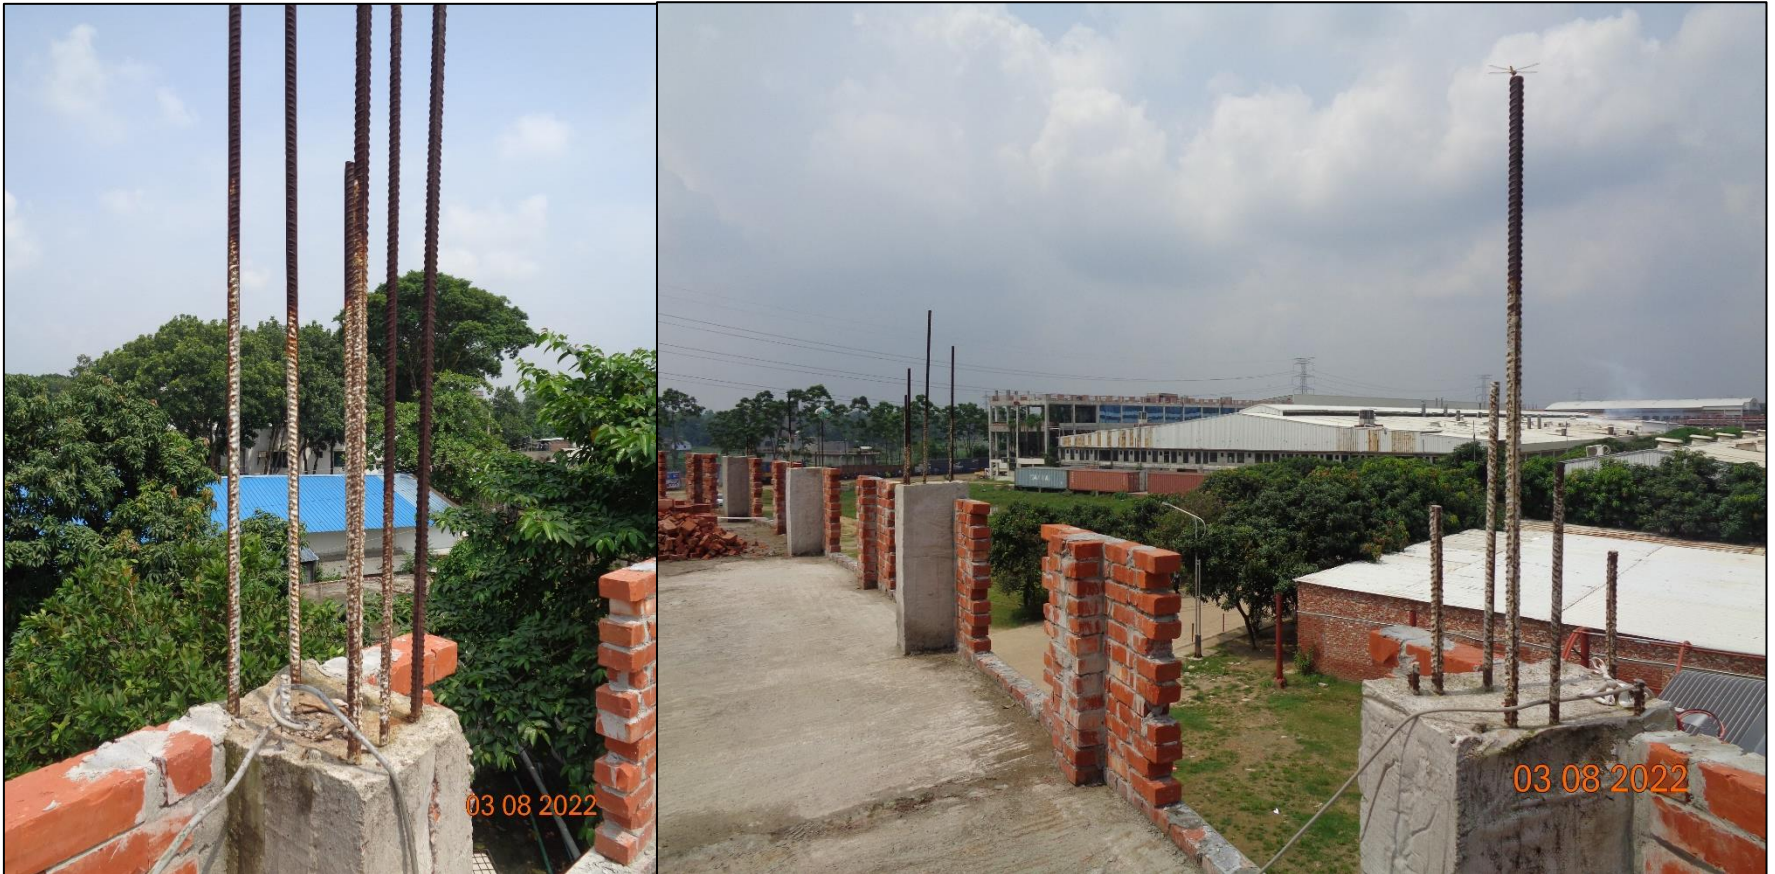
Exposed rebar at roof

Exposed reinforcement was found on the roof which is susceptible to corrosion that may cause deterioration of concrete. The building engineer is required to take necessary measures to prevent the corrosion on exposed rebar.

| Item No. | Observation | Recommended Action Plan | Recommended Timeline |
|---|---|---|---|
| 19 | Exposed rebar at roof level (Admin Building) | All exposed reinforcement is to be protected from corrosion which may cause degradation of the concrete. | 6-weeks |

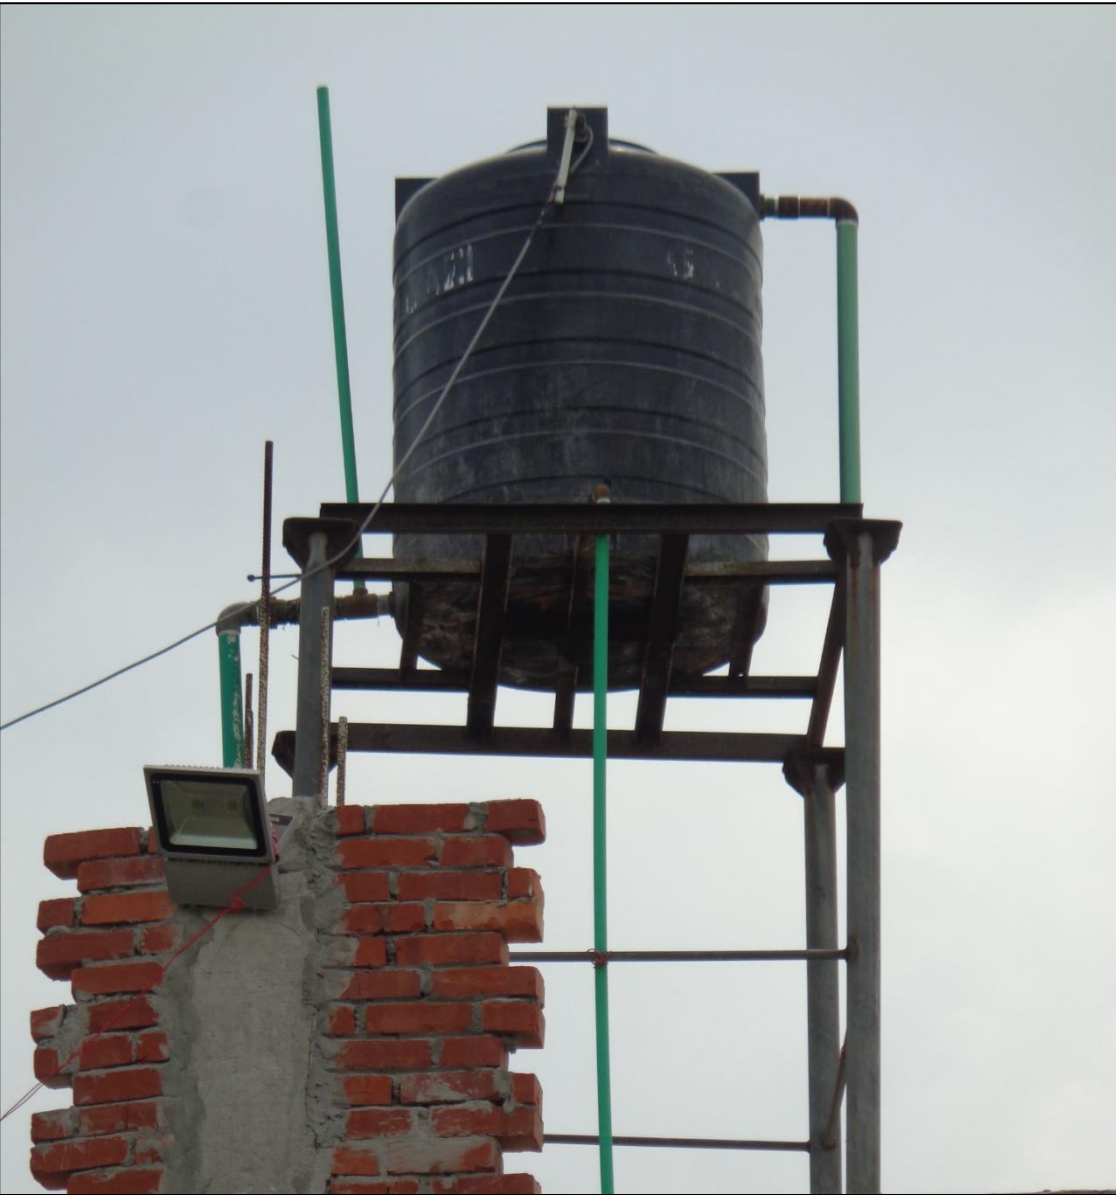
Plastic water tank at roof

Plastic water tank at roof is not adequately anchored or braced to resist lateral (earthquake) forces.

Adequately anchor and brace all non-structural elements to resist earthquake forces. If the tanks cannot be structurally accommodated, that should be removed.

| Item No. | Observation | Recommended Action Plan | Recommended Timeline |
|---|---|---|---|
| 20 | Non-structural elements not anchored or braced (Admin Building) | Adequately anchor and brace all non-structural elements to resist earthquake forces. | 6-weeks |

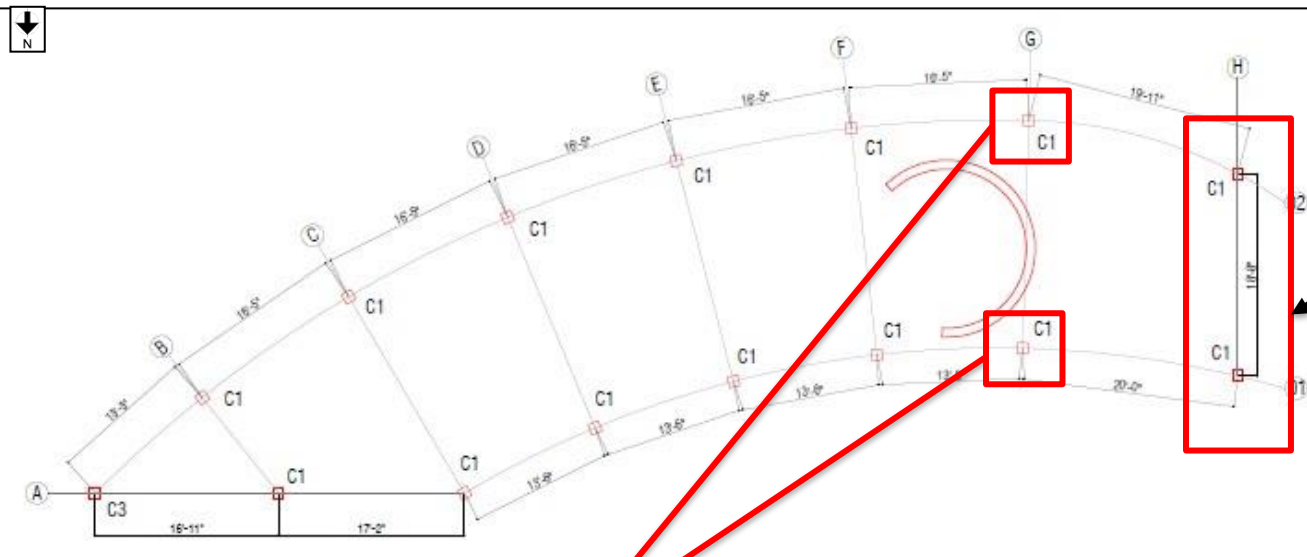
The marked two columns has not been constructed

The marked portion has not been constructed. But the design documents prepared considering the extended part

The building geometry does not match the as-built drawing. Additional column & grid has been shown in the drawing which has not been constructed yet. The building engineer is required to survey the whole structure and update the as-built drawing as well as design document as per site conditions.

| Item No. | Observation | Recommended Action Plan | Recommended Timeline |
|---|---|---|---|
| 21 | Discrepancy in as-built drawing & design documents (Medical Building) | Building engineer to update the design document including a design report, and a set of structural drawings in compliance with section 1.9.1.1 and section 1.9.1.2 as per BNBC. | 6-weeks |

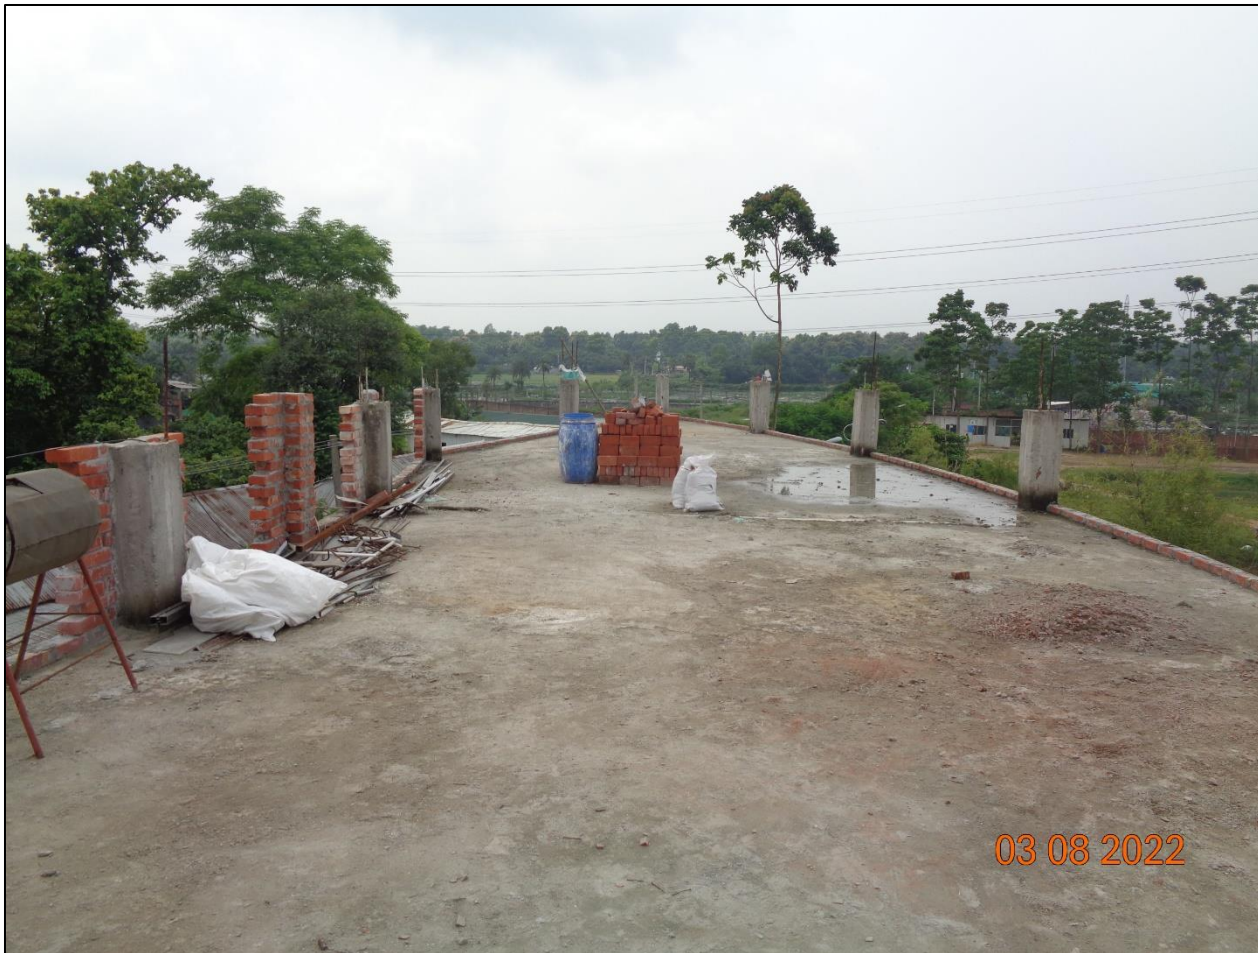
Parapet wall missing at roof

Edge protection (Parapet wall/Railing) was not observed on the roof and stairs. The factory is required to provide edge protection to avoid the falling hazard.

| Item No. | Observation | Recommended Action Plan | Recommended Timeline |
|---|---|---|---|
| 23 | Lack of edge protection (Medical Building) | Factory is required to provide edge protection on roof and stair to avoid falling hazard. | 6-weeks |

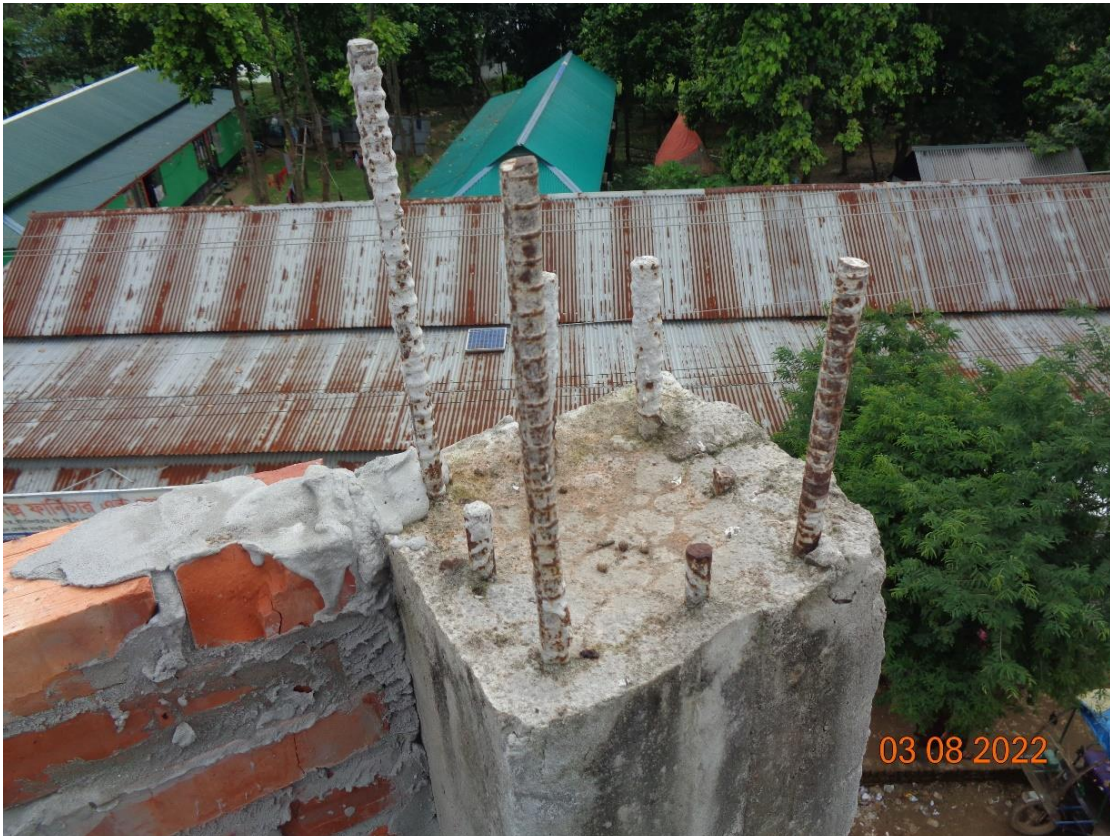
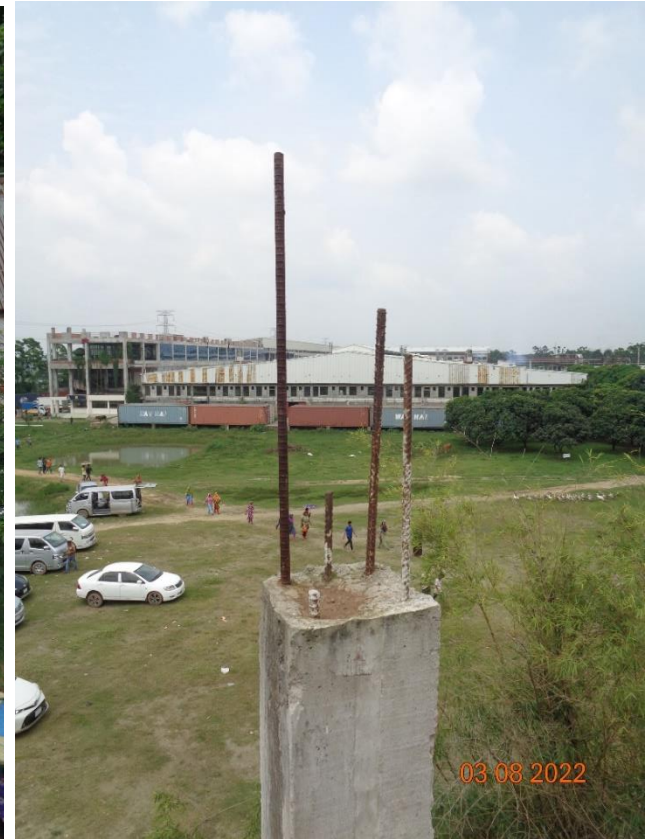
Exposed rebar at roof

Exposed reinforcement was found on the roof which is susceptible to corrosion that may the cause deterioration of concrete. The building engineer is required to take necessary measures to prevent the corrosion on exposed rebar.

| Item No. | Observation | Recommended Action Plan | Recommended Timeline |
|---|---|---|---|
| 24 | Exposed rebar at roof level (Medical Building) | All exposed reinforcement is to be protected from corrosion which may cause degradation of the concrete. | 6-weeks |

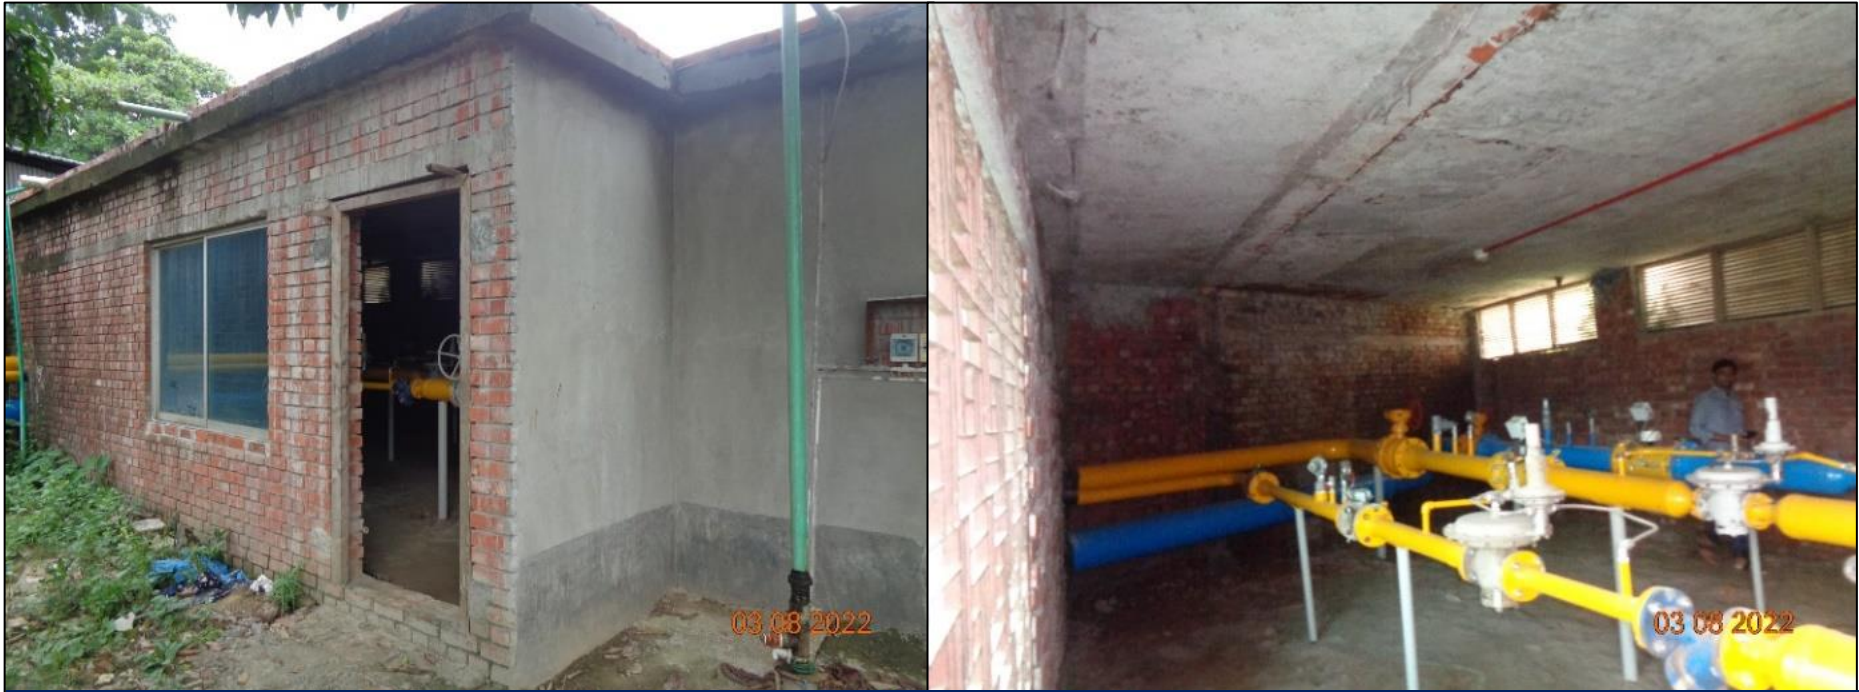
RMS Building

The RMS building do not have any design document except architectural & structural drawing. As per BNBC, every building or structure designed shall have its design documents prepared in accordance with the provision of Section 1.9.1. The design document shall include a design report, and a set of structural drawings, which shall be prepared in compliance with section 1.9.1.1 and section 1.9.1.2 as per BNBC. The building engineer is required to prepare the design documents including the design report based on the software-based analysis and in compliance with section 1.9.1 (part-6, BNBC).

| Item No. | Observation | Recommended Action Plan | Recommended Timeline |
|---|---|---|---|
| 25 | Design report needs to be prepared (RMS Building) | Building engineer to prepare the design document including a design report, and a set of structural drawings in compliance with section 1.9.1.1 and section 1.9.1.2 as per BNBC. | 6-weeks |
