# Famkam Fashion Ltd.

Shirir Chala, Bagher Bazer, Gagipur Shadar, Gazipur

28<sup>th</sup> July 2022 & 03<sup>rd</sup> August 2022

# Executive Summary

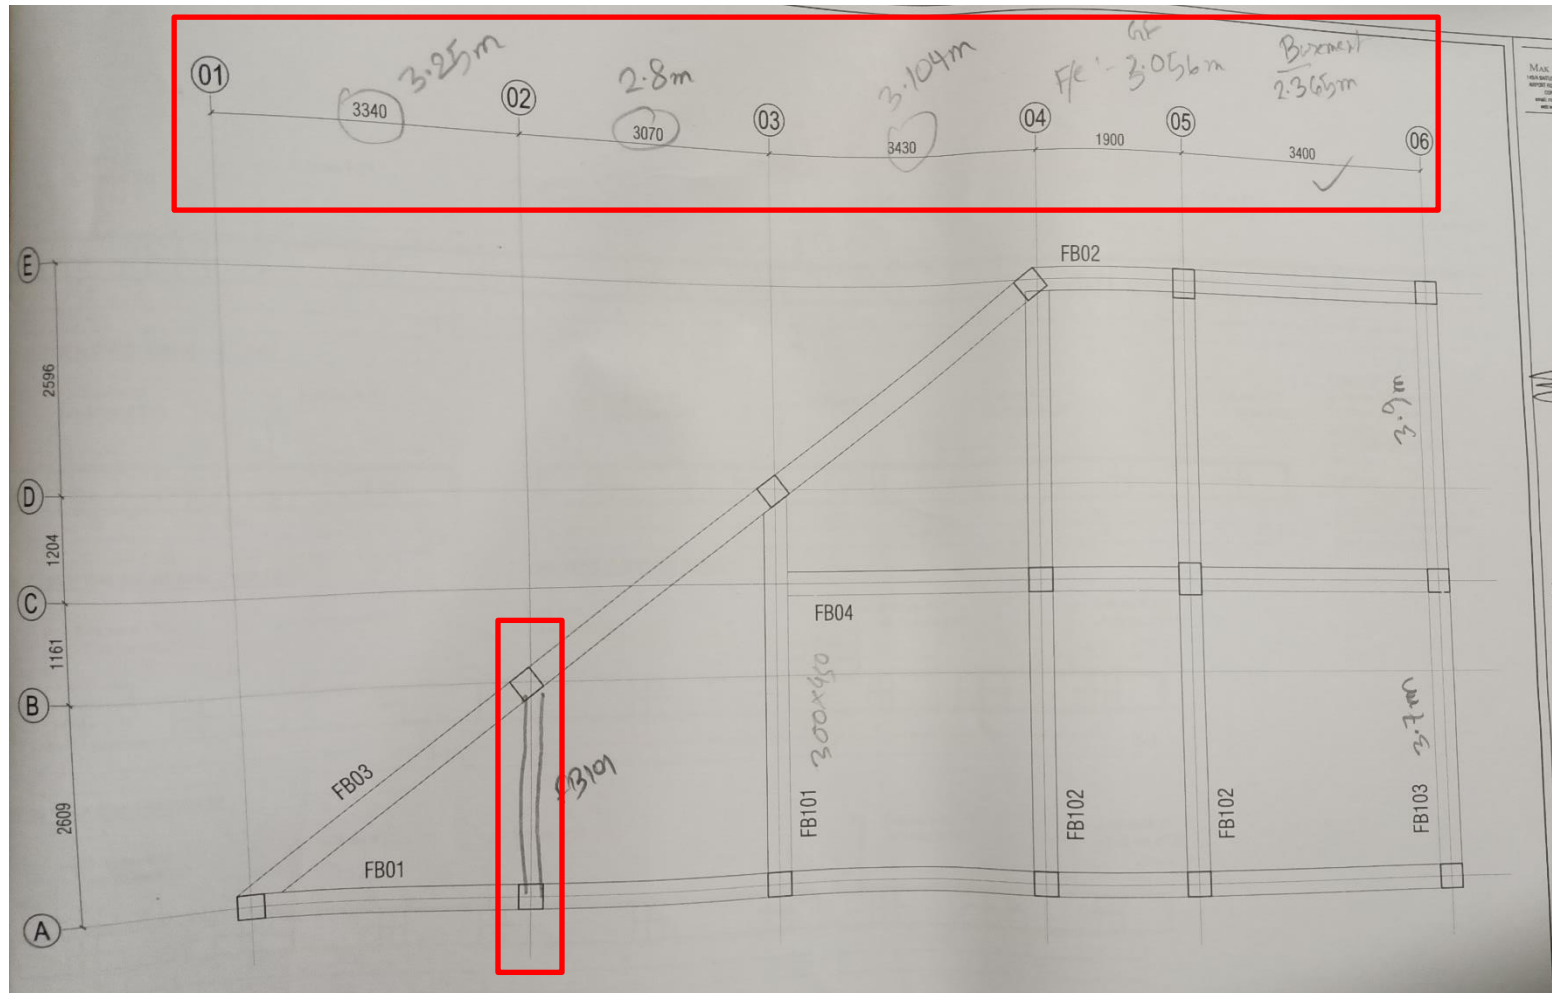
Beam Layout

Grid dimensions are not matched with the as-built condition. Also, a floor beam (red marked) is not shown in the drawing.

| Item No. | Observation | Recommended Action Plan | Recommended Timeline |
|---|---|---|---|
| 27 | Prepared as-built drawings and design report need to be revised (Fire Pump Building) | Building engineer to revise the design document including a design report, and a set of structural drawings in compliance with section 1.9.1.1 and section 1.9.1.2 as per BNBC. | 6-weeks |

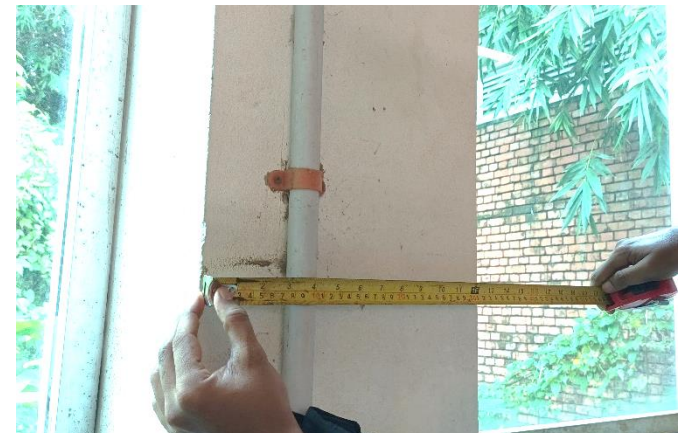
C-02 column  
300 mm instead of 375 mm

The size of C-02 and C-03 columns were found 300 mm & 375 mm instead of 375 mm & 400 mm respectively. The building engineer is required to revise the as-built documentation including the design report and submit it to RSC for review.

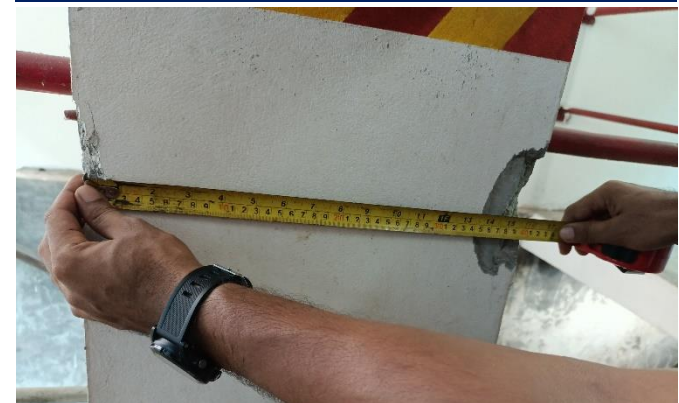
C-03 column  
375 mm instead of 400 mm
