# INITIAL FIRE SAFETY INSPECTION REPORT

**Masco Printing and Embroidery Ltd.**

**RSC ID: 24424**

**Date: 30-May-2022**

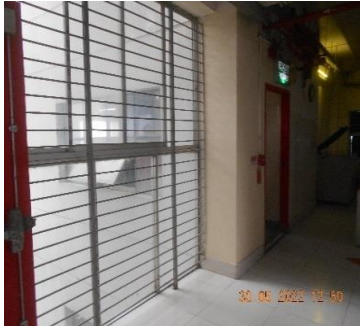
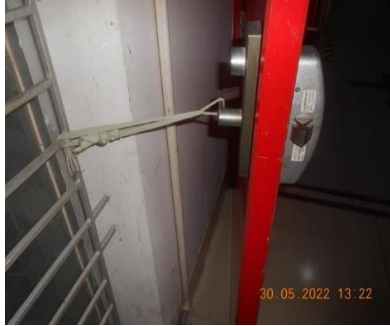
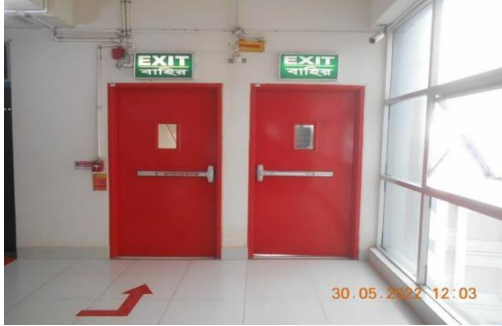
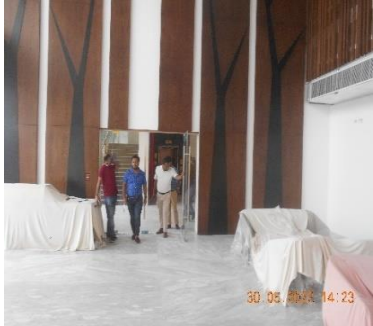
| SI No. | Category | Findings | Required Action | Remediation Time Frame |
|---|---|---|---|---|
| F-01 | Fire Rated Construction | <p><b>Building-01:</b></p> <p>The exit stairs are not separated from [work areas, other spaces] on each floor by fire-rated construction.</p> | <p>Provide minimum 2-hr fire rated construction for buildings 4 storied or more and 1-hr for upto 3 storied. Seal all unprotected openings to separate the exit stairs from work areas and other spaces on all floor levels by 90 minutes for 2 hr construction and 60 minutes for 1-hr construction. Ensure that the fire rated doors are self-closing and positive latching and that they are provided with fire exit (panic) hardware where serving production floors and provide vestibules to avoid direct discharge from storage to exit stair enclosure.</p> <p>If fire rated doors are required to be held open for functional reasons, provide automatic closing devices tied to the fire alarm system.</p> <p>Once fire doors are installed, every door in a stair enclosure serving more than 5 stories shall be provided with re-entry unless it meets RSC Technical Guidelines (Standard) 6.8.3.1</p> <p>If fire doors are required to be held open for functional reasons, provide automatic-closing devices tied to the fire alarm system.</p> | Within 3 months |

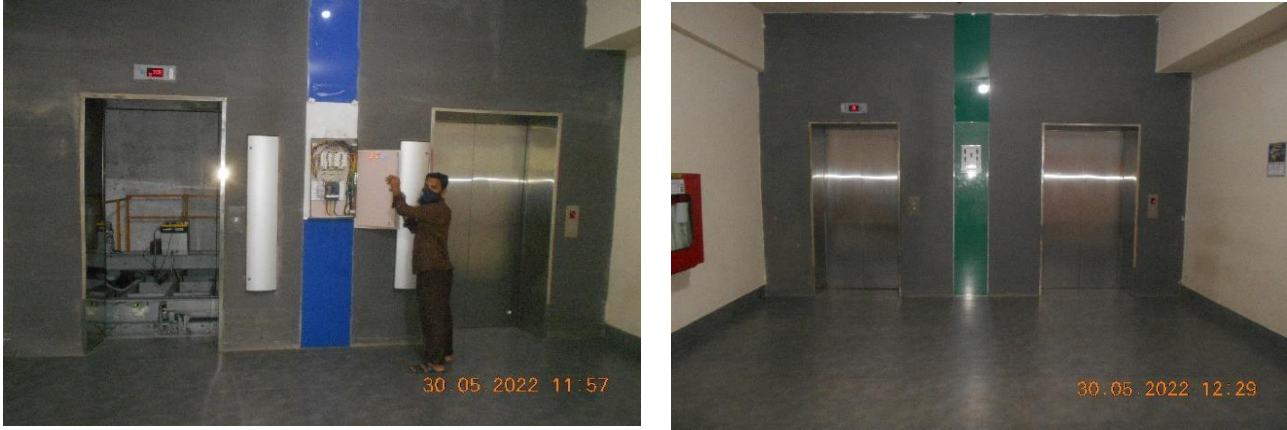
| SI No. | Category | Findings | Required Action | Remediation Time Frame |
|---|---|---|---|---|
| F-02 | Fire Rated Construction | Elevator open directly inside of exit enclosure which is a violation of RSC Technical Guidelines - 6.14.3. Location: Stair-1, and stair-3 of Building-1. | In new construction, elevators shall not open into an exit enclosure [RSC Technical Guidelines - 6.14.3]. So, rearrange the facility to provide separate enclosure for lifts. If not possible anyway provide a minimum 2-hr fire- rated elevator shaft with listed fire rated lift landing door to separate from each floor level. | Within 4 months |

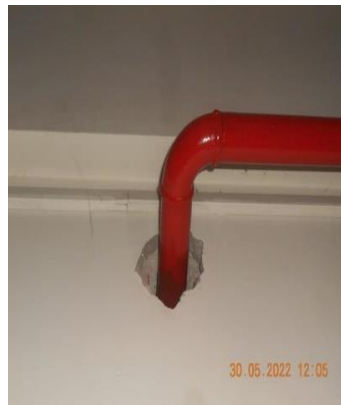
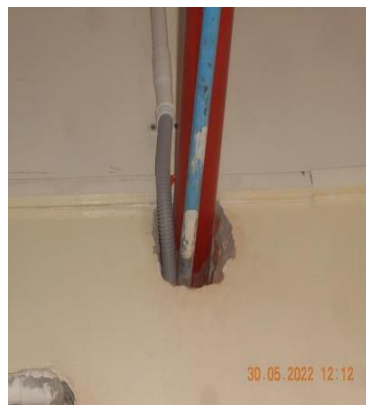
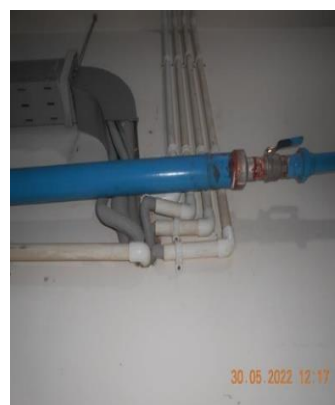
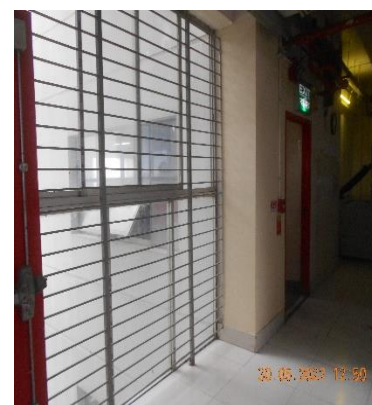
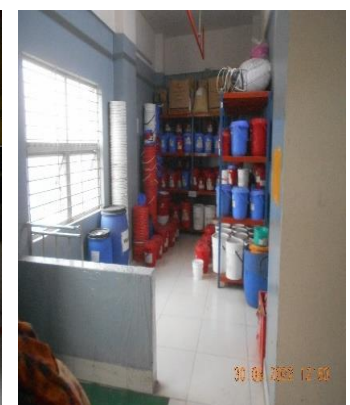
| SI No. | Category | Findings | Required Action | Remediation Time Frame |
|---|---|---|---|---|
| F-03 | Fire Rated Construction | <p>Unsealed penetrations and openings (non-rated exterior walls within 3050 mm (10 ft) horizontally and an angle of less than 180 degrees of stair-5) are located in the exit stair enclosures.</p> <p><b>Location:</b> Most of the stairs of building-1.</p> | Seal all penetrations and openings in exit stair enclosure walls to maintain the fire separations. | Within 3 months |

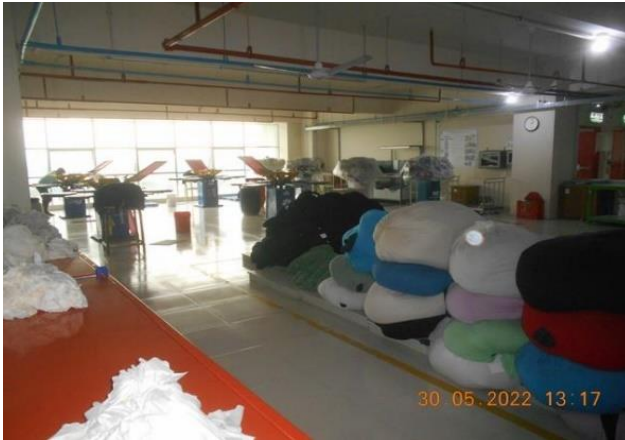
| SI No. | Category | Findings | Required Action | Remediation Time Frame |
|---|---|---|---|---|
| F-04 | Fire Rated Construction | Areas used for in-process storage of combustible materials are open to the surrounding occupancy. Location: On 2nd and 3rd floor of production building (B-1) | <p>Provide defined storage areas and limit the storage arrangement as follows: -</p> <ol style="list-style-type: none"> <li>1. General Condition: Maximum height of 2.4m and maximum area of 23m<sup>2</sup>. Separate areas of unenclosed combustible storage by a minimum clear distance of 3m.</li> <li>2. If sprinkler protected: maximum height of 3.66m and maximum area of 93m<sup>2</sup>. Separate areas of unenclosed combustible storage by a minimum clear distance of 3m.or</li> <li>3. Enclose the storage area from the surrounding occupancy with a minimum 1-hour construction.</li> </ol> | Within 3 months |

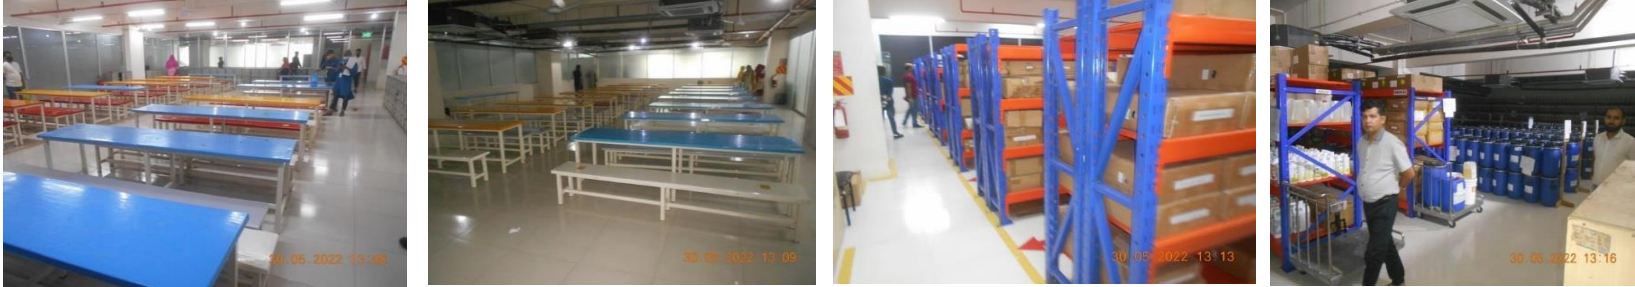
| SI No. | Category | Findings | Required Action | Remediation Time Frame |
|---|---|---|---|---|
| F-05 | Fire Rated Construction | Dining and prayer halls (E-3, capacity more than 300) were located on 4th floor with Chemical (J2) and Storage (H2) occupancy. The above and bottom floor of the dining and prayer were occupied for production (G2) and Chemical (J2).<br>Location: On 4th floor of building-1. | The dining and prayer areas (E3) is not permitted with moderate hazard occupancies (G2) and chemical hazard occupancy (J2) following table 3.2.1 of BNBC-2006. Relocate the dining and prayer hall(s) as table 3.2.1 of BNBC-2006 (or BNBC-2020 where applicable). | Within 3 months |

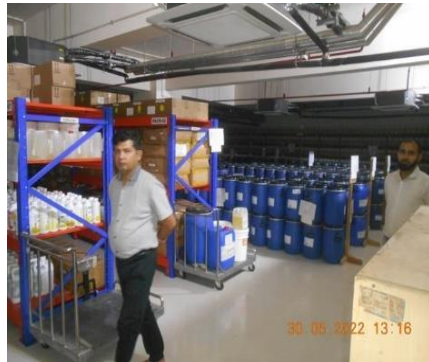
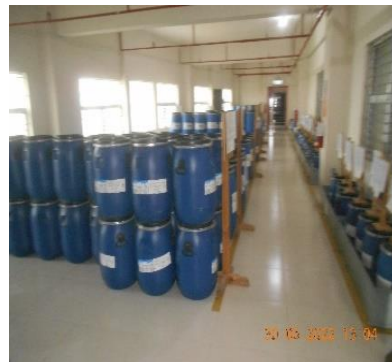
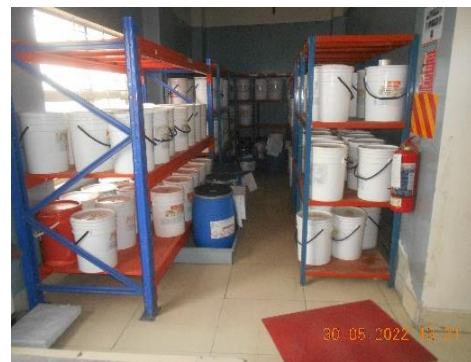
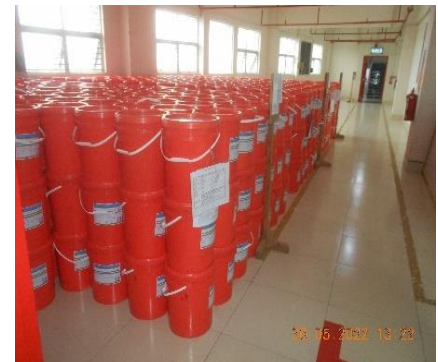
| SI No. | Category | Findings | Required Action | Remediation Time Frame |
|---|---|---|---|---|
| F-06 | Fire Rated Construction | Chemical storage area is not properly separated by fire-rated construction due to openings & penetrations. Location: On 2nd to 8th floor of building-1. | Separate the chemical storage room by 4-hr fire rated construction. Seal all penetrations and protect the openings to maintain the required fire separations for 4-hrs. Opening is not permitted for 4-hrs fire rated separation. Keep 16-points SDS of all chemicals in the storage area. Note: Construction type shall be Type-1 and separation shall be as per Table 3.2.1 of BNBC-2006. | Within 3 months |

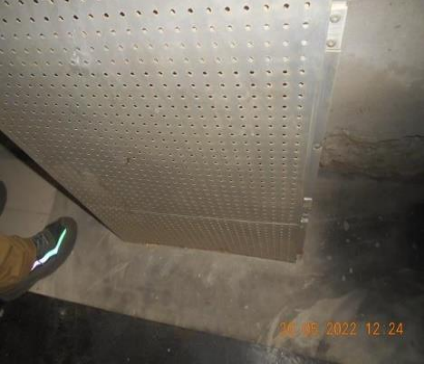
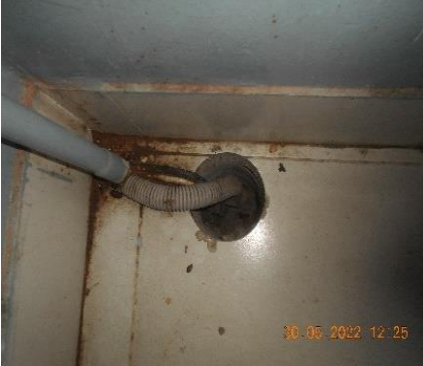
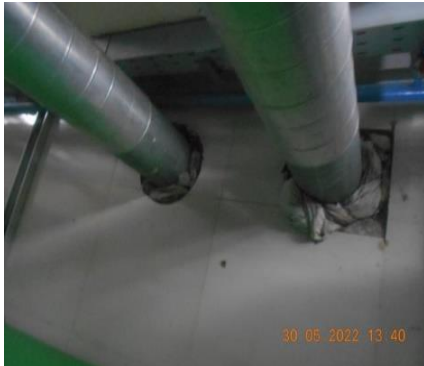
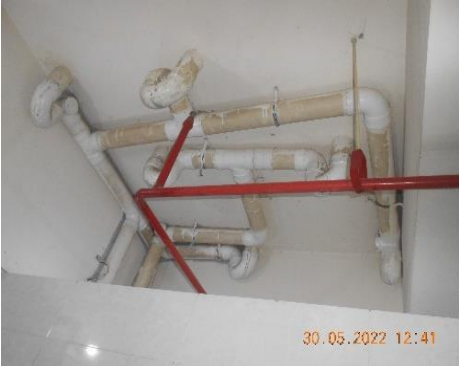
| SI No. | Category | Findings | Required Action | Remediation Time Frame |
|---|---|---|---|---|
| F-07 | Fire Rated Construction | <p>Unsealed penetrations and openings are located in the fire rated floor/ceiling assemblies. Followings are the description of openings or penetrations indicating specific locations:</p> <ol style="list-style-type: none"> <li>1. Passing of BBT through rated walls from MDB room to the production area in each floor of production building (B-1).</li> <li>2. PVC pipes penetrate the floor slabs in toilet block of production building (B-1).</li> <li>3. Floor penetrations due to fire alarm, IT and electrical cable riser in production building (B-1).</li> <li>4. Chiller pipes penetrate the floor slabs of production building (B-1).</li> </ol> | <p>Seal all penetrations and openings in floor/ceiling (full thickness of the floor/ceiling) assemblies by fire rated materials to maintain the fire resistance rating.</p> <p>Provide a minimum 2-hr fire rated shaft to separate the utility risers from each floor if required.</p> | Within 3 months |

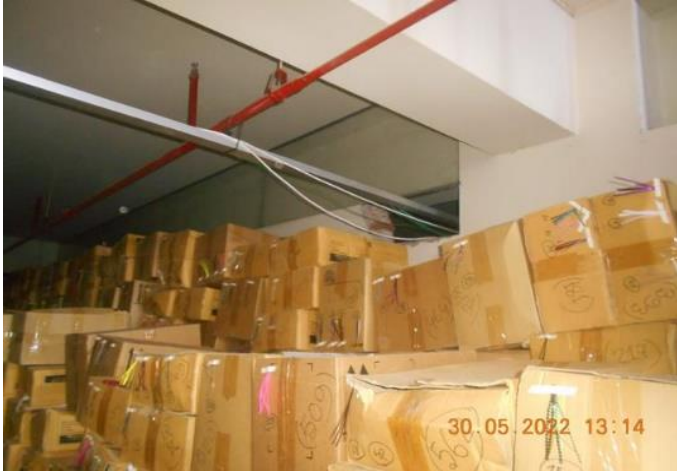
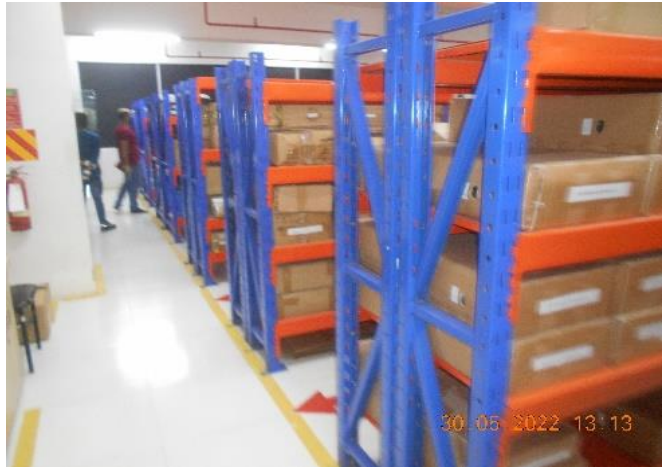
| SI No. | Category | Findings | Required Action | Remediation Time Frame |
|---|---|---|---|---|
| F-08 | Fire Rated Construction | Rooms used for combustible storage are not separated by fire rated construction.<br>Location: On 4th floor of building-1. | Separate the dedicated storage rooms by minimum 1-hr fire-rated construction. Provide 0.75 hr. fire rated door and seal all penetrations and openings by 1 hr. fire rated fire rated barrier construction. | Within 3 months |

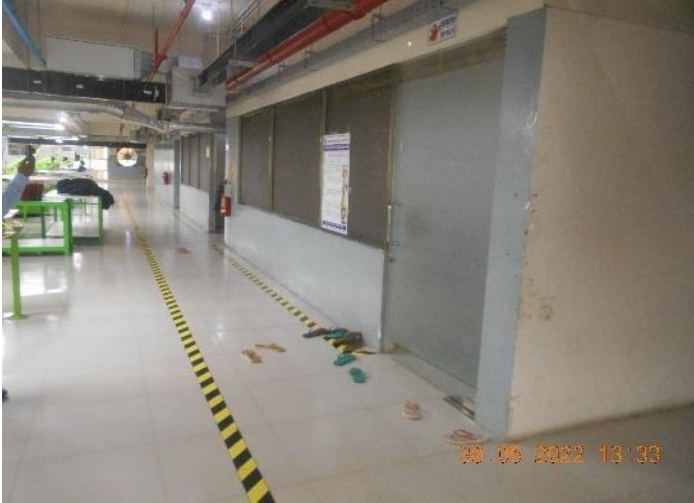
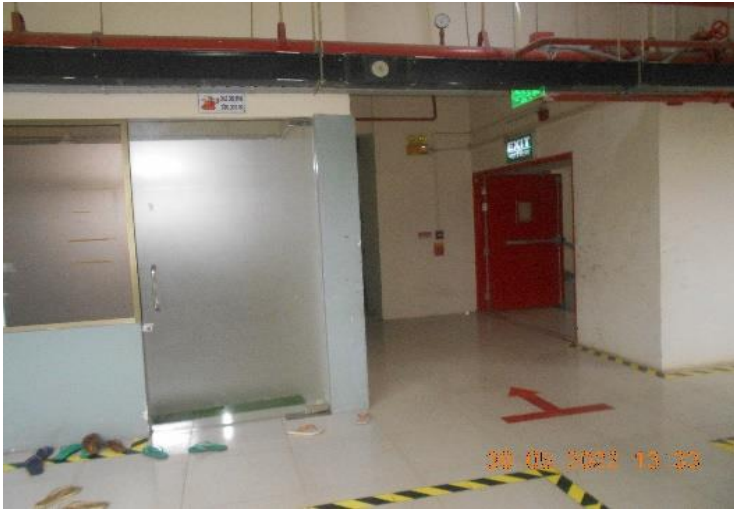
| SI No. | Category | Findings | Required Action | Remediation Time Frame |
|---|---|---|---|---|
| F-09 | Means of Egress | The day-care room does not have the direct access to an exit stair.<br>Location: On 2nd floor of building-1. | Relocate day-care room to ground floor with a maximum travel distance of 9 meter (30 feet).<br><br>Or Relocate to first floor where direct access to an exit enclosure is provided. | Within 3 months |

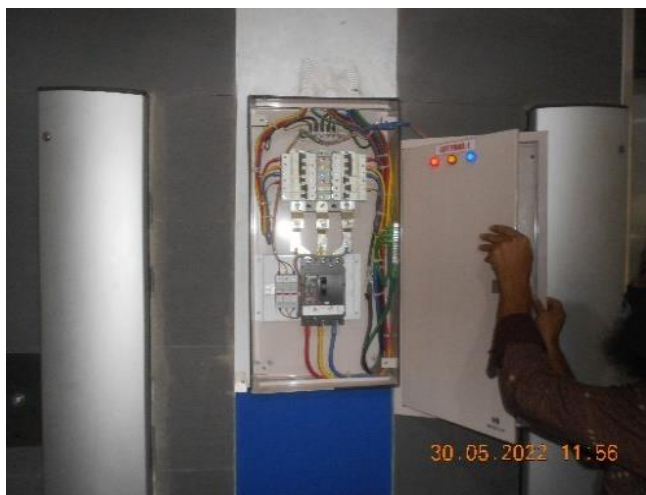
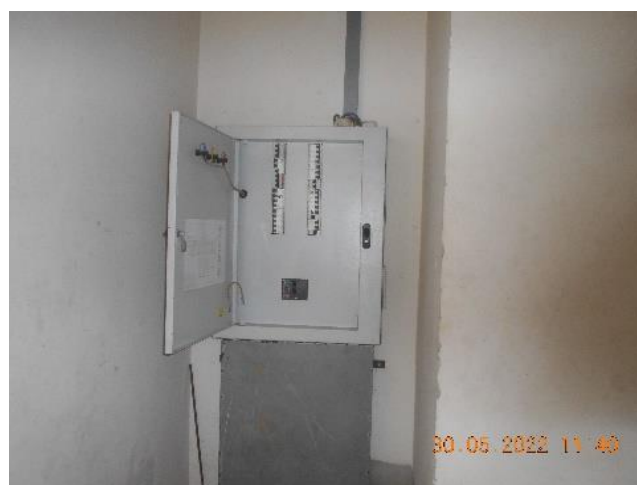
| SI No. | Category | Findings | Required Action | Remediation Time Frame |
|---|---|---|---|---|
| F-10 | Means of Egress | Electrical DB panel has been found in the exit stair.<br>Location: Stair-2 (North-west) on roof floor, Stair-1 (South-west) on 9th floor and stair-3 (North-east) on 1st floor of building-1. | Remove the electrical DB panel from exit stair to a safe location. | Within 1 month |

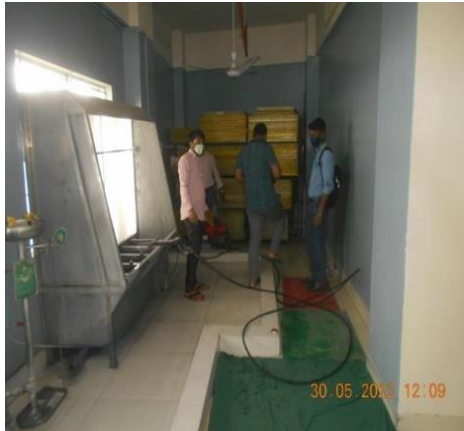
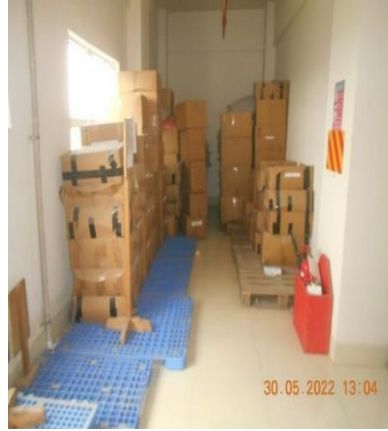
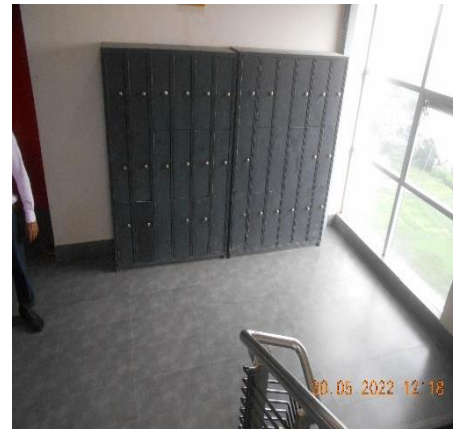
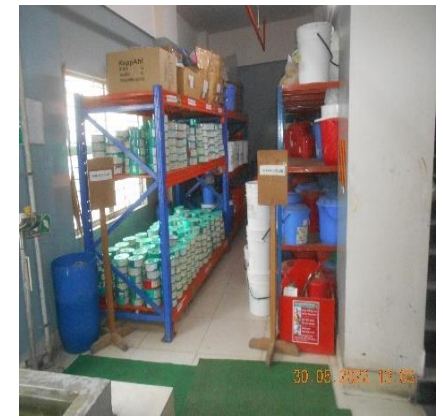
| SI No. | Category | Findings | Required Action | Remediation Time Frame |
|---|---|---|---|---|
| F-11 | Means of Egress | Storage (shoe rack/storage/office/operation) was located in the exit stair.<br>Location: On 2nd to 9th floor of stair-1 and stair-3 of building-1. | Remove storage from the exit stairs and egress path. | Immediately |

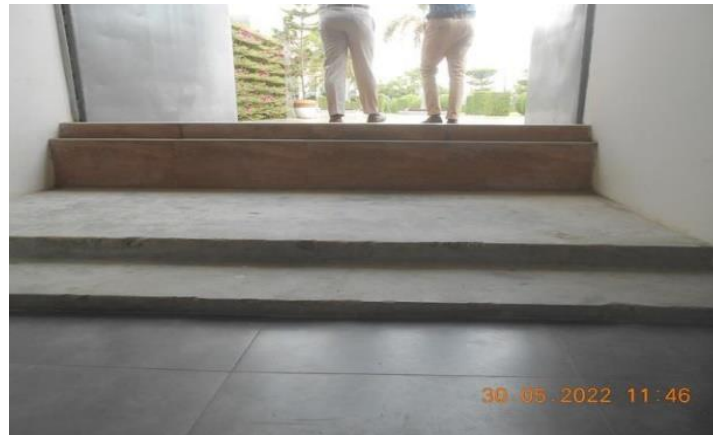
| SI No. | Category | Findings | Required Action | Remediation Time Frame |
|---|---|---|---|---|
| F-14 | Means of Egress | The stairway treads was not found uniform, it may lead tripping/dropping hazard.<br>Location: Stair-4 on roof floor of buiding-1. | Stair treads shall be of nominal uniformity. The maximum riser height for any stair shall be 215 mm (8.5 in.). | Within 1 month |

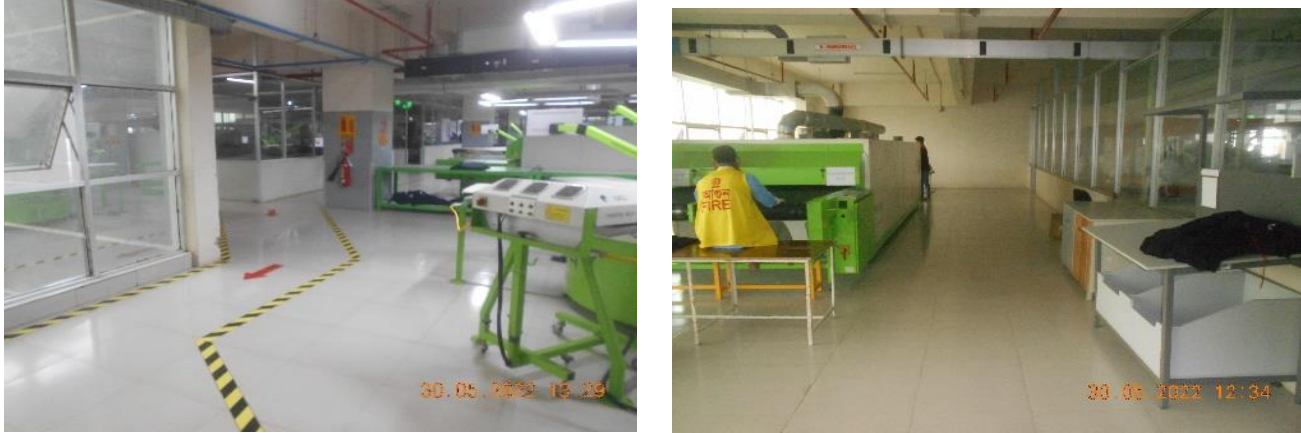
| SI No. | Category | Findings | Required Action | Remediation Time Frame |
|---|---|---|---|---|
| F-15 | Egress Lighting | Based on the number and location of emergency lights observed, adequate illumination levels are not anticipated along egress routes. Location: On 1st, 2nd, 3rd, 5th, 7th and 8th floor of building-1. | Test the emergency lighting system on each floor and provide additional emergency fixtures to provide adequate illumination along the means of egress. Provide a minimum illumination of 10 lux at the floor level within exit stairs and exit discharge paths and minimum 2.5 lux along exit access aisles. | Within 3 months |

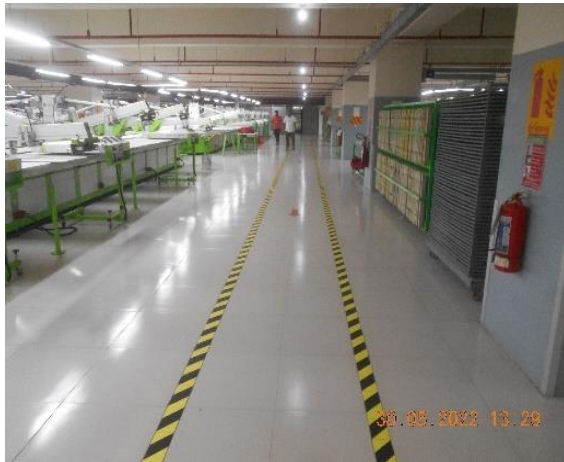
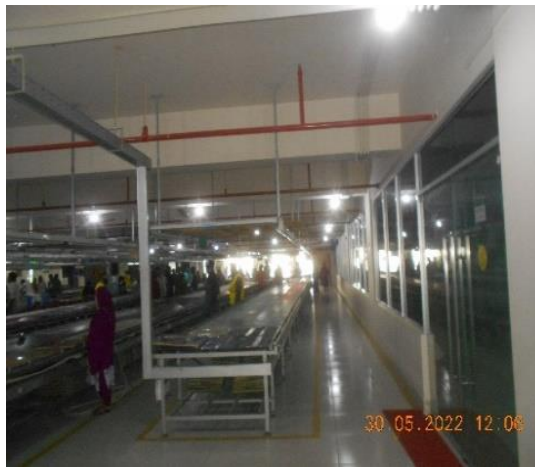
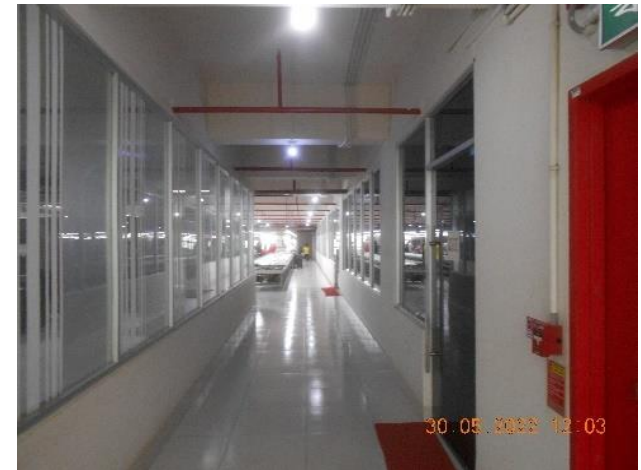
| SI No. | Category | Findings | Required Action | Remediation Time Frame |
|---|---|---|---|---|
| F-16 | Egress Lighting | The directional signs are not provided where there is a change in direction and where the continuation of the egress path is not obvious.<br>Location: On all floors of building-1. | Install illuminated directional signs shall be provided where there is a change in the direction for the path of travel and the direction to an exit is not obvious. | Within 1 month |

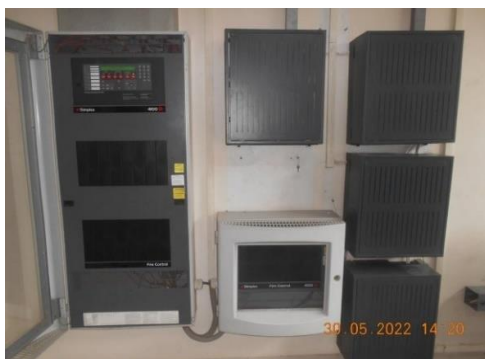
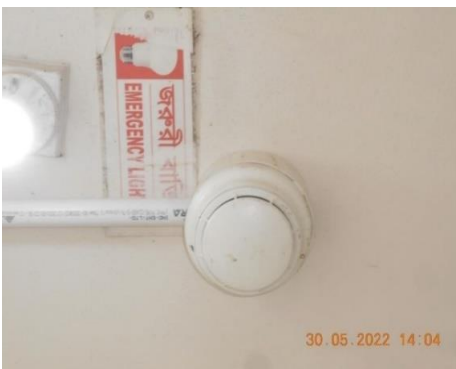
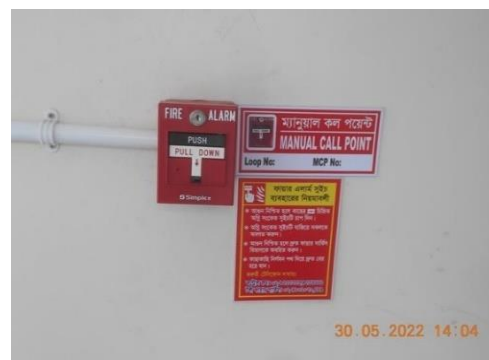
| SI No. | Category | Findings | Required Action | Remediation Time Frame |
|---|---|---|---|---|
| F-18 | Fire Alarm & Detection system | Fire alarm and detection system installation complete which requires detailed review to confirm compliance with NFPA 72 and RSC Technical Guidelines (Standard). | Submit the fire alarm system design to RSC for review. Once the design is reviewed, install and modify the fire detection and alarm system throughout the buildings in accordance with review comment, RSC Technical Guidelines (Standard) and NFPA 72. After installation the owner shall conduct internal testing and commissioning and then contact the RSC for witness of final acceptance testing. Also inspect, test and maintain the fire alarm system, and keep written records on-site, in accordance with Table-14.3.1 of NFPA 72. | Design Review within 2 months and installation within 6 months |

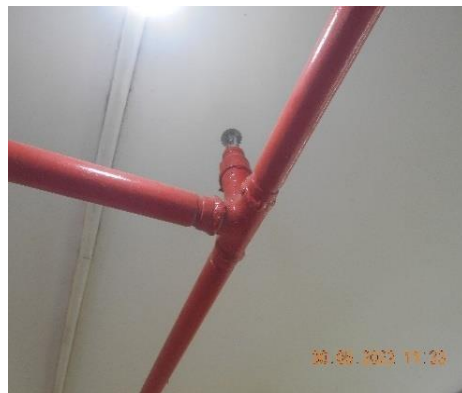
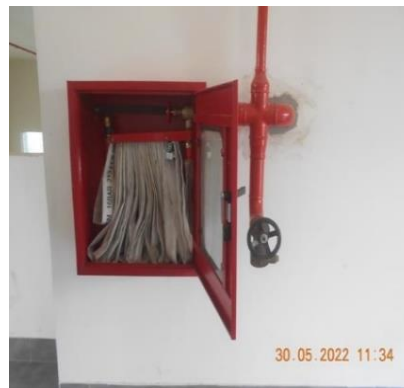
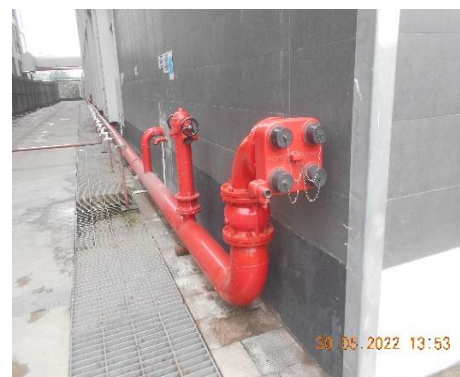
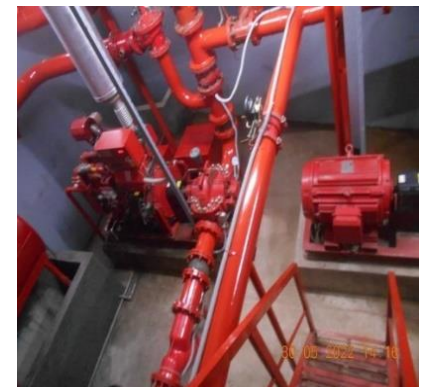
| SI No. | Category | Findings | Required Action | Remediation Time Frame |
|---|---|---|---|---|
| F-20 | Fire Protection System | Sprinkler system installation requires detailed review to confirm compliance with NFPA 13, 14, 20, 22 and RSC Technical Guideline (Standard).<br>Location: Building-1. | Submit the fire pump, standpipe and sprinkler system drawing to RSC for review. Once reviewed, install or modify the standpipe system throughout the building in accordance with RSC Technical Guideline (Standard) and NFPA 13, 14, 20,22 and 24. After installation the owner shall contact the RSC for witness of conducting the final acceptance testing of the standpipe system. | Design Review within 2 months and installation within 4 months. |

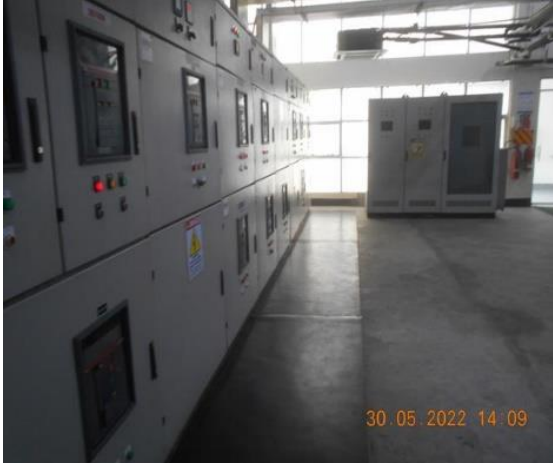
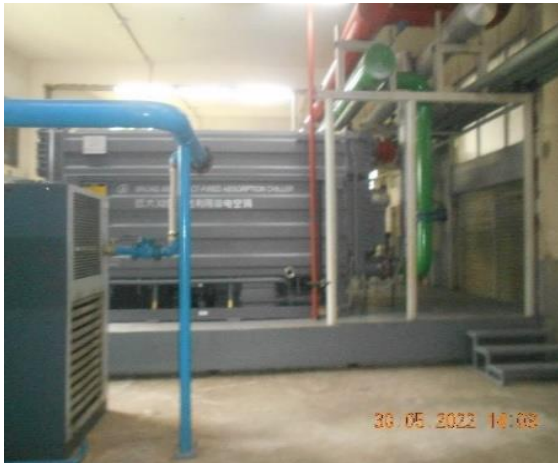
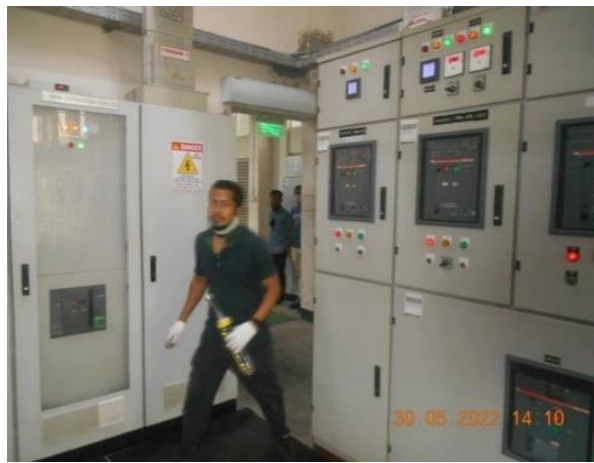
| SI No. | Category | Findings | Required Action | Remediation Time Frame |
|---|---|---|---|---|
| F-25 | Fire Rated Construction | <b>B-2</b><br>Sub-station, compressor and air handling unit are not separated by fire rated construction.<br>Location: On 1st floor of utility building (B-2). | Separate the substation compressor and air handling unit by a minimum 2-hr fire rated construction. Seal and/or protected all openings to maintain fire separations. | Within 3 month |

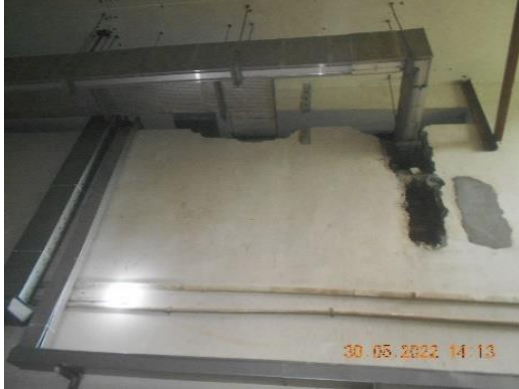
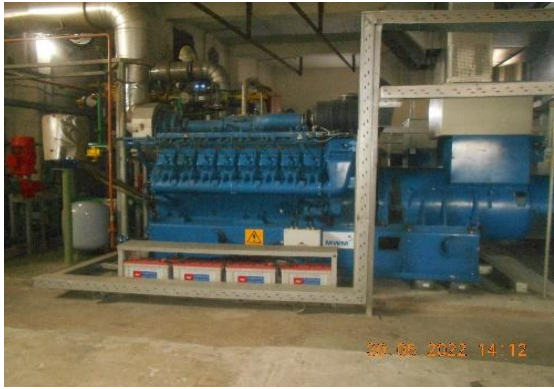
| SI No. | Category | Findings | Required Action | Remediation Time Frame |
|---|---|---|---|---|
| F-26 | Fire Rated Construction | <p><b>B-2</b><br/>Unsealed penetrations and openings (generator to sub-station room) are located in the fire rated floor/ceiling assemblies.<br/>Location: Ground to 1st floor of building-2.</p> | Seal all penetrations and openings in floors/ceiling assemblies to maintain the fire separation. | Within 3 month |
