KSS Knit Composite Ltd. (Extension Buildings)

Boherar Chala, Sreepur, Maowna
(24.200929, 90.401977)
29 May 2022

Observations

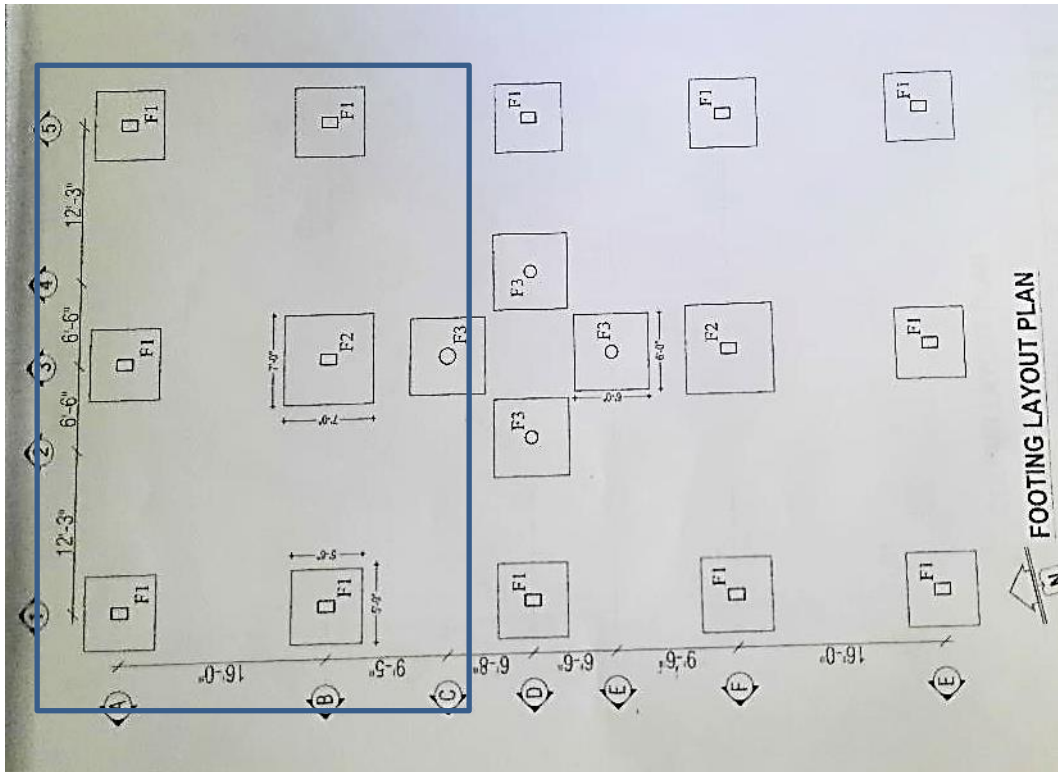
Mat Details

Preliminary calculations indicate high punching shear stress in footing

Preliminary calculations indicates high punching shear stresses on the footing considering the minimum concrete strength of brick chips aggregate & prepared live load plan of 3 kPa. A Detail Engineering Assessment is required to carry out by the Building Engineer.

| Item No. | Observation | Recommended Action Plan | Recommended Timeline |
|---|--|--|---|
| 01 | Preliminary calculations indicate high punching shear stress in footing. (Building-04) | Building Engineer to review design, loads and punching shear stresses. | Immediate - Now |
| 02 | Preliminary calculations indicate high punching shear stress in footing. (Building-04) | Verify in-situ concrete strengths (using 100mm dia. cores min 4 nos). | Immediate - Now |
| 03 | Preliminary calculations indicate high punching shear stress in footing. (Building-04) | A Detail Engineering Assessment to be commenced. | Immediate - Now |
| 04 | Preliminary calculations indicate high punching shear stress in footing. (Building-04) | Produce and actively manage a loading plan for all floor plates considering foundation, floor and column capacity. | 6-weeks |
| 05 | Preliminary calculations indicate high punching shear stress in footing. (Building-04) | Detail Engineering Assessment to be completed. | 6-weeks |
| 06 | Preliminary calculations indicate high punching shear stress in footing. (Building-04) | Carry out remedial works where required. | 6-months |

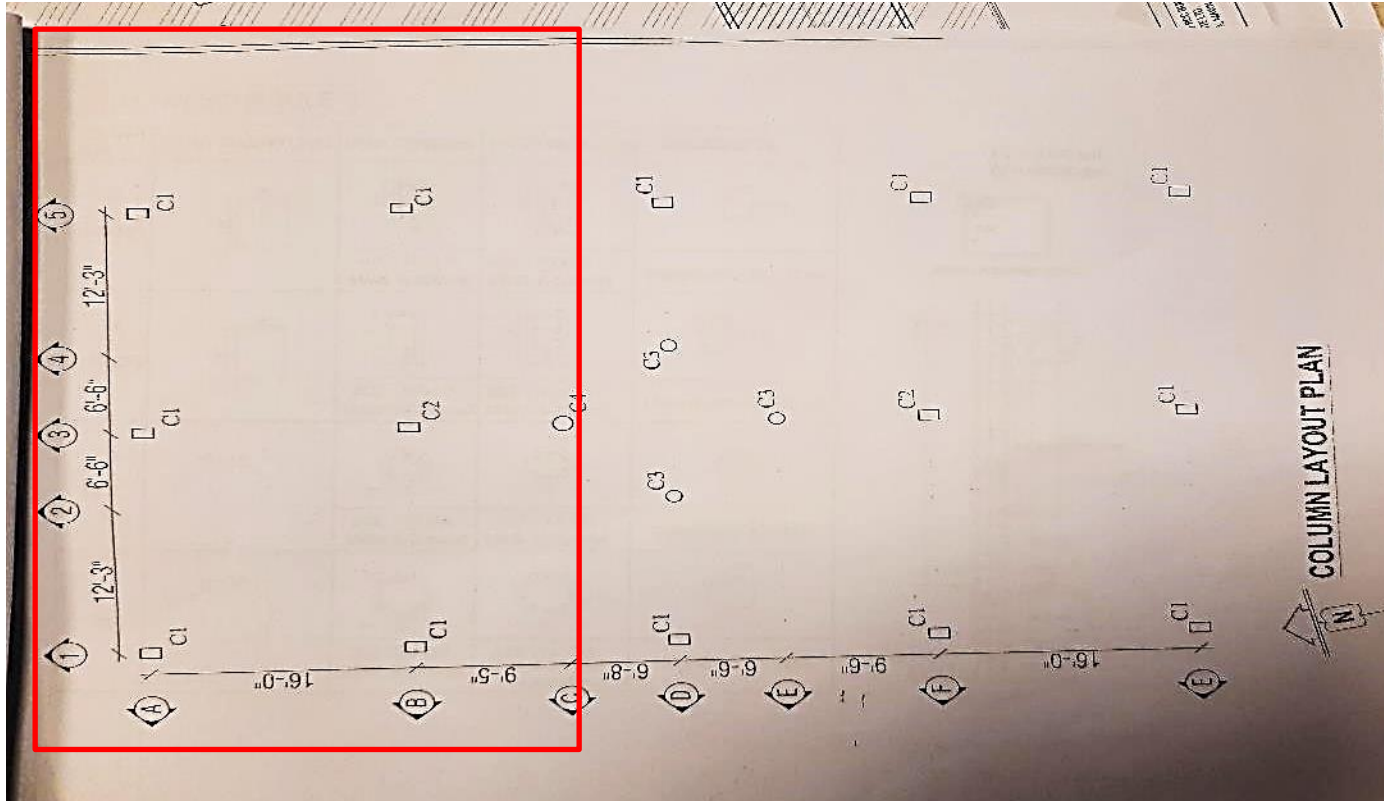
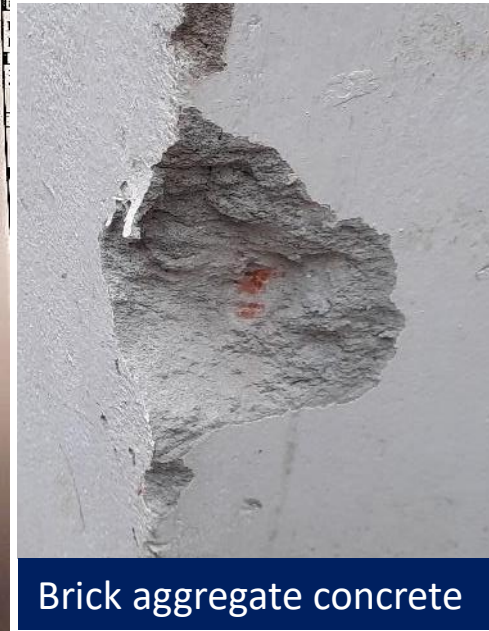
Columns are stressed above normal design limit

Brick aggregate concrete

Cursory calculation indicates that the working stress of ground floor column exceeds the normal design limits considering the minimum concrete strength of brick chips aggregate & prepared live load plan of 3 kPa. A Detail Engineering Assessment is required to carry out by the Building Engineer.

| Item No. | Observation | Recommended Action Plan | Recommended Timeline |
|---|--|---|---|
| 08 | Columns are stressed above normal design limit. (Building-04) | Building Engineer to review design, loads and column stresses. | 6-weeks |
| 09 | Columns are stressed above normal design limit. (Building-04) | Produce and actively manage a loading plan for all floor plates considering foundation, floor and column capacity. | 6-weeks |
| 10 | Columns are stressed above normal design limit. (Building-04) | Continue to implement load plan. | 6-months |
| 11 | Columns are stressed above normal design limit. (Building-04) | Carry out remedial works where required. | 6-months |

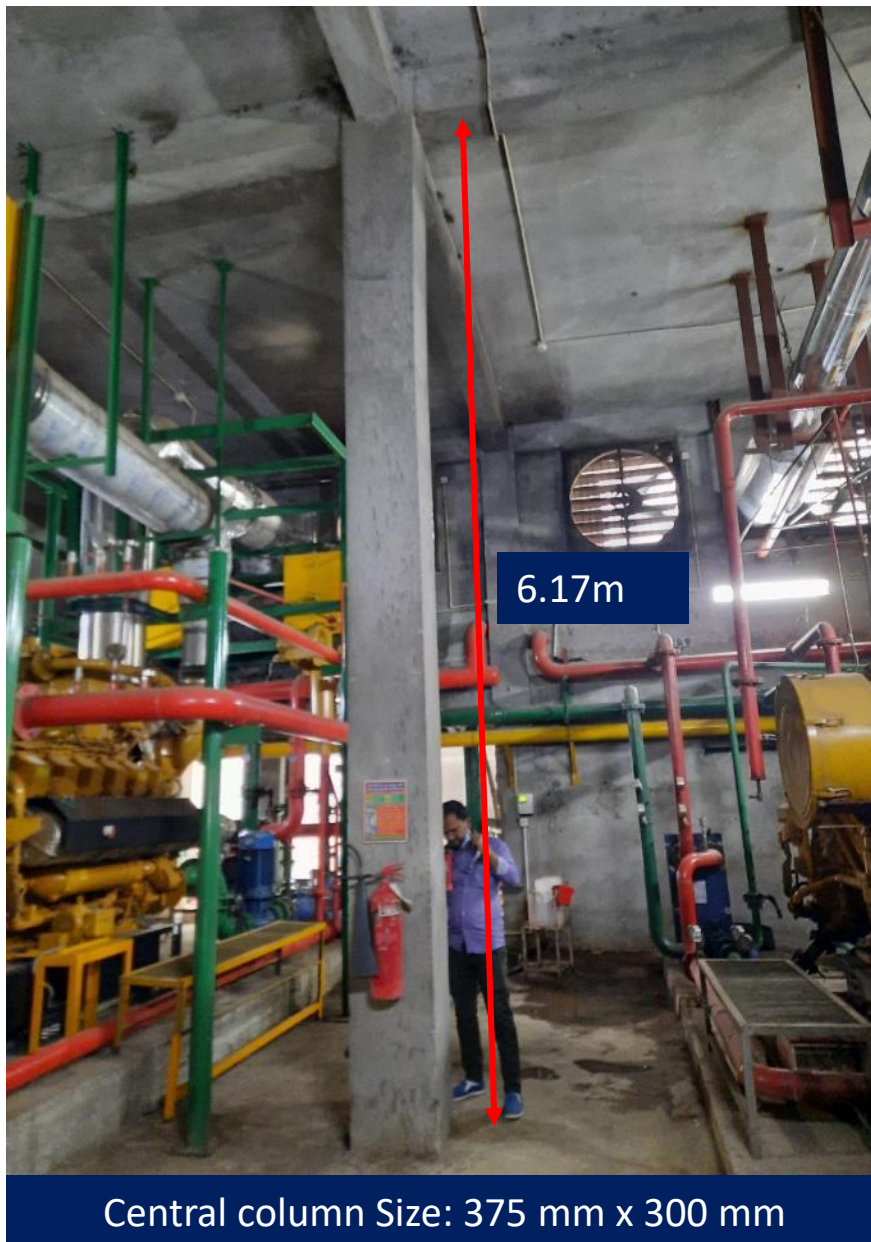
Slenderness effect of column

The ground floor height is 7.0 m and clear height of column is 6.17 m. The least dimension is 300 mm. There is no intermediate tie beam. The building engineer is required to check the slenderness effect of the column.

| Item No. | Observation | Recommended Action Plan | Recommended Timeline |
|---|--|---|---|
| 12 | Slenderness effect of column. (Building-05) | Building engineer is required to check the slenderness effect of the column as part of Engineering Assessment (EA). | 6-weeks |

| Item No. | Observation | Recommended Action Plan | Recommended Timeline |
|---|---|---|---|
| 13 | Slenderness effect of column. (Building-05) | Carry out remedial works where required. | 6-months |

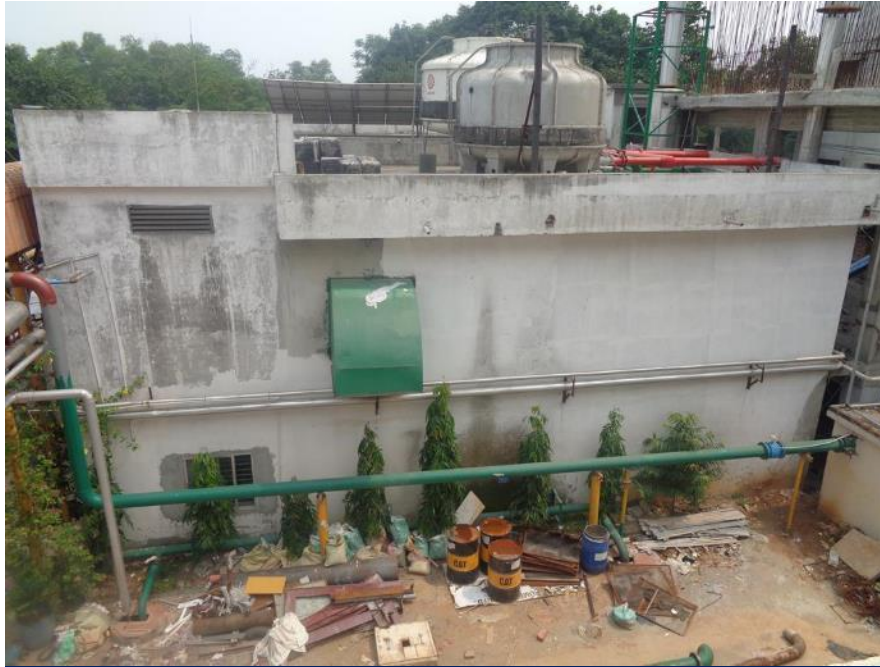
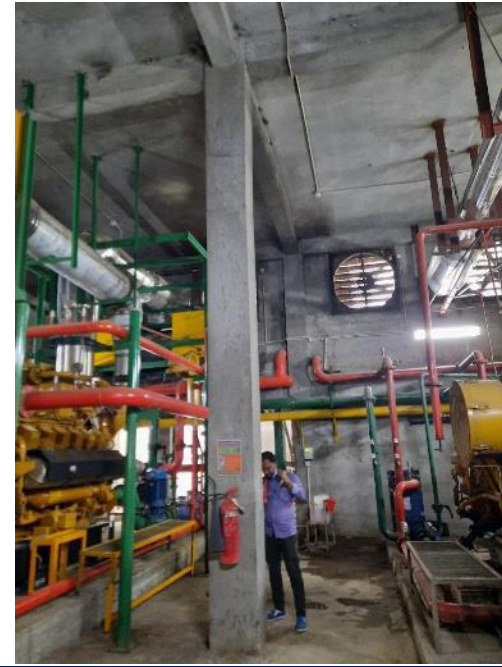
Onsite typical structural system

Structural design report not available

As per BNBC every building or structure designed shall have its design documents prepared in accordance with the provision of Section 1.9.1. The design document shall include a design report, and a set of structural drawings, which shall be prepared in compliance with section 1.9.1.1 and section 1.9.1.2 as per BNBC. Design report was not found which is required to be prepared in compliance with section 1.9.1.1 (part-6, BNBC).

| Item No. | Observation | Recommended Action Plan | Recommended Timeline |
|---|---|---|---|
| 14 | Structural design report not available. (Building-05) | Building engineer is required to be prepared design documents in compliance with section 1.9.1.1 (part-6, BNBC). | 6-weeks |
| 15 | Structural design report not available. (Building-05) | Carry out remedial works where required. | 6-months |

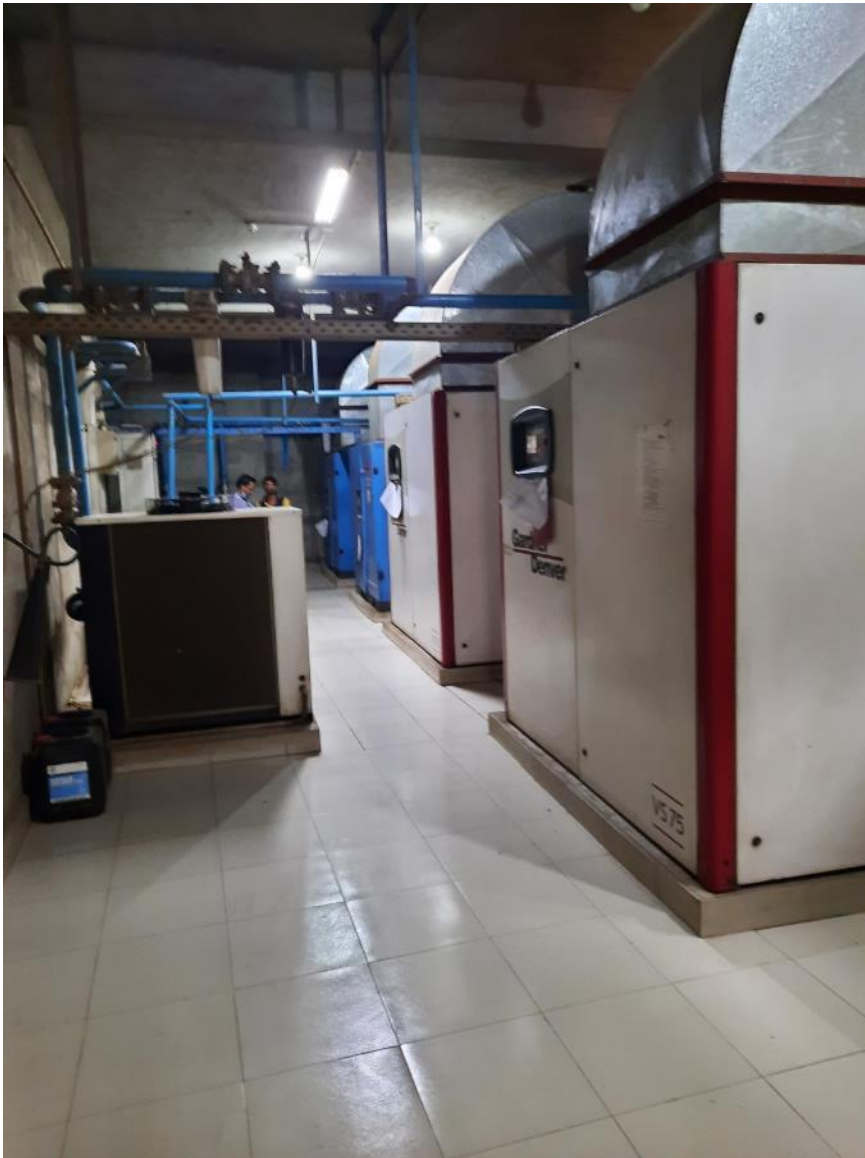
Vibration at 1st floor

Generator machine at 1st floor of Utility Building

During inspection, vibration was observed at 1st floor of utility building due to heavy generator machine. The building engineer is required to check the specific reason of the vibration and provide the required suggestion where required.

| Item No. | Observation | Recommended Action Plan | Recommended Timeline |
|---|---|---|---|
| 16 | Vibration at 1st floor. (Building-05) | Building engineer is required to check the specific reason of the vibration and provide the required suggestion where required. | 6-weeks |
| 17 | Vibration at 1st floor. (Building-05) | Carry out remedial works as per the engineers' suggestion. | 6-weeks |

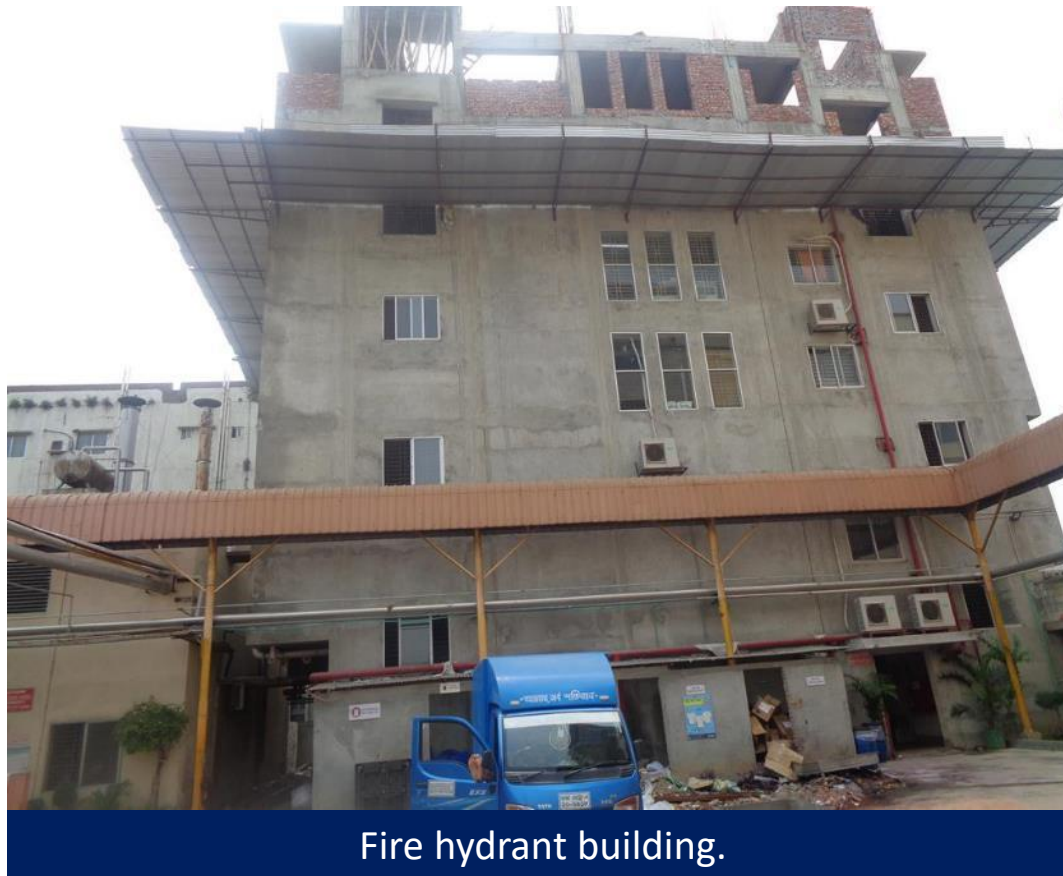
Fire hydrant building.

Structural design report not available

As per BNBC every building or structure designed shall have its design documents prepared in accordance with the provision of Section 1.9.1. The design document shall include a design report, and a set of structural drawings, which shall be prepared in compliance with section 1.9.1.1 and section 1.9.1.2 as per BNBC. Design report was not found which is required to be prepared in compliance with section 1.9.1.1 (part-6, BNBC).

| Item No. | Observation | Recommended Action Plan | Recommended Timeline |
|---|---|---|---|
| 18 | Structural design report not available. (Building-06) | Building engineer is required to be prepared design documents in compliance with section 1.9.1.1 (part-6, BNBC). | 6-weeks |

| Item No. | Observation | Recommended Action Plan | Recommended Timeline |
|---|---|---|---|
| 19 | Structural design report not available. (Building-06) | Carry out remedial works where required. | 6-months |

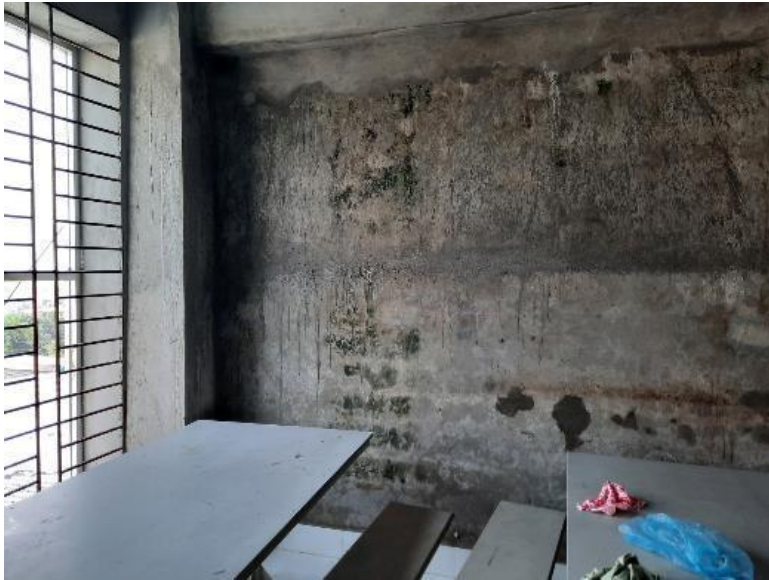
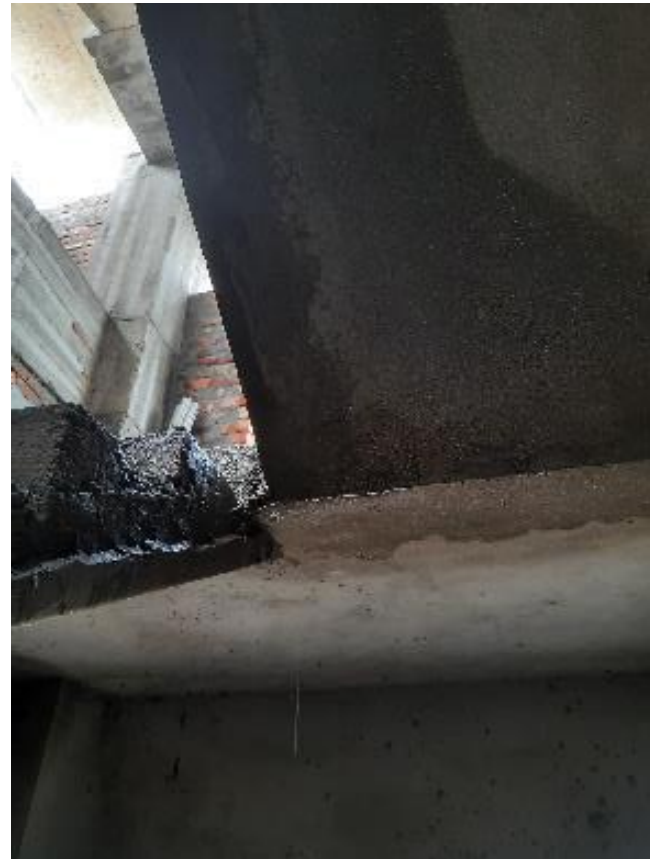
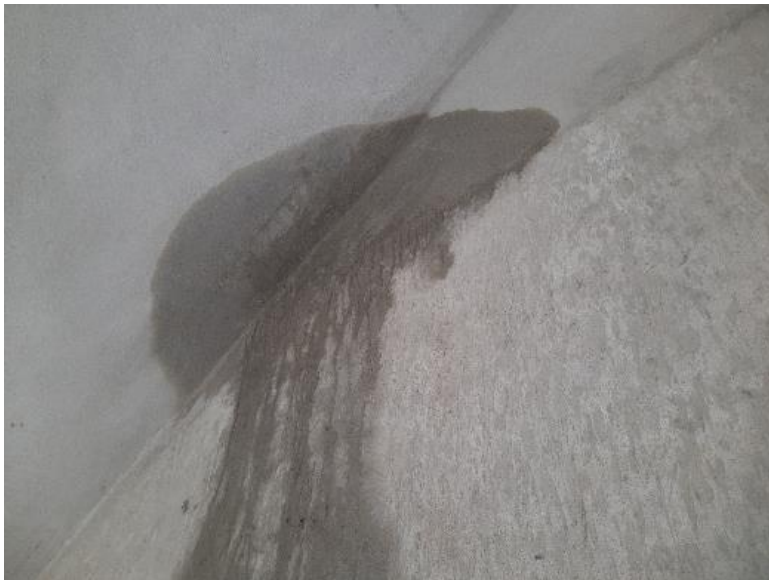
Dampness in several locations

Damp area observed at staircase and several place due to water leakage. Building engineer is required to provide remedial measure to repair the damped areas.

| Item No. | Observation | Recommended Action Plan | Recommended Timeline |
|---|---|---|---|
| 20 | Dampness in several locations. (Building-06) | Building engineer is required to provide remedial measure to repair the damped area. | 6-weeks |

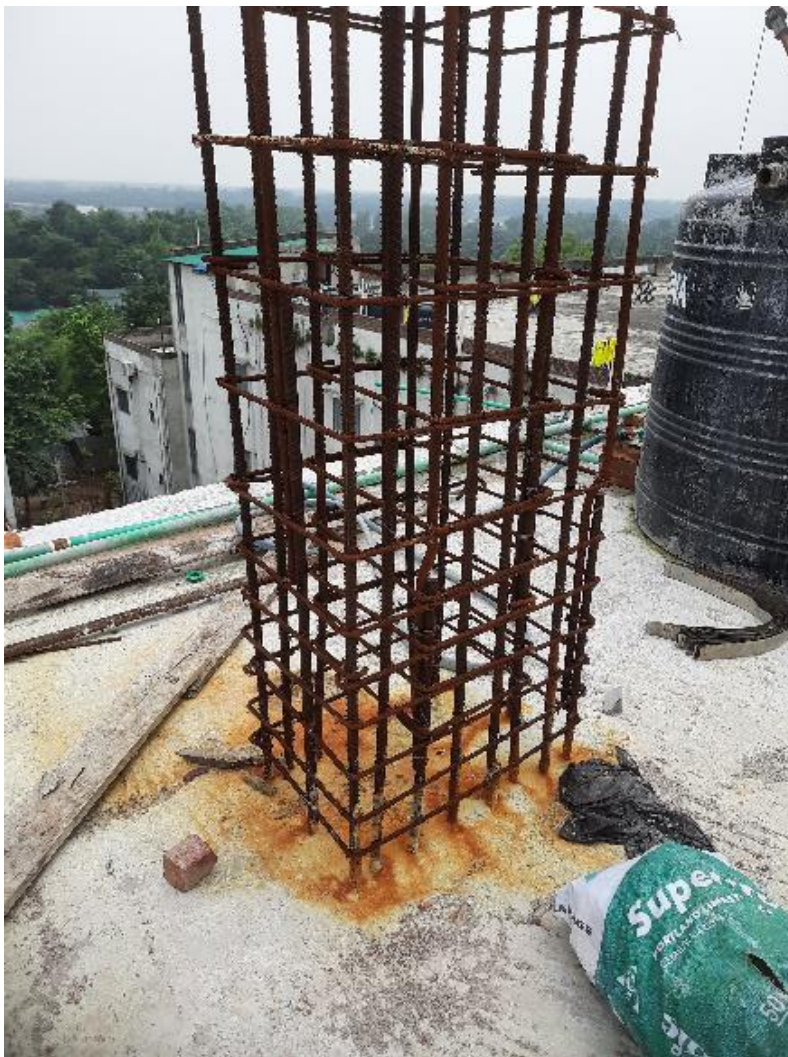
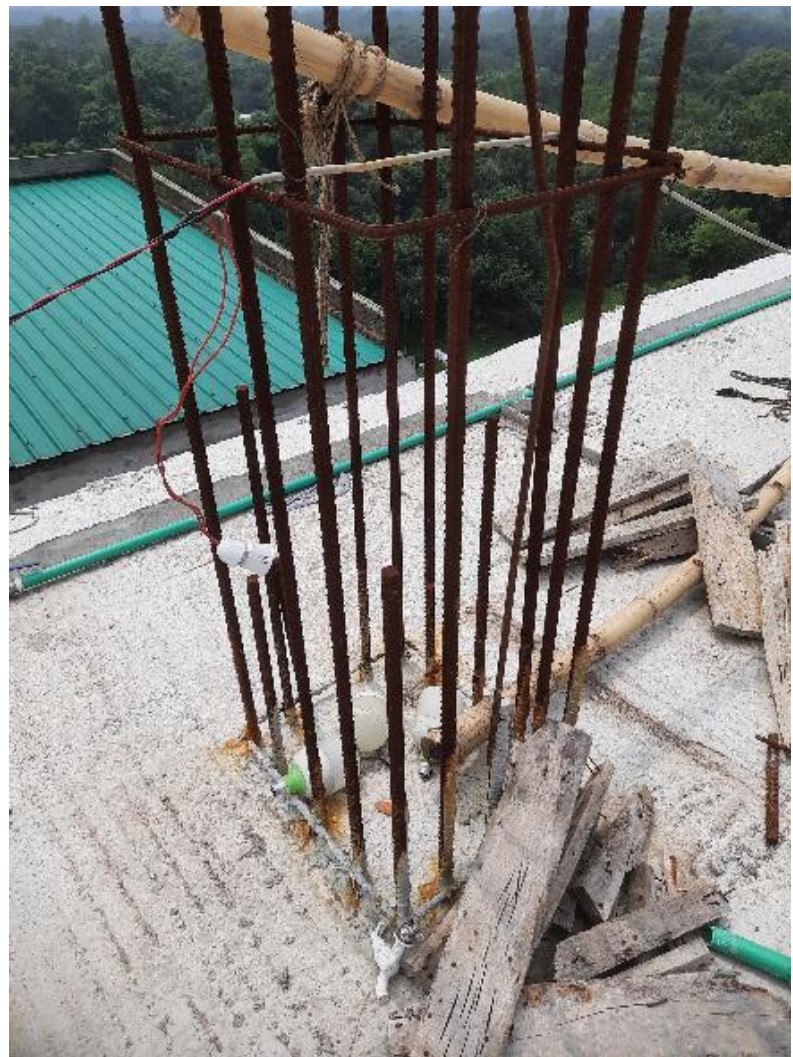
Exposed rebar at roof

Exposed reinforcement was found on roof columns. Building engineer is required to take necessary measures to prevent the corrosion in exposed rebar.

| Item No. | Observation | Recommended Action Plan | Recommended Timeline |
|---|---|---|---|
| 21 | Exposed rebar at roof floor. (Building-06) | Building engineer is required to take necessary measures to prevent the corrosion in exposed rebar. | 6-weeks |

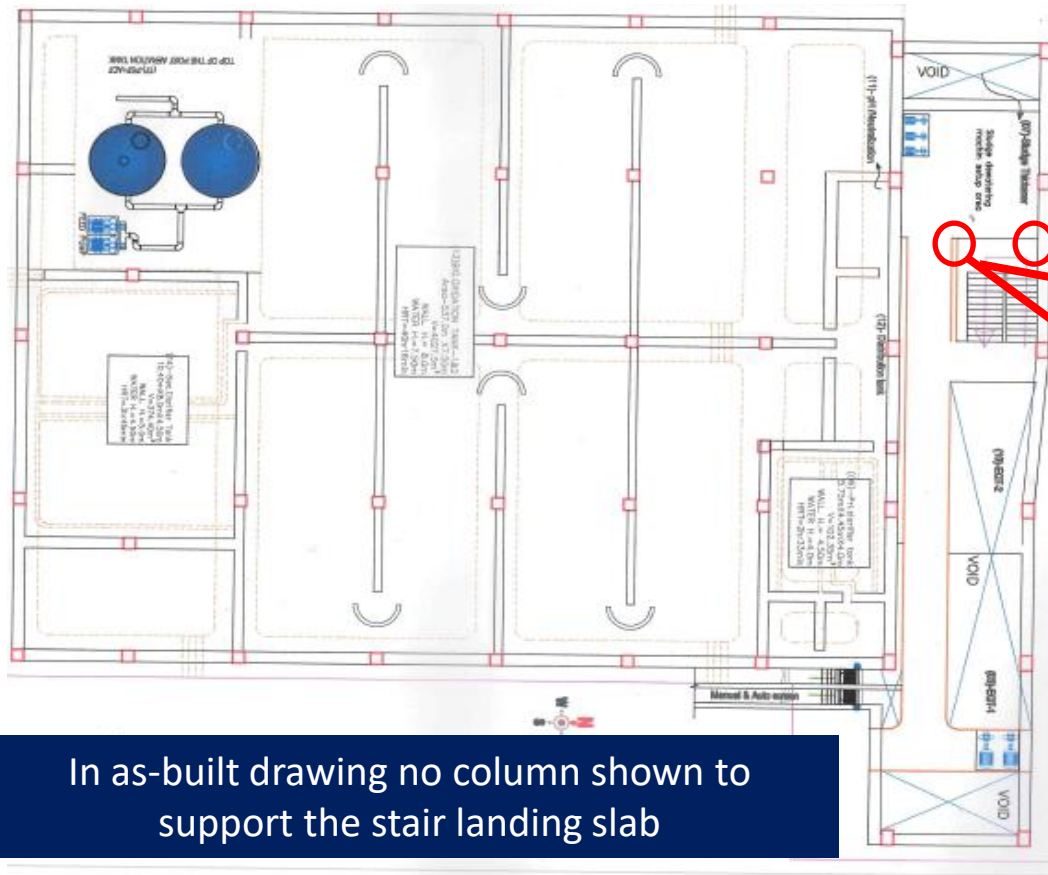
Mismatch found in as-built drawing and questionable vertical load path

In as-built drawing no column shown to support the stair landing slab

No column was shown in as-built drawing to support stair landing slab. But on-site it was found two columns were constructed from the floor beam. Factory Engineer is required to survey the whole structure to prepare accurate as-built drawing and to check the vertical load path of stair columns loads.

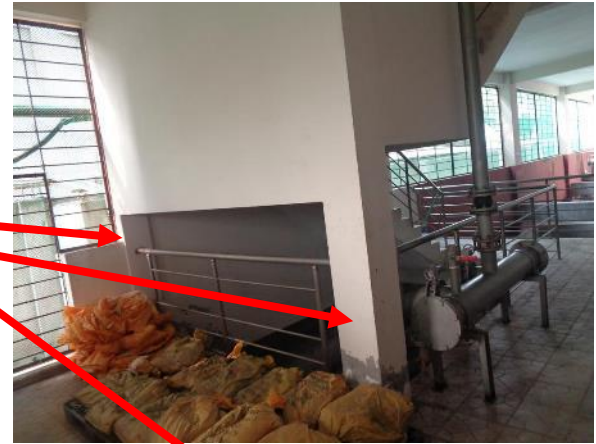
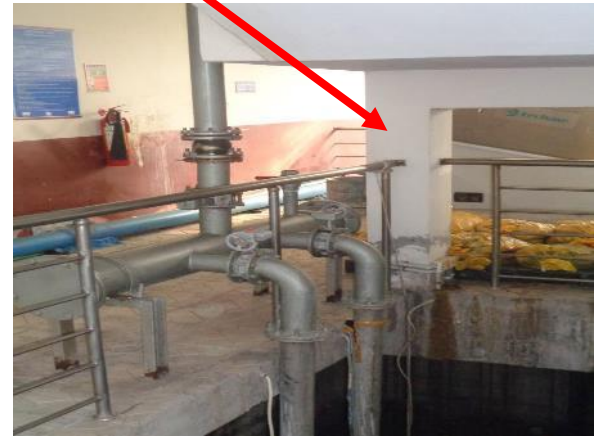
Stair landing supported on column which is constructed over floor beam without any foundation.

| Item No. | Observation | Recommended Action Plan | Recommended Timeline |
|---|---|---|---|
| 22 | Mismatch found in as-built drawing and questionable vertical load path. (Building-07) | Building engineer is required to prepare accurate as-built drawing. | 6-weeks |
| 23 | Mismatch found in as-built drawing and questionable vertical load path. (Building-07) | Check the vertical load path of staircase load and suggest remedial actions. | 6-weeks |
| 24 | Mismatch found in as-built drawing and questionable vertical load path. (Building-07) | Implement suggested remedial actions (if required). | 6-months |

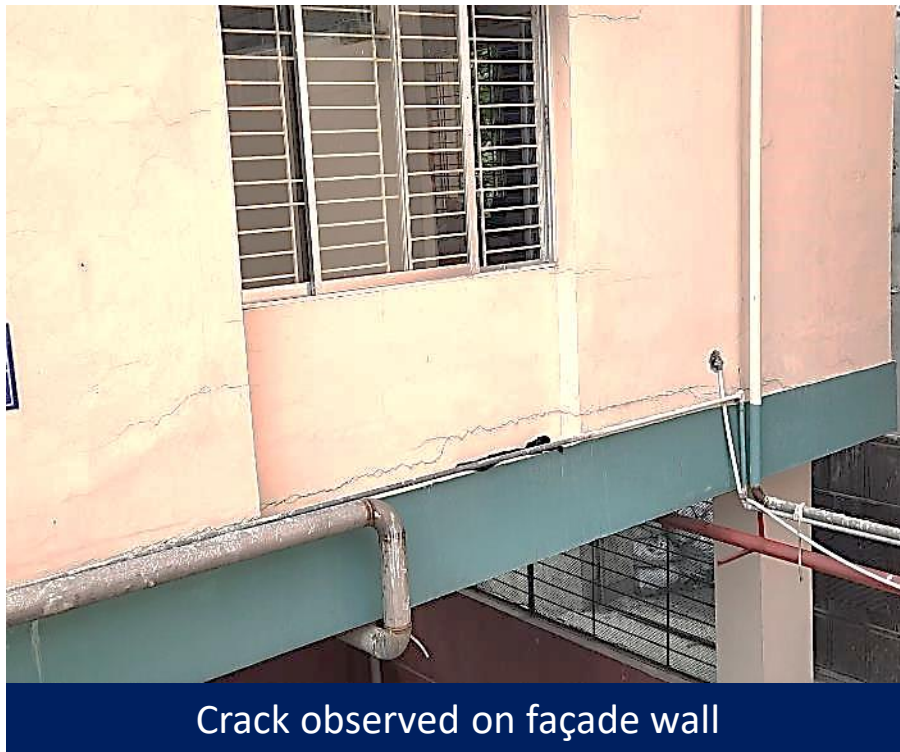
Crack observed on façade wall

Cracks were found in several area of the brick walls of the building. Building engineer is required to investigate the cracks, produce investigation report showing extent of cracks and repair methodology. Building is required to repair the cracks as per crack investigation report.

| Item No. | Observation | Recommended Action Plan | Recommended Timeline |
|---|---|--|---|
| 25 | Crack on façade wall & brick wall. (Building-07) | Building engineer is required to investigate the cracks, produce investigation report showing extent of cracks and repair methodology. | 6-weeks |
| 26 | Crack on façade wall & brick wall. (Building-07) | Building is required to repair the cracks as per crack investigation report. | 6-weeks |

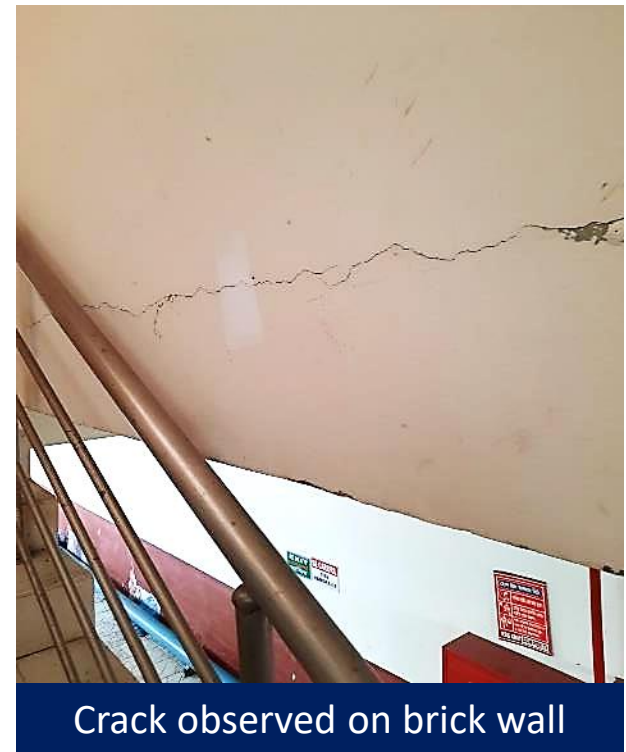
Crack observed on brick wall

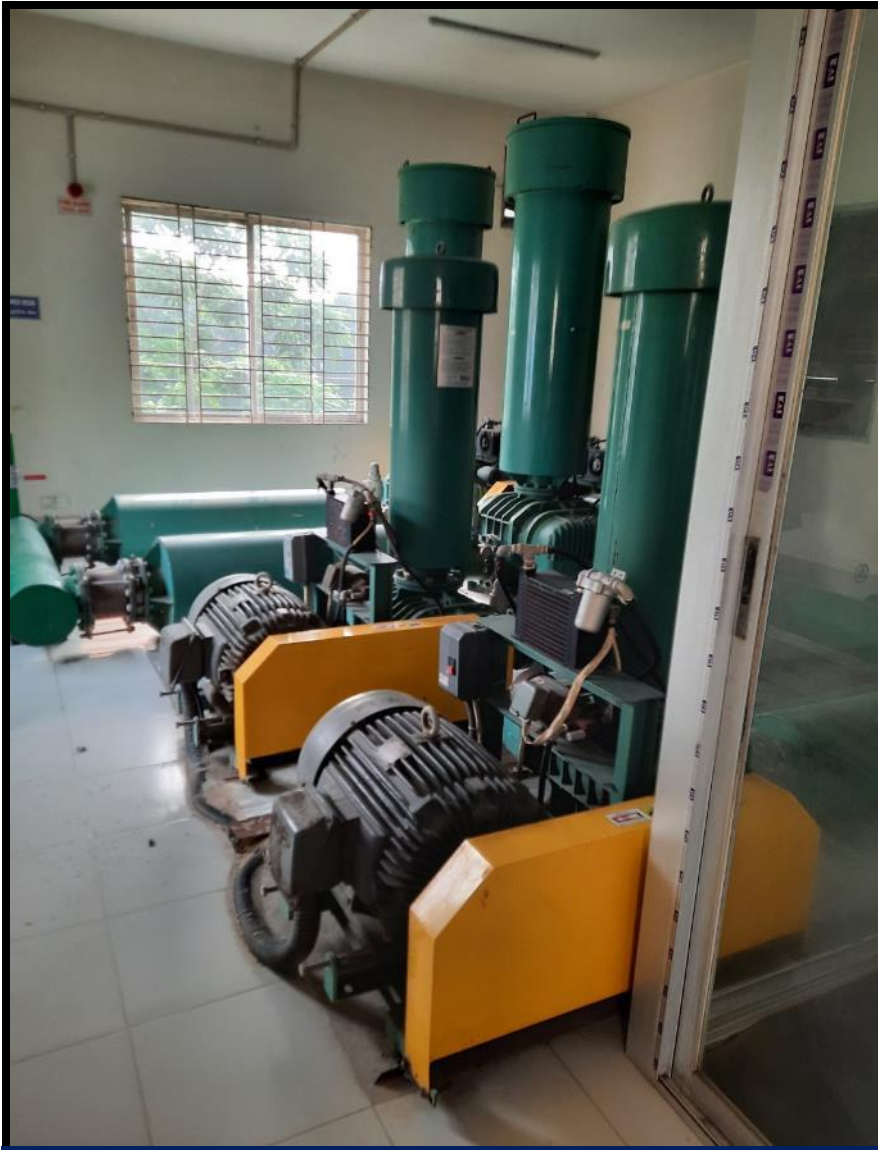
Significant vibration at 1st floor

Air blower machine at 1st floor of ETP building

Significant vibration was observed at 1st floor of ETP Building (Building-07) due to operation of air blower machine. Building engineer is required to check the specific reason of the vibration and provide the required suggestion if required.

| Item No. | Observation | Recommended Action Plan | Recommended Timeline |
|---|---|--|---|
| 27 | Significant vibration at 1st floor. (Building-07) | Building engineer is required to check the specific reason of the vibration and provide the required suggestion if required. | 6-weeks |
| 28 | Significant vibration at 1st floor. (Building-07) | Carry out remedial works where required. | 6-weeks |

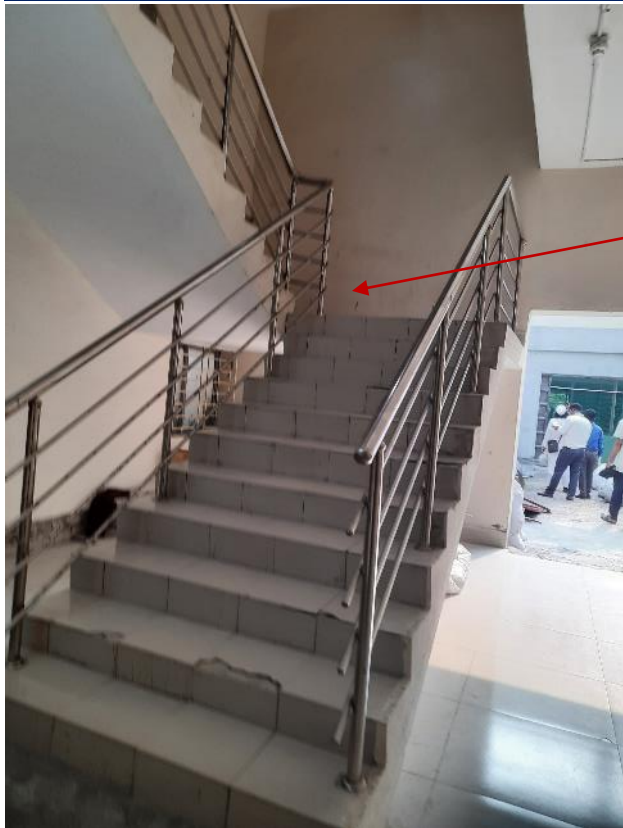
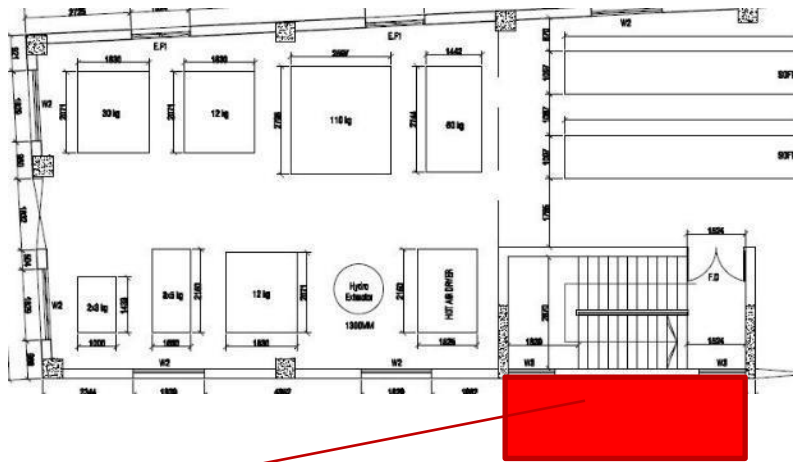
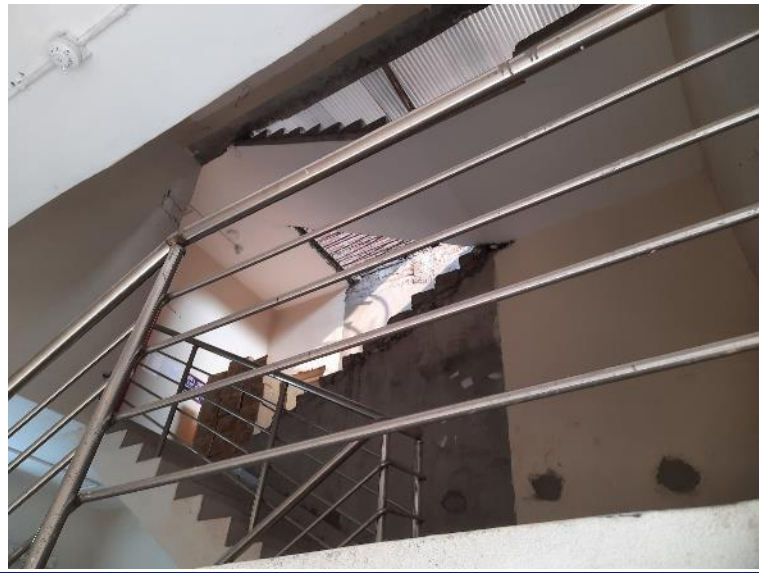
Mismatch found in as-built drawing and questionable vertical load path

Not shown in drawing

Marked portion not shown in architectural drawing at ground floor level. Building engineer is required to prepare accurate as-built drawing. Also check the vertical load path of stair loads.

Staircase at ground floor not shown in drawing

| Item No. | Observation | Recommended Action Plan | Recommended Timeline |
|---|---|--|---|
| 29 | Mismatch found in as-built drawing and questionable vertical load path. (Building-08) | Check the vertical load path of staircase load and suggest remedial actions. | 6-weeks |
| 30 | Mismatch found in as-built drawing and questionable vertical load path. (Building-08) | Implement suggested remedial actions (if required). | 6-months |

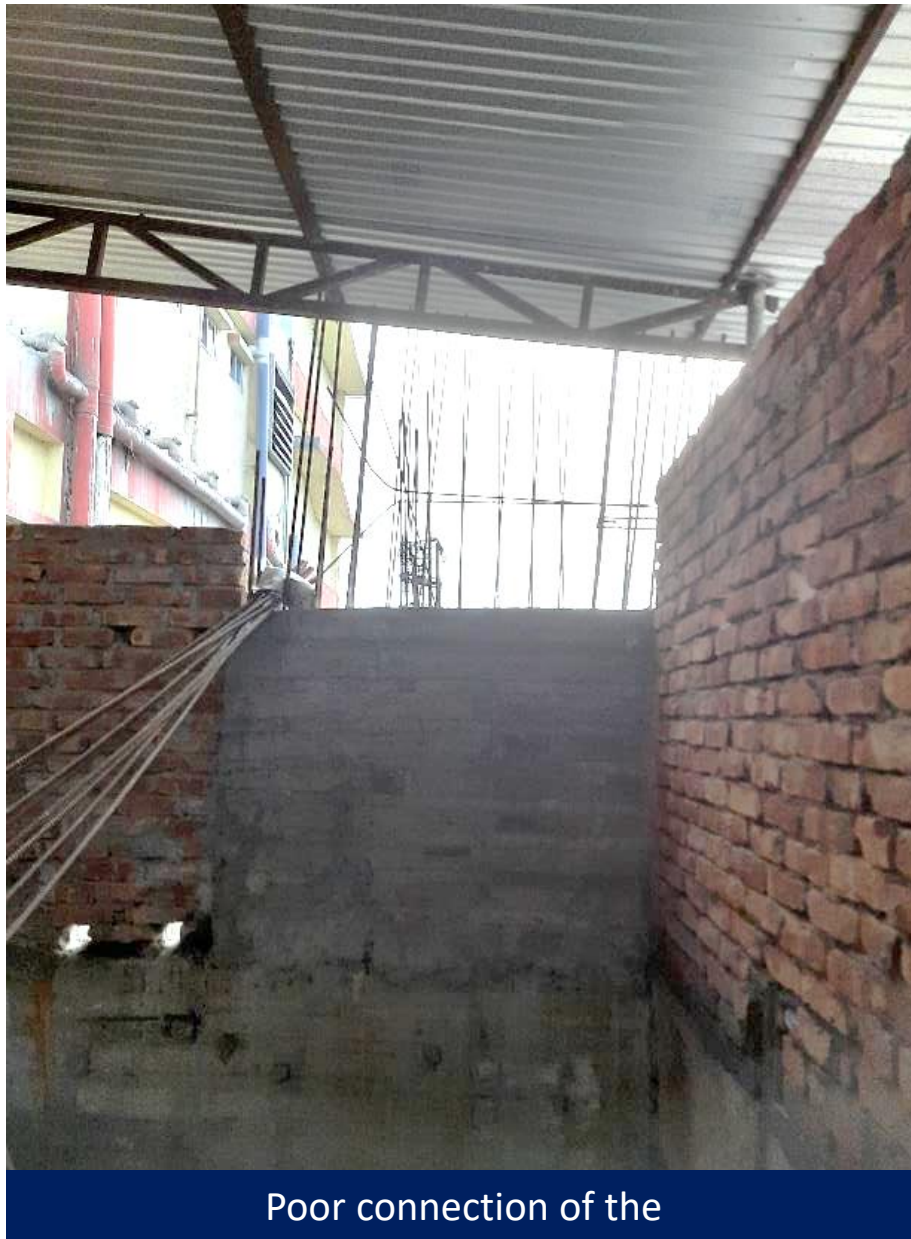
Apparently non-engineered staircase roof

Apparently non engineered steel roof shed was found over the stair case. Building engineer is required to check the stability of the roof.

| Item No. | Observation | Recommended Action Plan | Recommended Timeline |
|---|---|---|---|
| 31 | Apparently non-engineered staircase roof. (Building-08) | Building engineer is required to check the stability of the roof structure over staircase. | 6-weeks |
| 32 | Apparently non-engineered staircase roof. (Building-08) | Carry out remedial works where required. | 6-months |

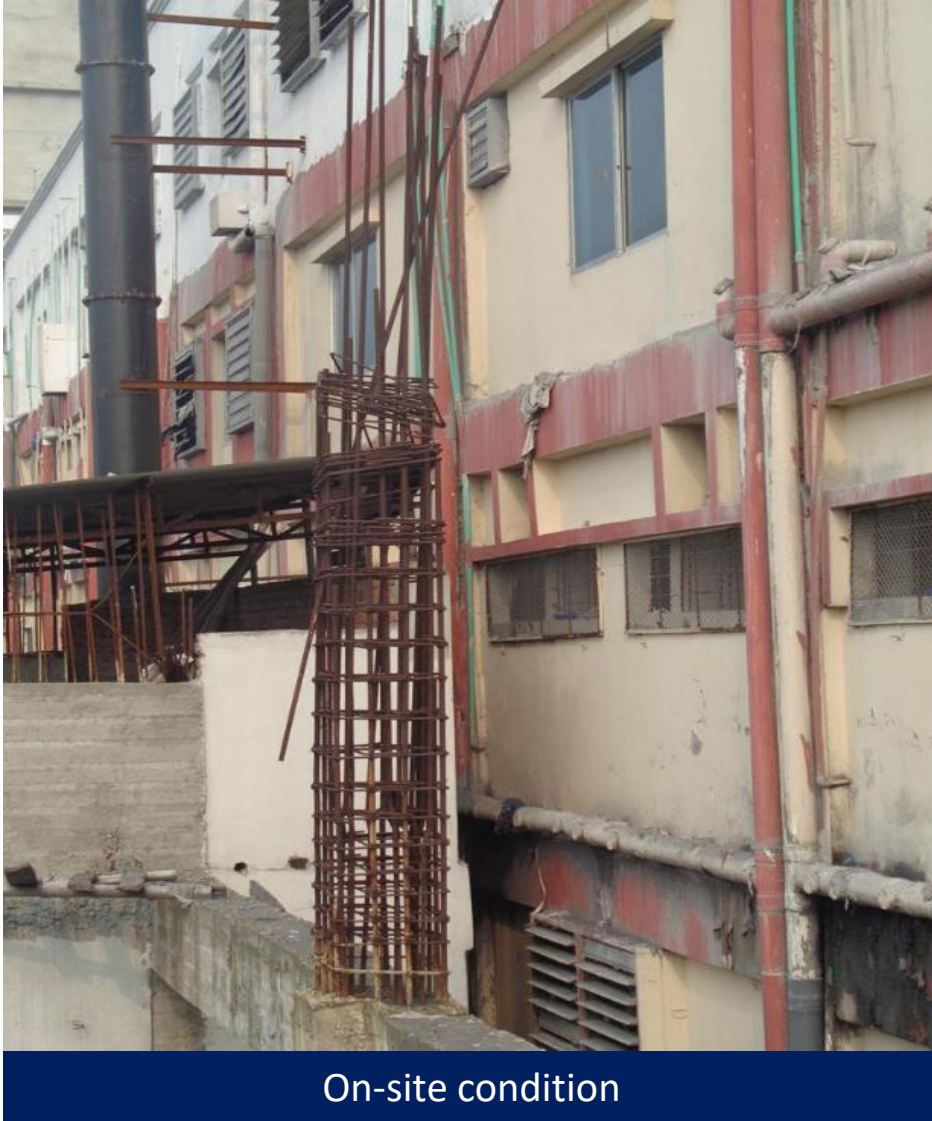
Falling hazard due to poor connection of exposed rebar

Some exposed rebars were found which are poorly connected to tie bar. Building engineer is required to take remedial action regarding this issue immediately.

| Item No. | Observation | Recommended Action Plan | Recommended Timeline |
|---|---|---|---|
| 33 | Falling hazard due to poor connection of exposed rebar. (Building-08) | Building engineer is required to provide adequate preventive measure to avoid potential falling hazard. | 6-weeks |

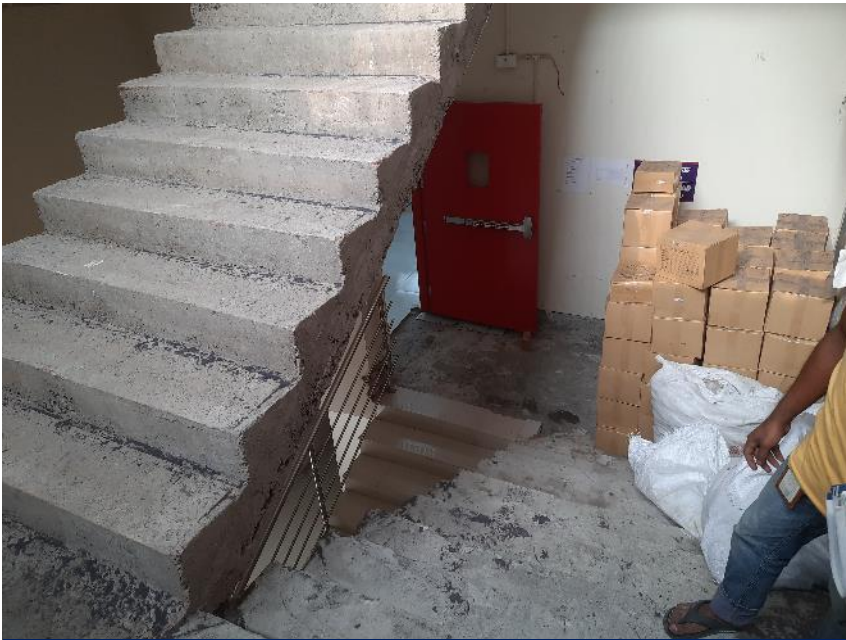
Missing stair railing

Building engineer is required to provide adequate prevention to avoid falling hazard issue.

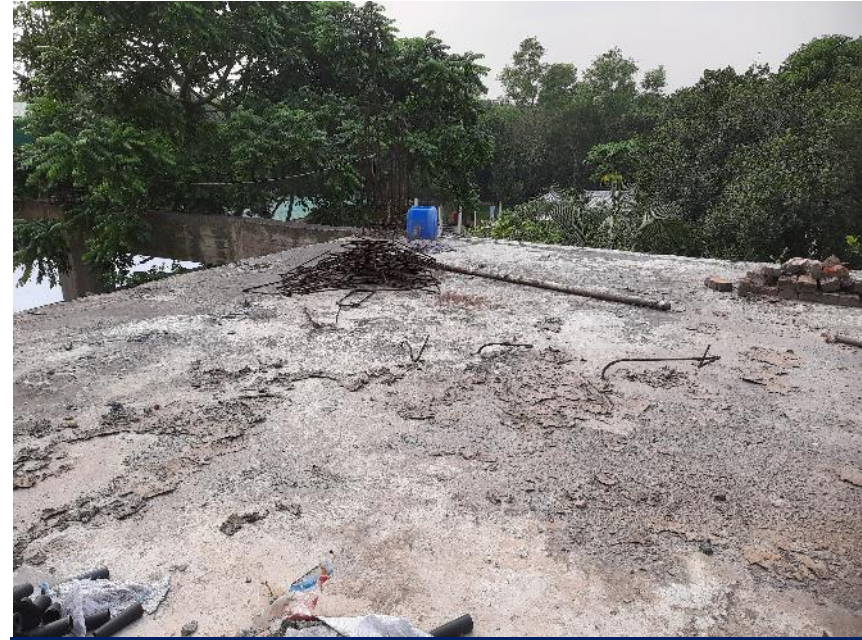
Missing parapet wall

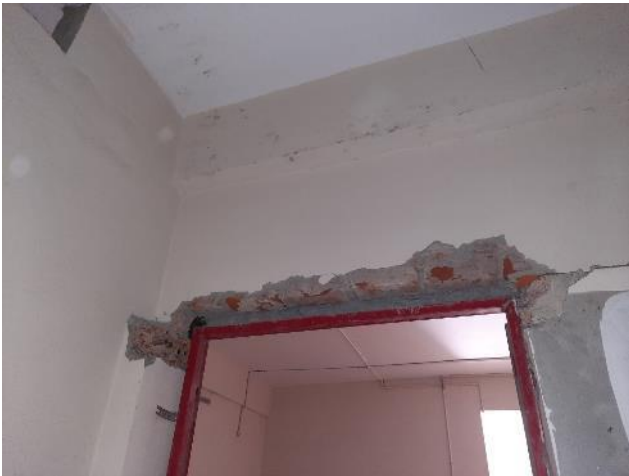
Missing lintel

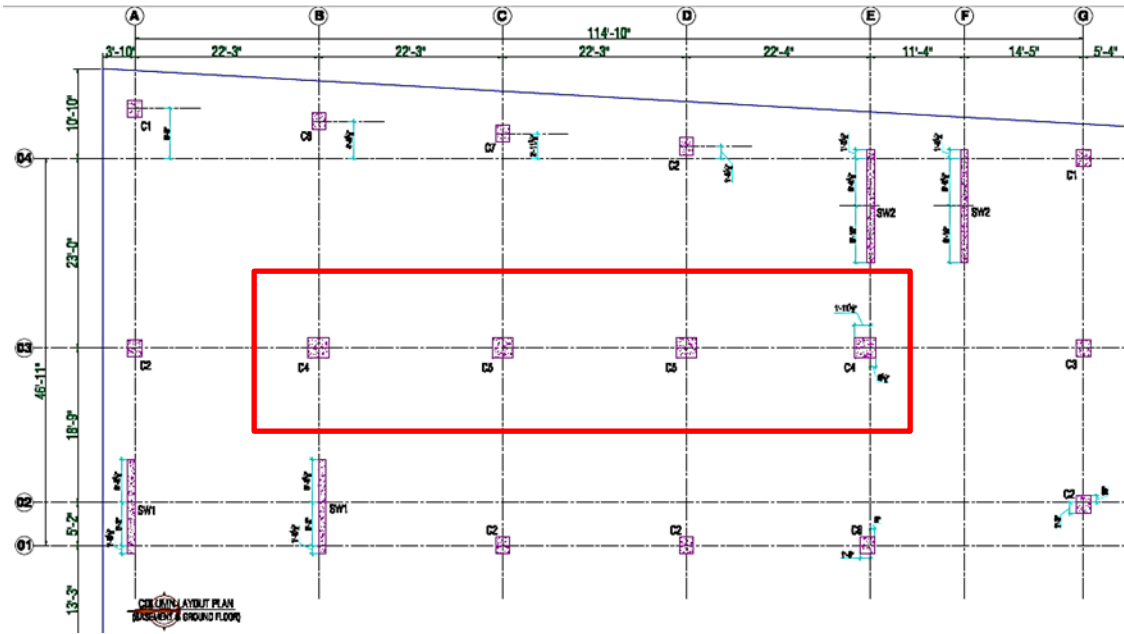
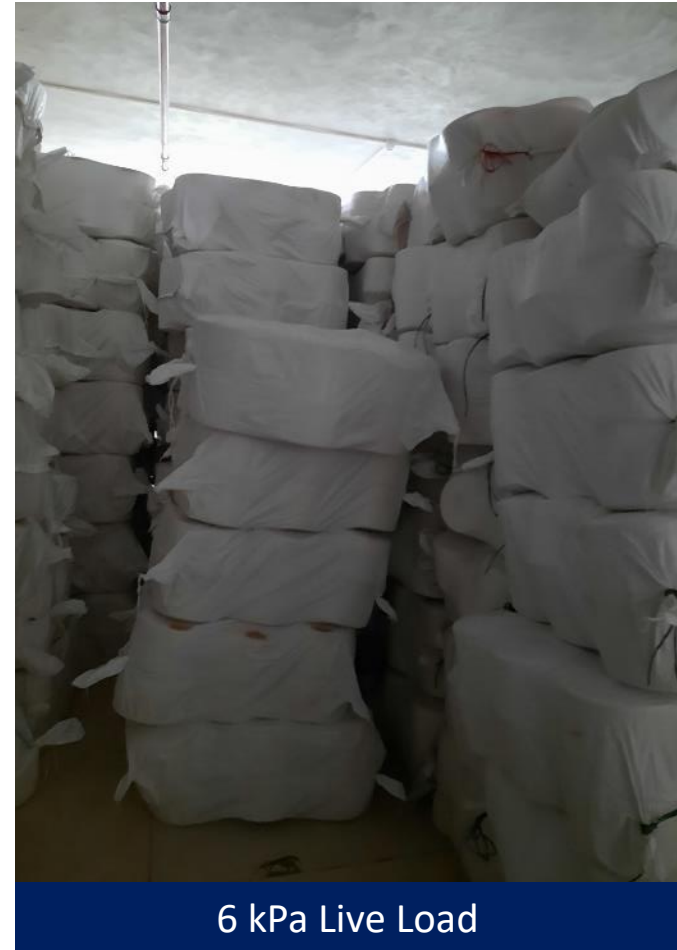
Columns are stressed above normal design limit

Cursory calculation indicates that the working stress of ground floor column exceeds the normal design limits considering the minimum concrete strength of stone chips aggregate & prepared live load plan of 6 kPa. The building engineer is required to review the design, load and column stress.

6 kPa Live Load

| Item No. | Observation | Recommended Action Plan | Recommended Timeline |
|---|---|---|---|
| 36 | Columns are stressed above normal design limit. (Building-09) | Building Engineer to review design, loads and column stresses. | 6-weeks |

| Item No. | Observation | Recommended Action Plan | Recommended Timeline |
|---|--|---|---|
| 37 | Columns are stressed above normal design limit. (Building-09) | Verify in-situ concrete strengths (using 100mm dia. cores min 4 nos from columns). | 6-weeks |
| 38 | Columns are stressed above normal design limit. (Building-09) | Produce and actively manage a loading plan for all floor plates considering floor and column capacity. | 6-weeks |
| 39 | Columns are stressed above normal design limit. (Building-09) | Carry out remedial works where required. | 6-months |
| 40 | Columns are stressed above normal design limit. (Building-09) | Continue to implement load plan. | 6-months |
