KSS Knit Composite Ltd. (Extension Buildings)

Boherar Chala, Sreepur, Maowna
(24.200929, 90.401977)
29 May 2022

Observations

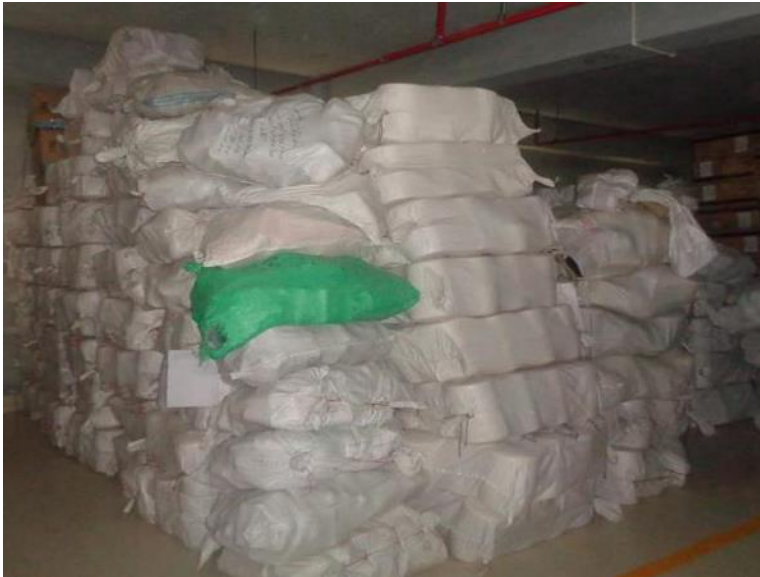
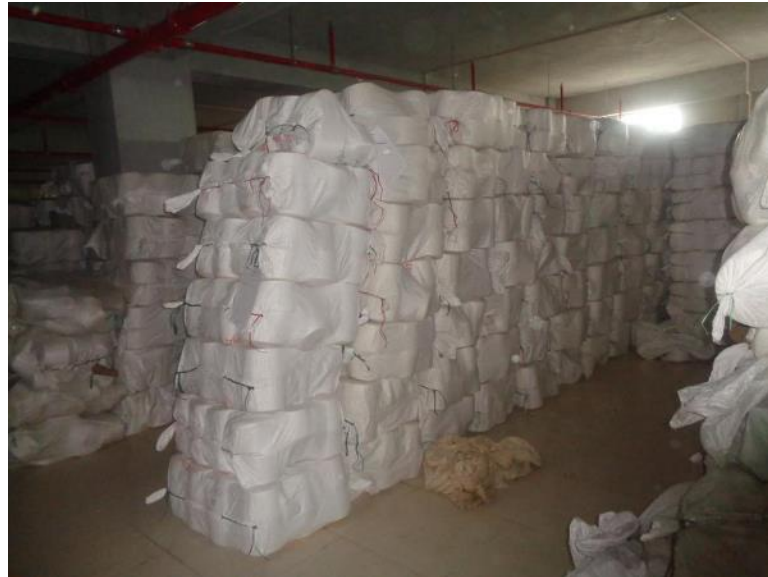
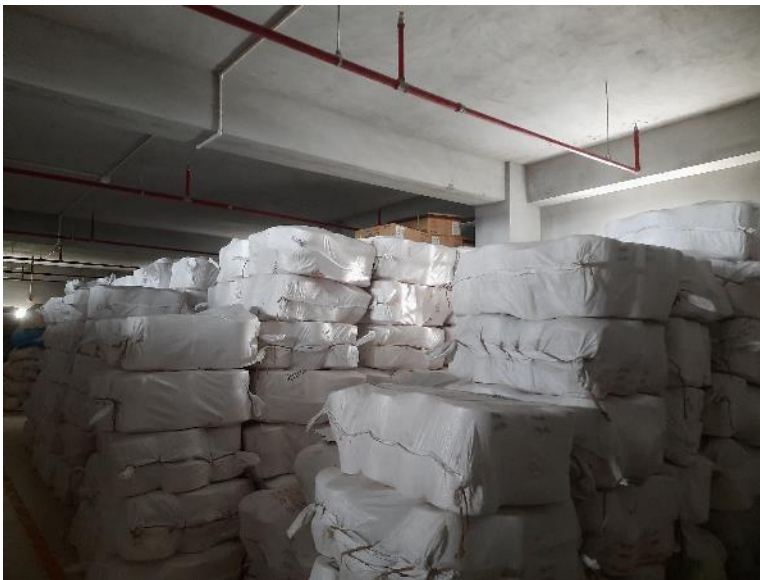
Uncontrolled loading on 5th floor

Uncontrolled stack of yarn observed at the 5th floor of the warehouse building. Building engineer is required to establish a proper load management system to avoid any kind of fallen of stack over anyone. Also, load restriction height is required to marked in the storage area.

Uncontrolled yarn store at 5th floor

| Item No. | Observation | Recommended Action Plan | Recommended Timeline |
|---|--|---|---|
| 41 | Uncontrolled loading on 5th floor. (Building-09) | Building engineer is required to establish a proper load management system to avoid any kind of fallen of stack over anyone. Also, provide load restriction height marking in the storage area. | 6-weeks |

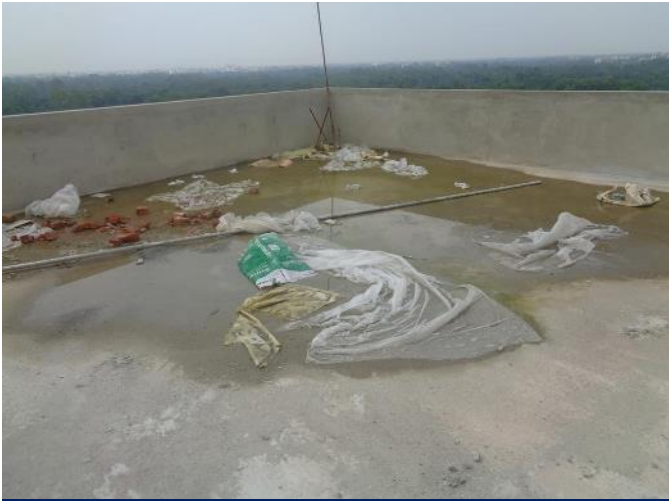
Standing water on roof

Standing water on the roof observed due to lack of proper sloping and drainage system. Exposed rebar also found on the roof as well as construction debris not removed from roof (although construction work is completed).

Building Engineer is required to provide proper slope on roof and to developed drainage system to avoid water clogging in future as well as to remove excess exposed rebar & construction debris from the roof.

| Item No. | Observation | Recommended Action Plan | Recommended Timeline |
|---|--|---|---|
| 42 | Exposed rebar, standing water and construction debris on the roof. (Building-09) | Building Engineer is required to provide proper slope on roof and to developed drainage system to avoid water standing in future. | 6-weeks |

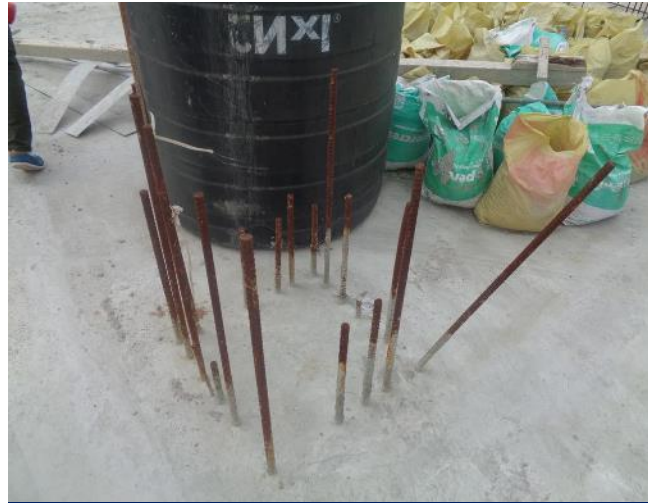
Exposed rebar

| Item No. | Observation | Recommended Action Plan | Recommended Timeline |
|---|--|---|---|
| 43 | Exposed rebar, standing water and construction debris on the roof. (Building-09) | Remove excess exposed rebar & construction debris from the roof. | 6-weeks |

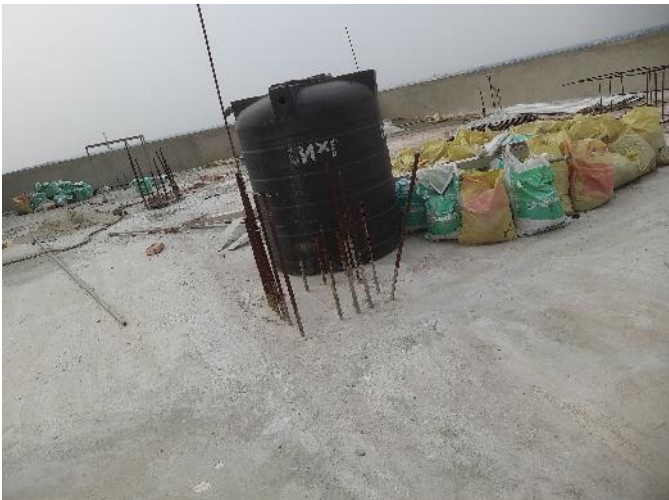
Construction debris on roof

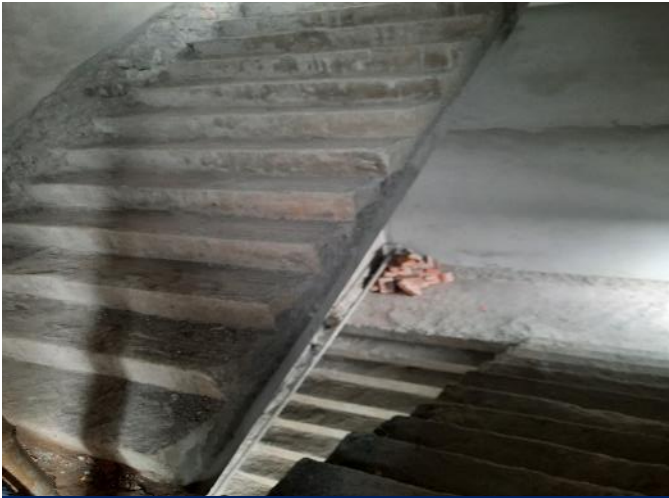
Stair without handrail

No handrail and window grill observed at the stair of the warehouse. As well as unrestrained brick wall found in the stair due to installation of fire hydrant pipe line.

Building Engineer is required to provide proper handrail in the stair and to install grill in the window to avoid falling hazard. Factory is also required to provide proper support below the unrestrained brick wall.

| Item No. | Observation | Recommended Action Plan | Recommended Timeline |
|---|--|---|---|
| 44 | Falling hazard from stair and unrestrained brick walls. (Building-09) | Building Engineer is required to provide proper handrail in the stair and to install grill in the window to avoid falling hazard. | 6-weeks |

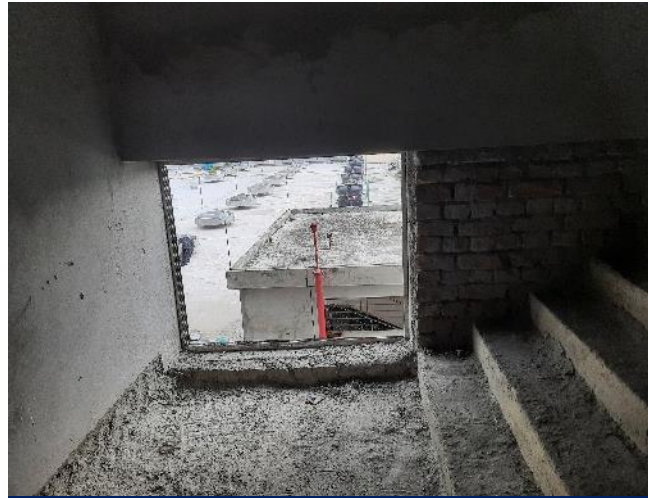
No window grill installed at stair

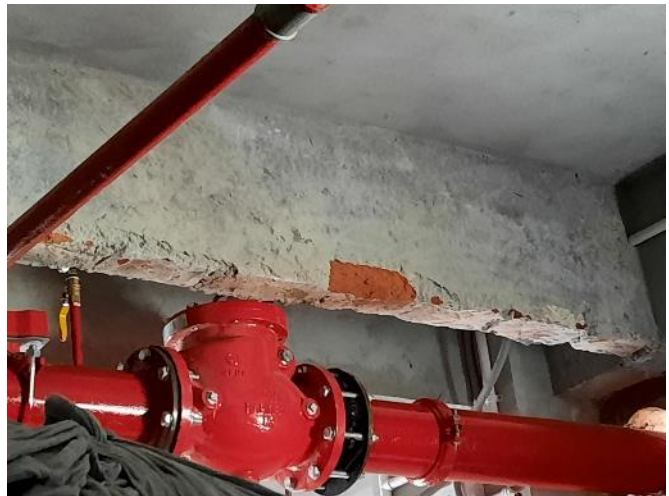
Unrestrained brick wall at stair without lintel/support.

| Item No. | Observation | Recommended Action Plan | Recommended Timeline |
|---|--|---|---|
| 45 | Falling hazard from stair and unrestrained brick walls. (Building-09) | Building is also required to provide proper support below the unrestrained brick wall. | 6-weeks |

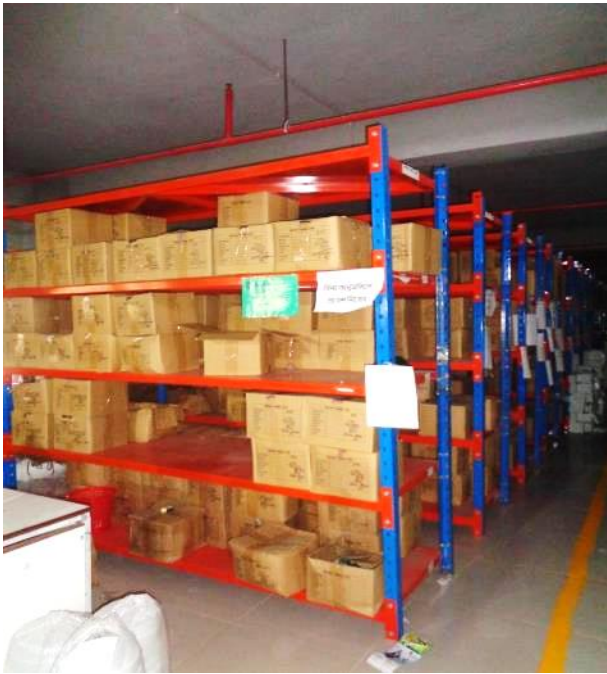
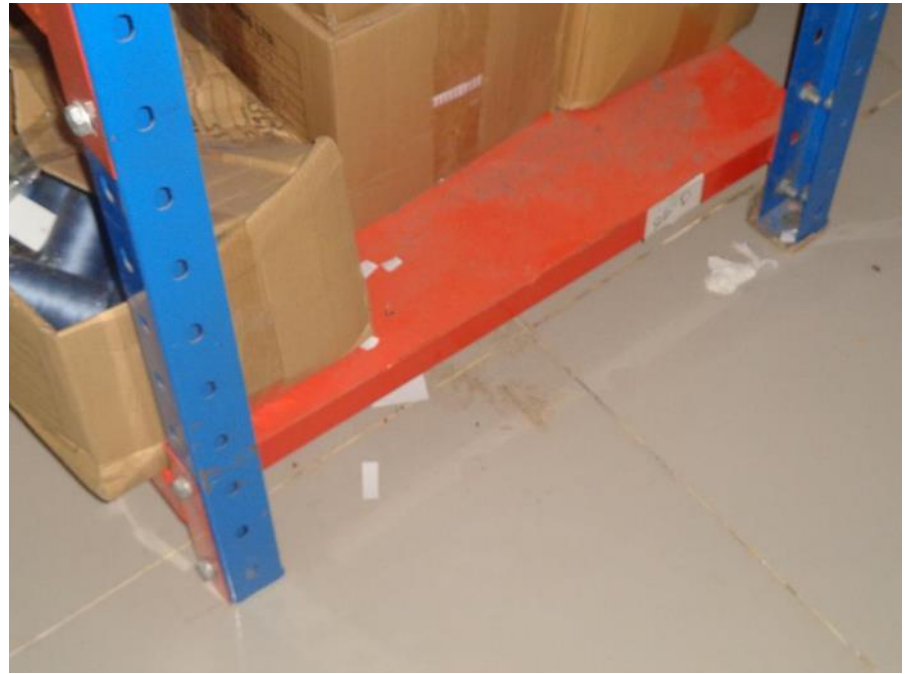
Storage rack without bracing and not anchored

Non-structural storage racks were not anchored or braced properly with floor or slab to protect against the earthquake load. Building is required to install bracing or anchor the rack with floor properly to make it stable against the earthquake load.

| Item No. | Observation | Recommended Action Plan | Recommended Timeline |
|---|--|---|---|
| 46 | Storage racks found without bracing/anchored. (Building-09) | Building is required to install bracing or anchored the rack with floor properly to make it stable against the earthquake load. | 6-weeks |

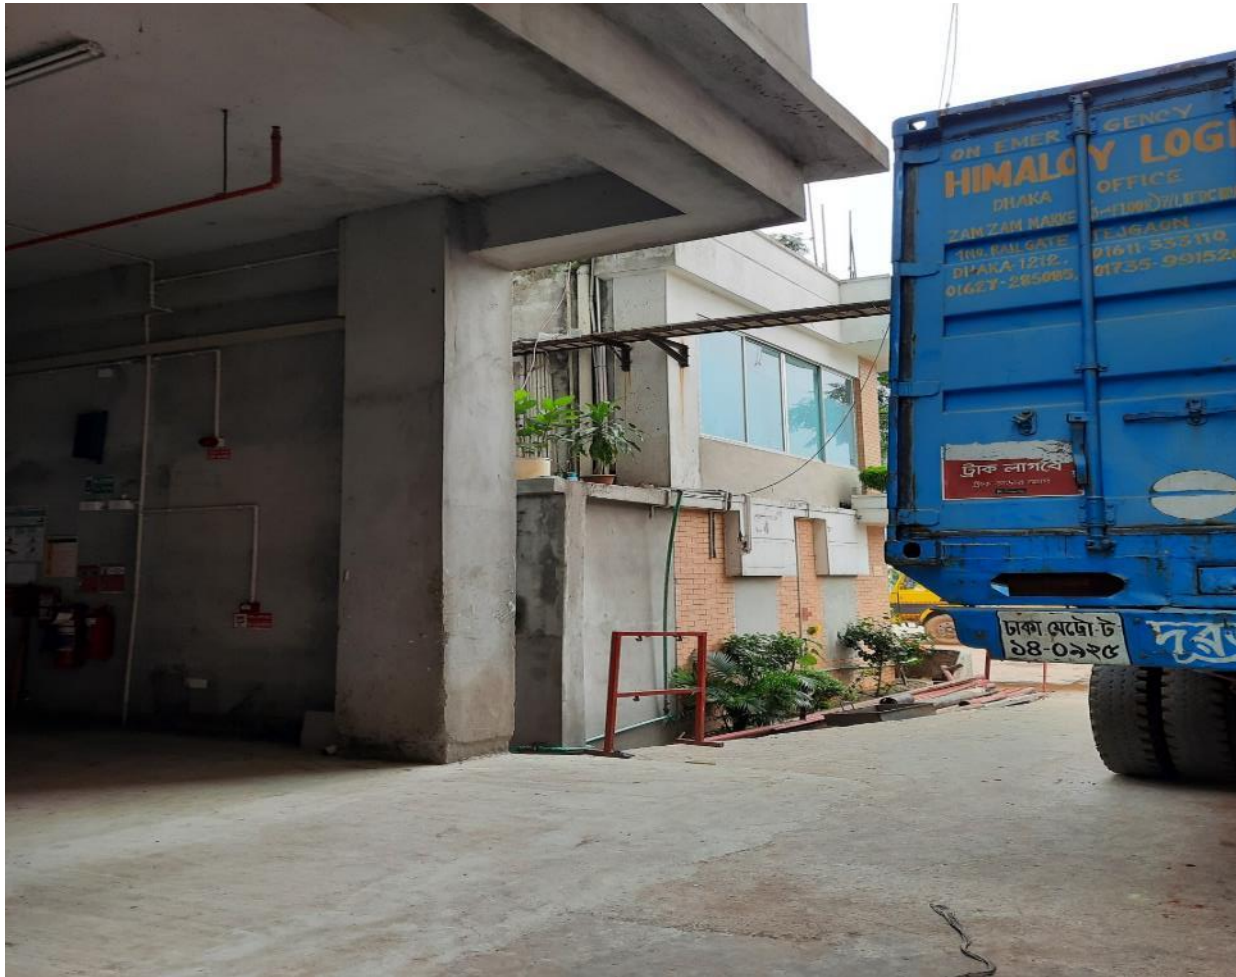
Ground Floor Column at Parking

Possibility of impact of vehicle on column

No column guard provided to protect the ground floor column from the vehicle impact. Building engineer is required to install column guard around the column to avoid the vehicle impact.

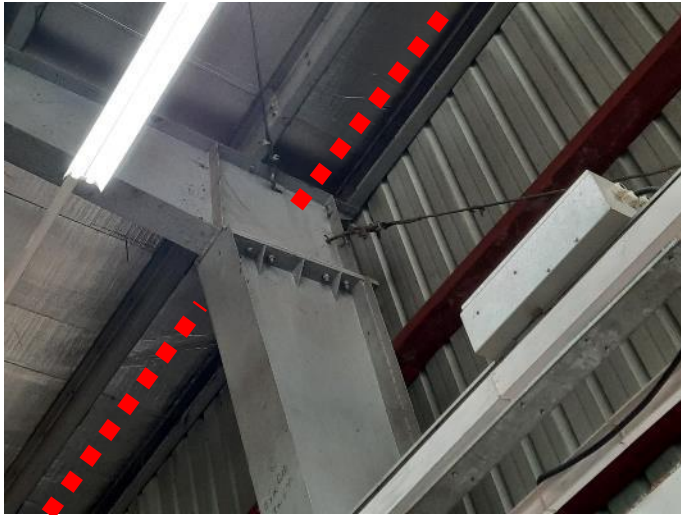
No compression strut along the length of building

No compression strut or vertical bracing
found in the long direction of the shed.
Building engineer is required to check
the lateral stability of the shed.

| Item No. | Observation | Recommended Action Plan | Recommended Timeline |
|---|---|---|---|
| 49 | Lack of lateral stability. (Building-10) | Carry out remedial works where required. | 6-months |

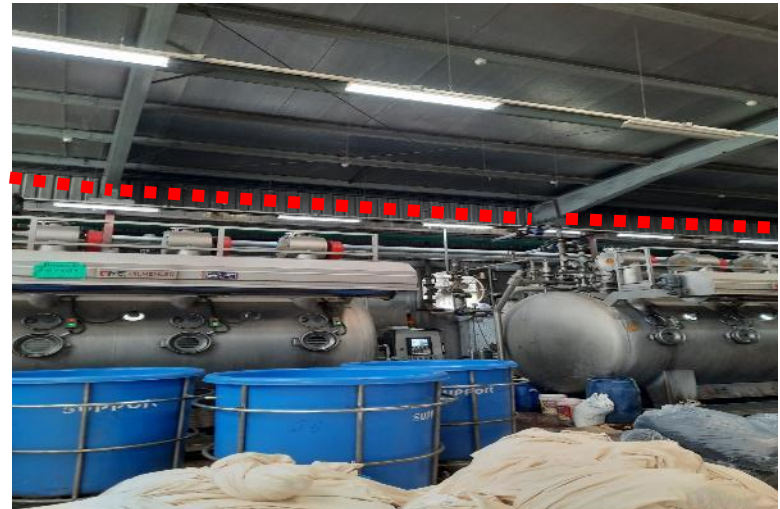
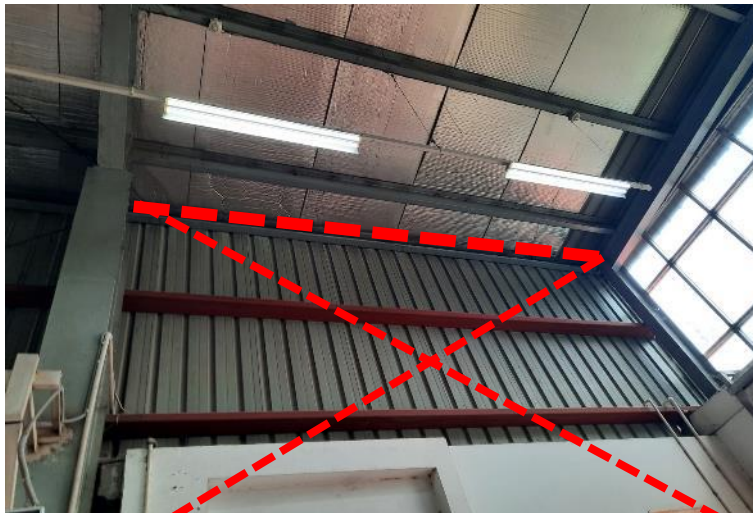
No compression strut or vertical bracing
at end bay

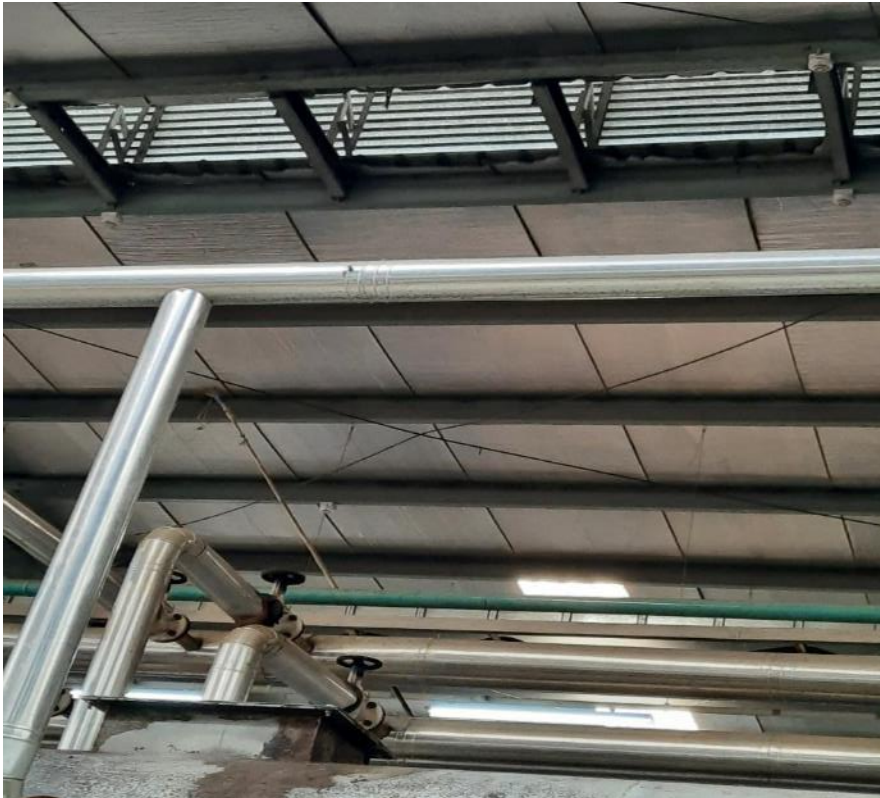
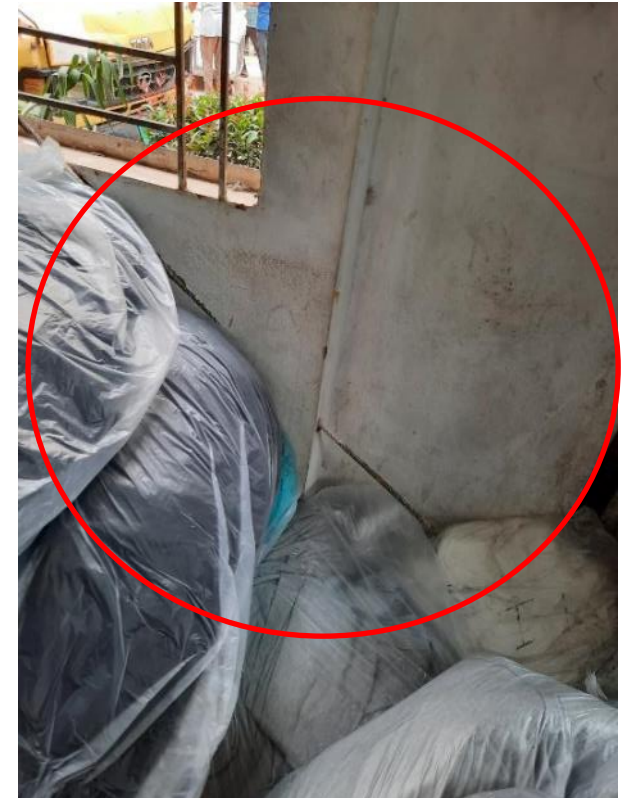
Loose and inactive cable bracing

Loose and inactive cable bracing was observed in roof of the shed. Building engineer is required to tightened the bracing

| Item No. | Observation | Recommended Action Plan | Recommended Timeline |
|---|---|---|---|
| 50 | Loose and inactive cable bracing. (Building-10) | Building engineer is required to tightened the loose bracing and take proper action to active the bracings. | 6-weeks |

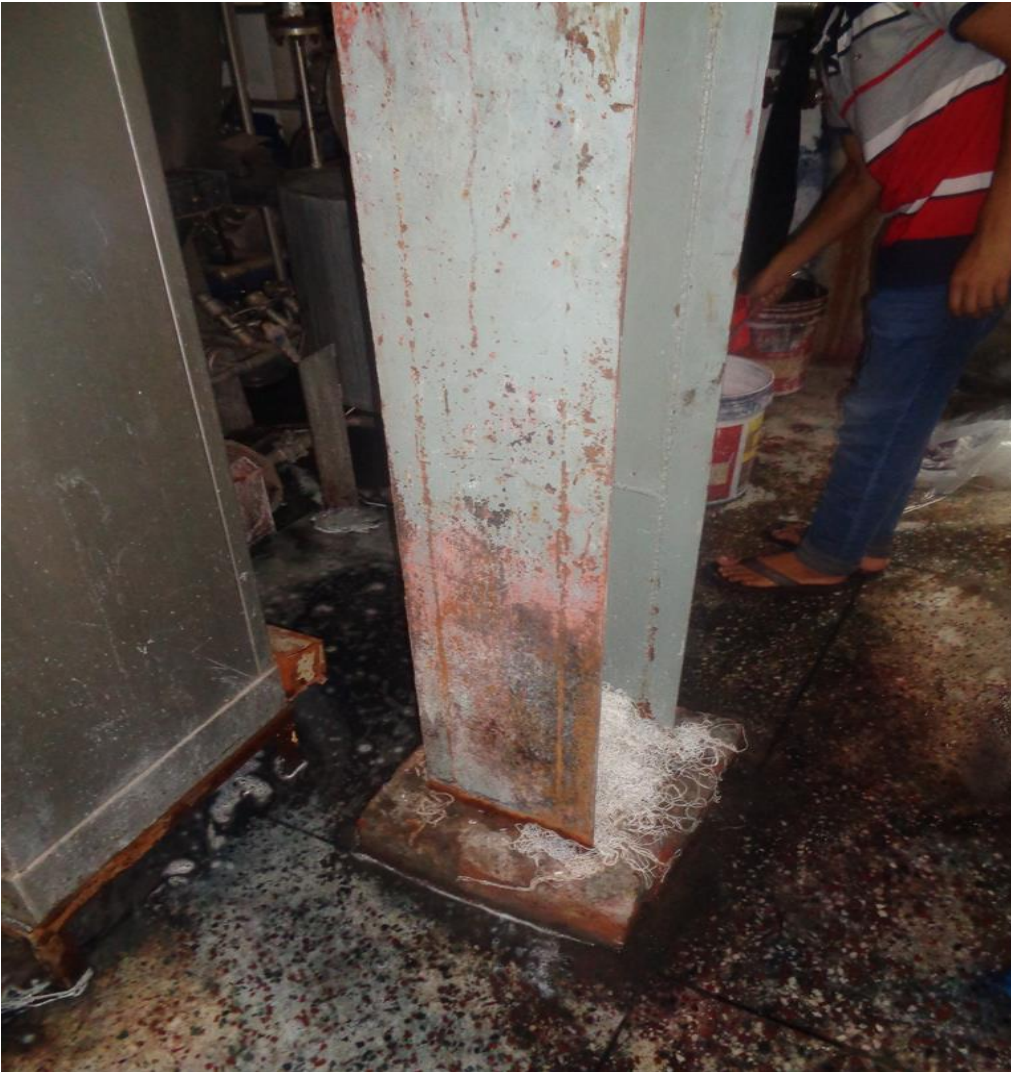
Corrosion on steel member

Corrosion was observed in the steel column of the shed. Building engineer is required to take proper measures to remove the corrosion from the steel column.

| Item No. | Observation | Recommended Action Plan | Recommended Timeline |
|---|---|---|---|
| 51 | Corrosion on steel member. (Building-10) | Building engineer is required to remove the corrosion and apply protective coating to the steel members. | 6-weeks |

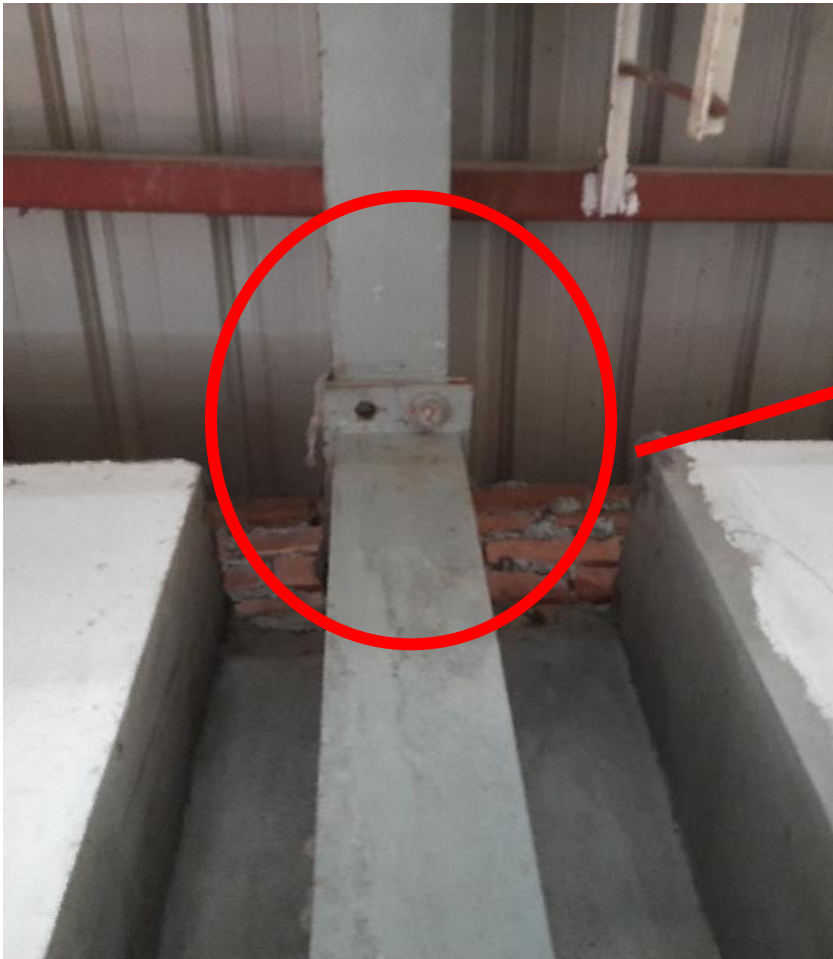
Missing bolt in steel column
and rafter joint

Building is required to install the missing bolt of the
steel structure.

| Item No. | Observation | Recommended Action Plan | Recommended Timeline |
|---|---|---|---|
| 52 | Missing bolt. (Building-10) | Building is required to re-install the missing bolt as per the specification. | 6-weeks |
