# INNOVATIVE KNITEX LIMITED

A/177/178, BSCIC, I/A, PANCHABOTY, FATULLAH, NARAYANGANJ.

04 December 2022

# Building Information

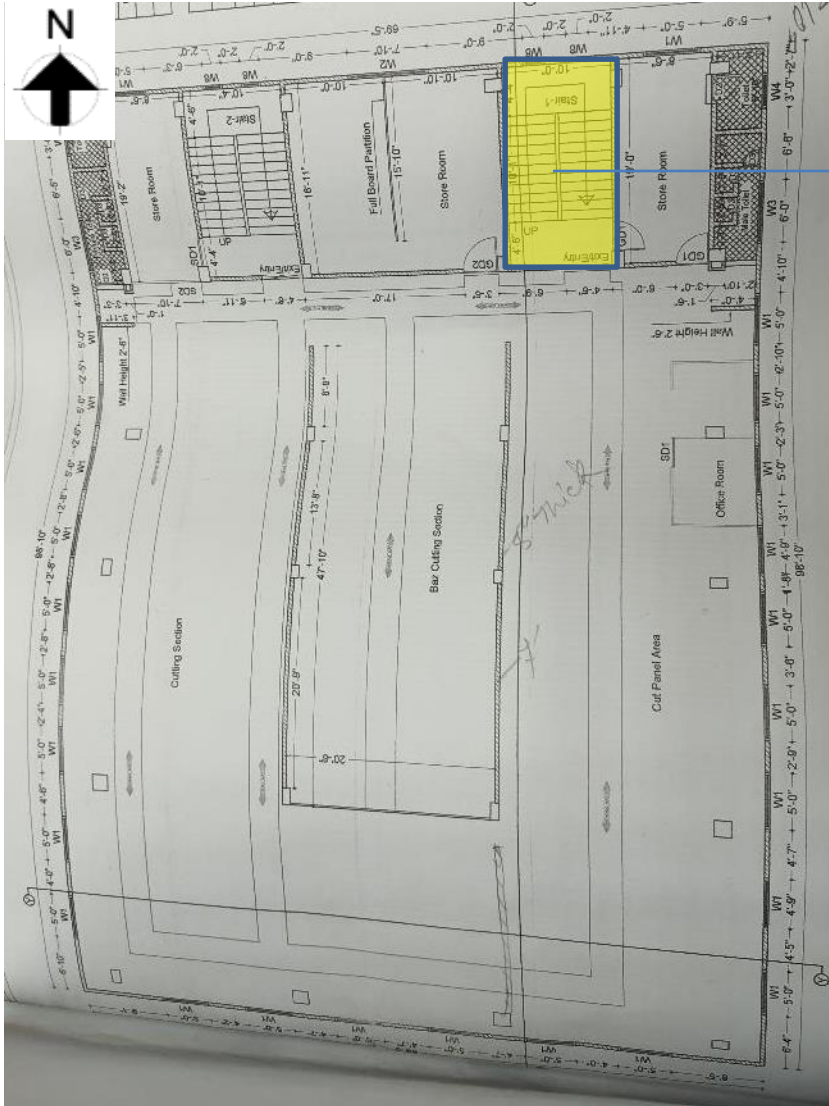
Floor layout

**Stress in column exceeds  
normal design limit**

The cursory calculation indicates that column's (under water tank) stress exceeds the normal design limit considering a typical floor live load 2kPa, stair live load of 4 kPa, and minimum concrete strength of 16.31 MPa. The building engineer is required to review the design, loads, and column stresses for the marked columns based on in-situ material strength. Verify in-situ concrete stresses by 100 mm diameter cores from a minimum of 4 columns. Produce and actively manage a loading plan for all floors considering floor and column capacity.

| Item No. | Observation | Recommended Action Plan | Recommended Timeline |
|---|---|---|---|
| 01 | Stress in column exceeds normal design limit. | Building Engineer to review design, loads and columns stresses in area identified above. | 6-weeks |
| 02 | Stress in column exceeds normal design limit. | Verify in-situ concrete stresses by 100mm dia. cores from minimum of 4 columns. | 6-weeks |
| 03 | Stress in column exceeds normal design limit. | Produce and actively manage a loading plan for all floor plates considering floor and column capacity. | 6-weeks |

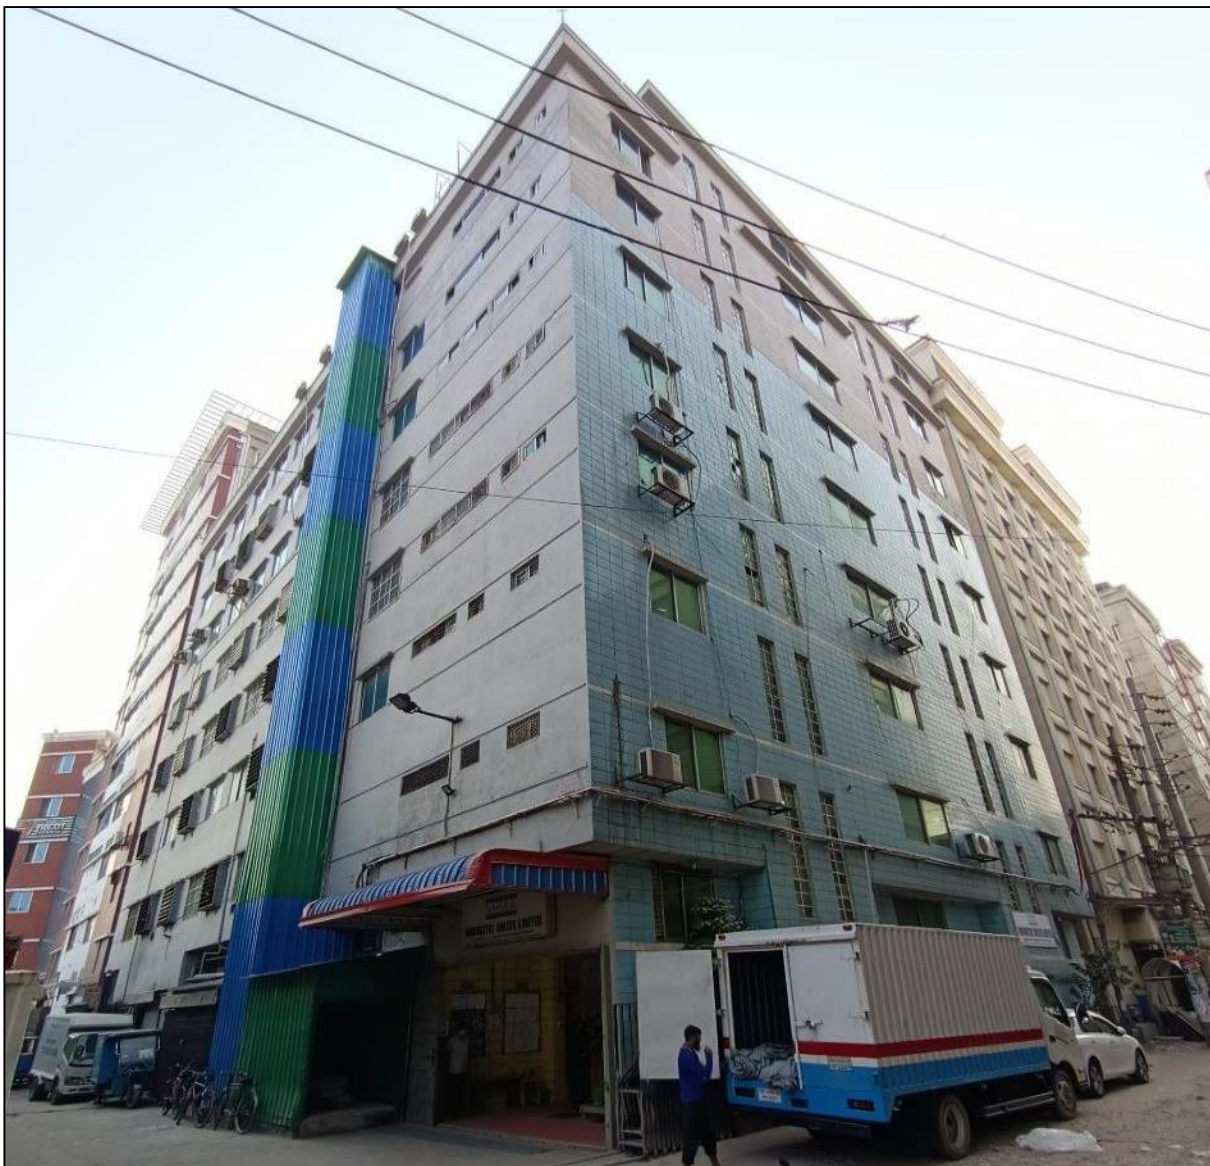
No design report was available for partially nine storied (G+8)  
Factory Building

As per BNBC, every building or structure designed shall have its design documents prepared in accordance with the provision of Section 1.9.1. The design document shall include a design report, and a set of structural drawings, which shall be prepared in compliance with section 1.9.1.1 and section 1.9.1.2, part-6 of BNBC. At the time of inspection, only as-built drawing, load plan and geotechnical report were available, but no design report was available which are required to be prepared in compliance with section 1.9.1.1 (part-6, BNBC).

| Item No. | Observation | Recommended Action Plan | Recommended Timeline |
|---|---|---|---|
| 06 | Absence of design documents. | Building engineer is required to prepare the design documents including a design report, and a set of structural drawings in compliance with section 1.9.1.1 and section 1.9.1.2, part-6 of BNBC and submit it to RSC for review. | 6-weeks |

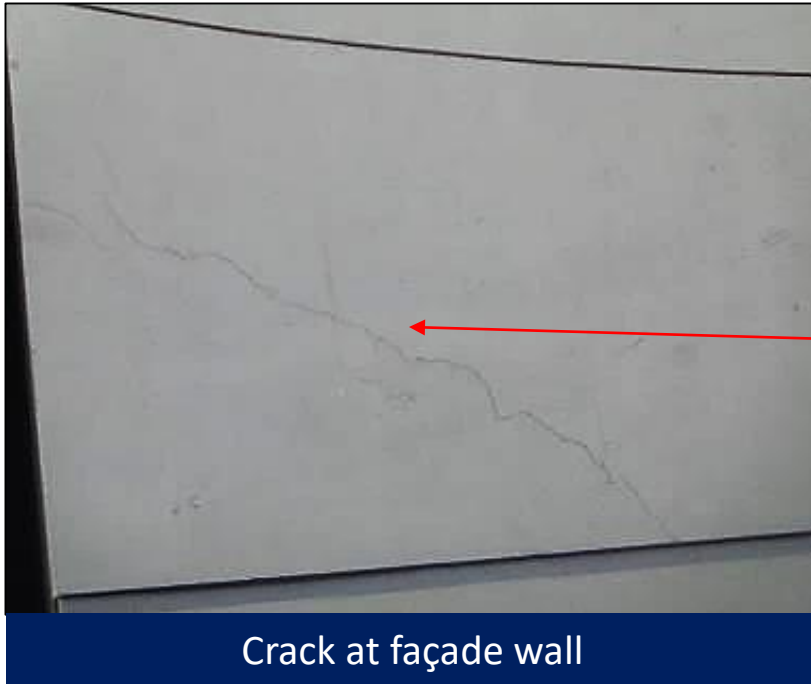
Crack at façade wall

Hairline cracks were observed at several locations of the building. Building engineer is required to investigate the reason of the crack & suggest proper remedial actions.

| Item No. | Observation | Recommended Action Plan | Recommended Timeline |
|---|---|---|---|
| 08 | Hairline cracks at façade wall. | Building engineer is required to investigate the reason of the crack & suggest proper remedial actions. | 6-weeks |

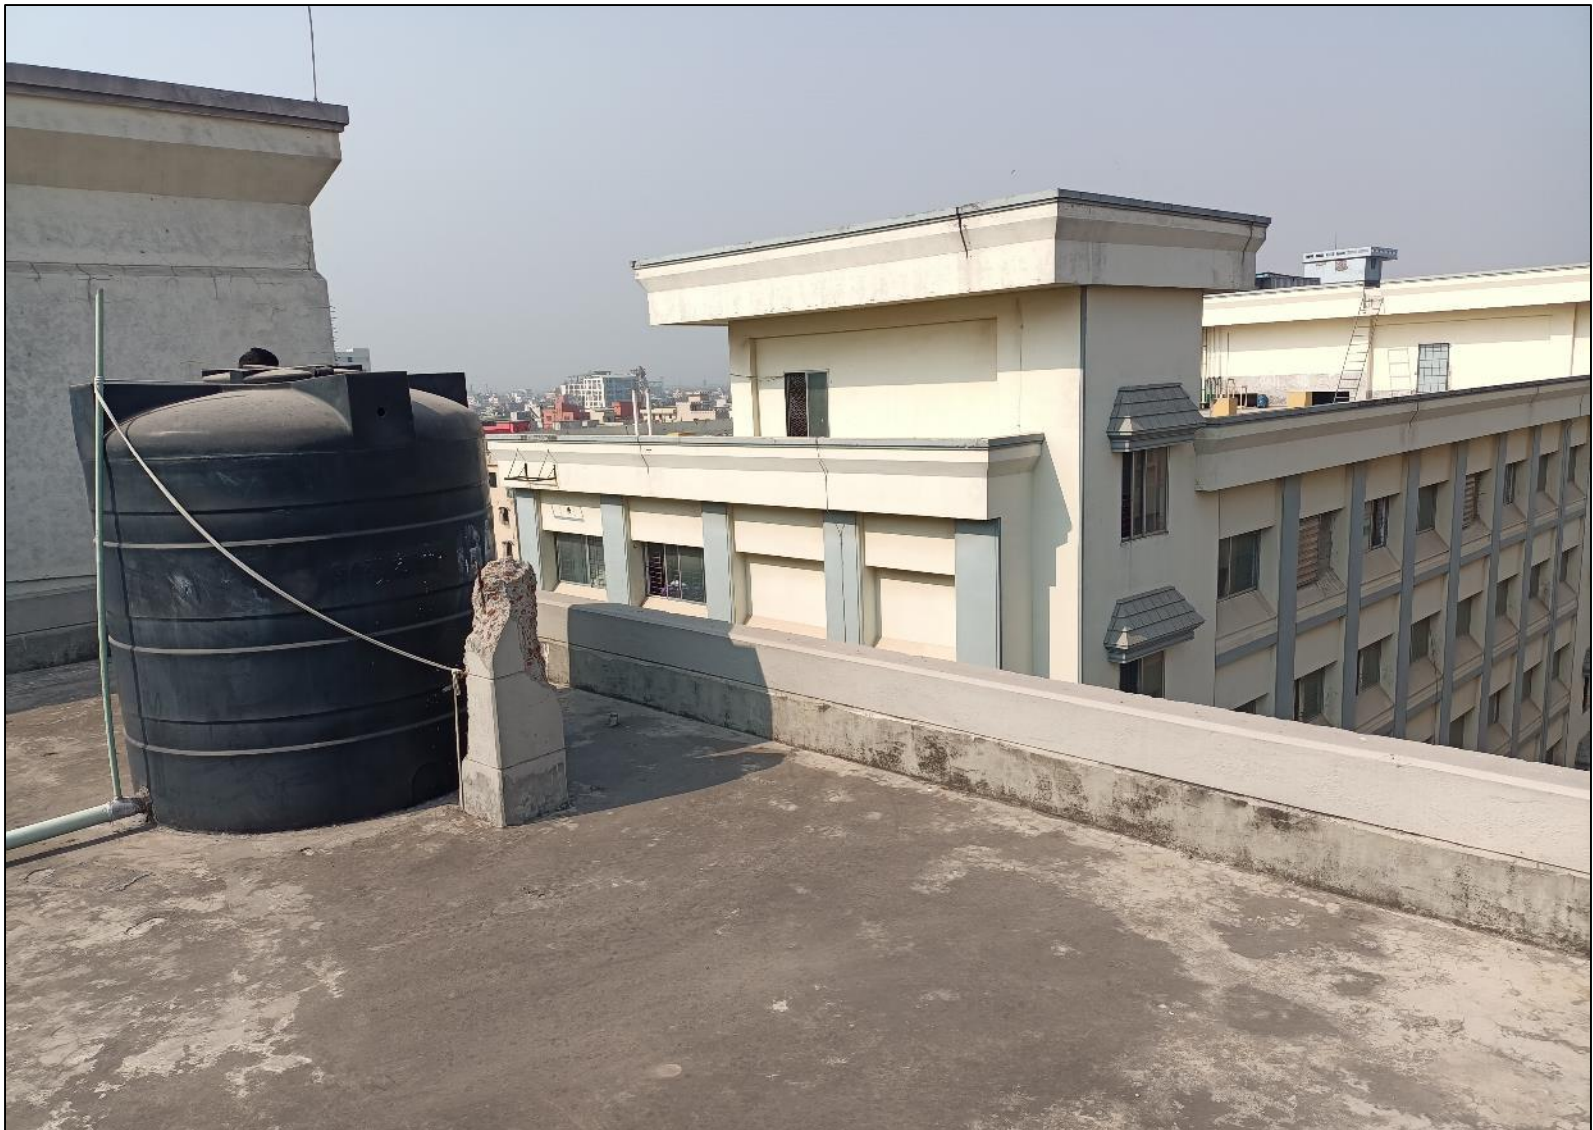
The height of the parapet wall above roof were found inadequate. Building engineer is required to increase the parapet wall to avoid possible falling hazard.

| Item No. | Observation | Recommended Action Plan | Recommended Timeline |
|---|---|---|---|
| 09 | Inadequate parapet wall. | Building is required to complete the construction of parapet wall to avoid potential of falling hazard. | 6-weeks |

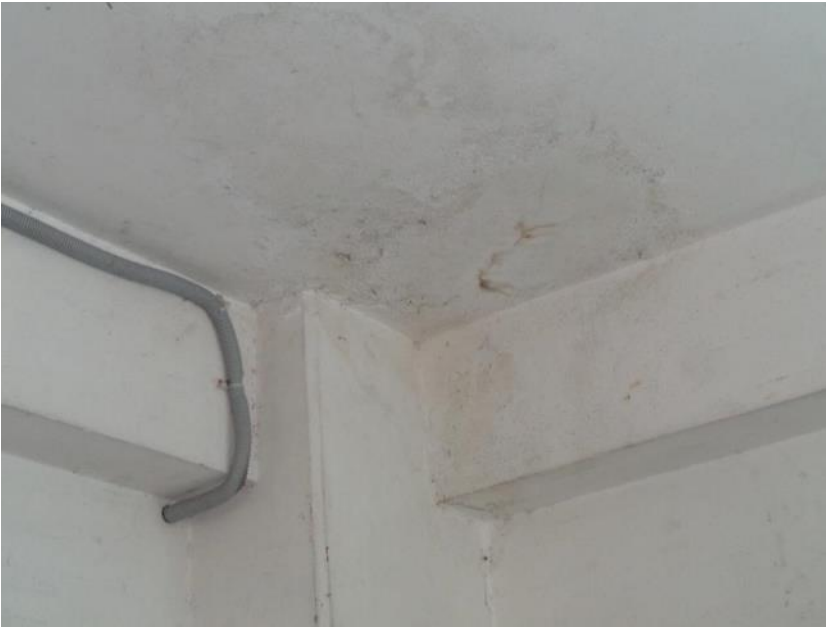
Signage of dampness at slab, beam & column

Signage of dampness was observed several locations of the building. Building engineer is required to investigate the reason of the dampness and suggest proper remedial actions.

| Item No. | Observation | Recommended Action Plan | Recommended Timeline |
|---|---|---|---|
| 10 | Dampness observed at several locations. | Building engineer is required to investigate the reason of the dampness and suggest proper remedial actions. | 6-weeks |

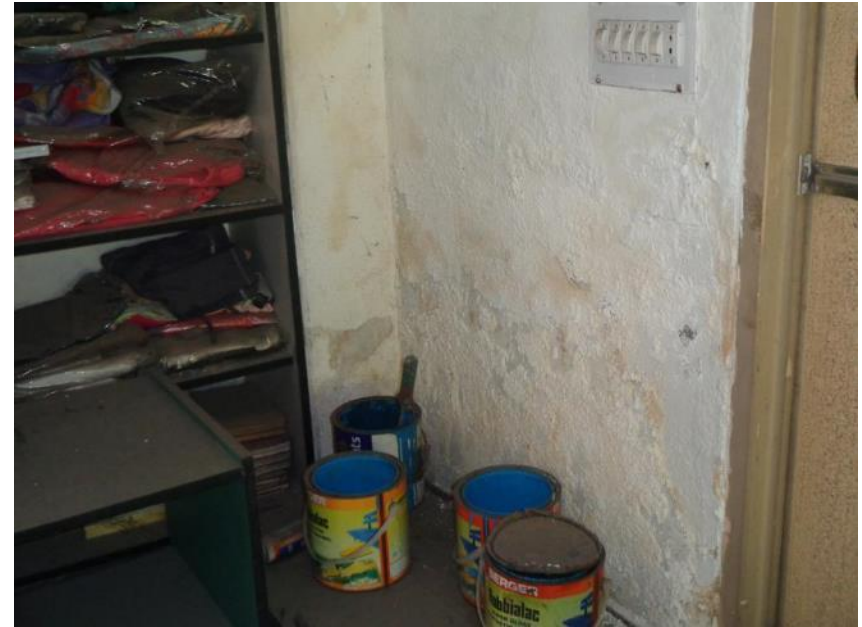
Signage of dampness at partition wall at toilet

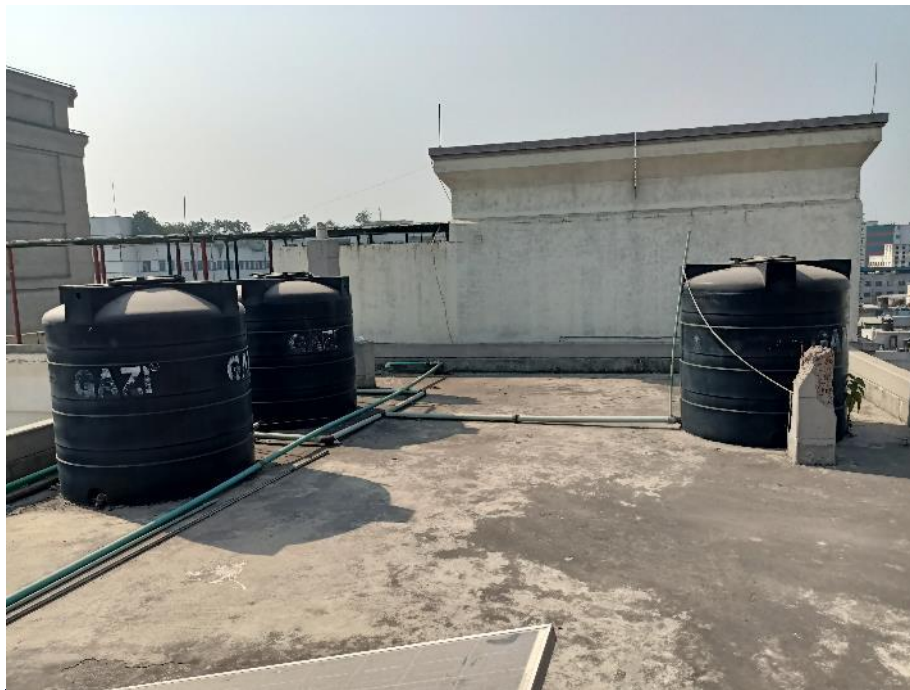
Some plastic tanks resting on the rooftop and racks on different floors are not adequately anchored or braced to resist lateral (earthquake) forces.

Plastic water tank on roof

Adequately anchor and brace all non-structural elements (all buildings) to resist earthquake forces to comply with the BNBC.

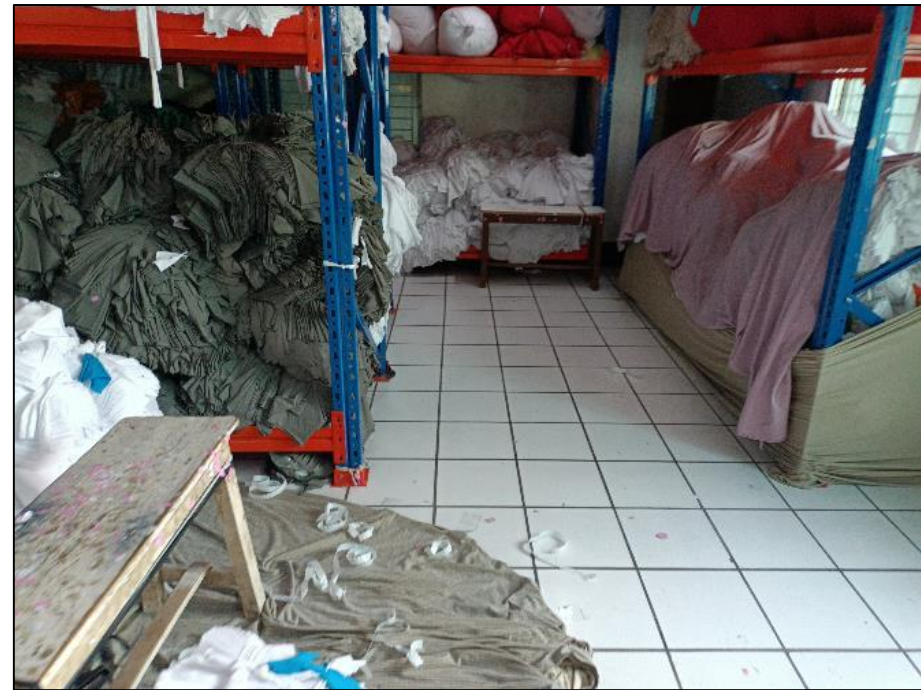
Rack on floor level

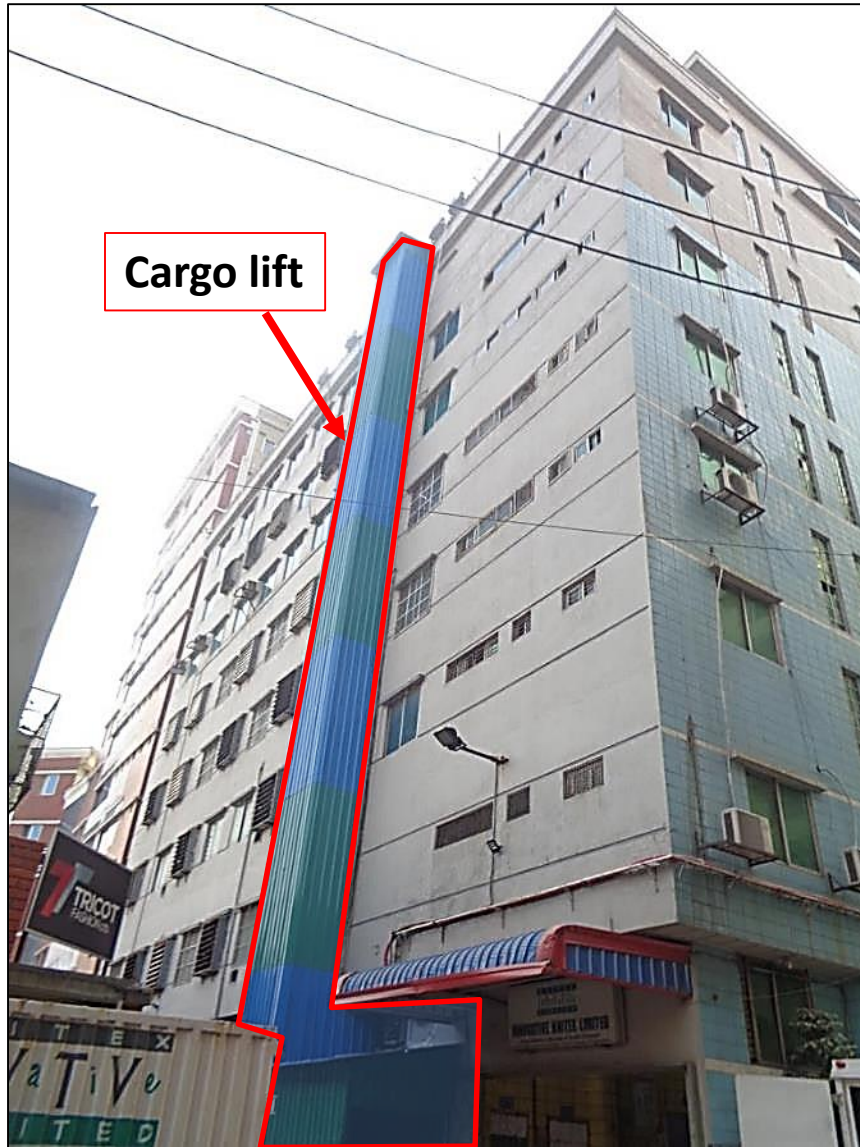
**Cargo lift**

Cargo lift at east side of the building

No bracing was observed at the steel frame of the cargo lift. Building engineer is required to check lateral stability and capacity of the cargo lift.

| Item No. | Observation | Recommended Action Plan | Recommended Timeline |
|---|---|---|---|
| 12 | No obvious lateral stability at cargo lift. | Building engineer is required to check lateral stability and capacity of the cargo lift and suggest proper remedial actions accordingly. | 6-weeks |

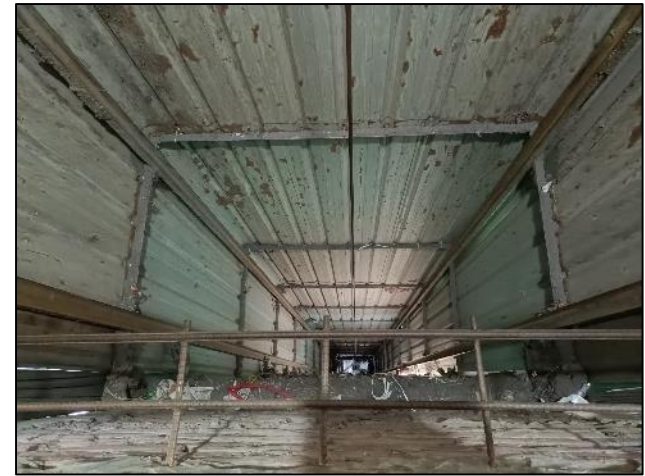
No bracing observed from inside the lift

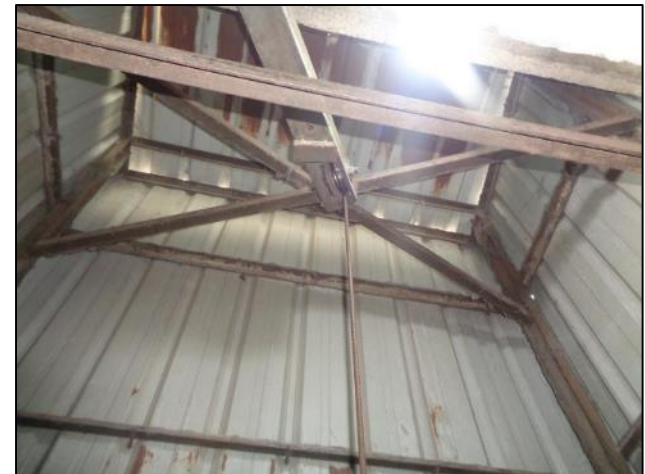
Pulley hoist of the lift

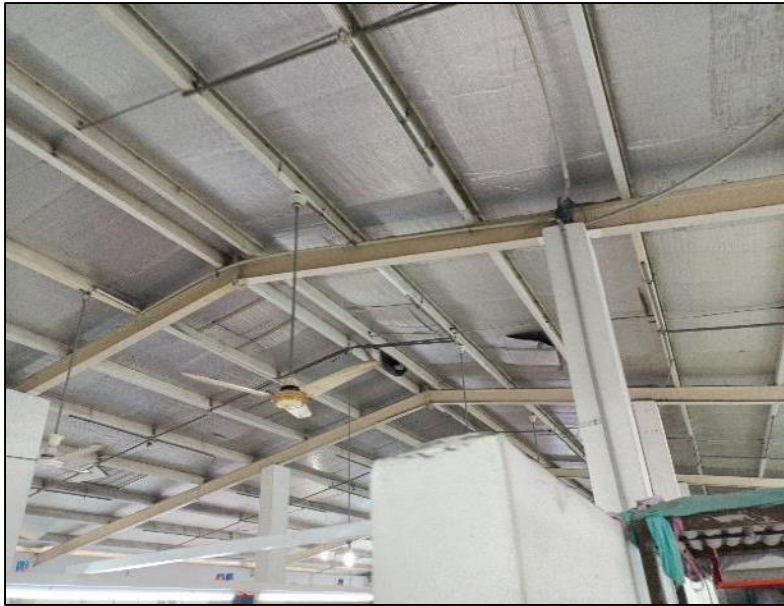
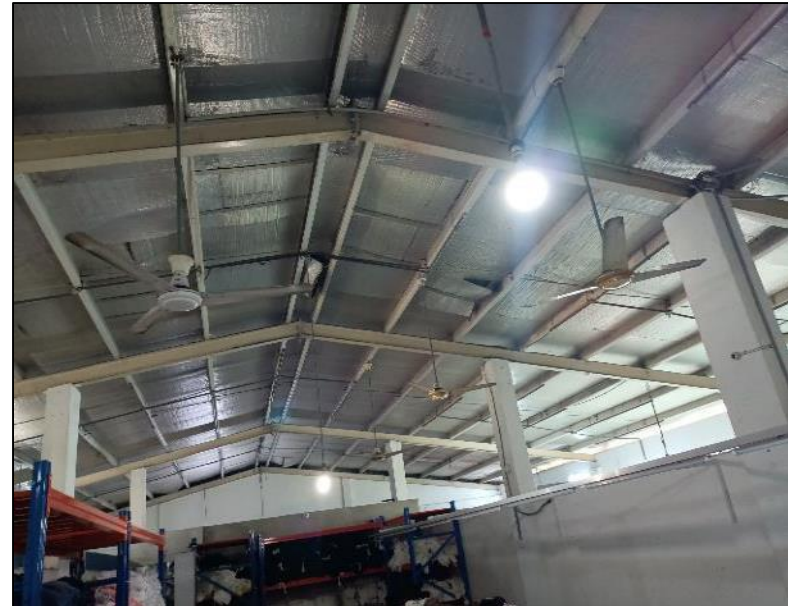
Lack of compression member along long direction of the shed. No roof bracing observed.

The building engineer is required to check the lateral stability system of the steel shed.

| Item No. | Observation | Recommended Action Plan | Recommended Timeline |
|---|---|---|---|
| 14 | Lack of lateral stability system (Roof Shed). | Building engineer is required to check the lateral stability system and suggest proper remedial actions accordingly. | 6-weeks |
