# Green Fibre Composite Ltd.

Baniarchala, Mohoha Bhabanipur, Gazipur Sadar, Gazipur  
(24.166900, 90.418758)  
13 November 2022

# Buildings Information

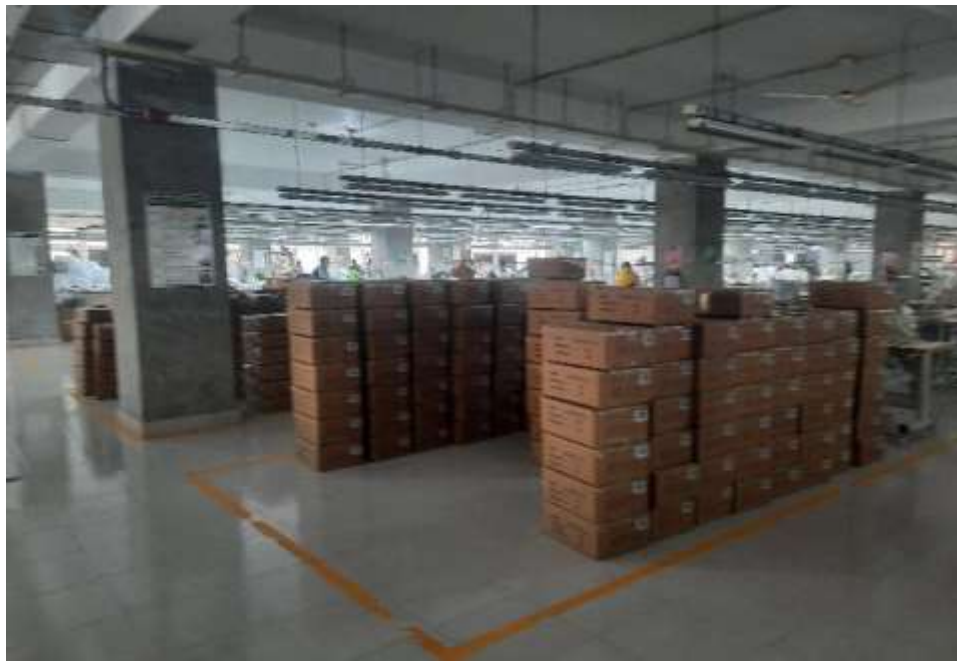
# Implement floor load management program

No load management program was visible. Building engineer is required to implement load management program (Display Load plan on floors, provide signage to the store areas) as per its floor loading capacity and follow the load plans for all floors of the buildings and make sure that the workers understand the loading requirements.

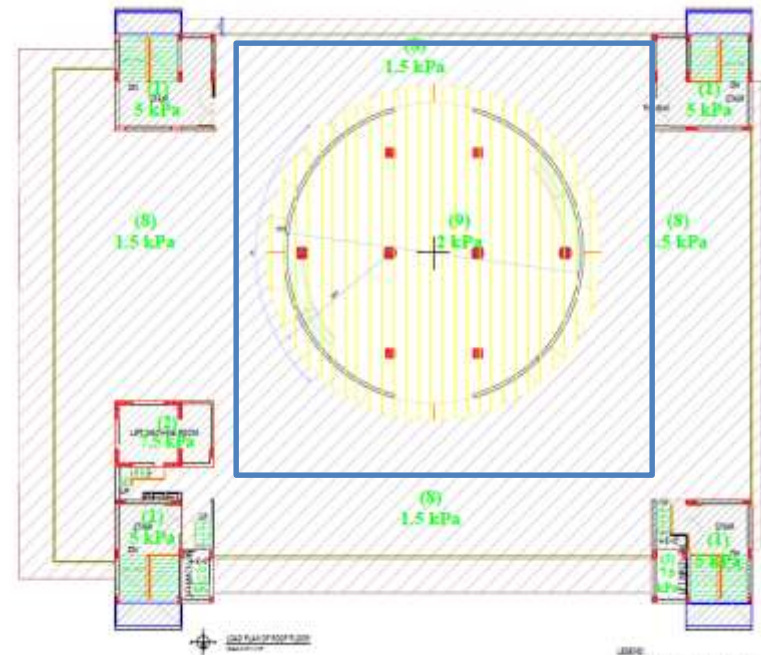
Helipad live loading considered 2 kPa in the load plan. Building engineer is required to follow NBC for the helipad live load and revise the load plan accordingly.

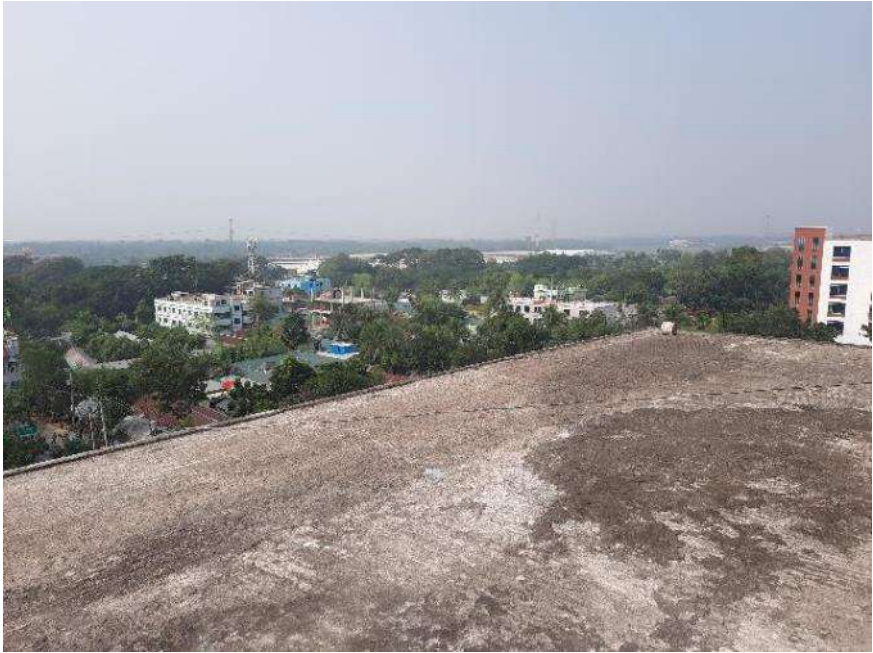
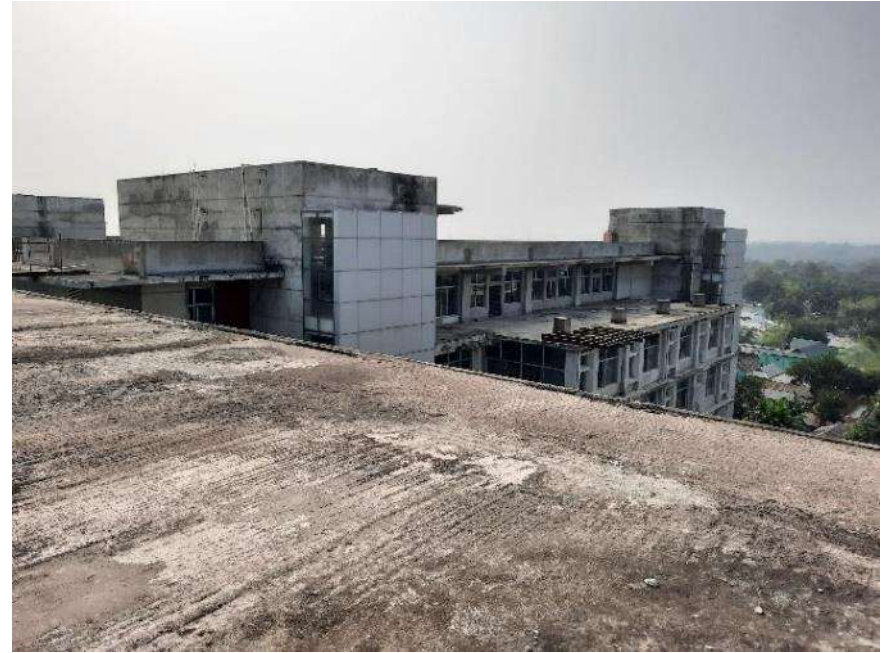
# Falling hazard on the roof

Parapet missing on the roof. Building engineer is required to provide parapet on the roof as per code requirement to avoid falling hazard.

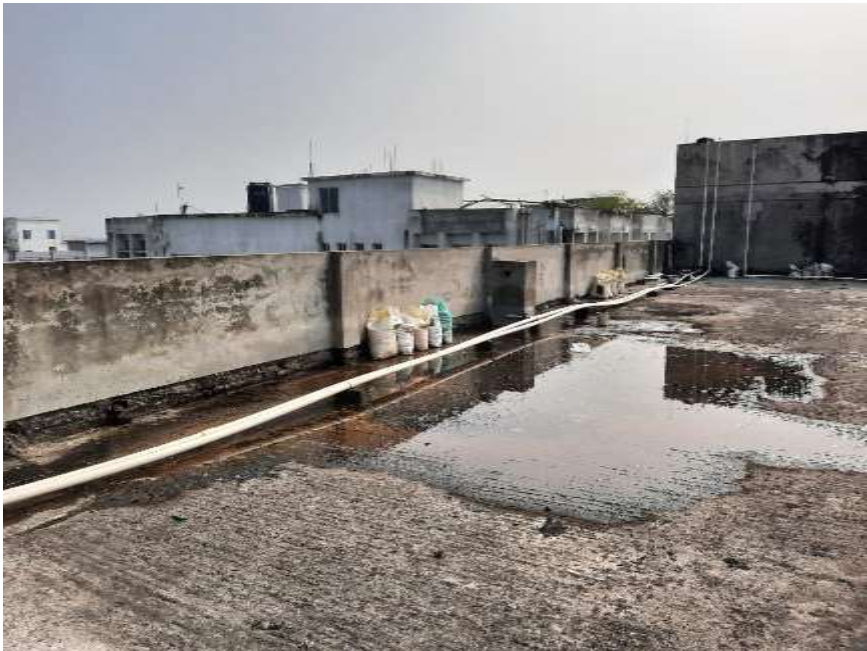
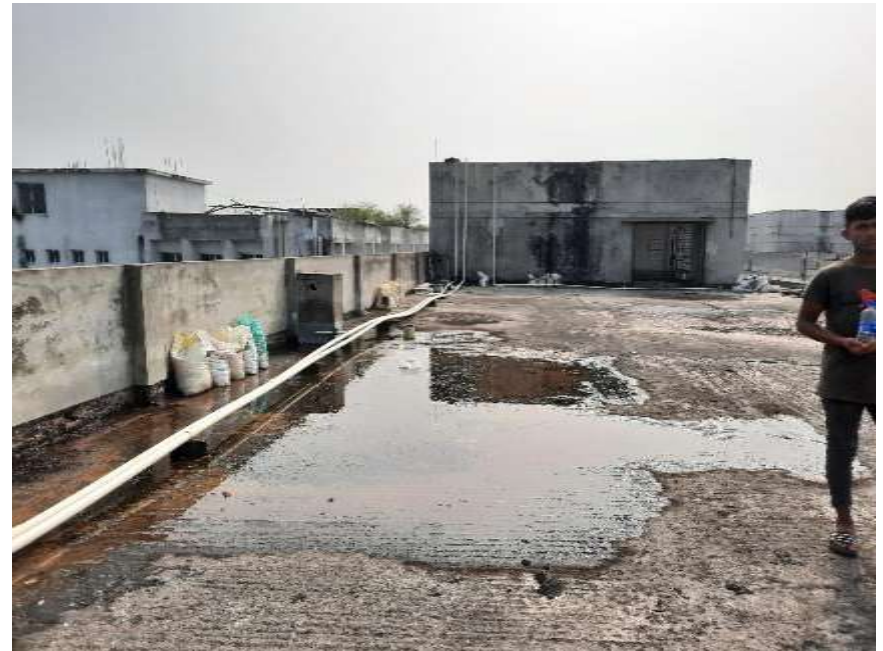
# Water ponding on the roof

Water ponding observed on the roof. Building engineer is required to provide water proofing layer and improve roof drainage system.
