**Revision : Issue-1**  
**Date: 10<sup>th</sup> April 2022**

# **Chorka Apparels Ltd.**

Kazirchor, Danga, Polash, Narshingdi  
(23.898113, 90.573466)

15<sup>th</sup> November 2021

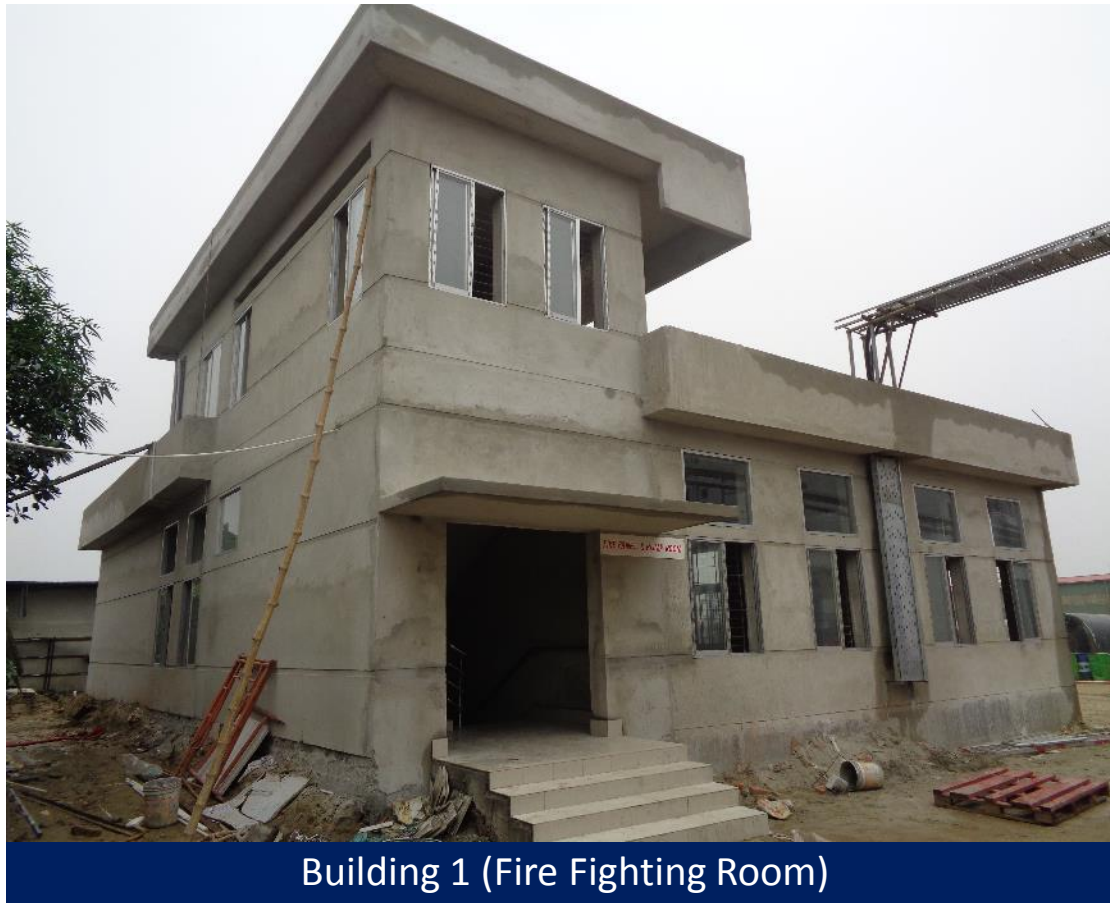
Building 1 (Fire Fighting Room)

As per BNBC, every building or structure shall have its design documents prepared in accordance with the provision of Section 1.9.1. of BNBC part-6. The design document shall include a design report, and a set of structural drawings. However, design report was not available during inspection. The building engineer is required to prepare a design report in compliance with part-6, BNBC-2020.

| Item No. | Observation | Recommended Action Plan | Recommended Timeline |
|---|---|---|---|
| 01 | Lack of design documents: Building-1 (Fire Fighting Room). | Building engineer to prepare the design document including a design report, in compliance with section 1.9.1 as per BNBC-2020. | 6-weeks |

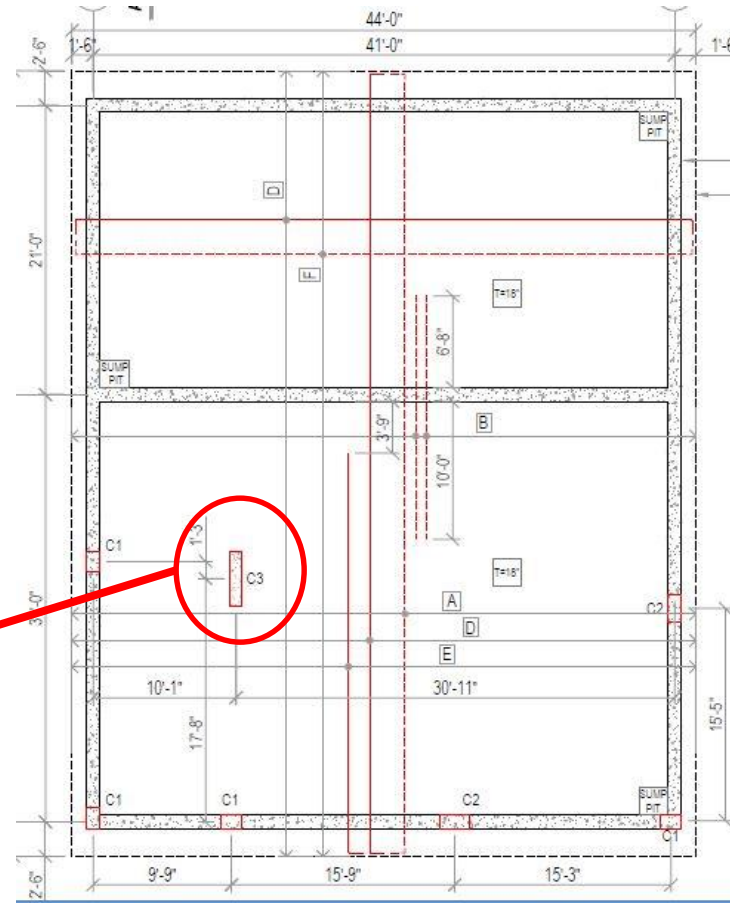
Column C-3 in layout

Column C-3 is shown as C-2 in schedule

Column C-3 is shown as C-2 in schedule.  
Factory engineer is required to update the as-built drawing.

| Item No. | Observation | Recommended Action Plan | Recommended Timeline |
|---|---|---|---|
| 03 | Inconsistency in as-built drawing: Building-1 (Fire Fighting Room) | Factory engineer is required to survey the structure and update the as-built drawings accordingly. | 6-weeks |

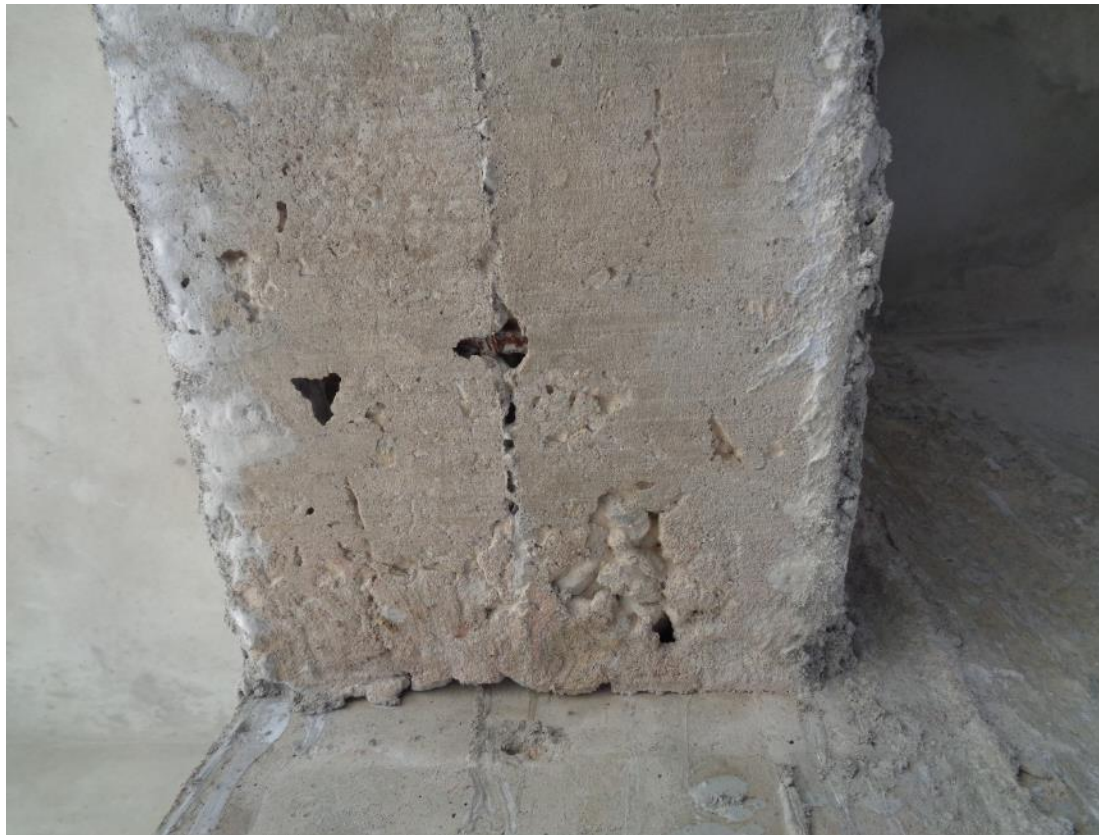
Honeycomb observed in stair roof beam

Honeycomb observed in stair roof beam which may have been occurred due to poor workmanship during construction. Factory is required to repair the affected areas as per guidance of engineer.

| Item No. | Observation | Recommended Action Plan | Recommended Timeline |
|---|---|---|---|
| 04 | Honeycomb observed in stair roof beam: Building-1 (Fire Fighting Room) | Factory is required to repair the affected areas as per guidance of engineer. | 6-weeks |

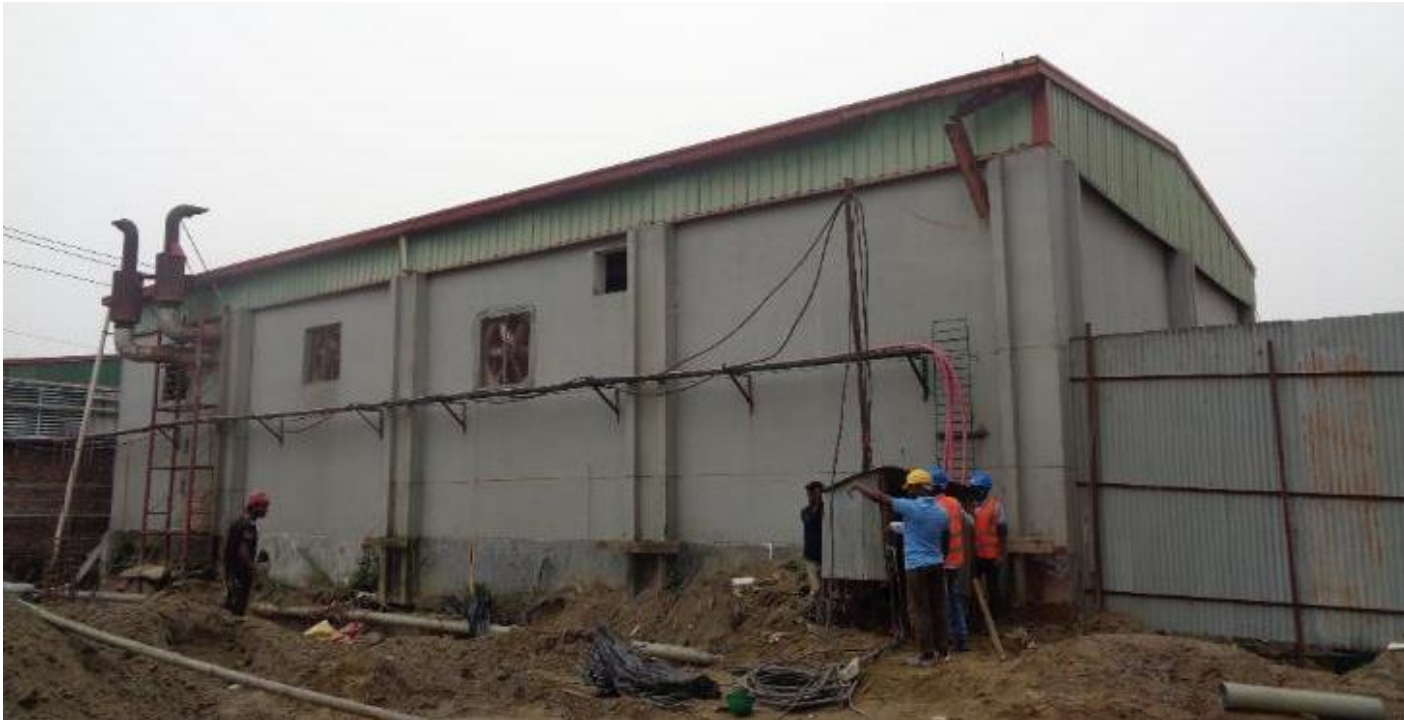
As per BNBC, every building or structure designed shall have its design documents prepared in accordance with the provision of Section 1.9.1. The design document shall include a design report, and a set of structural drawings, which shall be prepared in compliance with section 1.9.1.1 and section 1.9.1.2 of part-6, BNBC. However, design report was not available during inspection. The building engineer is required to prepare a design report in compliance with BNBC.

| Item No. | Observation | Recommended Action Plan | Recommended Timeline |
|---|---|---|---|
| 05 | Lack of design documents: Building-2 (Substation Shed) | Building engineer to prepare the design document including a design report, in compliance with section 1.9.1.1 as per BNBC. | 6-weeks |

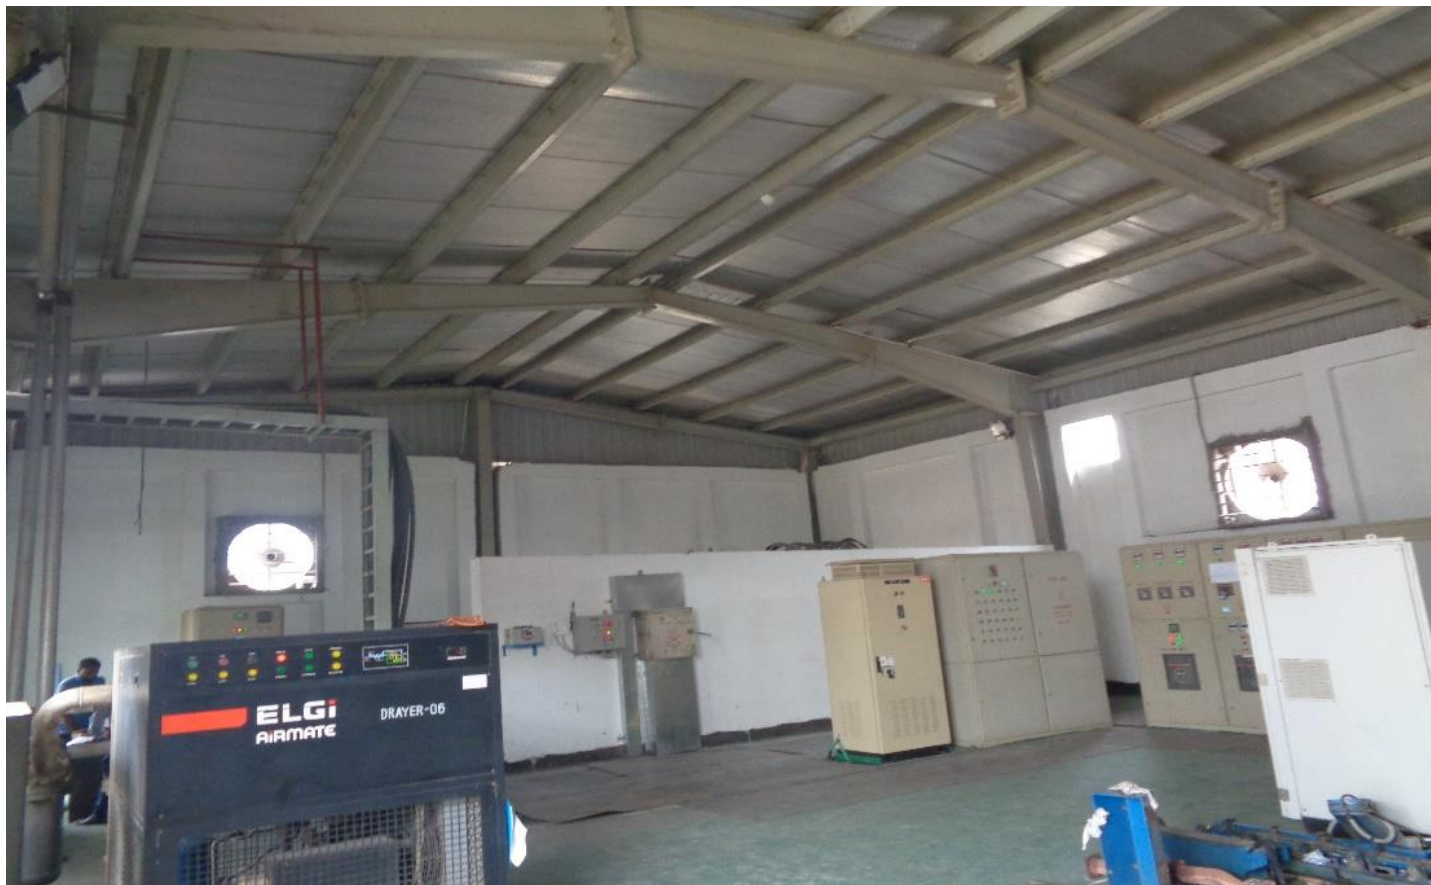
No vertical/horizontal bracing provided in wall and roof

Only strut member along the long direction (eave level) is present but no bracing is provided in the roof and wall to resist the lateral loads. Therefore, stability system along long direction is incomplete. Factory engineer is required to check the lateral stability of the structure.

| Item No. | Observation | Recommended Action Plan | Recommended Timeline |
|---|---|---|---|
| 07 | Lack of lateral stability: Building-2 (Substation Shed) | Building engineer is required to check the lateral stability system of the structure and suggest necessary actions. | 6-weeks |

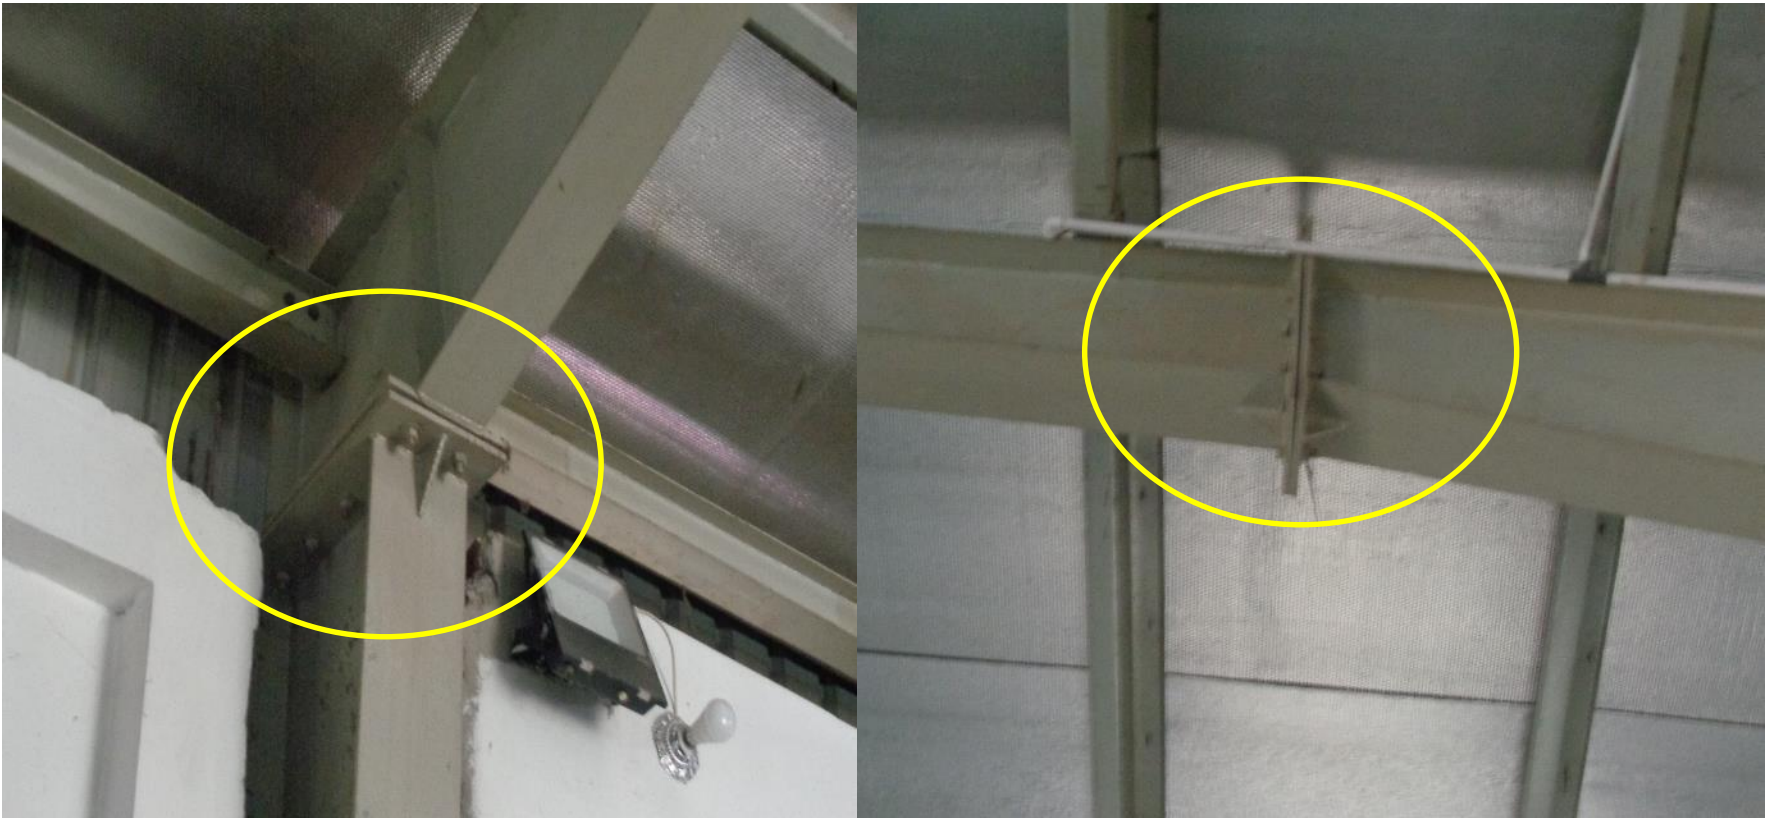
Connection gap found at several locations

Connection gap found at several locations. Factory is required to repair the connection gaps as per any suitable method suggested by the engineer.

| Item No. | Observation | Recommended Action Plan | Recommended Timeline |
|---|---|---|---|
| 09 | Gap in connections: Building-2 (Substation Shed) | Factory is required to repair the connection gaps as per any suitable method suggested by the factory engineer. | 6-weeks |

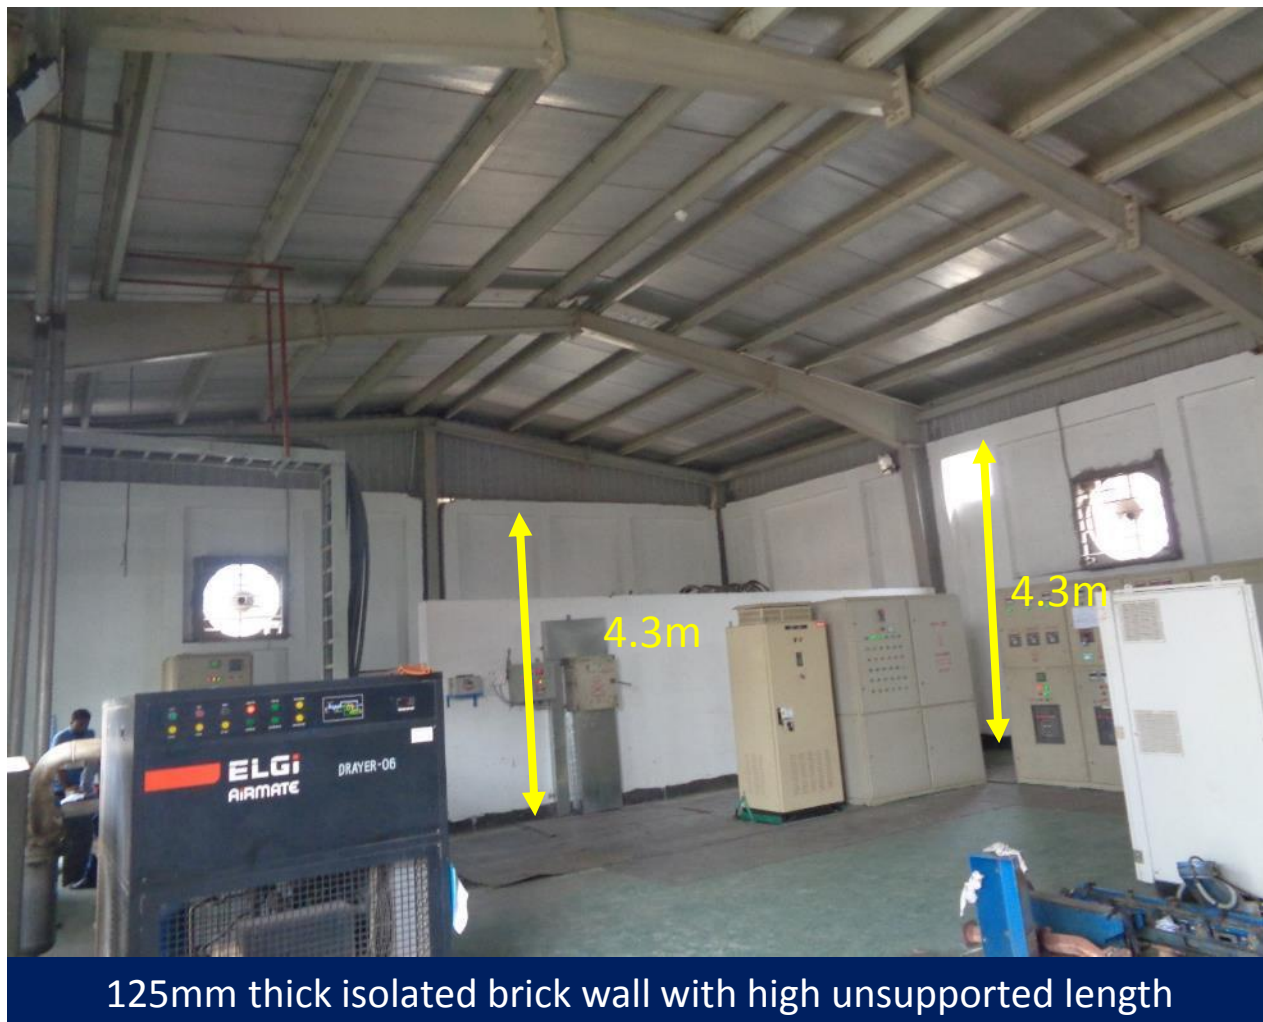
125mm thick isolated brick wall with high unsupported length

4.3 m high and 125 mm thick brick walls are standing between column spans without any connection with steel columns. Therefore, these walls were apparently laterally unstable. Factory engineer is required to check the lateral stability of the unsupported brick walls and implement necessary remediation measures.

| Item No. | Observation | Recommended Action Plan | Recommended Timeline |
|---|---|---|---|
| 10 | Apparently unstable brick wall: Building-2 (Substation Shed) | Factory engineer is required to check the lateral stability of the unsupported brick walls and suggest remedial actions. | 6-weeks |

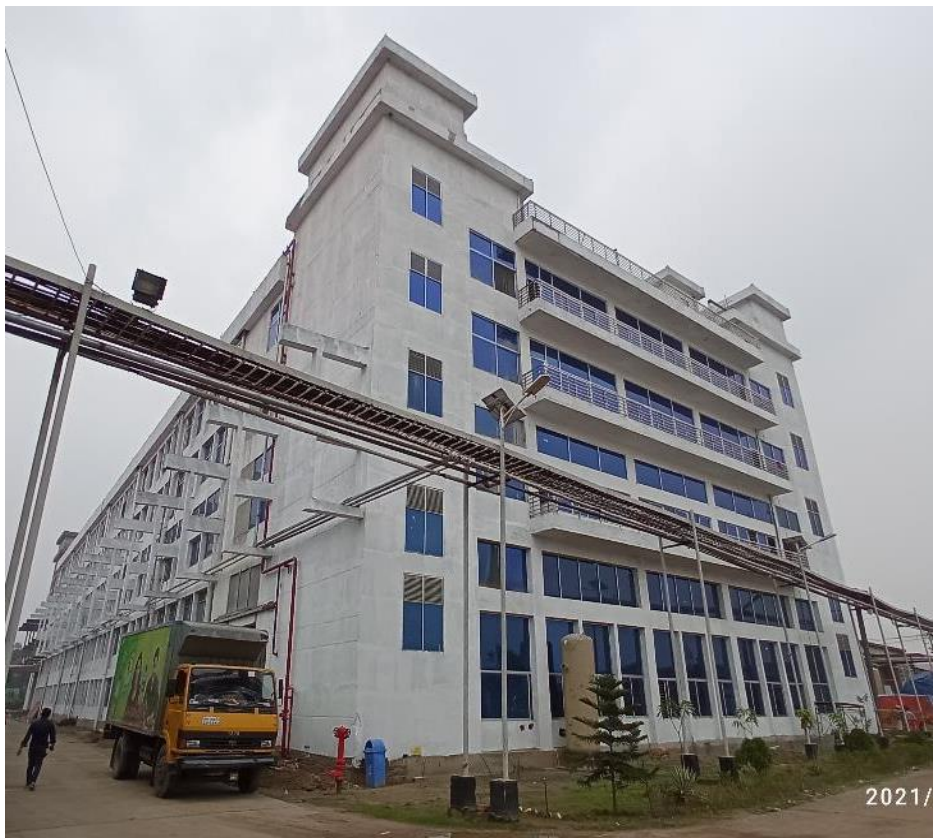
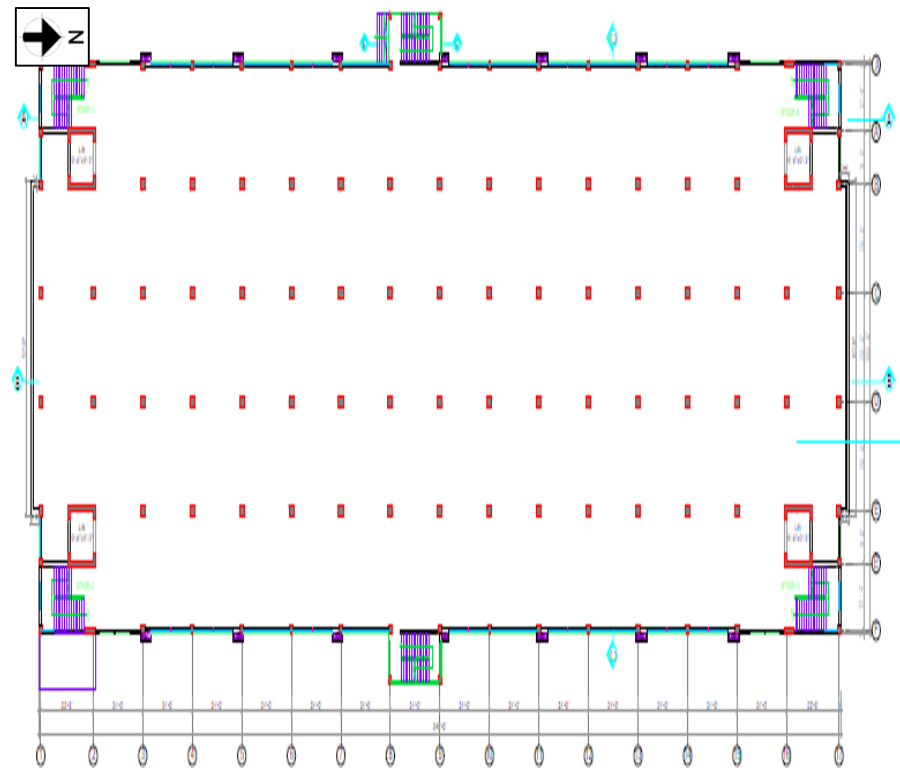
Building 4 (Production Building)

As per BNBC, every building or structure shall have its design documents prepared in accordance with the provision of Section 1.9.1. of BNBC part-6. The design document shall include a design report, and a set of structural drawings. However, design report was not available during inspection. The building engineer is required to prepare a design report in compliance with part-6, BNBC-2006.

| Item No. | Observation | Recommended Action Plan | Recommended Timeline |
|---|---|---|---|
| 12 | Lack of design documents: Building-4 (Production Building) | Building engineer to prepare the design document including a design report, in compliance with section 1.9.1 as per BNBC-2006. | 6-weeks |

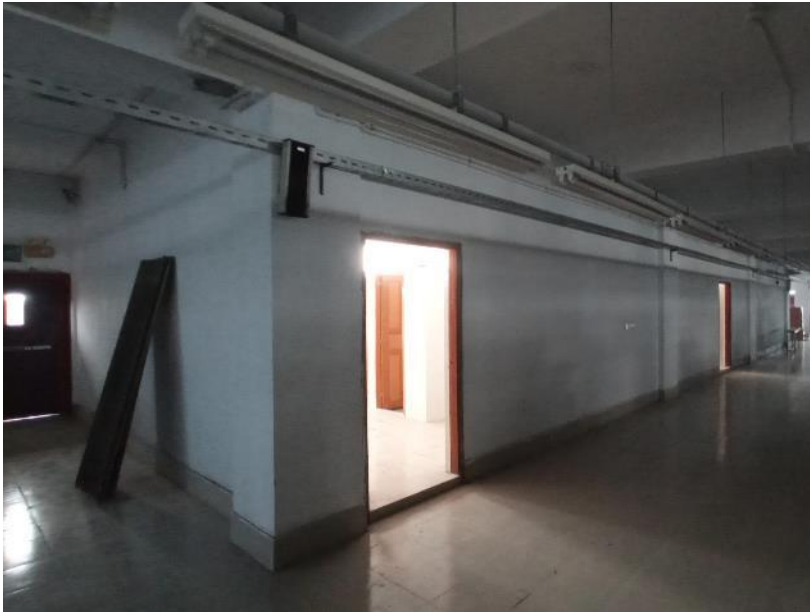
Undocumented toilet block on typical floor

Newly built toilet block, cantilever slab (North & South side) not shown in as built drawings. Emergency stair at west side has not been constructed. The building engineer is required to survey the structure and produce accurate as-built drawings.

| Item No. | Observation | Recommended Action Plan | Recommended Timeline |
|---|---|---|---|
| 14 | Discrepancies between drawings and as-built condition: Building 4 (Production Building) | The building engineer is required to survey the structure and produce accurate as-built drawings. | 6-weeks |

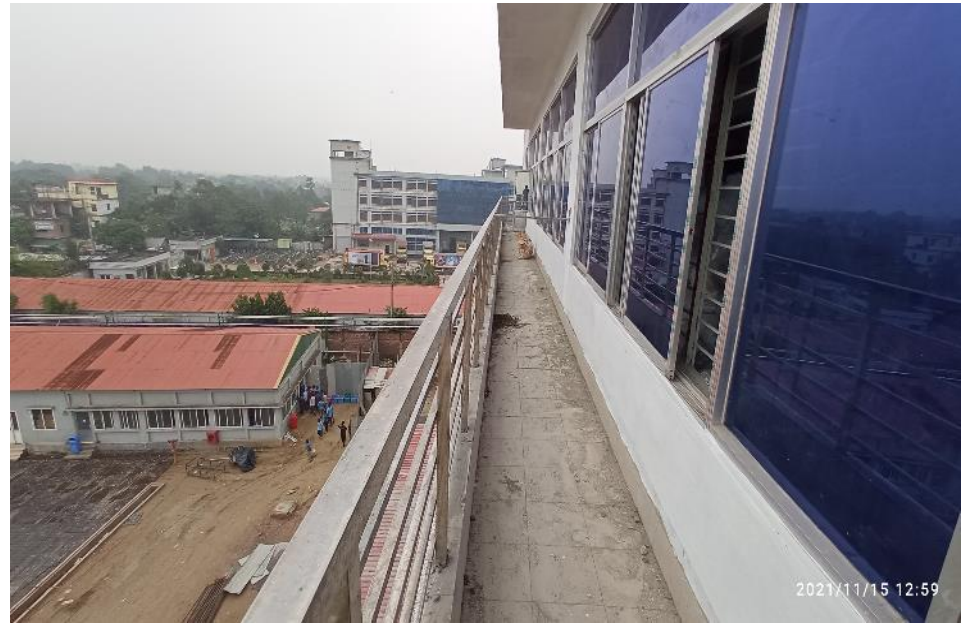
Cantilever slab at south and north side of 1F to 4F

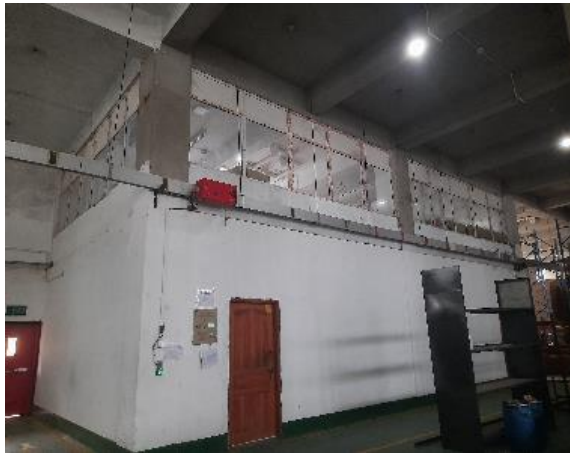
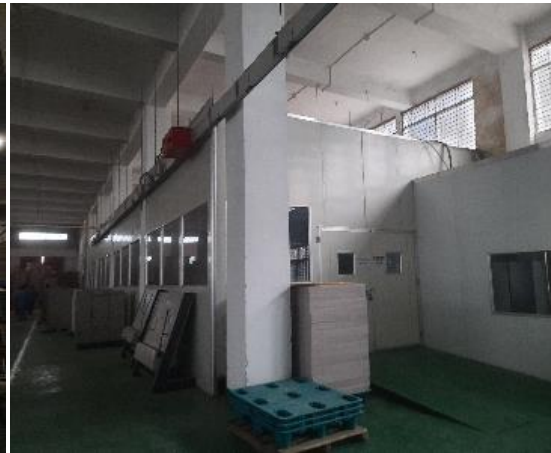
Undocumented mezzanine and printing section at GF

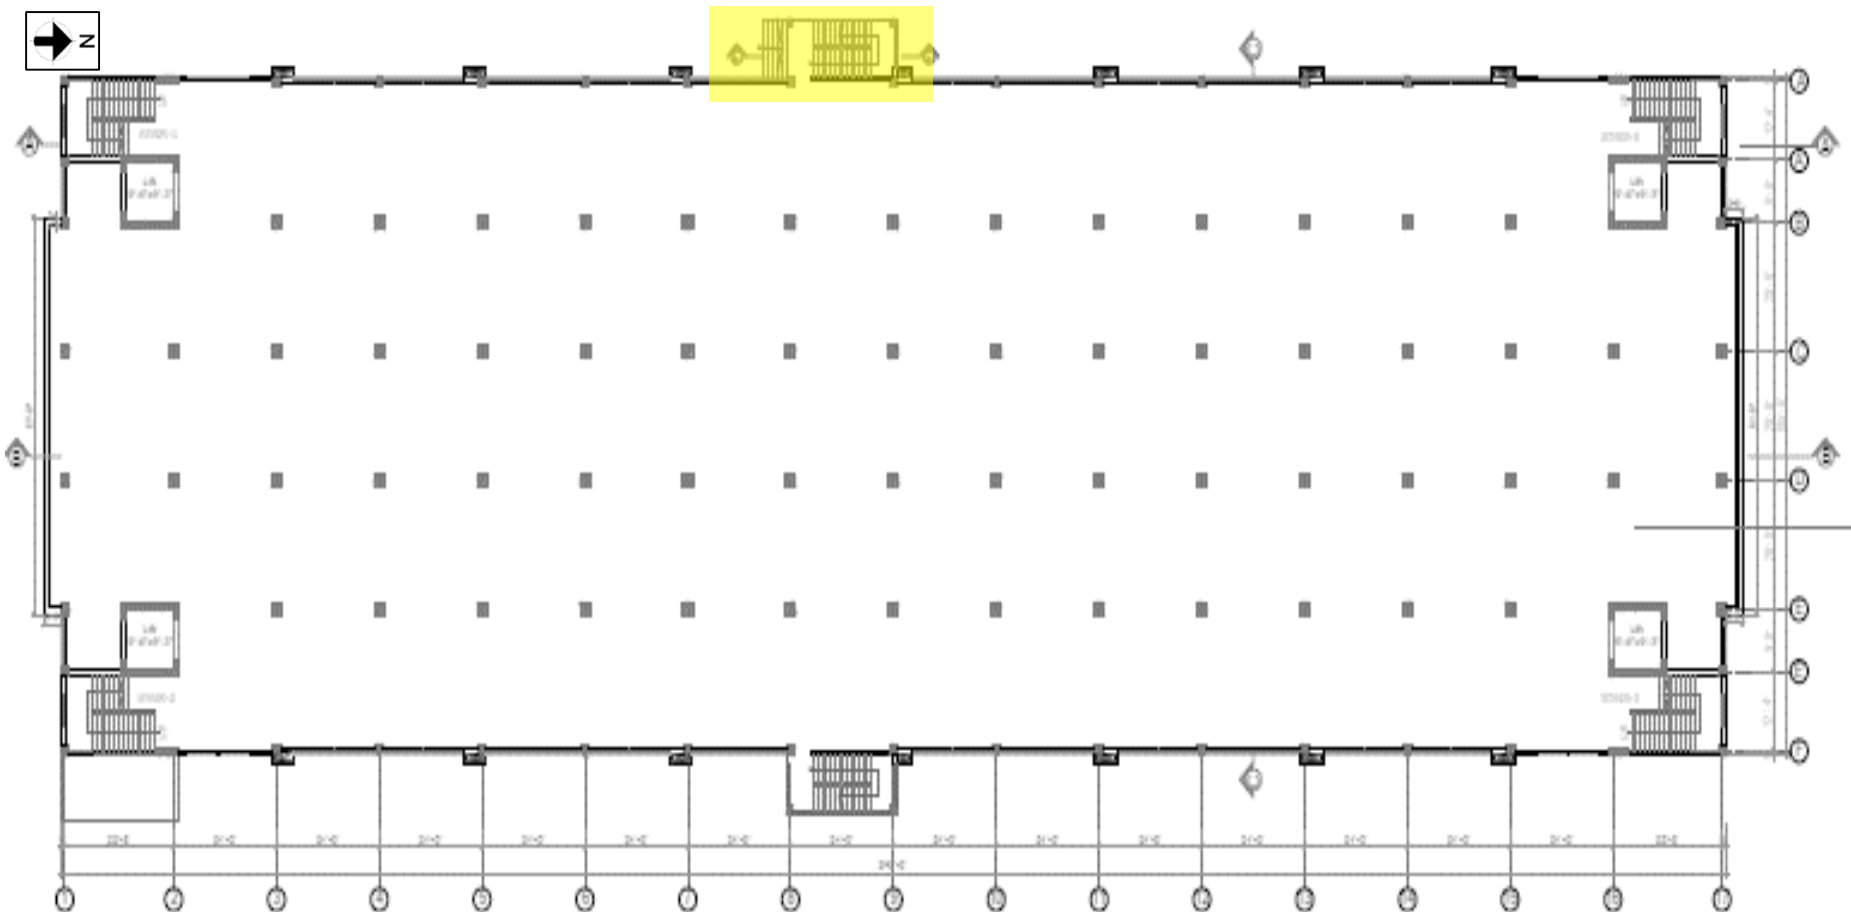
Emergency stair at west side has not been constructed.

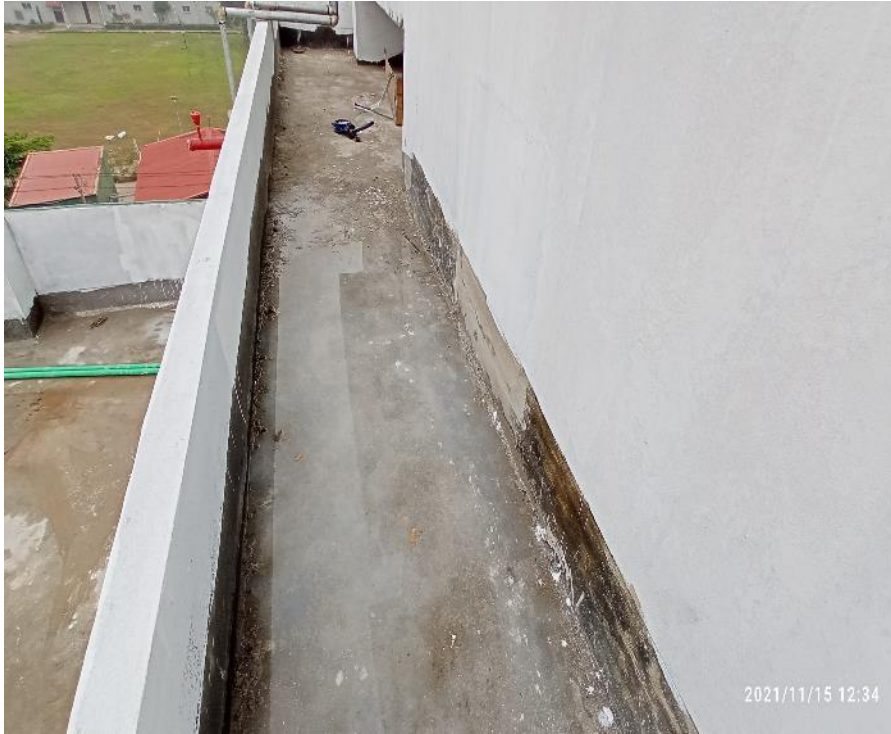
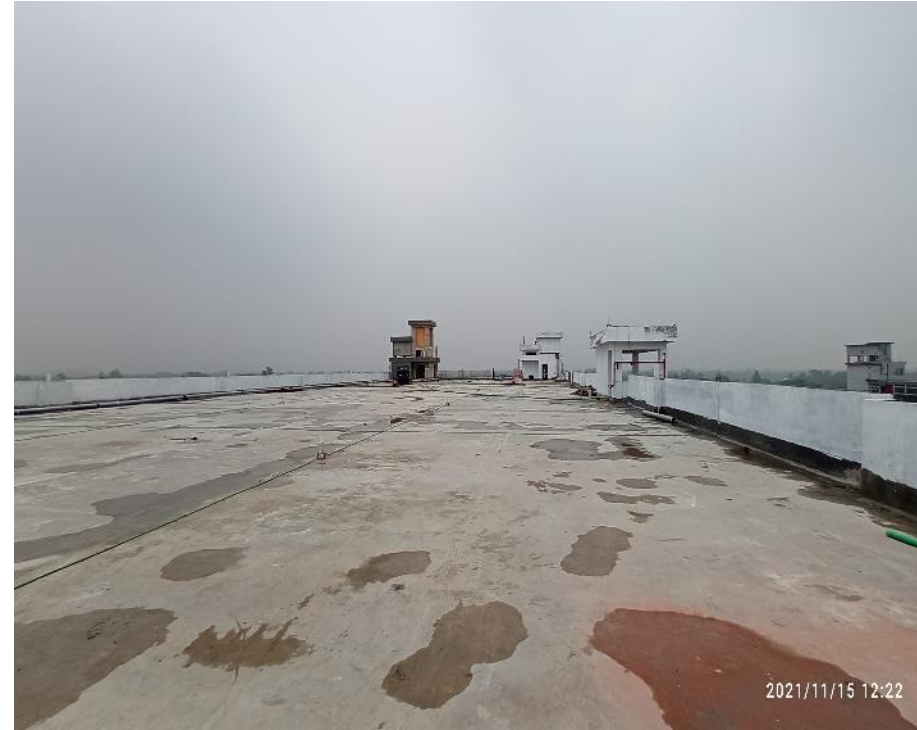
Stagnant water observed on roof and roof top slab

Develop proper drainage system on the roof with adequate slope or apply water proofing layer on the roof to resist water ingress into the slab.

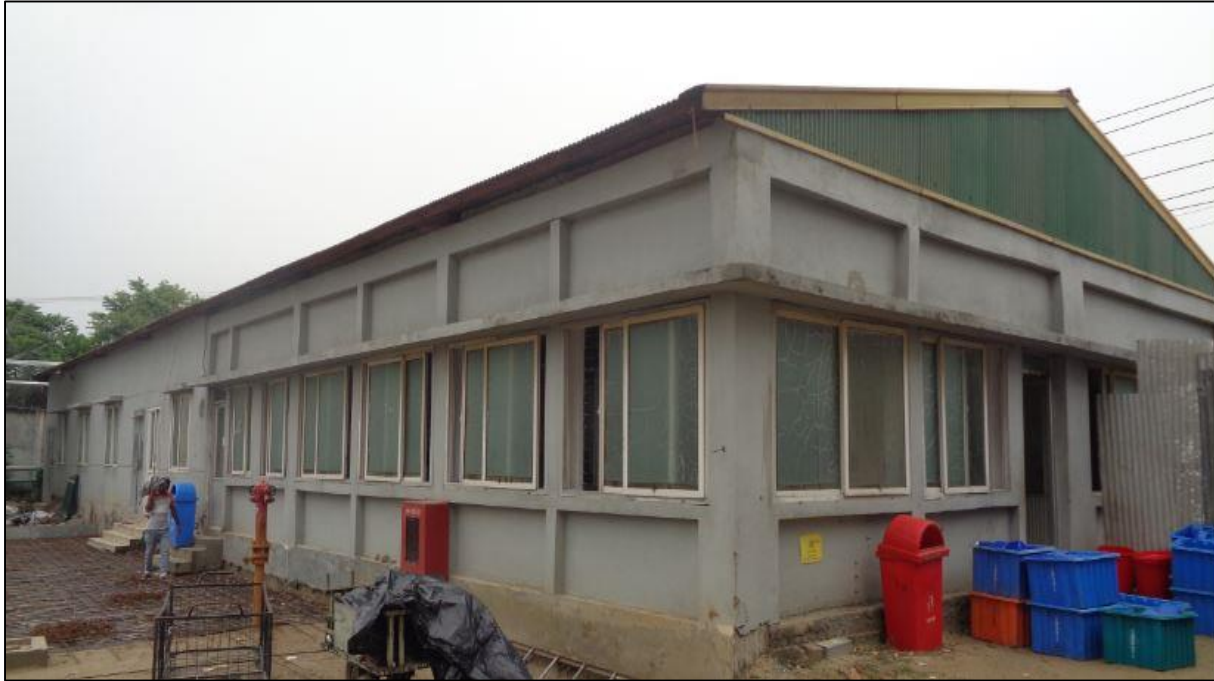
No design reports were available for facility shed

As per BNBC, every building or structure designed shall have its design documents prepared in accordance with the provision of Section 1.9.1. The design document shall include a design report, and a set of structural drawings, which shall be prepared in compliance with section 1.9.1.1 and section 1.9.1.2 as per BNBC. At the time of inspection, no design report was available which is required to be prepared in compliance with section 1.9.1.1 (part-6, BNBC).

| Item No. | Observation | Recommended Action Plan | Recommended Timeline |
|---|---|---|---|
| 16 | Lack of design documents: Building-5 (Facility shed) | Building engineer to prepare the design document including a design report, in compliance with section 1.9.1.1 as per BNBC. | 6-weeks |

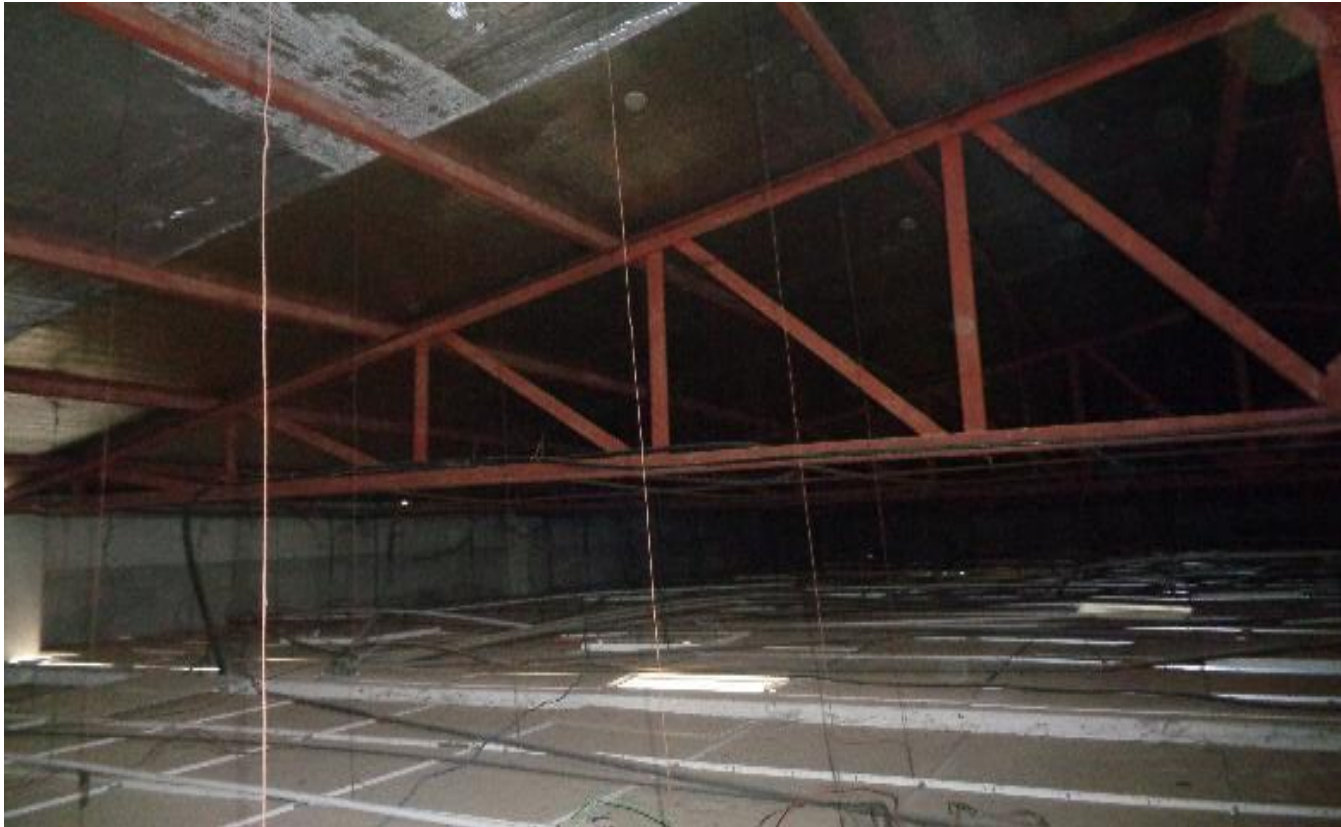
No roof bracings provided at roof

RC tie beam is provided along long direction (periphery only) but no bracing is provided at roof. Therefore, lateral stability of roof truss is apparently inadequate. Factory engineer is required to check the lateral stability of the structure.

| Item No. | Observation | Recommended Action Plan | Recommended Timeline |
|---|---|---|---|
| 18 | Lack of lateral stability: Building-5 (Facility shed) | Building engineer is required to check the lateral stability of the roof truss. | 6-weeks |

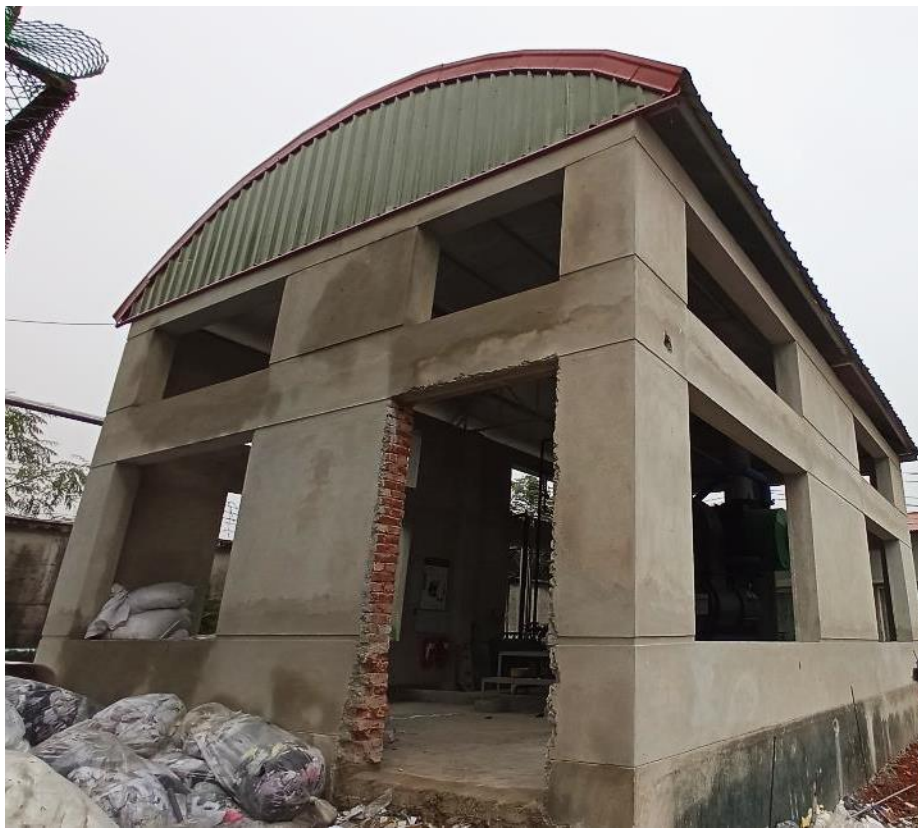
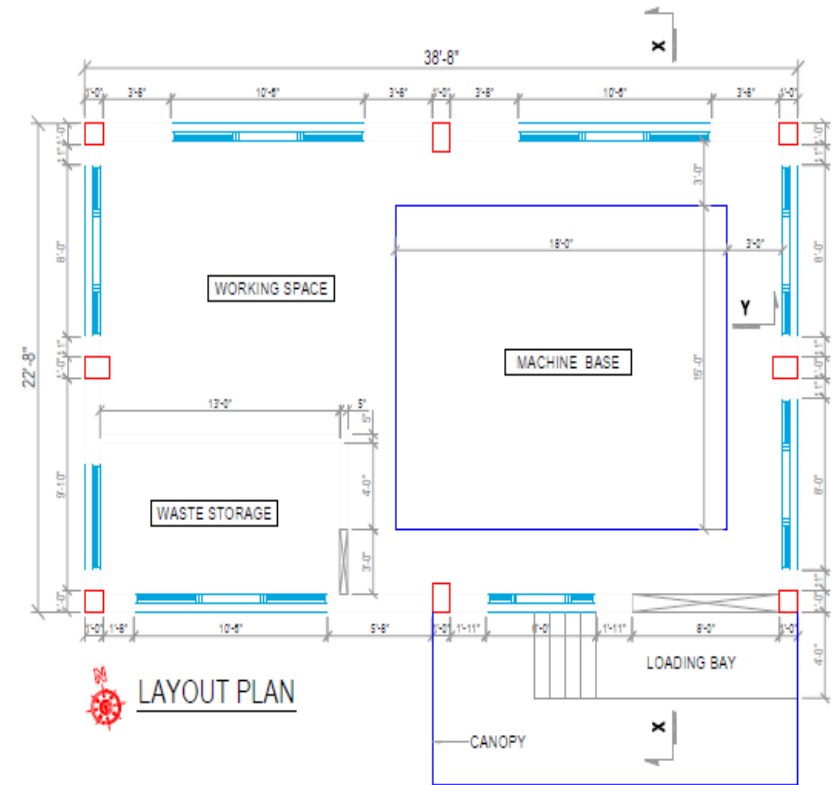
Boiler room

As per BNBC, every building or structure designed shall have its design documents prepared in accordance with the provision of Section 1.9.1. The design document shall include a design report, and a set of structural drawings, which shall be prepared in compliance with section 1.9.1.1 and section 1.9.1.2 of part-6, BNBC.

However, design report & material test report was not available during inspection. The building engineer is required to prepare a design report in compliance with BNBC.

| Item No. | Observation | Recommended Action Plan | Recommended Timeline |
|---|---|---|---|
| 20 | Lack of design documents: Building-6 (Boiler room) | Building engineer to prepare the design document including a design report, in compliance with section 1.9.1.1 as per BNBC. | 6-weeks |

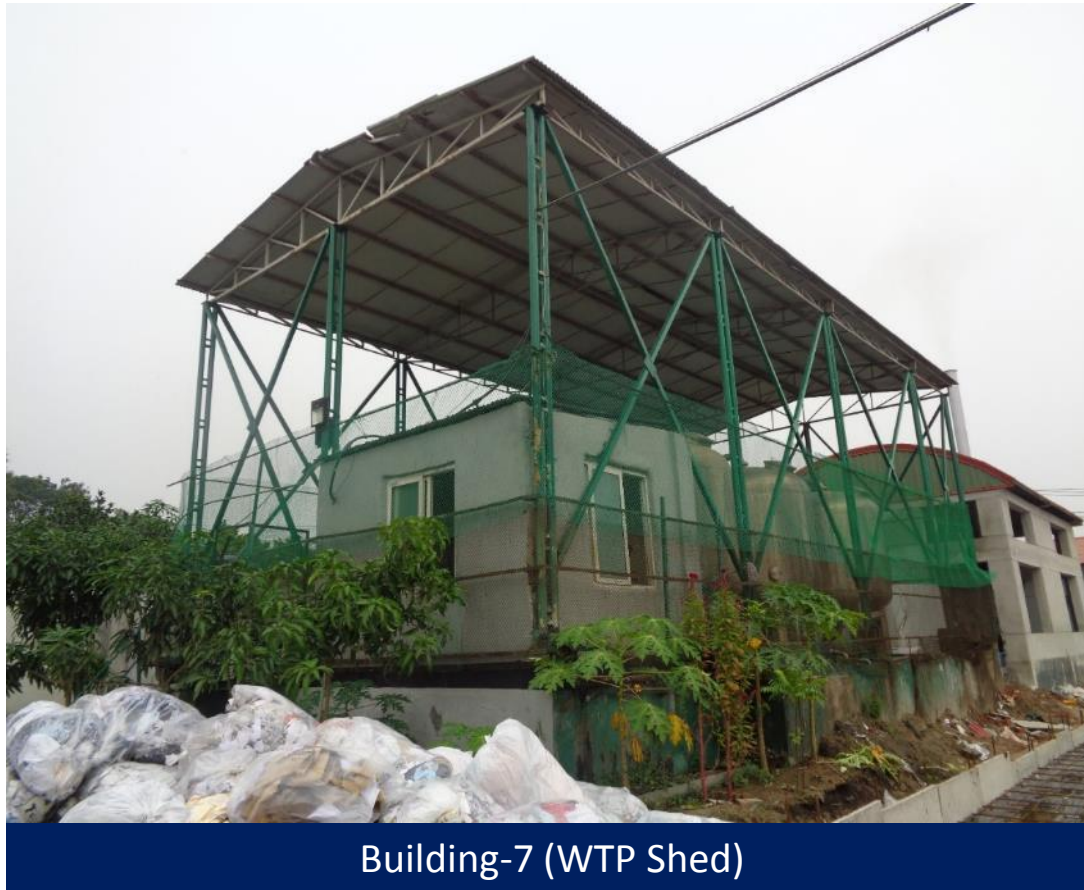
As per BNBC, every building or structure designed shall have its design documents prepared in accordance with the provision of Section 1.9.1. The design document shall include a design report, and a set of structural drawings, which shall be prepared in compliance with section 1.9.1.1 and section 1.9.1.2 of part-6, BNBC. However, design report was not available during inspection. The building engineer is required to prepare a design report in compliance with BNBC.

| Item No. | Observation | Recommended Action Plan | Recommended Timeline |
|---|---|---|---|
| 22 | Lack of design documents: Building-7 (WTP Shed) | Building engineer to prepare the design document including a design report, in compliance with section 1.9.1.1 as per BNBC. | 6-weeks |

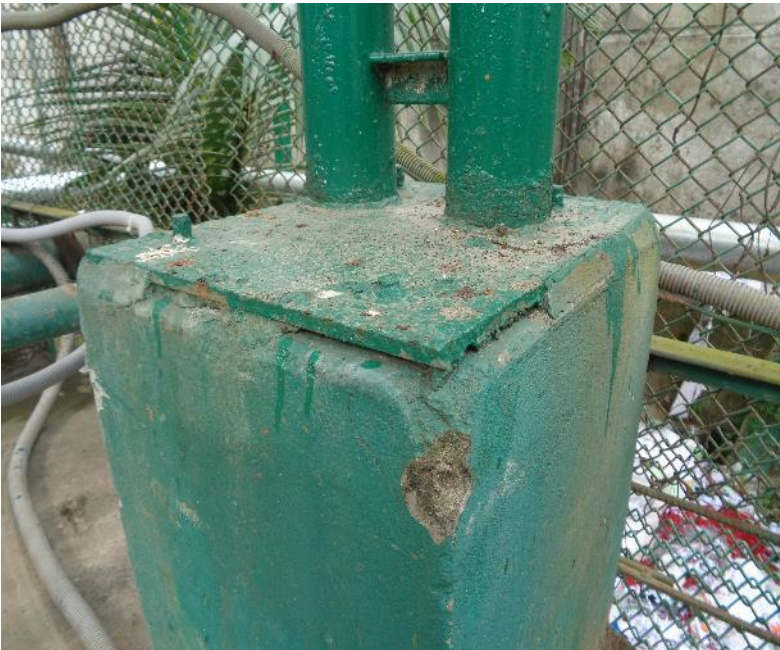
Poor connection with pedestal column

Poor connection between RC pedestal column and steel pipe was observed. Also, roof bracing is missing. Factory engineer is required to check the connection adequacy for uplift forces and check the adequacy of roof trusses.

| Item No. | Observation | Recommended Action Plan | Recommended Timeline |
|---|---|---|---|
| 24 | Poor connection: Building-7 (WTP Shed) | Factory engineer is required to check the connection adequacy for uplift forces and check the adequacy of roof trusses. | 6-weeks |

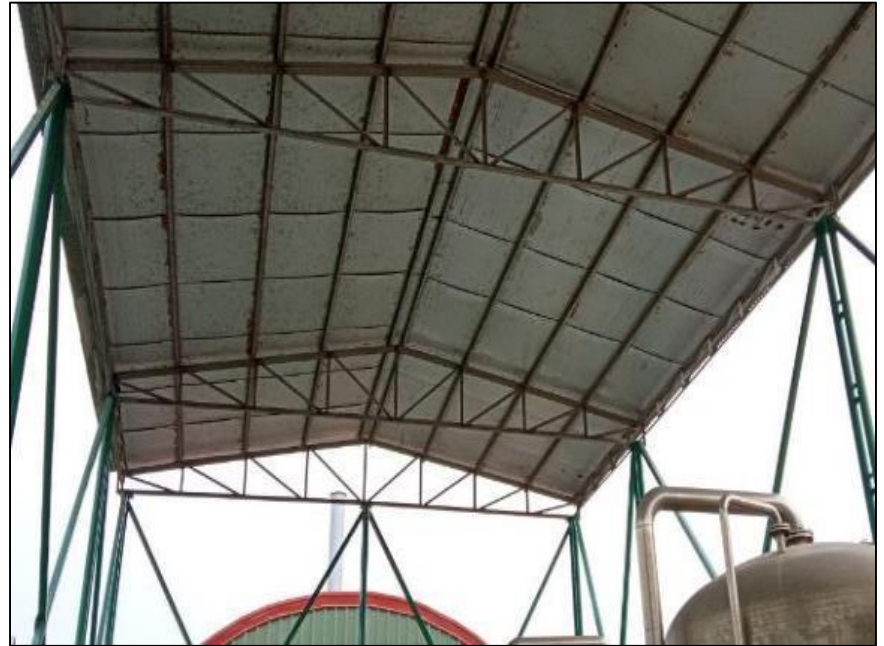
No roof bracing provided
