# Tusuka Stitches Ltd.

40/4, Hazrat Shahjalal Road, Rajnagar, Sataish, Tongi.  
(23.92210, 90.35882)

10<sup>th</sup> October 2021

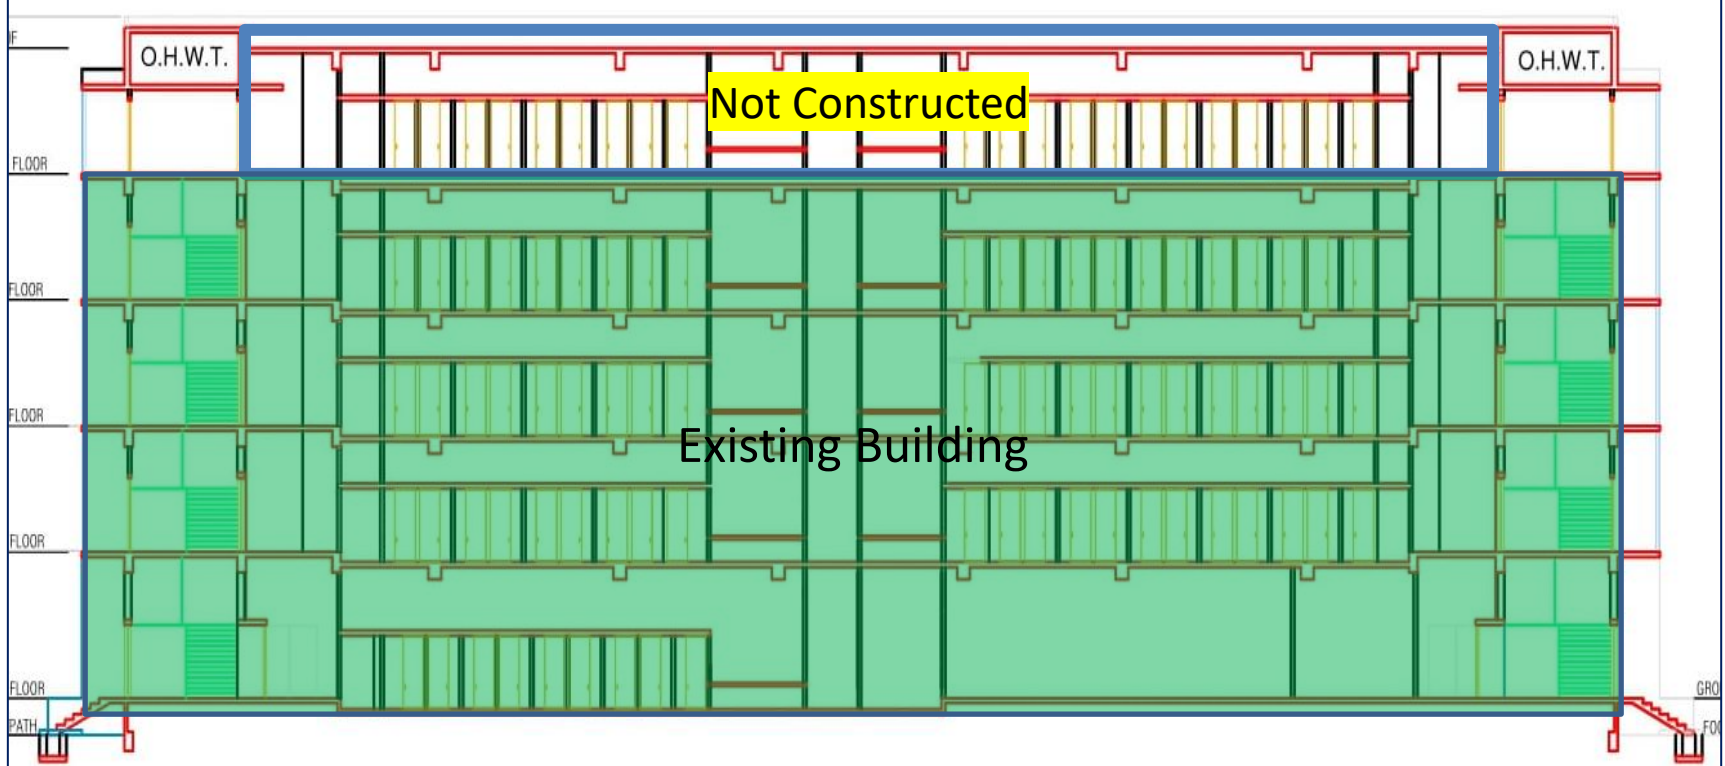
**Verify insitu concrete strength for proposed 4<sup>th</sup> floor (Vertical Extension over 3rd floor)**

Only two sets of concrete cylinder test were available for column. FoS of columns are found satisfactory considering minimum concrete strength of stone for existing building.

The factory has a plan to construct an additional floor. The cursory calculation indicates that columns are marginally stressed above normal design limit considering minimum concrete strength of stone chips aggregate . The building engineer is required to verify insitu concrete strength by taking 100 mm diameter cores from the column and review the design before commencing any vertical extension works.

| Item No. | Observation | Recommended Action Plan | Recommended Timeline |
|---|---|---|---|
| 01 | Verify insitu concrete strength for proposed 4th floor (Vertical Extension over 3rd floor). (Building 1) | Building engineer is required to verify insitu concrete strength by taking 100 mm diameter cores from column and review the design before commencing any vertical extension works. | 6-months |
| 02 | Verify insitu concrete strength for proposed 4th floor (Vertical Extension over 3rd floor). (Building 1) | Building engineer is required to complete the DEA and the recommendation before commencing the vertical extension works. | 6-months |

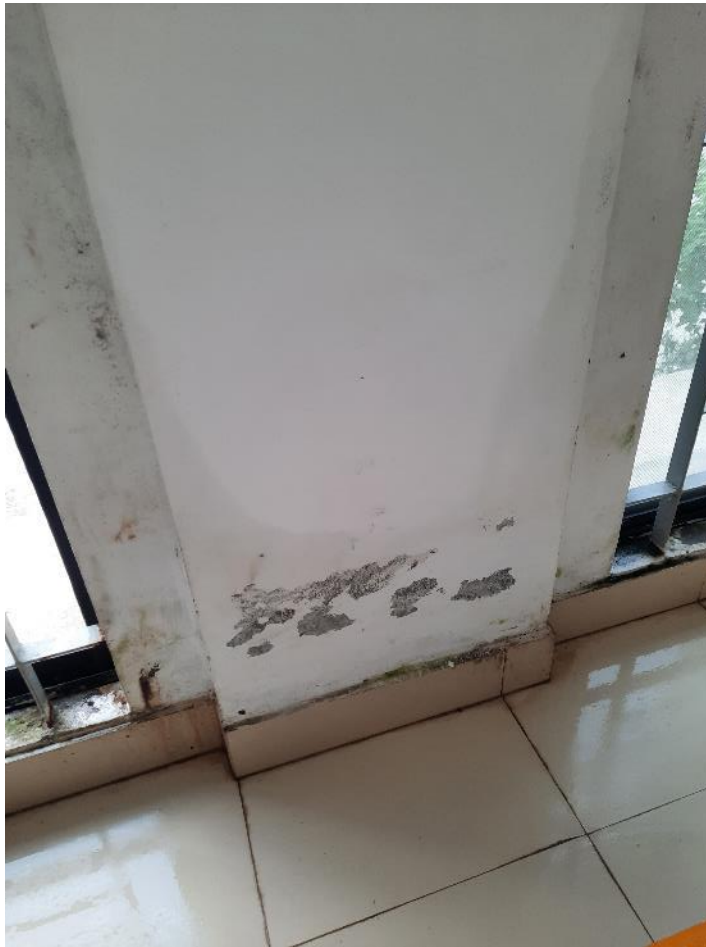
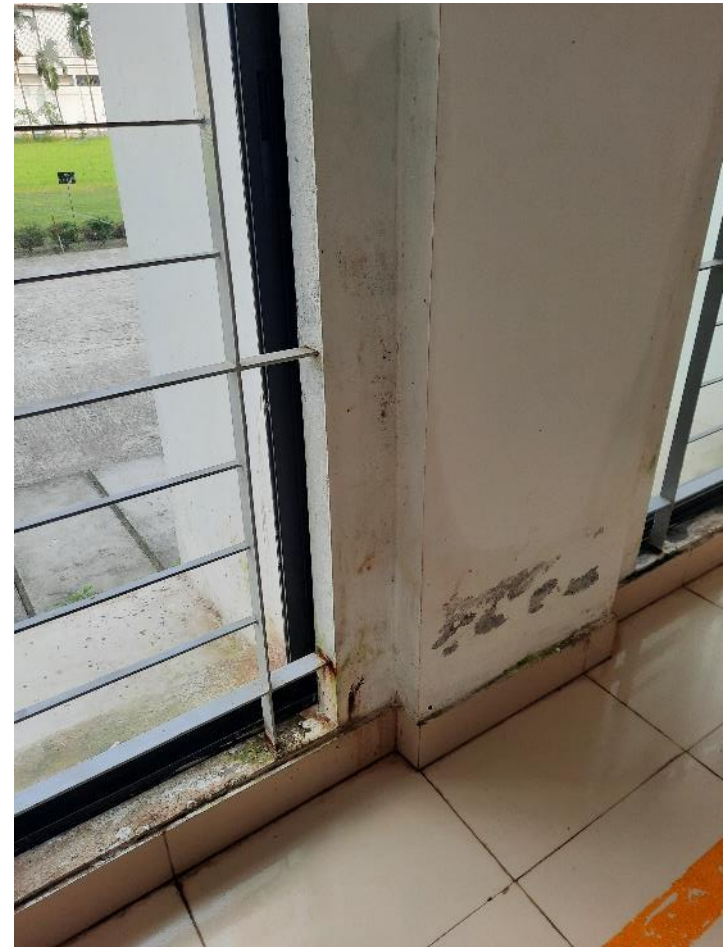
# Signage of dampness

Signage of dampness observed in the building. Building engineer is required to identify the reason of the dampness and suggest suitable repair works.

| Item No. | Observation | Recommended Action Plan | Recommended Timeline |
|---|---|---|---|
| 03 | Signage of dampness. (Building 1) | Building engineer is required to identify the reason of the dampness and suggest suitable repair works. | 6-weeks |
| 04 | Signage of dampness. (Building 1) | Carryout repair works where necessary. | 6-weeks |

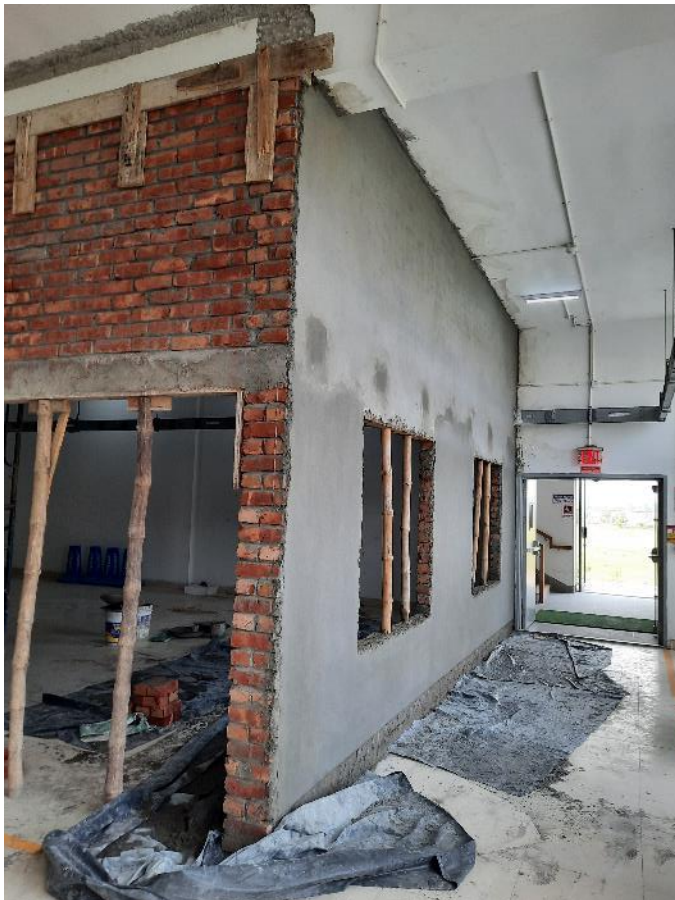
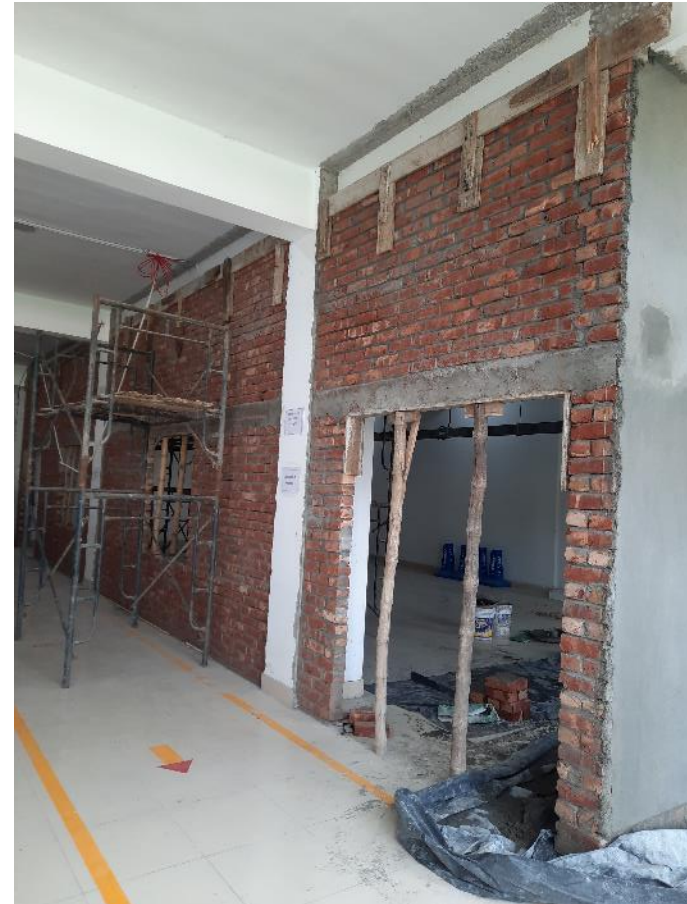
# **Lack of construction safety practice in local refabrication works**

Lack of construction safety practice works observed around the renovation area. No caution sign, safety barrier, PPE of the construction worker observed. Building engineer to ensure all the construction safety practices are implemented around the renovation areas.

| Item No. | Observation | Recommended Action Plan | Recommended Timeline |
|---|---|---|---|
| 05 | Lack of construction safety practice in local refabrication works. (Building 1) | Building engineer to ensure all the construction safety practices are implemented around the renovation areas. | 6-weeks |

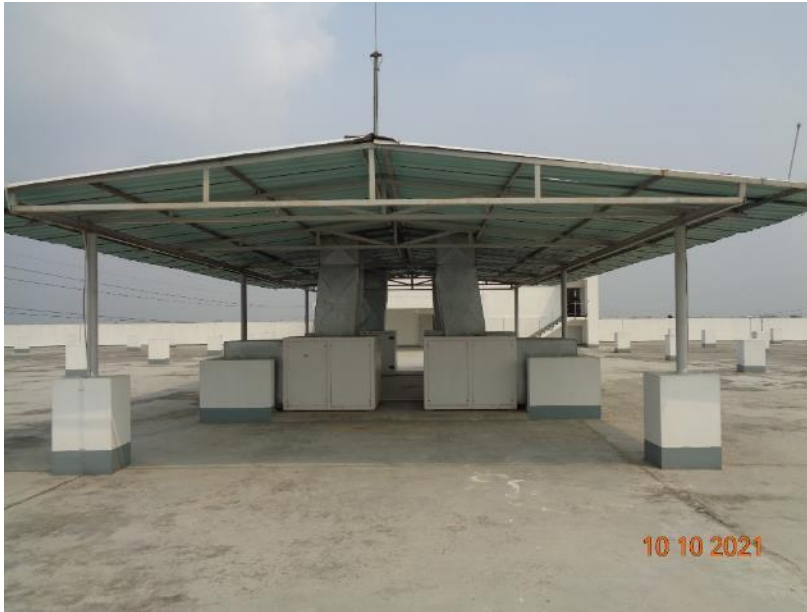
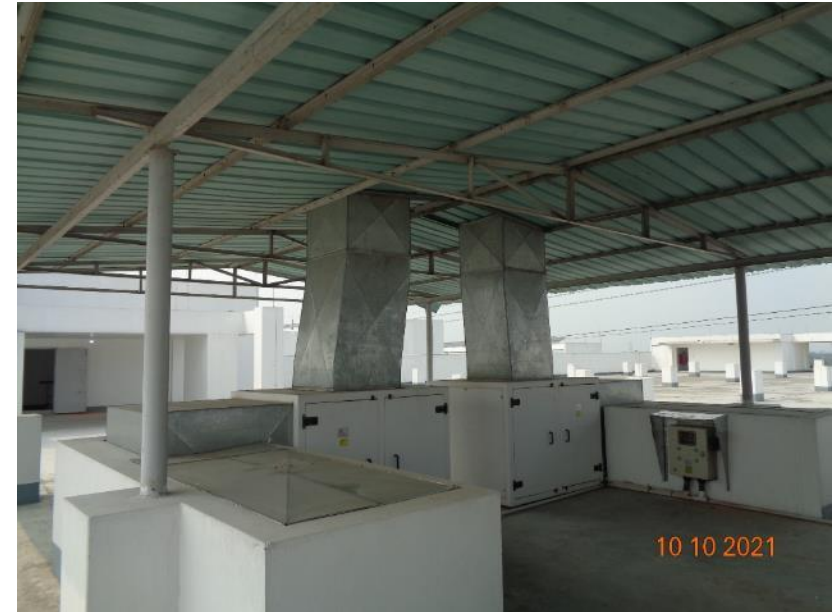
# **Lack of as-built drawing of roof shed**

No as-built drawings were available onsite for the roof shed. Building engineer is required to produce a as-built drawings.

| Item No. | Observation | Recommended Action Plan | Recommended Timeline |
|---|---|---|---|
| 06 | Lack of as-built drawing of roof shed. (Building 1) | Building engineer is required to produce a as-built drawings of the roof shed. | 6-weeks |

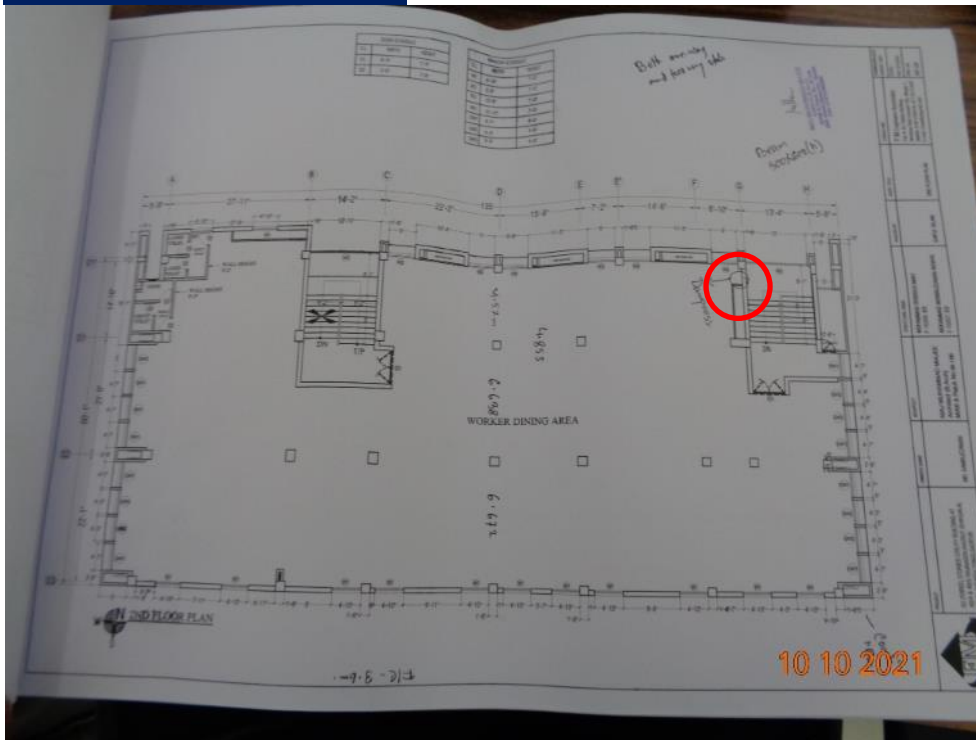
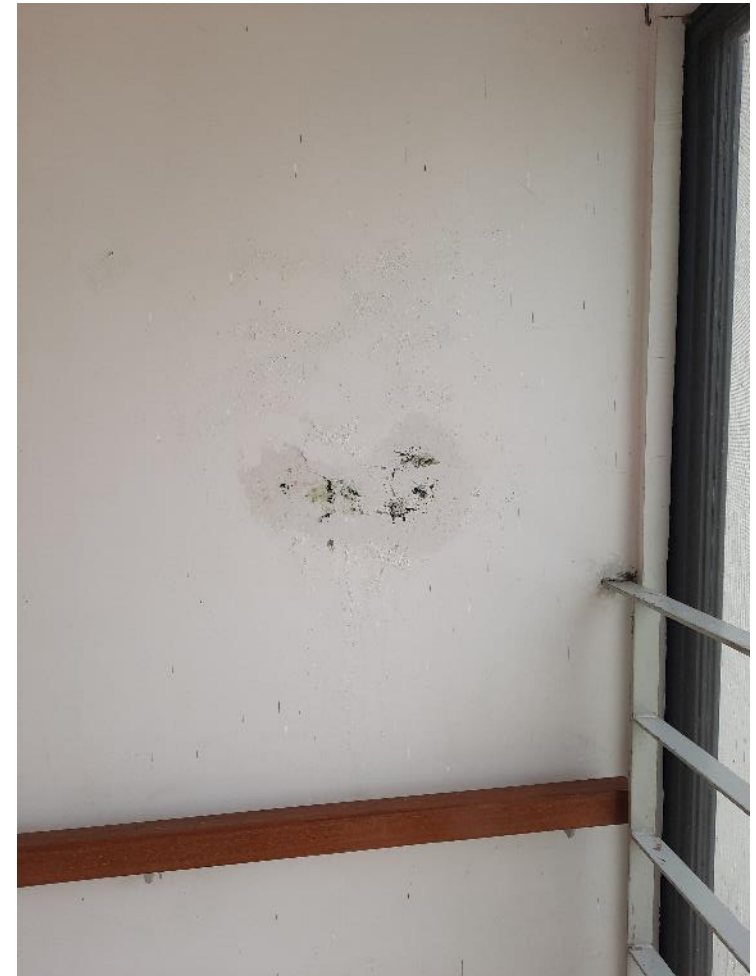
## 2<sup>nd</sup> floor layout plan

# Signage of dampness

Signage of dampness observed in the building. Building engineer is required to identify the reason of the dampness and suggest suitable repair works.

| Item No. | Observation | Recommended Action Plan | Recommended Timeline |
|---|---|---|---|
| 07 | Signage of dampness. (Building 3) | Building engineer is required to identify the reason of the dampness and suggest suitable repair works. | 6-weeks |
| 08 | Signage of dampness. (Building 3) | Carryout repair works where necessary. | 6-weeks |
