# Impress Newtex Composite Textiles Ltd. (Extension)

Gorai Industrial Area, Mirzapur, Tangail  
(24.089497, 90.171619)  
7 November 2021

# Observations

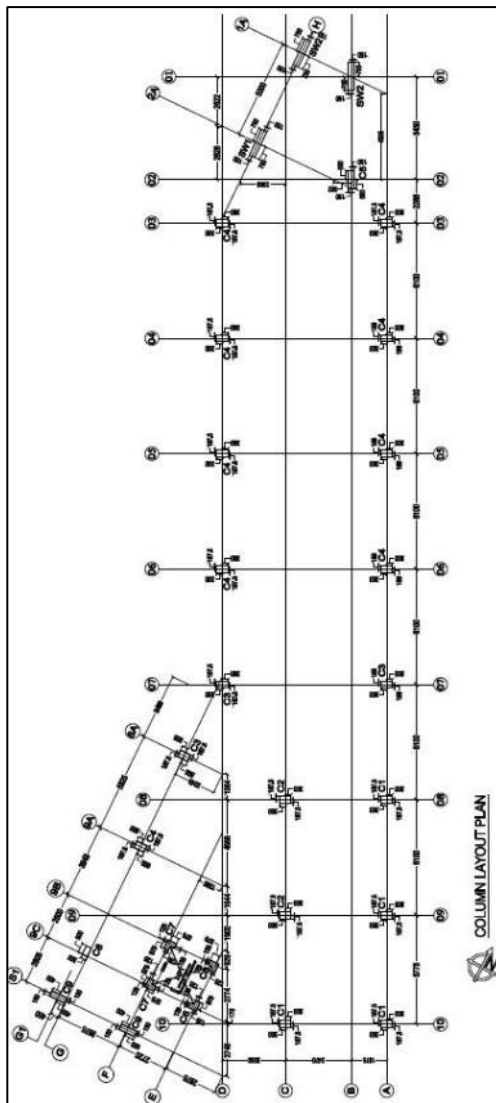
Column layout

Building is irregular in shape which having one side shear wall which may occur torsional irregularity. In column capacity check there was not shown PMM ratio. No adequacy check of shear wall also found. Building engineer is required to revise design report showing all criteria.

| Item No. | Observation | Recommended Action Plan | Recommended Timeline |
|---|---|---|---|
| 01 | Inconsistency in the design report. (Multipurpose office building) | Factory is required to check the adequacy of shear wall and incorporate all kinds of irregularity (Torsional, mass, diaphragm discontinuity, stiffness, etc.) check in design report according to BNBC. | 6-weeks |

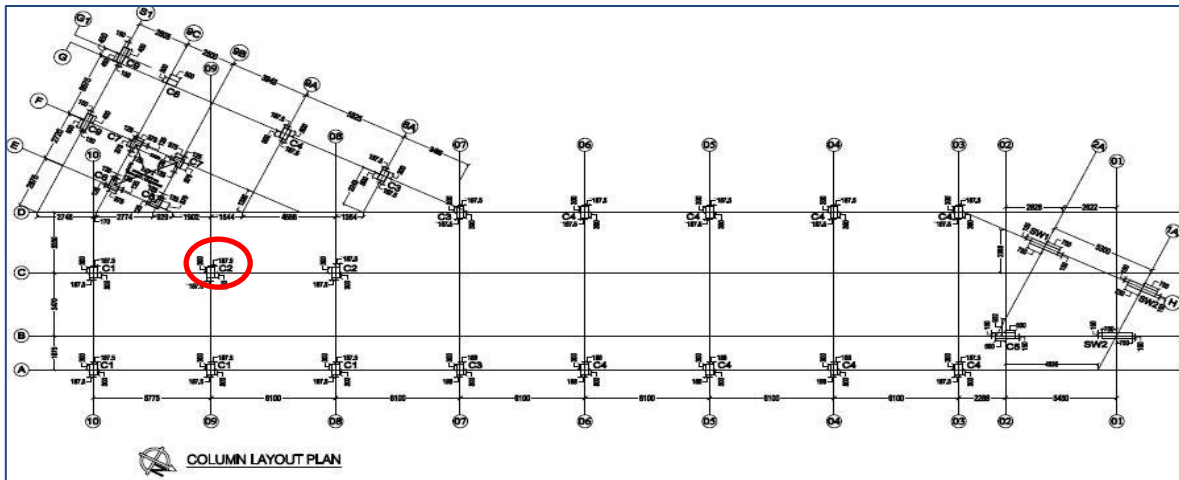
Column layout plan

At 2<sup>nd</sup> floor to roof rebar of C2 column shown in long side is 6 in which was found 5  
Building engineer is required to update the as-built drawing.

| Item No. | Observation | Recommended Action Plan | Recommended Timeline |
|---|---|---|---|
| 05 | Discrepancy in as-built drawing. (Multipurpose office building) | Building engineer is required to survey the structure & prepare as-built drawings. | 6-weeks |

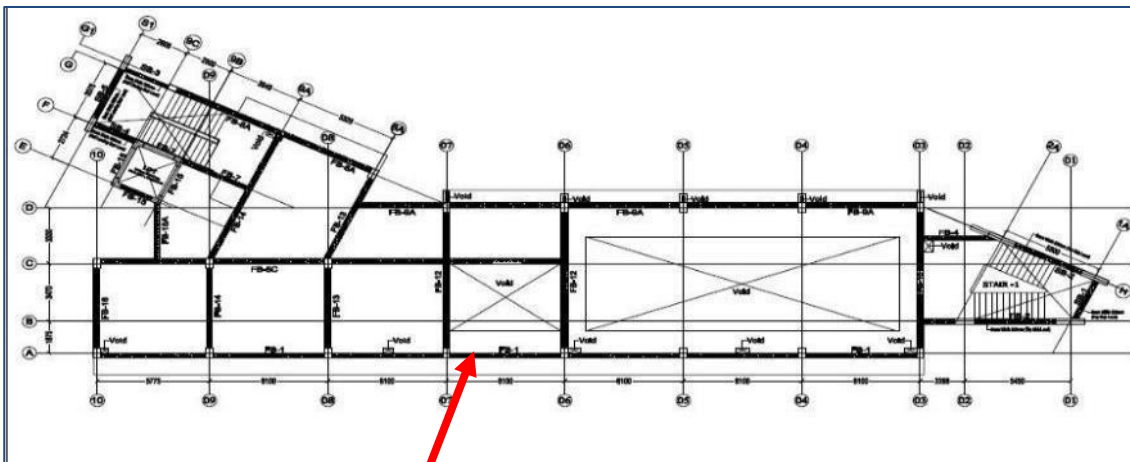
3<sup>rd</sup> floor roof beam layout

At 3<sup>rd</sup> floor roof FB1 size in drawing was 300mm X 600mm, which depth is found 675mm including slab . Building engineer is required to update the as-built drawing.

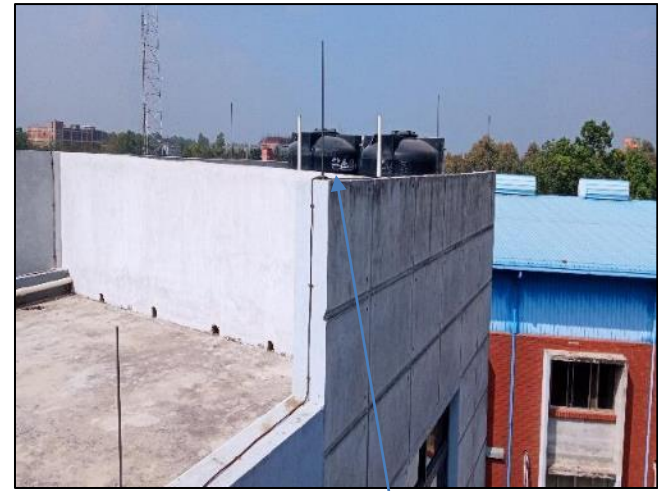
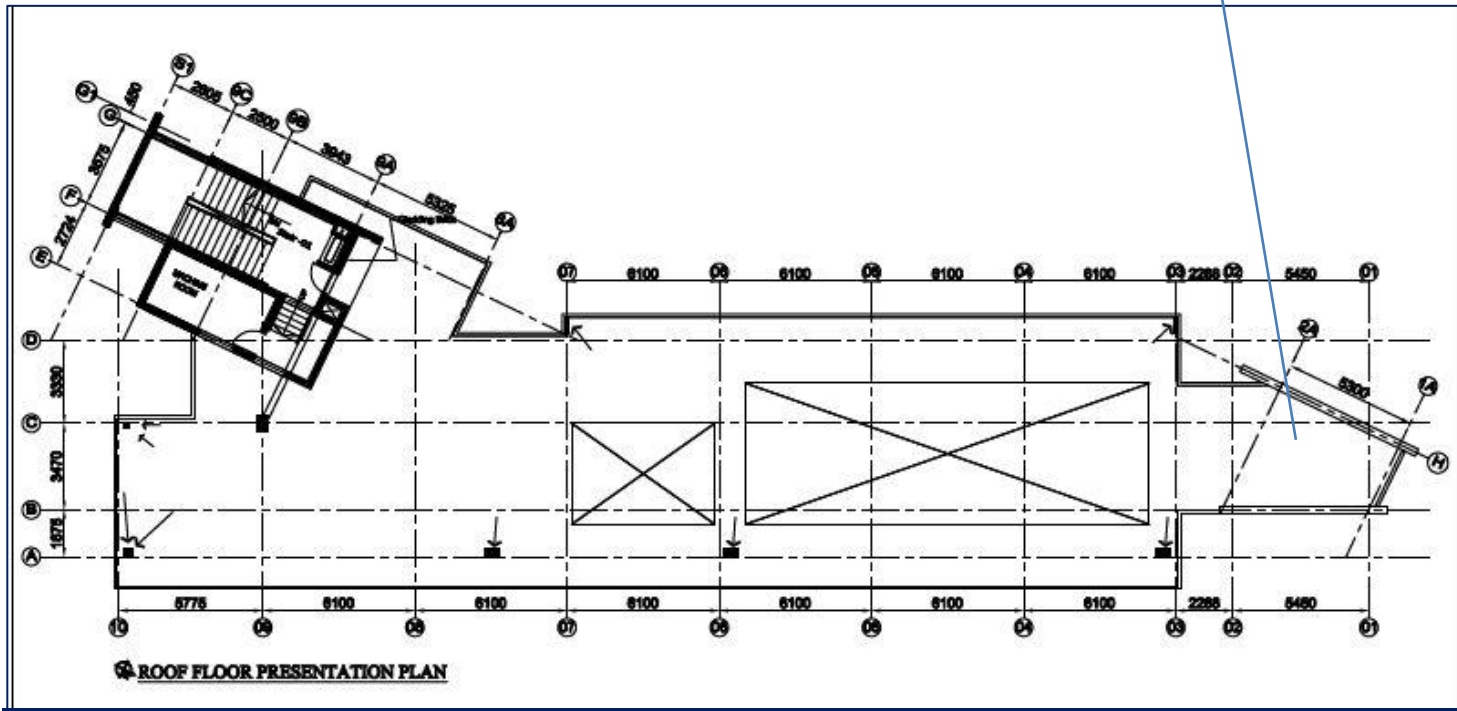
Roof Layout

At roof there were two plastic water tank of 2000 litre capacity each which is not shown in drawing. Building engineer is required to update the as-built drawing showing those in roof layout plan.

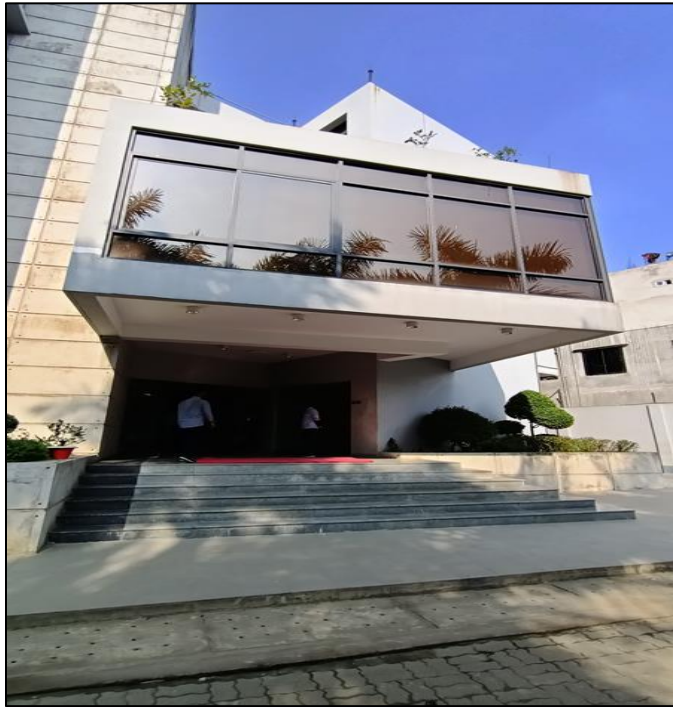
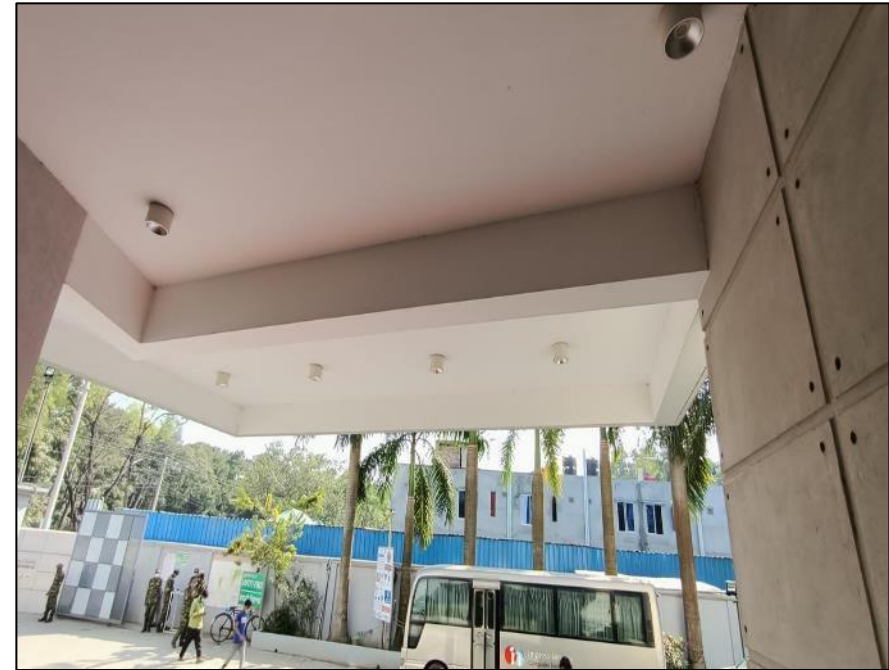
At first floor 3.2 m cantilever slab is observed. The building engineer is required to check adequacy & deflection of the cantilever slab and beam.

| Item No. | Observation | Recommended Action Plan | Recommended Timeline |
|---|---|---|---|
| 06 | Deflection check of 3.2 m cantilever beam and slab. (Multipurpose office building) | Building engineer is required to check the adequacy & deflection of the cantilever slab and beam. | 6-weeks |

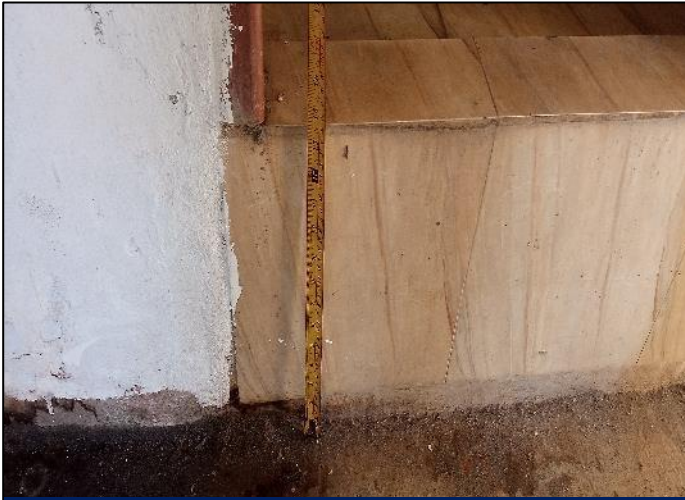
Toilet Built up (300mm)

Toilet Built up at 2<sup>nd</sup> floor stair and 250mm brick wall at first floor were found on site which are not mentioned in provided as-built drawing. Building engineer is required to update the as-built drawing.

| Item No. | Observation | Recommended Action Plan | Recommended Timeline |
|---|---|---|---|
| 10 | Lack of documents and discrepancy in as-built drawing. (Utility Building) | Building engineer is required to survey the structure & prepare complete as-built drawings. | 6-weeks |

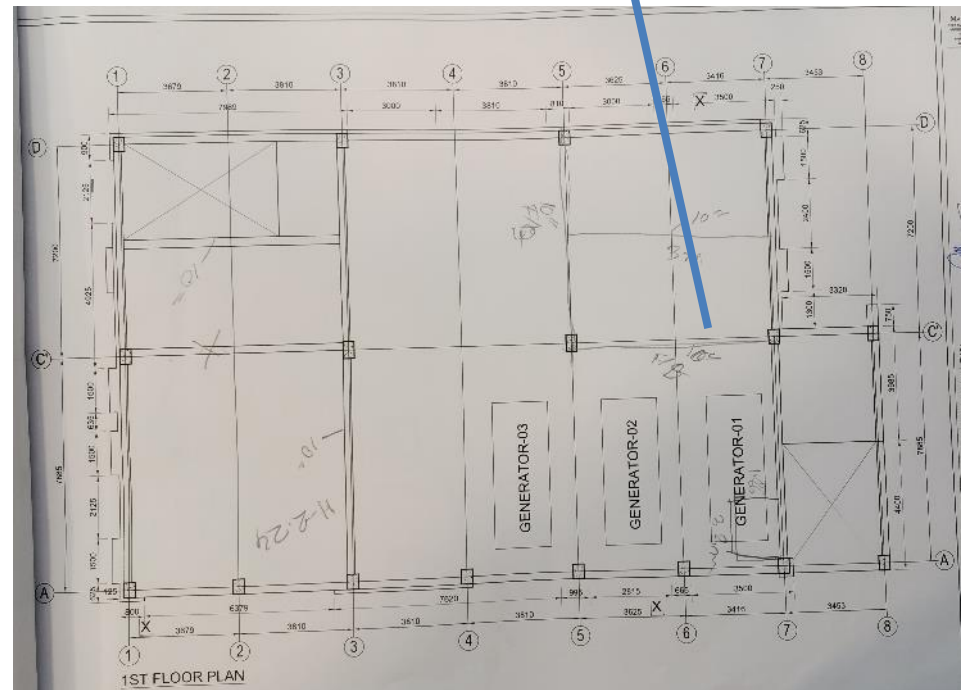
No bracings were found in as-built condition. Apparently non-engineered connection were found. Building engineer is required to check the lateral stability and connection adequacy of the structure for uplift forces.

| Item No. | Observation | Recommended Action Plan | Recommended Timeline |
|---|---|---|---|
| 11 | Lack of lateral stability. (Kitchen Room) | Building engineer is required to check the lateral stability and connection adequacy of the structure for uplift forces. | 6-weeks |

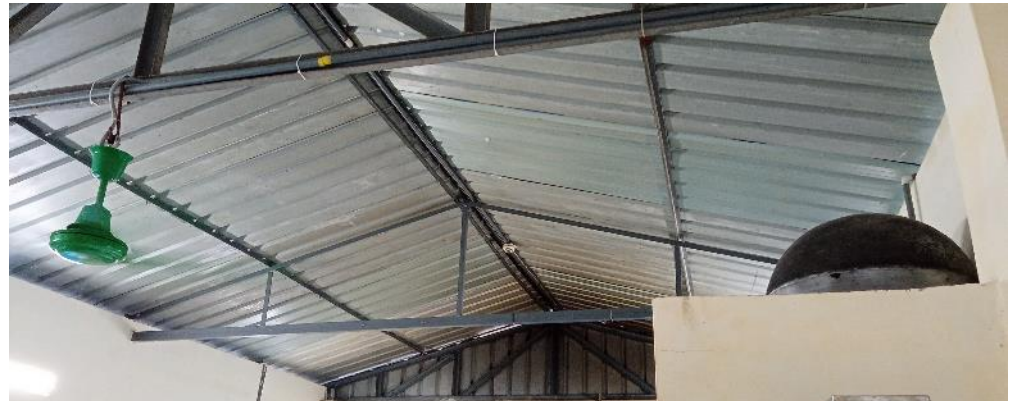
No bracings

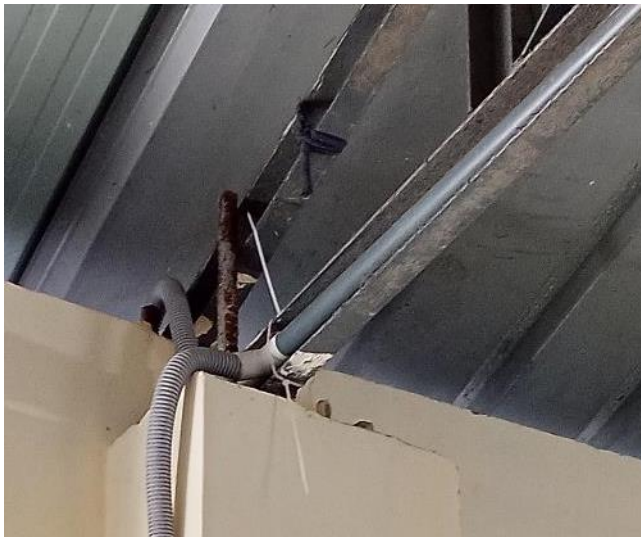
Truss welded with rebar of column

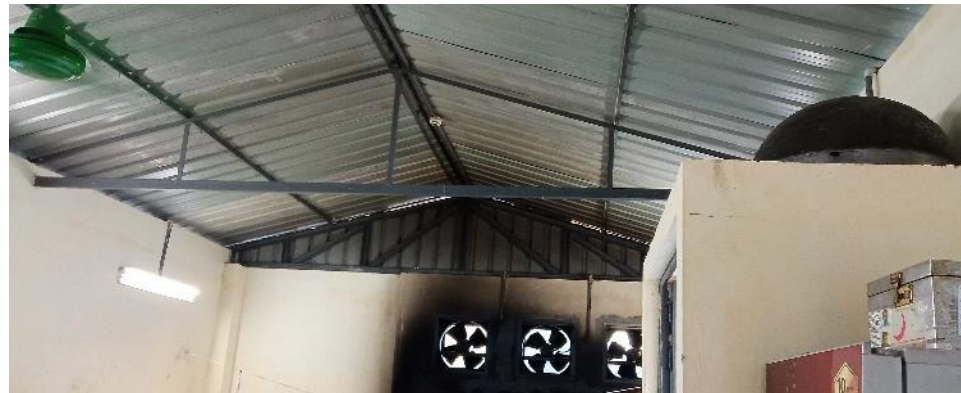
Truss section in as-built condition

Truss sections and sizes are not matched with provided as-built drawings.

Building engineer is required to survey the whole structure and prepare as-constructed drawing.
