# Russel Apparels & Ekram Sweater Ltd (New Building)

Kathali, Bhaluka-2240, Mymensingh , Bangladesh  
(24.380511, 90.377977 )  
14<sup>th</sup> November 2021

# Buildings Information

1. Factory Building-2 (G+6)
2. Dining Building (G+5)
3. Utility Building (G+1)

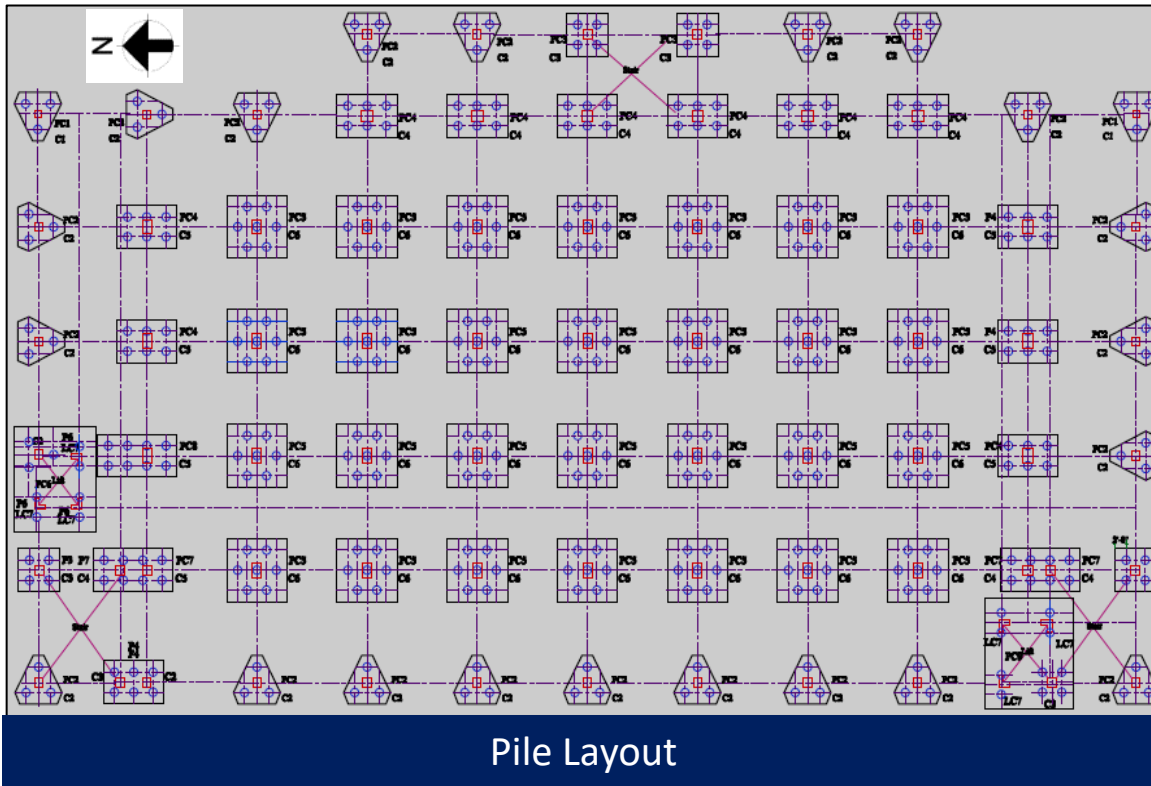
Data from provided soil test report

**Foundation stressed above normal design limit**

Cursory calculation indicates that bearing capacity of pile exceeds the normal design limit, considering 3 kPa live load on typical floors. Allowable capacity of pile has been considered 30 ton (FoS=2.5) at 15.25m depth from table of provided soil test report. Factory Engineer to review design, loads and foundation stresses.

| Item No. | Observation | Recommended Action Plan | Recommended Timeline |
|---|---|---|---|
| 01 | Foundation stressed above normal design limits. [Factory Building-2] | Factory Engineer to review design, loads, footings stresses and prepare the design documents including a design report & a set of structural drawings in compliance with section 1.9.1.1 and section 1.9.1.2 as per BNBC part 6 and submit to RSC for review. | 6-weeks |
| 02 | Foundation stressed above normal design limits. [Factory Building-2] | Produce and actively manage a loading plan for all floor plates within the factory, considering floor, column and foundation capacity. | 6-weeks |

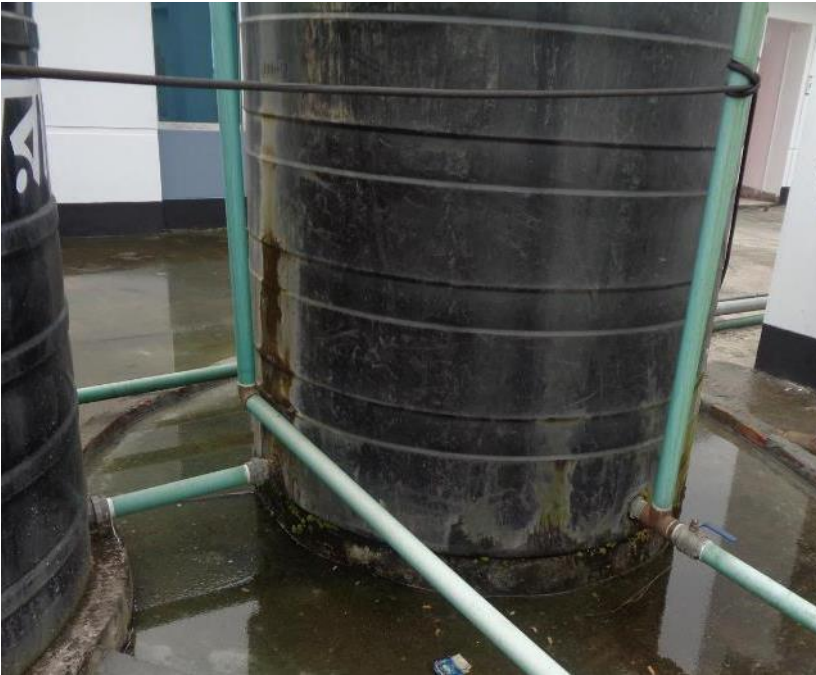
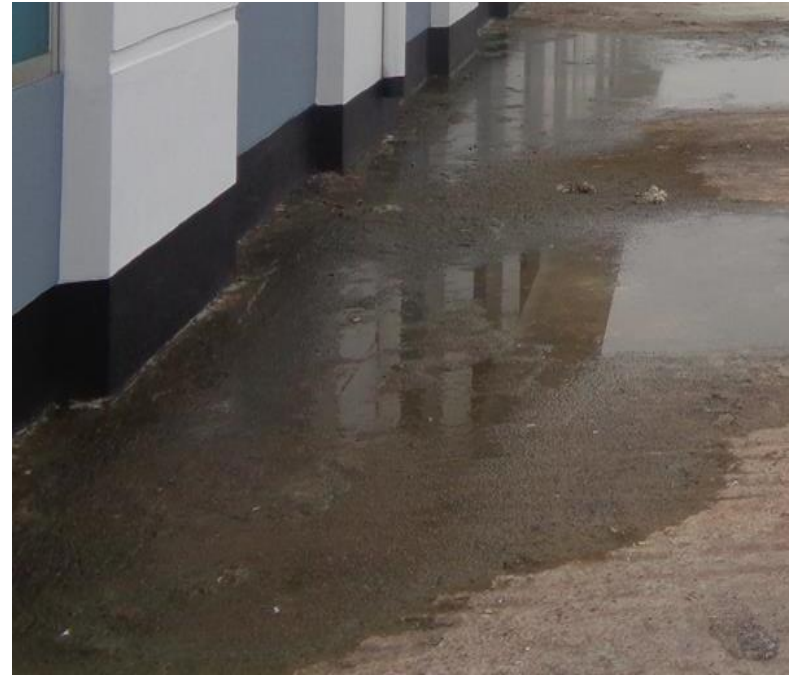
## Water Ponding on roof

**Water ponding on roof**

Factory is required to develop proper drainage system on roof with adequate slope or apply water proofing compound on roof slab to resist water ingress.

| Item No. | Observation | Recommended Action Plan | Recommended Timeline |
|---|---|---|---|
| 05 | Water ponding on roof. [Factory Building-2] | Factory engineer is required to develop proper drainage system on roof with adequate slope or apply water proofing compound on roof slab to resist water ingress. | 6-weeks |

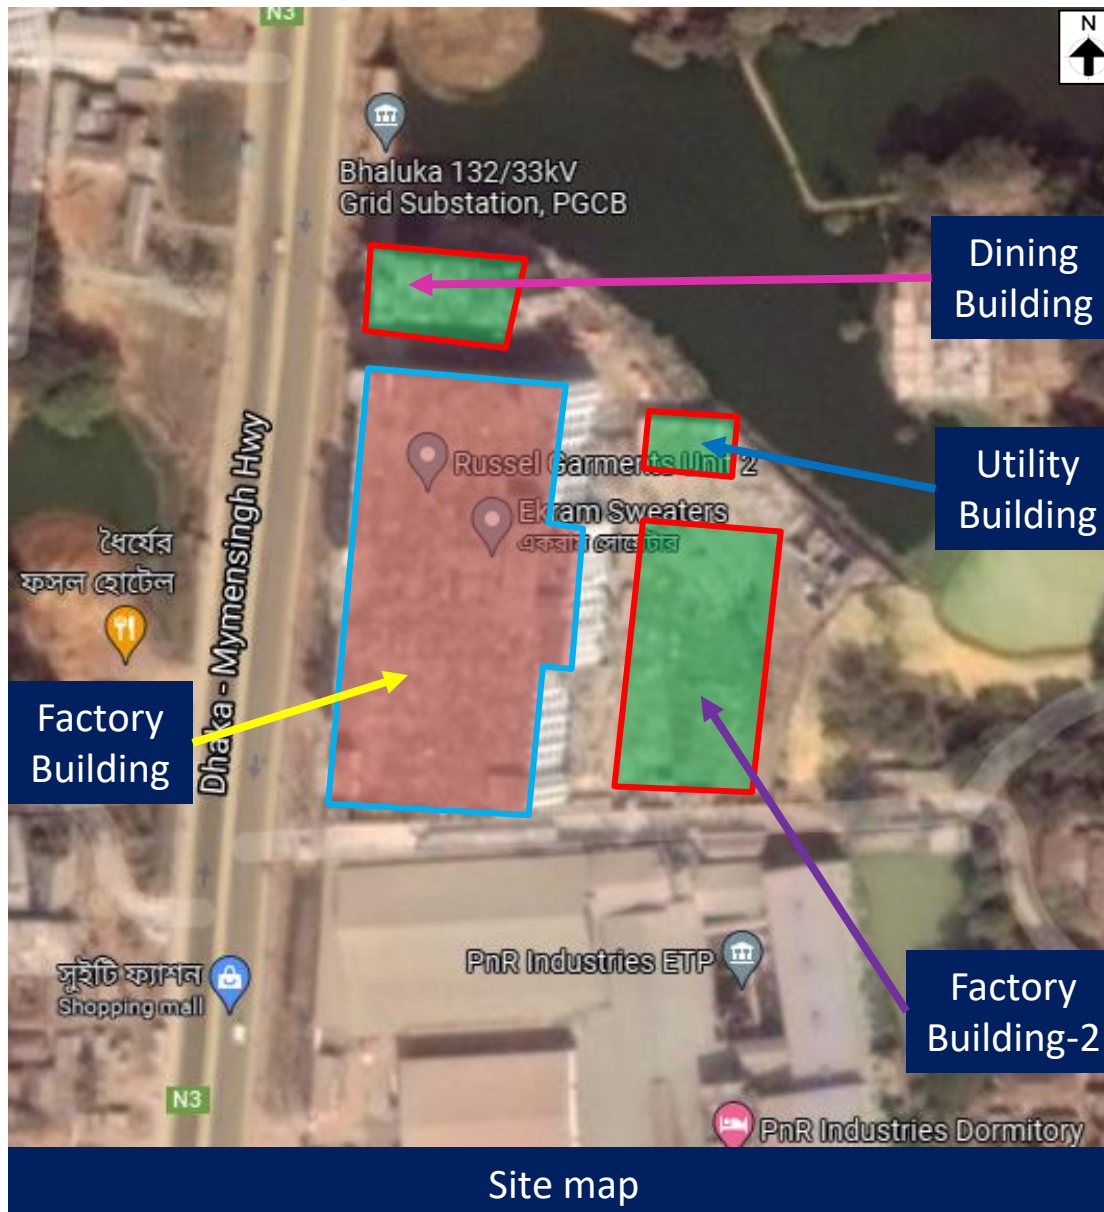
**No geotechnical investigation report**

No geotechnical investigation report was found for the Dining Building and Utility Building. The factory management stated that, the geotechnical evaluation was done for the mentioned buildings based on the previous geotechnical investigation report that was produced for the Factory Building & Factory Building-2. But no bore hole sample for Dining Building and Utility Building has been taken in the previous geotechnical investigation report. Thus, new geotechnical investigation report for the mentioned buildings is required to confirm the adequacy of foundation.

| Item No. | Observation | Recommended Action Plan | Recommended Timeline |
|---|---|---|---|
| 06 | No geotechnical investigation report. [Dining Building and Utility Building] | Carryout geotechnical investigation to confirm the ground bearing capacity. | 6-weeks |

| Item No. | Observation | Recommended Action Plan | Recommended Timeline |
|---|---|---|---|
| 07 | No geotechnical investigation report. [Dining Building and Utility Building] | Check the foundation adequacy and include in the design report. | 6-weeks |

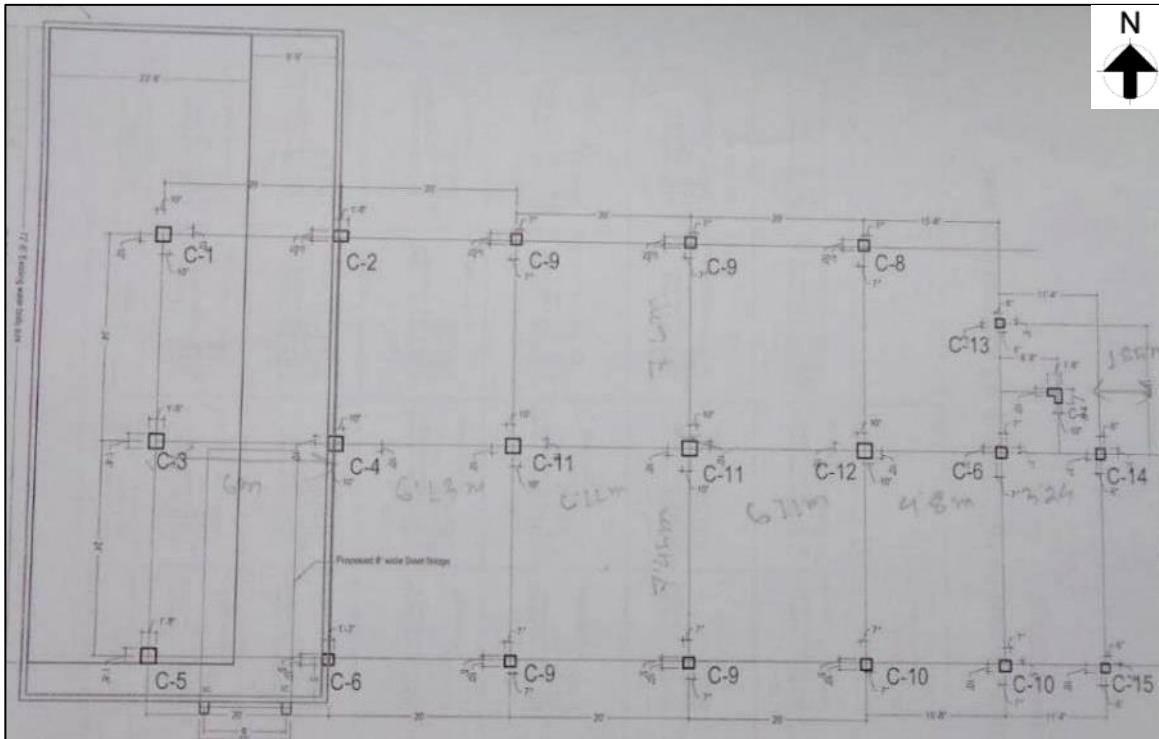
Column layout plan

**Column stressed above normal design limit**

Cursory calculation indicates that columns are stressed above normal design limit considering 3 kPa live load and minimum concrete strength (16.34 MPa) based on aggregate type. Factory engineer is required to review design, load & column stresses of the building.

| Item No. | Observation | Recommended Action Plan | Recommended Timeline |
|---|---|---|---|
| 09 | Columns stressed above normal design limit. [Dining Building] | Factory Engineer to review design, loads and columns stresses. | 6-weeks |
| 10 | Columns stressed above normal design limit. [Dining Building] | Verify in situ concrete stresses either by 100mm dia. Cores(Min.4 nos.) or existing cylinder strength data. | 6-weeks |
| 11 | Columns stressed above normal design limit. [Dining Building] | Produce and actively manage a loading plan for all floor plates within the factory considering floor capacity and column capacity.. | 6-weeks |

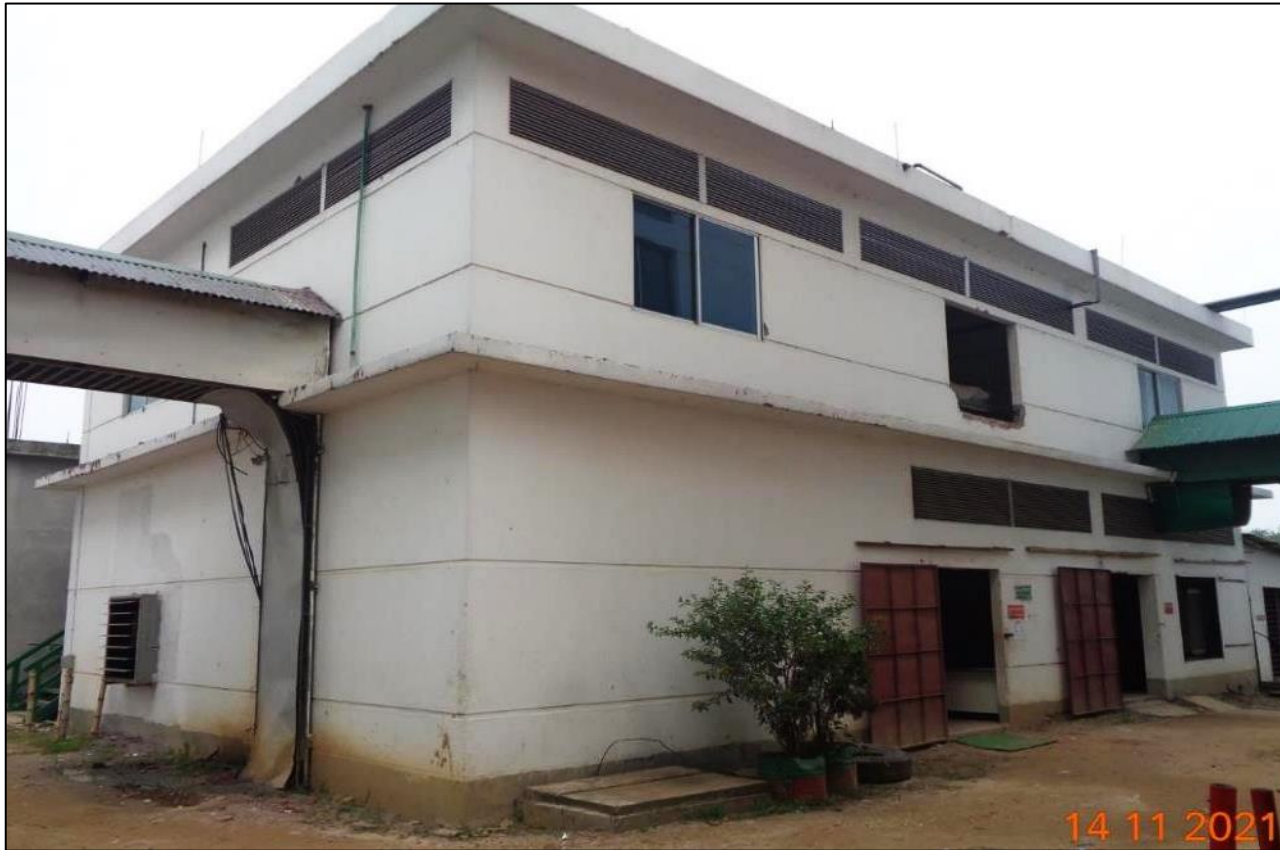
**Structural design report not available**

No design reports was available for Utility Building

As per BNBC, every building or structure designed shall have its design documents prepared in accordance with the provision of Section 1.9.1. The design document shall include a design report, and a set of structural drawings, which shall be prepared in compliance with section 1.9.1.1 and section 1.9.1.2 as per BNBC. At the time of inspection, no design report was available which is required to be prepared in compliance with section 1.9.1.1 (part-6, BNBC).

| Item No. | Observation | Recommended Action Plan | Recommended Timeline |
|---|---|---|---|
| 14 | Structural design report not available. [Utility Building] | Factory engineer is required to prepare the design documents including a design report, and a set of structural drawings in compliance with section 1.9.1.1 and section 1.9.1.2 as per BNBC part 6 and submit to RSC for review. | 6-weeks |

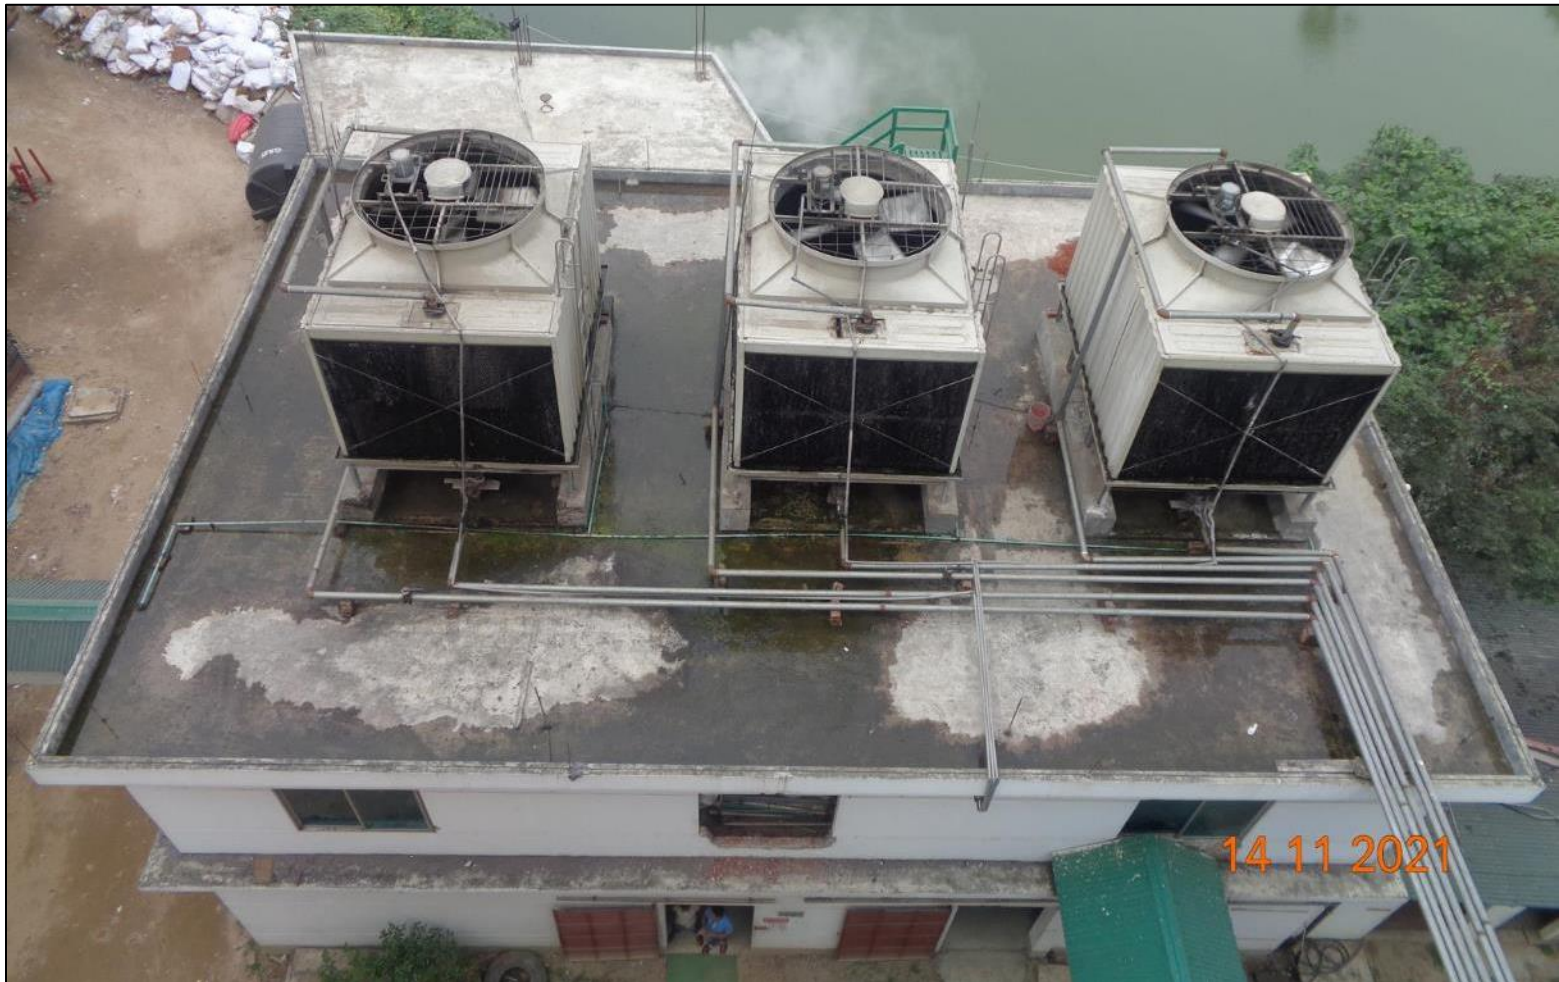
## Water Ponding on roof

**Water ponding on roof**

Factory is required to develop proper drainage system on roof with adequate slope and apply water proofing compound on roof slab to resist water ingress.

| Item No. | Observation | Recommended Action Plan | Recommended Timeline |
|---|---|---|---|
| 16 | Water ponding on roof. [Utility Building] | Factory engineer is required to develop proper drainage system on roof with adequate slope and apply water proofing compound on roof slab to resist water ingress. | 6-weeks |

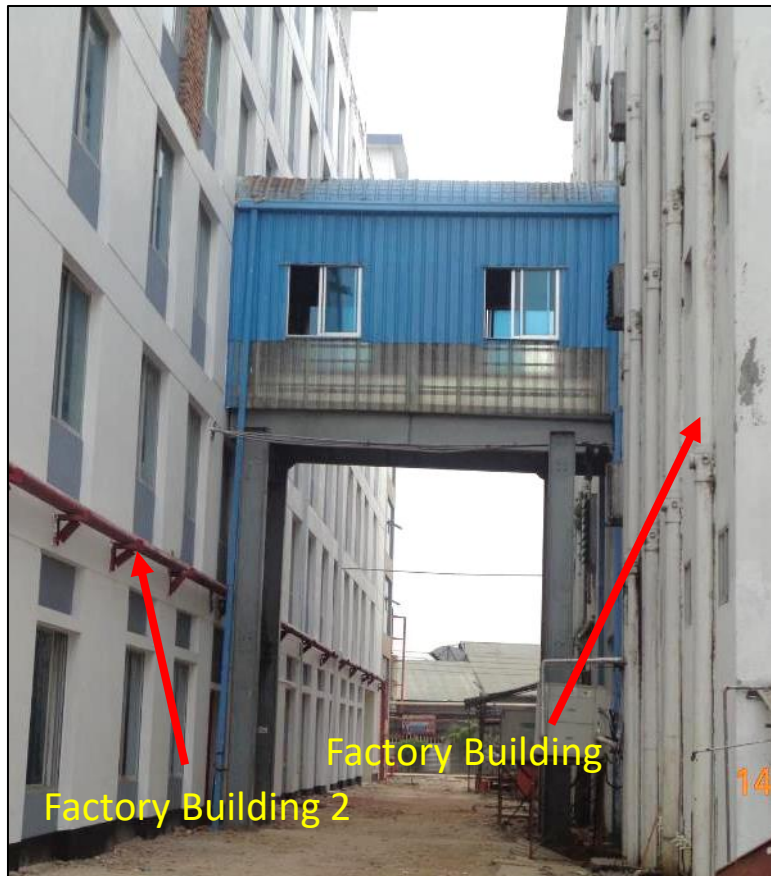
Connecting bridge between  
Factory Building & Factory Building-2

Building engineer is required to produce as-built drawing, check member adequacy for both connecting bridges and recommend remedial measures accordingly.

| Item No. | Observation | Recommended Action Plan | Recommended Timeline |
|---|---|---|---|
| 17 | Undocumented connecting bridges. | The factory engineer to produce as-built drawing with necessary structural details. | 6-weeks |
| 18 | Undocumented connecting bridges. | Carry out adequacy check for both the connecting bridges. | 6-weeks |

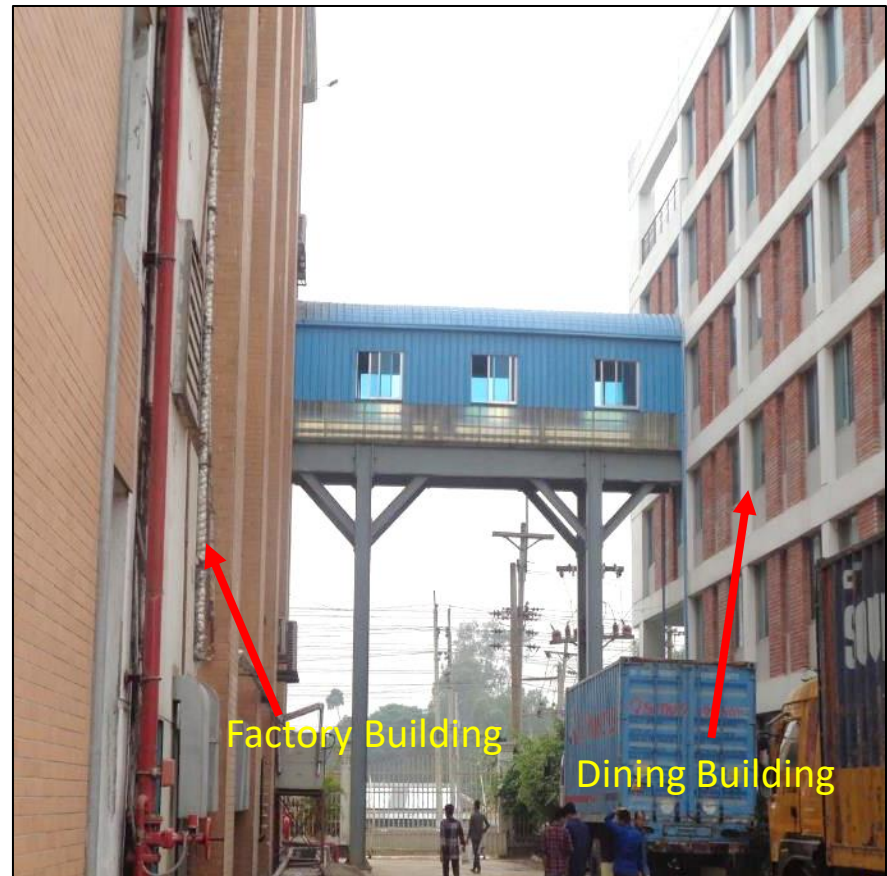
Connecting bridge between  
Factory Building & Dining Building
