Famkam Printing Ltd.

Shirir Chala, Bagher Bazer Gagipur Shadar, Gazipur

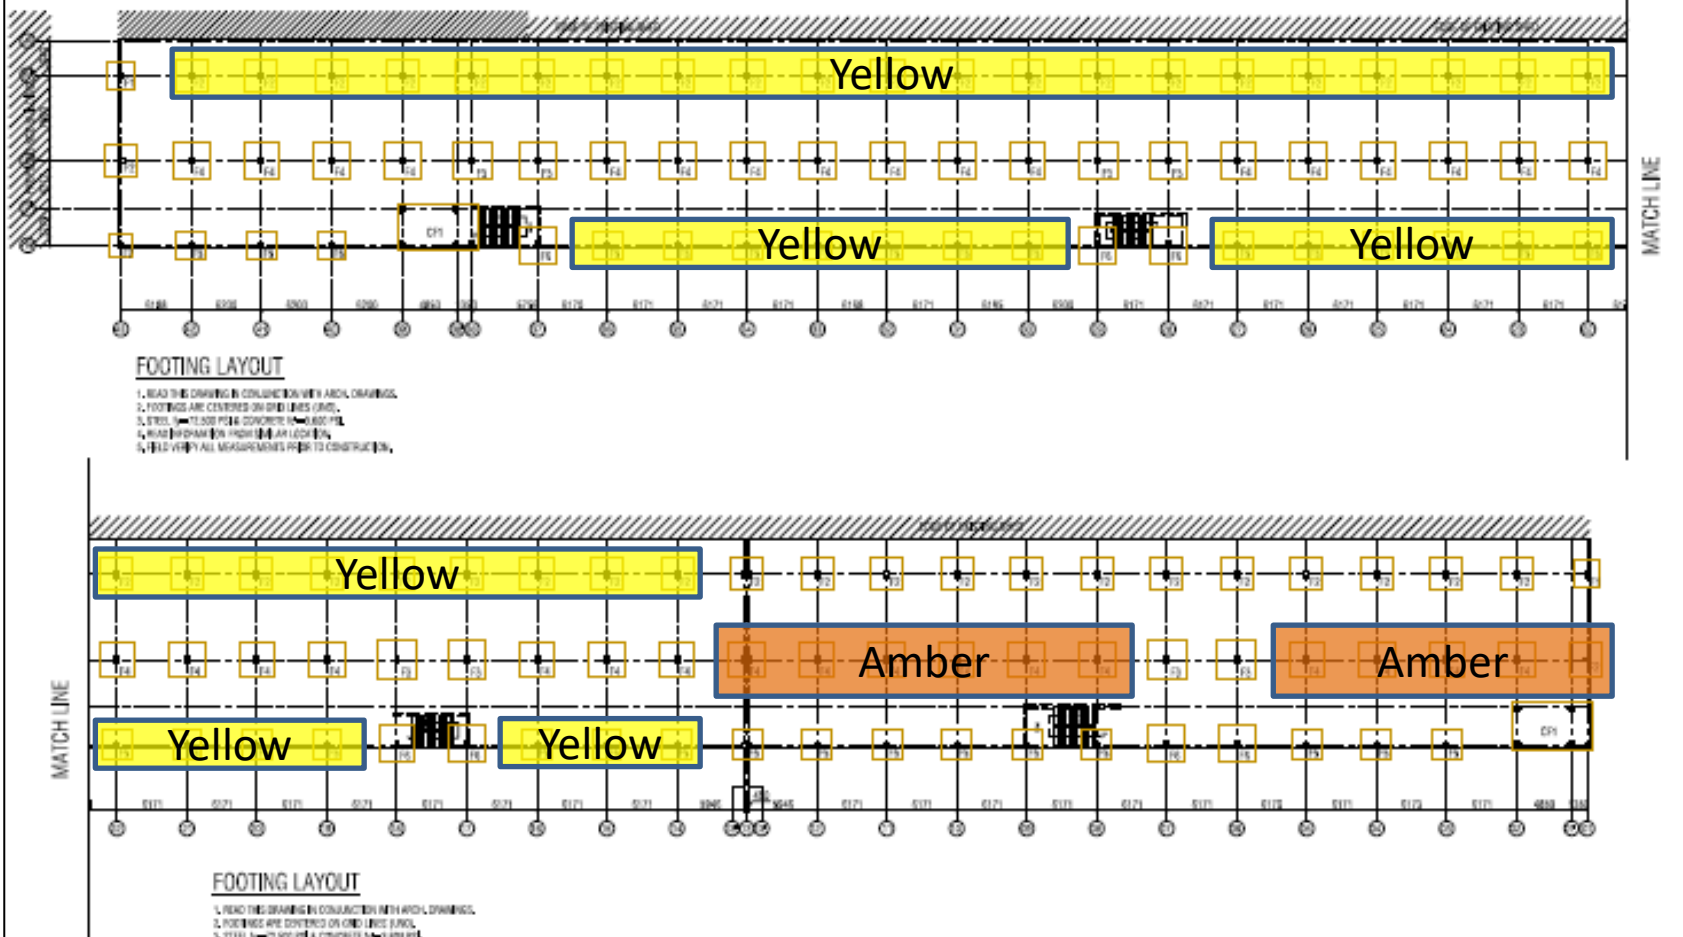
High stress level in foundation that require immediate review

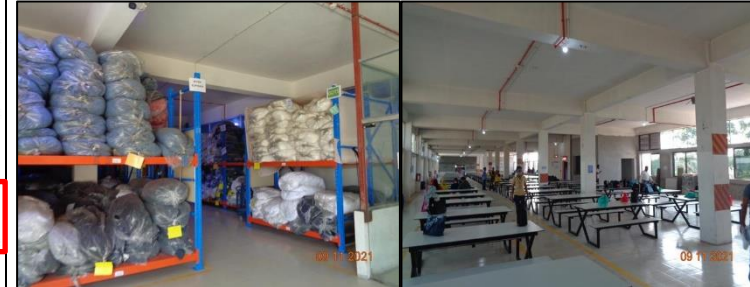
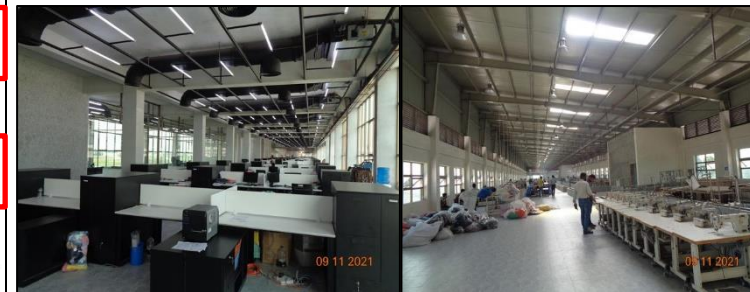
Typical Floor loading

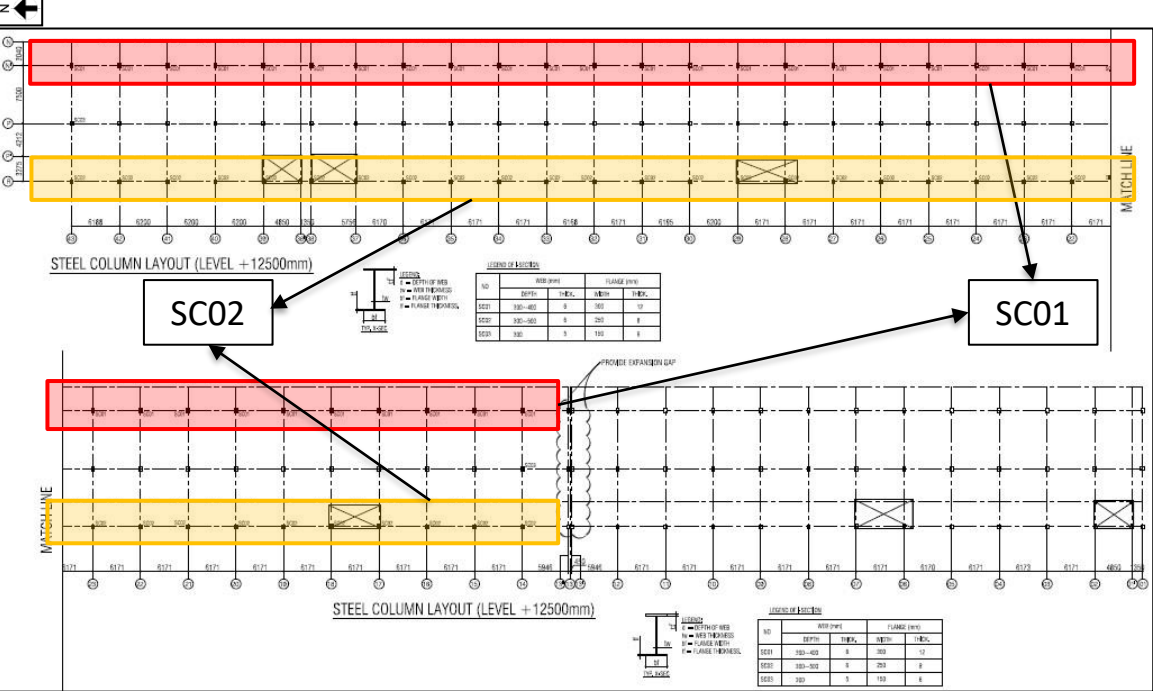
Discrepancies in as-built drawing

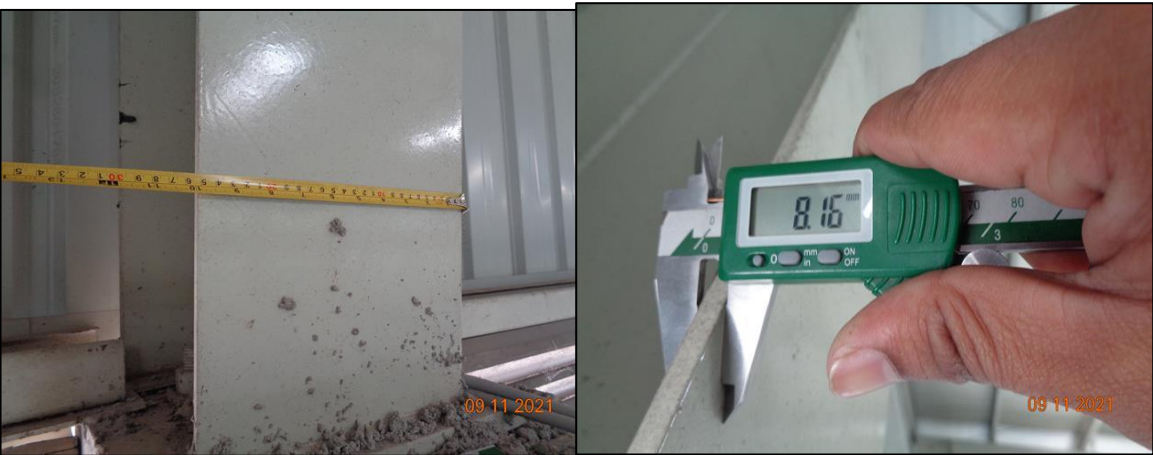
Size measured – Flange width: 250mm & Flange Thickness: 8mm

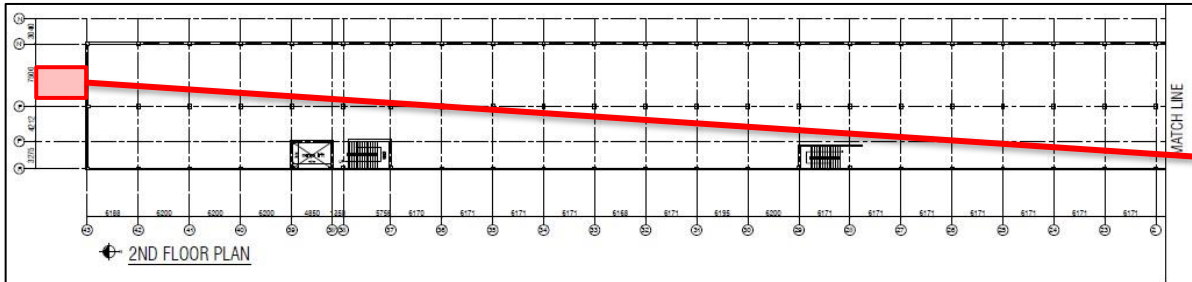
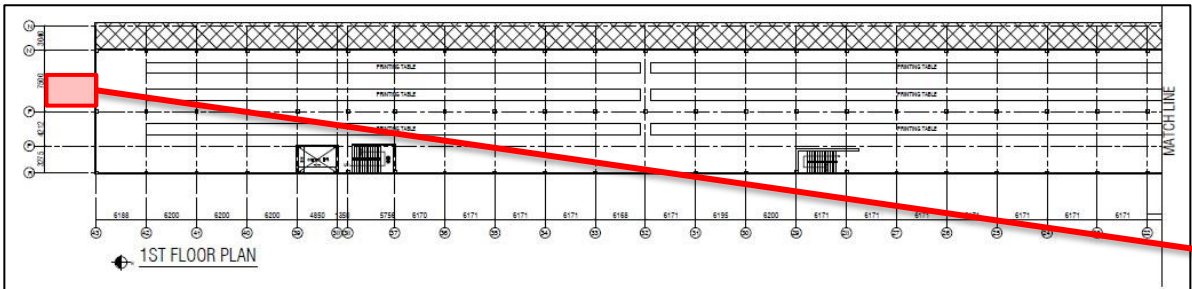
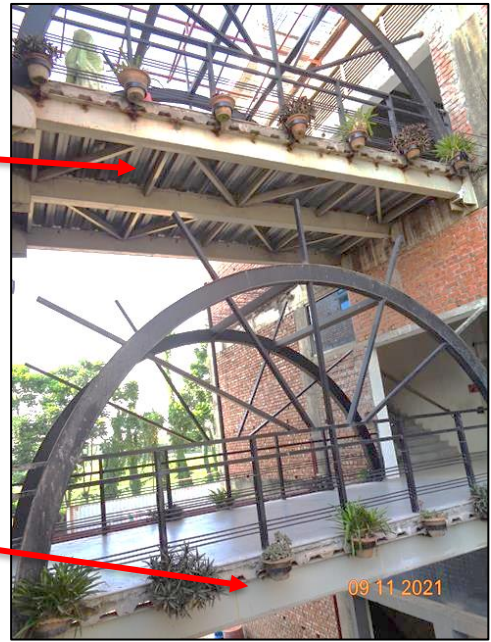
In as-built drawing, for the SC01 column; flange size 300 mm and flange thickness 12mm has been shown. During inspection, flange width was found 250mm and flange thickness was found 8mm. Building engineer is required to update the as-built drawing with the accurate on-site condition.

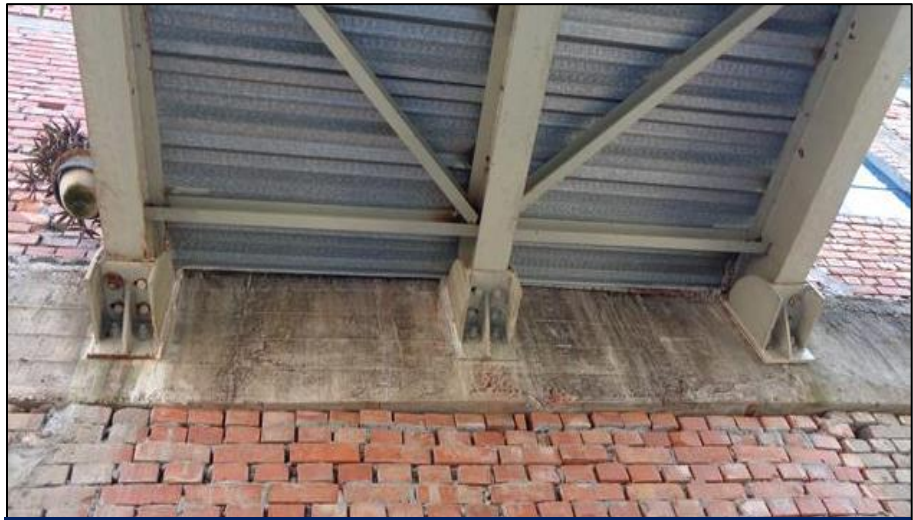
The connecting bridge was found connected with RC beam of the Famkam printing building.

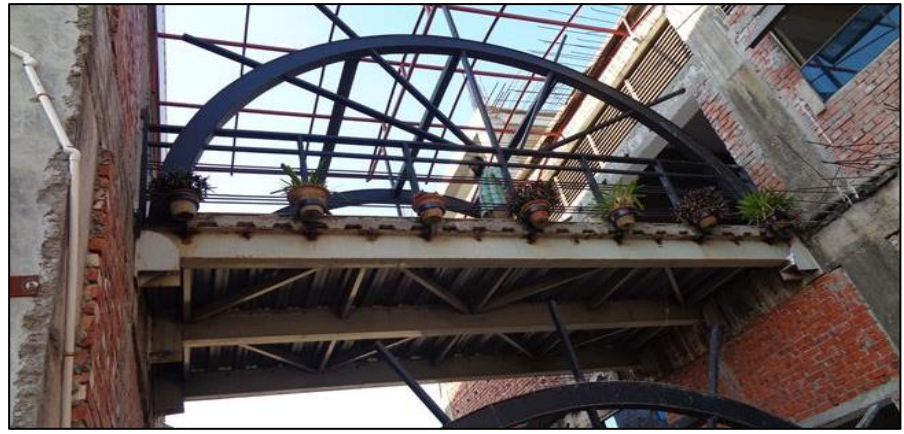
Undocumented steel connecting bridge was found. Building engineer is required to update the as-built drawing with the accurate on-site condition.

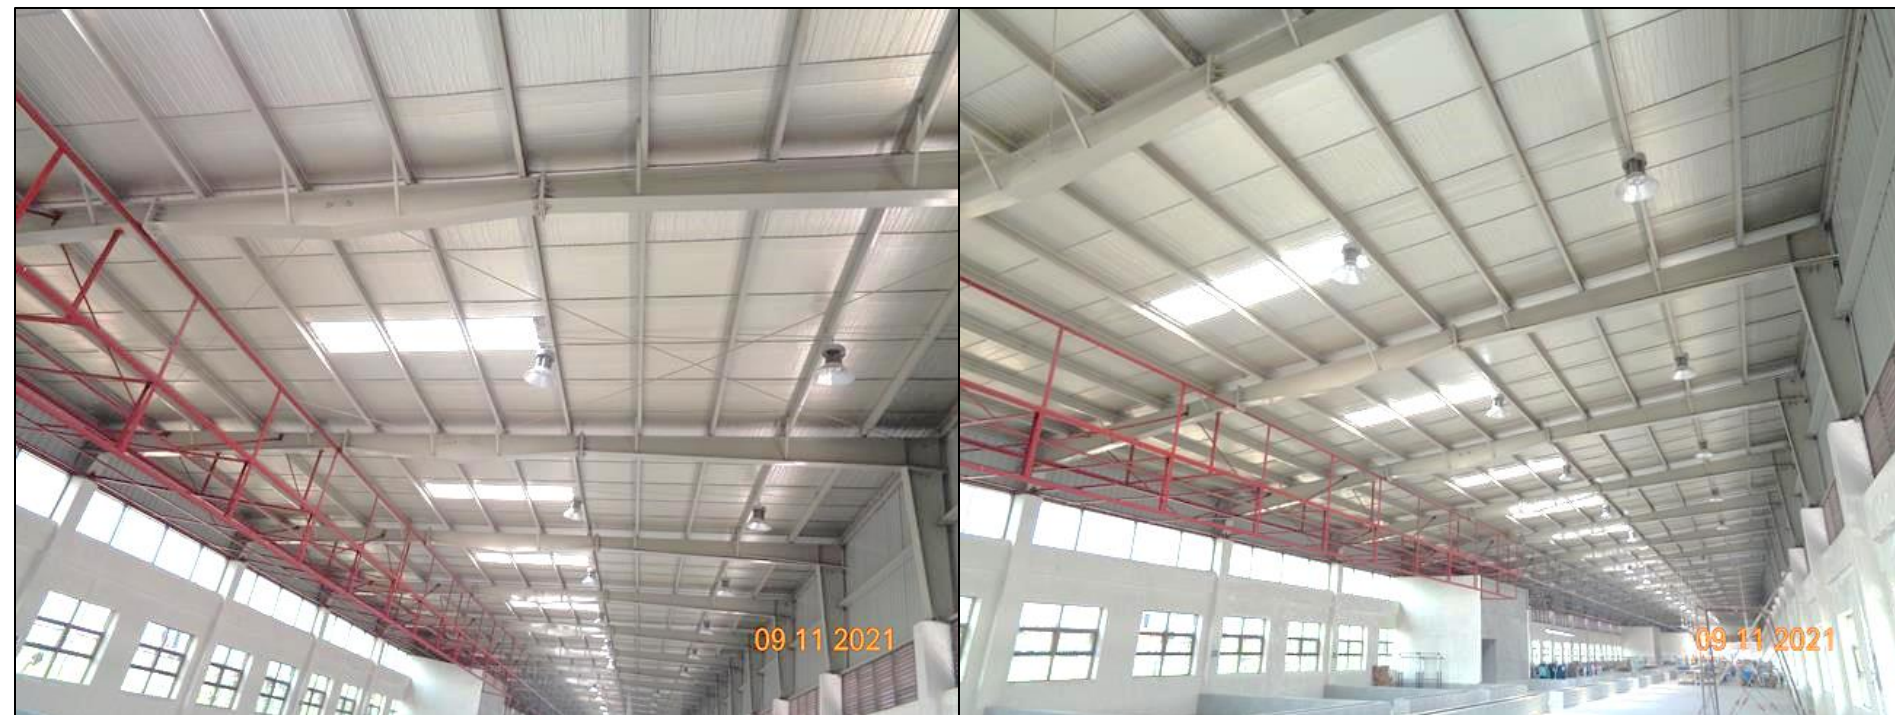
Portal steel roof shed - Lateral load transfer media missing at roof level

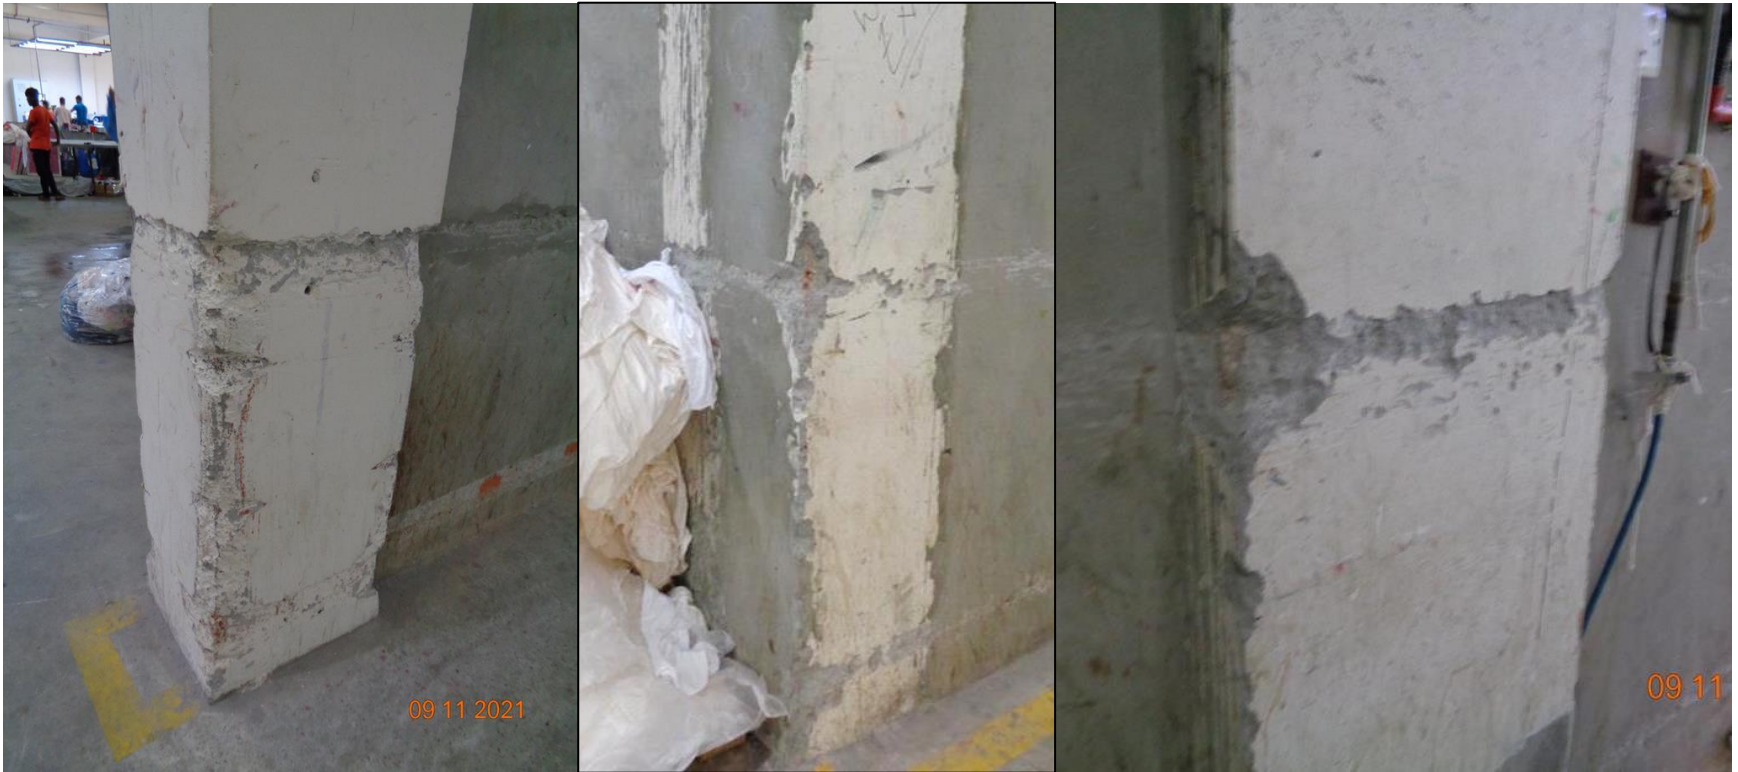
RC Column was found damaged due to the impact with trolley. Factory engineer is required to investigate the damage and suggest a remedial action as well as provide suggestion to prevent such damages in future. Factory is required to follow the suggestion of the engineer for remedial actions.

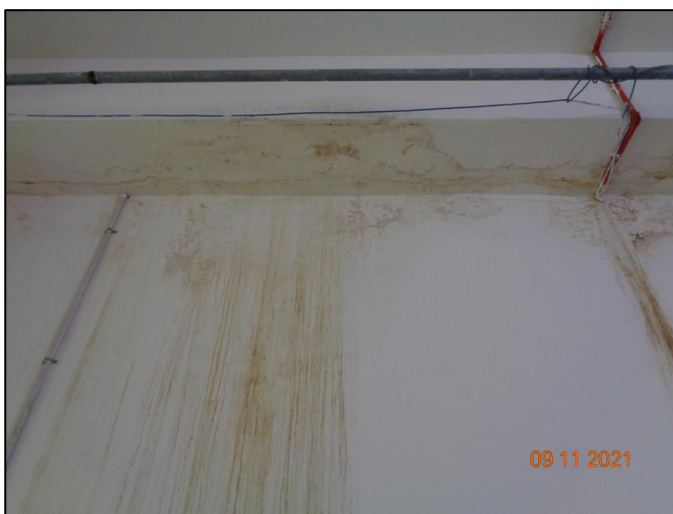
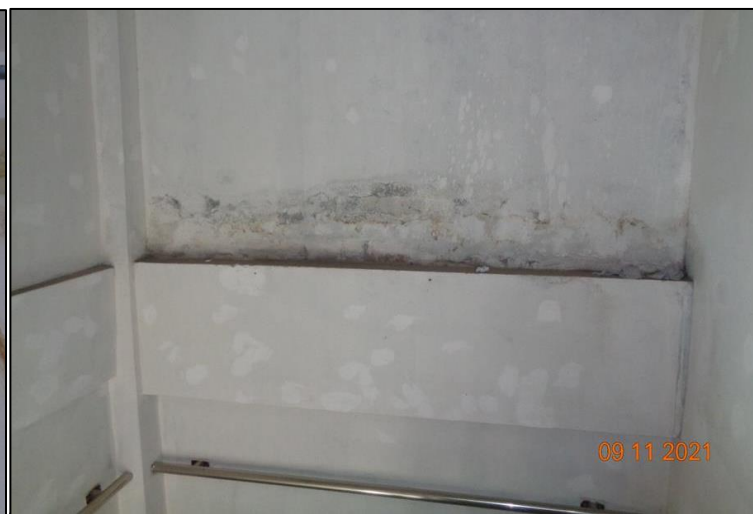
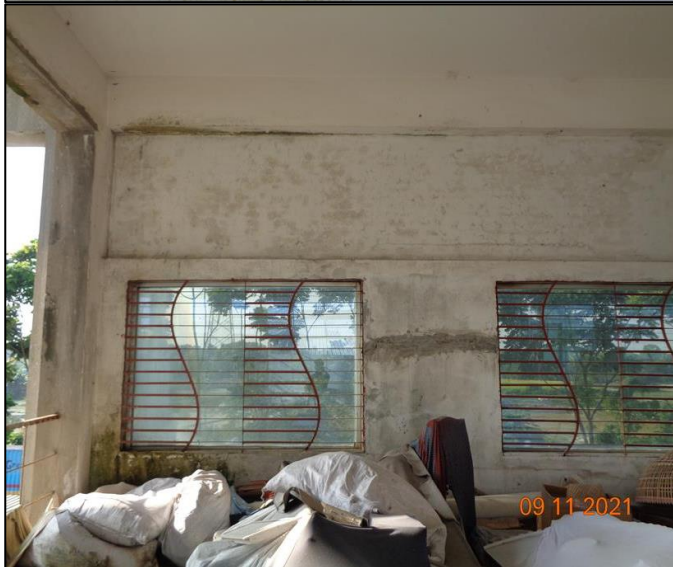
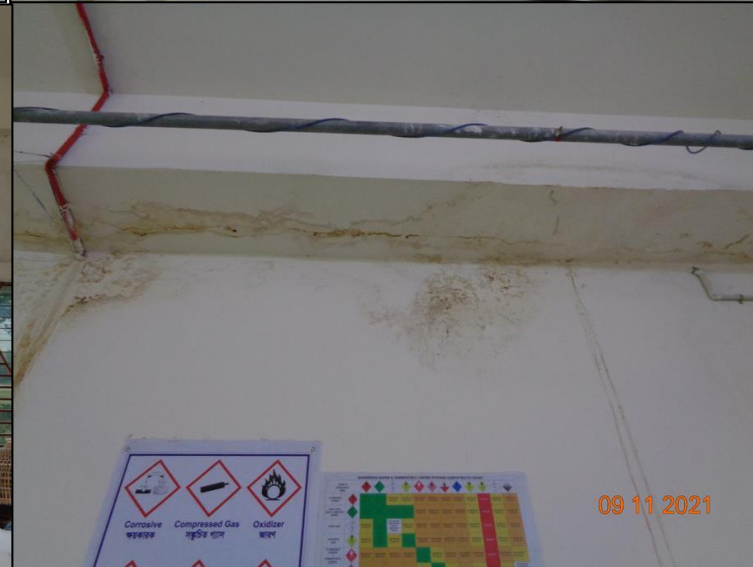
Due to water absorption, dampness was found on brick wall & RC beam. Building engineer is required to take necessary measures to prevent dampness in brick wall & RC beam.

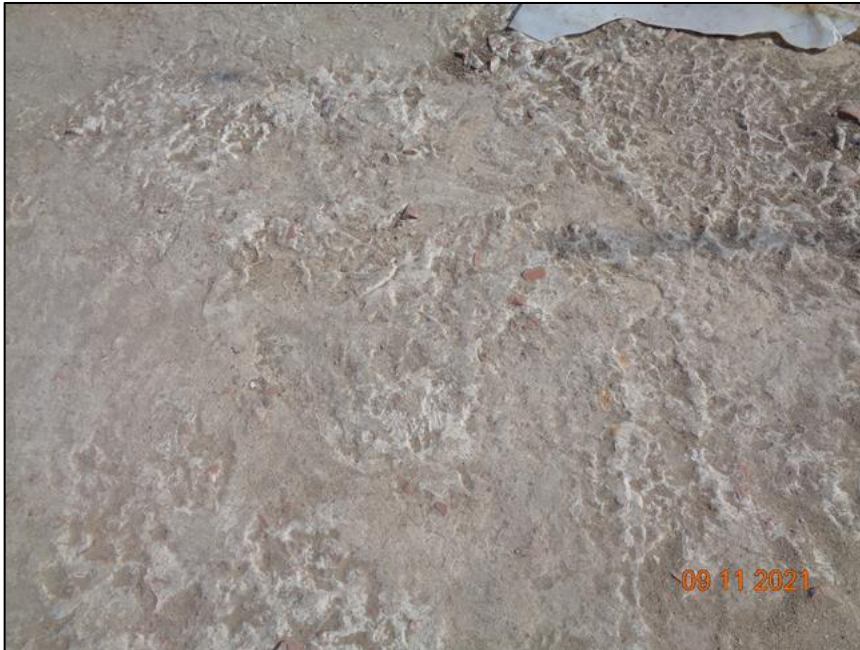
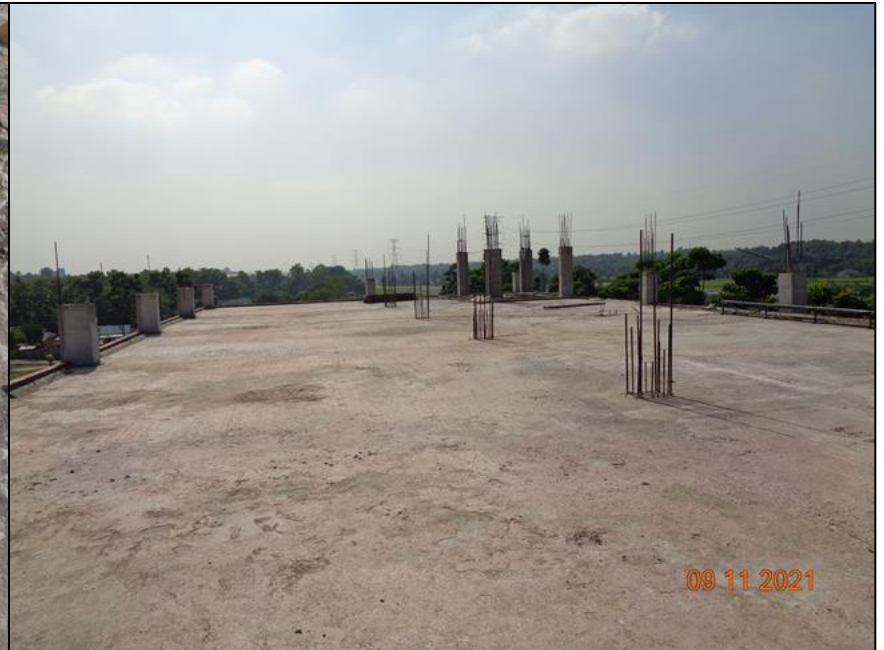
Lack of water proofing on roof slab

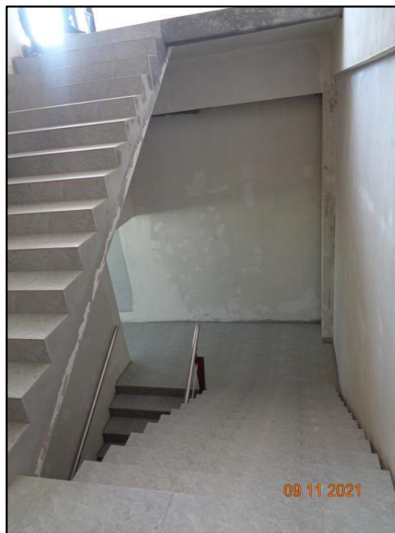
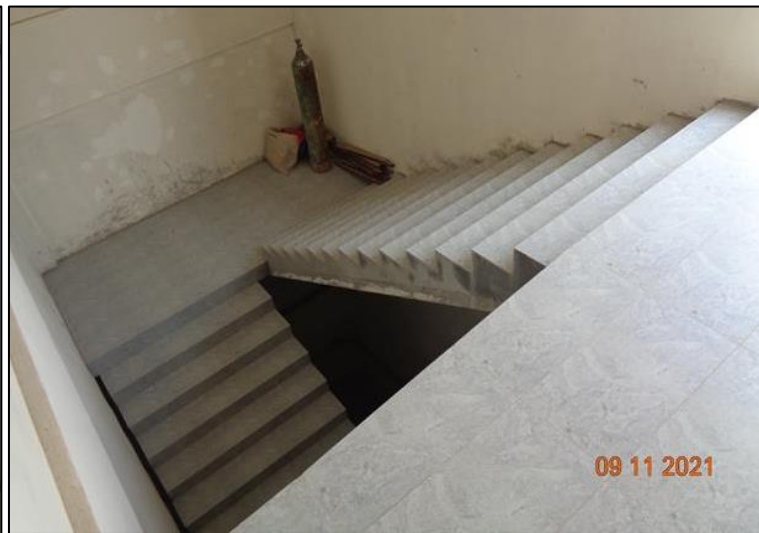
Missing railing at stair

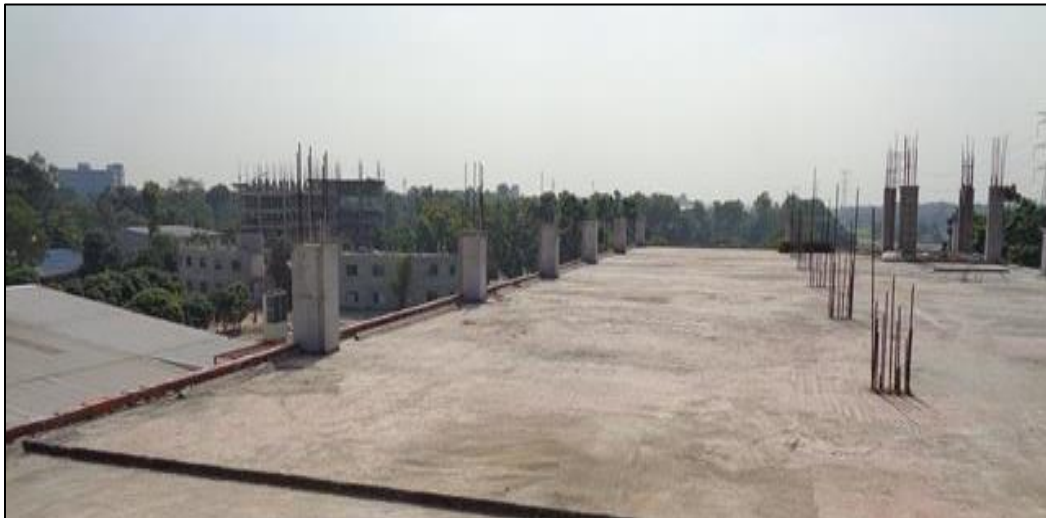
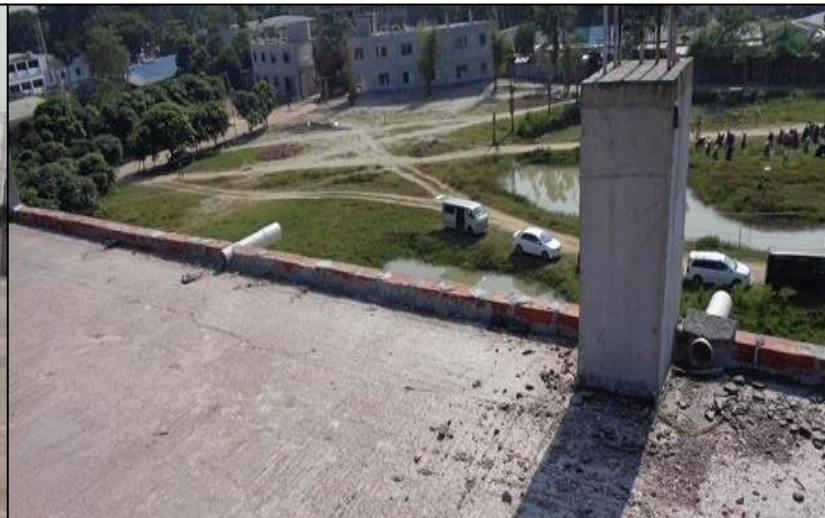
Parapet wall missing at roof

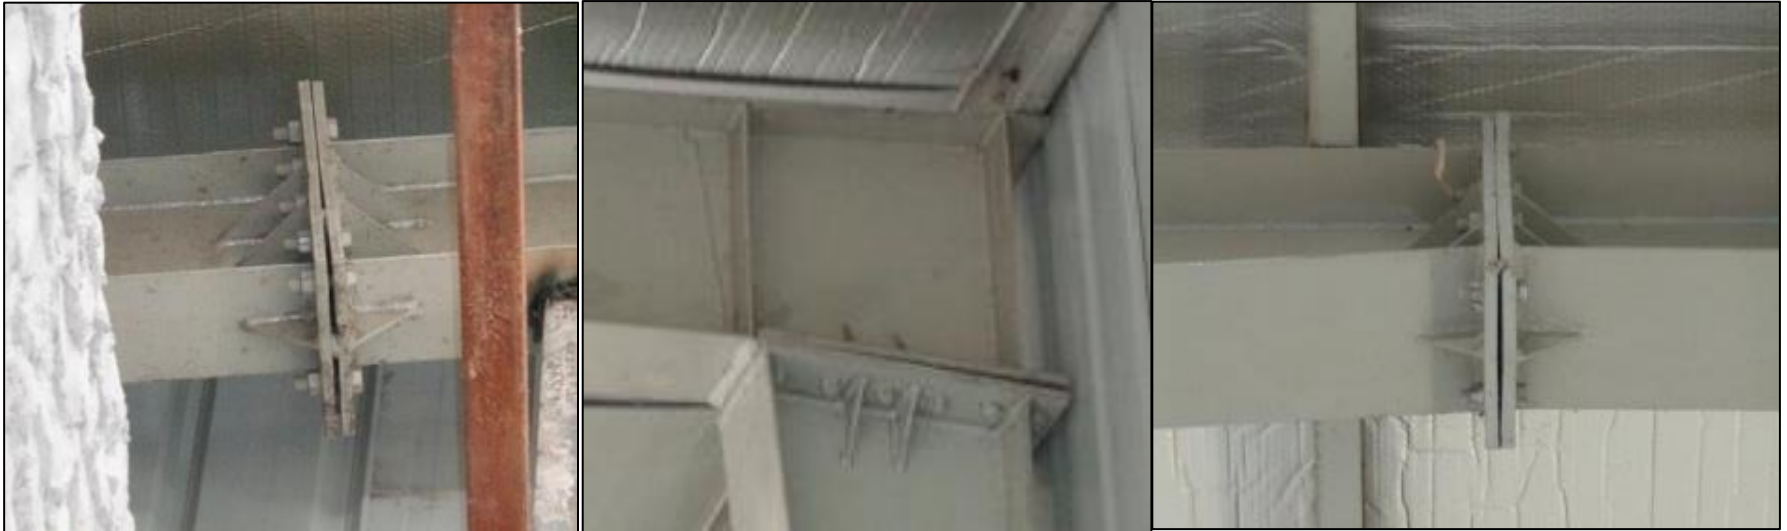
Connection gap was found in rafter-rafter & rafter-column connection

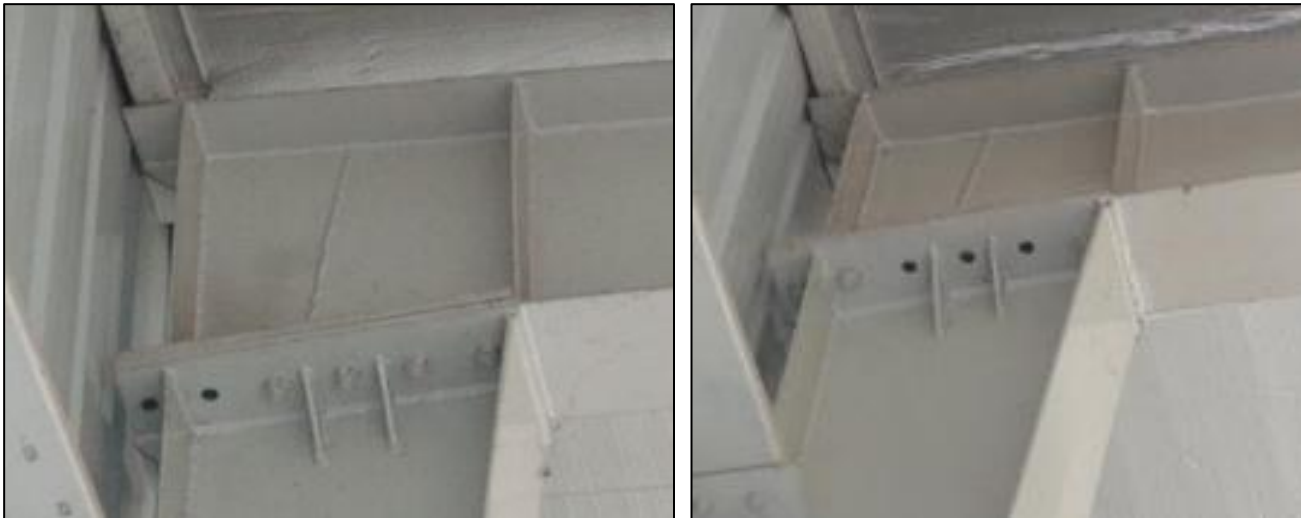
Bolt missing in Beam-column connection at ground floor

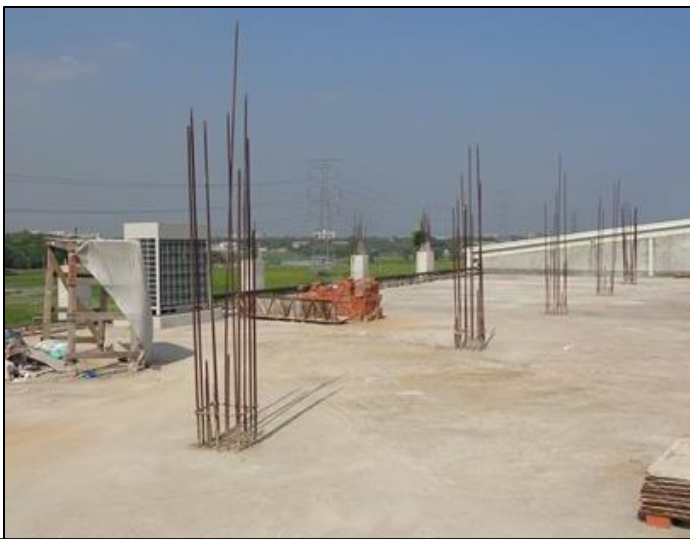
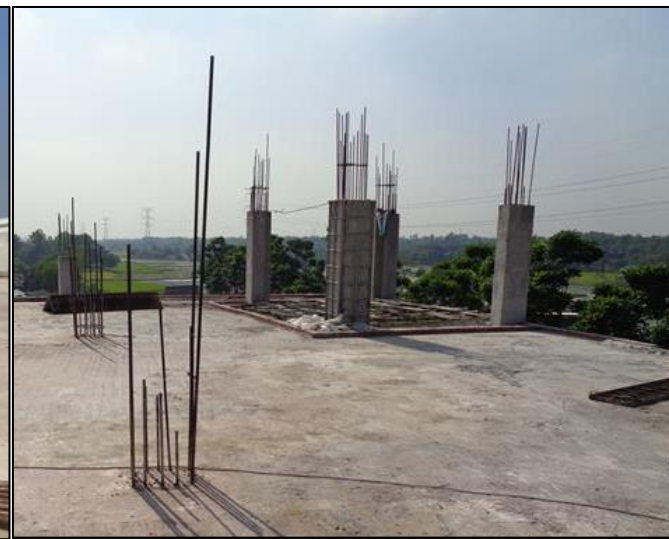
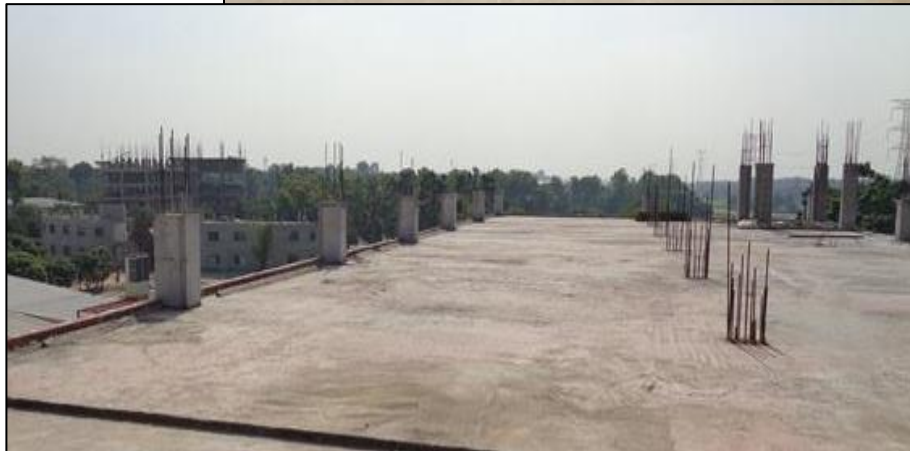
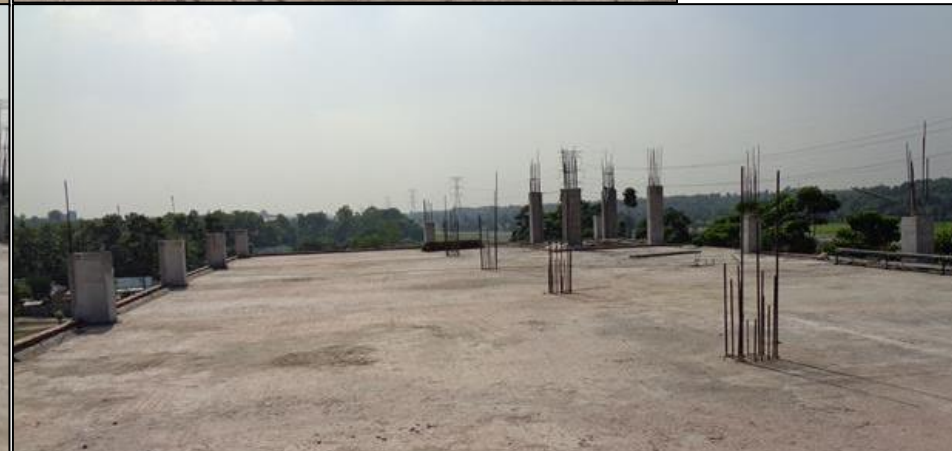
The building permission layout is for three storied only and construction of the building was found up-to the permit drawing. But There is also extended column re-bar at roof floor. So, there is a possibility of future vertical extension. But factory authority verbally informed that they do not have planning for vertical extension for this time being.

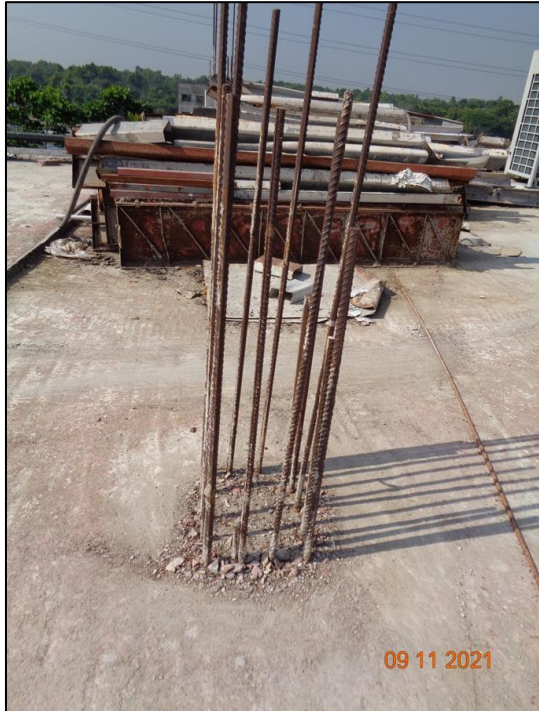
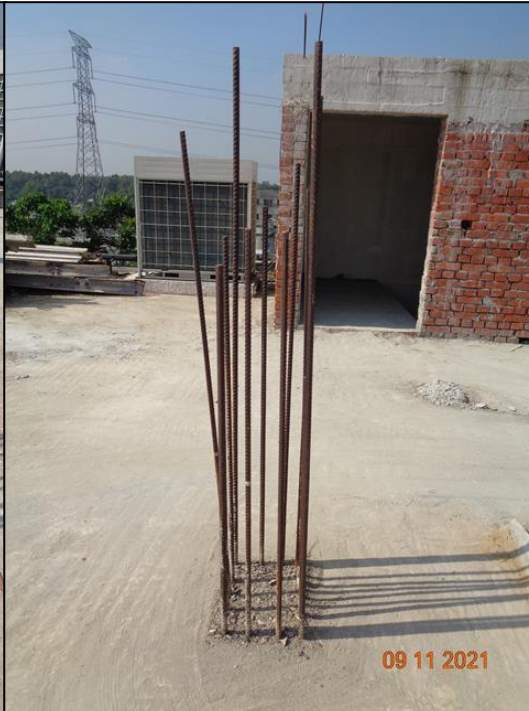
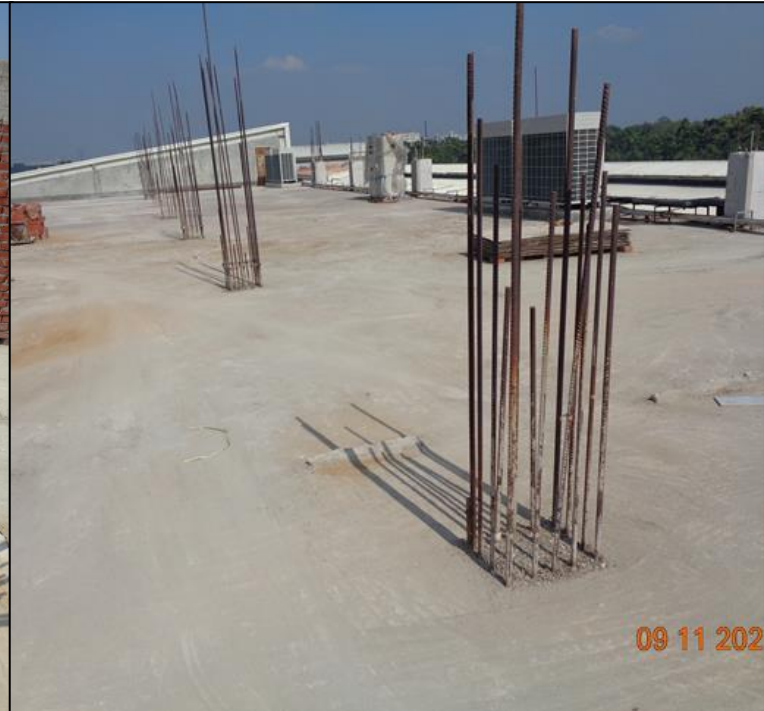
Exposed rebar at roof
