# FARIHA KNIT TEX LTD.

## (Extension Buildings)

Baroibogh, Enayet Nagar, Fatullah, Narayanganj.  
(23.619862N, 90.482921E)  
8th & 30th November 2021

# Observations

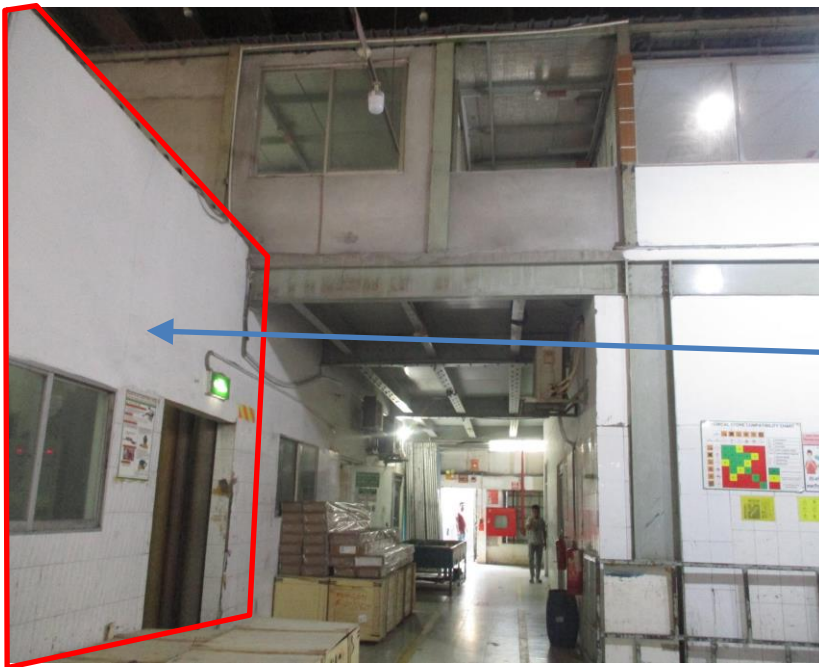
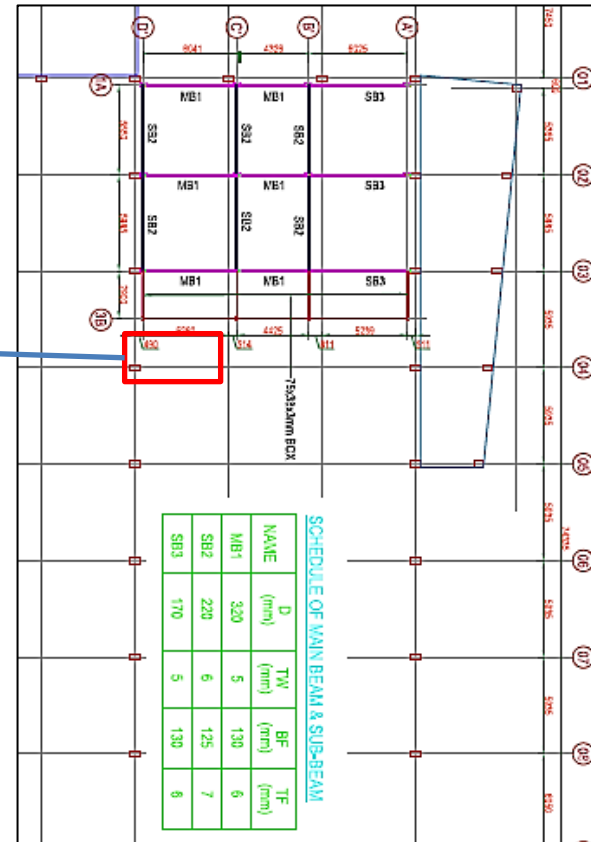
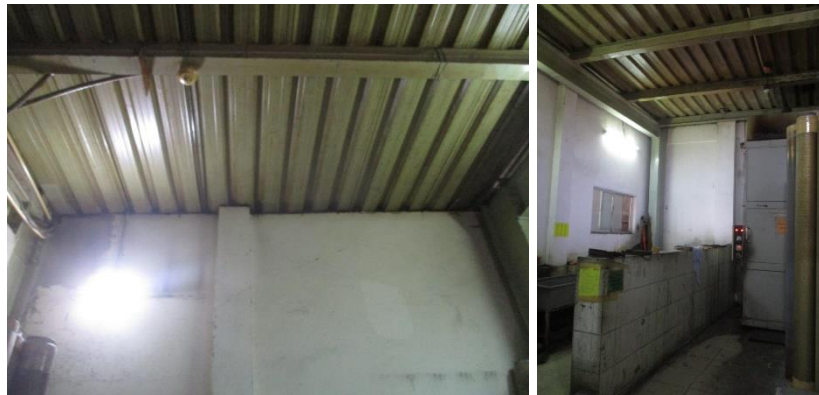
Expansion of mezzanine floor

Expansion of mezzanine floor was observed in the ground floor level. Also, the layout of mezzanine and size of column and beam did not match with provided drawings (mention the mismatches). Building engineer to survey the structure and prepare accurate as-built drawings.

| Item No. | Observation | Recommended Action Plan | Recommended Timeline |
|---|---|---|---|
| 01 | Discrepancy in the drawings: Shed-3 | The building engineer is required to survey the structure and produce accurate as-built drawings. | 6-weeks |

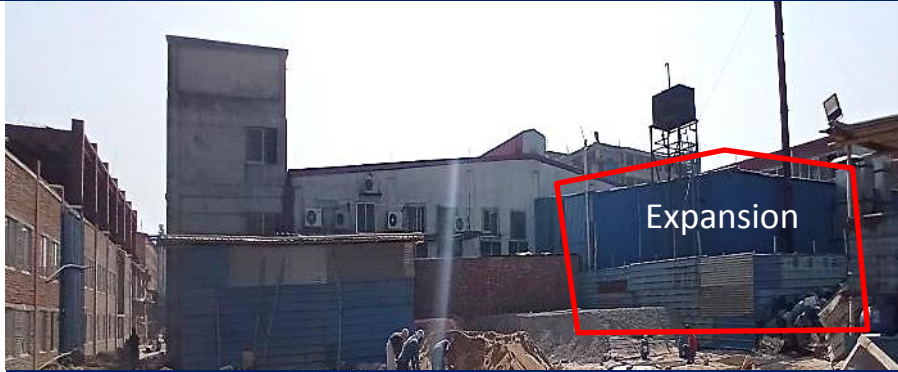
North Elevation

Undocumented horizontal expansion was observed on north side of the shed. Building engineer is required to survey the structure and prepare as-built drawings and check the adequacy of the structural members for the vertical & lateral forces.

| Item No. | Observation | Recommended Action Plan | Recommended Timeline |
|---|---|---|---|
| 02 | Undocumented horizontal expansion: Shed-3 | Building engineer is required to survey the structure and prepare as-built drawings. | 6-weeks |
| 03 | Undocumented horizontal expansion: Shed-3 | Check the adequacy of the structural members for the vertical & lateral forces. | 6-weeks |

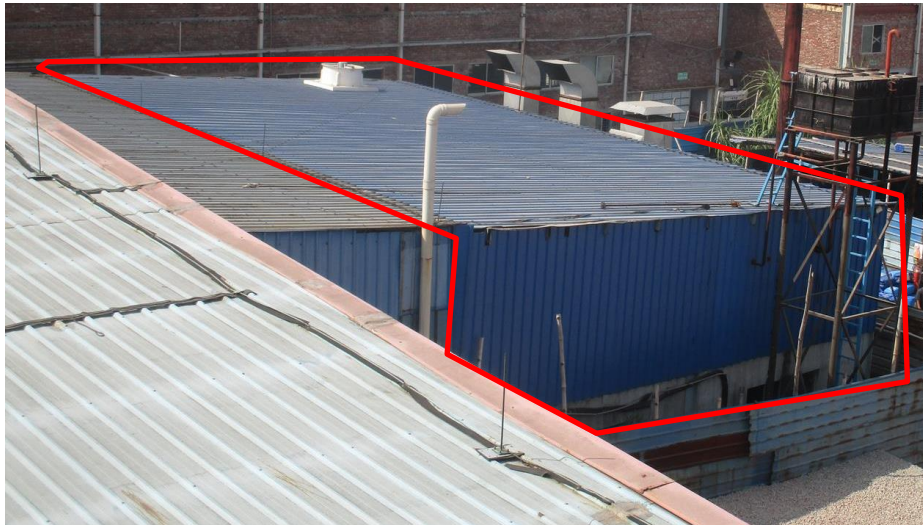
Undocumented expansion

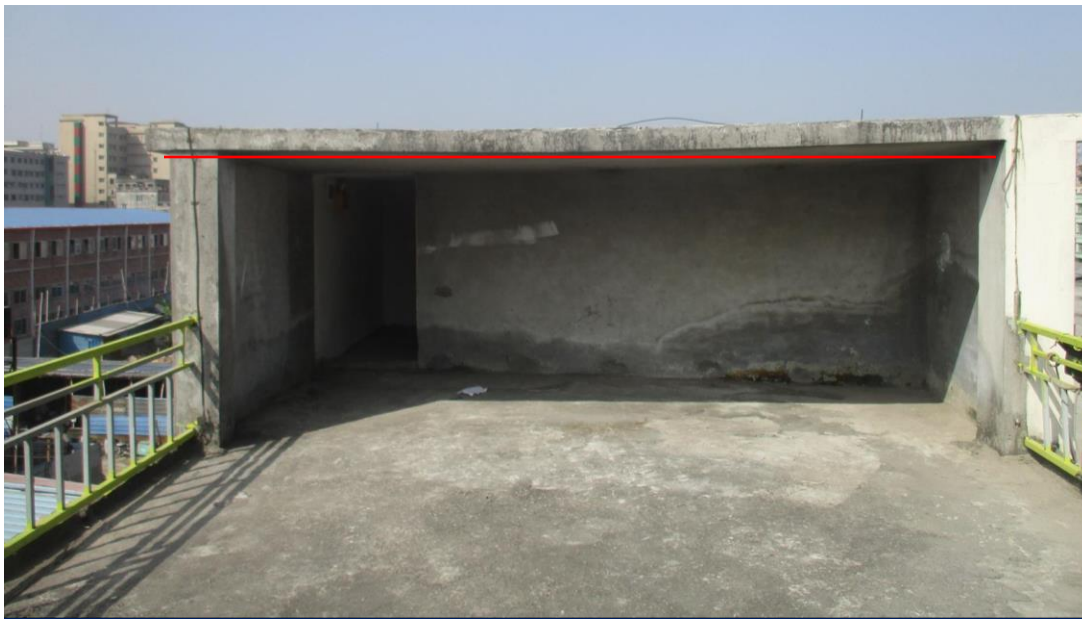
Slab deflection

The stair roof slab have about 5m span and 125 mm thickness. Deflection was observed at the mid span of the slab. Also, hairline crack on the slab soffit was observed. The slab have no periphery beams. The building engineer to check the adequacy of the slab and suggest necessary support to control the deflection.

| Item No. | Observation | Recommended Action Plan | Recommended Timeline |
|---|---|---|---|
| 05 | Deflection of roof top RC slab: Shed-3 | The building engineer to check the adequacy of the slab and suggest necessary remedial actions to control the deflection. | 6-weeks |

| Item No. | Observation | Recommended Action Plan | Recommended Timeline |
|---|---|---|---|
| 06 | Deflection of roof top RC slab: Shed-3 | Carry out remedial works suggested by the engineer. | 6-months |

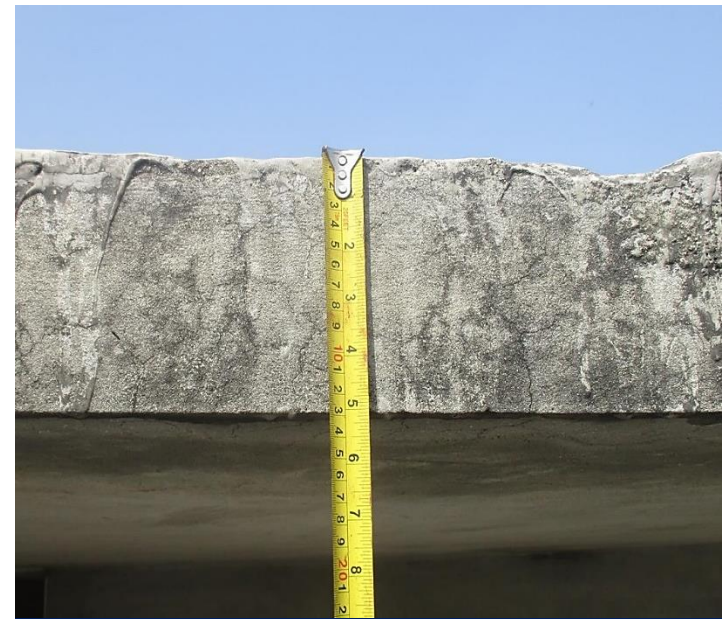
125 mm thick RC slab

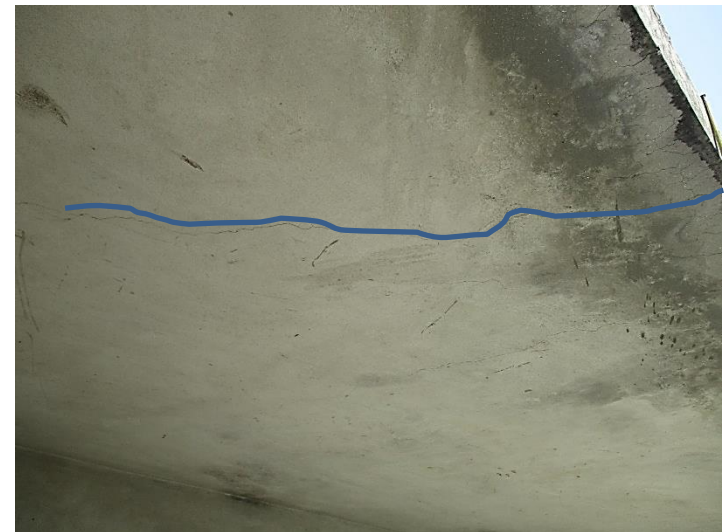
Hairline crack on the slab soffit

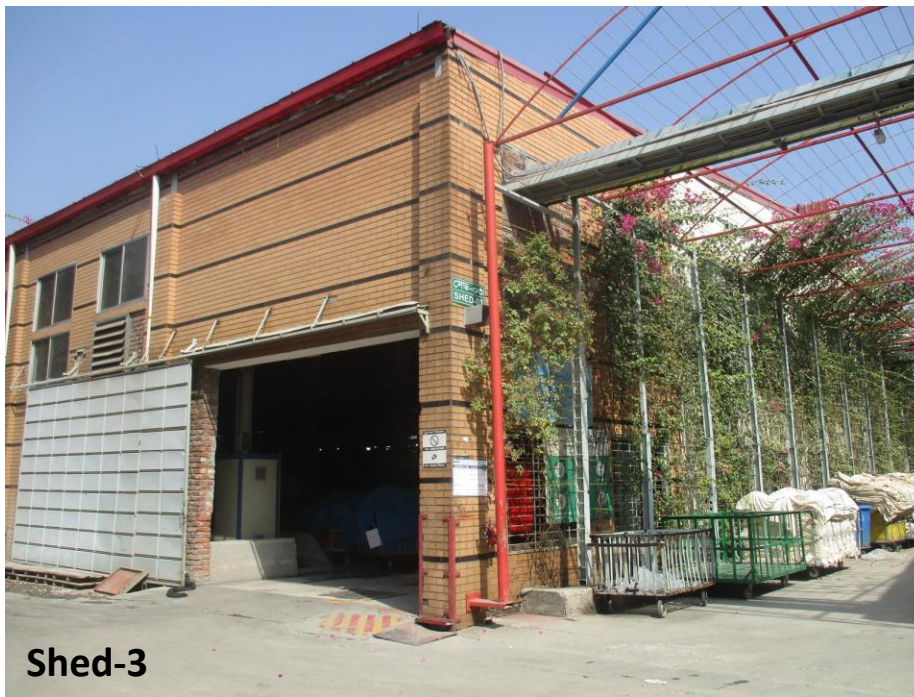
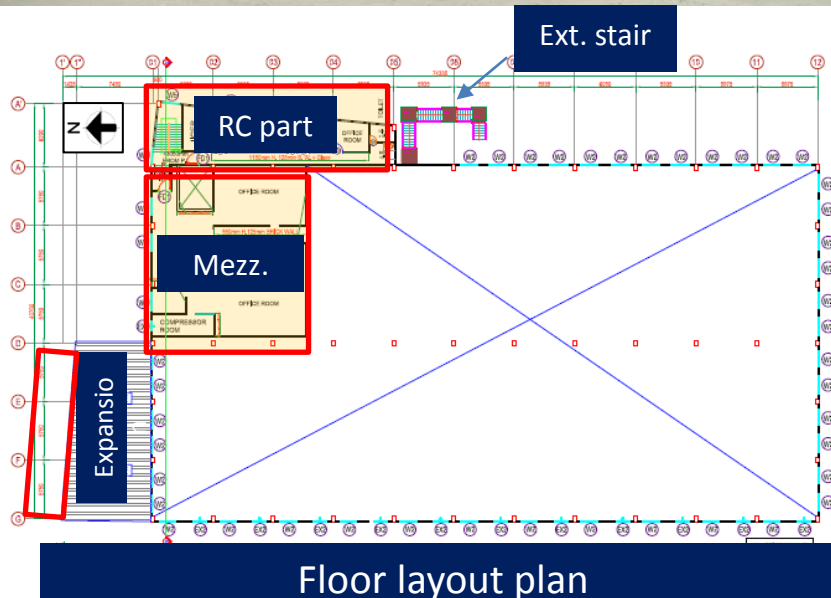
**Shed-3**

As per BNBC, every building or structure designed shall have its design documents prepared in accordance with the provision of Section 1.9.1. The design document shall include a design report, and a set of structural drawings, which shall be prepared in compliance with section 1.9.1.1 and section 1.9.1.2 as per BNBC. At the time of inspection, no design report was available which is required to be prepared in compliance with section 1.9.1.1 (part-6, BNBC).

Main shed, RC part and steel mezzanine floor are sharing common RC columns. Also, the expansion areas are structurally connected with main shed. Some RC columns, almost all the steel columns and rafters have been retrofitted by the factory. Mezzanine floor steel column has no foundation details. All the parts should be included in the analysis and design report.

| Item No. | Observation | Recommended Action Plan | Recommended Timeline |
|---|---|---|---|
| 07 | Lack of design report: Shed-3 | The building engineer is required to prepare design report in compliance with section 1.9.1.1 (part-6, BNBC). | 6-weeks |
| 08 | Lack of design report: Shed-3 | Implement the recommendation of design report. | 6-months |

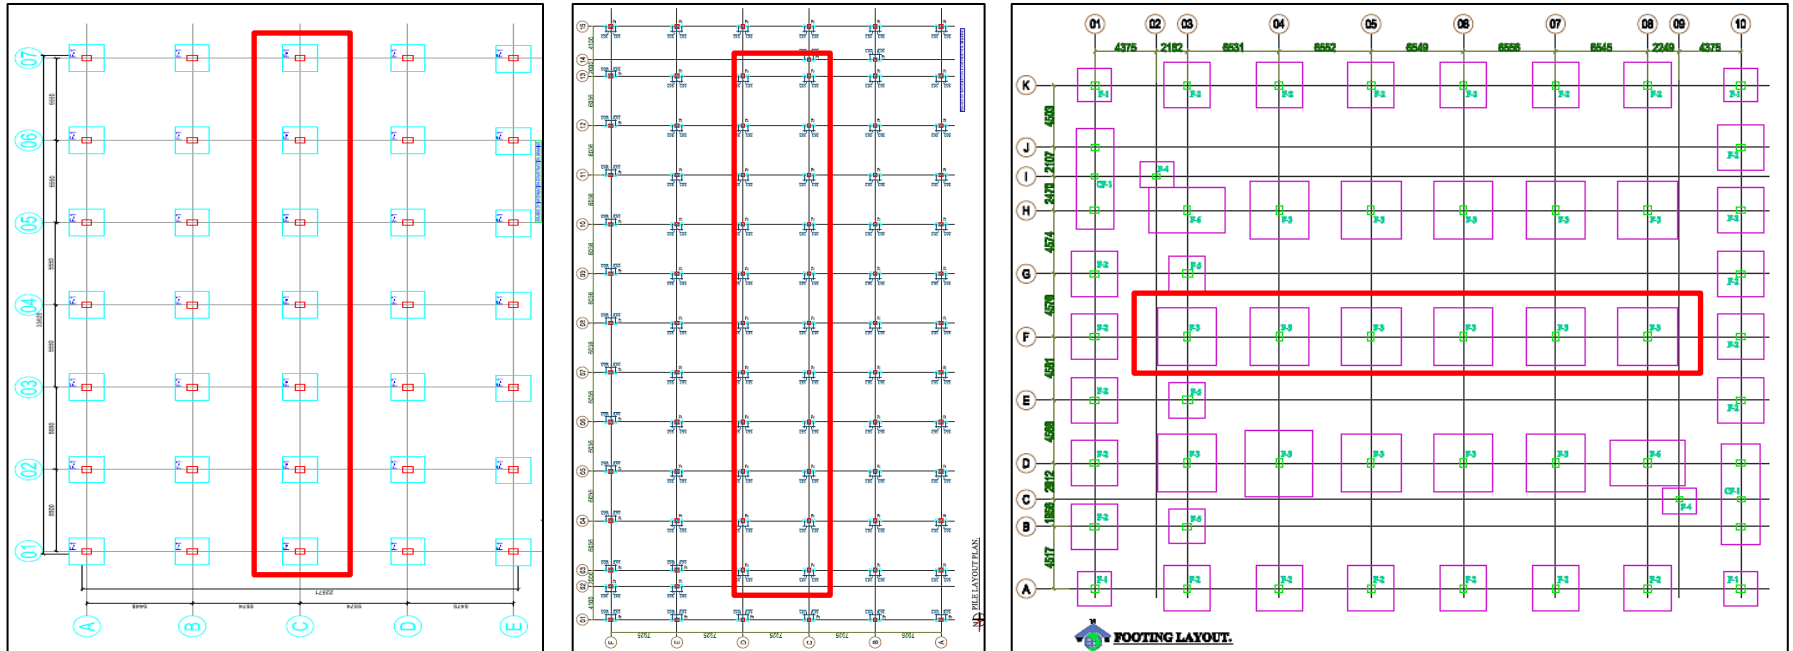
Foundation layout plan Shed- 5, 7 & 9

Cursory calculation indicates that the foundation stress exceeds normal design limit marginally for central column of shed- 5, 7 & 9 considering prepared live load plan and bearing capacity of foundation as per soil test report. The building engineer to calculate the actual FoS of foundations based on in-situ material strength and allowable live load limit.

| Item No. | Observation | Recommended Action Plan | Recommended Timeline |
|---|---|---|---|
| 09 | Foundation stress exceeds the normal design limit: Shed-5 | The building engineer to calculate the actual FoS of foundations based on in-situ material strength and allowable live load limit. | 6-weeks |
| 10 | Foundation stress exceeds the normal design limit: Shed-5 | Suggest remedial actions. | 6-weeks |

| Item No. | Observation | Recommended Action Plan | Recommended Timeline |
|---|---|---|---|
| 11 | Foundation stress exceeds the normal design limit: Shed-5 | Carry out remedial works where required. | 6-months |

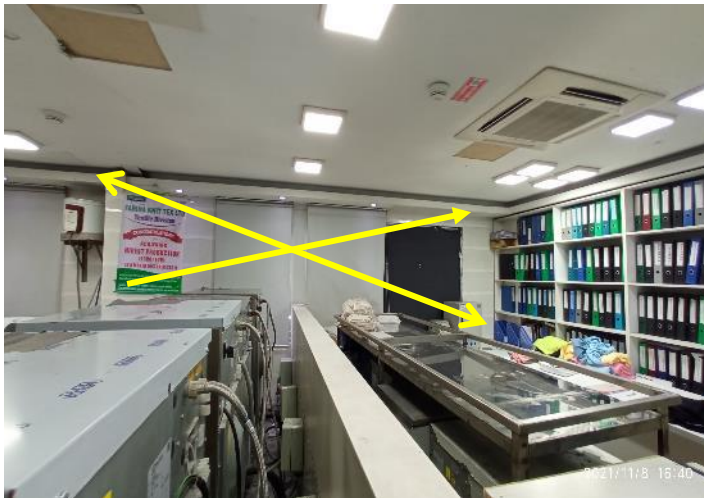
Missing bracing at different place

The building engineer is required to survey the structural components and produce accurate structural drawings.

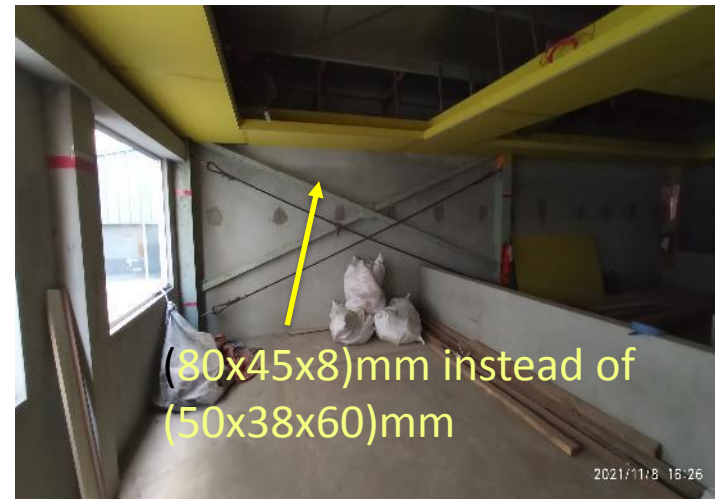
Mismatch in C-Channel bracing size

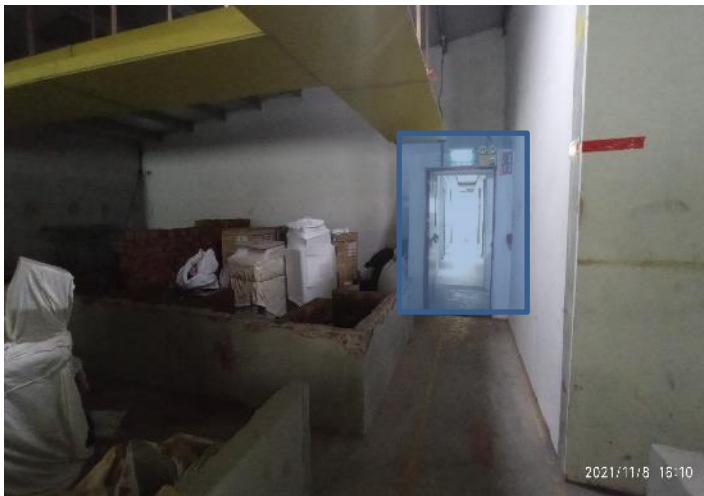
Mismatch in wall layout at 1F  
(Fire door wall)

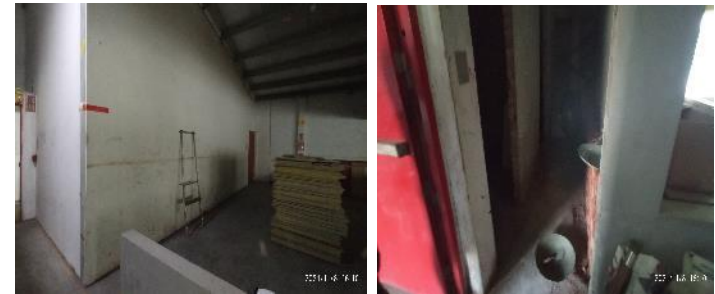
New toilet beside south side stair &  
shifting wall at storage

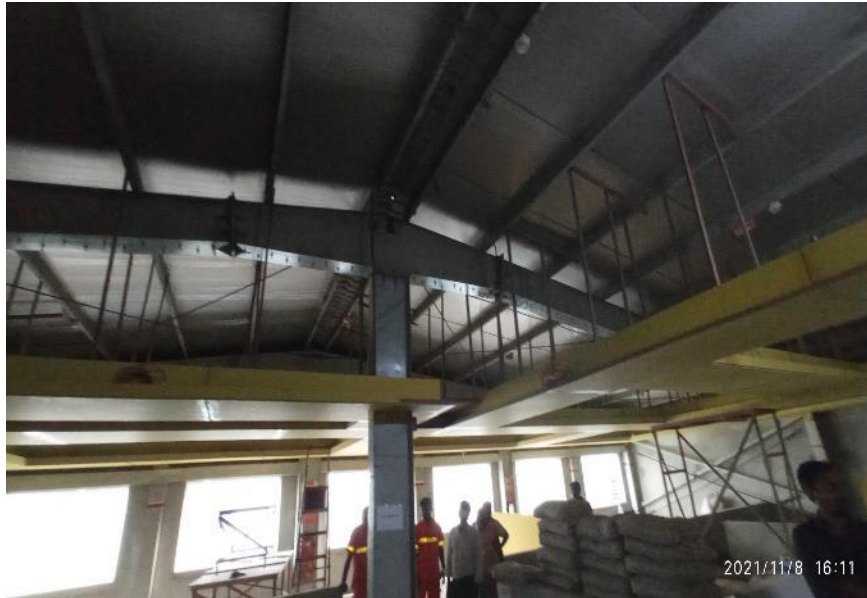
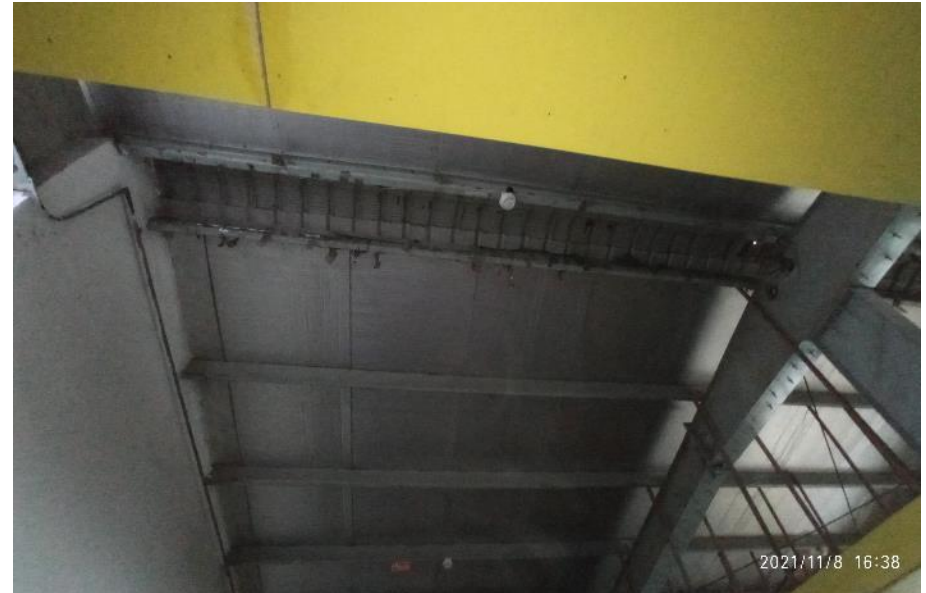
Absence of lateral load transfer media (compression strut) on roof

The factory engineer is required to check the stability of the structural system and provide the appropriate load transfer media.

| Item No. | Observation | Recommended Action Plan | Recommended Timeline |
|---|---|---|---|
| 13 | Lack of lateral stability: Shed-5 | As part of Engineering Assessment (EA), the building engineer is required to check the stability of the structure and suggest necessary remedial actions. | 6-weeks |
| 14 | Lack of lateral stability: Shed-5 | Carry out remedial works as the EA. | 6-months |

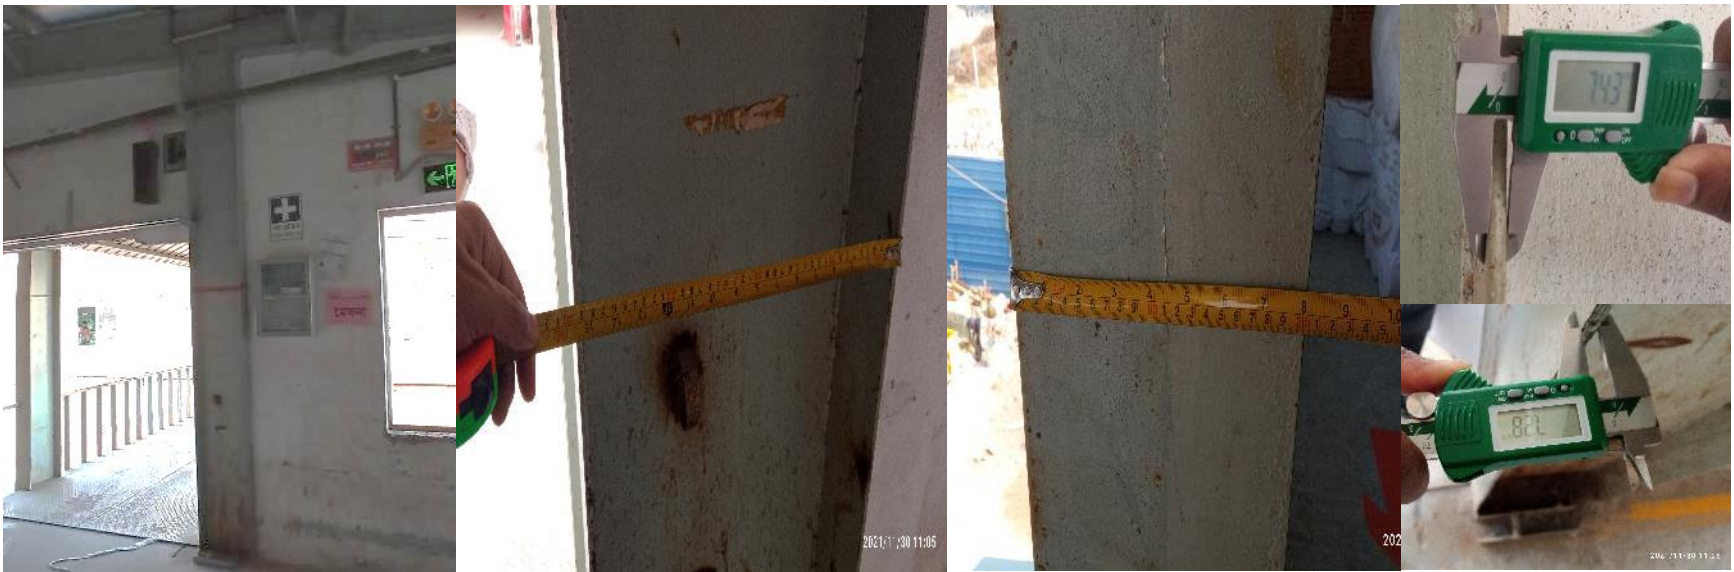
Miss match in column at 1<sup>st</sup> floor (SC-3A found 390x200x7 instead of 400x230x8)

Structural details of Lift core & steel stair for lift machine room are not shown in the structural drawings. Some discrepancies have been found between drawings & existing condition. The building engineer is required to survey the structural components and produce accurate structural details & incorporate mismatches in as built drawings.

| Item No. | Observation | Recommended Action Plan | Recommended Timeline |
|---|---|---|---|
| 15 | Discrepancies between drawings and as-built condition: Shed-6 | The building engineer is required to survey the structure and produce accurate as-built drawings. | 6-weeks |

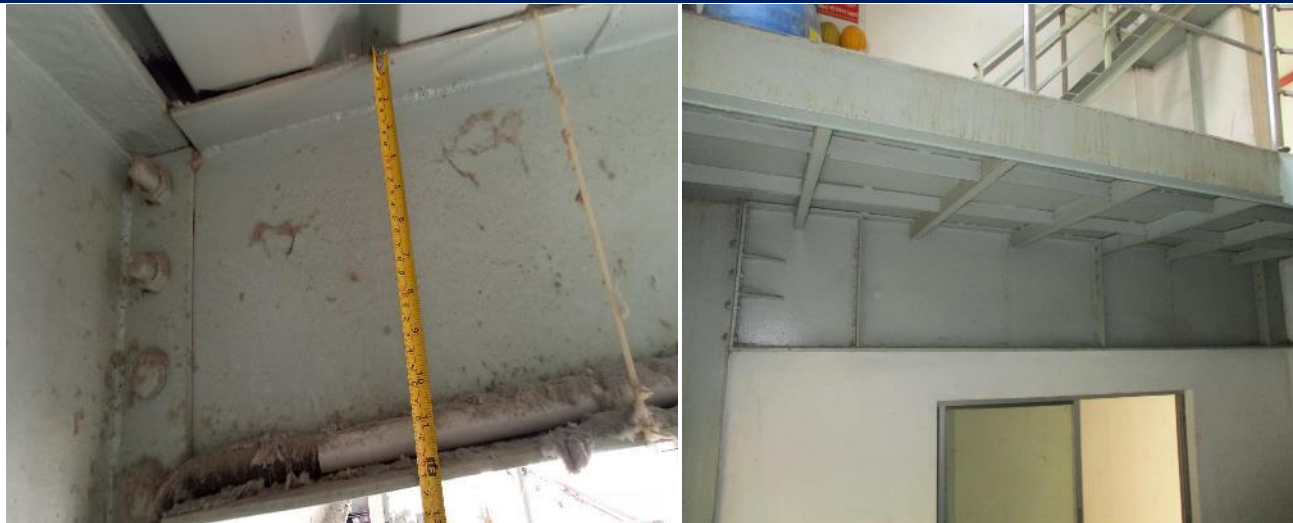
Miss match in beam (Web of SB1 found 310mm instead on 320mm & No extra plate was found in RMB1)

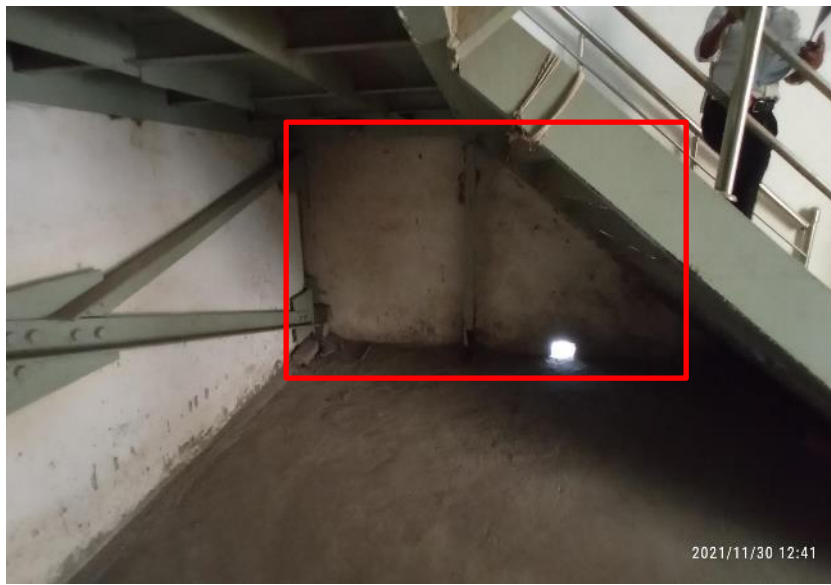
Missing bracing in stair

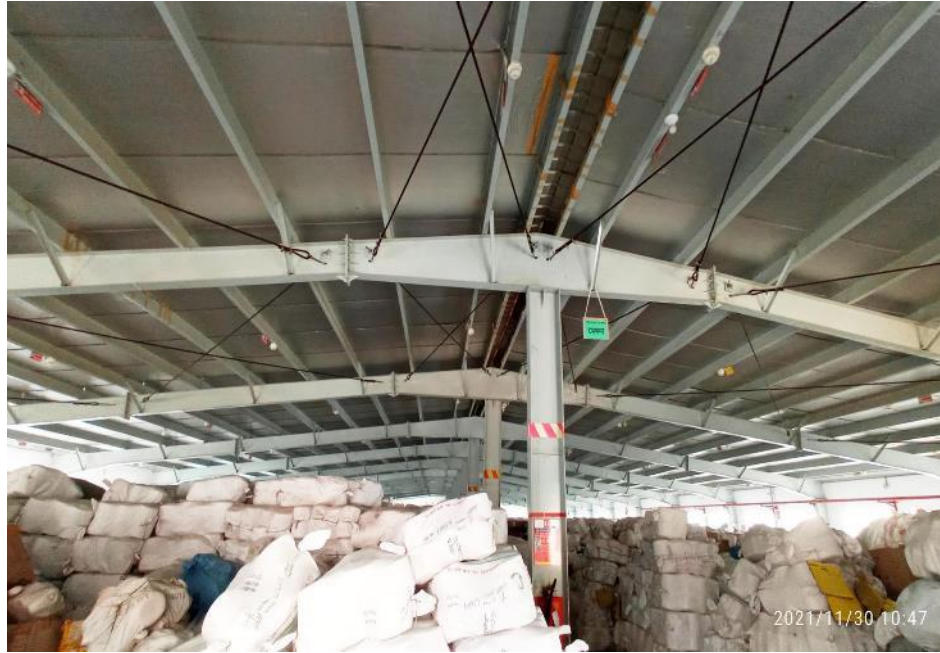
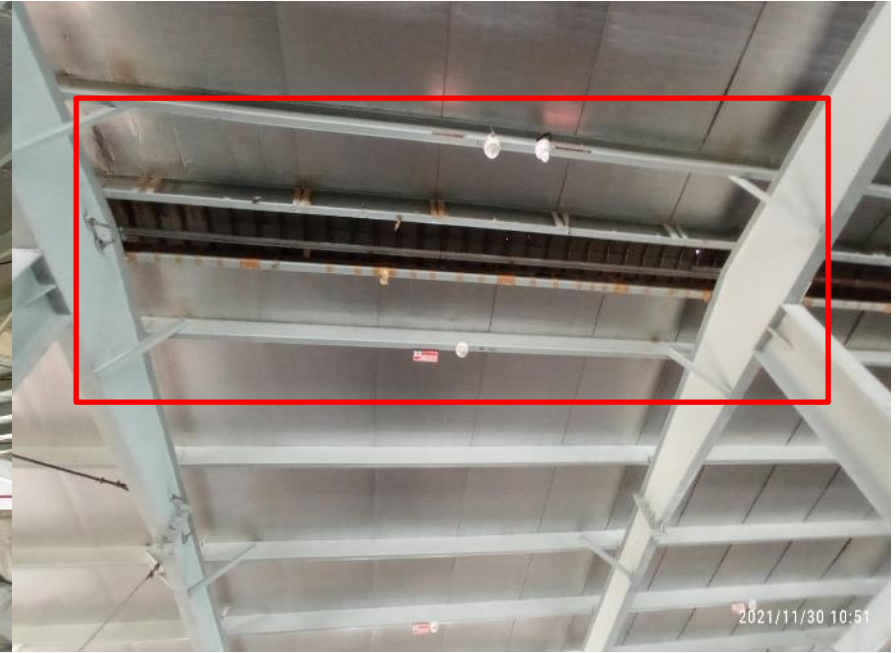
Absence of lateral load transfer media (compression strut) on roof

The building engineer is required to check the stability of the structural system and provide the appropriate load transfer media.

| Item No. | Observation | Recommended Action Plan | Recommended Timeline |
|---|---|---|---|
| 16 | Lack of lateral stability: Shed-6 | As part of Engineering Assessment (EA), the building engineer is required to check the stability of the structure and suggest necessary remedial actions. | 6-weeks |
| 17 | Lack of lateral stability: Shed-6 | Carry out remedial works as the EA. | 6-months |

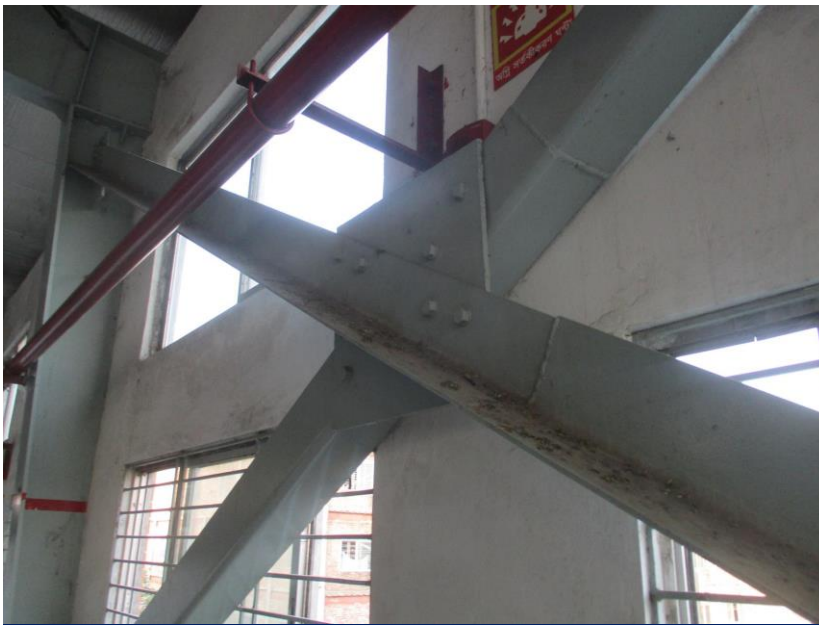
Vertical angle bracing on-site

Vertical angle bracing was observed on 1st floor instead of box bracing. RMB-2 beam was shown in the schedule and layout but did not found on-site. Building engineer to survey the structure and prepare accurate as-built drawings.

| Item No. | Observation | Recommended Action Plan | Recommended Timeline |
|---|---|---|---|
| 18 | Discrepancy in the drawings: Shed-7 | The building engineer is required to survey the structure and produce accurate as-built drawings. | 6-weeks |

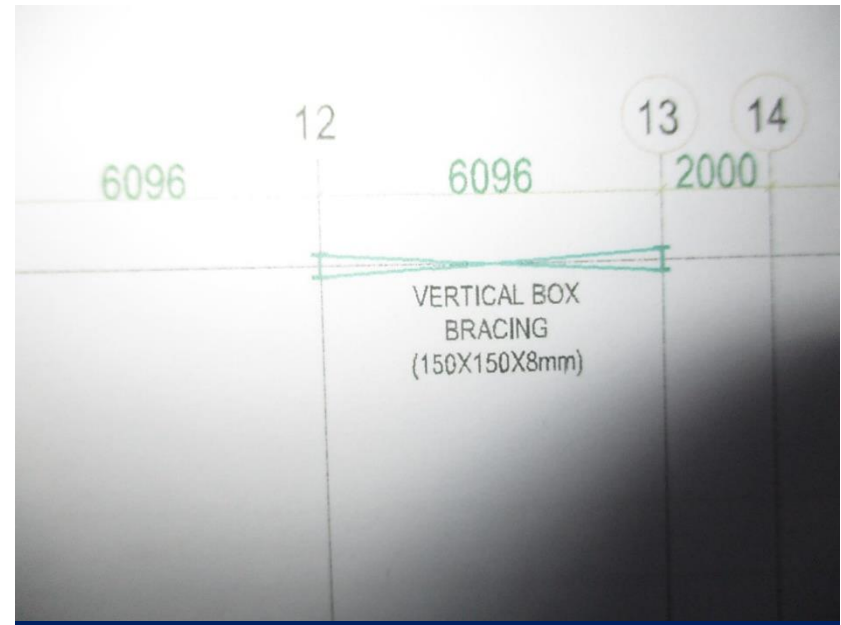
Vertical box bracing in drawing

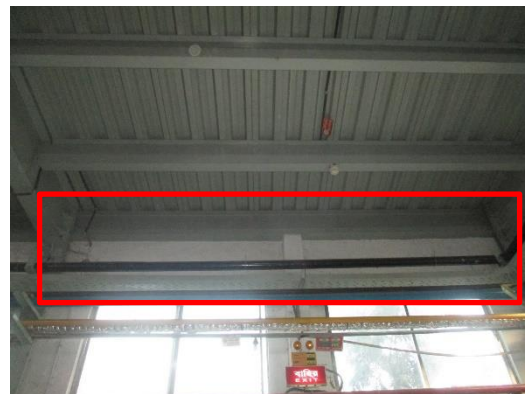
Beam MB-2 found on-site instead of RMB-2

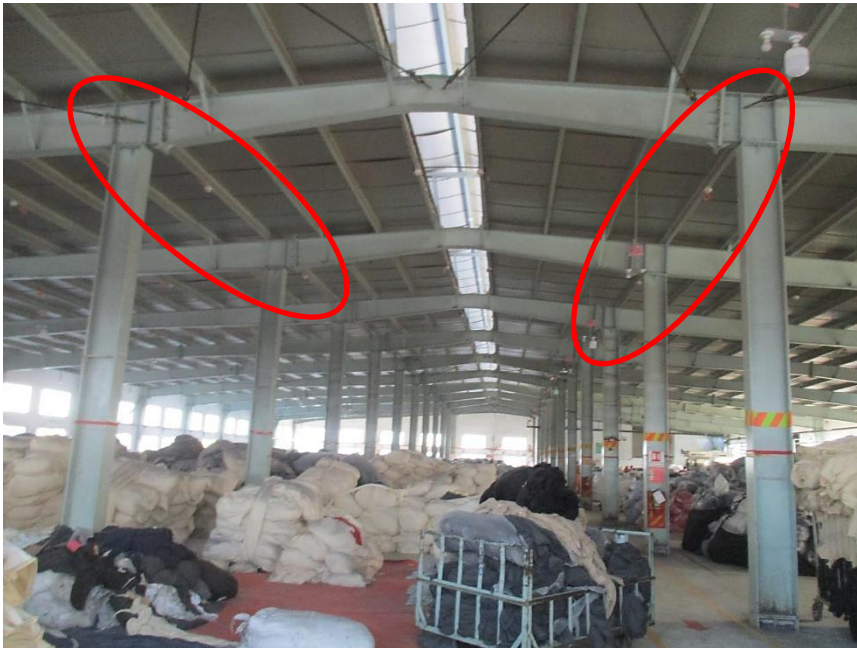
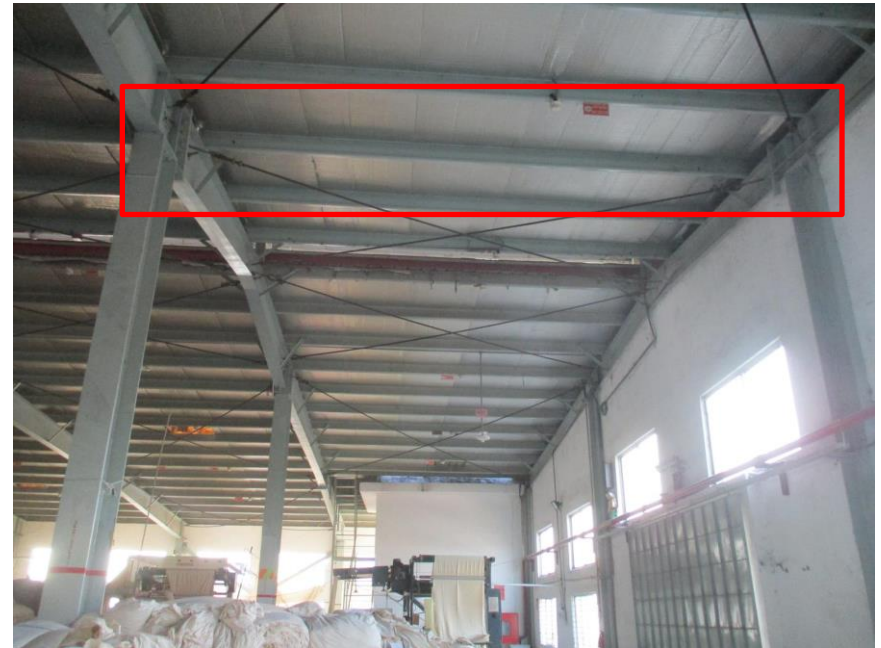
Absence of lateral load transfer media (compression strut) on roof

The factory engineer is required to check the stability of the structural system and provide the appropriate load transfer media.

| Item No. | Observation | Recommended Action Plan | Recommended Timeline |
|---|---|---|---|
| 19 | Lack of lateral stability: Shed-7 | As part of Engineering Assessment (EA), the building engineer is required to check the stability of the structure and suggest necessary remedial actions. | 6-weeks |
| 20 | Lack of lateral stability: Shed-7 | Carry out remedial works as the EA. | 6-months |

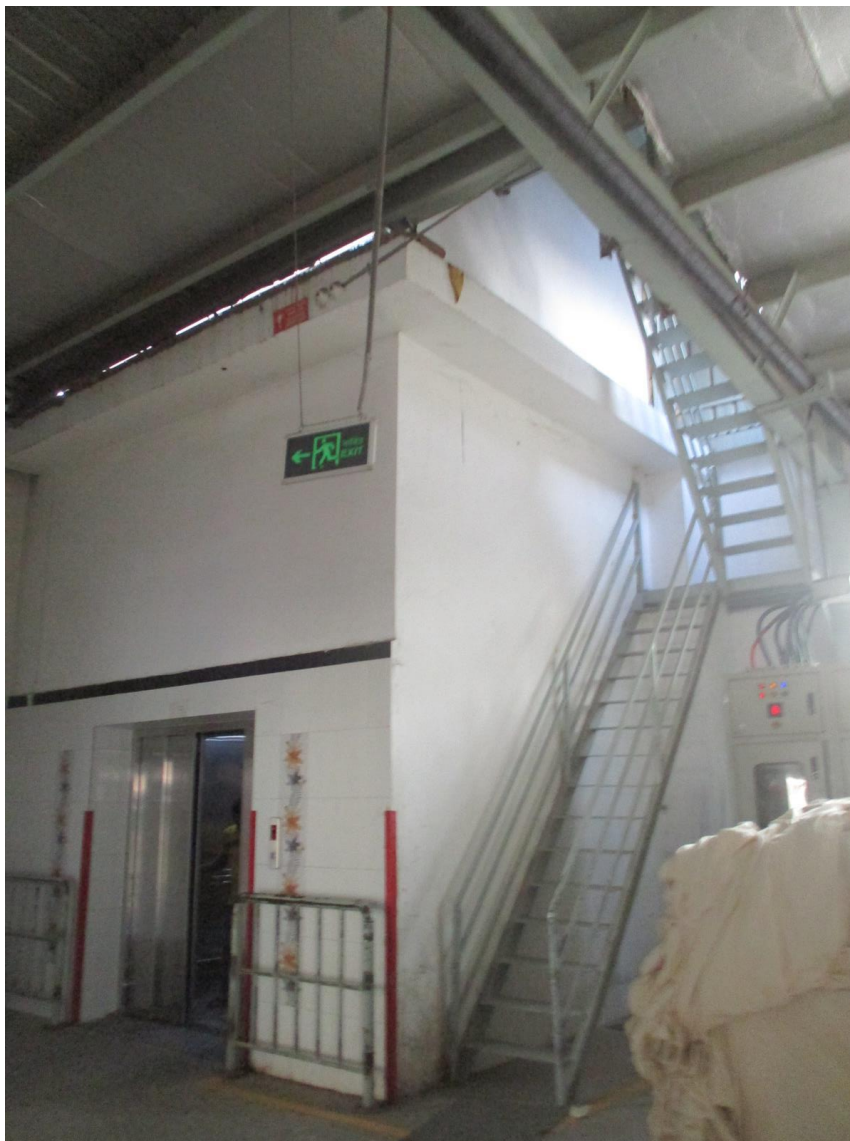
Steel stair from 1st floor to lift machine room

Building engineer is required to check  
the connections, stability system and  
structural adequacy of the steel stair.

| Item No. | Observation | Recommended Action Plan | Recommended Timeline |
|---|---|---|---|
| 21 | Apparently non-engineered steel stair: Shed-7 | The building engineer is required to check the connections, stability system and structural adequacy of the steel stair. | 6-weeks |
| 22 | Apparently non-engineered steel stair: Shed-7 | Carry out remedial works where required. | 6-months |

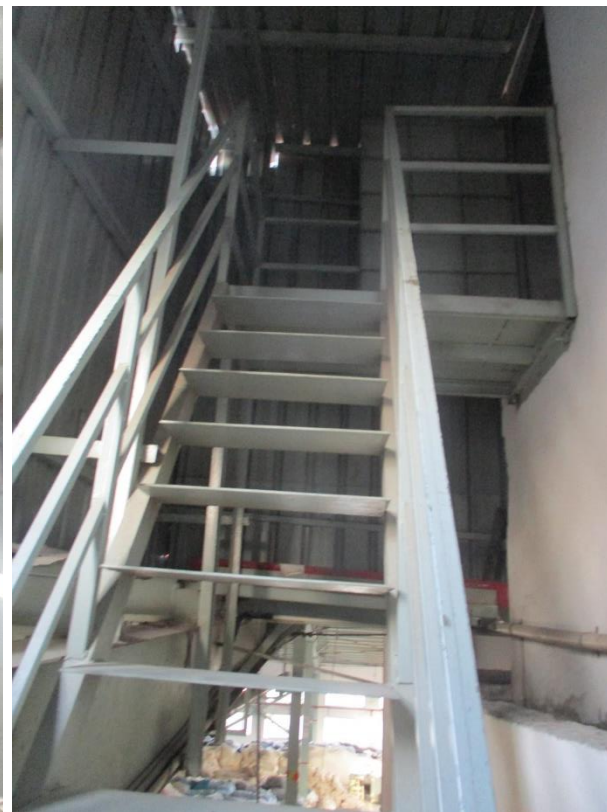
Steel stair connected with lift  
core brick wall

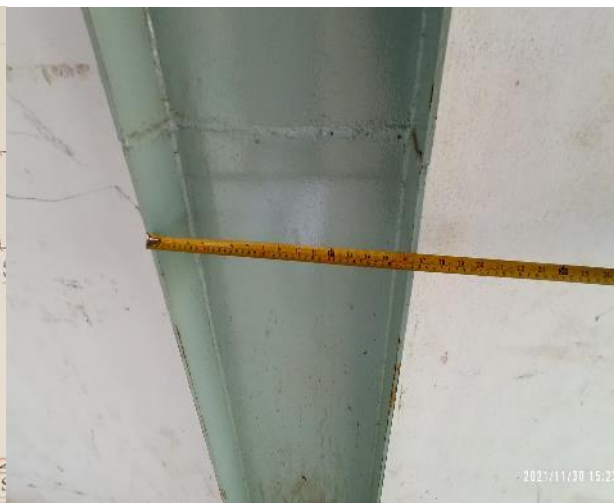
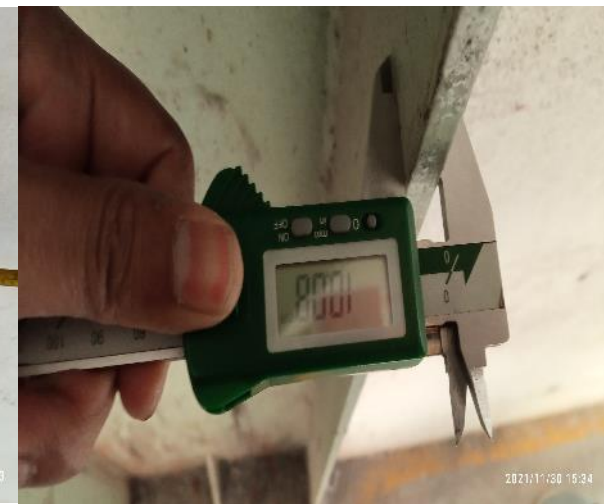
Mismatch in column (Flange thickness of column SC-1,2,3,4 found 10mm instead of 16mm, SC-1 at 1<sup>st</sup> floor found 600x400x10 (F) mm instead of 450x300x16 (F) & SC-2 at 1<sup>st</sup> floor found 425x200x10 (F) instead of 450x300x18 (F))

Some mismatches have been found between drawings & existing condition. The building engineer is required to survey the structural components and produce accurate structural details & incorporate mismatches in as built drawings.

| Item No. | Observation | Recommended Action Plan | Recommended Timeline |
|---|---|---|---|
| 26 | Discrepancy in the drawings: Shed-8 | The building engineer is required to survey the structure and produce accurate as-built drawings. | 6-weeks |

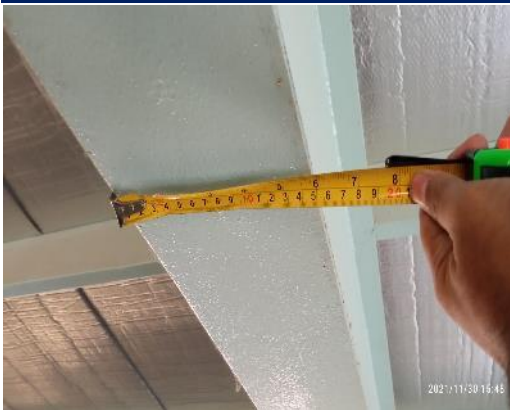
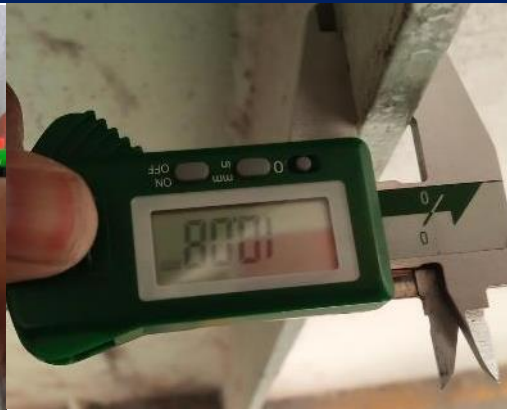
Mismatch in beam (Flange thickness of MB-1 found 12 instead of 16 & width of rafter at grid A-P found 150 although the rafter instead of 175 in middle part)

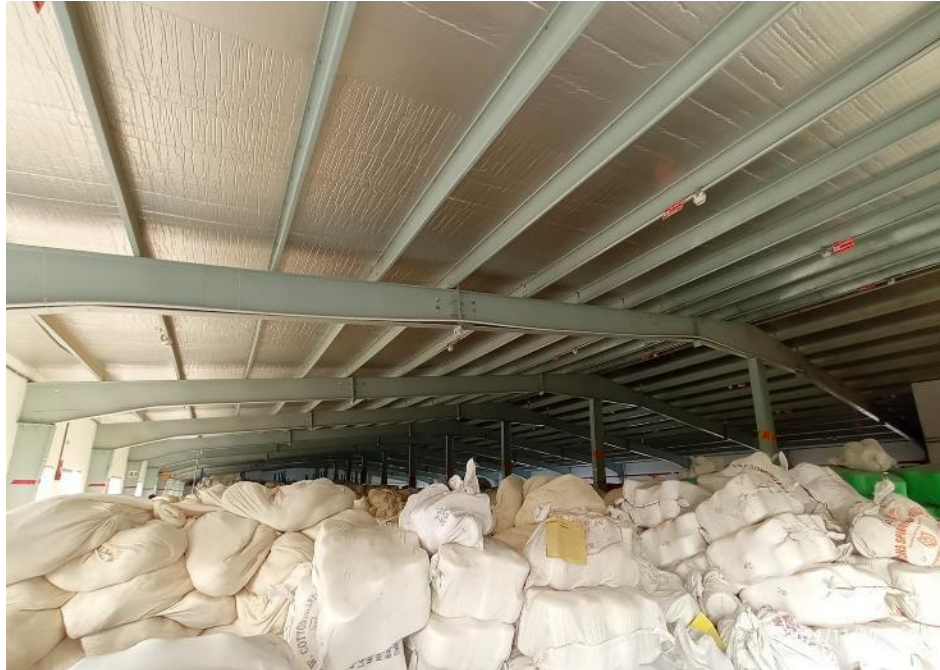
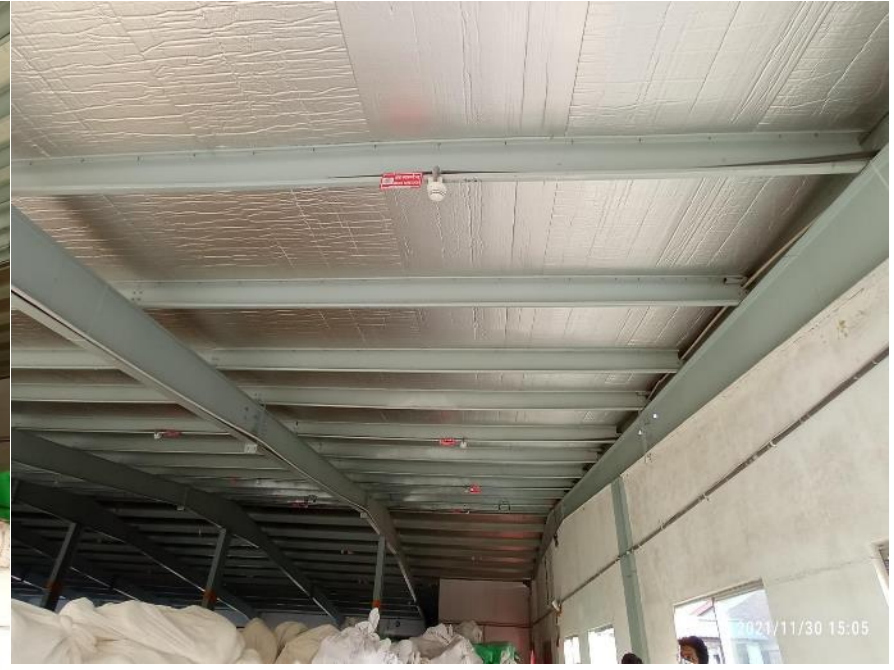
Apparently lack of lateral load resisting system observed in shed 8. Portal frame in the short direction but no compression strut and bracing observed in the long direction. Building engineer is required to check the lateral stability of the shed.

The factory engineer is required to check the stability of the structural system and provide the appropriate load transfer media.

| Item No. | Observation | Recommended Action Plan | Recommended Timeline |
|---|---|---|---|
| 27 | Lack of lateral stability: Shed-8 | As part of Engineering Assessment (EA), the building engineer is required to check the stability of the structure and suggest necessary remedial actions. | 6-weeks |
| 28 | Lack of lateral stability: Shed-8 | Carry out remedial works as the EA. | 6-months |

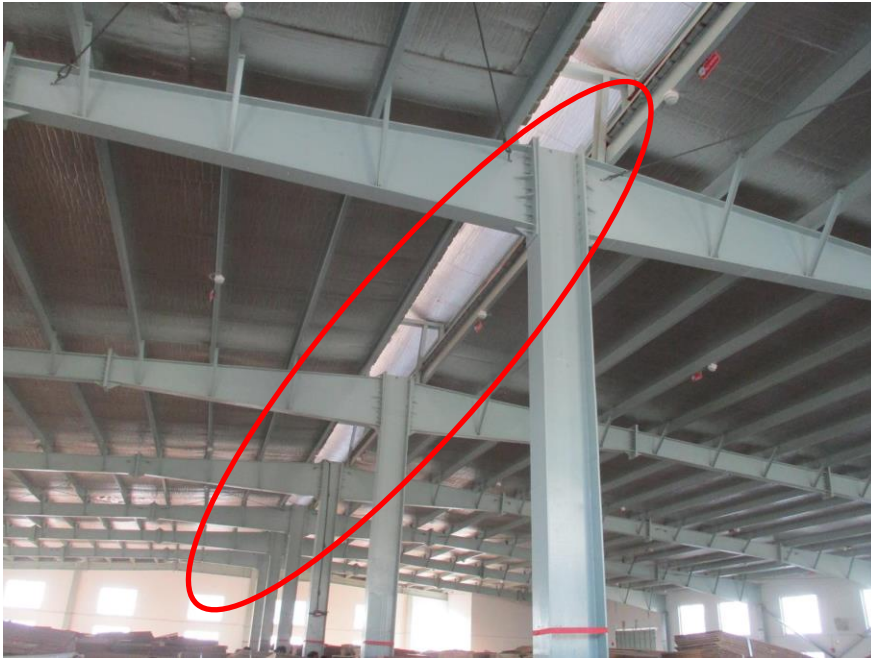
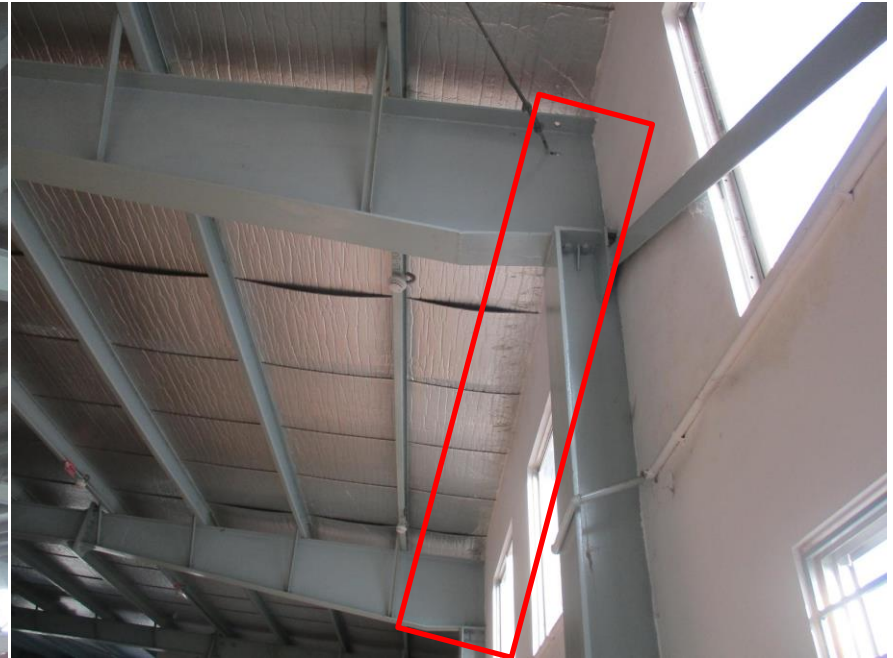
Absence of lateral load transfer media (compression strut) on roof

The factory engineer is required to check the stability of the structural system and provide the appropriate load transfer media.

| Item No. | Observation | Recommended Action Plan | Recommended Timeline |
|---|---|---|---|
| 32 | Lack of lateral stability: Shed-9 | As part of Engineering Assessment (EA), the building engineer is required to check the stability of the structure and suggest necessary remedial actions. | 6-weeks |
| 33 | Lack of lateral stability: Shed-9 | Carry out remedial works as the EA. | 6-months |

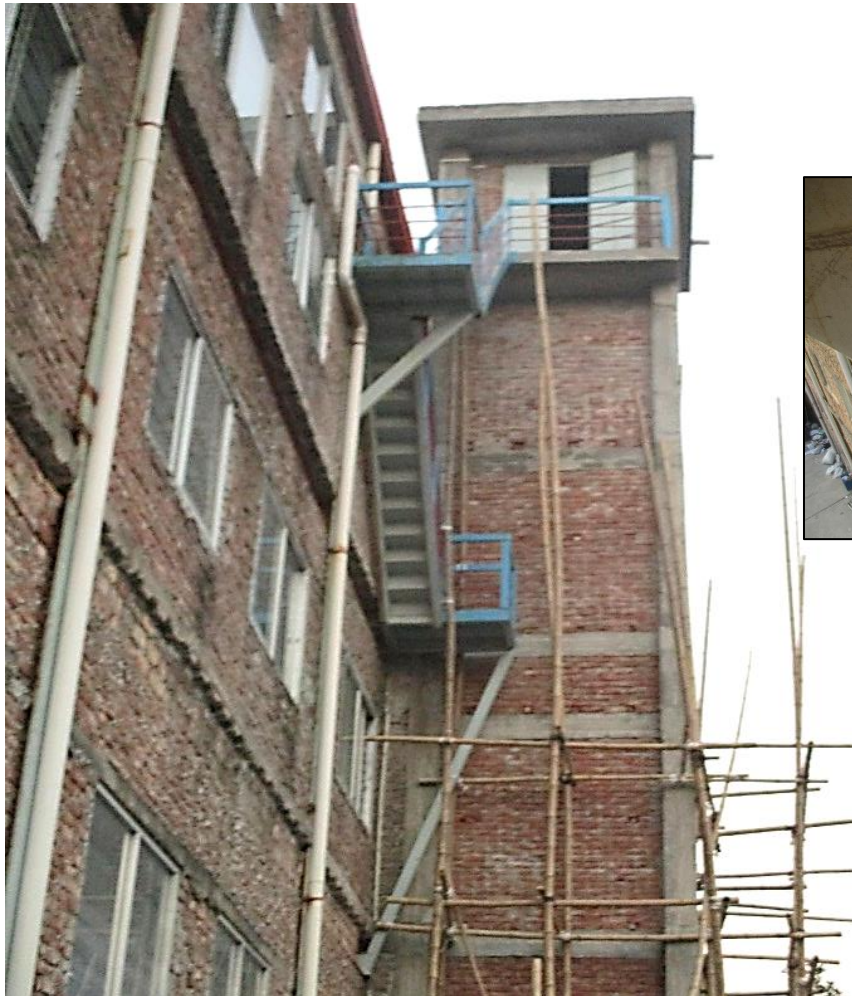
Steel stair from 1st floor to lift machine room

Building engineer is required to check the connections, stability system and structural adequacy of the steel stair.

| Item No. | Observation | Recommended Action Plan | Recommended Timeline |
|---|---|---|---|
| 34 | Apparently non-engineered steel stair: Shed-9 | The building engineer is required to check the connections, stability system and structural adequacy of the steel stair. | 6-weeks |
| 35 | Apparently non-engineered steel stair: Shed-9 | Carry out remedial works where required. | 6-months |
