# FARIHA KNIT TEX LTD.

## (Extension Buildings)

Baroibogh, Enayet Nagar, Fatullah, Narayanganj.  
(23.619862N, 90.482921E)  
8th & 30th November 2021

# Observations

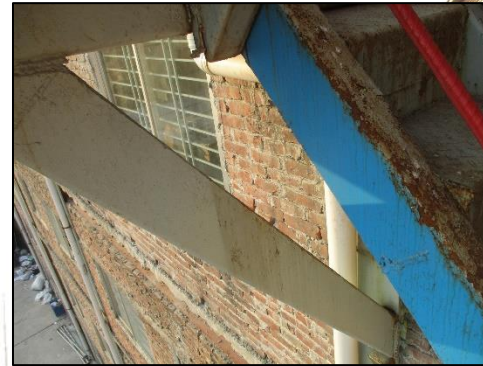
Steel stair connected with lift core and adjacent steel building

Building engineer is required to check the connections, stability system and structural adequacy of the steel stair.

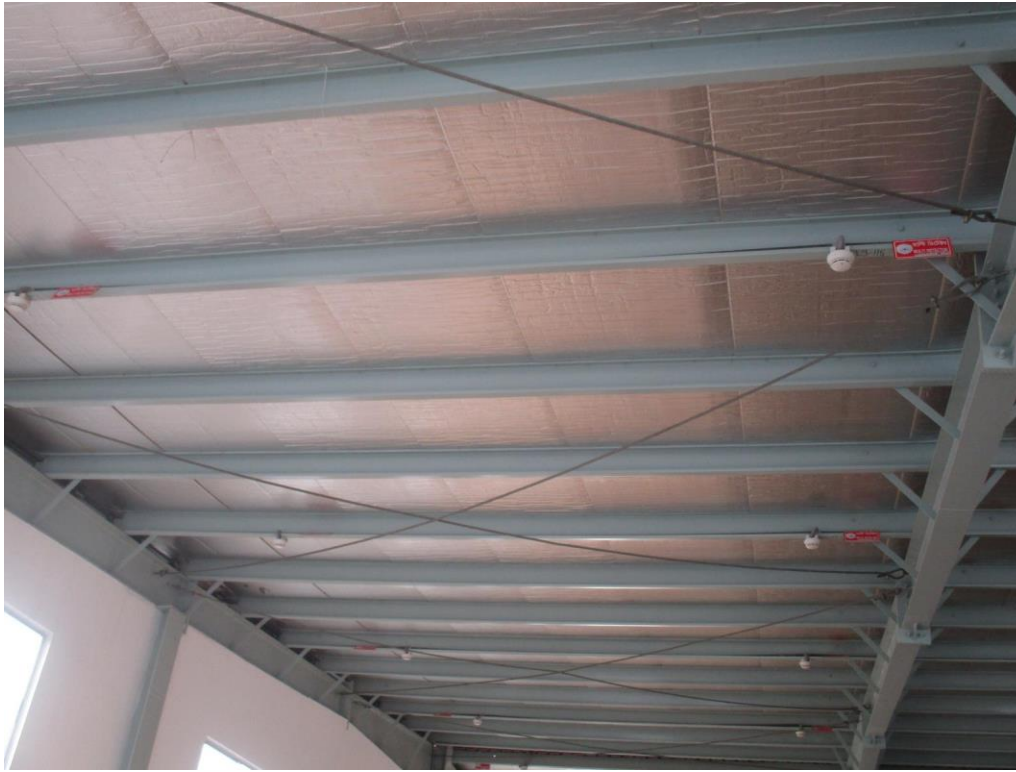
Loose cable bracing

Loose cable bracing and bolt missing in several locations were observed. The factory is required check the structure to identify the loose bracings and tighten those properly. And install the missing bolts where required.

| Item No. | Observation | Recommended Action Plan | Recommended Timeline |
|---|---|---|---|
| 36 | Loose cable bracings & bolt missing: Shed-9 | The factory is required check the structure to identify the loose bracings and tighten those properly. | 6-weeks |

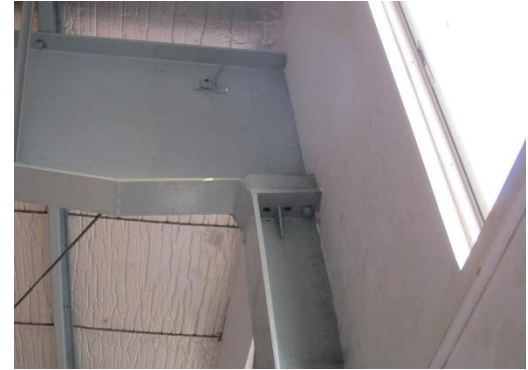
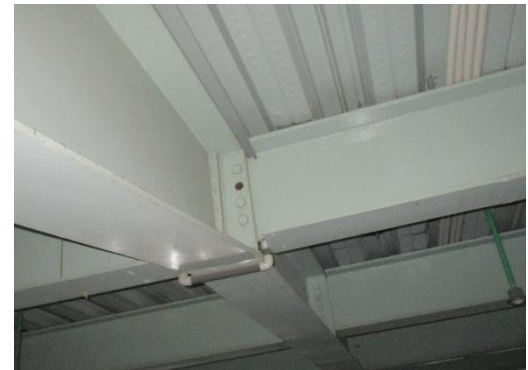
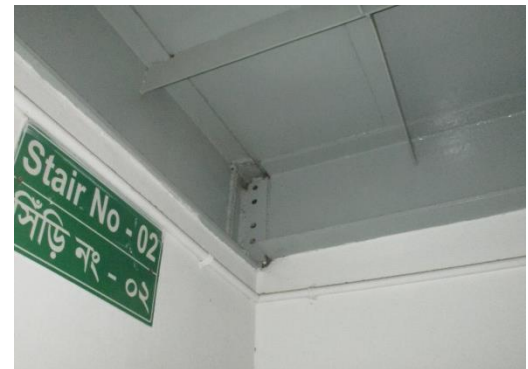
Bolt missing

| Item No. | Observation | Recommended Action Plan | Recommended Timeline |
|---|---|---|---|
| 37 | Loose cable bracings & bolt missing: Shed-9 | Install the missing bolts where required. | 6-weeks |

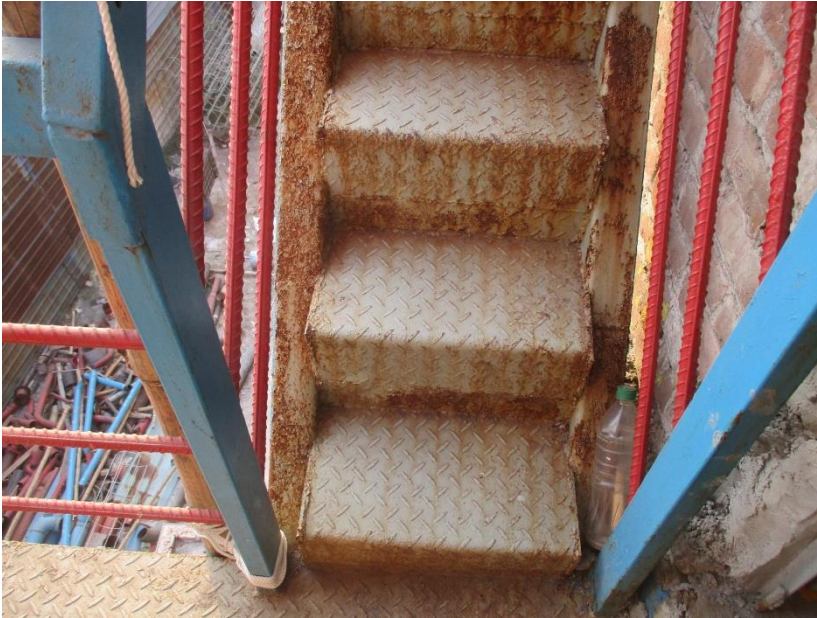
Loose cable bracing

Corrosion in steel member in several locations were observed. The factory is required to identify the locations, remove corrosion and apply corrosion resistance coating to the members.

| Item No. | Observation | Recommended Action Plan | Recommended Timeline |
|---|---|---|---|
| 38 | Corrosion in the steel member: Shed-9 | The factory is required to identify the locations, remove corrosion and apply corrosion resistance coating to the steel members. | 6-weeks |
