# Azmeri Composite Knit Ltd (Extension Buildings)

25<sup>th</sup> October 2021

# Buildings Information

1. Building 3 [G+M]
2. Building 4 (Store Shed-1) [G+M]
3. Building 5 (Store Shed-2) [B+G]

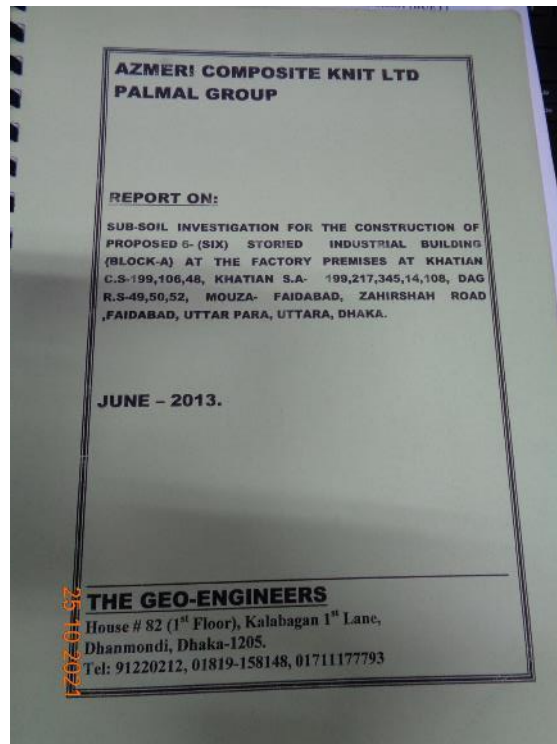
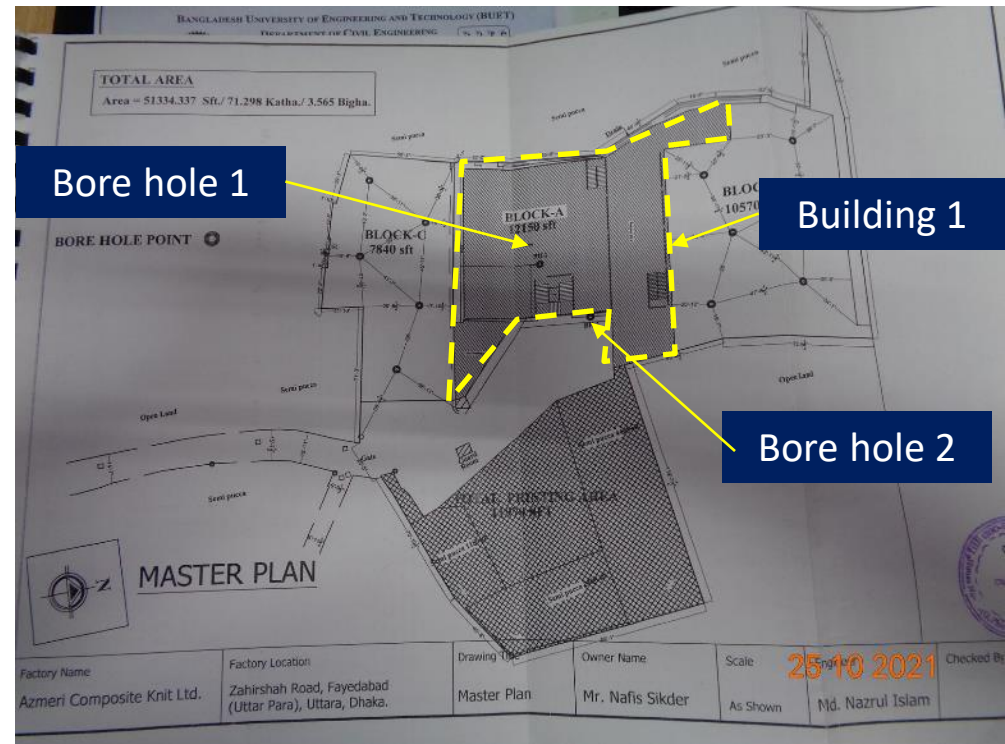
Geotechnical investigation report for Building 1

# **No geotechnical investigation report**

No geotechnical investigation report was found for the Building-3, Building-4 and Building-5. The factory management stated that, the geotechnical evaluation was done for the mentioned buildings based on the previous geotechnical investigation report that was produced for the Building 1 under ACCORD ID: 11361. But no bore hole sample for Building-3, 4 & 5 has been taken in the previous geotechnical investigation report. Thus, new geotechnical investigation report for the mentioned buildings is required to confirm the bearing adequacy of foundation.

| Item No. | Observation | Recommended Action Plan | Recommended Timeline |
|---|---|---|---|
| 01 | No geotechnical investigation report. [Building 3, 4, & 5] | Carryout geotechnical investigation. | 6-weeks |
| 02 | No geotechnical investigation report. [Building 3, 4, & 5] | Check the foundation adequacies and include in design report. | 6-weeks |
| 03 | No geotechnical investigation report. [Building 3, 4, & 5] | Carry out remedial works if necessary | 6-months |

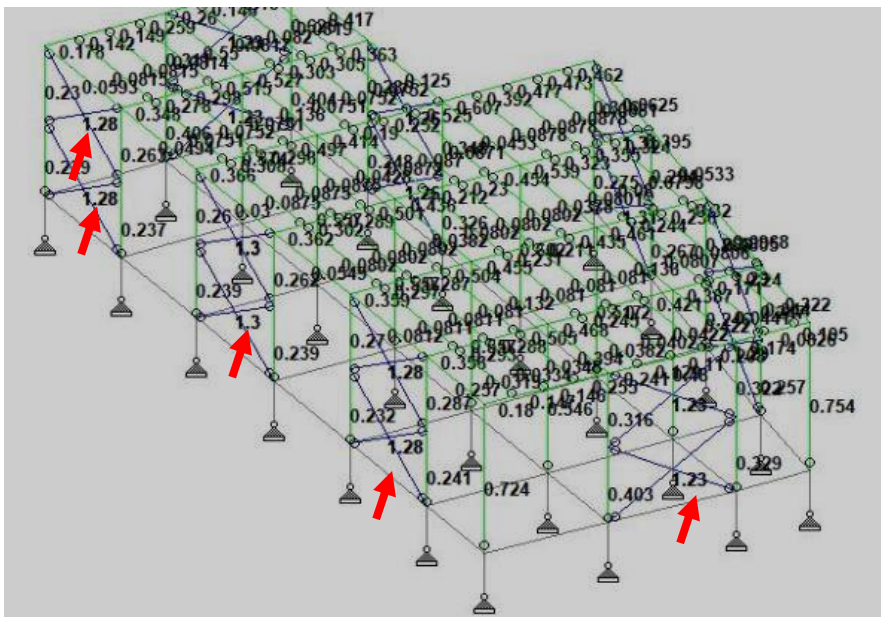
#### Material property in provided Design Report

**Design report need to be revised**

In provided design report, steel plate strength, concrete compressive strength and allowable bearing capacity of soil have been considered 50 ksi, 3379 psi and 2.6 ksf respectively. No credible test report has been found regarding that values. On the other hand, vertical pipe bracing are overstressed in provided FEM. Factory is required to revise the full set of Design Report in compliance with section 1.9.1.1 and section 1.9.1.2 of BNBC and submit to RSC for further review.

| Item No. | Observation | Recommended Action Plan | Recommended Timeline |
|---|---|---|---|
| 04 | Design report need to be revised. [Building 3] | Factory is required to revise the full set of Design Report in compliance with section 1.9.1.1 and section 1.9.1.2 of BNBC and submit to RSC for further review. | 6-weeks |
| 05 | Design report need to be revised. [Building 3] | Complete remedial works arising from design report. | 6-months |

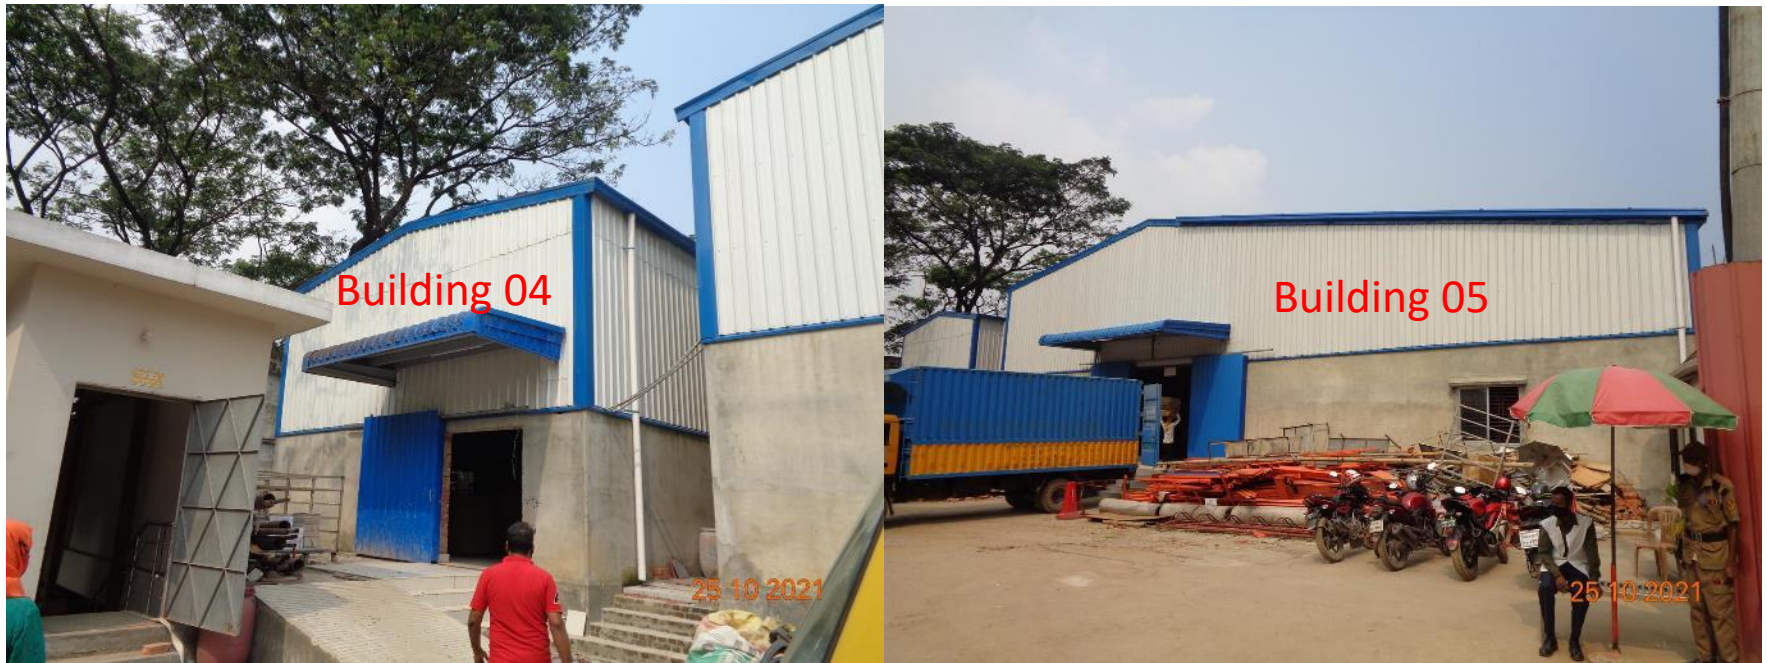
**Structural design report not available**

No design reports were available for Building 04 & 05

As per BNBC, every building or structure designed shall have its design documents prepared in accordance with the provision of Section 1.9.1. The design document shall include a design report, and a set of structural drawings, which shall be prepared in compliance with section 1.9.1.1 and section 1.9.1.2 as per BNBC. At the time of inspection, no design report was available which is required to be prepared in compliance with section 1.9.1.1 (part-6, BNBC).

| Item No. | Observation | Recommended Action Plan | Recommended Timeline |
|---|---|---|---|
| 06 | Structural design report not available. [Building 4, & 5] | Factory engineer is required to prepare the design documents including a design report, and a set of structural drawings in compliance with section 1.9.1.1 and section 1.9.1.2 as per BNBC part 6 and submit to RSC for review. | 6-weeks |
| 07 | Structural design report not available. [Building 4, & 5] | Complete remedial works arise from design report. | 6-months |

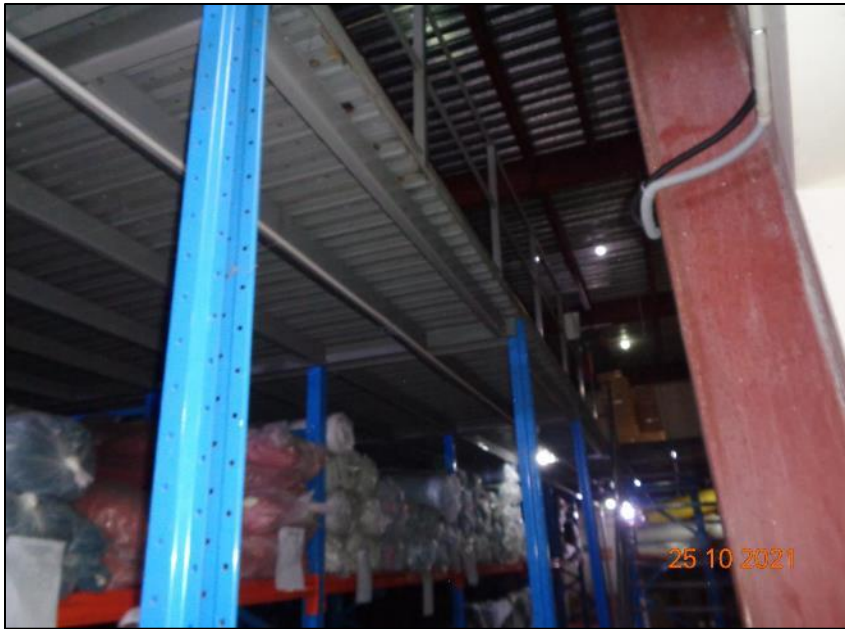
Mezzanine supported by rack post - Building 3

Building engineer is required to produce as-built drawing, check member adequacy for both mezzanine & canopy and recommend remedial measures accordingly.

| Item No. | Observation | Recommended Action Plan | Recommended Timeline |
|---|---|---|---|
| 08 | Undocumented mezzanine and canopy. [Building 3, 4, & 5] | The factory engineer to develop as-built drawing with necessary structural details. | 6-weeks |
| 09 | Undocumented mezzanine and canopy. [Building 3, 4, & 5] | Carry out adequacy check for the mezzanine floor and canopy. | 6-weeks |
| 10 | Undocumented mezzanine and canopy. [Building 3, 4, & 5] | Implement necessary remedial actions. | 6-months |

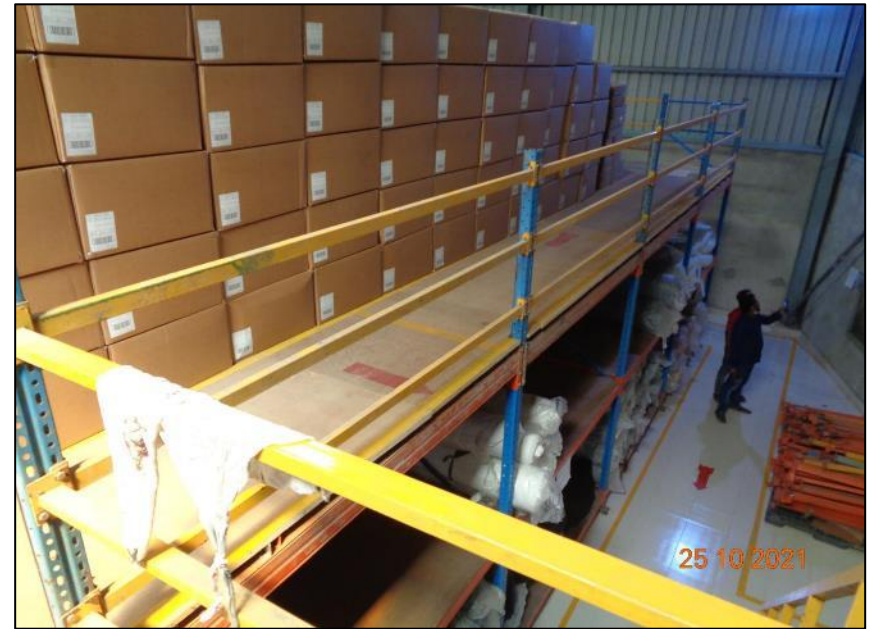
Mezzanine supported by rack post - Building 4

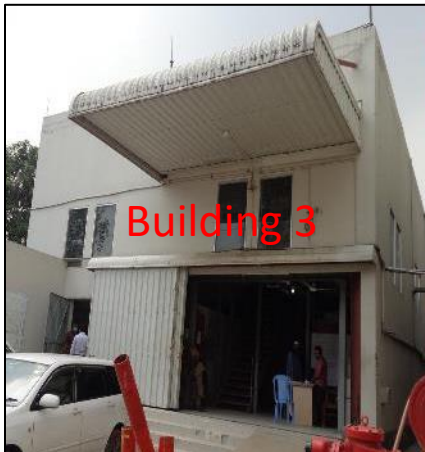
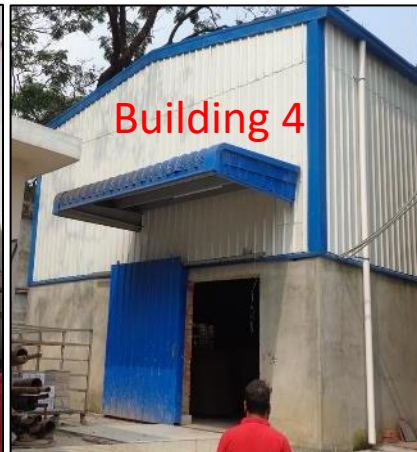
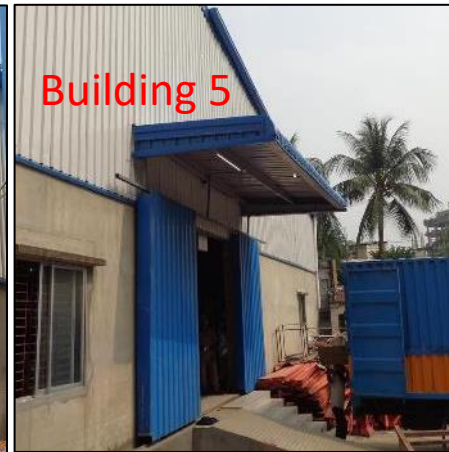
Undocumented Canopy

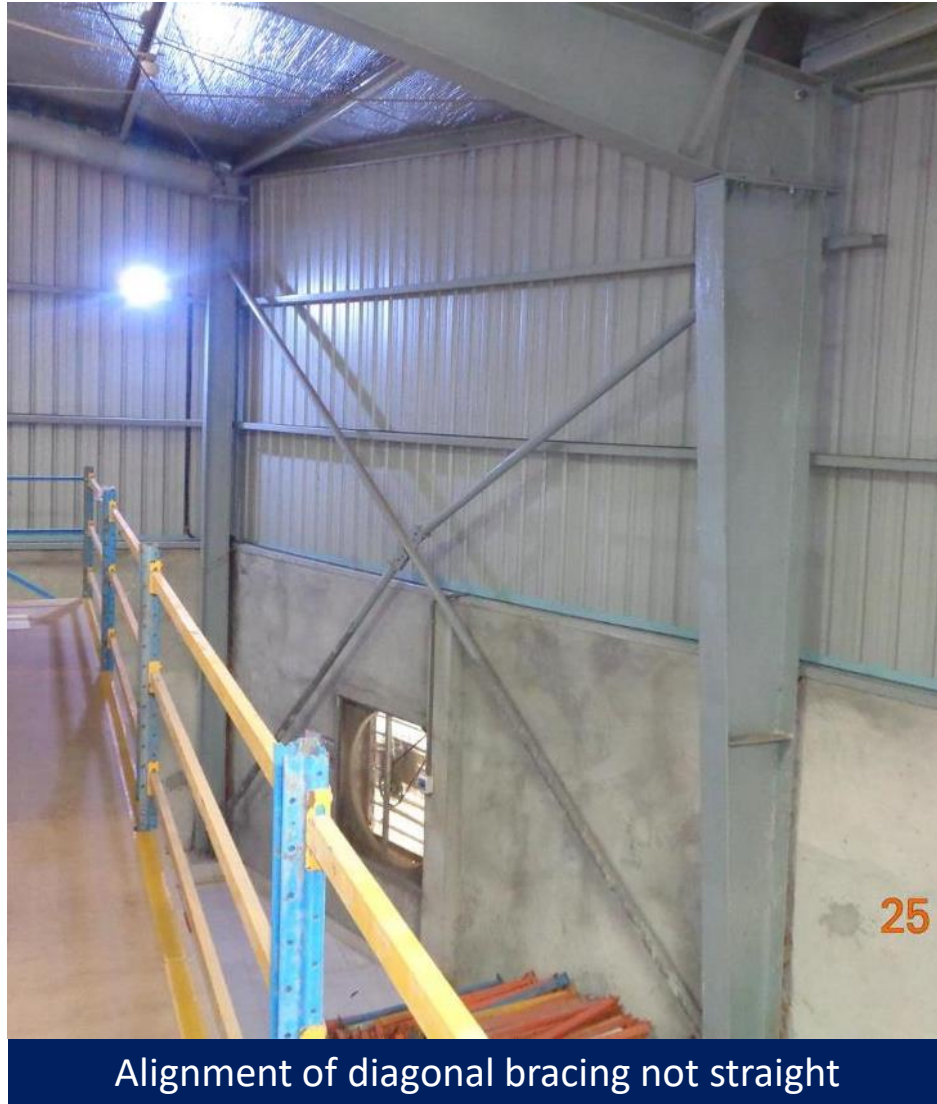
# Bracing misalignment

Alignment of diagonal bracing not straight

Factory engineer is required to align the bracing in proper position.

| Item No. | Observation | Recommended Action Plan | Recommended Timeline |
|---|---|---|---|
| 11 | Bracing misalignment. [Building 4] | Factory engineer is required to align the bracing in proper position. | 6-weeks |

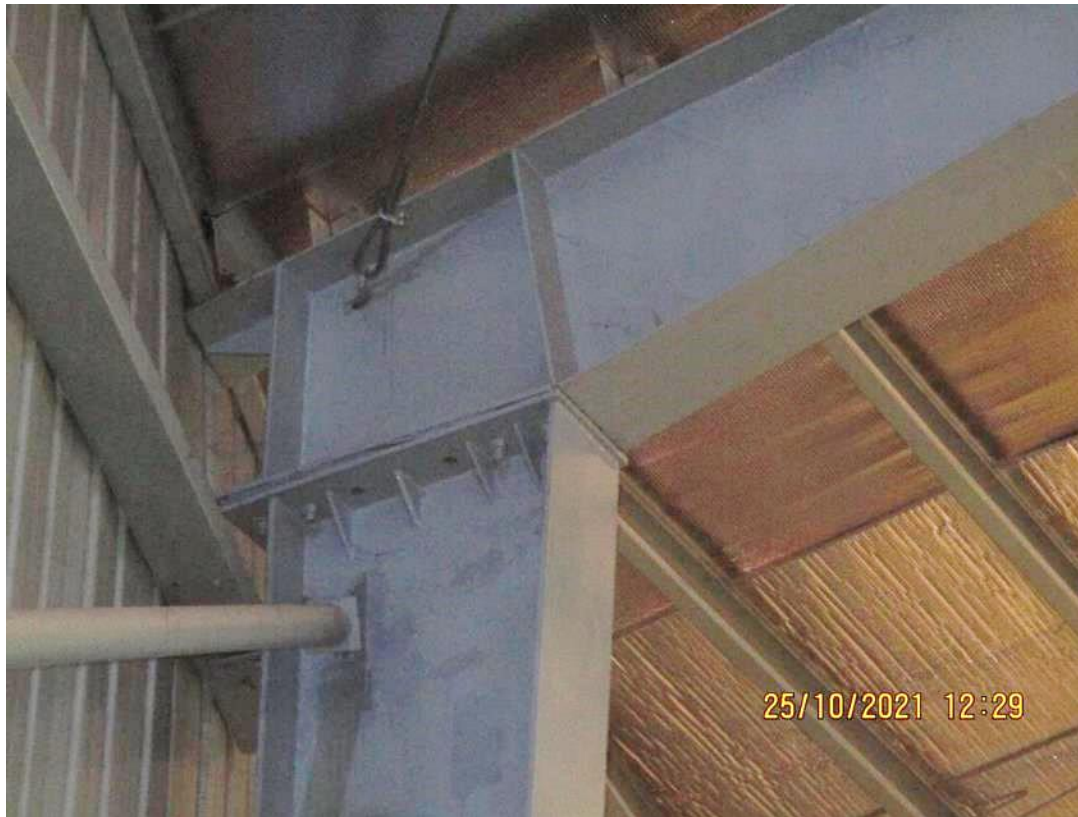
# Missing bolts in structural members

Bolts were missing at several locations

Factory to check the structure and install missing bolts where required.

| Item No. | Observation | Recommended Action Plan | Recommended Timeline |
|---|---|---|---|
| 12 | Missing bolts in structural members. [Building 4] | Install all missing bolts. | 6-weeks |

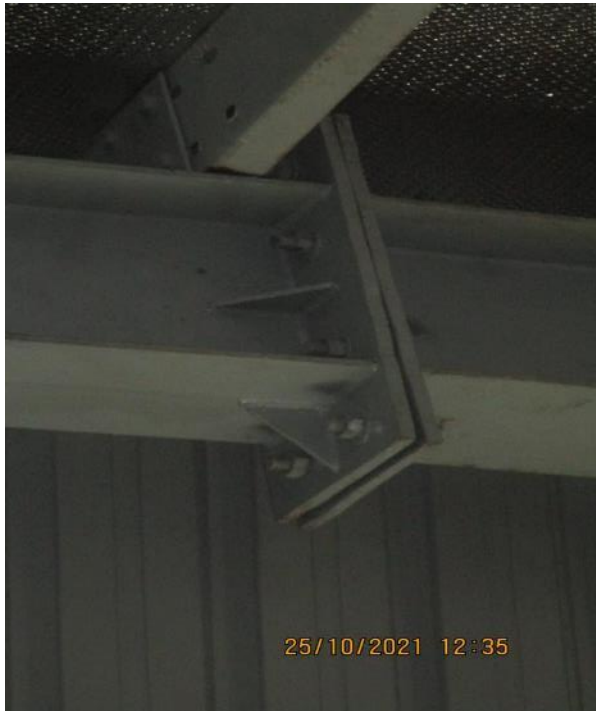
Connection gap – Building 4

Significant gap in the connections were observed at several locations. Factory engineer is required to carry out suitable remedial works.

| Item No. | Observation | Recommended Action Plan | Recommended Timeline |
|---|---|---|---|
| 13 | Significant gap between connection plates. [Building 4, & 5] | Repair the connections with a suitable method. | 6-weeks |

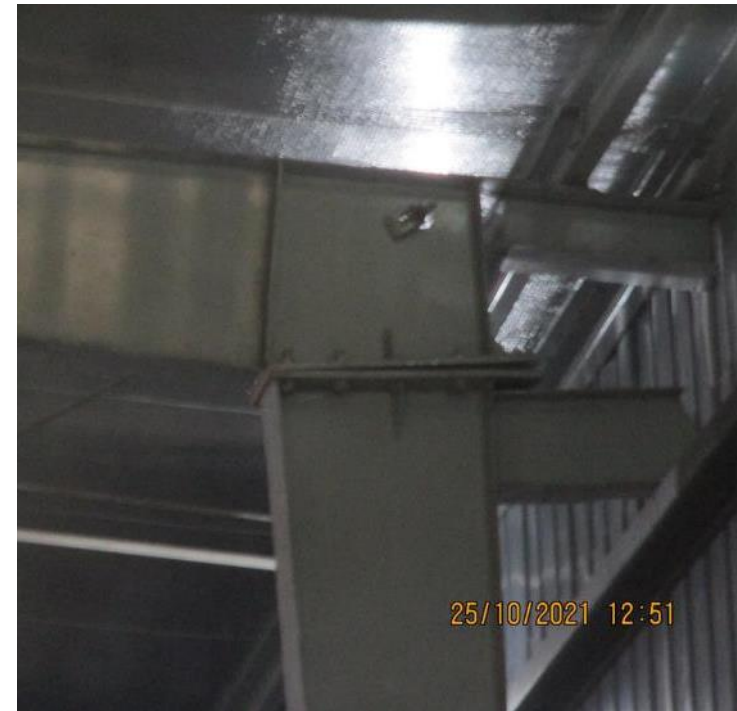
Connection gap – Building 5

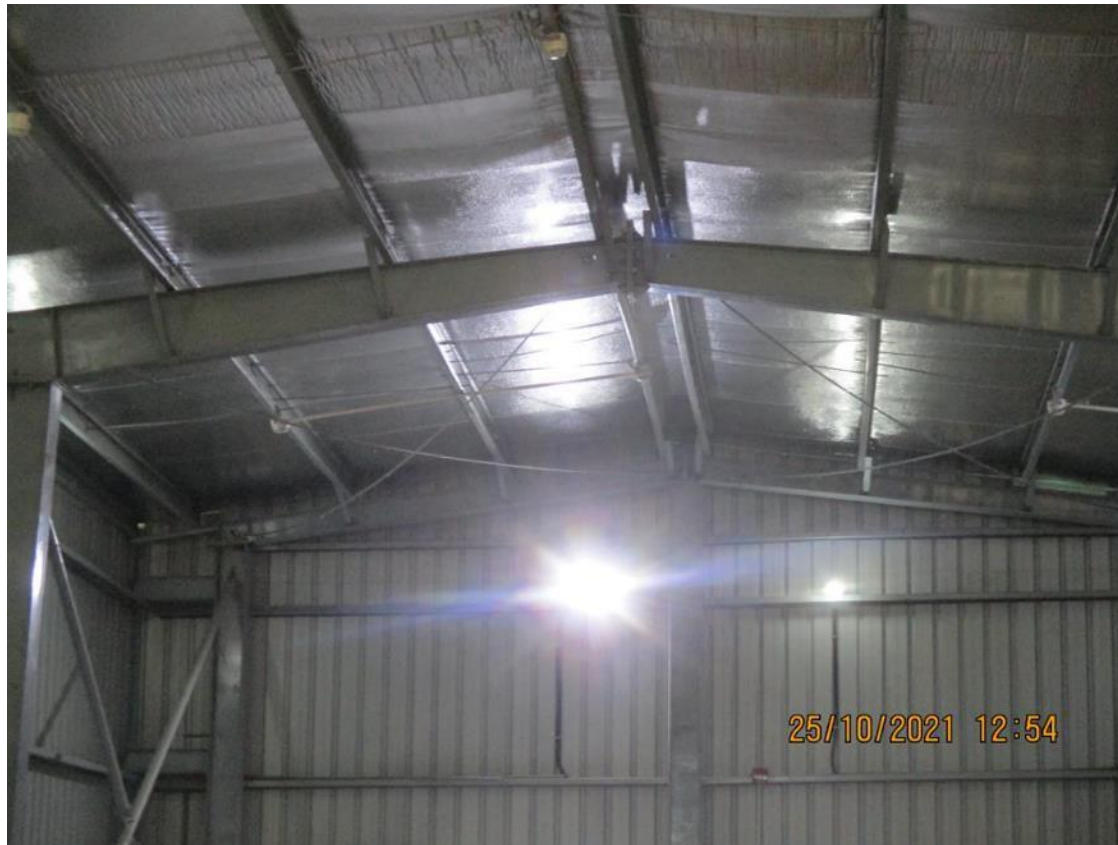
# Loose cable bracing

Loose bracings.

Factory engineer is required to tighten the loose bracings to active the lateral load resisting system.

| Item No. | Observation | Recommended Action Plan | Recommended Timeline |
|---|---|---|---|
| 14 | Loose cable bracing. [Building 5] | Tighten the loose bracings to active the lateral load resisting system. | 6-weeks |
