# Tech Max Ltd.

Beron, Diakhali, Yearpur Union, Ashulia, Dhaka-1349.

24<sup>th</sup> October 2021

# Observations

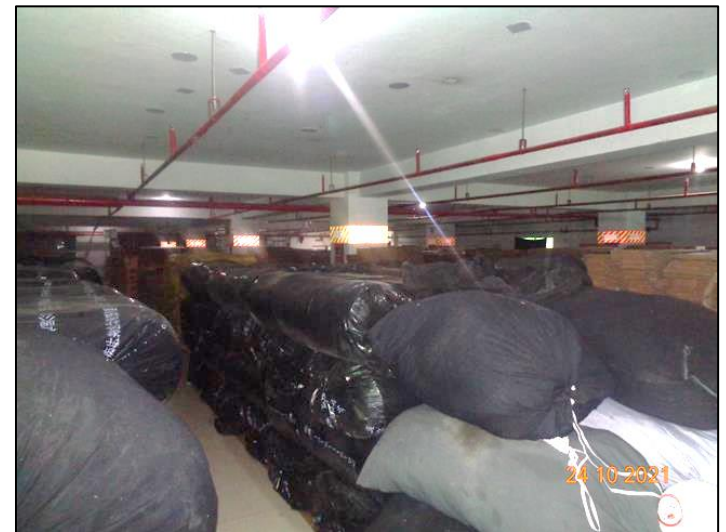
1) 1<sup>st</sup> floor load plan. 2) 2<sup>nd</sup> floor load plan

Live load has been considered 5 kPa (105 psf) in load plan.

The live load of the storage area has been considered 5kPa (105 psf) which do not comply the floor load requirement of BNBC. As per BNBC, minimum loading 6 Kpa is required for the light storage warehouse. Building engineer is required to update the floor loading plan, software-based analysis and design report following BNBC loading requirement.

| Item No. | Observation | Recommended Action Plan | Recommended Timeline |
|---|---|---|---|
| 02 | Inconsistency in the design report | Produce and actively manage a loading plan for all floor plates within the factory giving consideration to floor capacity and column capacity. | 6-weeks |

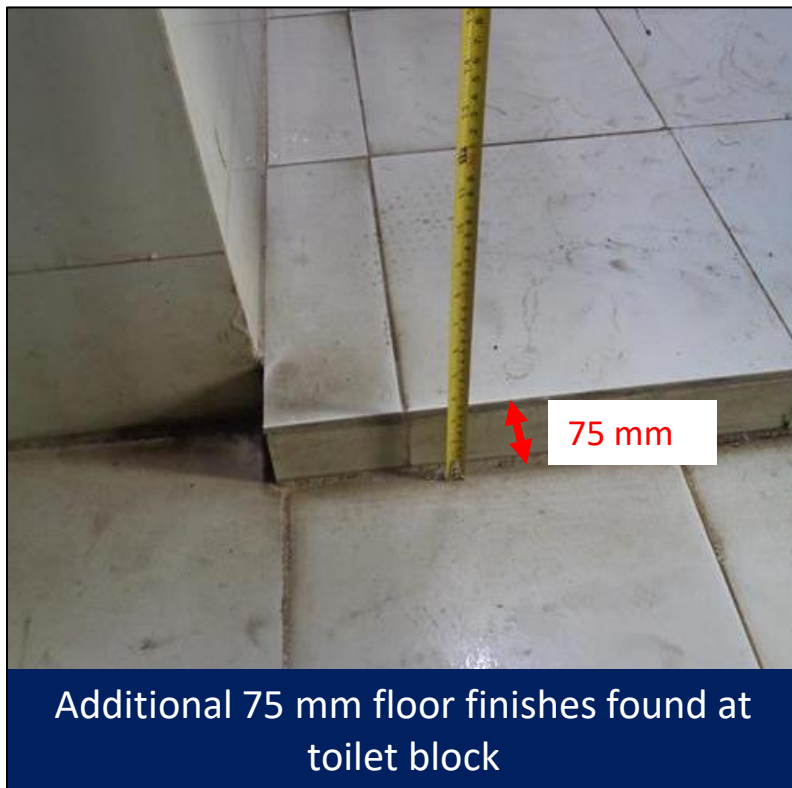
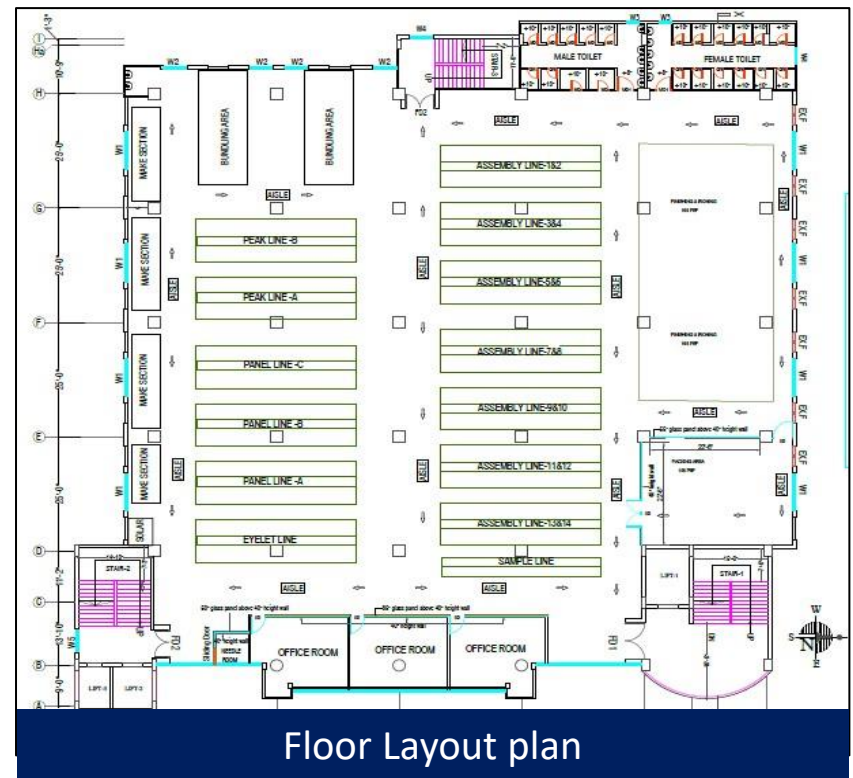
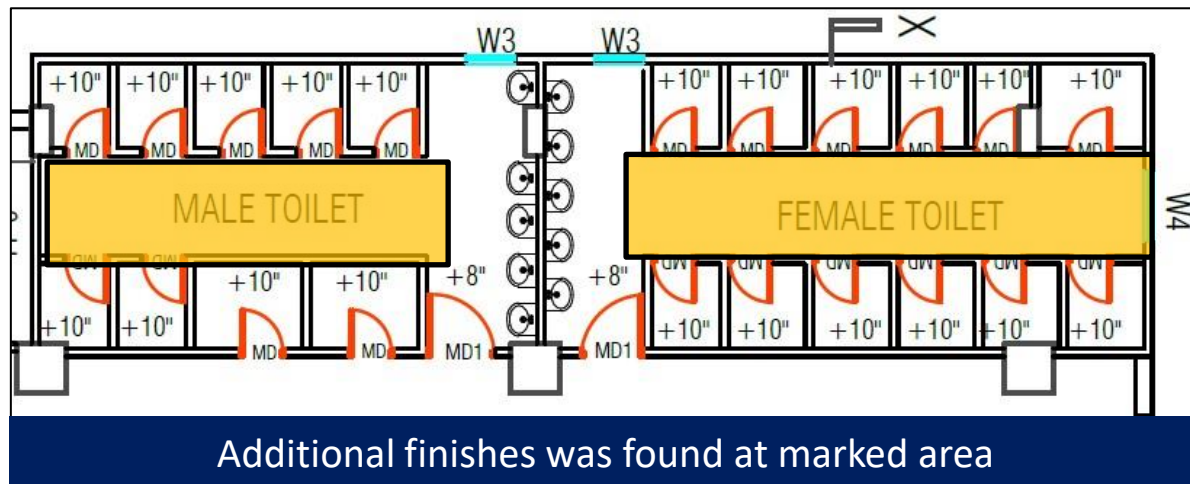
During inspection, additional Floor finishes was found 75 mm in toilet zone area. Which has not been shown in drawing. Building engineer is required to update the as-built drawing and revise the DEA document which to reviewed by RSC.

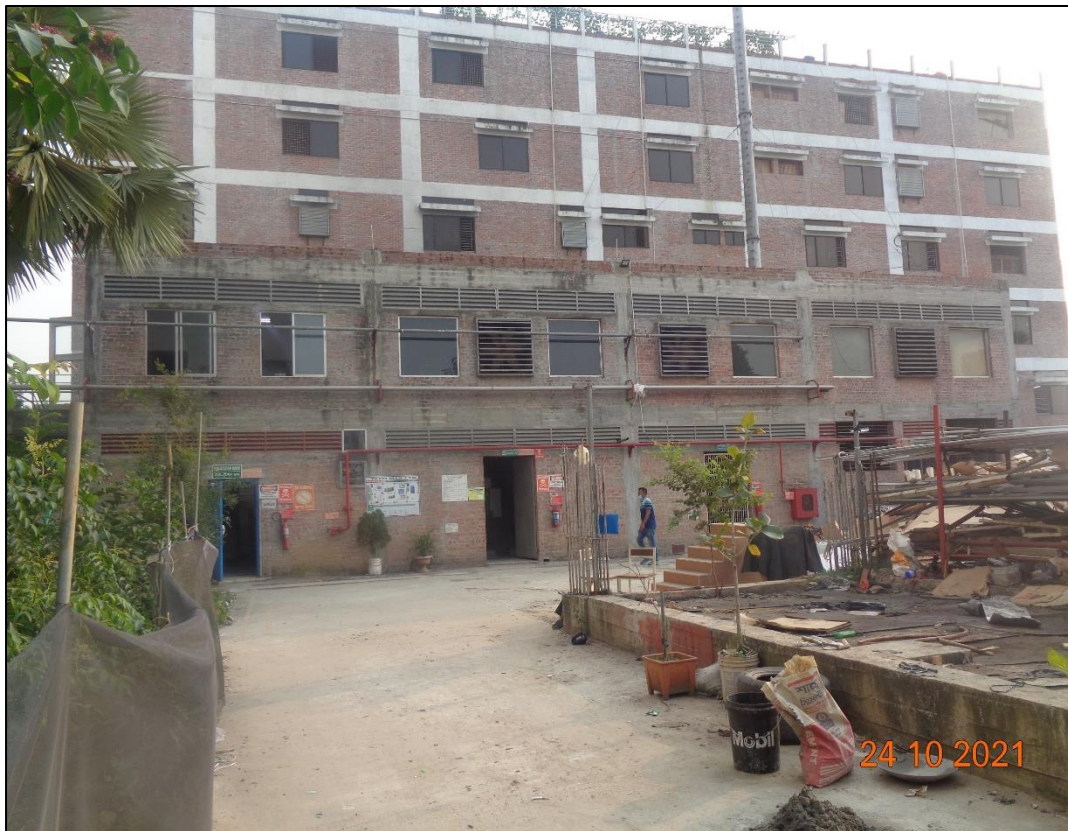
No design report for utility building

As per BNBC, every building or structure designed shall have its design documents prepared in accordance with the provision of Section 1.9.1. The design document shall include a design report, and a set of structural drawings, which shall be prepared in compliance with section 1.9.1.1 and section 1.9.1.2 as per BNBC (Part-6). Factory provided only as-built drawing for this structure, but no design report was available at the time of inspection.

Building engineer is required to prepare design documents including design report, load plan following BNBC-2006 requirements.

| Item No. | Observation | Recommended Action Plan | Recommended Timeline |
|---|---|---|---|
| 05 | Design report needs to be prepared | Building engineer to prepare the design report in compliance with section 1.9.1.1 as per BNBC. | 6-weeks |

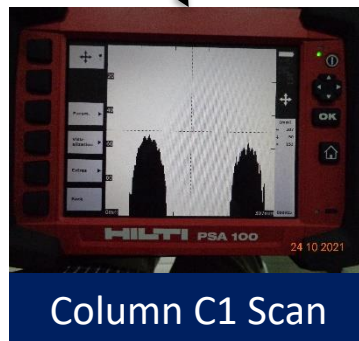
Column C1 Scan

As-built drawing no. of rebar of C1, C2 & C3 column was mentioned as 8-20mm, 10-20mm & 12-20mm, respectively. But during the inspection by Ferro scanning no. of rebar of C1, C2 & C3 column was found 4-20mm, 8-20mm & 8-20mm, respectively. Building engineer is required to update the as-built drawing with the accurate on-site condition.

| Item No. | Observation | Recommended Action Plan | Recommended Timeline |
|---|---|---|---|
| 07 | Discrepancies in as-built drawing | Building engineer is required to update the as-built drawing as per onsite condition. | 6-weeks |

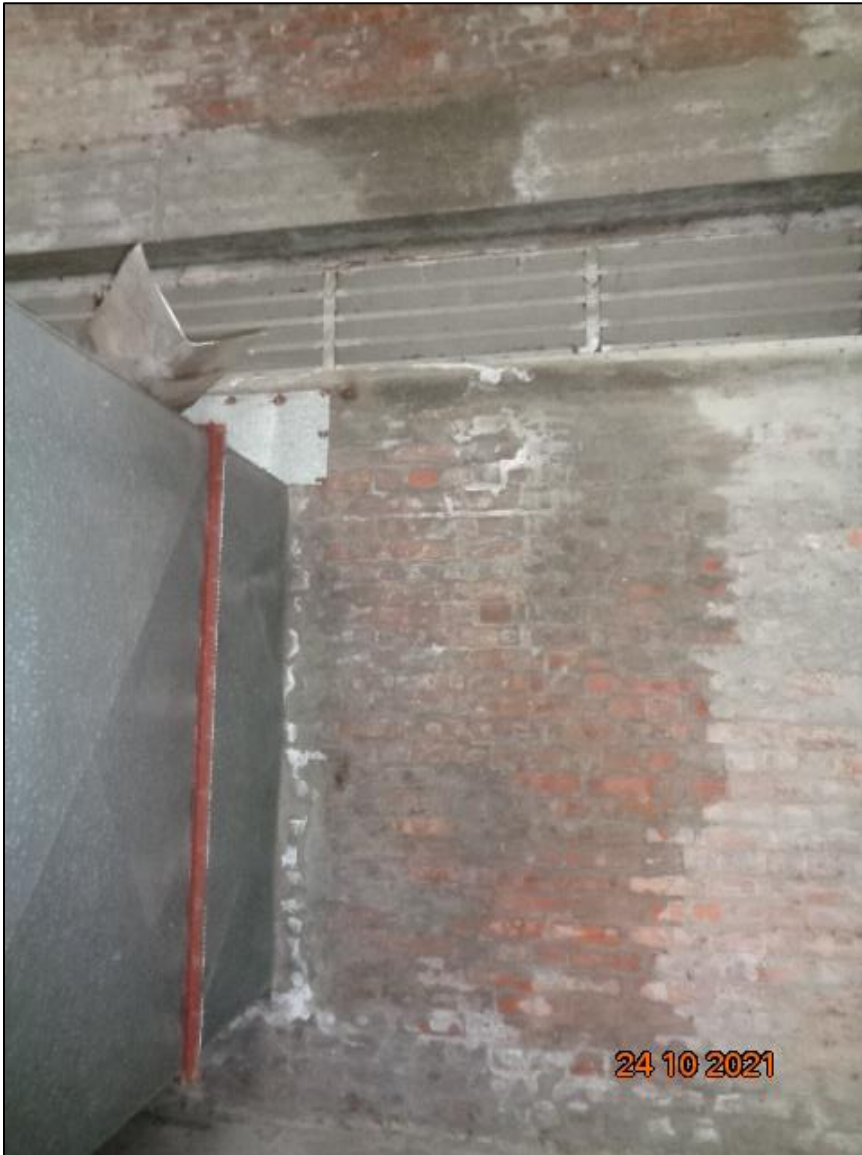
Due to water absorption, dampness was found on brick wall & RC beam. Building engineer is required to take necessary measures to prevent dampness in brick wall & RC beam.

Dampness on brick wall

| Item No. | Observation | Recommended Action Plan | Recommended Timeline |
|---|---|---|---|
| 08 | Dampness on brick wall | Building engineer is required to investigate the damp area to verify if any damaged occurred due to the presence of the moisture and repair accordingly. | 6-weeks |

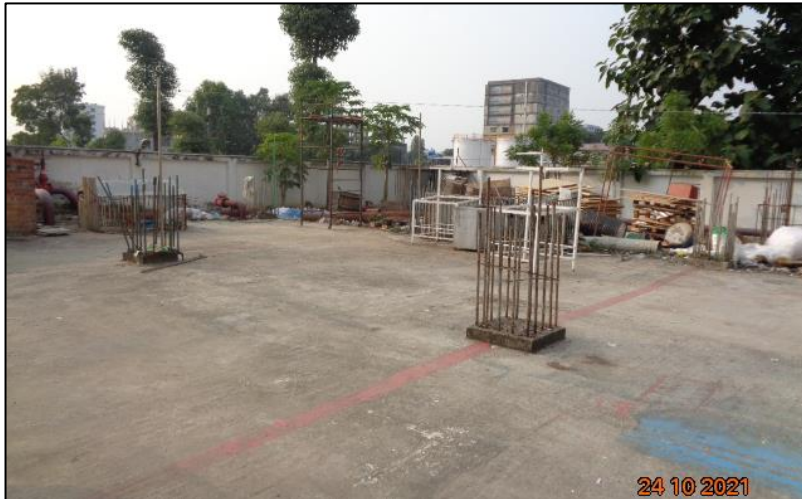
Extended column re-bar at ground floor

The building permission layout is for basement only. Till the date of this inspection, Construction was done at only basement. There is also extended column re-bar at ground floor. So, there is a possibility of future vertical extension.

Building engineer is required to perform Detail Engineering Assessment (DEA) for the structure prior to commencement of further extension work.

| Item No. | Observation | Recommended Action Plan | Recommended Timeline |
|---|---|---|---|
| 09 | Possibility of future vertical extension | Prior to vertical extension, Building engineer is required to produce Detailed Engineering Assessment(DEA) of the structure according to BNBC and submit to RSC for review. | 6-weeks |

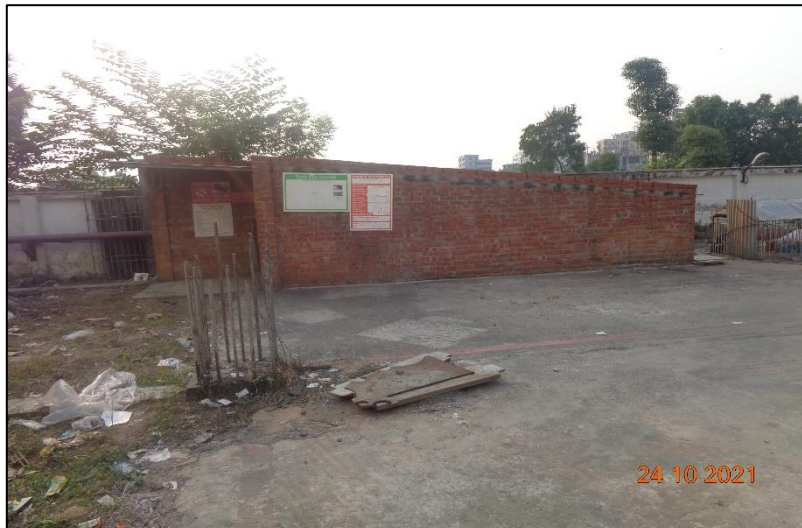
Building constructed only at basement

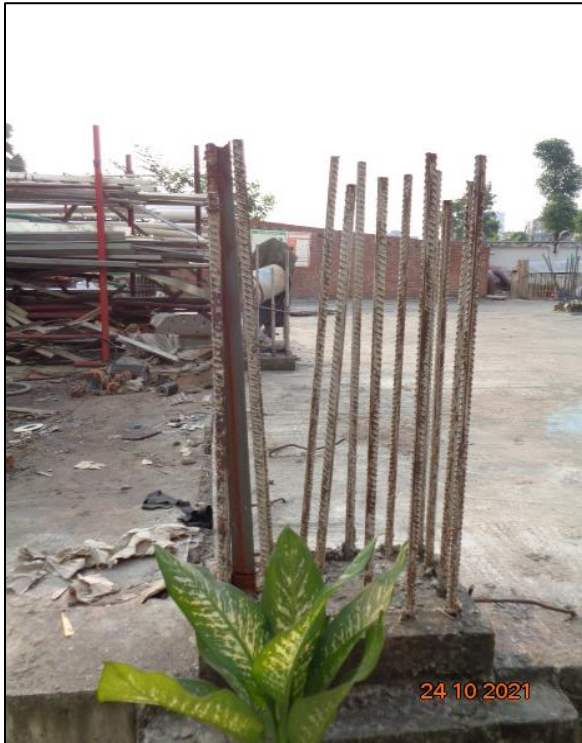
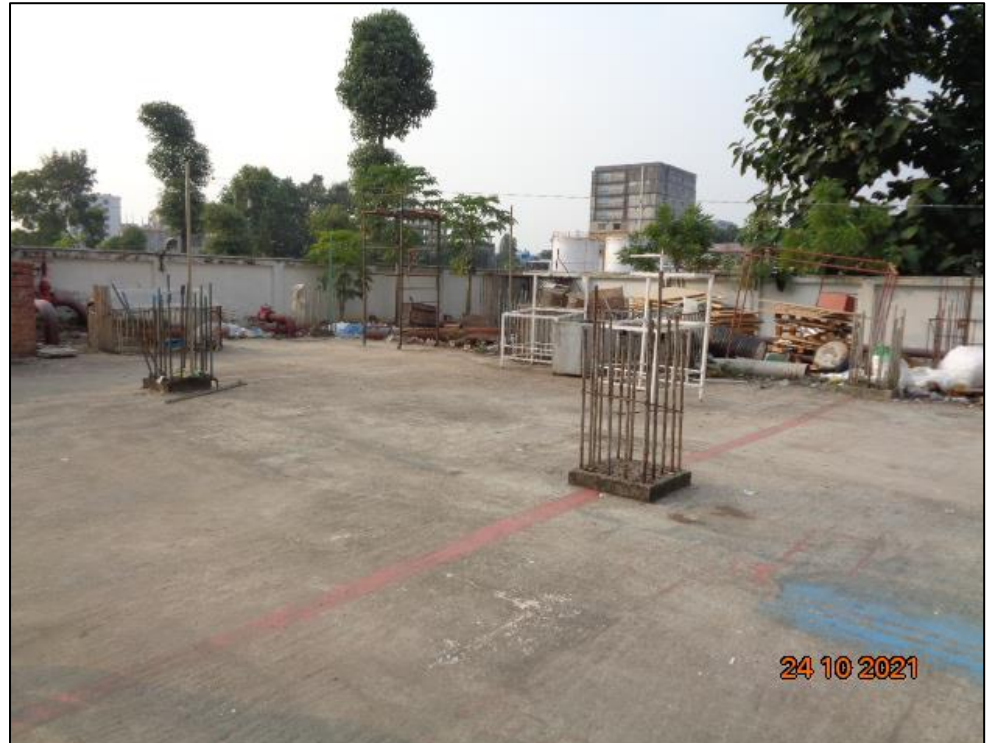
Exposed rebar at ground floor

Exposed reinforcement was found at ground floor. Building engineer is required to take necessary measures to prevent the corrosion in exposed rebar.

| Item No. | Observation | Recommended Action Plan | Recommended Timeline |
|---|---|---|---|
| 11 | Exposed rebar at ground floor | All exposed reinforcement is to be protected from corrosion which may cause degradation of the concrete. | 6-weeks |
