# Cotton Club (BD) Ltd. (Extension)

Jarun (South), Kashimpur, Gazipur, Bangladesh.

19 & 31 October 2021

# Observations

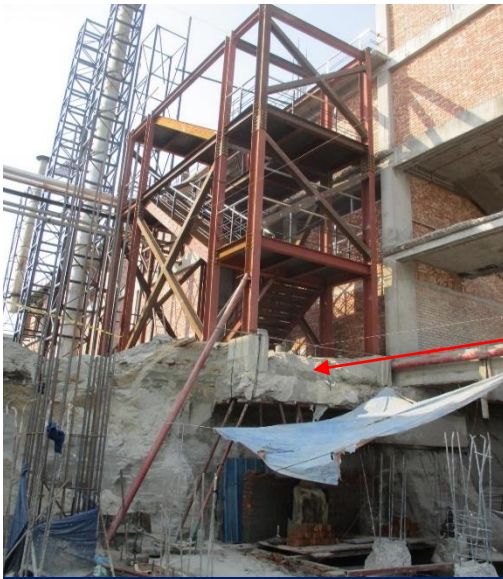
Building-14, Because of soil excavation, soil under the shallow foundation of the steel stair has been moved away and the steel stair is now overhanging, supported by some steel props that have the potential to collapse at any time

Soil excavation for the construction of a new building was found adjacent to Building-11 and Building-14. Because of that excavation, the soil under the shallow foundation of the steel stair adjacent to Building-14 has been moved away and the steel stair is now overhanging, supported by some steel props that have the potential to collapse at any time. The ground-bearing slab at EGL level, and one landing of the RC stair of Building-14 that connects to the mezzanine floor was found demolished. The upper floors' RC slab still lacks a railing and safety briary, potentially posing a fall hazard. The factory need to take following immediate actions.

1. The operation of Building-14 and the construction of a new building must be ceased immediately. Ensure that the steel stair is properly cordoned off to restrict access.

2. A retaining wall must be constructed immediately. Backfilling the moved soil beneath the stairwell and buildings must be completed after the retaining wall is constructed. The design and construction of the retaining wall must comply with the structural requirements of the BNBC 2020 provisions.

3. Stop all excavation work for the construction of the new building immediately. All existing and adjoining structures must be protected from any damage due to construction operations.

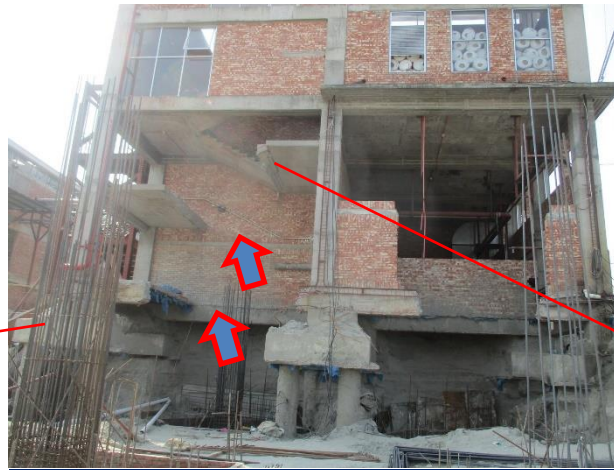
Building-14, foundation exposed due soil excavation. Ground bearing slab at EGL level was demolished. RC stair slabs below mezz. floor partially demolished.

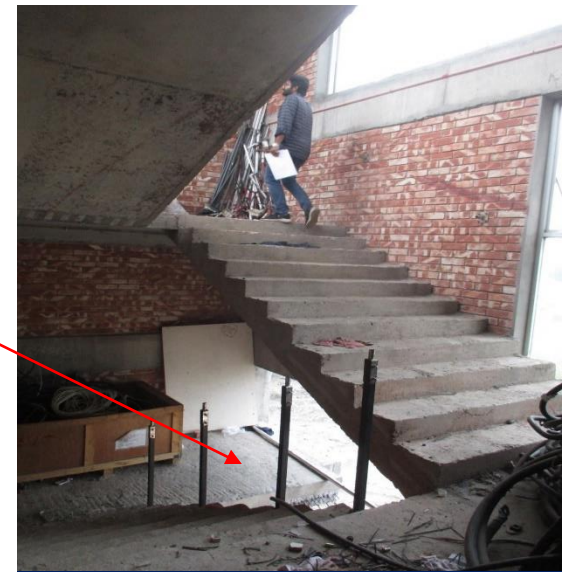
Building-14, upper floors' RC slab still lacks a railing and safety briary, potentially posing a fall hazard.

4. Factory to ensure that the contractors are following H&S measures and takes all precautions to safeguard all persons that can be affected by the under-construction Building/site works.

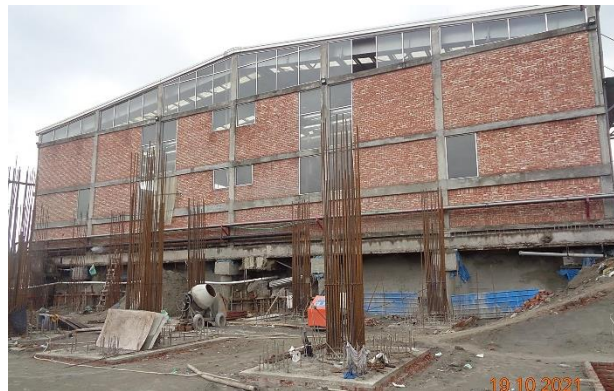
Building-11, foundation exposed due soil excavation

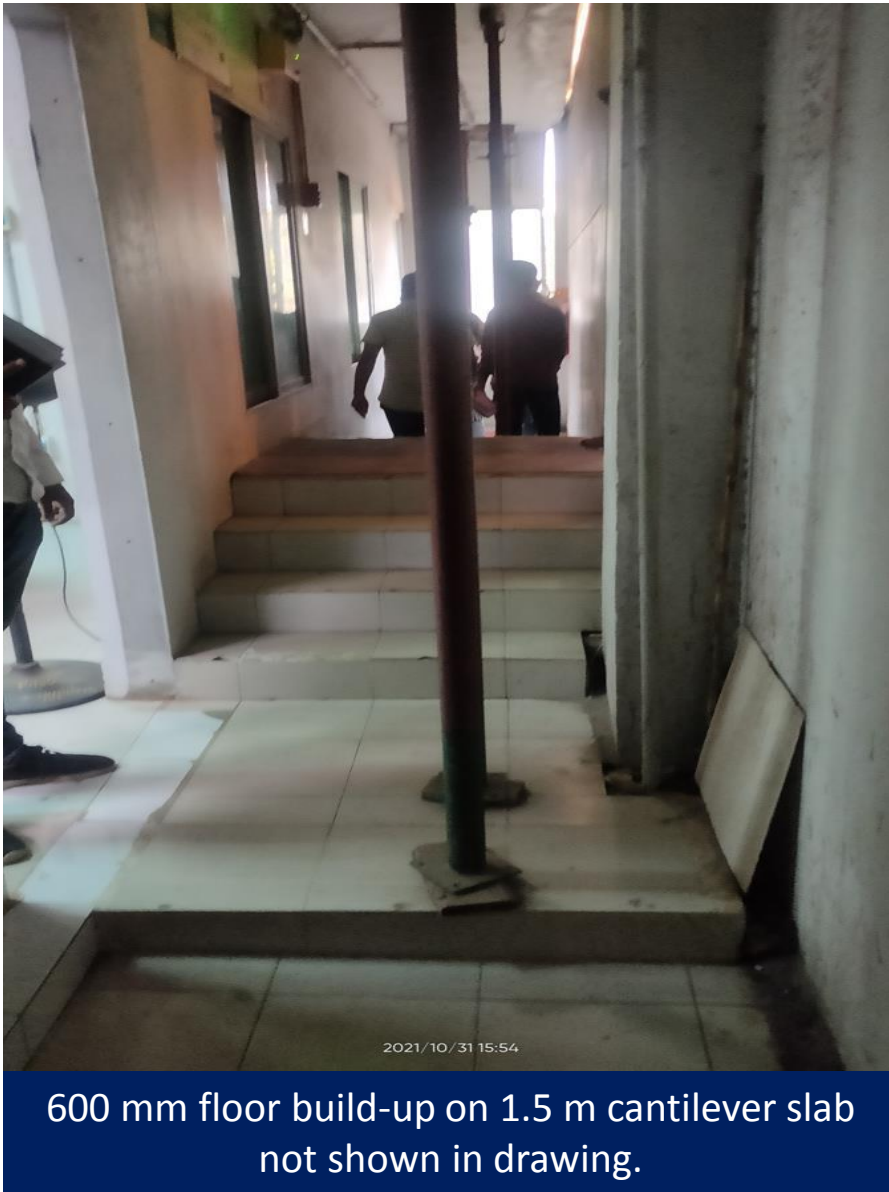
600 mm floor build-up on 1.5 m cantilever slab  
not shown in drawing.

Factory engineer is required to survey the whole structure and update as-built drawings as per actual site condition and check the cantilever slab adequacy.

| Item No. | Observation | Recommended Action Plan | Recommended Timeline |
|---|---|---|---|
| 10 | Built-up on cantilever slab. (Building-2) | Check the cantilever slab adequacy and produce floor live loading plan for the building considering the floor, column & foundations capacity. | 6-weeks |

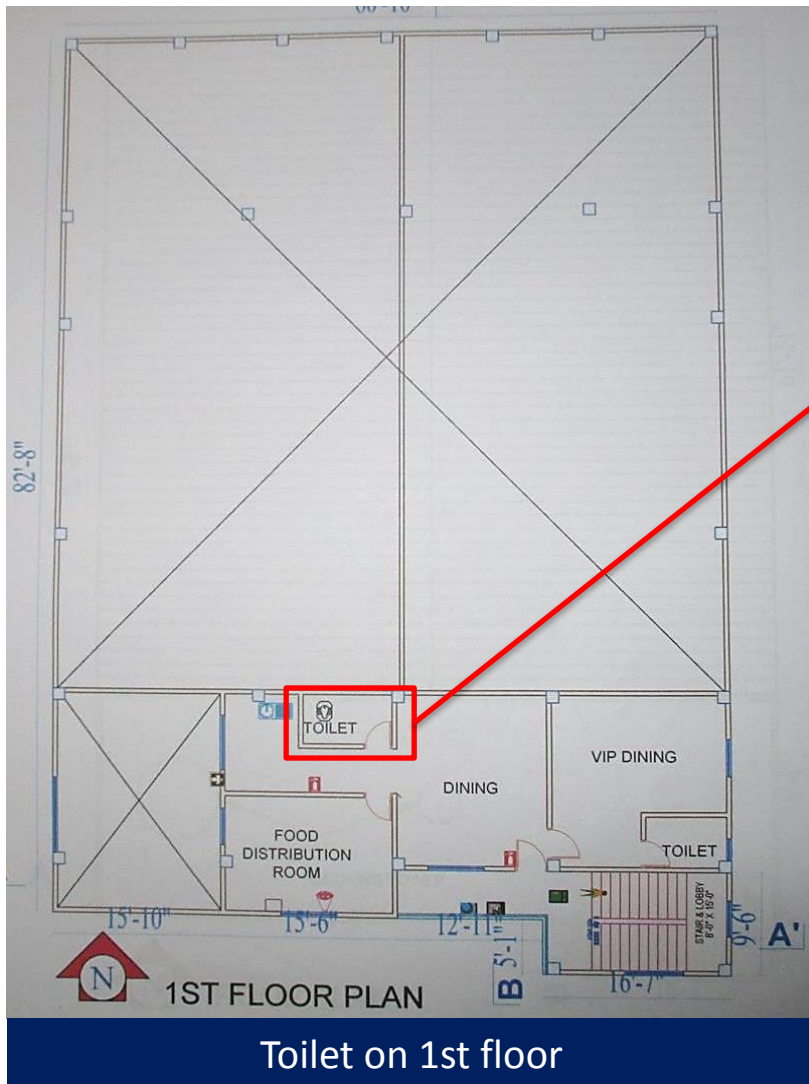
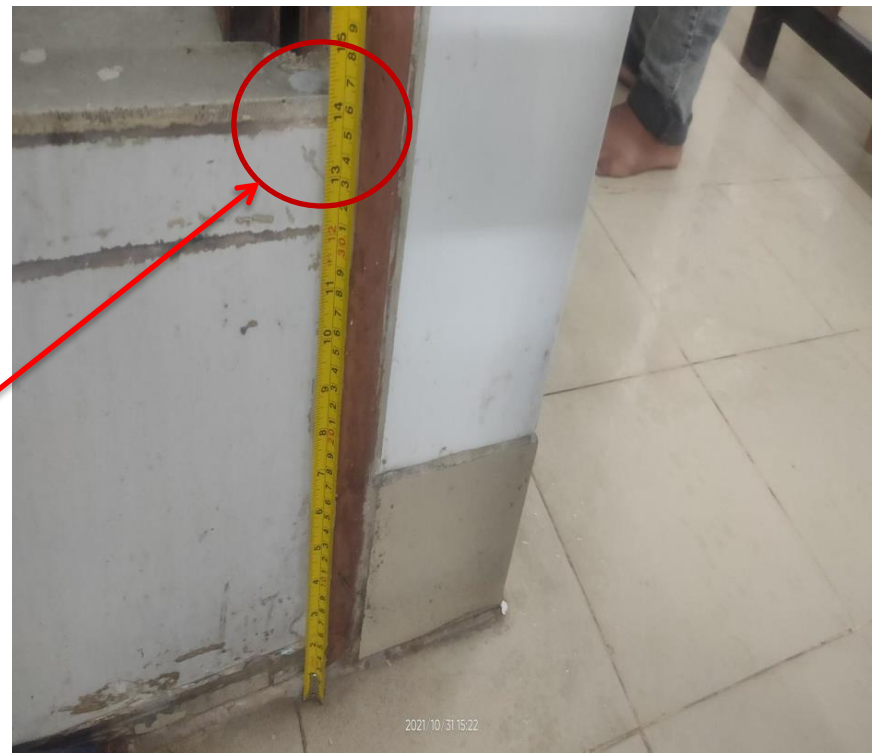
300 mm floor build-up was observed in toilet.

Factory engineer is required to survey the structure and update as-built drawings as per actual site condition.

| Item No. | Observation | Recommended Action Plan | Recommended Timeline |
|---|---|---|---|
| 13 | Built-up in toilet. (Building-6) | The building engineer is required to survey the structure and produce accurate as-built drawings. | 6-weeks |

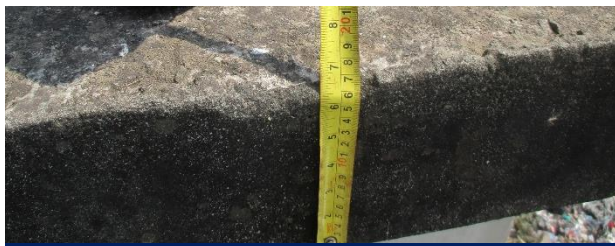
150 mm roof slab

Floor beam was missing on 1st floor roof (red marked) and stair top room (yellow marked). Also, slab thickness was measured 150 mm instead of 125 mm. The building to survey the structure and update the as-built structural drawings accordingly.

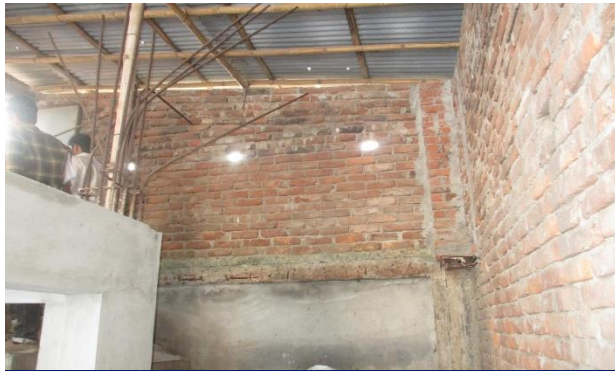
Beam missing on roof

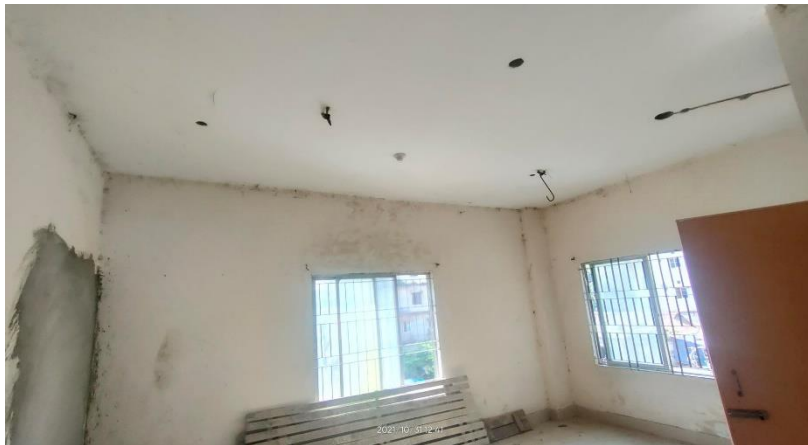
Beam missing on 1st floor roof

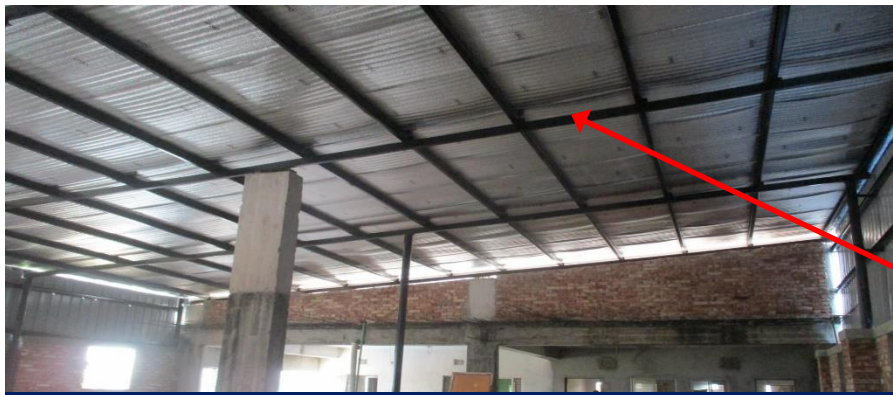
1st floor: Steel rafter on steel pipe & RC column

The building is irregular in shape and structural arrangement. There are different structural systems in same floor level. The building engineer to verify the lateral load path and check structural integrity.

| Item No. | Observation | Recommended Action Plan | Recommended Timeline |
|---|---|---|---|
| 15 | Lack of structural integrity. (Building-8) | As part of Engineering Assessment (EA), the building engineer to verify the lateral load path and check structural integrity of the structure. | 6-weeks |

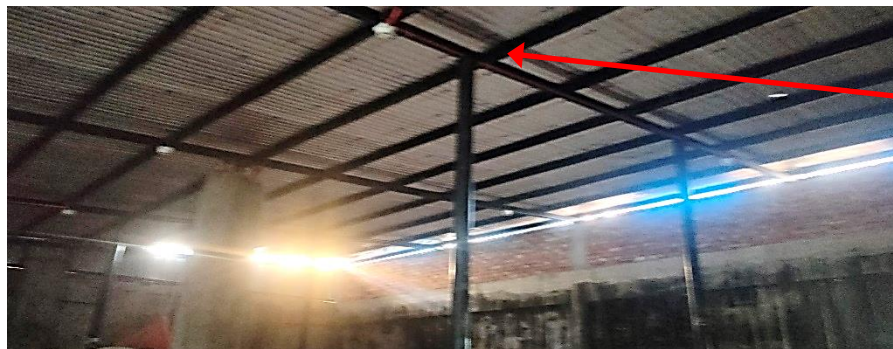
Ground floor: Steel rafter on steel pipe

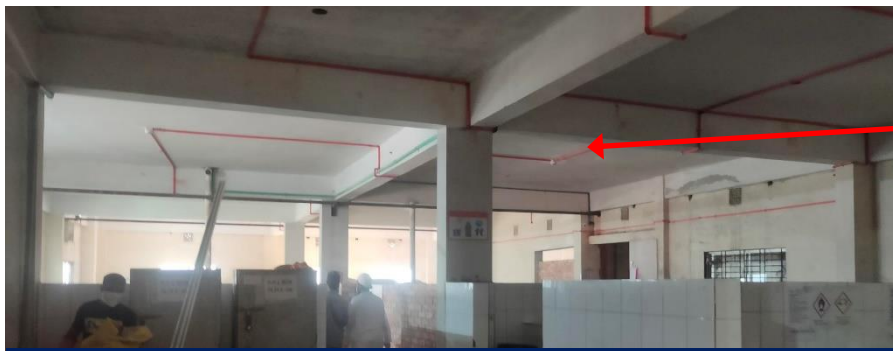
Ground & 1st floor: RC beam-column frame

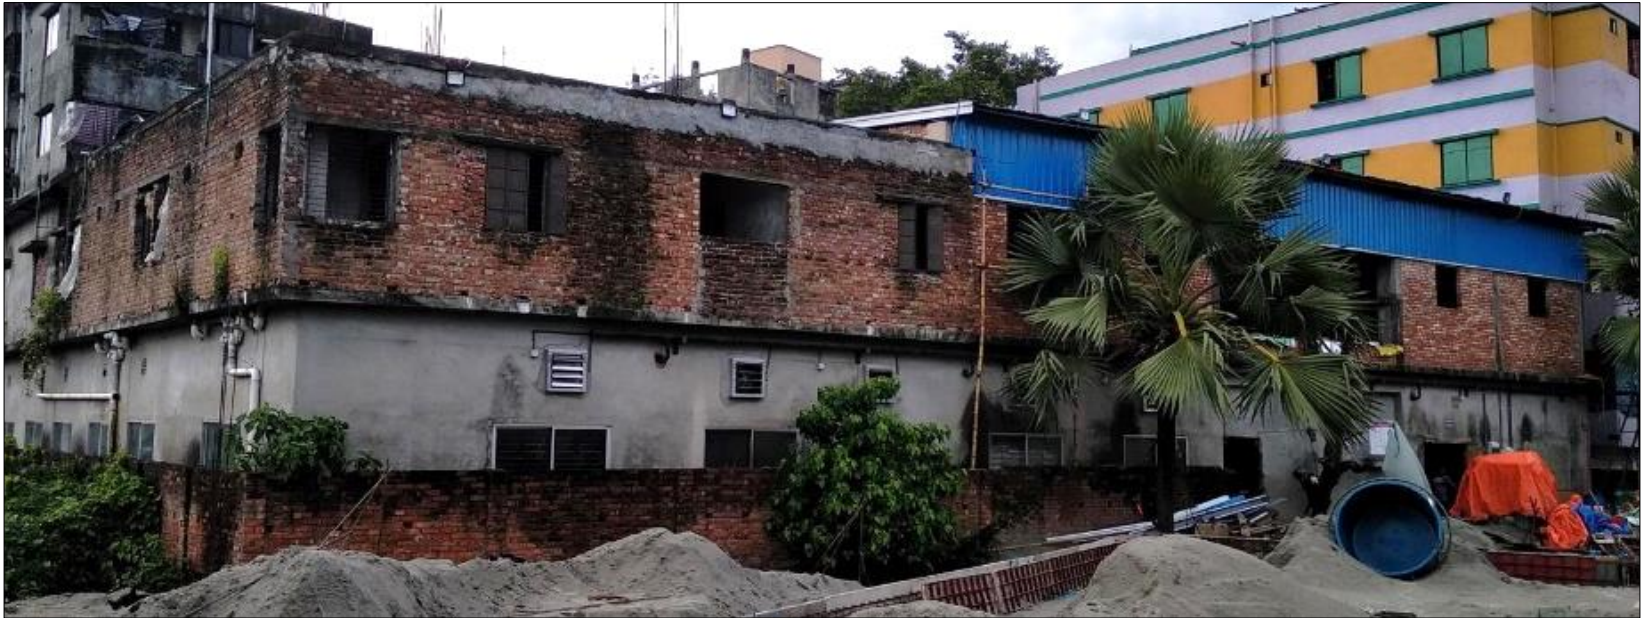
Geotechnical investigation report not available for Building- 8

The building engineer to carry out a geotechnical investigation to the close vicinity of existing building. Check the foundation adequacy and incorporate necessary calculation in the Engineering Assessment (EA) report.

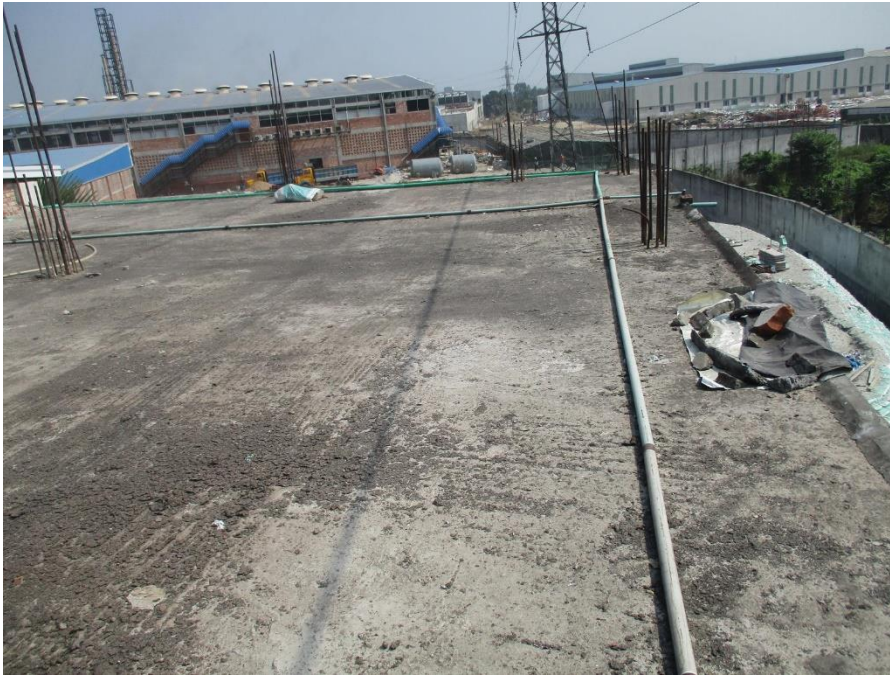
No parapet/barrier on roof

The factory is required to provide parapet/barrier on roof and stair zone to prevent possible falling hazard. Remove rusting and apply rust proof coating to the exposed rebars to protect from further corrosion.

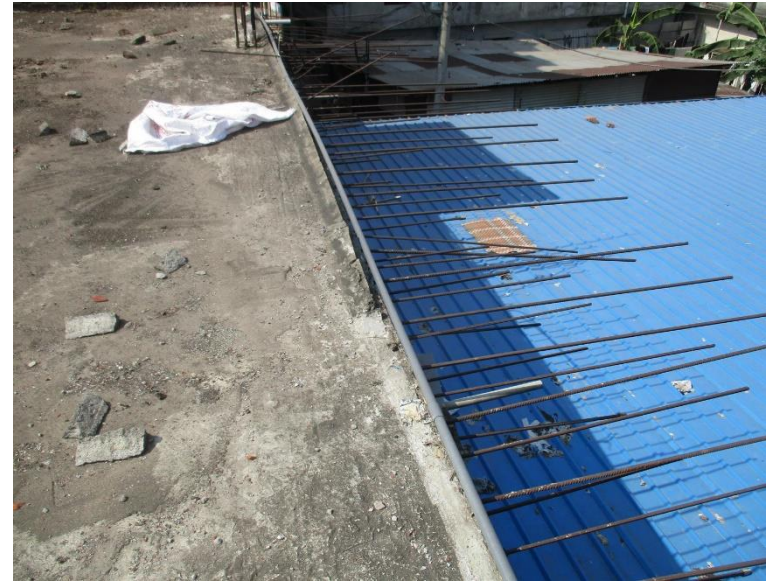
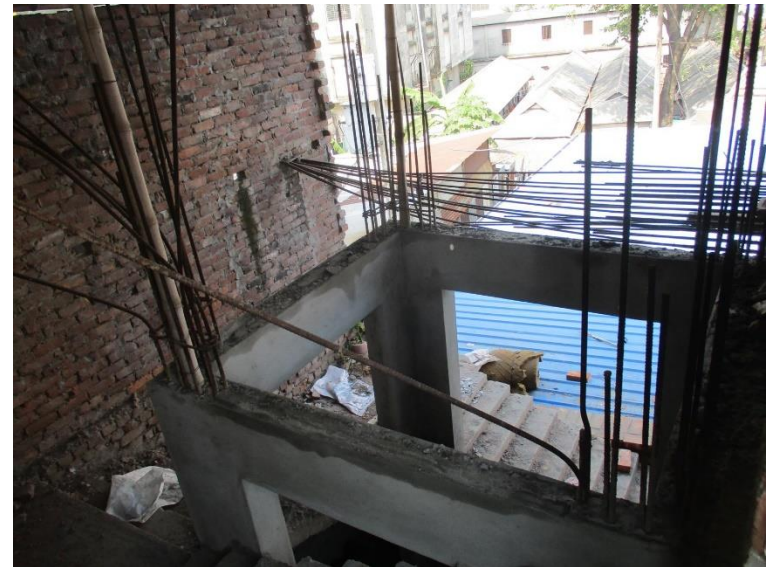
Exposed rebar on roof and stair zone

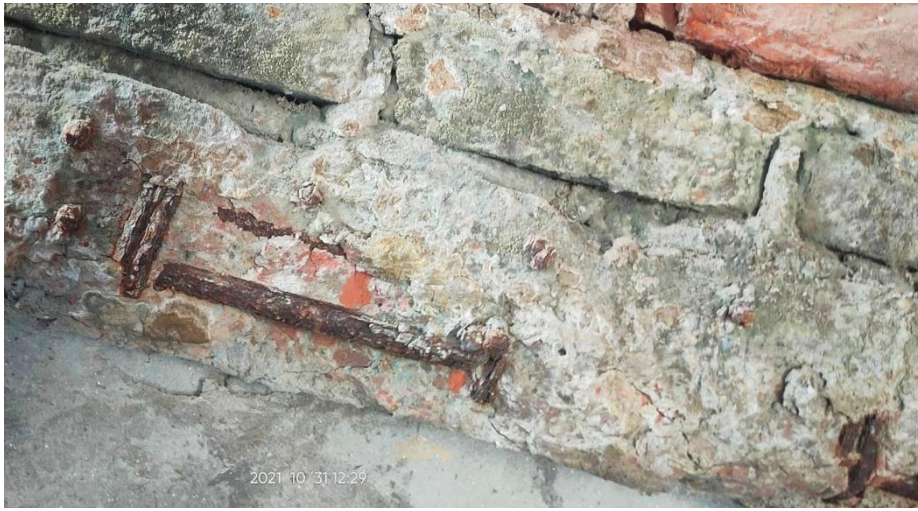
Corrosion of slab rebar

Corrosion of slab rebar and spalling of concrete was observed in the stair zone roof slab. The building engineer to investigate the reason & extend to of corrosion & concrete spalling and prepare an investigation report with suitable remedial measure.

| Item No. | Observation | Recommended Action Plan | Recommended Timeline |
|---|---|---|---|
| 23 | Corrosion of rebar and concrete spalling. (Building-8) | Carry out remedial works as per investigation report. | 6-weeks |

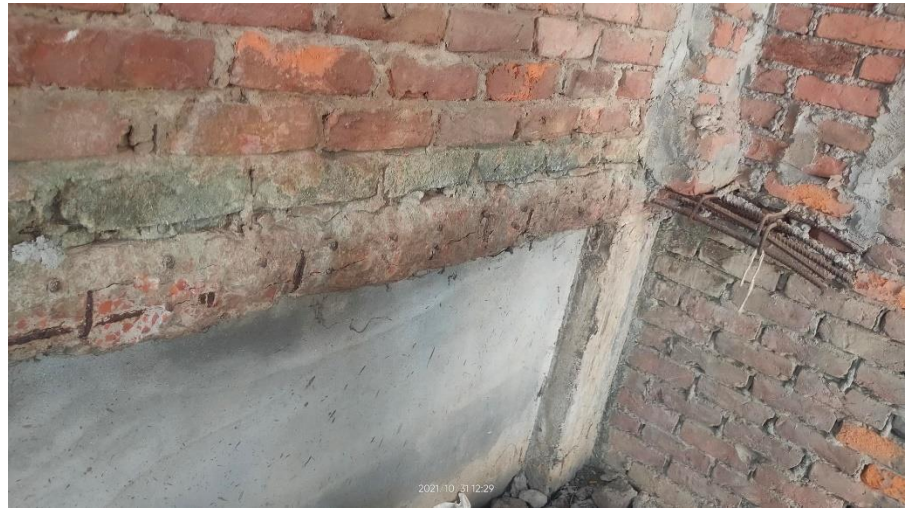
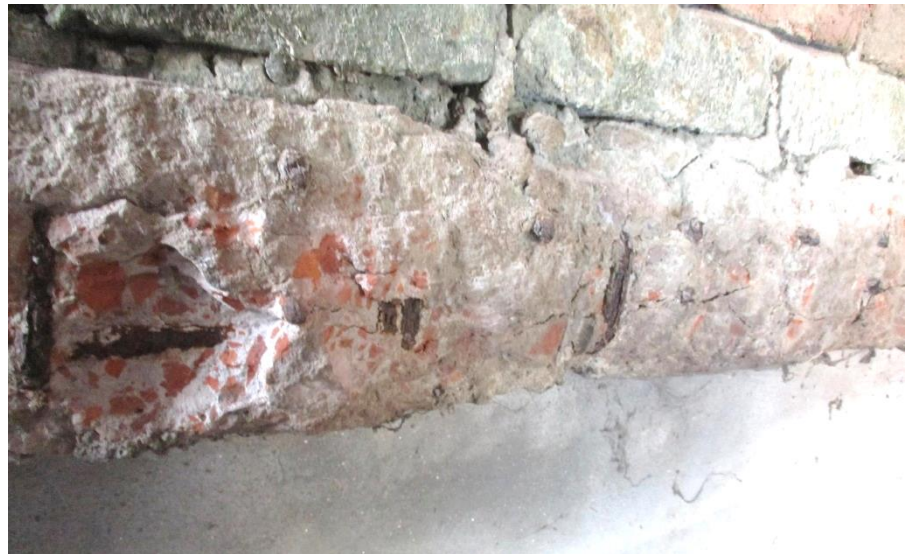
Spalling of concrete

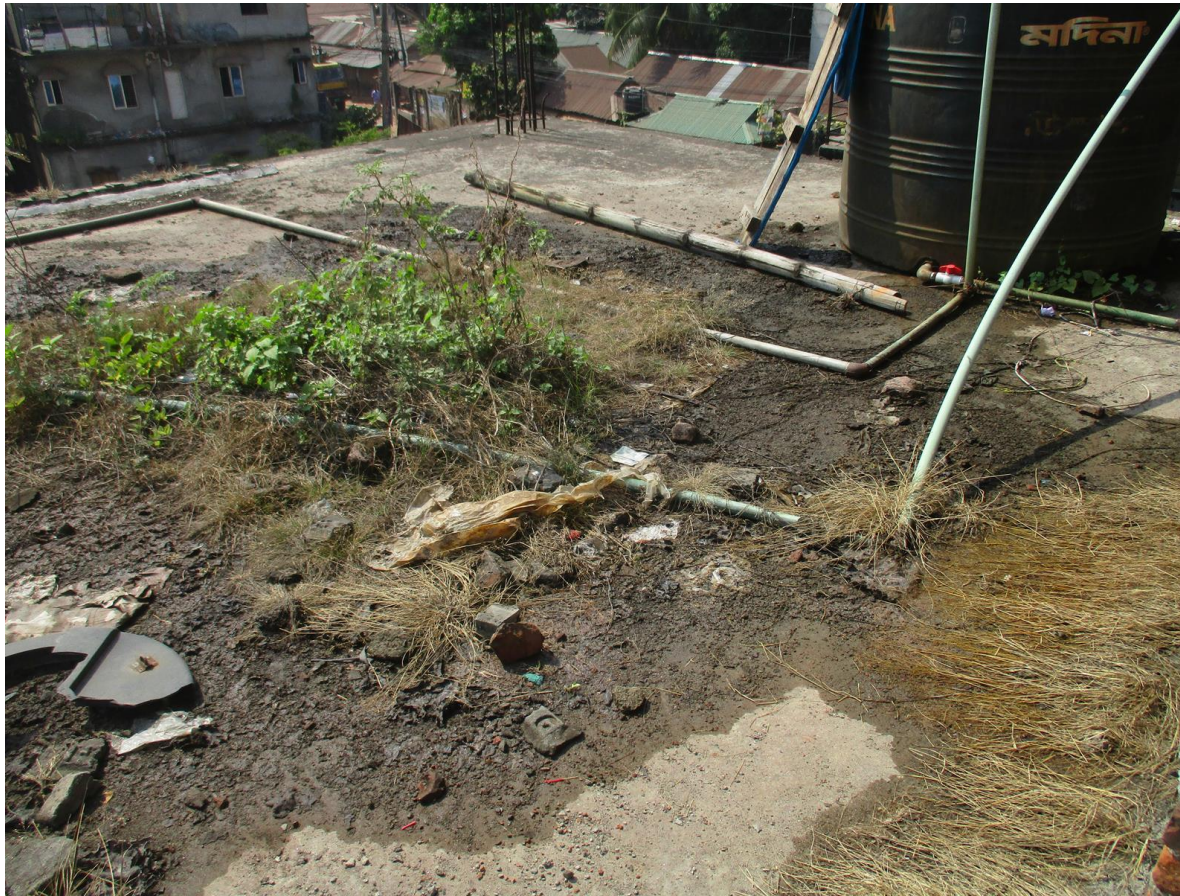
Water ponding and vegetation on roof

The factory is required to remove vegetation & debris from roof. Apply water proofing layer on the roof slab with adequate slope to protect water infiltration into the slab.

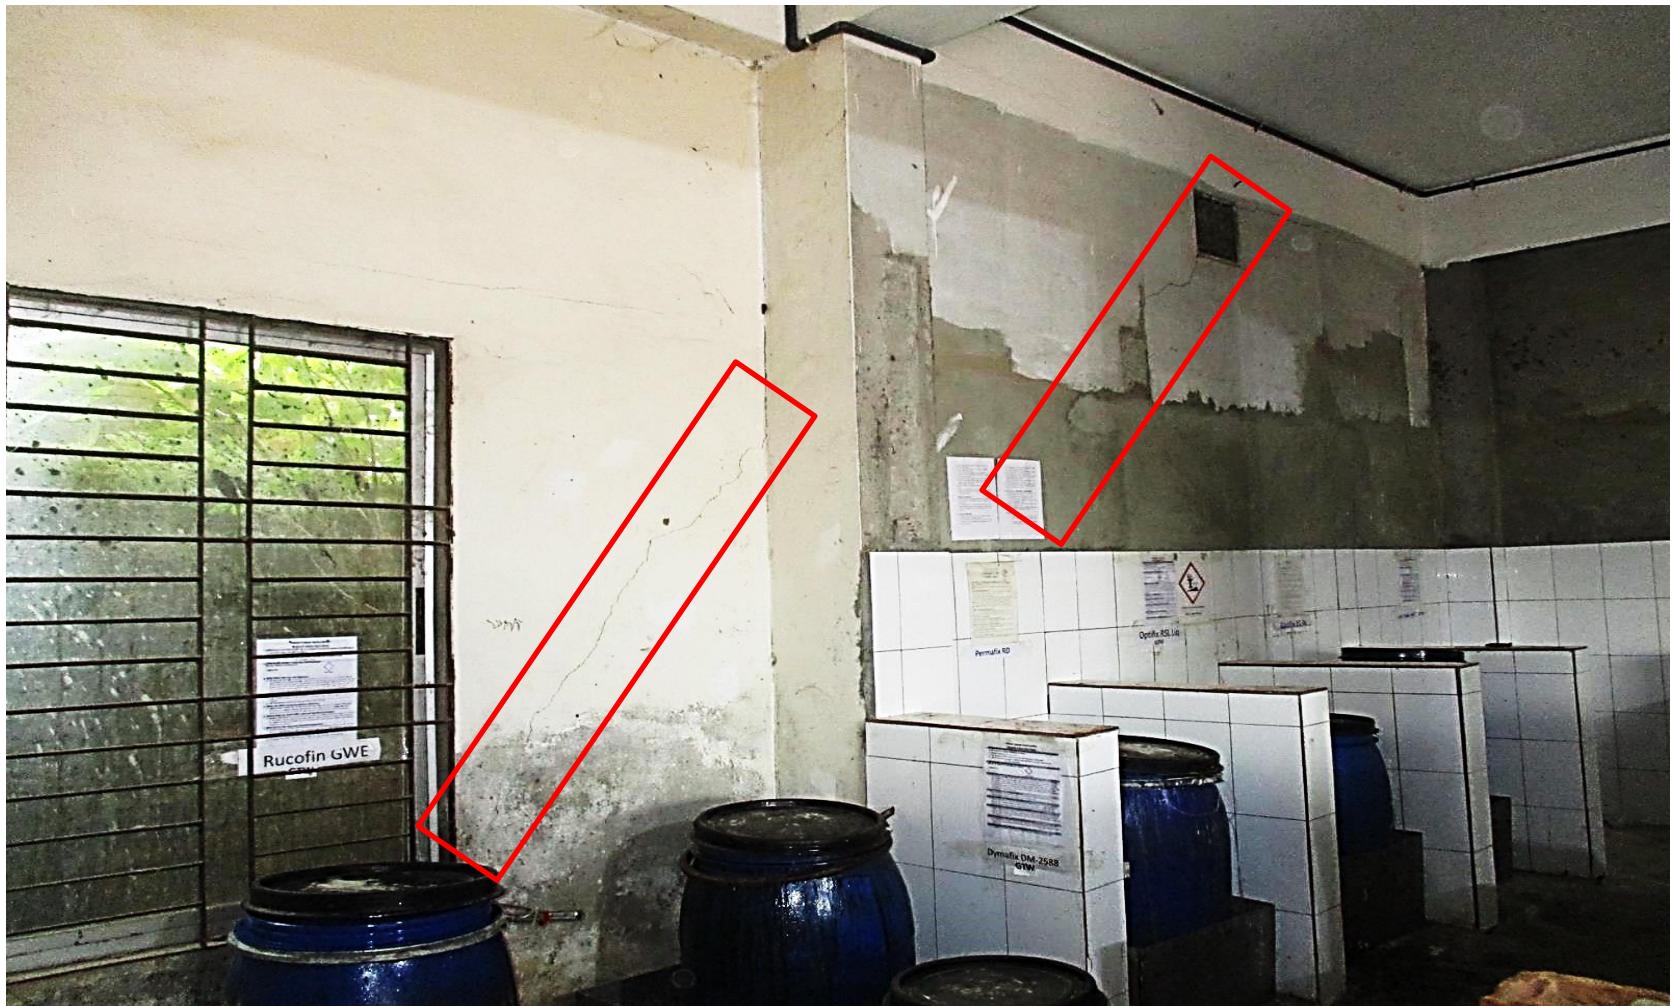
Crack on brick wall was observed in ground floor

The building engineer to investigate the reason & extend to of crack and prepare an investigation report with suitable remedial measure.

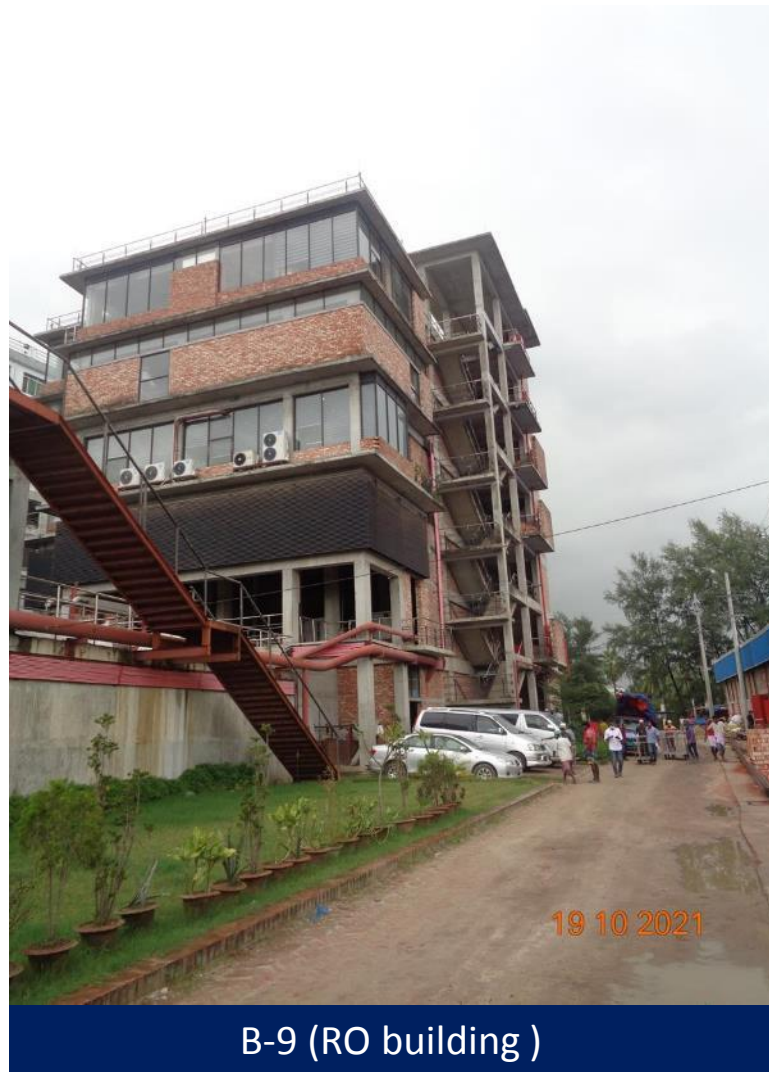
B-9 (RO building )

As per BNBC, every building or structure designed shall have its design documents prepared in accordance with the provision of Section 1.9.1. The design document shall include a design report, and a set of structural drawings, which shall be prepared in compliance with section 1.9.1.1 and section 1.9.1.2 of part-6, BNBC. However, design report was not available during inspection. The building engineer is required to prepare a design report in compliance with BNBC.

| Item No. | Observation | Recommended Action Plan | Recommended Timeline |
|---|---|---|---|
| 28 | Absence of design report (Building-9) | Prepare a set of design documents including Engineering Assessment (EA) report as per BNBC (part-6, section 1.9.1). | 6-weeks |

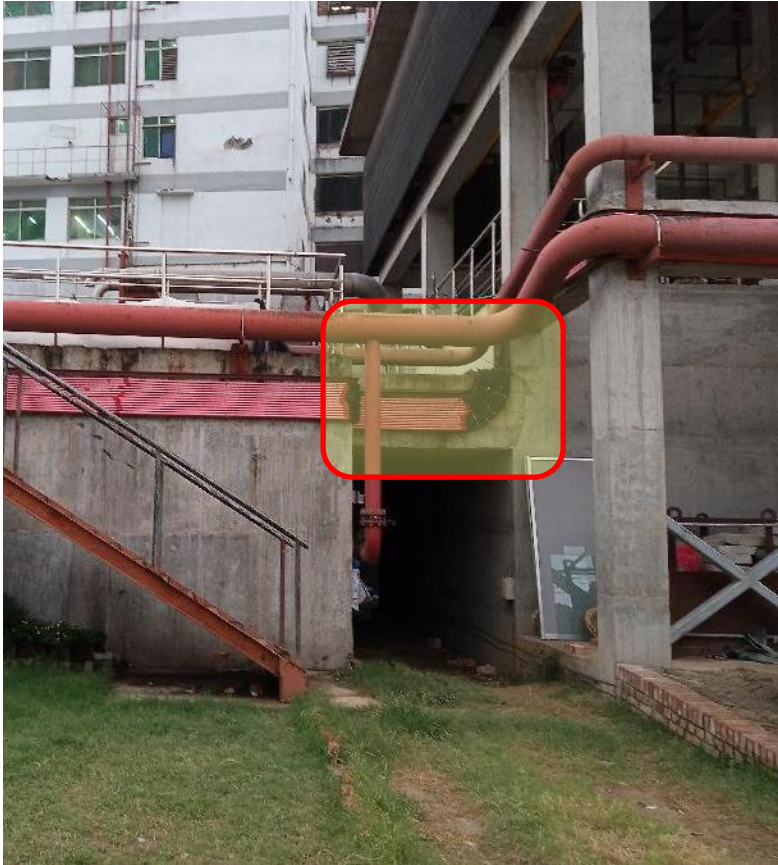
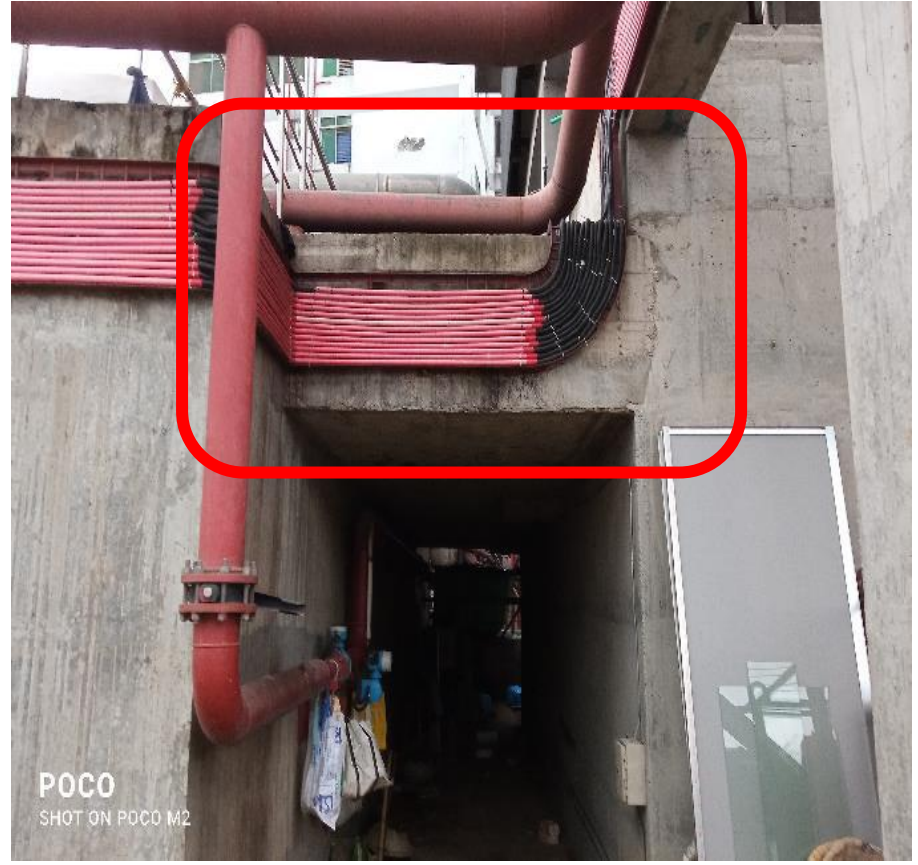
The aeration tank is connected to the middle of Building-9 column

The building engineer is required to check the lateral support to the building columns, consider the effect/support condition in structural analysis and suggest necessary actions accordingly.

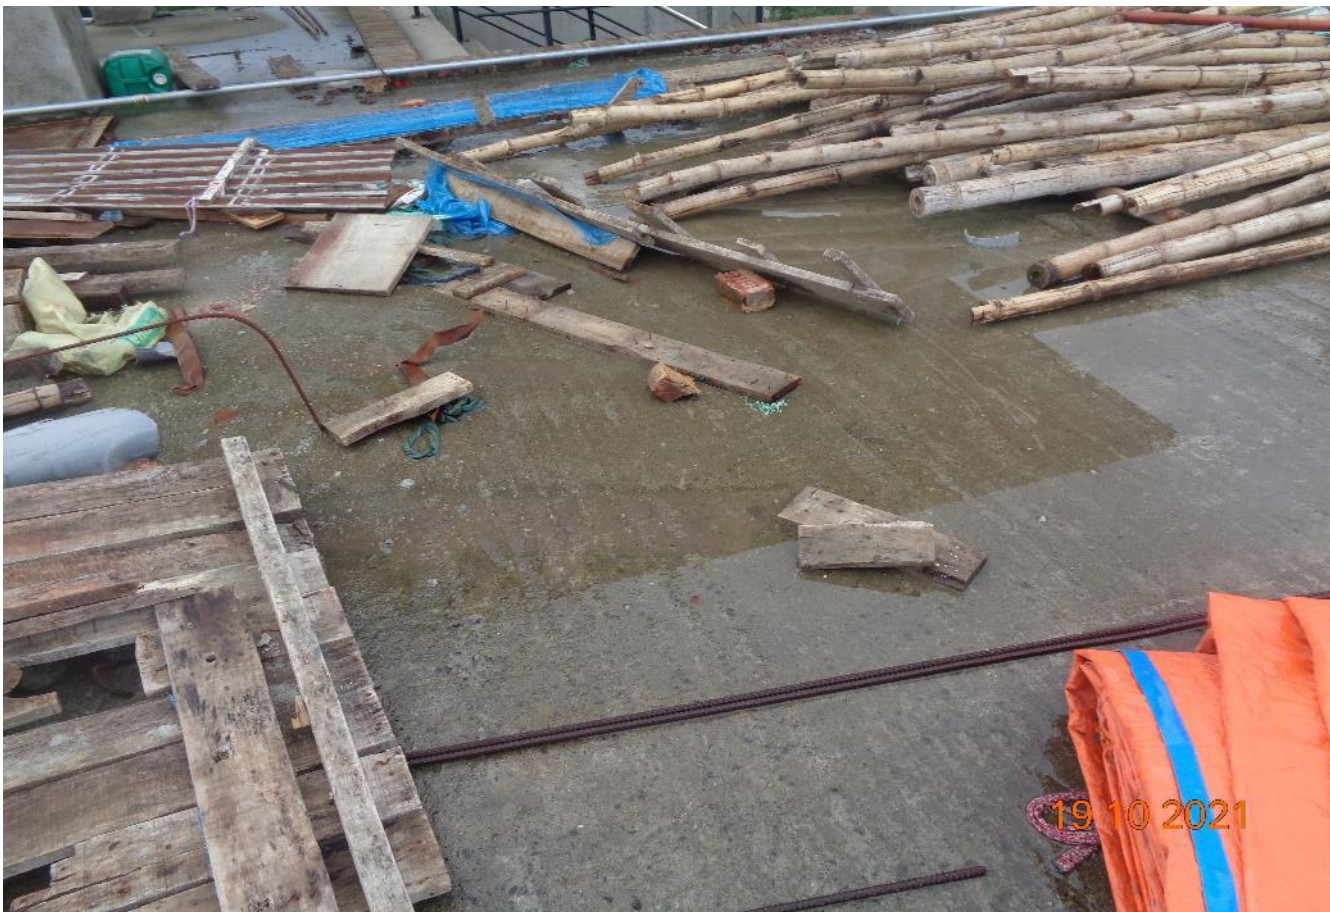
Stagnant water observed on roof

Develop proper drainage system on the roof with adequate slope or apply water proofing layer on the roof to resist water ingress into the slab.

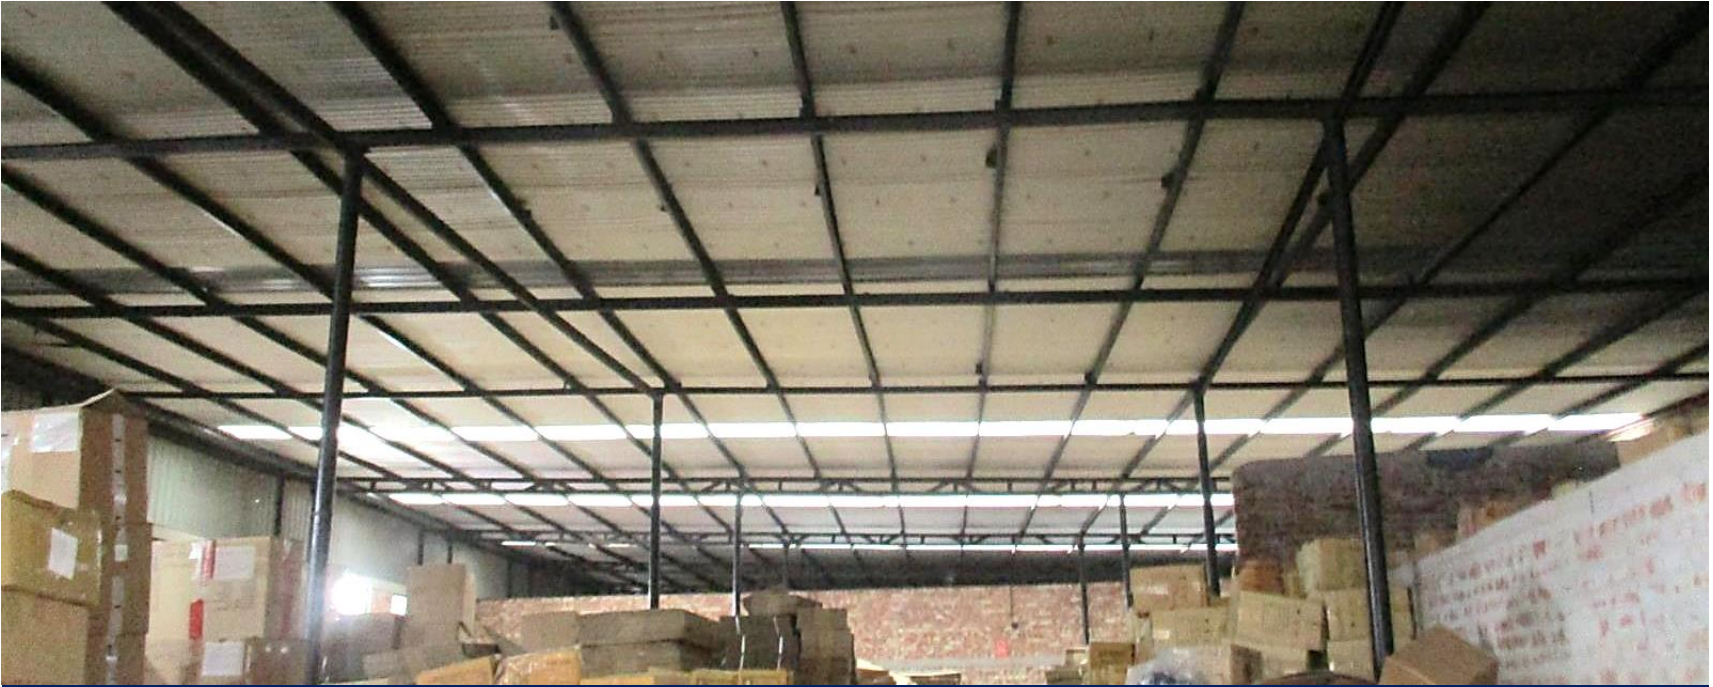
Absence of bracing and lateral load transfer media (compression strut) on roof

The building has no bracing system and lateral load transfer media. The building engineer is required to check the lateral stability of the structure and suggest proper remedial actions accordingly.

| Item No. | Observation | Recommended Action Plan | Recommended Timeline |
|---|---|---|---|
| 35 | Lack of lateral stability. (Building-10) | As part of EA, building engineer is required to check the lateral stability of the structure and suggest proper remedial actions accordingly. | 6-weeks |

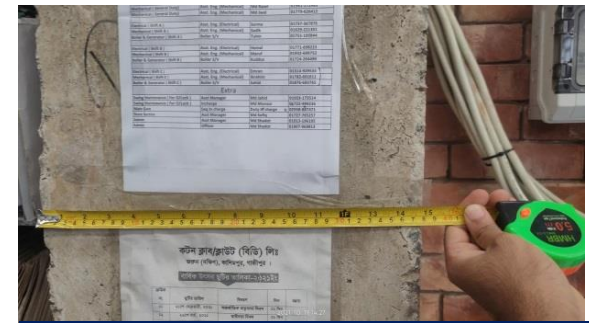
C2 column: Different size in column schedule.  
15"x 35" (375 mm x 1175 mm) and 17" x 37" (425 mm x 1225 mm)

C2 column measured (above GL) 375mm instead of 425mm

| Item No. | Observation | Recommended Action Plan | Recommended Timeline |
|---|---|---|---|
| 37 | Discrepancy in as-built drawing. (Building-11) | The building engineer is required to survey the structure and produce accurate as-built drawings with structural details. | 6-weeks |

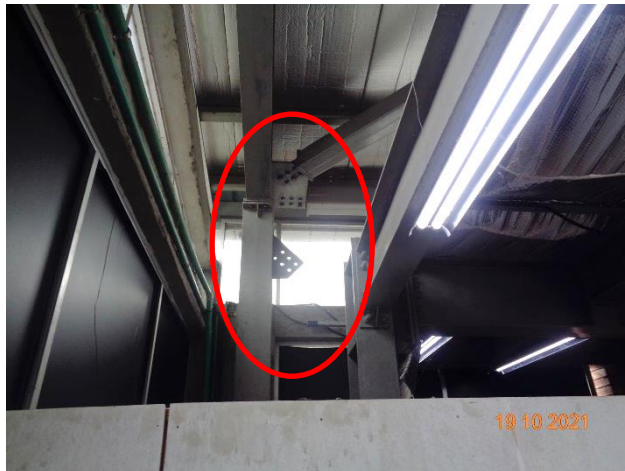
Bracing missing at toilet zone

Vertical bracing location did not matched with as-built drawings. Some bracings found onsite which were not shown in drawing in grid i-H, K-L, A-B any many others locations. Some bracings were missing on-site as per drawings location. Some cross bracings were found in half length of column where full length was shown in drawings. The building engineer to prepare as-built drawings.

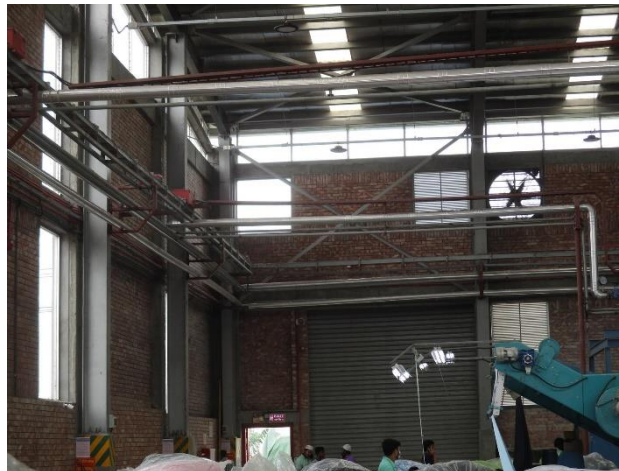
Half cross-bracing instead full

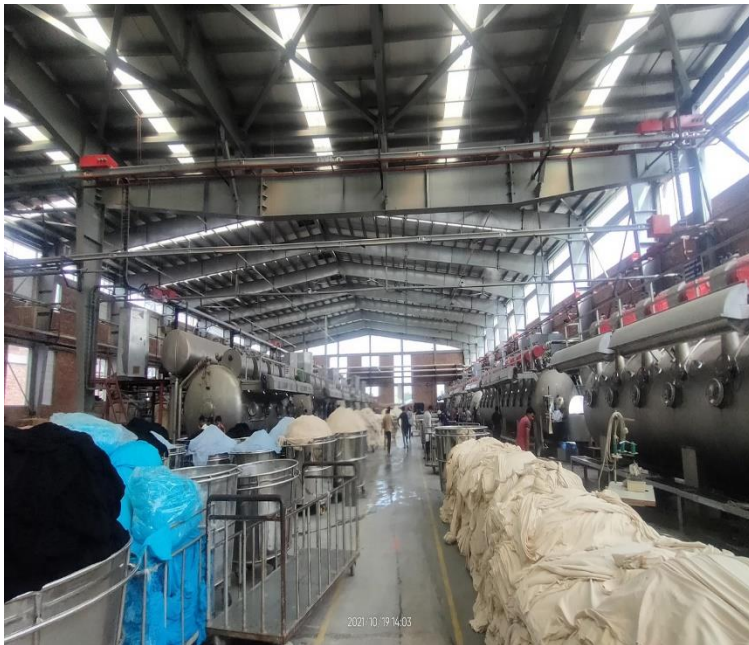
Design review of jack beam is required

Design report was not available for the Building-11. As per BNBC, every building or structure designed shall have its design documents prepared in accordance with the provision of Section 1.9.1. The design document shall include a design report, and a set of structural drawings, which shall be prepared in compliance with section 1.9.1.1 and section 1.9.1.2 of part-6, BNBC.

However, the building engineer is required to prepare a design report in compliance with BNBC.

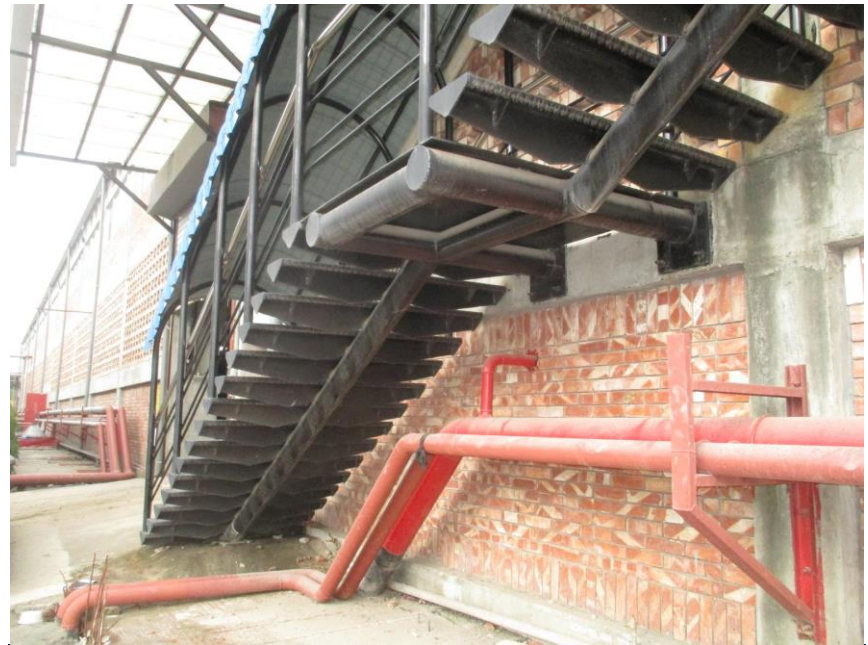
Design review steel stair is required

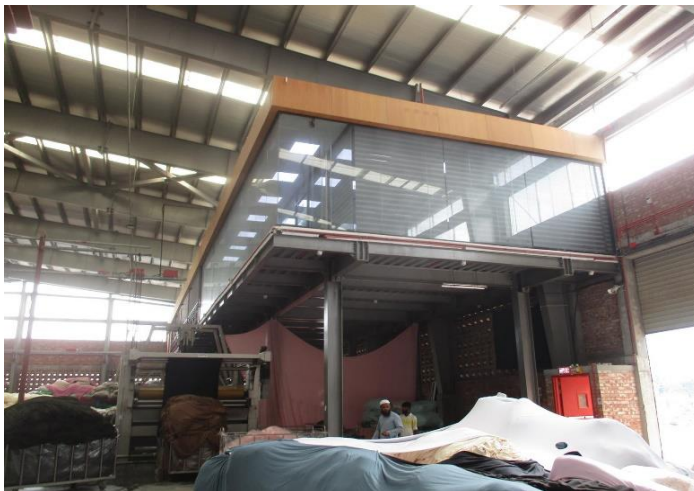
Design review required for mezzanine

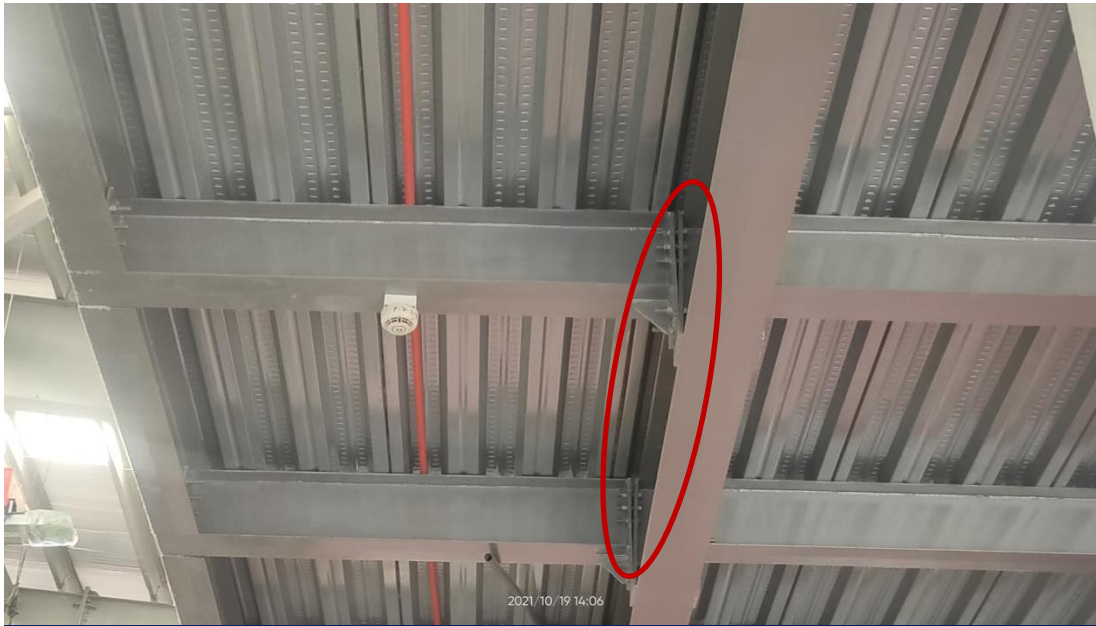
Gap between steel joints

Gap between connection plates were observed in several steel members connections. Also, bolt was missing in some locations. Factory engineer in required to survey the whole building, re-install missing bolt and apply remedial actions for connections.

| Item No. | Observation | Recommended Action Plan | Recommended Timeline |
|---|---|---|---|
| 41 | Gap between connection plates and missing bolts. (Building-11) | Building engineer is required to check all the joint and fill the gap between connection plates with suitable materials. | 6-weeks |

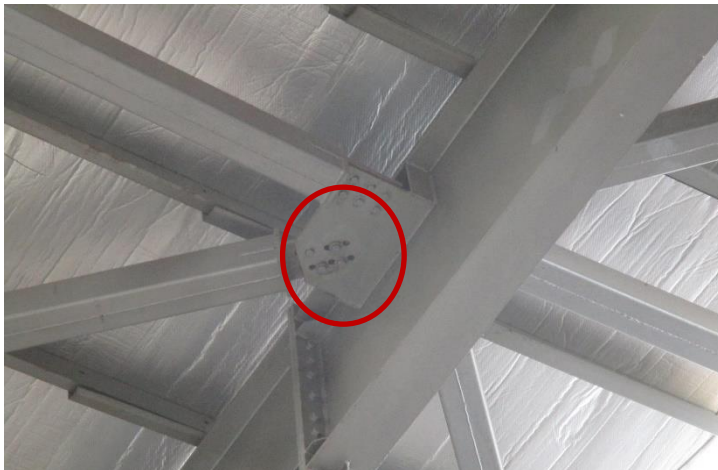
Bolts missing

| Item No. | Observation | Recommended Action Plan | Recommended Timeline |
|---|---|---|---|
| 42 | Gap between connection plates and missing bolts. (Building-11) | Install missing bolt where required. | 6-weeks |
