# Cotton Club (BD) Ltd. (Extension)

Jarun (South), Kashimpur, Gazipur, Bangladesh.

19 & 31 October 2021

# Observations

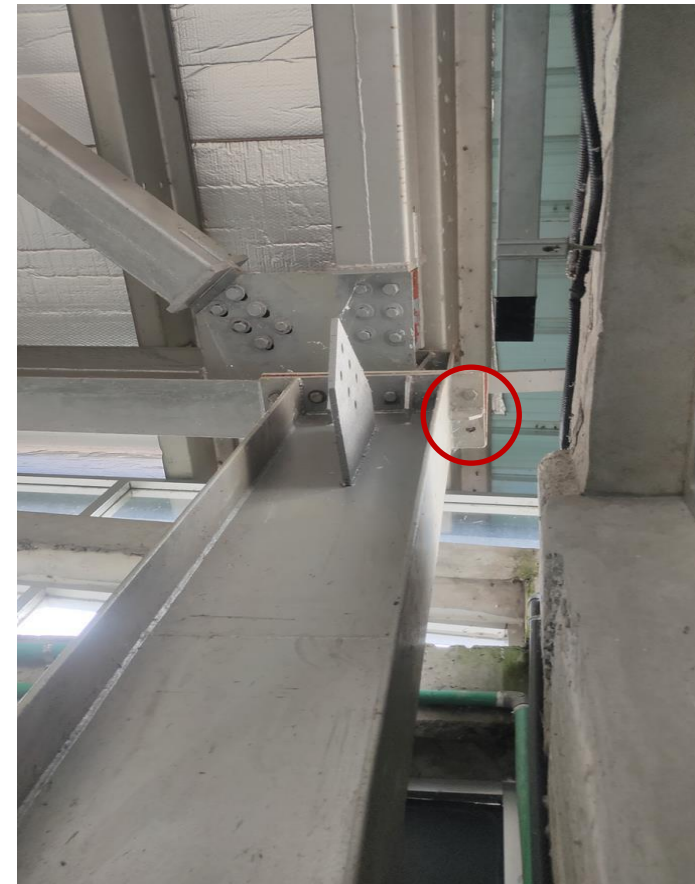
Bolts missing

| Item No. | Observation | Recommended Action Plan | Recommended Timeline |
|---|---|---|---|
| 42 | Gap between connection plates and missing bolts. (Building-11) | Install missing bolt where required. | 6-weeks |

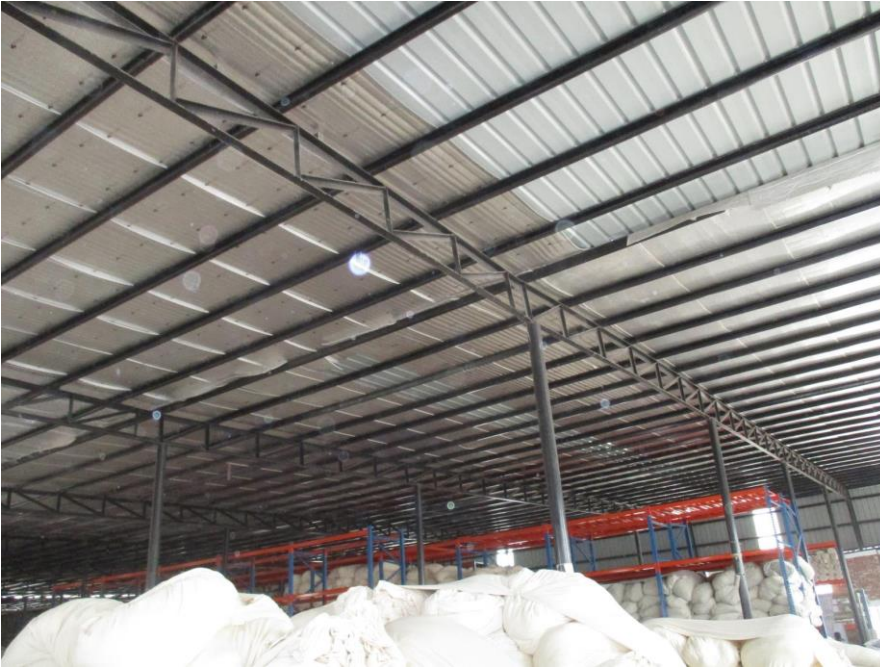
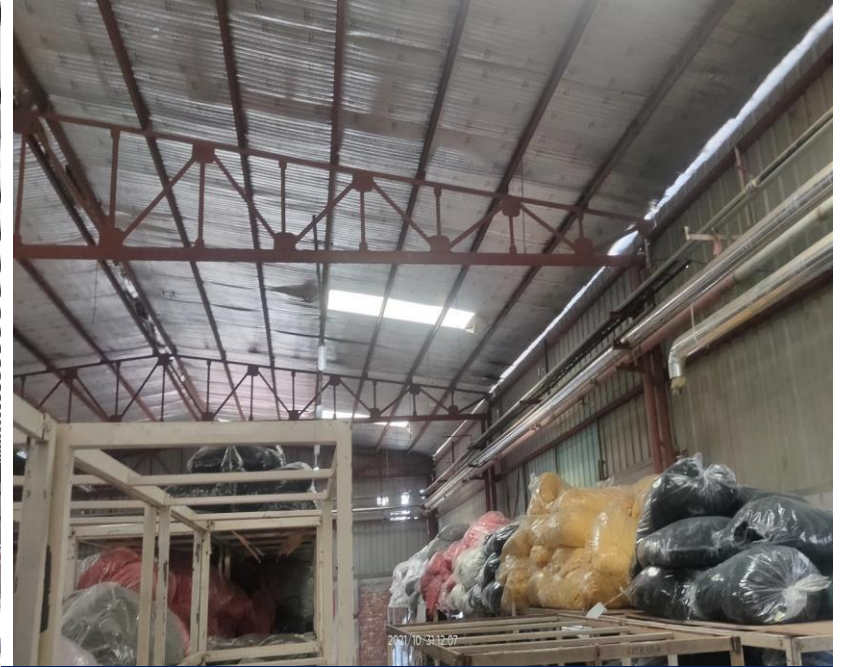
Absence of bracing and lateral load transfer media (compression strut) on roof

The building has no bracing system and lateral load transfer media. The building engineer is required to check the lateral stability of the structure and suggest proper remedial actions accordingly.

| Item No. | Observation | Recommended Action Plan | Recommended Timeline |
|---|---|---|---|
| 43 | Lack of lateral stability. (Building-12) | As part of EA, building engineer is required to check the lateral stability of the structure and suggest proper remedial actions accordingly. | 6-weeks |

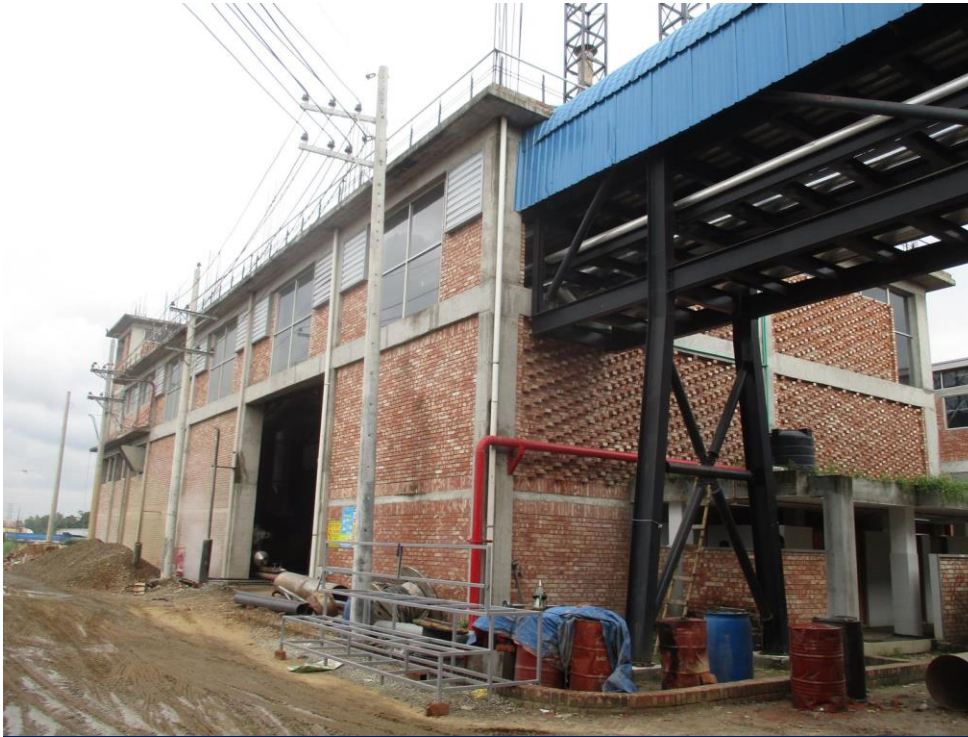
Building-14

Design report was not available for the Building-14. As per BNBC, every building or structure designed shall have its design documents prepared in accordance with the provision of Section 1.9.1. The design document shall include a design report, and a set of structural drawings, which shall be prepared in compliance with section 1.9.1.1 and section 1.9.1.2 of part-6, BNBC.

However, the building engineer is required to prepare a design report in compliance with BNBC.

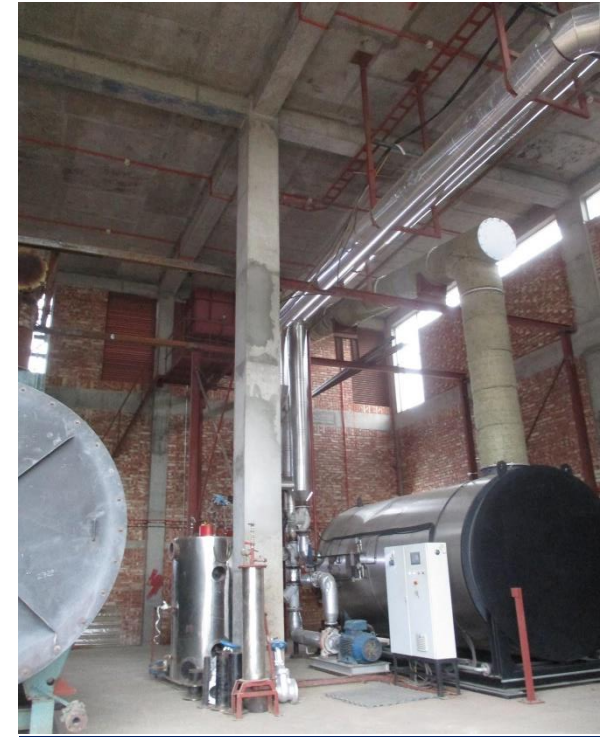
Long column design is required

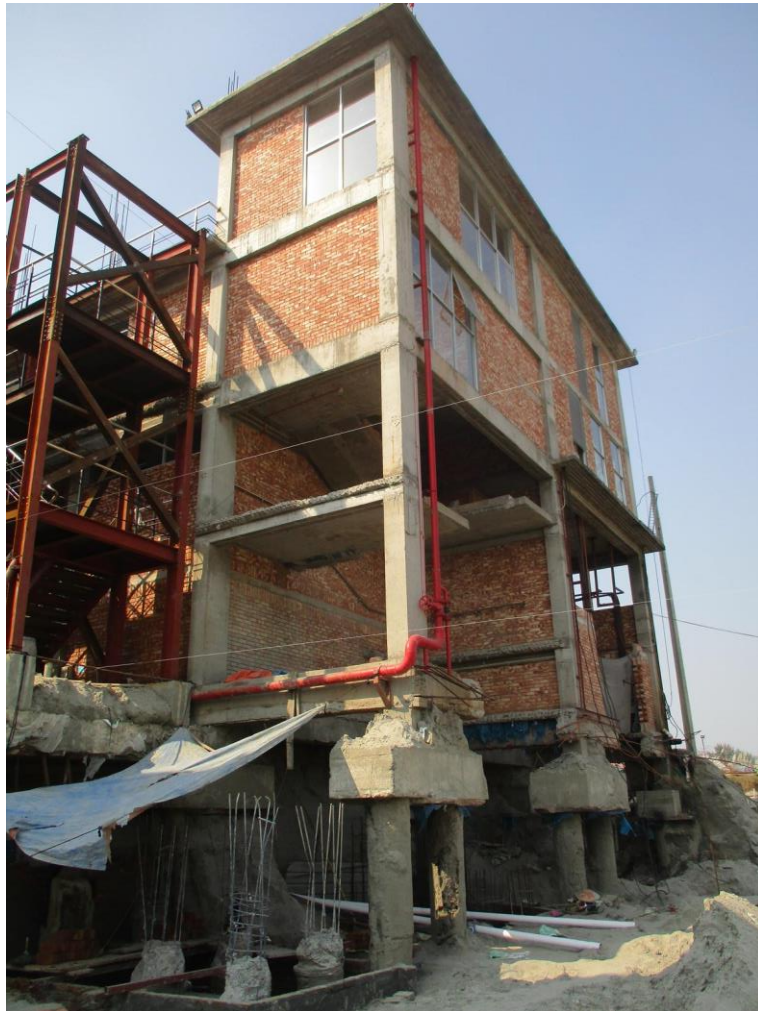
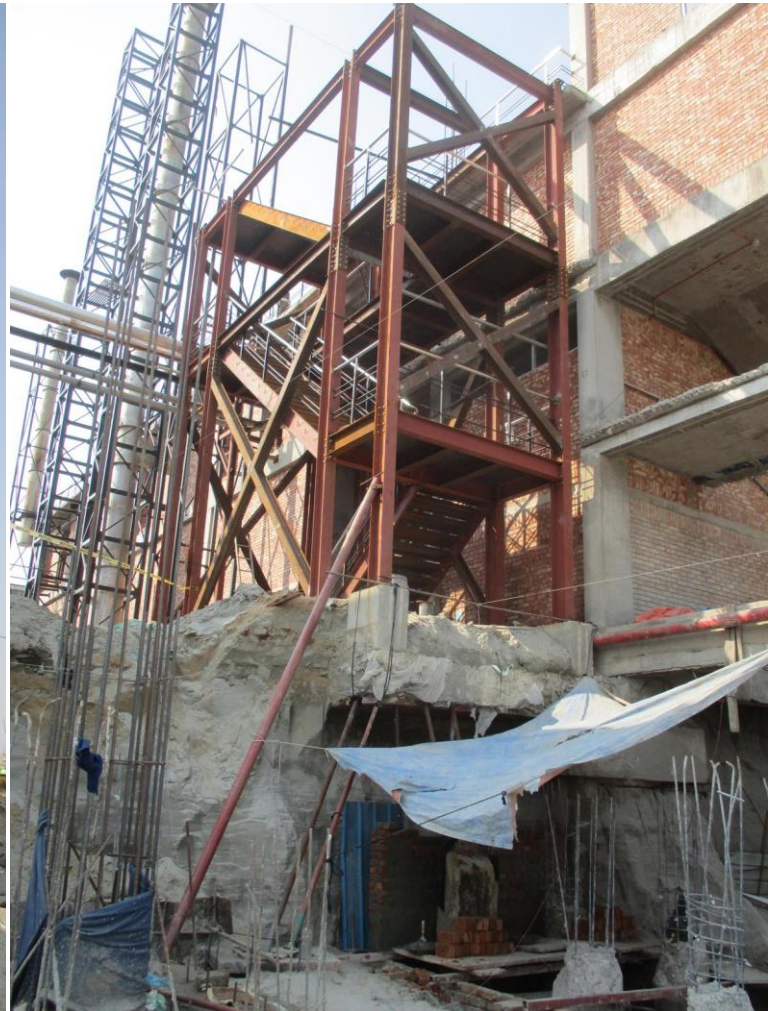
Due to excavation, soil from shallow foundation was moved away and 2.7 m pile was exposed. The factory engineer is required to provide the retaining wall to support loose soil, suggest compaction methodology of backfilling soil and re-check the foundation capacity accordingly.

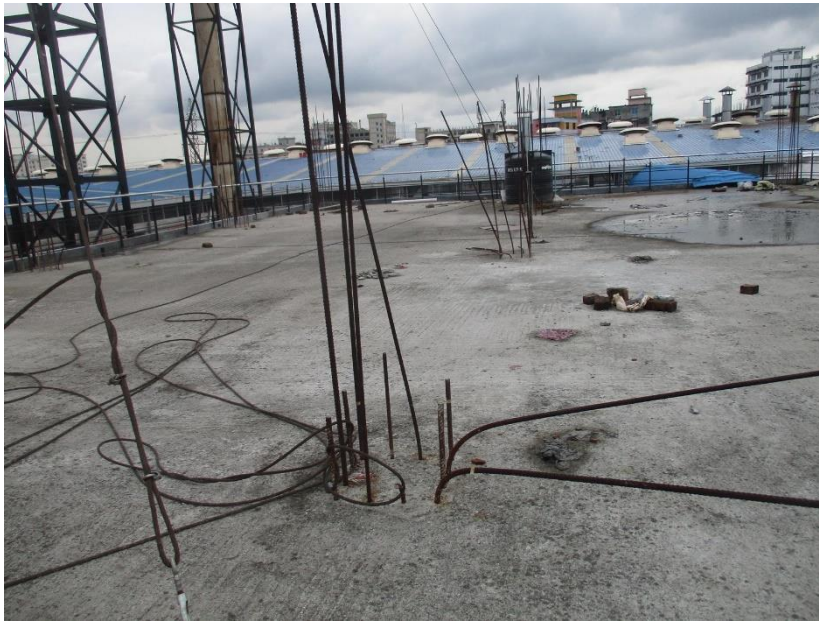
Exposed rebar on roof

Remove rusting and apply rust proof coating to the exposed rebars to protect from further corrosion.

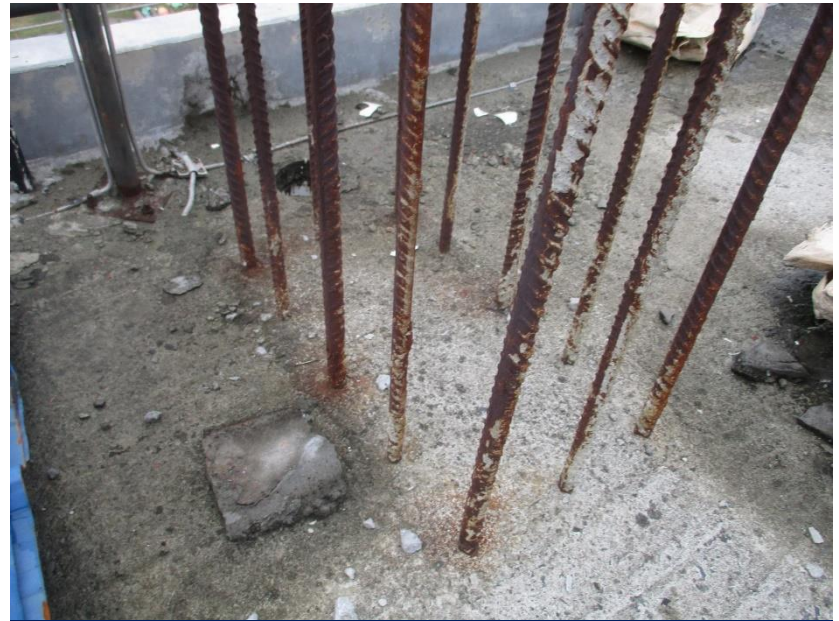
Rebar corrosion

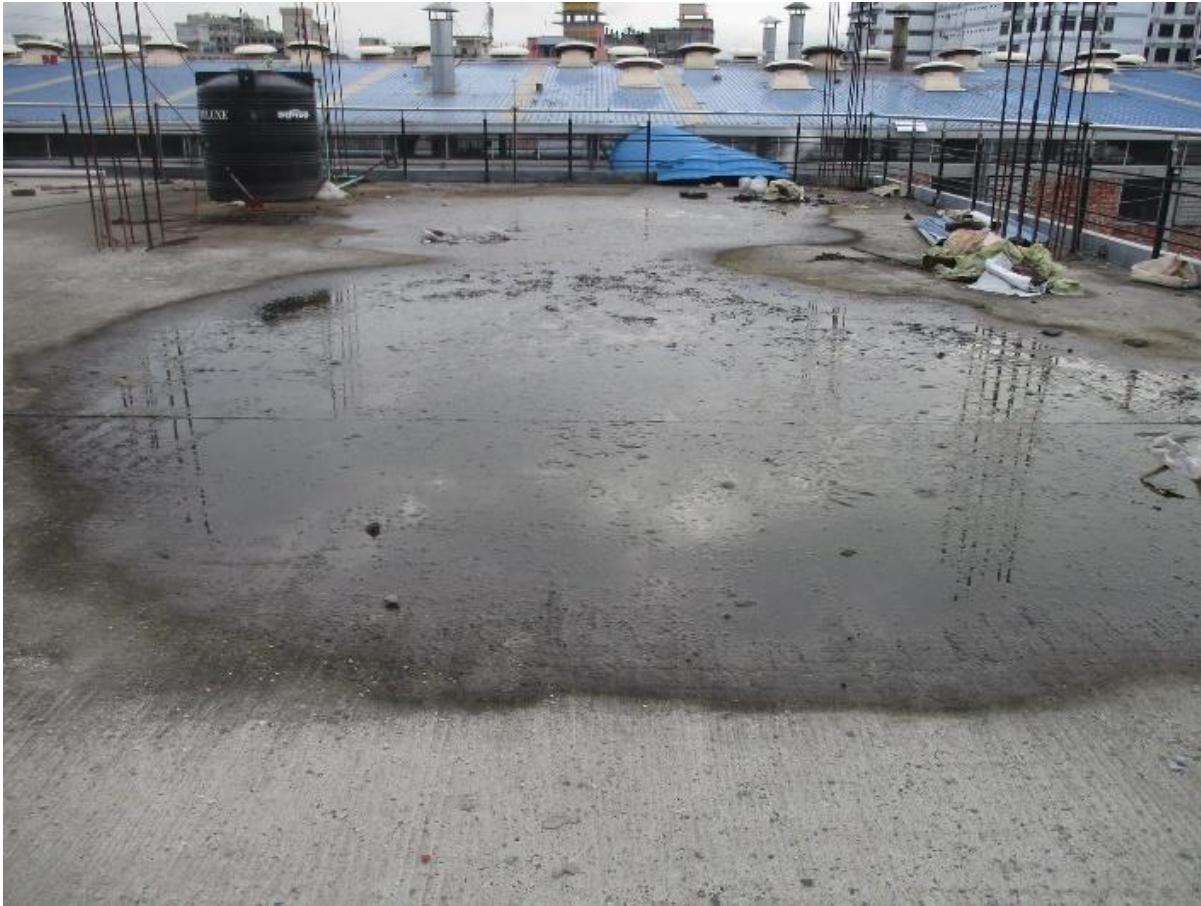
Water ponding on roof

Develop drainage system on roof with adequate slope to protect water infiltration into the slab.

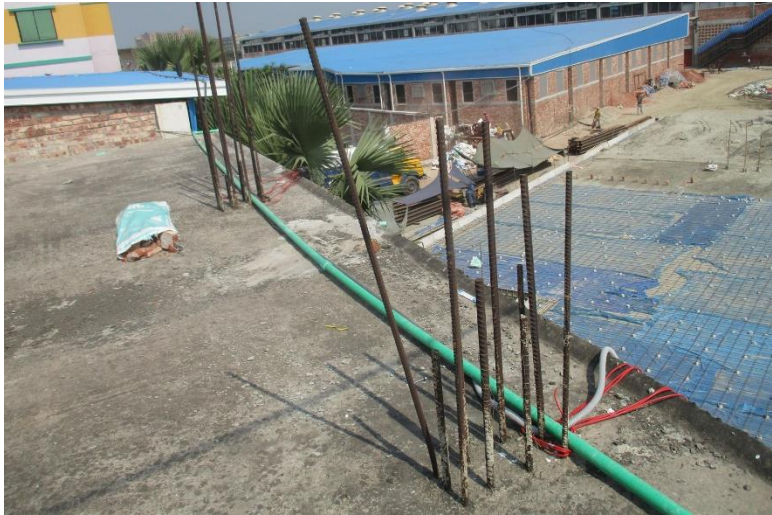
B-8: Exposed rebar on roof

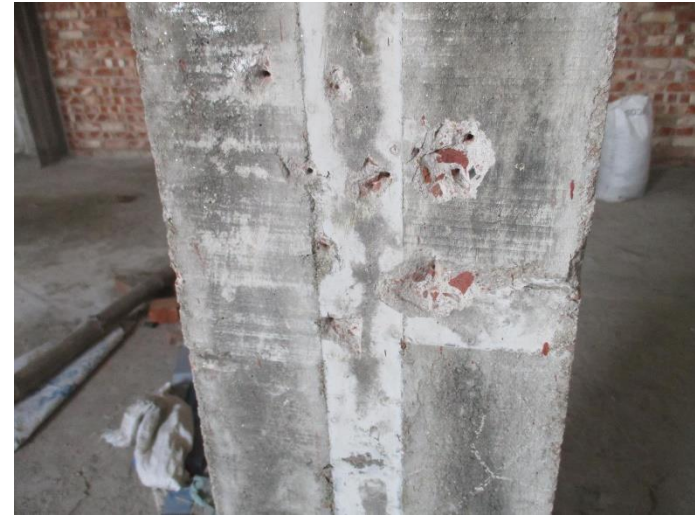
B-8: Brick aggregate on column

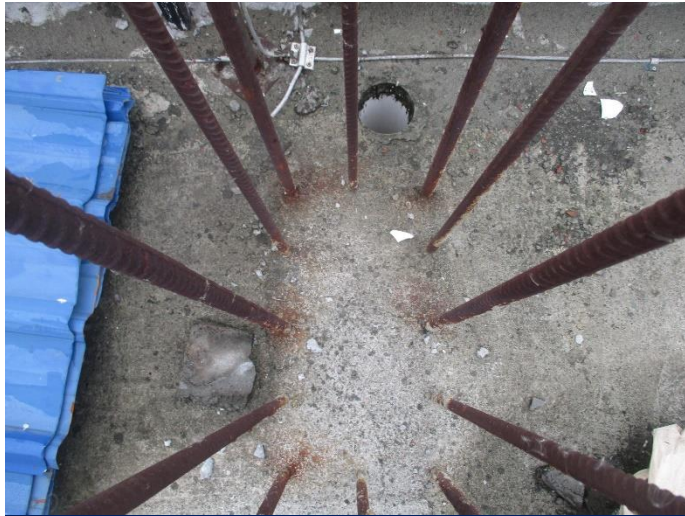
B-14: Exposed rebar on roof
