# **Orient Allure Lingerie Ltd. & LZ Textiles Ltd. (Extension Building)**

Dewallia Bari, Konabari, Gazipur, Dhaka  
(24.011924, 90.309907)

10 October 2021

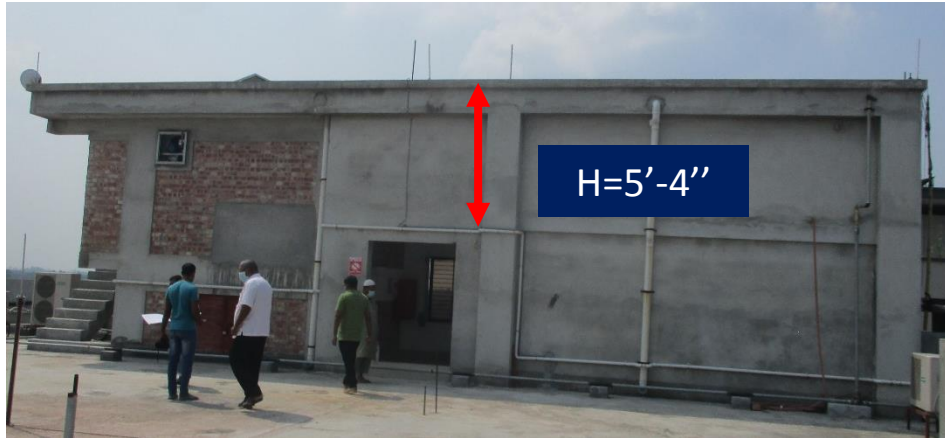
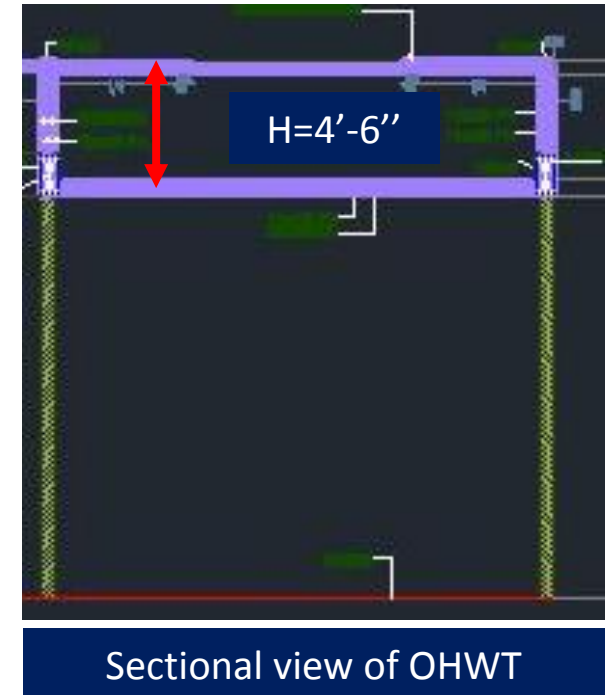
## **Mismatch in structural drawings**

RC OHWT height was provided 4'-6" (1.37m) in drawing but it was found 5'-4" (1.62m) onsite. Factory engineer is required to revise the structural drawing as per onsite condition. And check the design accordingly.

| Item No. | Observation | Recommended Action Plan | Recommended Timeline |
|---|---|---|---|
| 01 | Mismatch in structural drawings. Building-3 (Office Building) | Factory engineer to survey the structure and produce accurate as-built drawings. | 6-weeks |
| 02 | Mismatch in structural drawings. Building-3 (Office Building) | Check the design for extra loadings of overhead water tank and update the report accordingly. | 6-weeks |

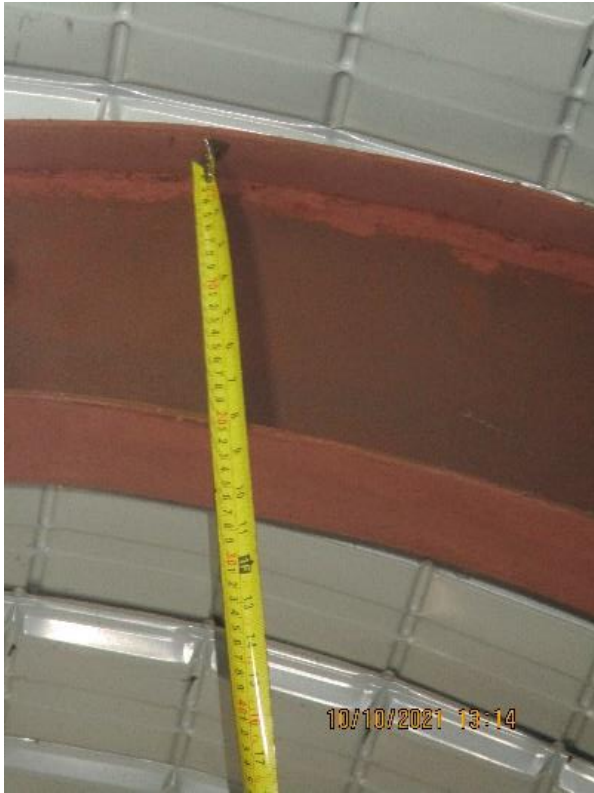
Mismatch in rafter size at top

Rafter size was found 50 mm less than the provided drawing in connection bridge. Also, all the connections with columns were found welded whereas in drawing, all joints were showed bolt connections. Factory engineer is required to revise the drawing as per onsite condition.

| Item No. | Observation | Recommended Action Plan | Recommended Timeline |
|---|---|---|---|
| 03 | Discrepancies between drawings and as-built condition. (Connecting Bridge) | Factory engineer to survey the structure and produce accurate as-built drawings with connection details. | 6-weeks |

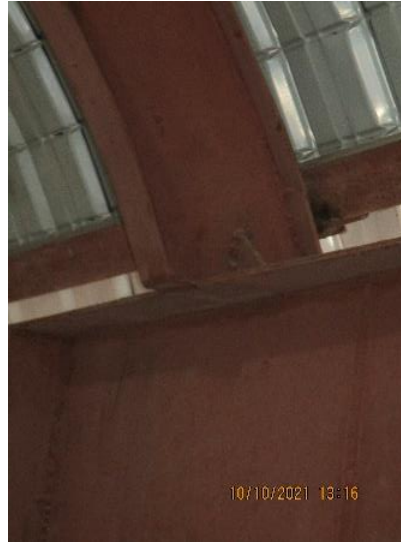
Welded connection

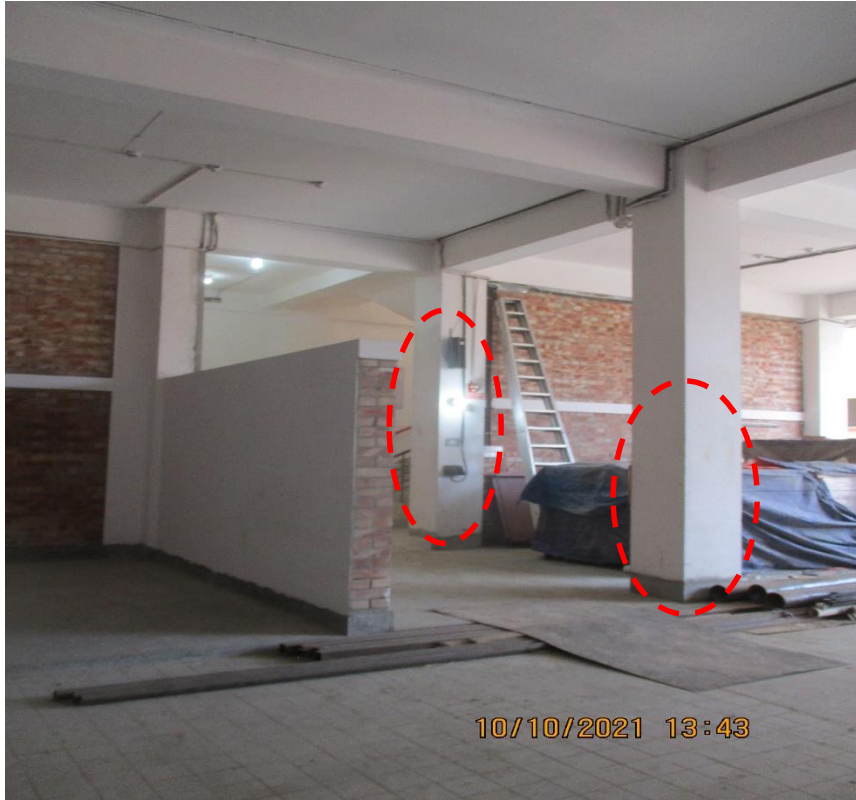
Column susceptible to vehicle impact

Some of the columns were found adjacent of driveway of parking & loading unloading platform. These column are susceptible to vehicle impact. The factory engineer is required to take necessary measures to prevent the vehicle impact by providing the barrier around the columns.

| Item No. | Observation | Recommended Action Plan | Recommended Timeline |
|---|---|---|---|
| 04 | Column susceptible to vehicle impact. Building-3 (Office Building) | The factory engineer is required to provide proper barrier around the columns to protect from possible vehicle impact. | 6-months |

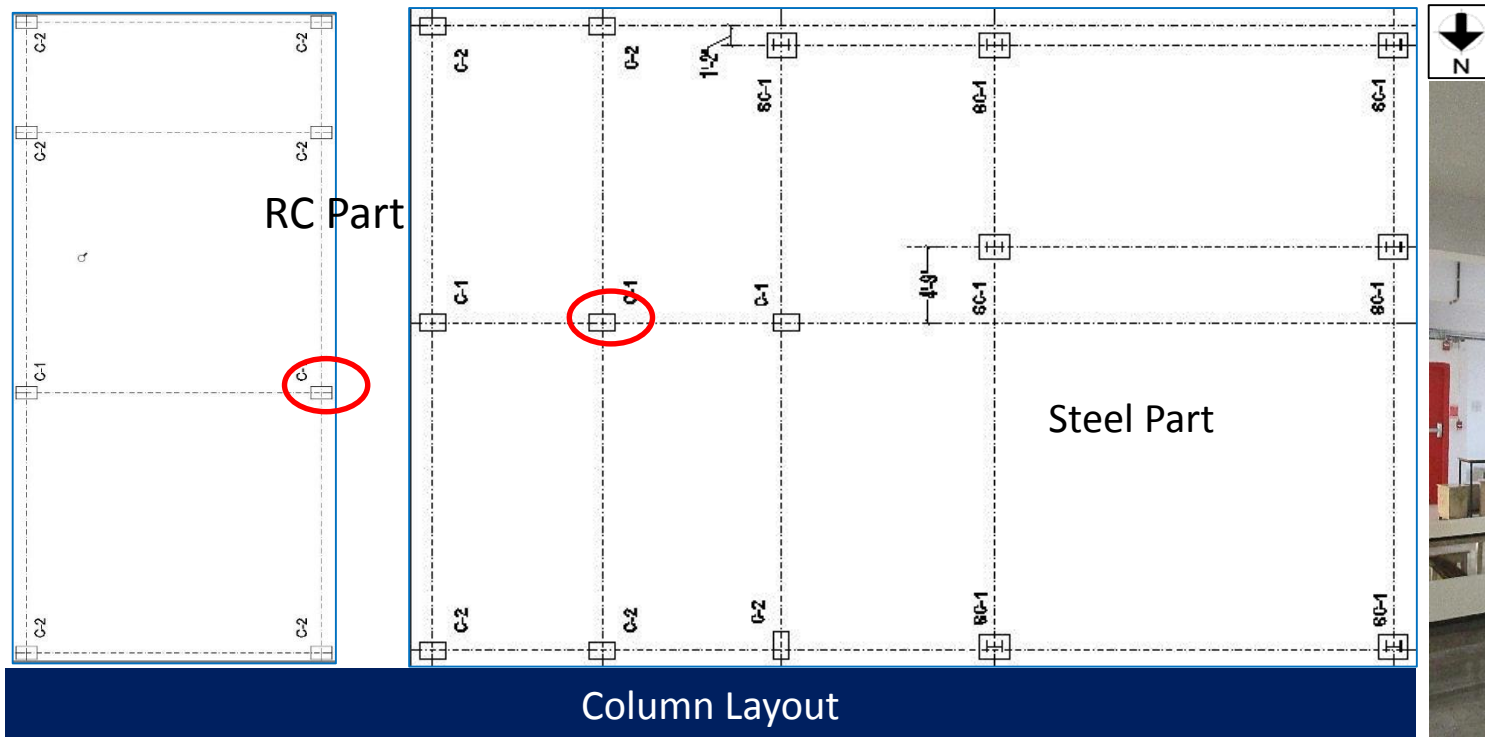
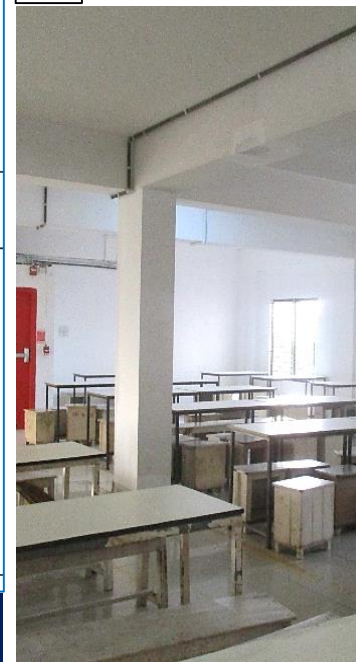
**Column stress exceeds normal design limit**

Cursory calculation indicate that the working stress of the marked columns exceed the normal design limit considering 3 kPa live load on typical floor, 1.5 KPa live load on roof and 16.37 MPa concrete strength. As part of Engineering Assessment (EA), factory engineer is required to verify the in-situ concrete strength, check the column capacity and suggest proper remedial actions accordingly.

| Item No. | Observation | Recommended Action Plan | Recommended Timeline |
|---|---|---|---|
| 05 | Column stress exceeds normal design limit. Building-2 (Dining Building) | As part of Engineering Assessment (EA), factory engineer is required to verify the in-situ concrete strength, check the column capacity and suggest proper remedial actions accordingly. | 6-weeks |
| 06 | Column stress exceeds normal design limit. Building-2 (Dining Building) | Produce and actively manage a loading plan for all floor plates considering floor, column and foundation capacity. | 6-weeks |
| 07 | Column stress exceeds normal design limit. Building-2 (Dining Building) | The factory engineer is required to prepare a set of design documents for all structures as per BNBC part-6, section 1.9.1 | 6-weeks |
| 08 | Column stress exceeds normal design limit. Building-2 (Dining Building) | Carry out remedial works if suggested in the EA report. <ul style="list-style-type: none"> <li>Continue to implement the load management plan.</li> </ul> | 6-months |

| Item No. | Observation | Recommended Action Plan | Recommended Timeline |
|---|---|---|---|
| 09 | Column stress exceeds normal design limit. Building-2 (Dining Building) | Continue to implement the load management plan. | 6-months |

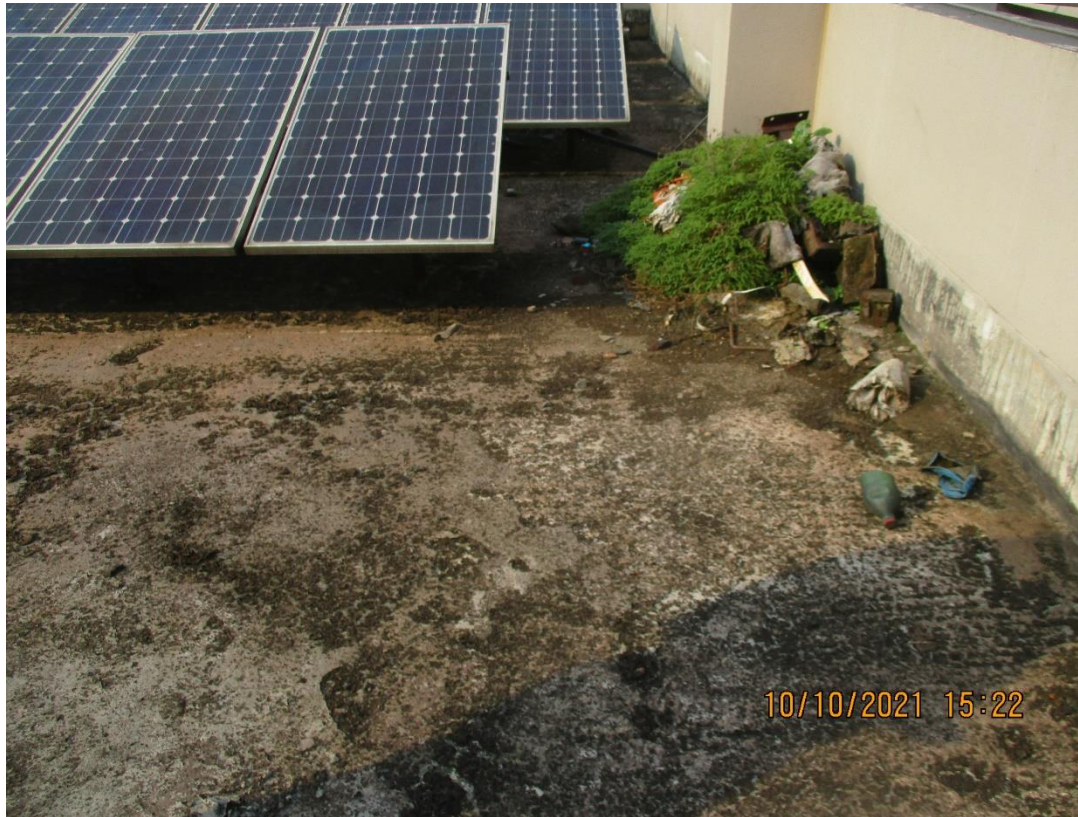
## **Drainage system at roof**

During inspection, signs of water ponding were observed on the roof. Factory engineer is required to improve drainage system to avoid stagnant water ingress into the slab.

| Item No. | Observation | Recommended Action Plan | Recommended Timeline |
|---|---|---|---|
| 13 | Drainage system at roof. Building-2 (Dining Building) | Develop drainage system on the roof with adequate slope to protect the roof slab from water ingress. | 6-months |
