# SP Garments Ltd. (Extension Building)

Shirir Chala, Mahona Vabanipur, Vawalgor, Gazipur Sadar, Gazipur.

31 October 2021

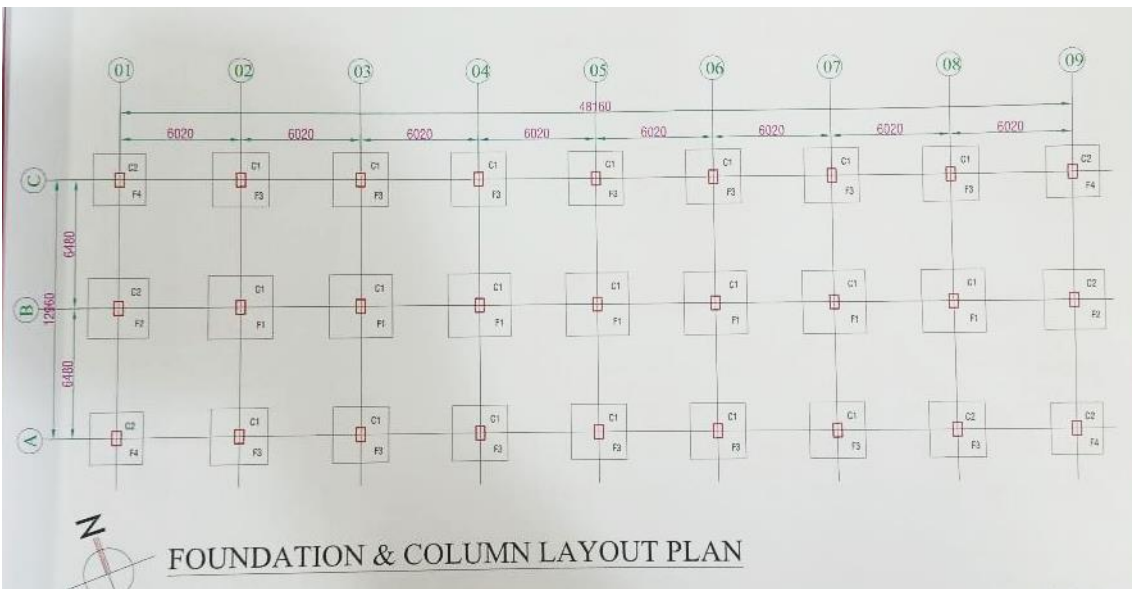
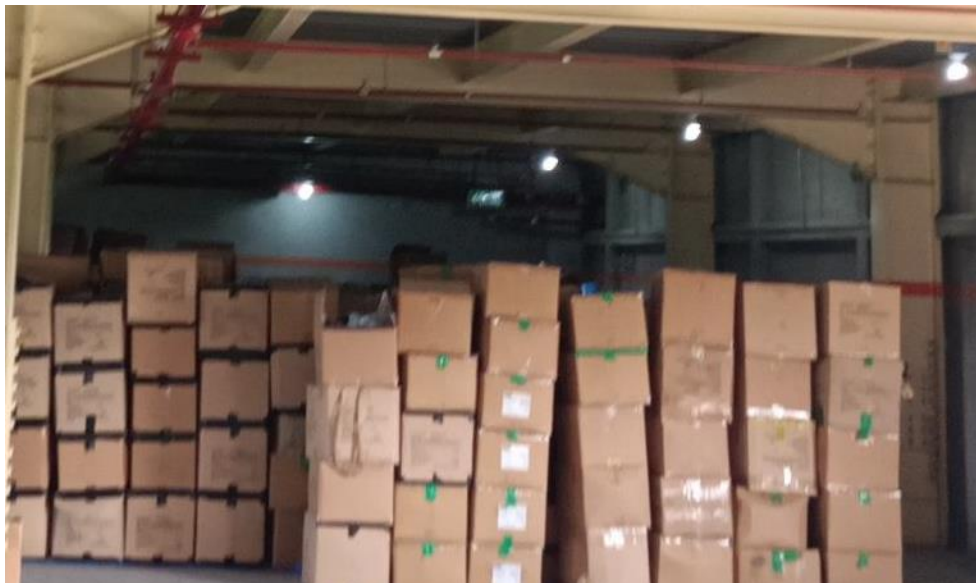
# Footings stressed above normal design limits

Cursory calculation indicates that footings are stressed above normal design limit considering 6 kPa (for store building) floor live load, equivalent concrete strength from core test value ( $f'_c$  2.227 ksi (15.35 MPa) and allowable bearing capacity 3.86 ksf (FS 2.5). The building engineer is required to review design, load, column & footing stress.

Item No.	Observation	Recommended Action Plan	Recommended Timeline
01	Footing stressed above normal design limits.	As part of Detail Engineering Assessment (DEA) Building engineer is required to review design, load & footing stress.	6-weeks
02	Footing stressed above normal design limits.	Produce and actively manage a set of floor loading plan within the factory building considering foundation, column and floor capacity.	6-weeks
03	Footing stressed above normal design limits.	Carry out remedial works as per DEA recommendations.	6-months
04	Footing stressed above normal design limits.	Implement floor load plan.	6-months

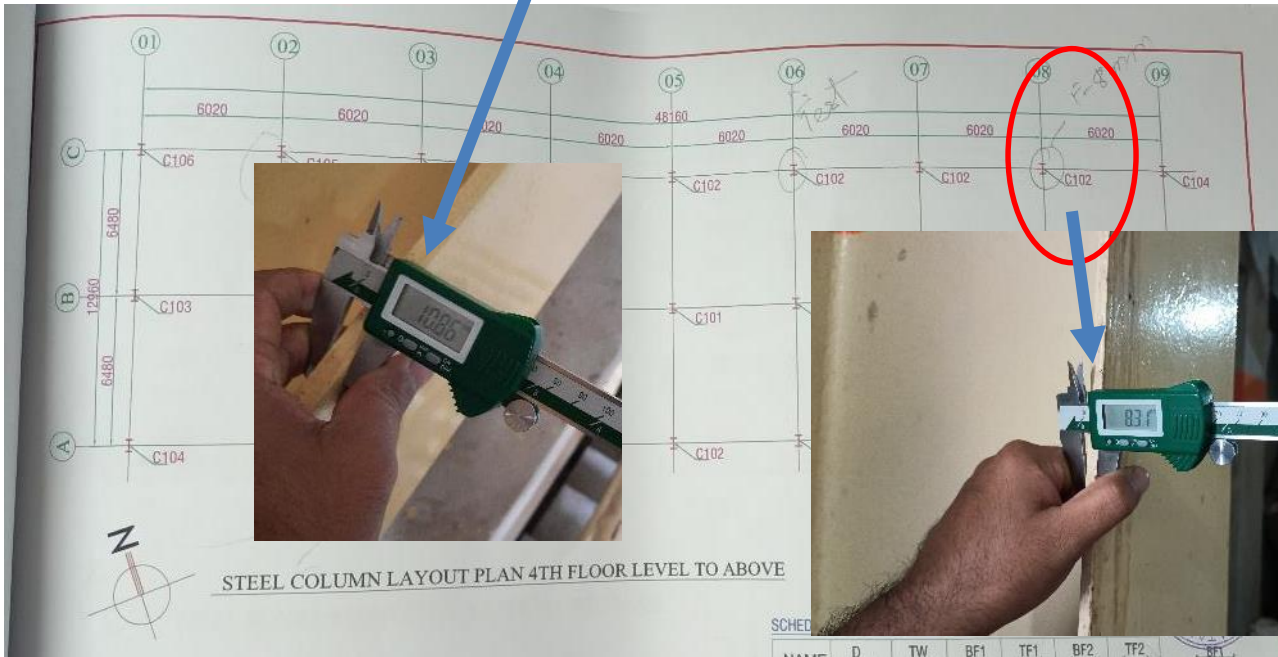
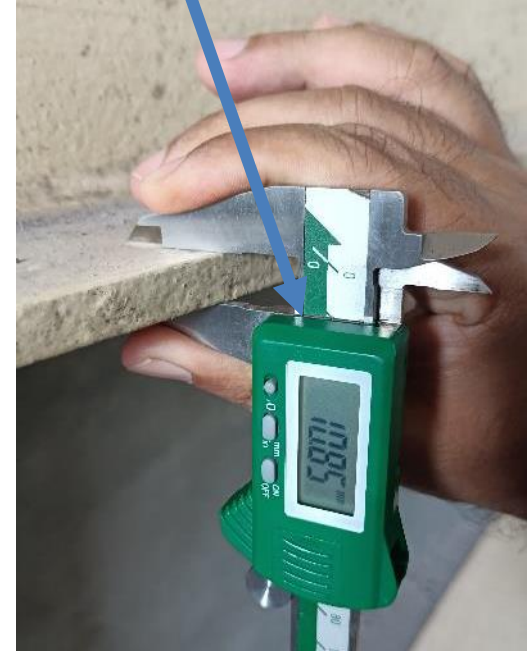
Flange thickness of steel column C-102 at grid 08-C and C-103 at 4<sup>th</sup> floor level were found 8 mm instead of 10 mm and 10 mm instead of 12 mm, respectively.  
 Also, the flange thickness of Main Beam at stair was found 10 mm instead of 12 mm

Item No.	Observation	Recommended Action Plan	Recommended Timeline
05	Prepared Design report not comply with BNBC.	The building engineer to check the occupancies and update the floor live loading plan for the building based on BNBC loading requirements and capacity of building floor, column & foundations.	6-weeks
06	Prepared Design report not comply with BNBC.	Revise the design report considering actual soil bearing capacity.	6-weeks
07	Prepared Design report not comply with BNBC.	Implement the floor loading plan (posting load plan, providing signage and maintaining loadings)	6-months
08	Discrepancies between as-built condition and drawings.	Building engineer is required to survey the structure and produce as-built drawing as per BNBC section 1.9.1	6-weeks

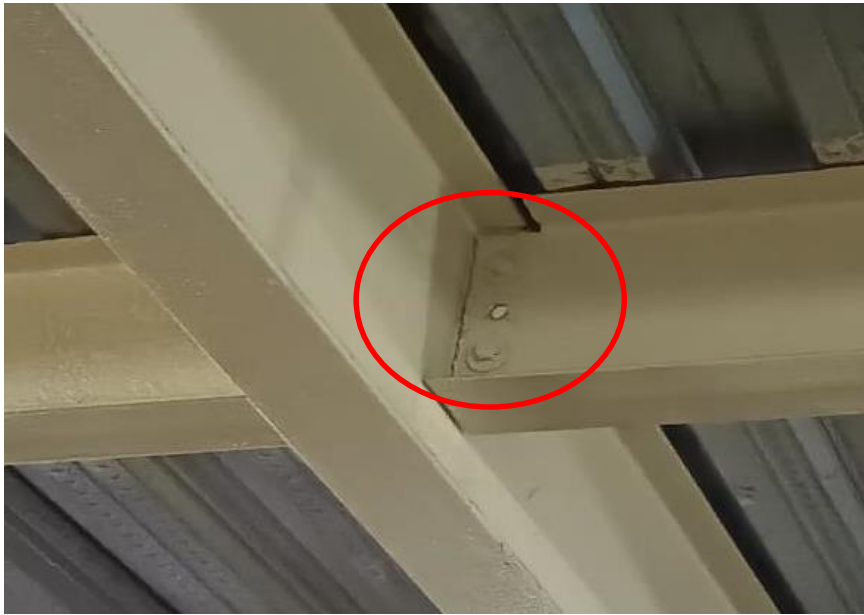
Bolt missing

Bolt missing in several connection joint.  
Building engineer is required to identify the all locations and install missing bolt accordingly.

Item No.	Observation	Recommended Action Plan	Recommended Timeline
09	Bolt missing in steel connection.	Building engineer is required to identify the all locations and install missing bolt accordingly.	6-weeks
10	Corrosion in steel member.	The building engineer to investigate the reason of corrosion and suggest proper remedial measure accordingly.	6-weeks
11	Corrosion in steel member.	Take necessary measures to prevent further corrosion and repair the corroded steel members as per engineer's suggestion.	6-months

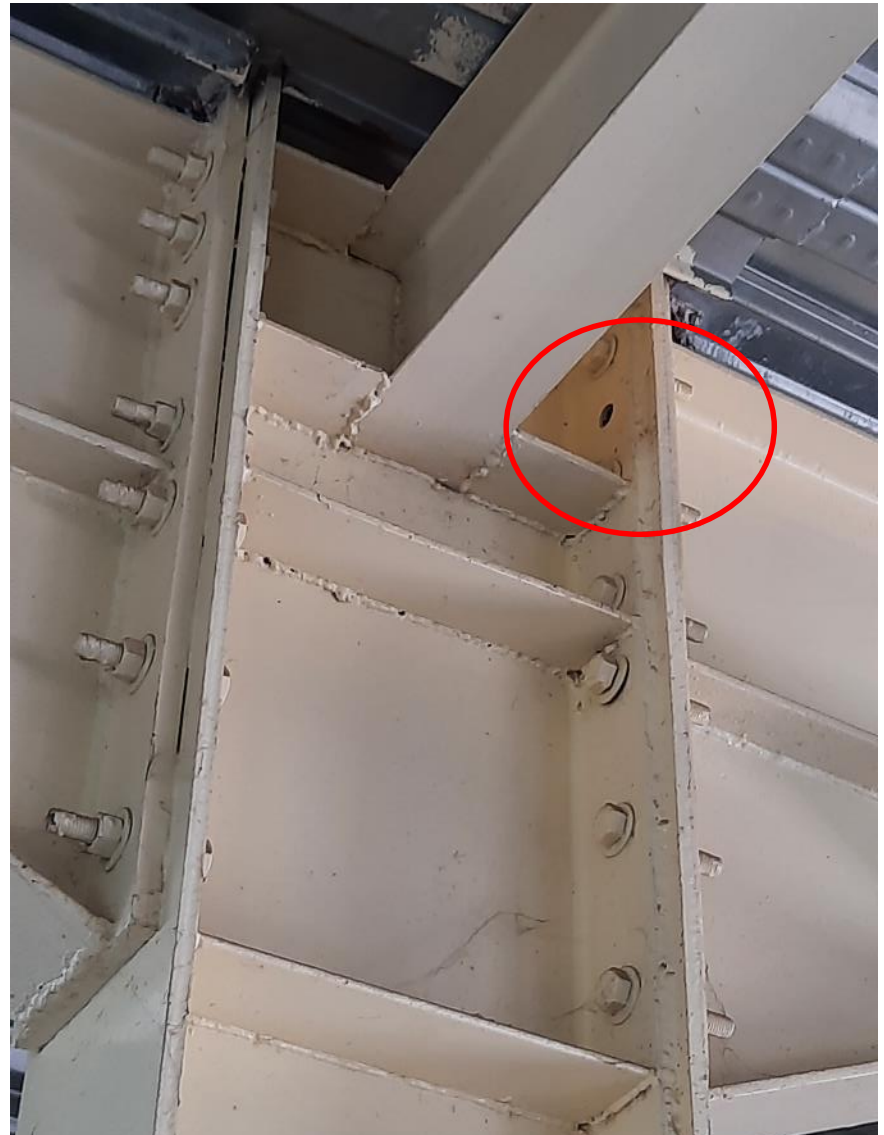
Bolt missing

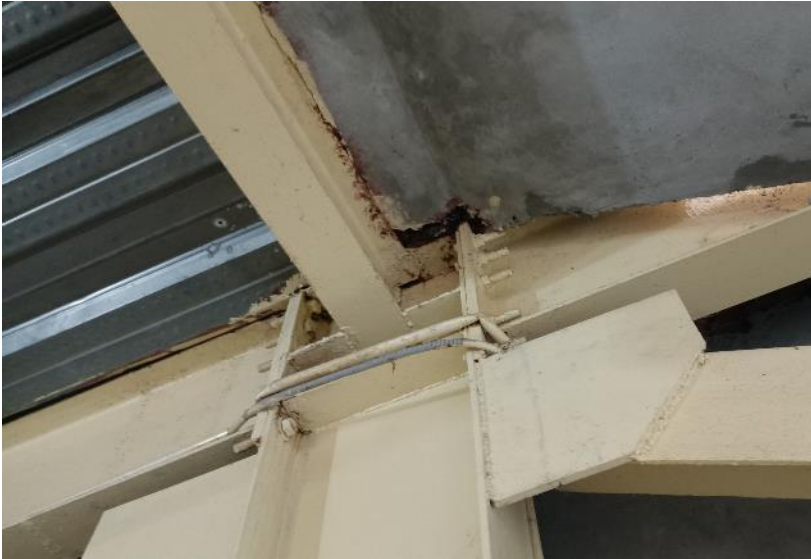
Corrosion in steel member was observed in several locations. The building engineer to investigate the reason of corrosion and suggest proper remedial measure accordingly.

Corrosion in joint

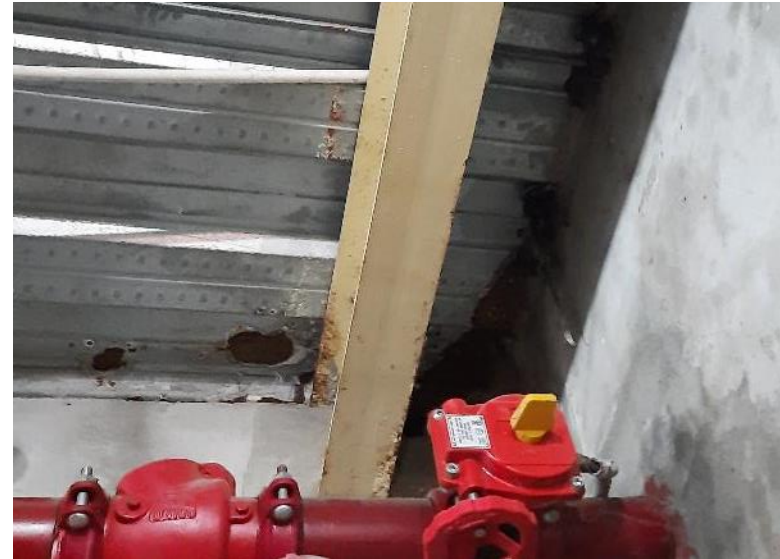
Corrosion in sub-beam
