# Apex Yarn Dyeing Ltd.

Chandora, Shofipur, Kaliakoir, Gazipur

18th October & 1st November 2021

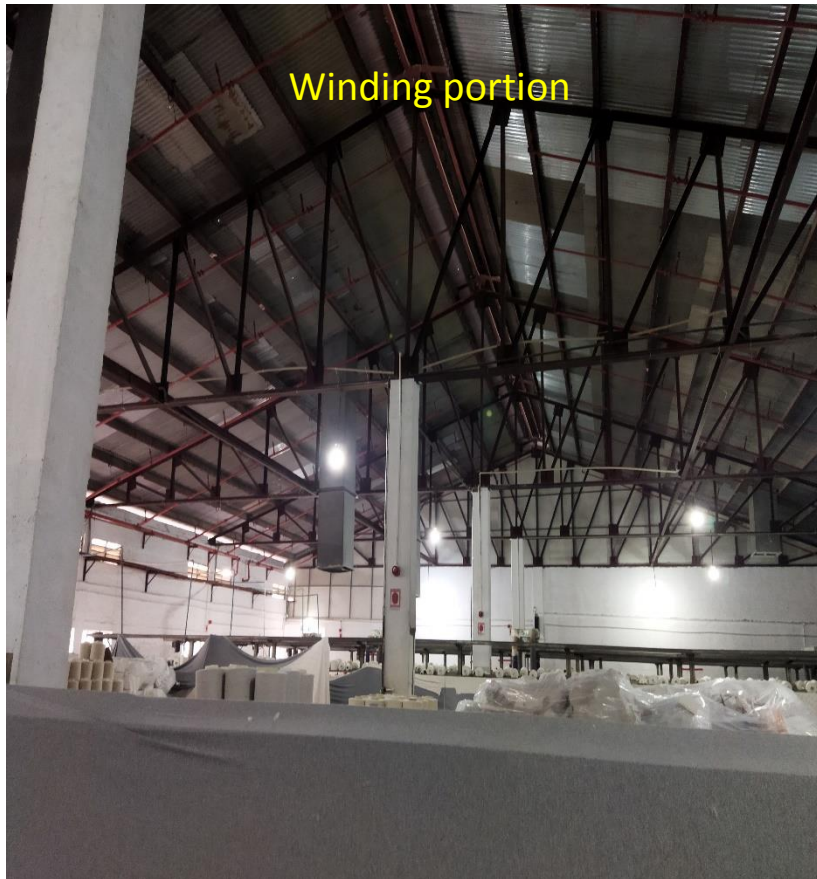
Winding portion

Roof bracing is not provided

Tie beam is provided along the long direction (periphery only). Some horizontal bracing are provided from truss to truss but roof bracing is not provided. Factory engineer is required to check the lateral stability system of the structure and review the design accordingly.

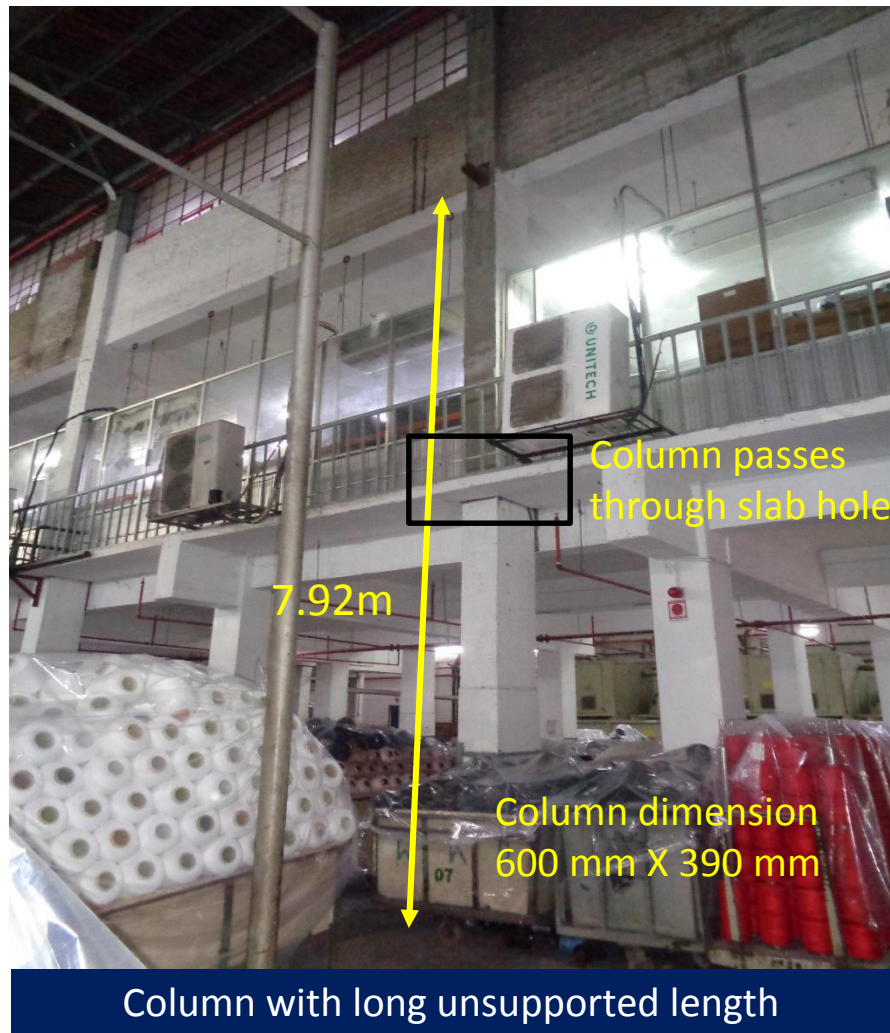
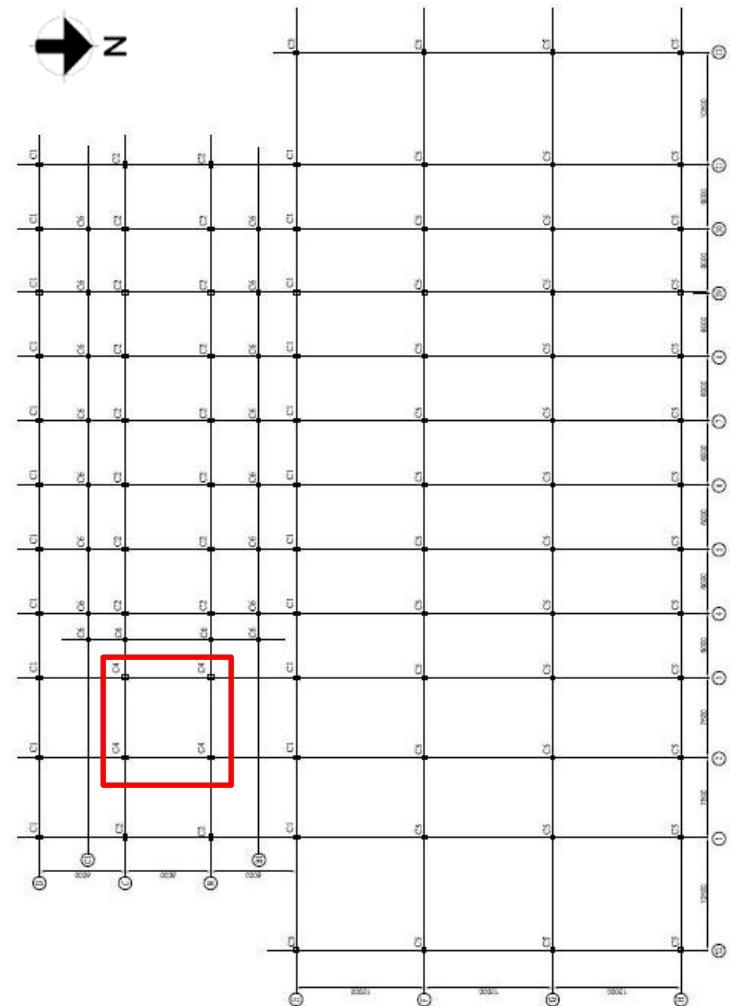
**Column appears to be slender**

The column is 7.92m long with least dimension 390 mm which may be critical for slenderness effect. Factory engineer is required to check the adequacy of the highlighted columns considering slenderness effect.

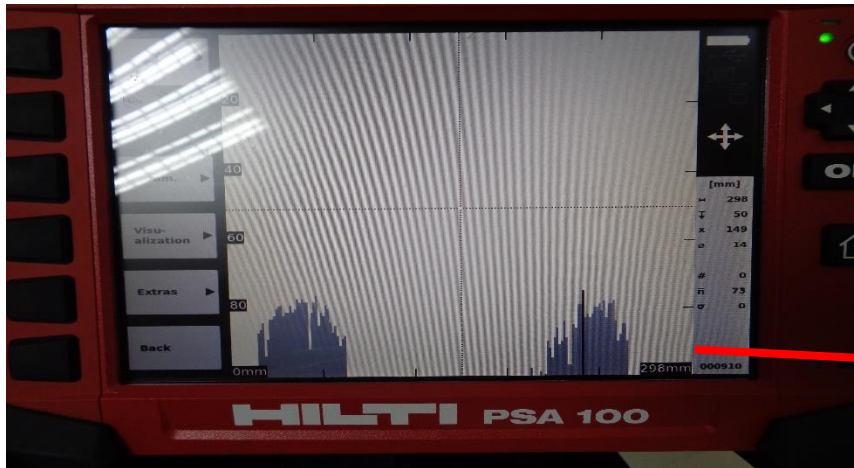
Ferro-scan shows 2-rebar along short face instead of 3-rebar (C-5)

Number of rebar of column C-5 found 6 instead of 8. Factory engineer is required to survey the structure, update the structural drawing and check the column capacity accordingly.

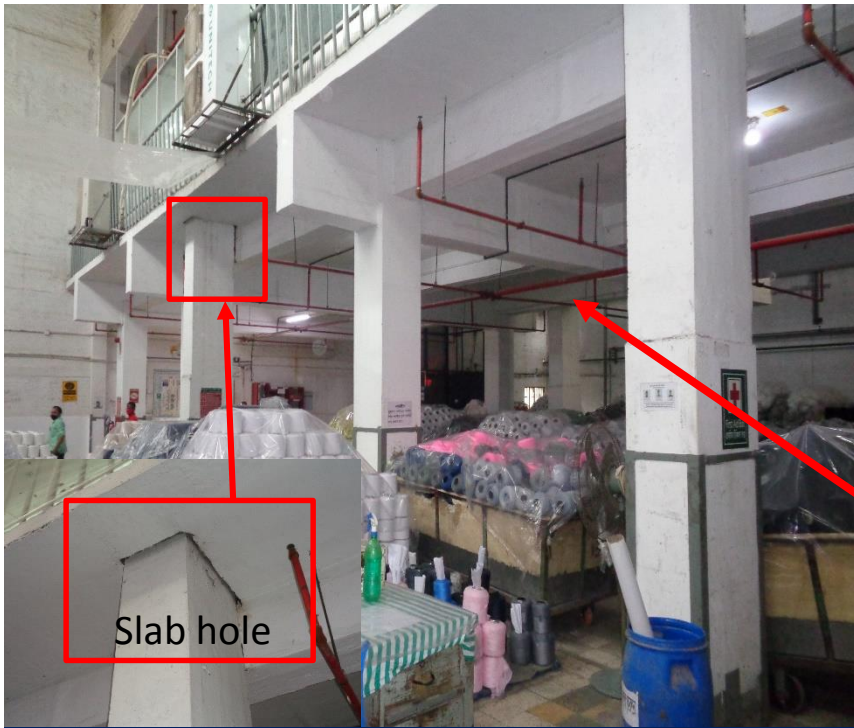
Rectangular hole in the slab not shown in the drawing

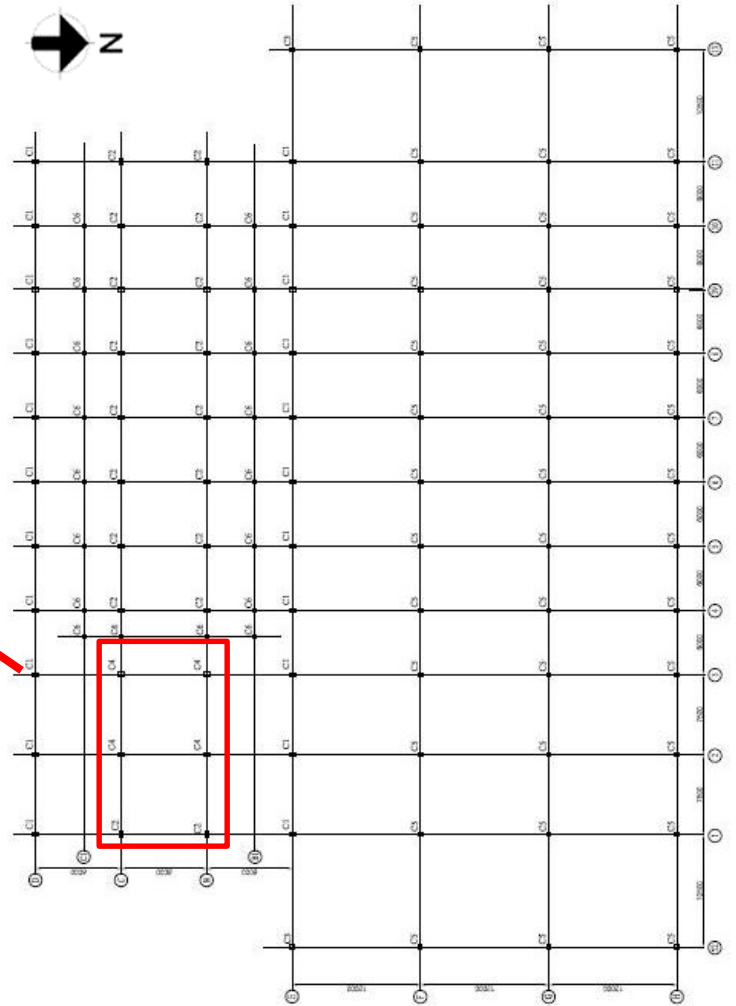
A single storied isolated RC structure was found the highlighted area of Dyeing area which was not shown in drawing. Factory engineer is required to update the as built drawing showing this structure.

Undocumented isolated RC portion at highlighted area

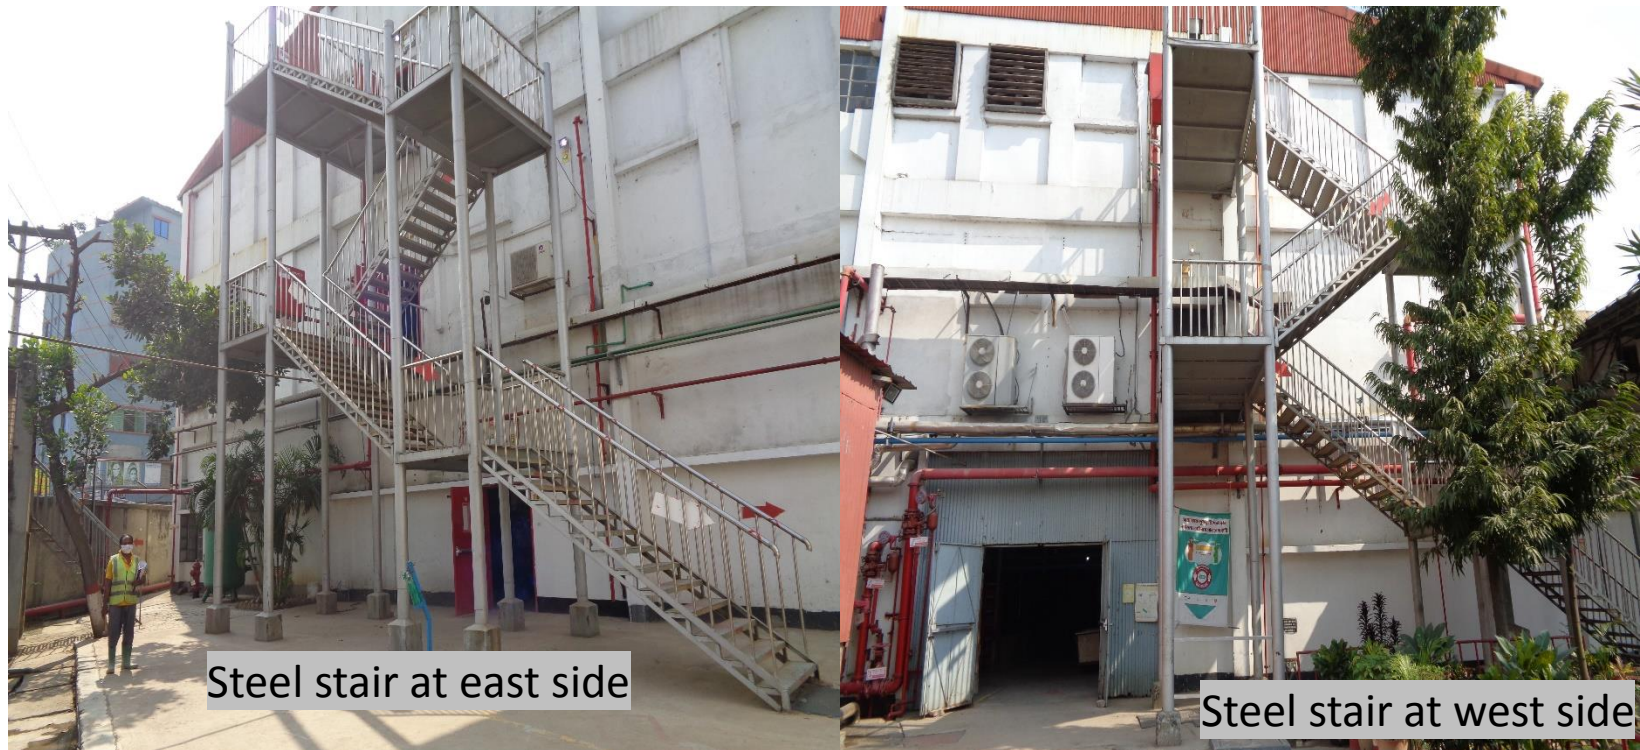
Steel stair at east side

Steel stair at west side

No bracing system is provided

Steel stair found at either side (East & West) of Dyeing & Winding Shed. No bracing system is provided to withstand the lateral load therefore there is no obvious stability system in those steel stairs. Factory engineer is required to check the lateral stability for both steel stair.

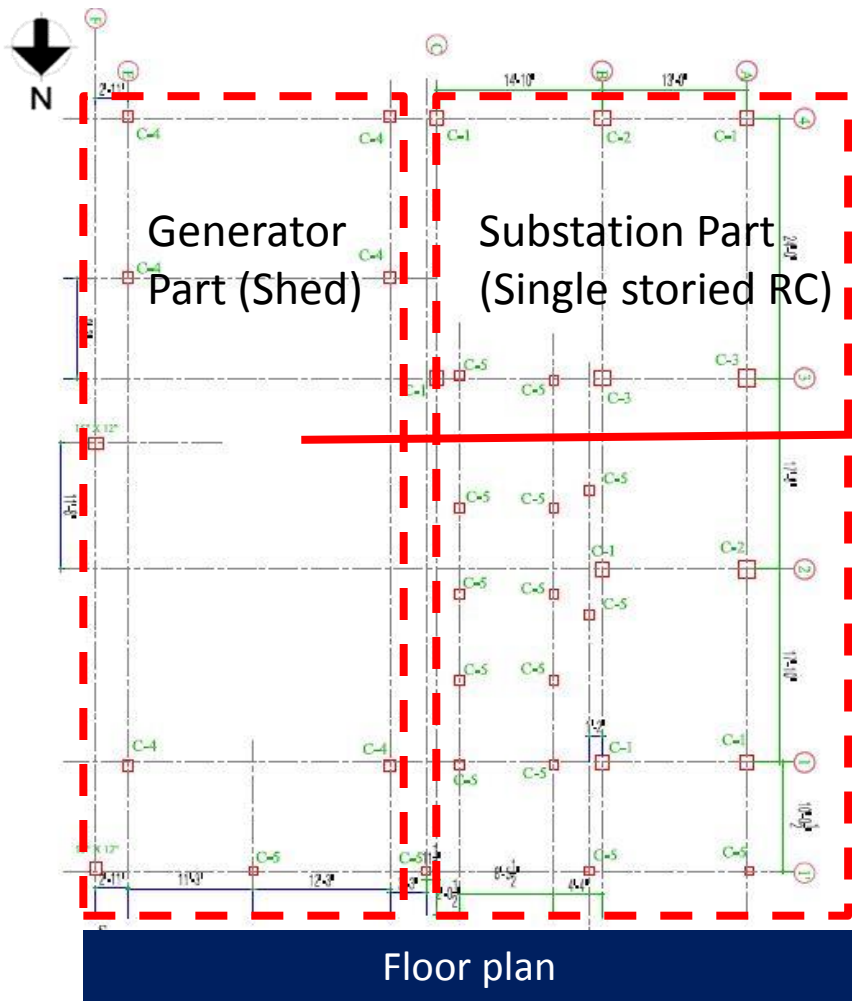
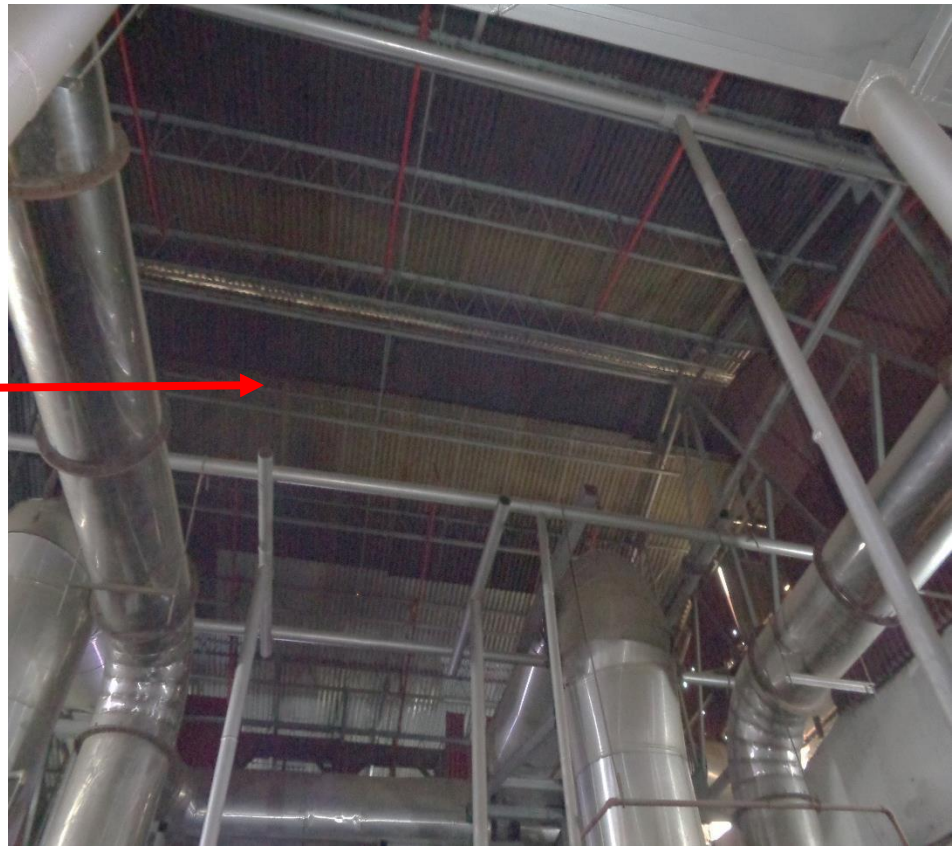
Roof bracing is not provided (Generator part)

There is no bracing at roof. Factory engineer is required to check the lateral stability of the structure.

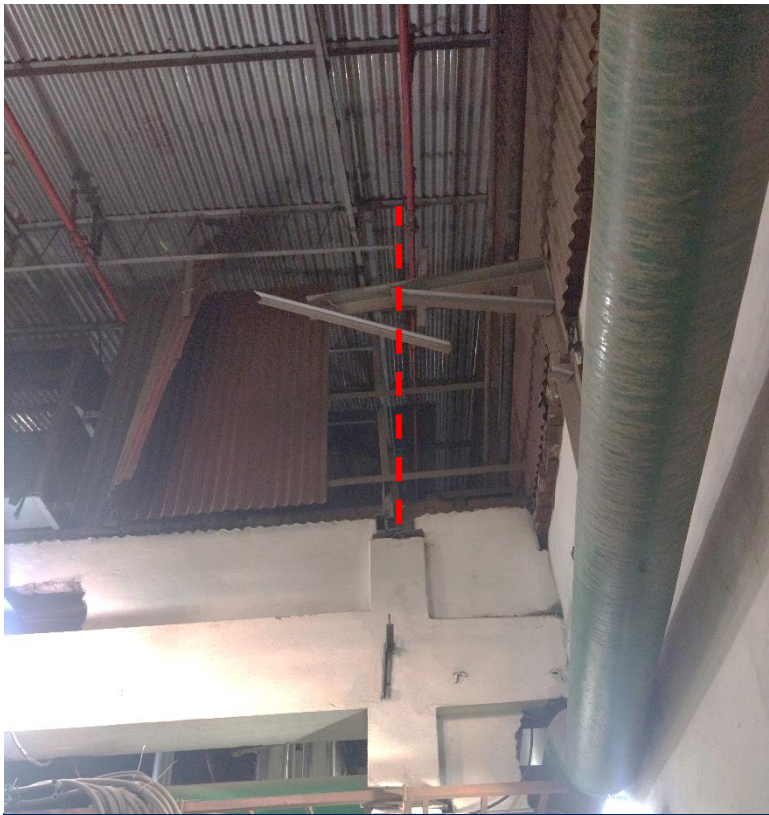
Truss found as out of plumb (Steel part)

Truss was found out of plumb, and a poor connection was found between truss and RC column at Steel part. Factory is required to check the truss alignment, support condition and suggest proper remedial actions accordingly.

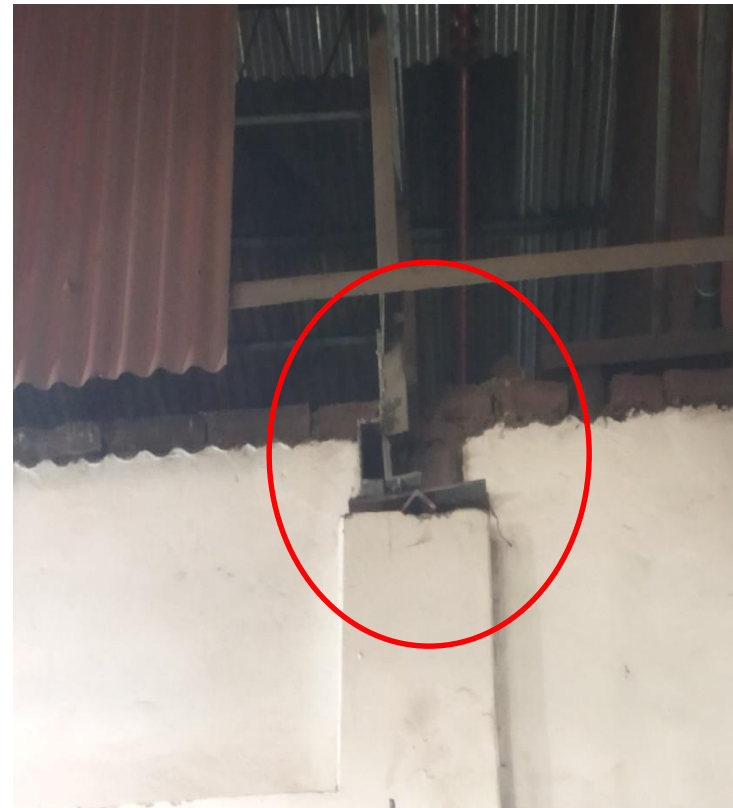
Poor connection between truss and RC column (Steel part)

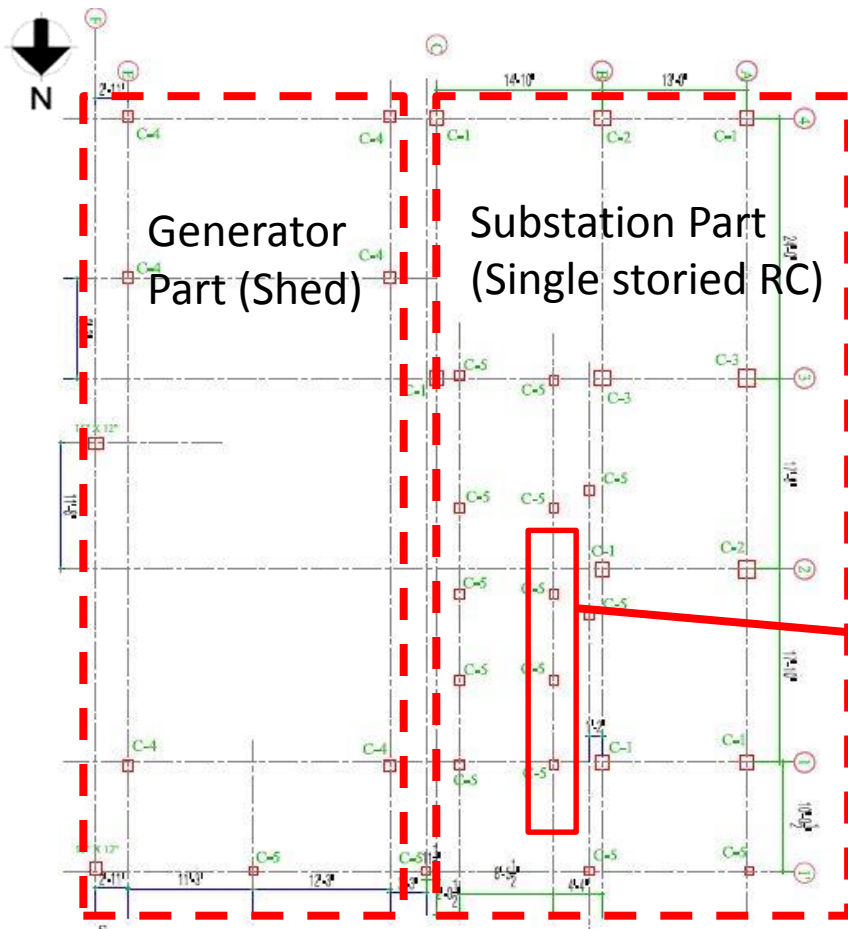
Columns shown in layout

Marked column were missing onsite but shown in drawing for RC part. Factory engineer is required to update the as-built drawings.

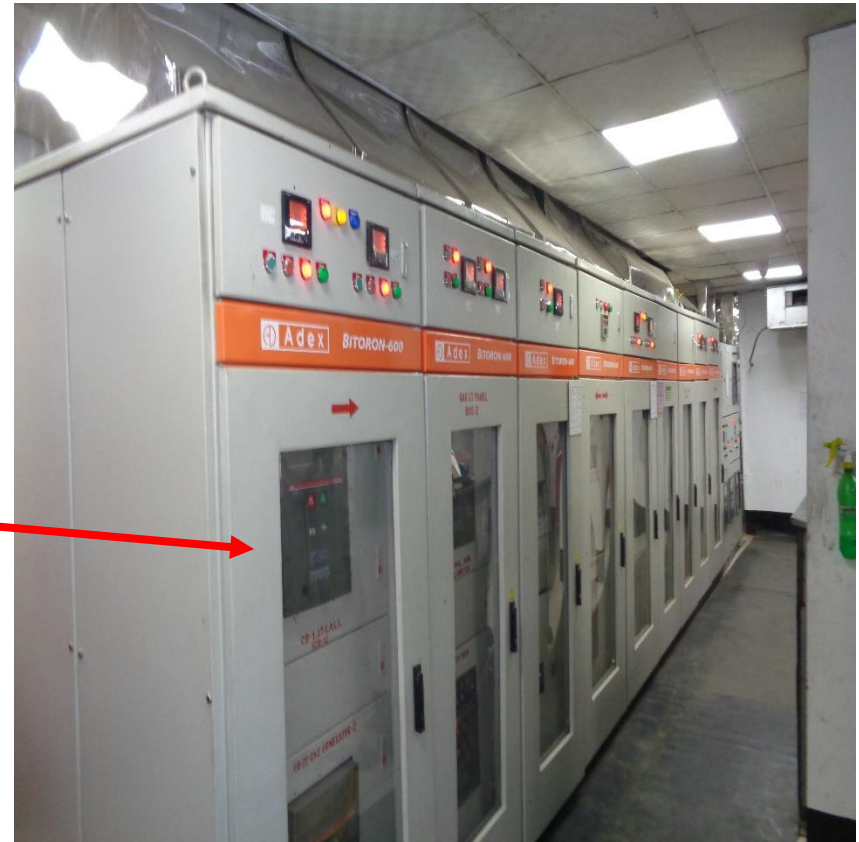
Columns not found on-site

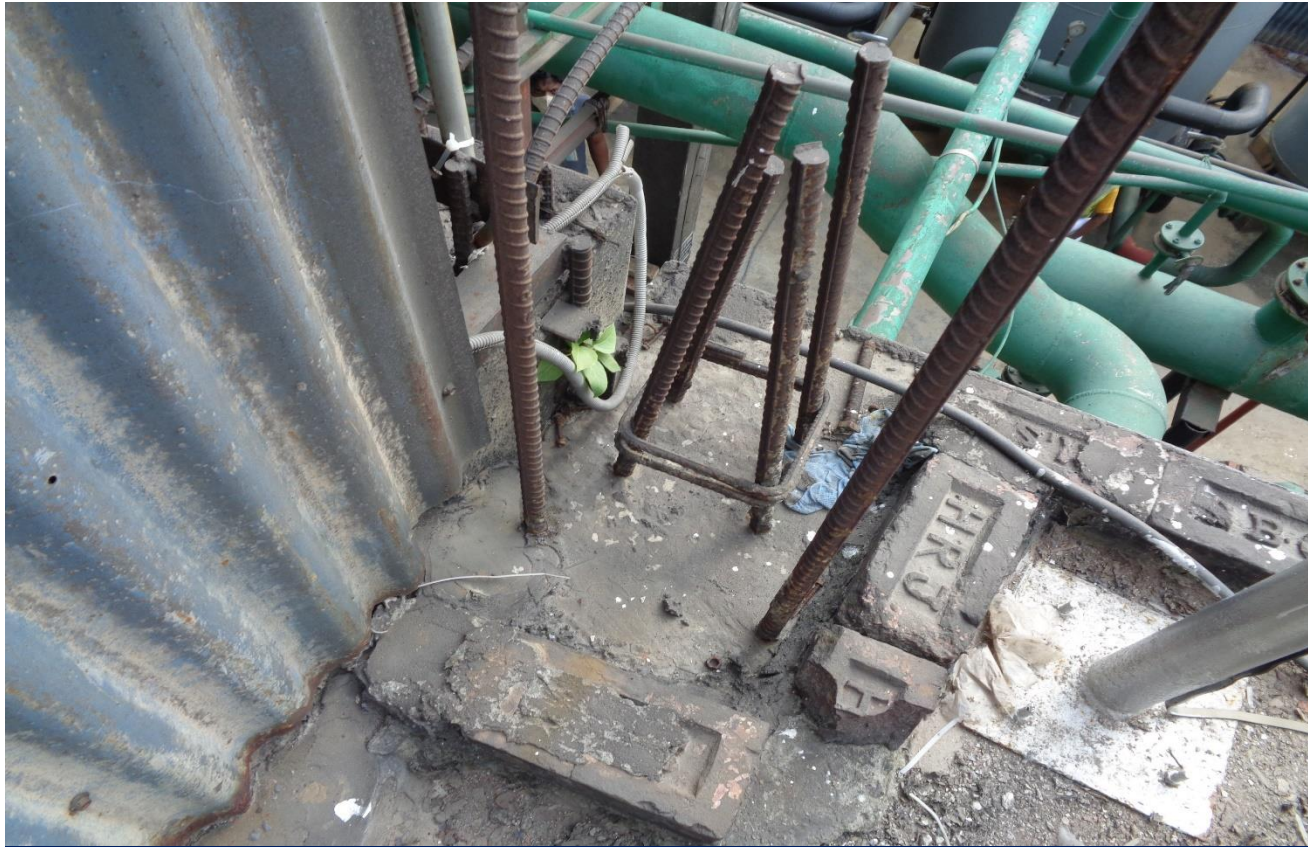
Exposed rebar at roof level (RC part)

Exposed reinforcement is left at roof level & staircase which was prone to corrosion. Factory is required to provide rust proof paint on exposed reinforcement to protect from corrosion.

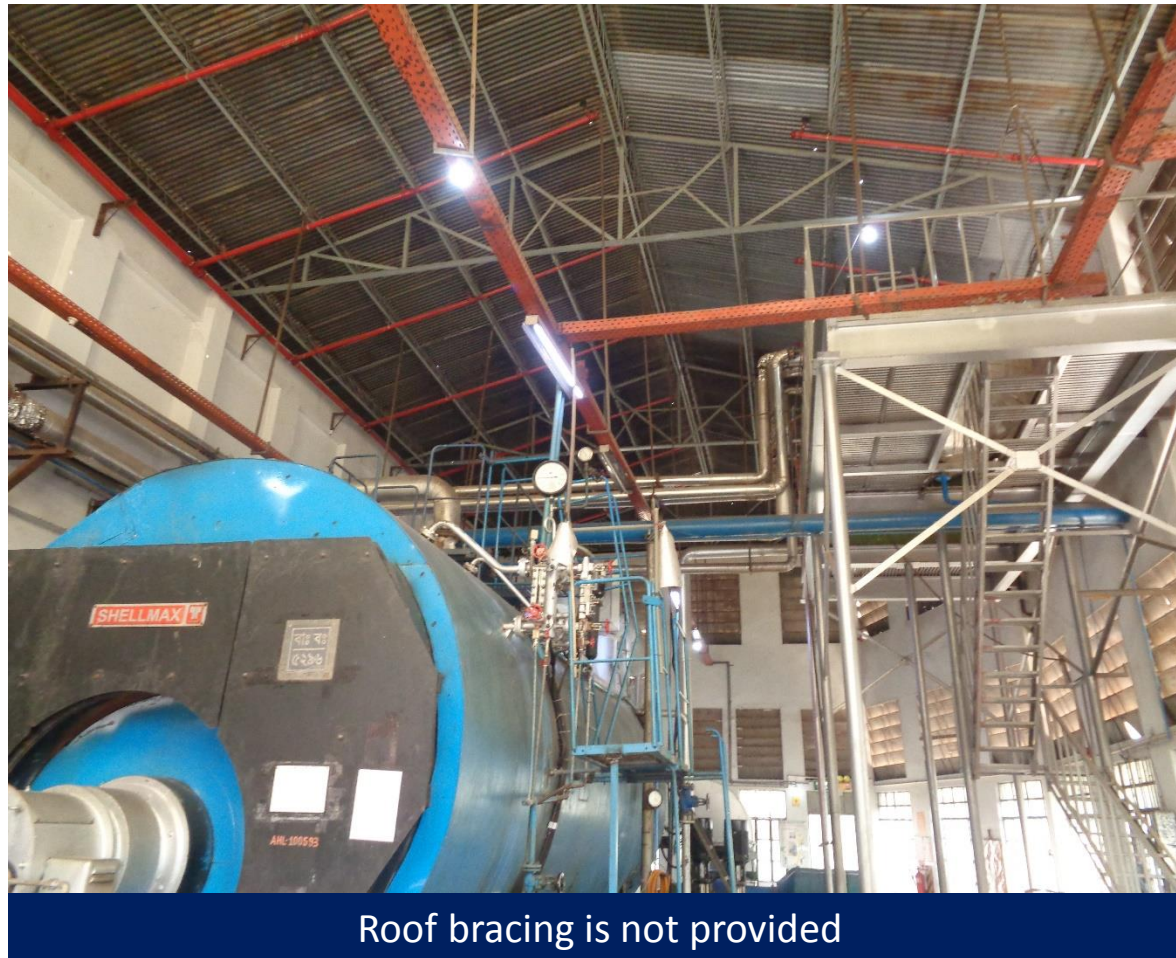
There is no bracing at roof level. Factory engineer is required to check the connections for uplift forces and lateral stability of roof truss. Suggest proper remedial suggestion if required.

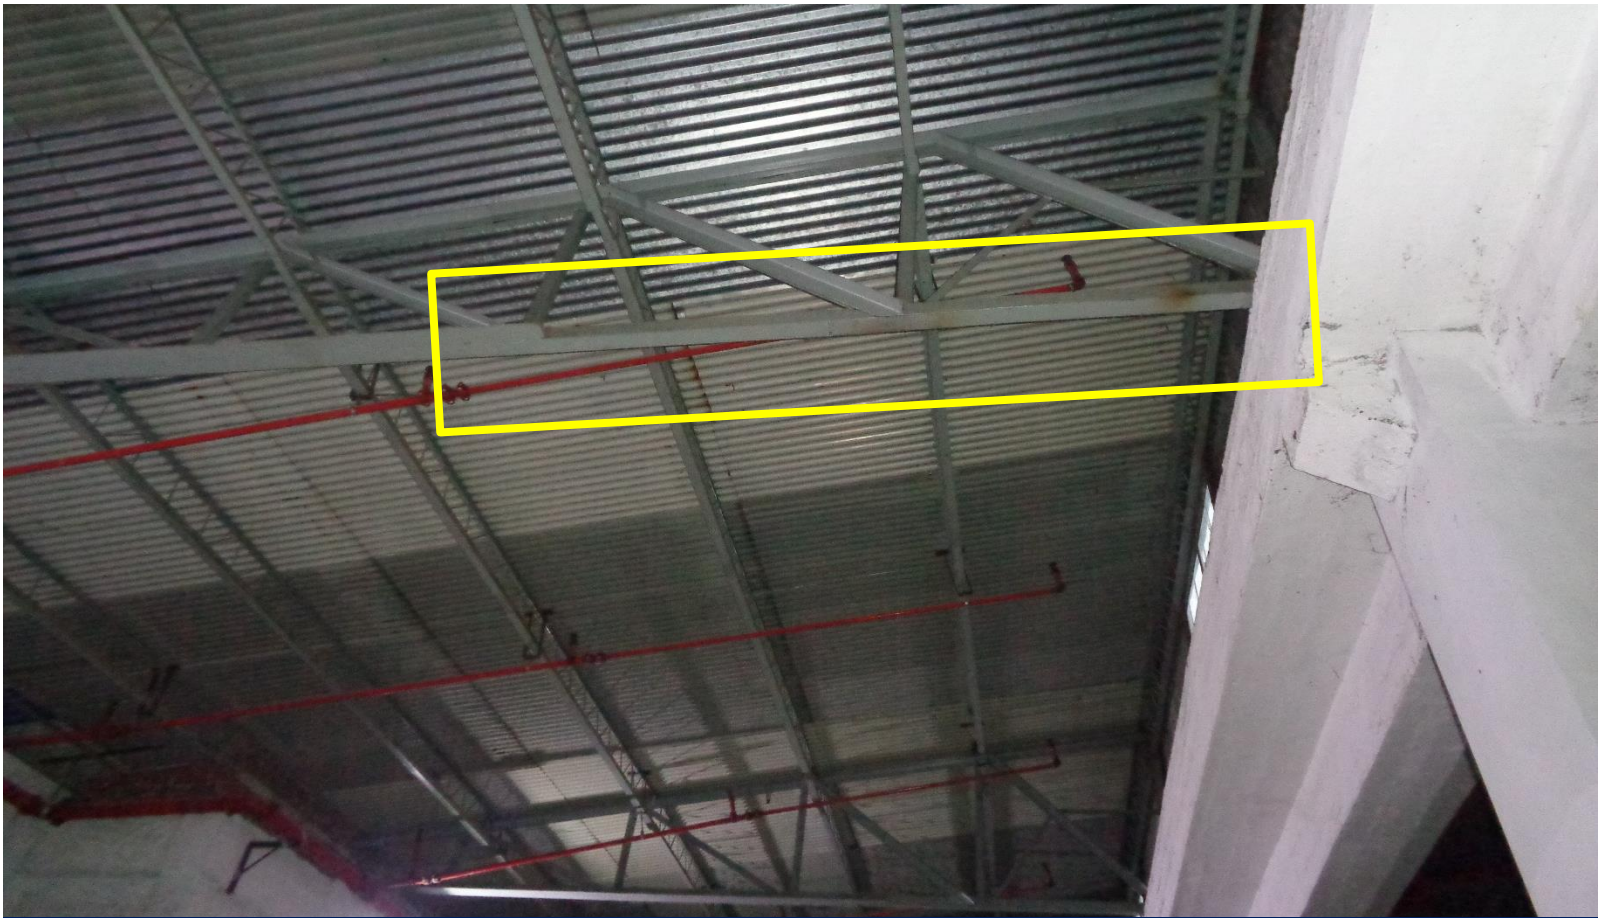
Bottom chord of truss is not uniform near support. Single angle bottom chord near support.

In some grid, double angled bottom cord discontinued before the support and continued as a single angle to the end. Factory engineer is required to check the truss system and review the design accordingly.

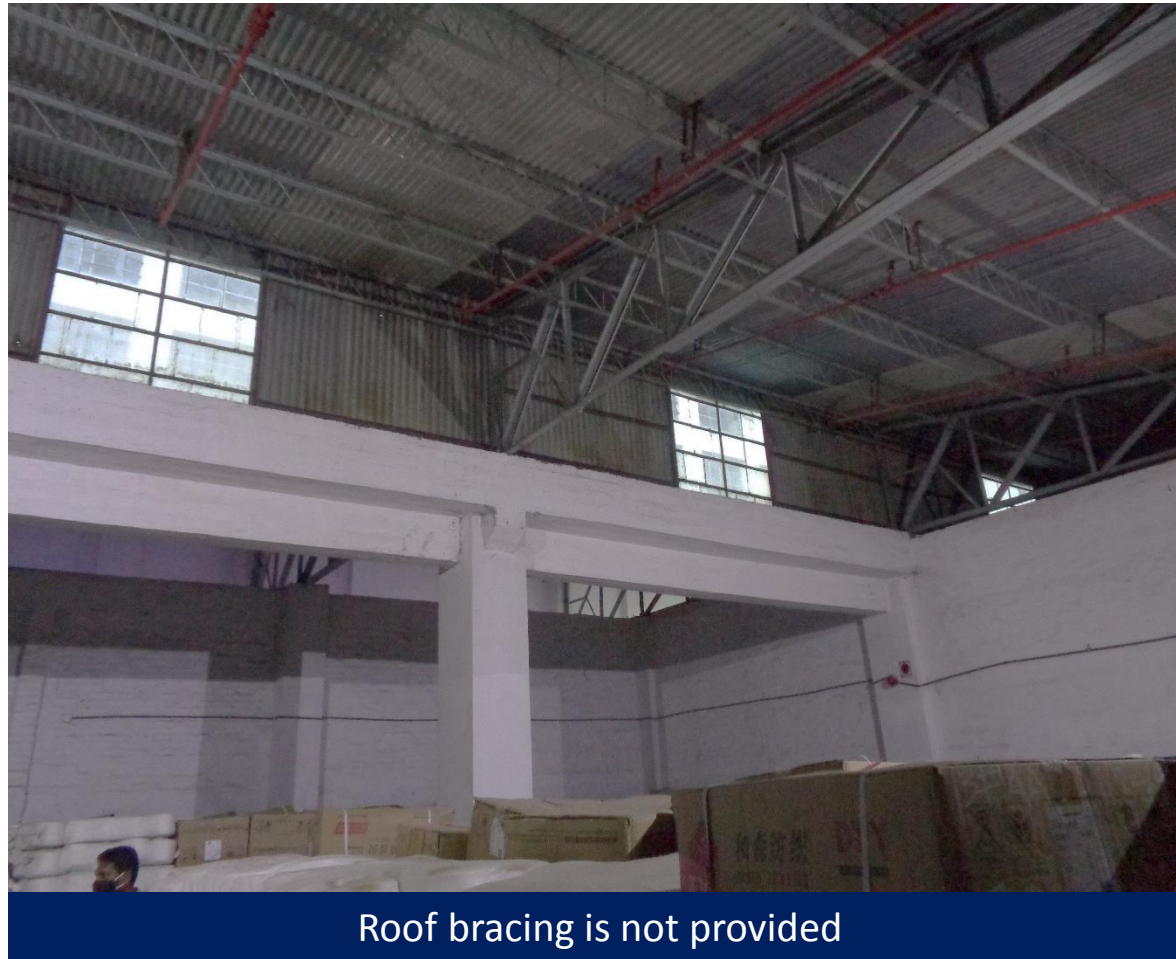
There is no bracing at roof level. Factory engineer is required to check the connections for uplift forces and lateral stability of roof truss. Suggest proper remedial suggestion if required.

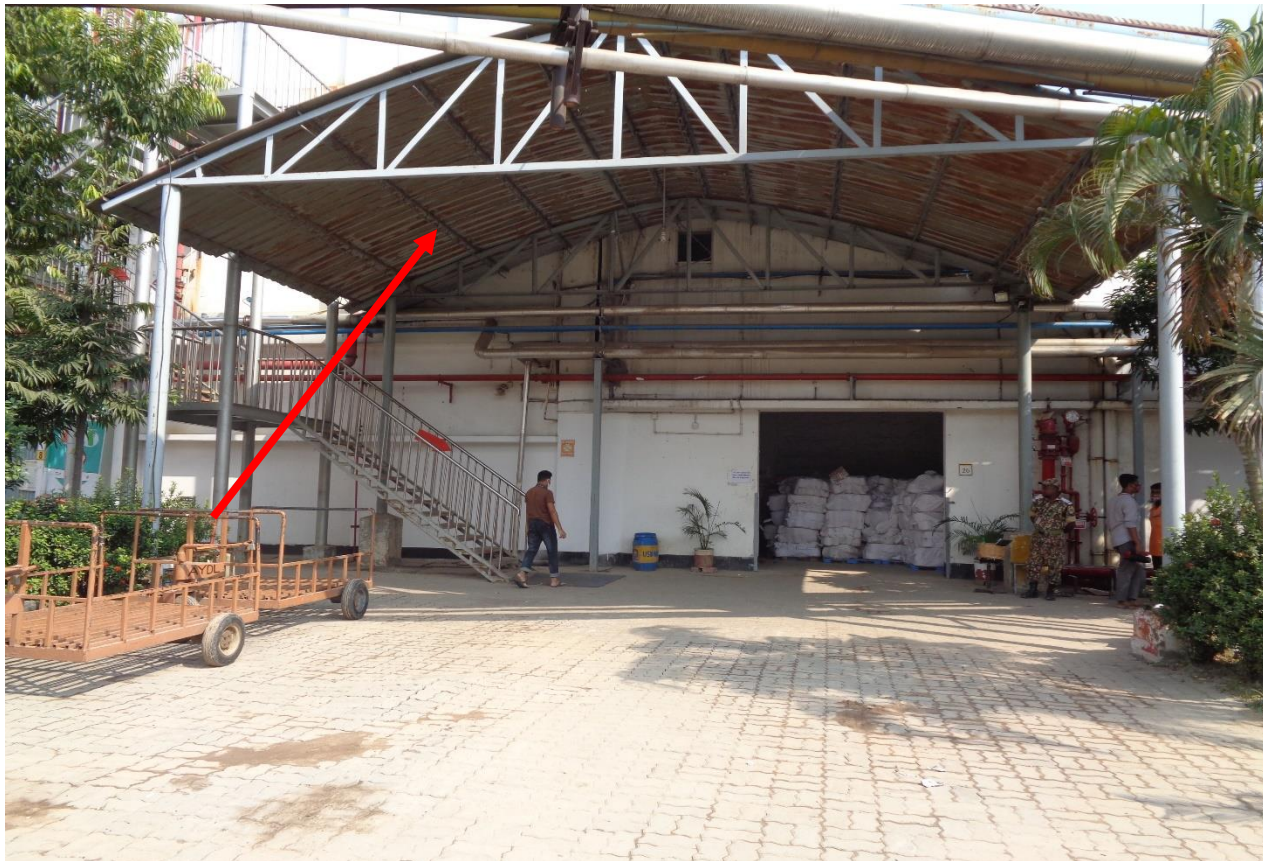
No bracing system is provided

An undocumented canopy was found at west side of Store Shed which has no obvious lateral stability system. No compression member/bracing system is provided to withstand the lateral load therefore the canopy is appeared to be unstable. Factory engineer is required to check the lateral stability of the structure.

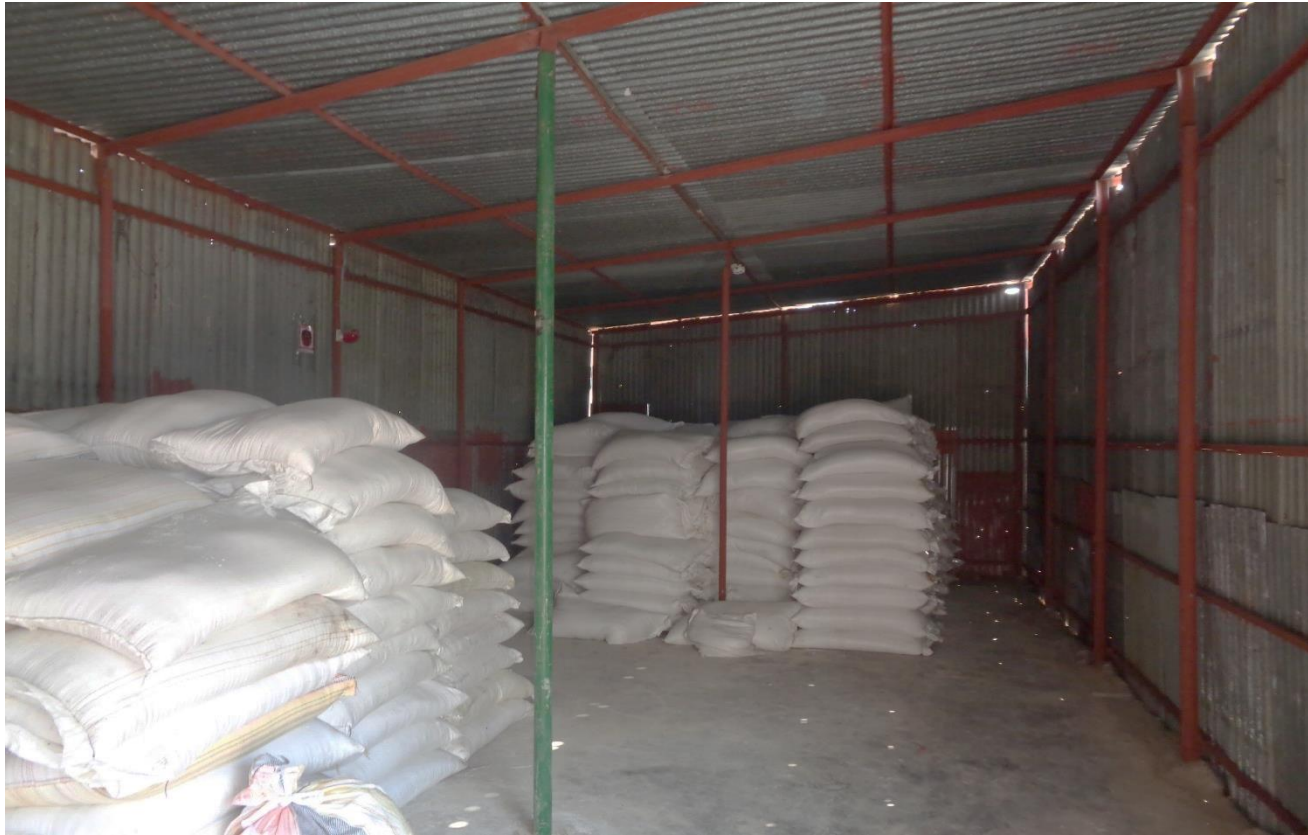
No obvious stability system with poor connection

This shed was appeared to be non-engineered due to lack of obvious stability system with poor connections and undersized members. Factory engineer is required to check the lateral stability for this shed otherwise replace the shed with an engineered one.

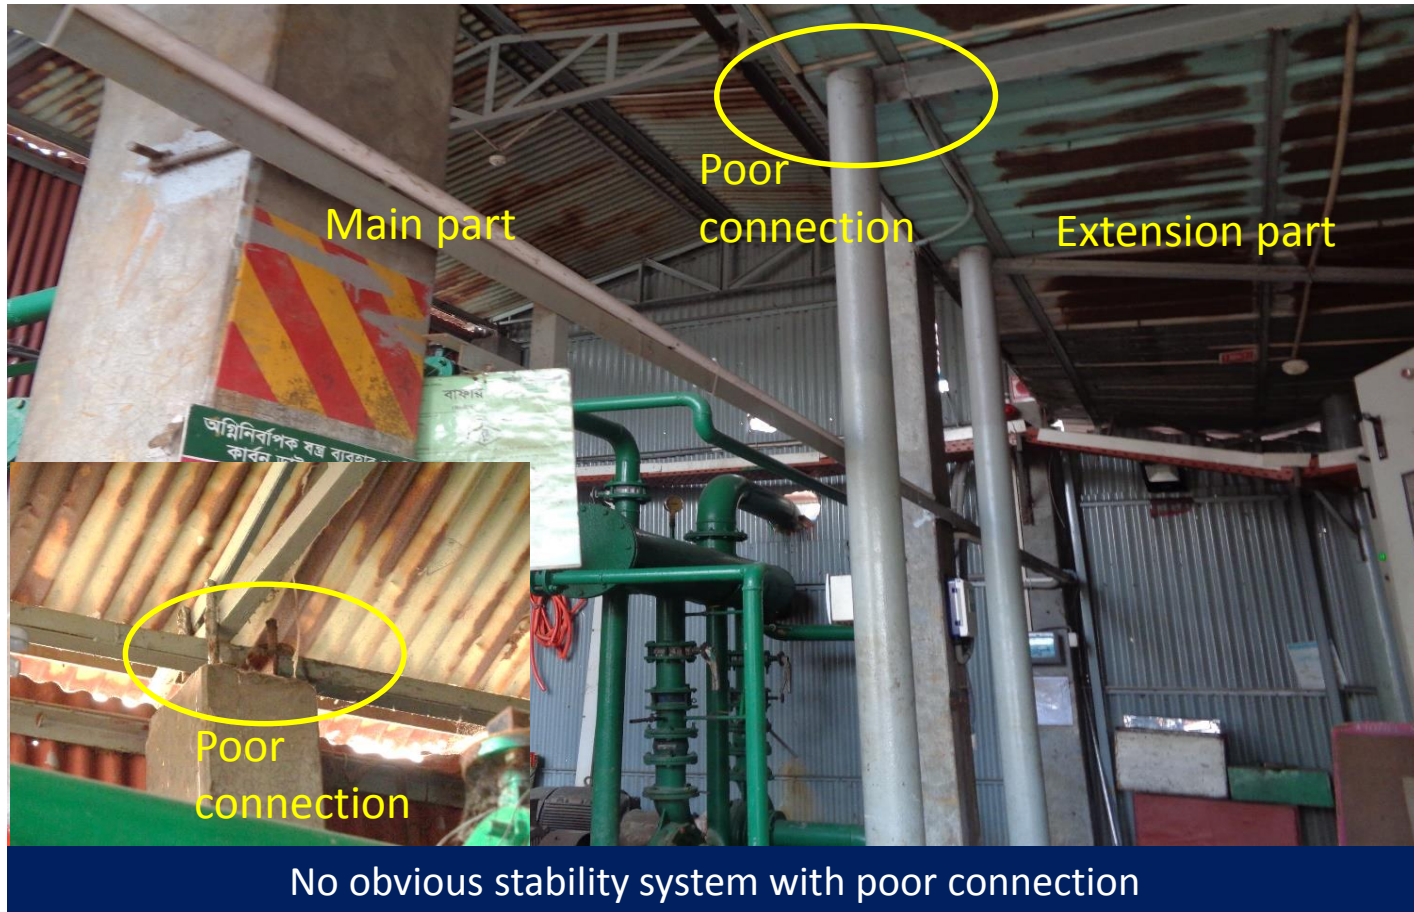
This shed was appeared to be non-engineered due to lack of obvious stability system with poor connections. Factory engineer is required to check the lateral stability for this shed otherwise replace the shed with an engineered one.
