# P.N. Composite Limited (Extension)

Ambabh, Konabari, Gazipur  
(24.020049, 90.321249)  
11<sup>th</sup> & 17<sup>th</sup> October 2021

# Observations

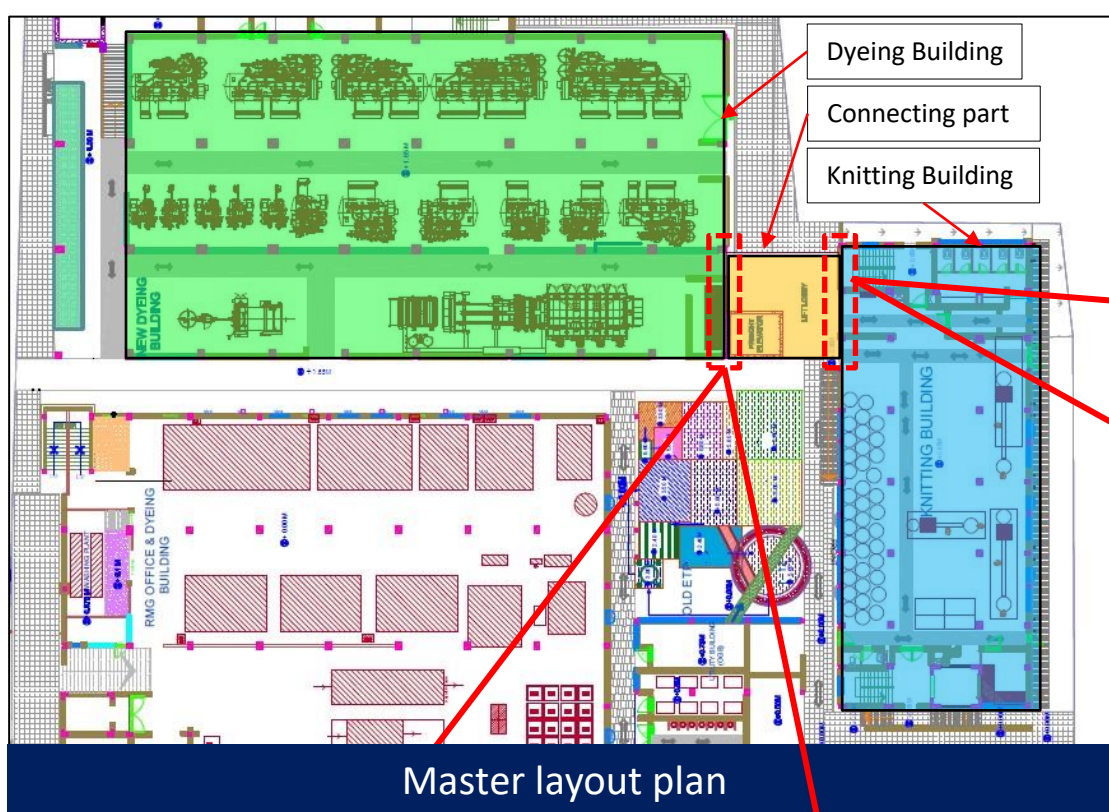
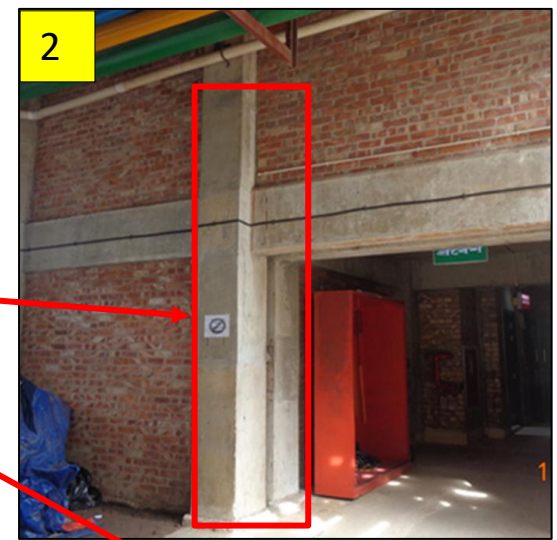
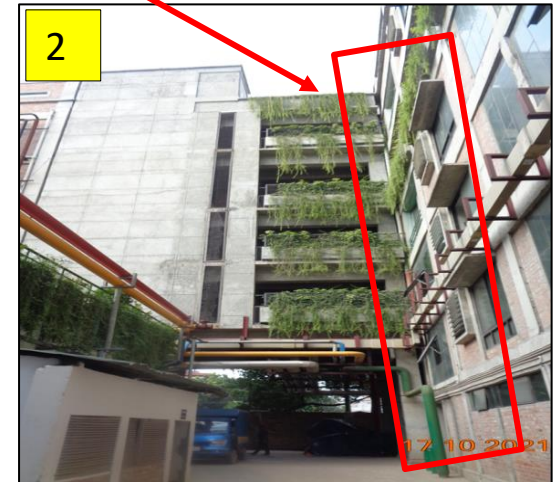
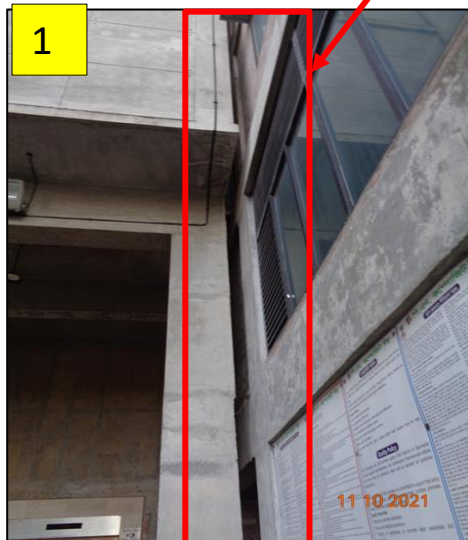
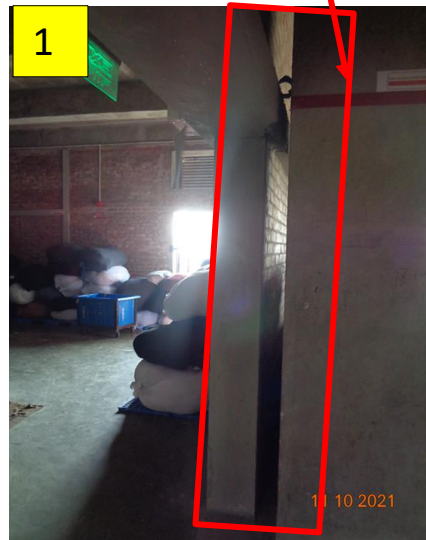
Expansion joints was found among the structures.

1. Expansion joint between connection part and Dyeing building.
2. Expansion joint between Connection part and knitting Building.

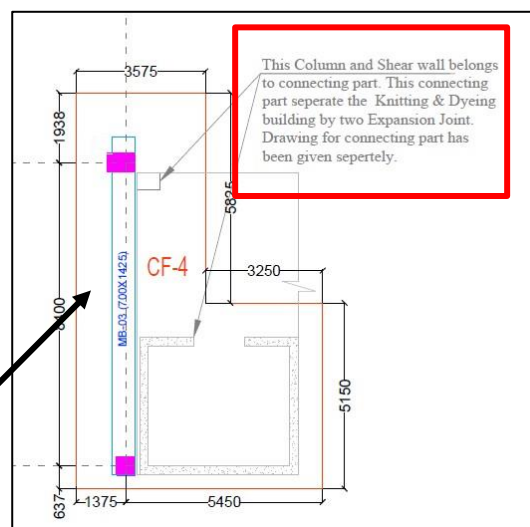
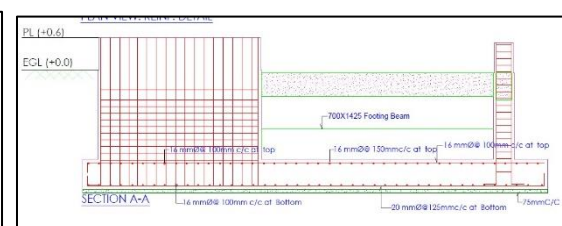
Depth of footing from EGL not shown in the section details of footing. So, this is not clear whether the foundations are overlapping or shearing same footing

| Item No. | Observation | Recommended Action Plan | Recommended Timeline |
|---|---|---|---|
| 01 | Design report needs to be revised for New Dyeing Building, Connecting part & New Knitting Building | Factory engineer to verify the foundation system and update as-built structural drawings showing each foundation depth from EGL. | 6-weeks |

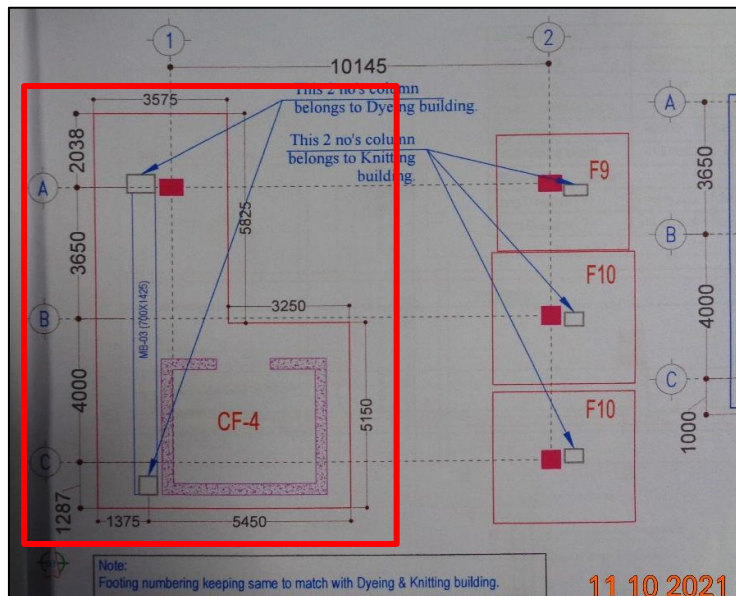
Foundation layout plan for the Connecting part

The combined footing named “CF4” denoted for both structure but load value found different in adequacy check table.

| Item No. | Observation | Recommended Action Plan | Recommended Timeline |
|---|---|---|---|
| 02 | Design report needs to be revised for New Dyeing Building, Connecting part & New Knitting Building | Check the foundation adequacy for shared/combined footings considering total imposed loads from adjacent building on it. | 6-weeks |

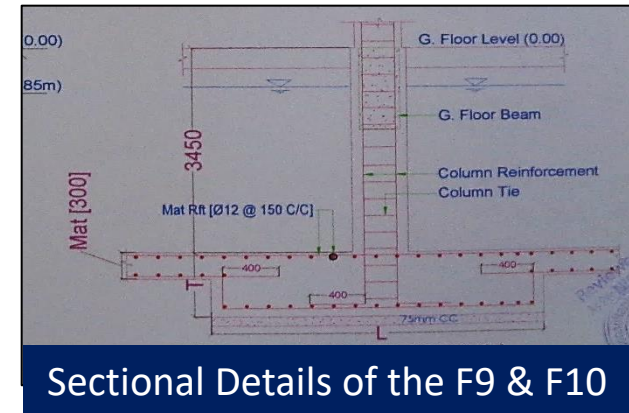
Sectional Details of the F9 &amp; F10

This is not clear whether the foundations of connecting part & knitting building are overlapping or shearing same footing.

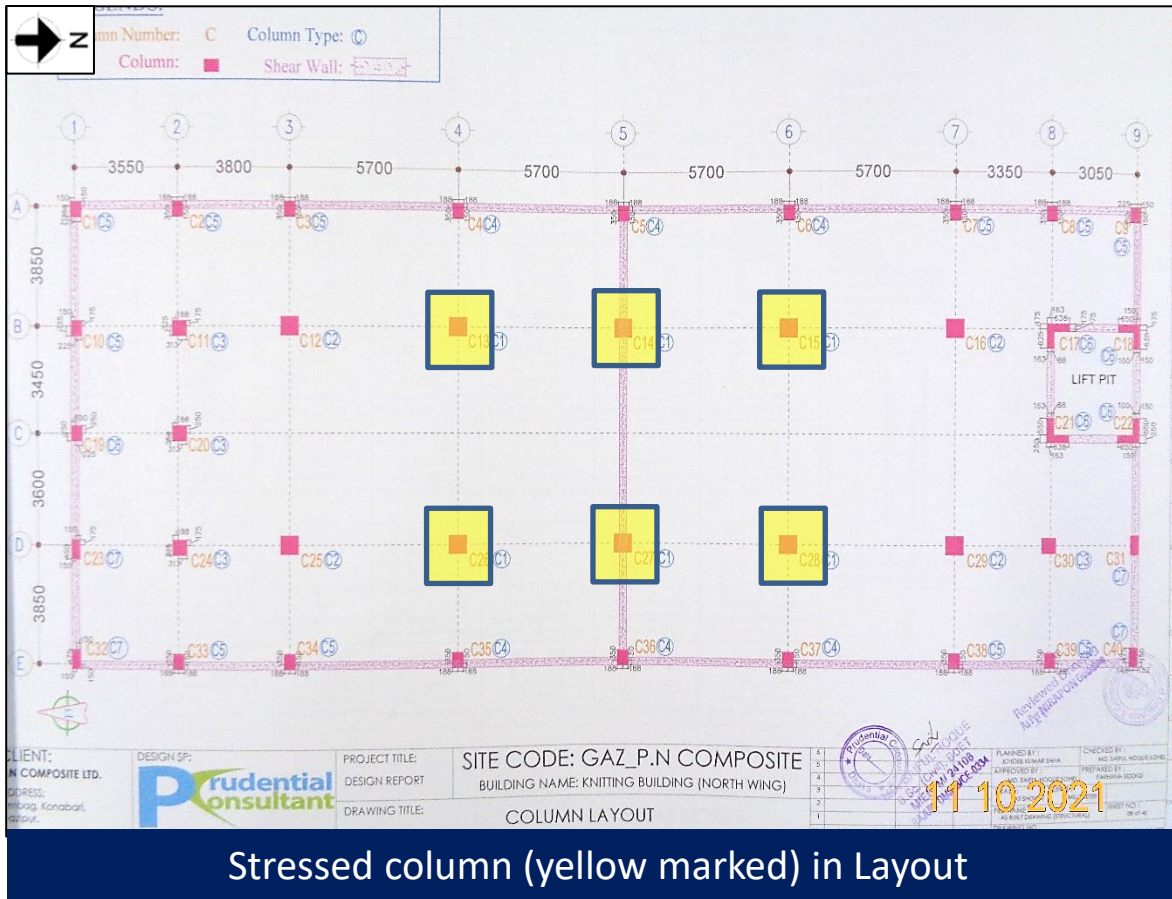
Stressed column (yellow marked) in Layout

Cursory calculation indicates that the working stress of ground floor column slightly exceeds the normal design limit considering the prepared live load 10 KPa on typical floor, 10 kPa on roof top and minimum concrete strength (16.3 MPa) based on aggregate type. Factory is required to verify the in-situ concrete strength of the building and review design, load & column stress for the area identified above

| Item No. | Observation | Recommended Action Plan | Recommended Timeline |
|---|---|---|---|
| 05 | Column to be stressed above normal design limit | Verify in-situ concrete strength either by existing cylinder strength data or taking minimum 4 number of 100mm diameter cores from the lower tier of the building. | 6-weeks |
| 06 | Column to be stressed above normal design limit | Factory is required to review design, load & column stress for the area identified above. | 6-weeks |

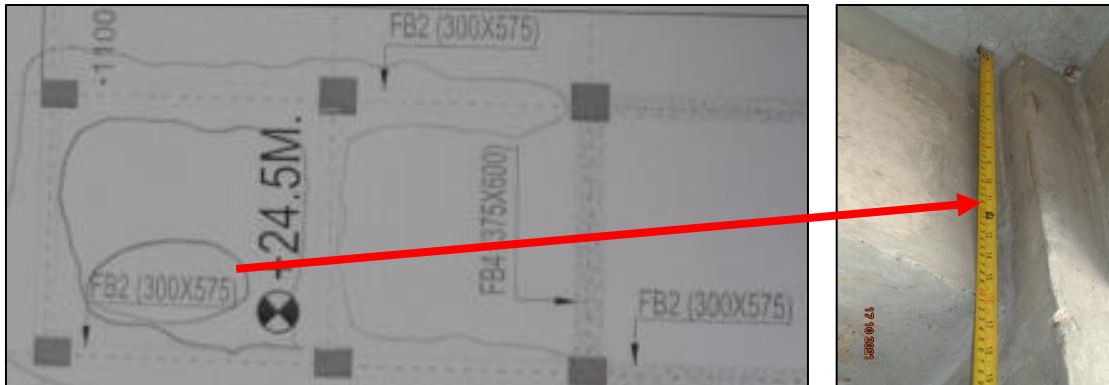
In as-built drawing roof beam was mentioned as 300 mm X 575 mm. Slab thickness in this portion was found 150 mm. But during inspection down stand (d/s) of the roof beam was found 400 mm instead of 425 mm.

Factory engineer is required to update the as-built drawing as per site condition in compliance with section 1.9.1.2 (part-6, BNBC).

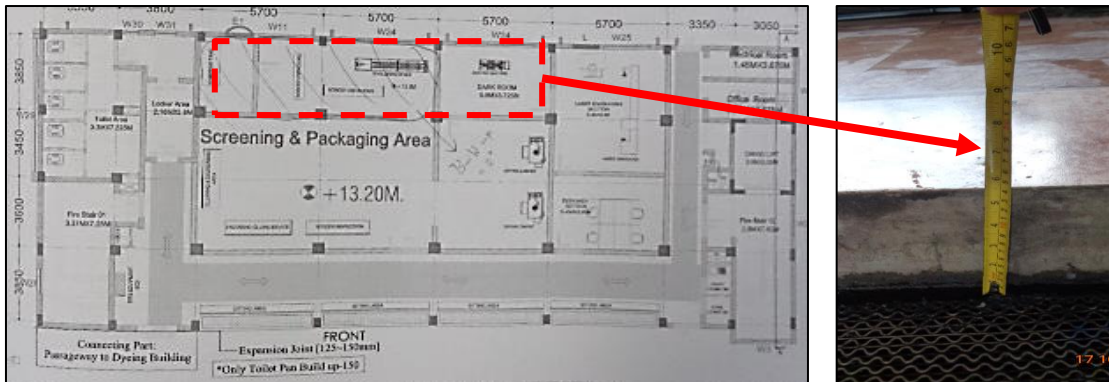
During inspection, 50mm build-up was found at 4<sup>th</sup> floor in screen & packing area. But in as-built drawing no build-up information was mentioned.

| Item No. | Observation | Recommended Action Plan | Recommended Timeline |
|---|---|---|---|
| 09 | Discrepancies in as-built drawing | Factory engineer is required to update the as-built drawing as per site condition in compliance with section 1.9.1.2 (part-6, BNBC). | 6-months |

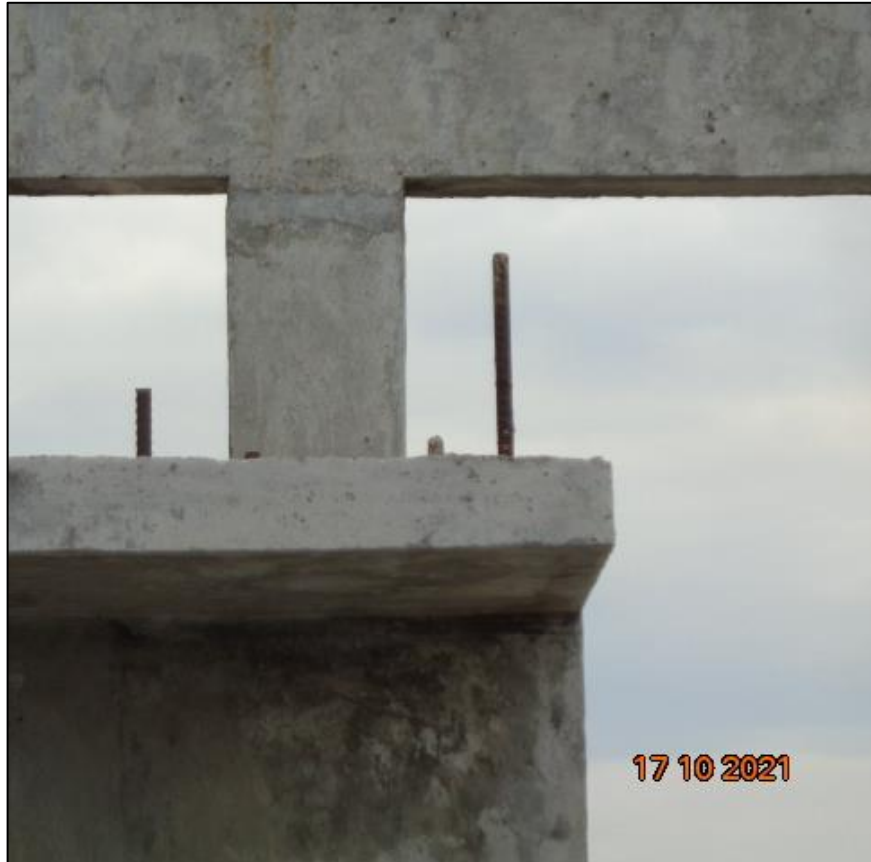
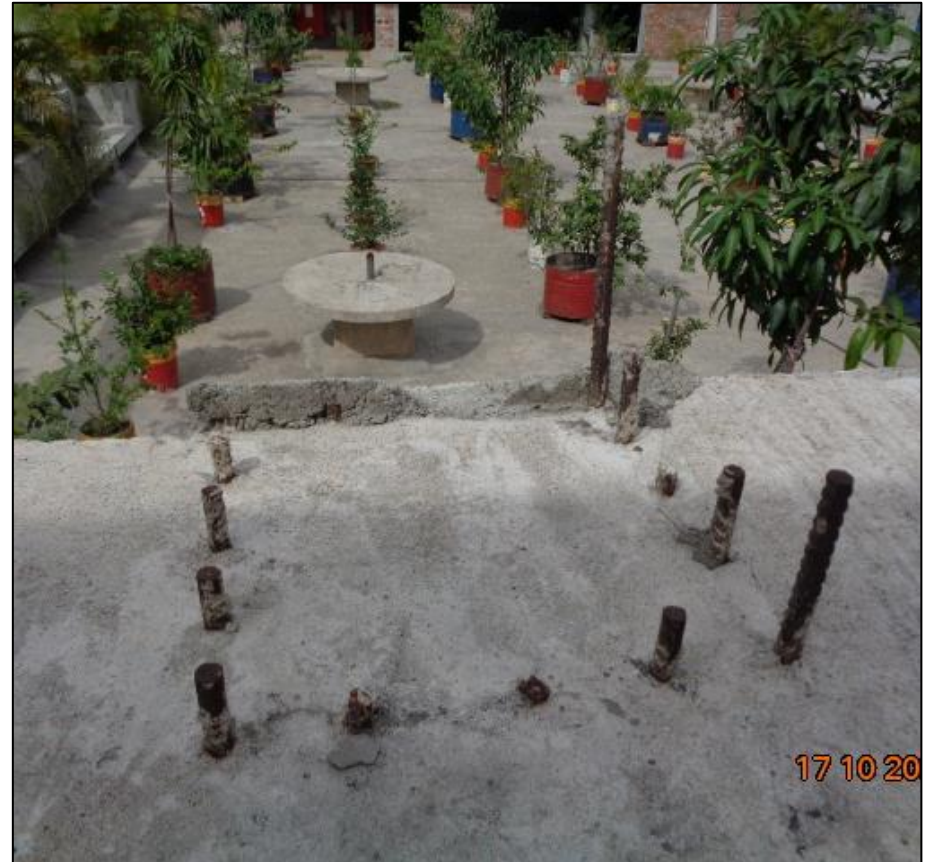
Exposed rebar at roof

Exposed reinforcement was found at roof which is susceptible to corrosion that may be the cause of deterioration for concrete. Factory engineer is required to take necessary measures to prevent the corrosion in exposed rebar.

| Item No. | Observation | Recommended Action Plan | Recommended Timeline |
|---|---|---|---|
| 10 | Exposed rebar at roof level | Factory engineer is required to identify the locations and all exposed reinforcement is to be protected from corrosion. | 6-months |

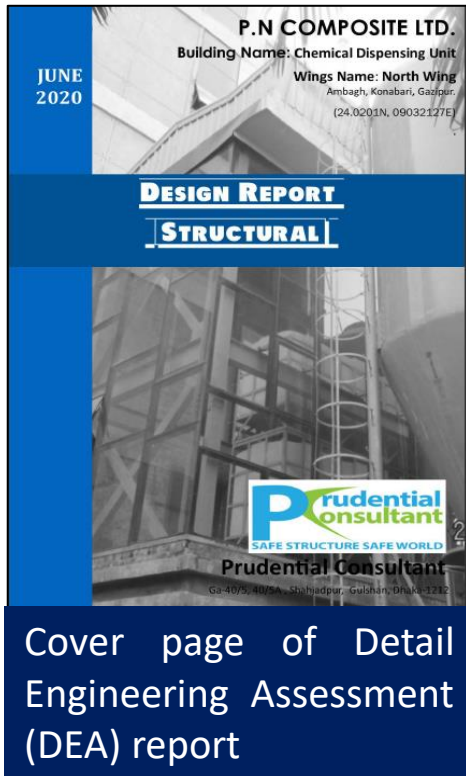
In DEA soil bearing capacity was mentioned 2.556 tsf (FS=2.5). But at the time of inspection no soil test report was found on-site for this structure.

In DEA, concrete strength was mentioned 4000 psi (27.58 MPa). But during inspection no cylinder test report was available on-site.

Factory engineer is required to update the design documents in compliance with section 1.9.1 (part-6, BNBC).

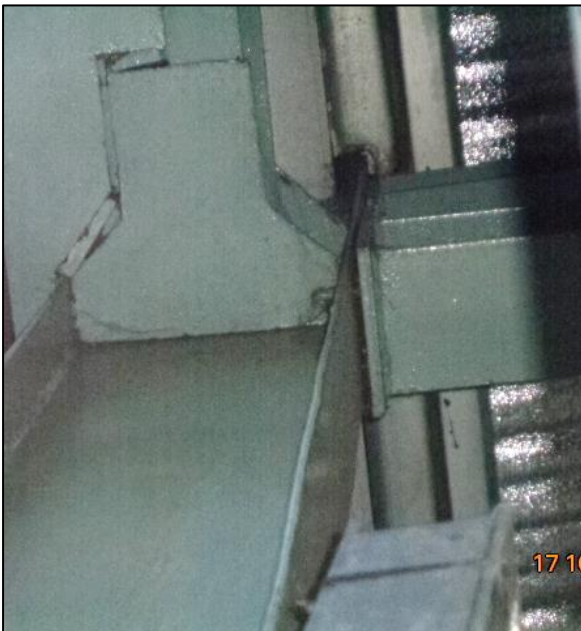
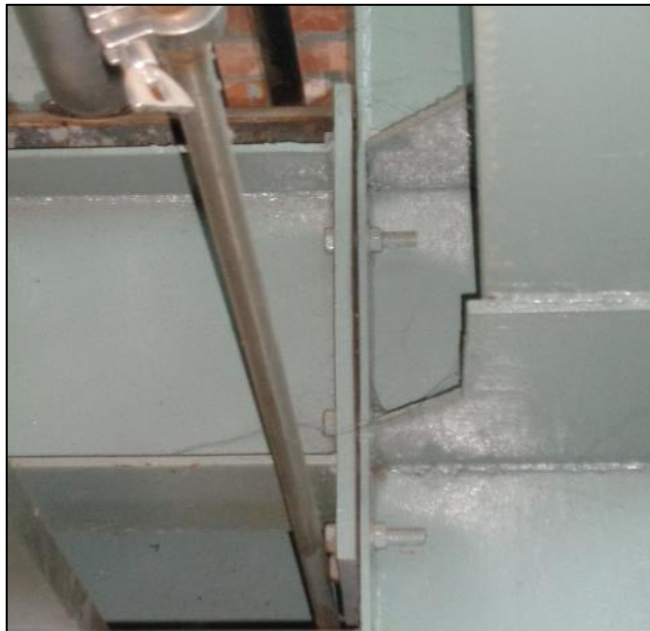
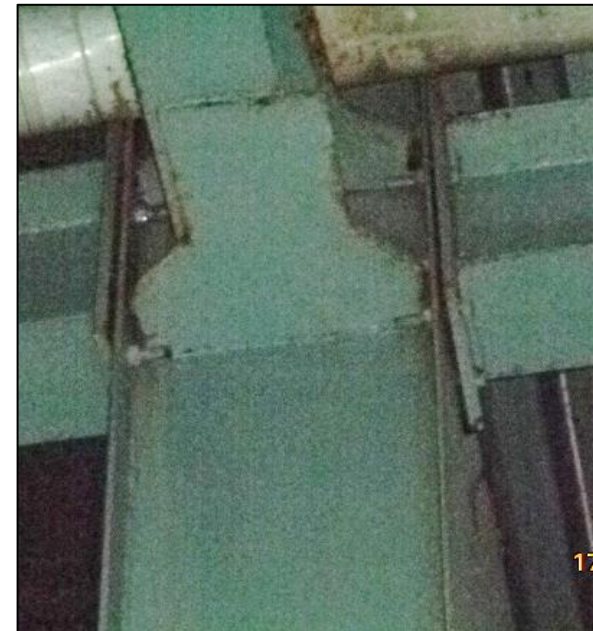
Connection gap was found in rafter-column connection

Connection gaps were observed at column rafter joint at several locations. Factory engineer is required to identify the locations and carry out suitable remedial works.

| Item No. | Observation | Recommended Action Plan | Recommended Timeline |
|---|---|---|---|
| 14 | Connection gap at several locations | Identify the locations and carryout suitable repair works where necessary. | 6-weeks |

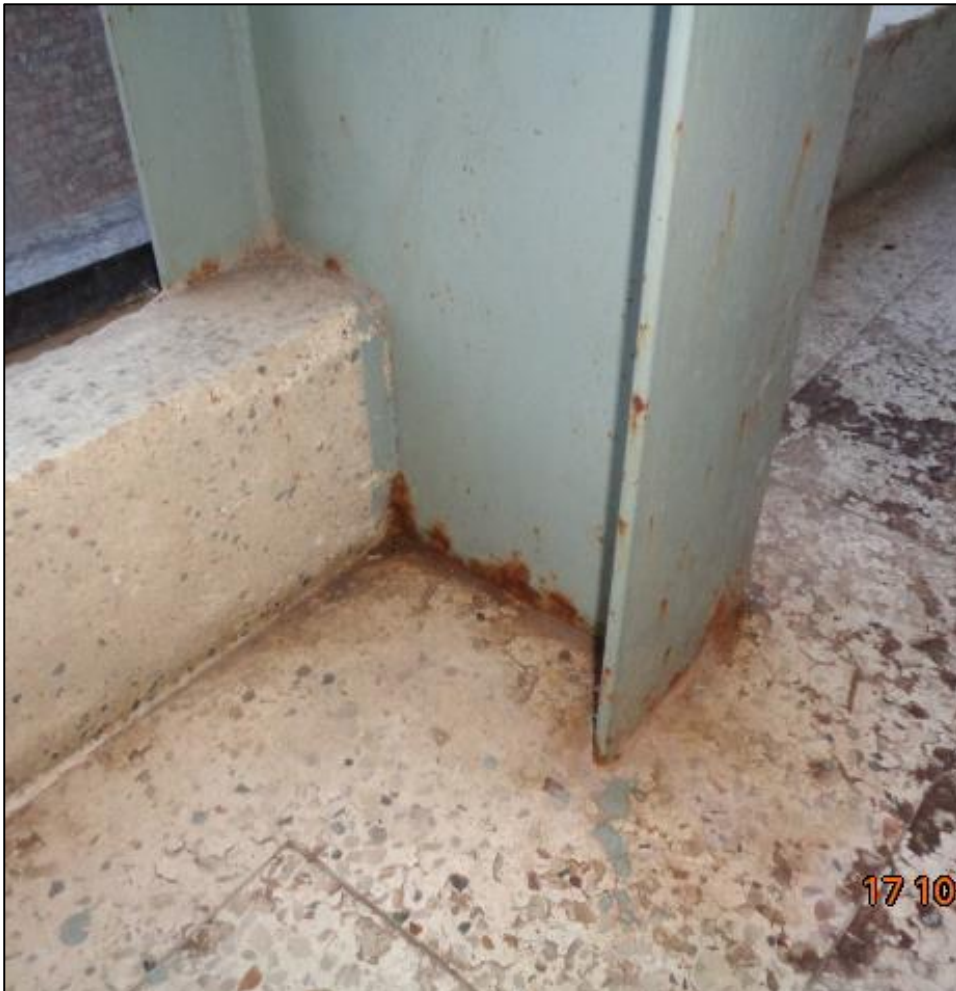
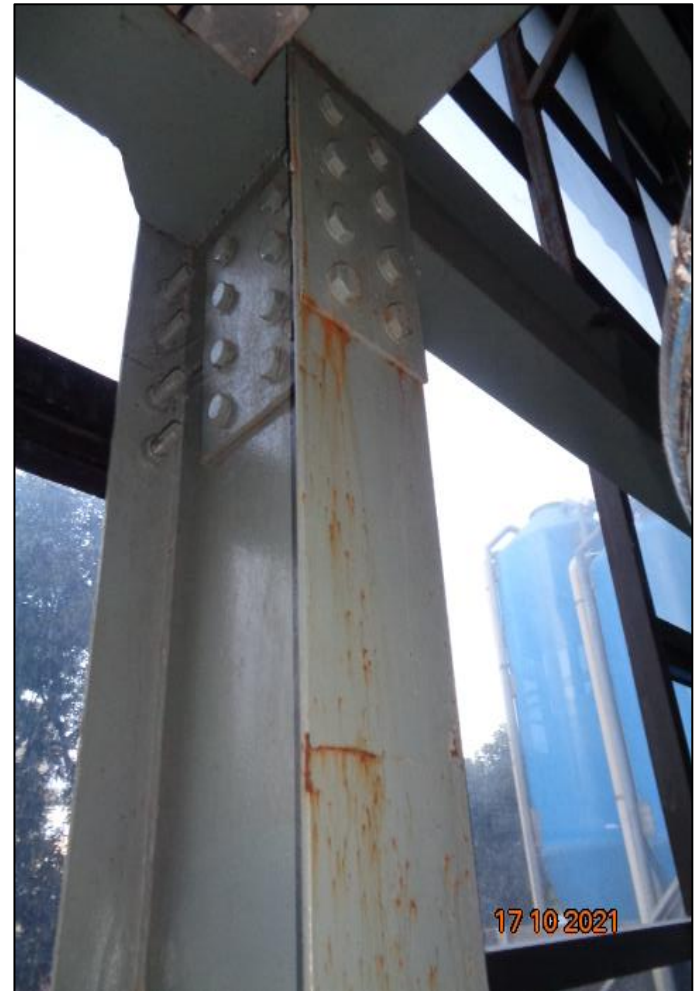
Corrosion was found in steel column

Corrosion was observed in column at several location. Factory engineer is required to identify the locations and carry out suitable remedial works to protect degradation of the concrete.

| Item No. | Observation | Recommended Action Plan | Recommended Timeline |
|---|---|---|---|
| 15 | Corrosion in steel member | Factory engineer is required to identify the locations and apply corrosion resistance coating to the steel member. | 6-weeks |
