# Graphics Textiles Ltd (Extension)

Sreerampur, Kalampurm Dhamrai, Dhaka  
(23.919336, 90.124829)

18<sup>th</sup> April 2022

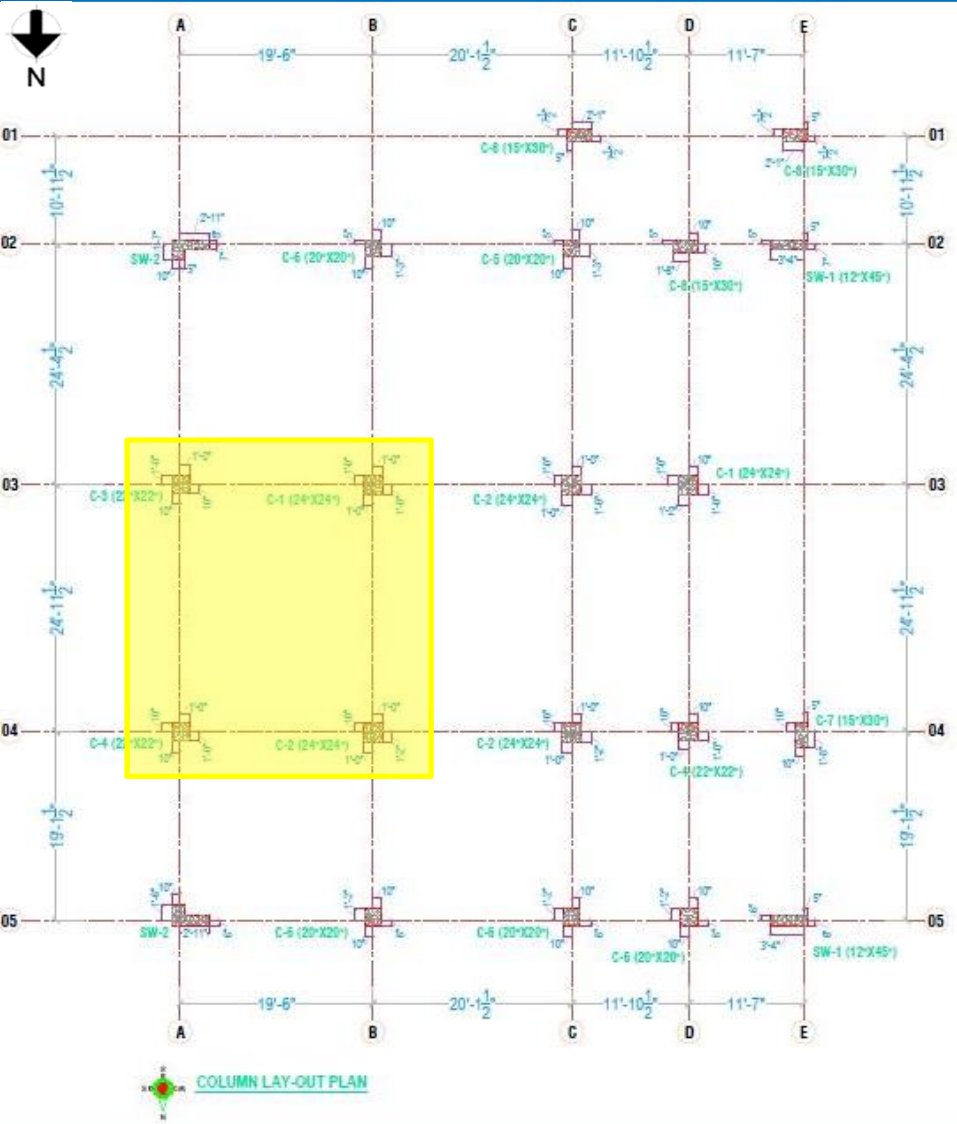
Stressed columns in layout (yellow marked)

The cursory calculation indicates that some column's stress exceeds the normal design limit considering a typical floor live load 5kPa, roof live load of 1.5 kPa, and concrete strength of 16.31 MPa. The building engineer is required to review the design, loads, and column stresses for the marked columns based on in-situ material strength.

Verify in-situ concrete stresses by 100 mm diameter cores from a minimum of 4 columns. Produce and actively manage a loading plan for all floors considering floor and column capacity.

| Item No. | Observation | Recommended Action Plan | Recommended Timeline |
|---|---|---|---|
| 01 | Stress in column exceeds normal design limit (Building-2) | Factory Engineer to review design, loads and columns stresses in area identified above. | 6-weeks |
| 02 | Stress in column exceeds normal design limit (Building-2) | Verify in-situ concrete stresses by 100mm dia. cores from minimum of 4 columns. | 6-weeks |
| 03 | Stress in column exceeds normal design limit (Building-2) | Produce and actively manage a loading plan for all floor plates considering floor and column capacity. | 6-weeks |

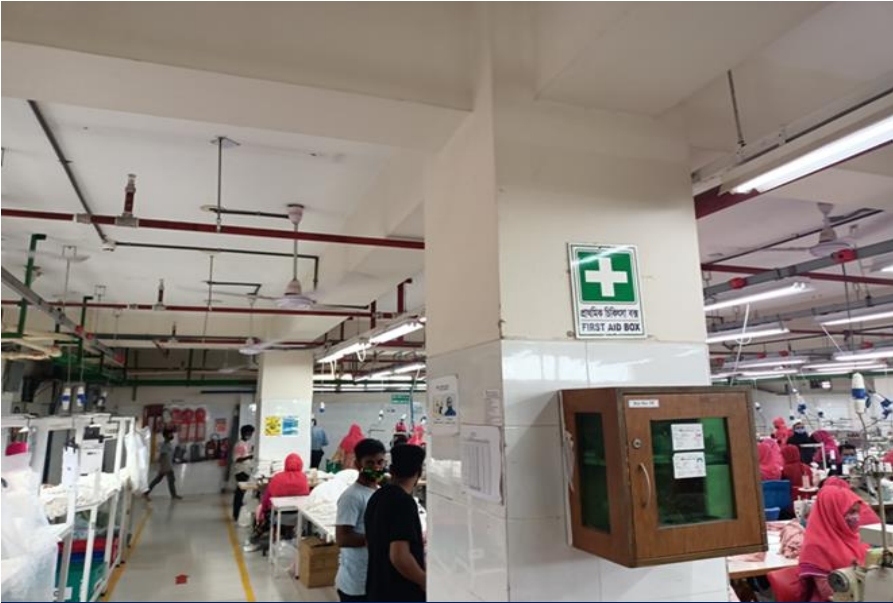
Typical stressed columns

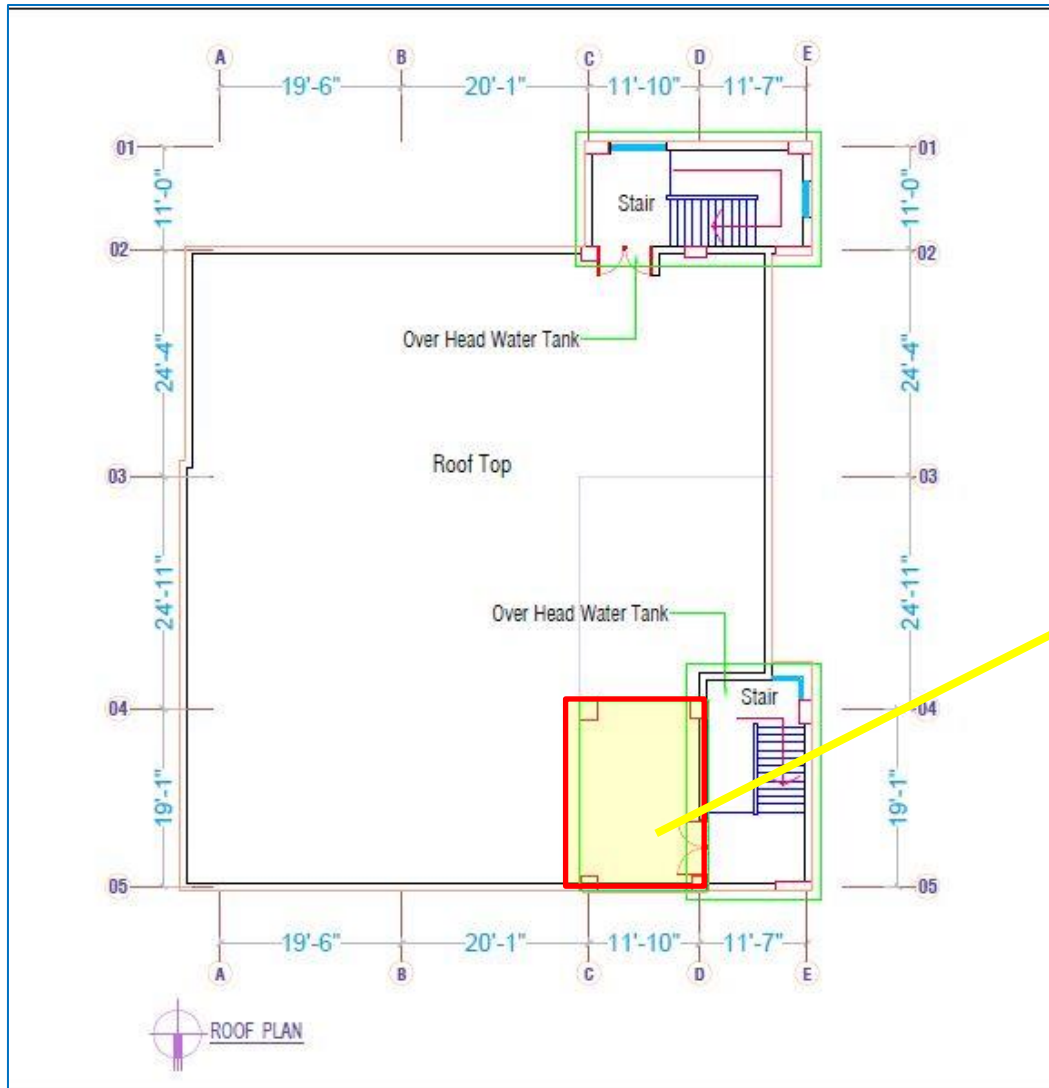
Roof layout

Plastic water tanks are not shown in the roof layout. Also, an additional room was found in front of the stair, and details weren't found in the structural drawings. The building engineer is to prepare an accurate as-built drawing with complete information.

| Item No. | Observation | Recommended Action Plan | Recommended Timeline |
|---|---|---|---|
| 06 | Lack of information in drawing (Building-2) | Building engineer is required to prepare accurate as-built drawing in compliance with section 1.9.1.2 (part-6, BNBC). | 6-weeks |

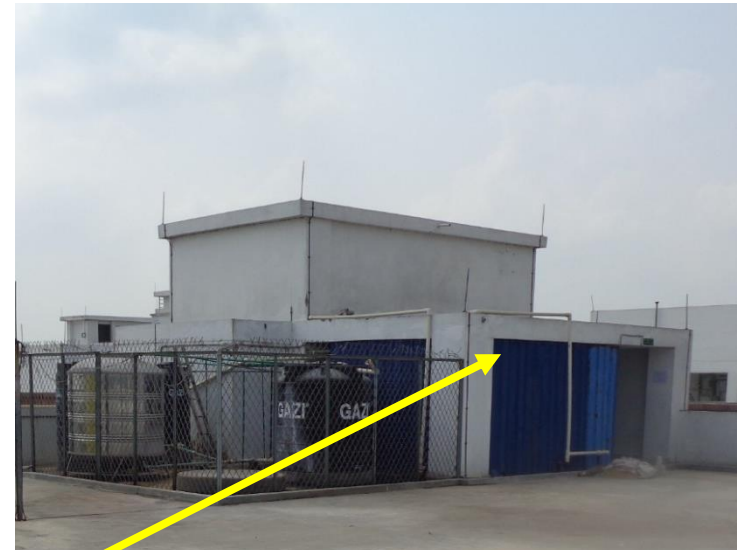
Additional room in front of stair

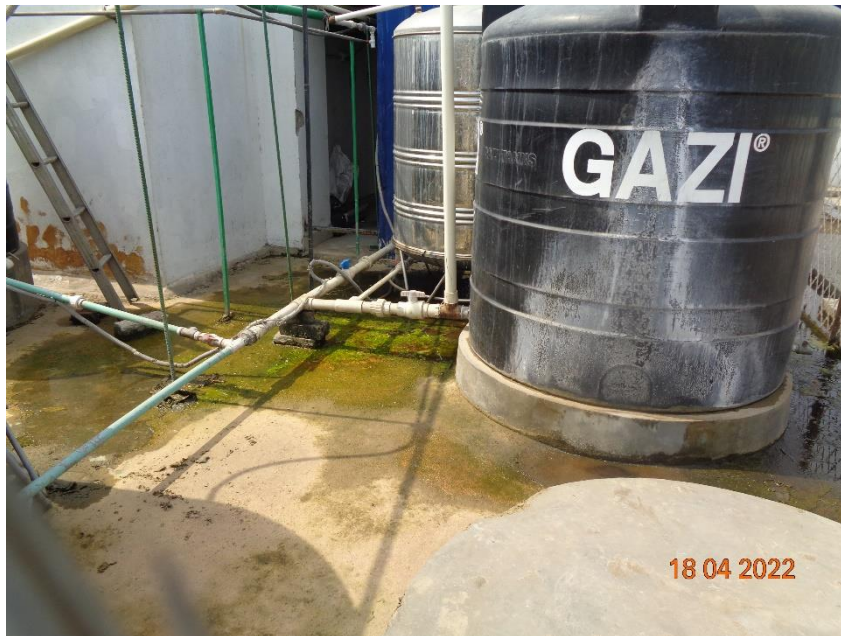
Some plastic tanks resting on the rooftop and racks on different floors are not adequately anchored or braced to resist lateral (earthquake) forces.

Plastic water tank on roof

Adequately anchor and brace all non-structural elements (all buildings) to resist earthquake forces to comply with the BNBC. If the tanks cannot be structurally accommodated, they should be removed.

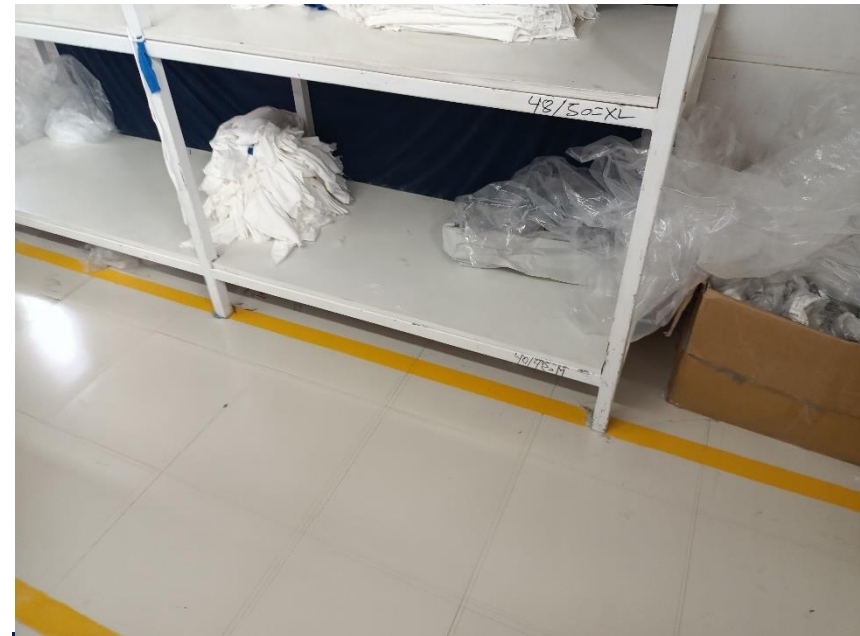
Rack on floor level

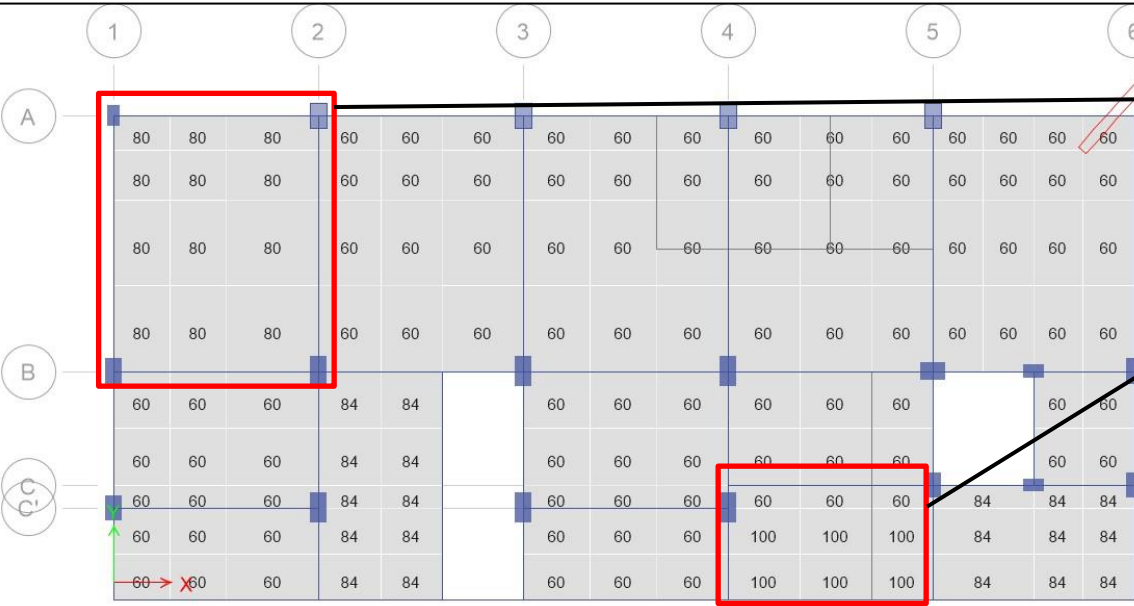
Live load input in E-tabs

Live load has been assigned 80 psf at all the floor level

Live load has been assigned 100 psf at 3<sup>rd</sup> floor

As per load plan of the building, 60 psf (3 kPa) has been shown. But in E-tabs, 80 psf (4 kPa) has been considered in all the floor level and 100 psf at 3<sup>rd</sup> floor (marked location).

As per BNBC, every building or structure designed shall have its design documents prepared in accordance with the provision of Section 1.9.1. The design document shall include a design report, and a set of structural drawings, which shall be prepared in compliance with section 1.9.1.1 and section 1.9.1.2 as per BNBC. Revise the software-based analysis model, design report and load plan following BNBC requirements.

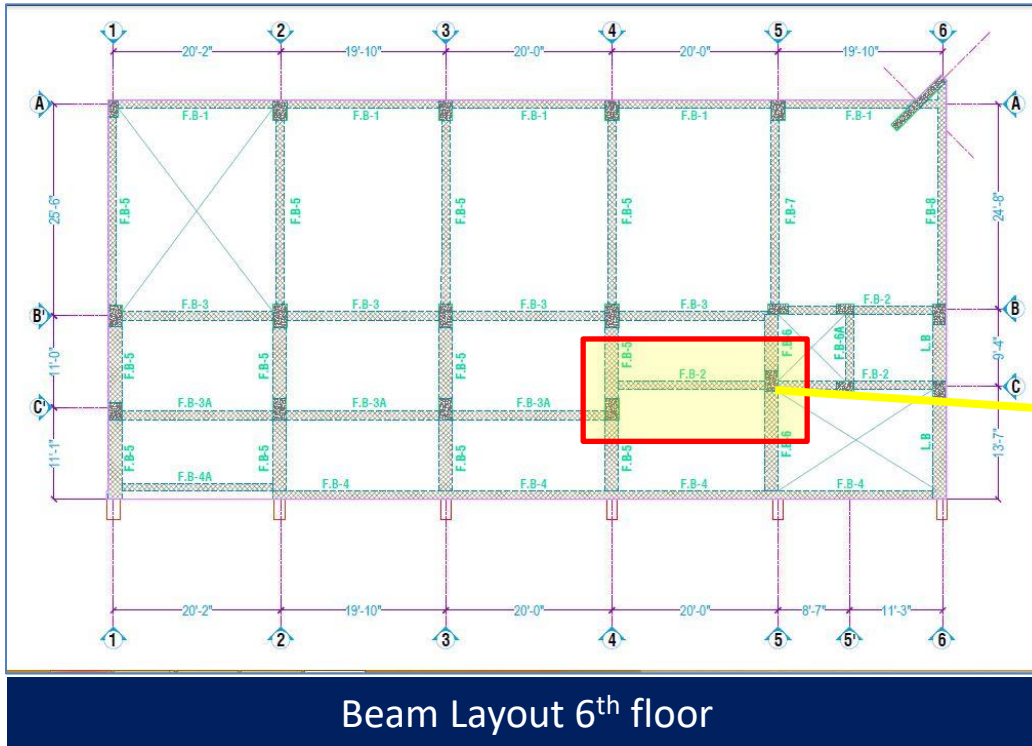
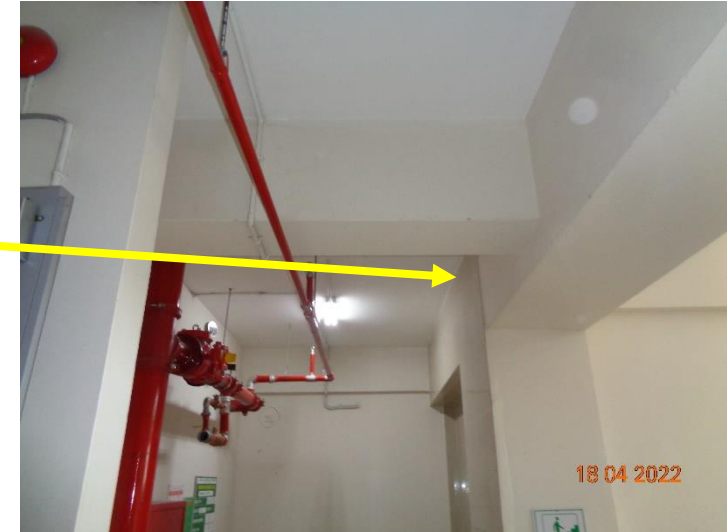
Beam layout of 5th & 6th floor didn't match fully. Mismatches are marked in the layout. The building engineer is required to revise the beam layout and prepare an accurate as-built drawing with complete information.

| Item No. | Observation | Recommended Action Plan | Recommended Timeline |
|---|---|---|---|
| 10 | Mismatch in structural drawings (Building-3) | Building engineer is required to prepare the accurate as-built drawing in compliance with section 1.9.1.2 (part-6, BNBC). | 6-weeks |

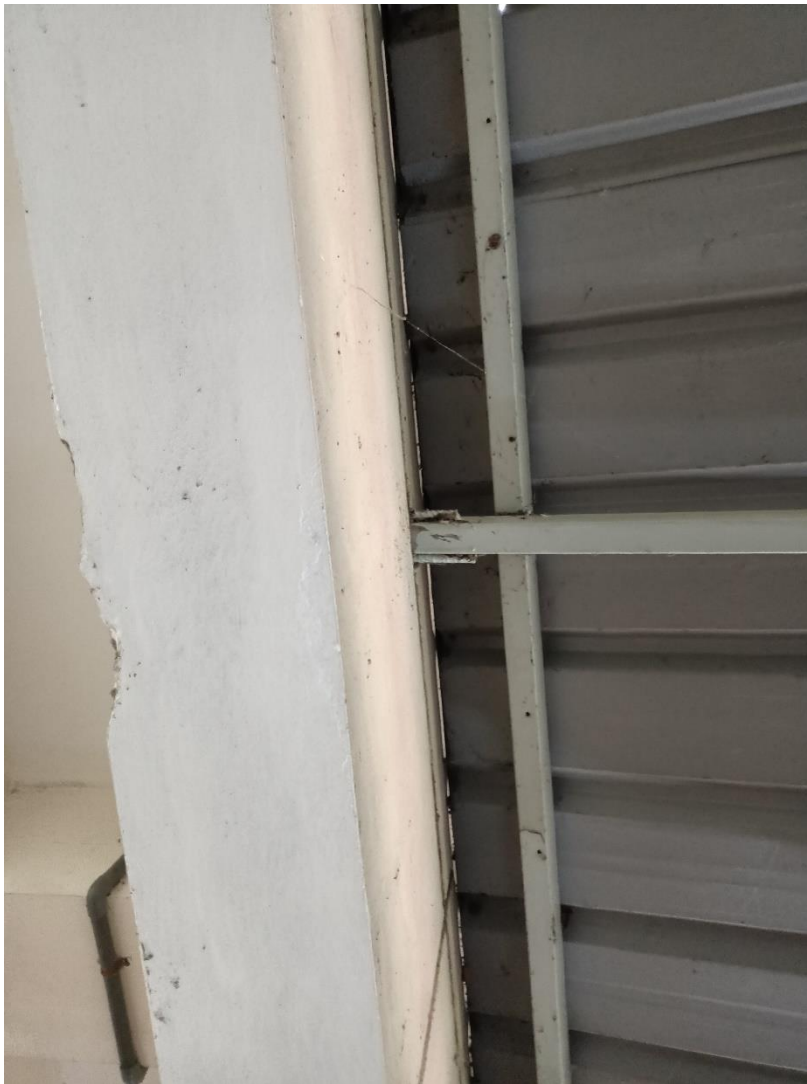
Apparently inadequate connection

Apparently Inadequate structural member, poor connection details were found. Building engineer is required to check the adequacy of the steel members & connection for uplift and lateral forces and suggest necessary remedial actions accordingly.

| Item No. | Observation | Recommended Action Plan | Recommended Timeline |
|---|---|---|---|
| 11 | Inadequate connection (Building-3: Pump House) | Factory engineer is required to check adequacy of the steel members & connection for uplift and lateral forces and suggest necessary remedial actions accordingly. | 6-weeks |

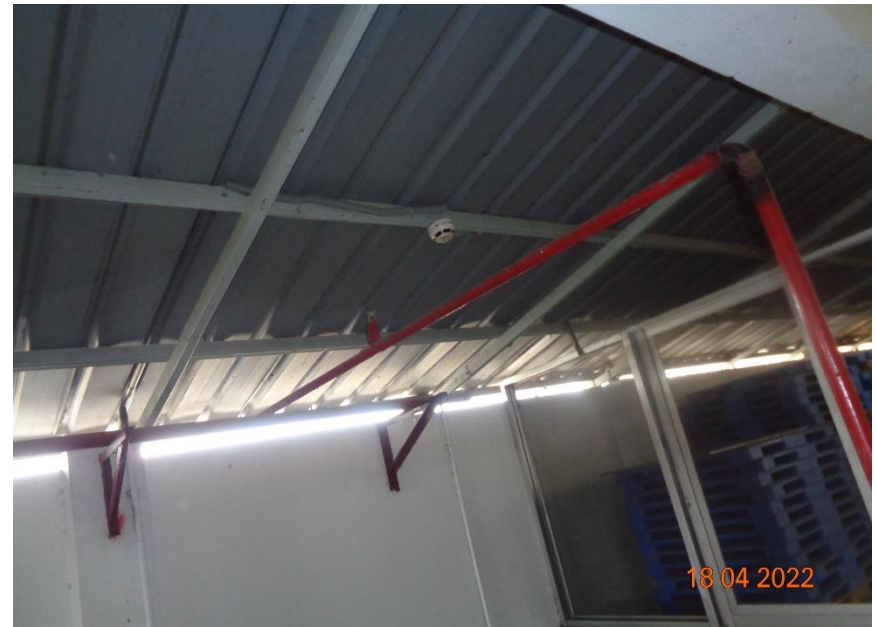
Lightweight roof of pump house

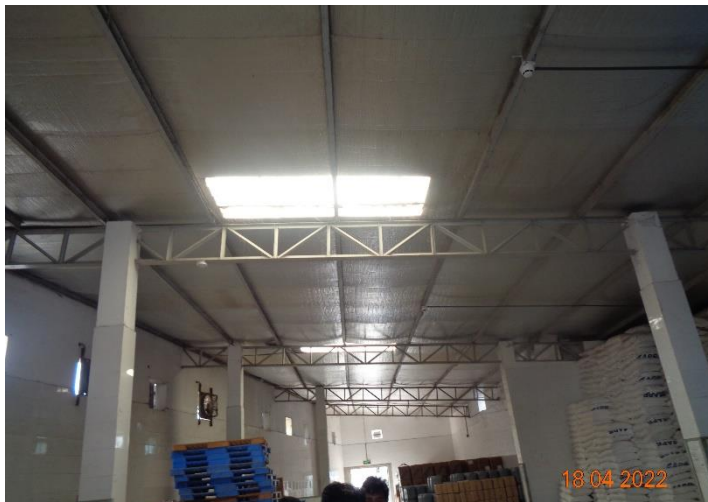
Chemical Shed

Structural and architectural drawings were not available for the mentioned structures. Building engineer is required to produce as-built drawing (both structural and architectural) with complete information.

| Item No. | Observation | Recommended Action Plan | Recommended Timeline |
|---|---|---|---|
| 13 | Lack of drawings (Structural & Architectural) (Connection Bridge, Chemical Shed, Jhut Boiler, Gate House & RMS Room) | Building engineer is required to prepare the full set of as-built drawing (both architectural & structural) in compliance with BNBC (part-6, section 1.9.1.2). | 6-weeks |

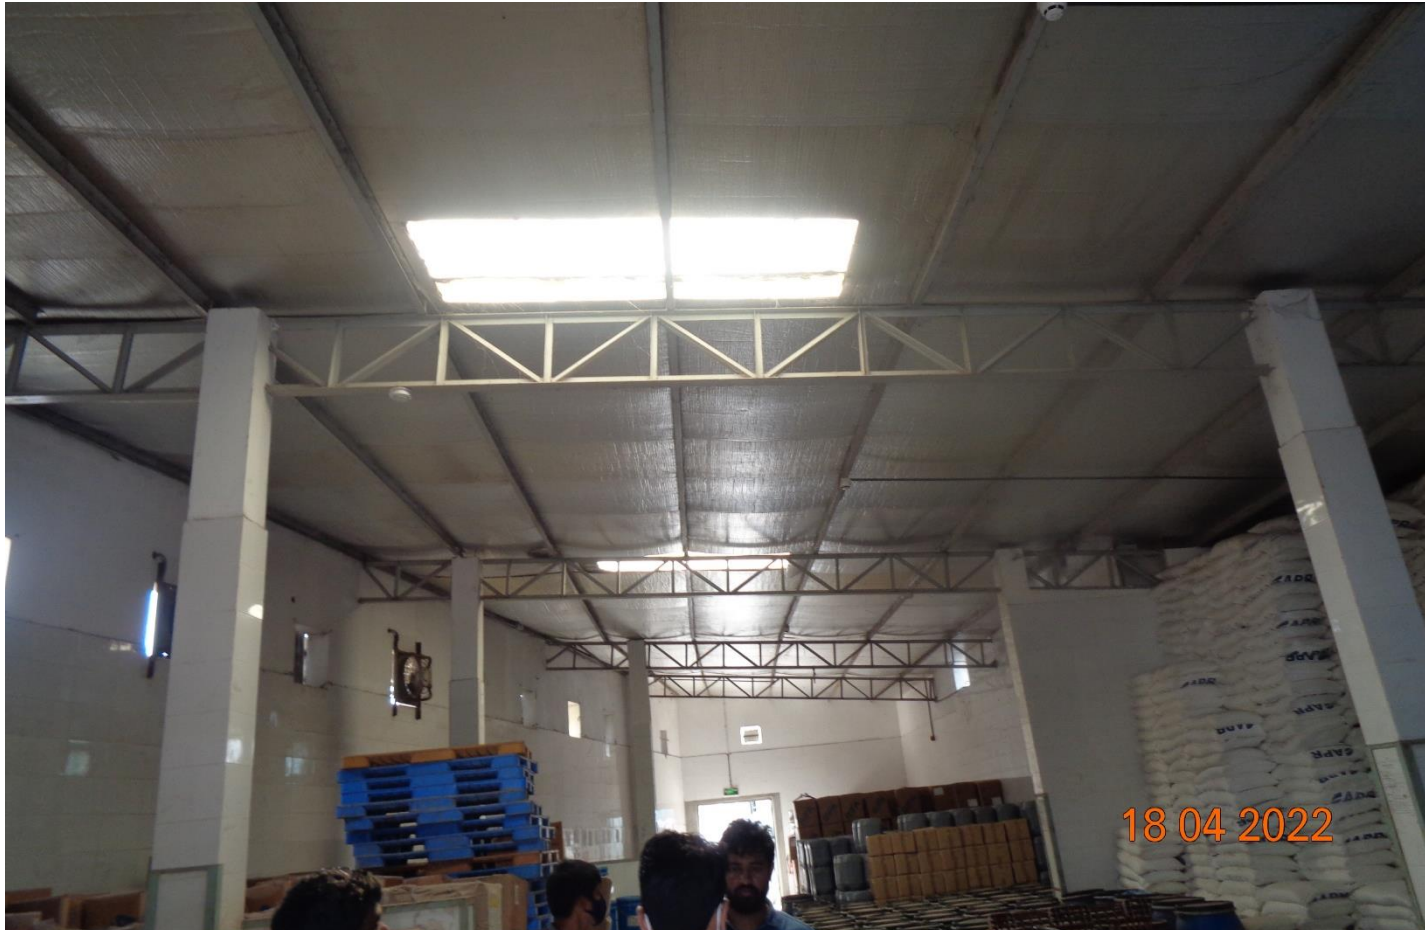
Framing System

Load transfer media is absent along the long direction. The building engineer is required to check the lateral stability of the structure and provide necessary alternatives.

| Item No. | Observation | Recommended Action Plan | Recommended Timeline |
|---|---|---|---|
| 14 | Lack of lateral stability system.<br>(Chemical Shed) | As part of Engineering Assessment (EA), the building engineer is required to check the lateral stability of the structure and provide necessary remedial actions. | 6-weeks |

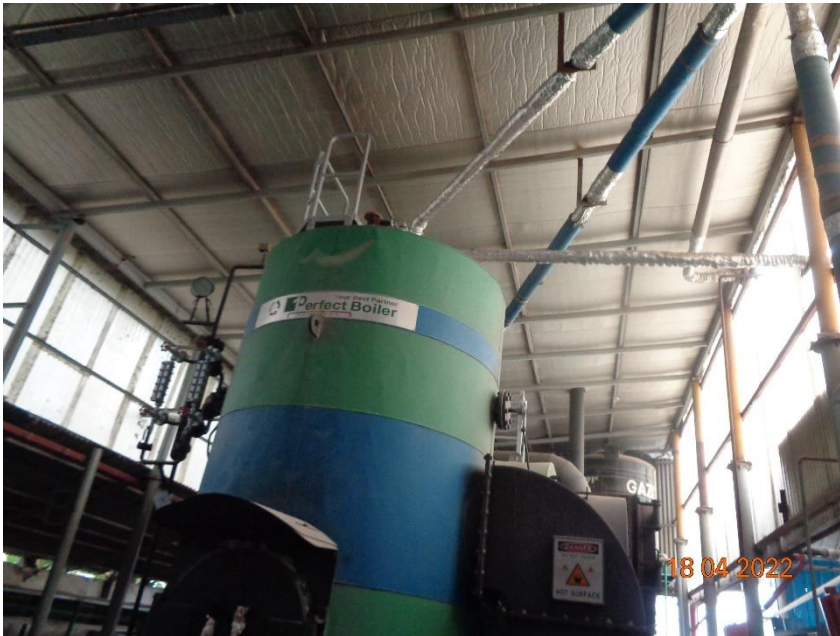
Inside of Jhut Boiler

Apparently Inadequate structural members and poor connection details were found. The building engineer is required to check the adequacy of the steel members & connections for uplift and lateral forces and suggest proper alternatives.

| Item No. | Observation | Recommended Action Plan | Recommended Timeline |
|---|---|---|---|
| 16 | Apparently non-engineered connection<br>(Jhut Boiler Shed) | As part of Engineering Assessment (EA), the building engineer is required to check the adequacy of the steel members & connections for uplift and lateral forces and suggest proper alternatives. | 6-weeks |

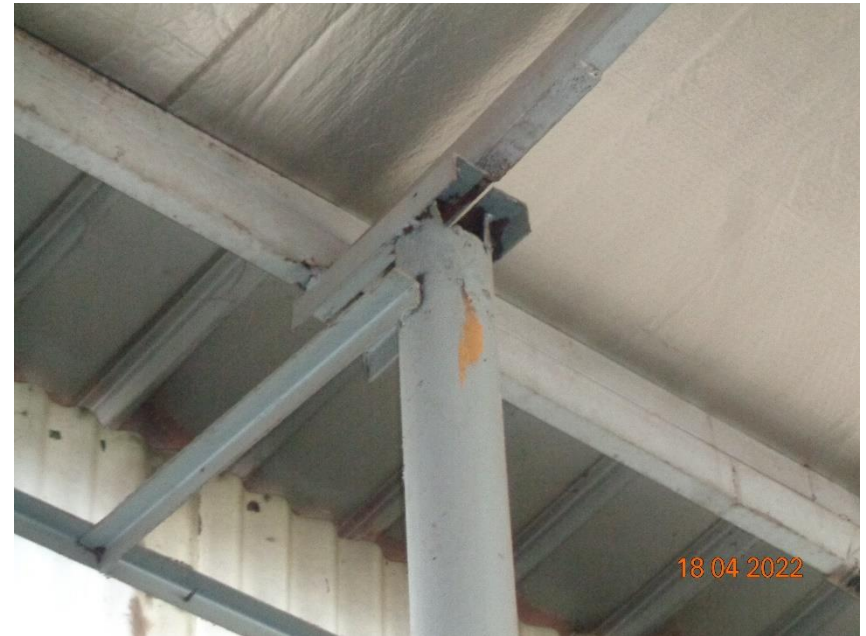
Non engineered connection

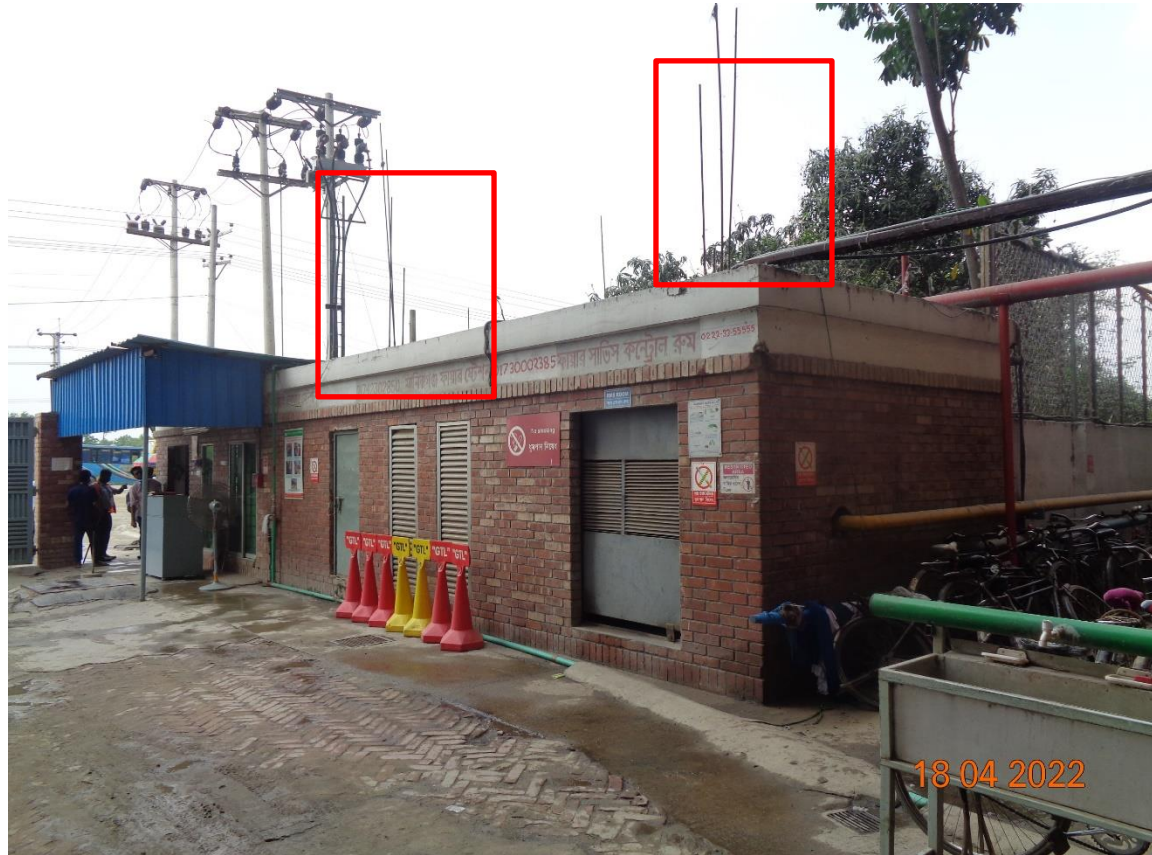
Exposed rebar at column on the roof

Exposed column's rebar was found on the roof. All exposed rebar is to be protected from corrosion which may cause degradation of the concrete. Factory is required to take necessary measures to prevent the corrosion in exposed rebar.

| Item No. | Observation | Recommended Action Plan | Recommended Timeline |
|---|---|---|---|
| 18 | Exposed re-bar. (Gate House & RMS Room) | All exposed reinforcement is to be protected from corrosion which may cause degradation of the concrete. | 6-weeks |
