Karooni Fashions Ltd.

Ratanpur, Shafipur, Kaliakoir, Gazipur

5 October 2021

1. KFL Building(B+G+7)

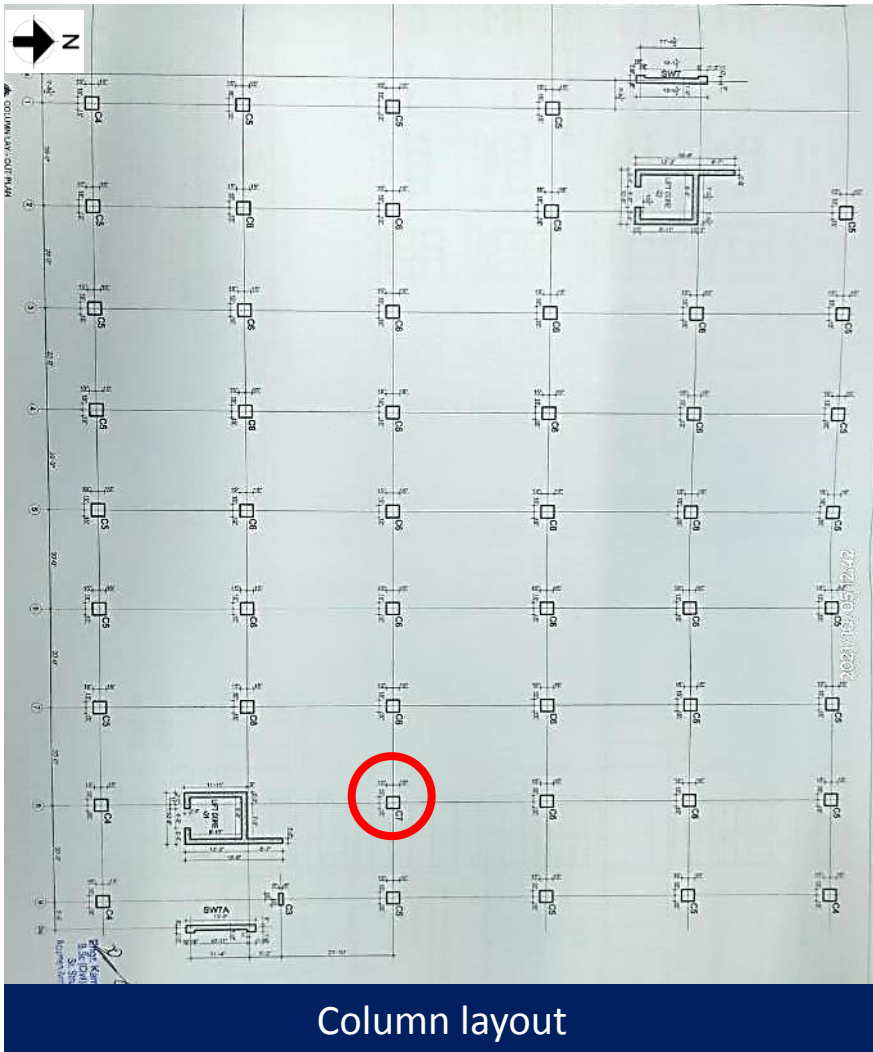
Column layout

Column stresses above normal design limit

Cursory calculation indicate that column stress exceeds the normal design limit considering minimum concrete strength (16.3 MPa) and prepared floor live load plan (3 kPa on typical floors and 6 kPa on storage areas). The building engineer is required to verify the in-situ concrete strength, review the column stress.

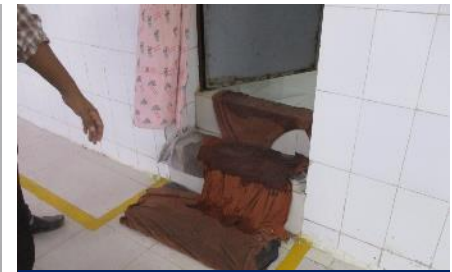
Additional imposed 400 mm floor built up

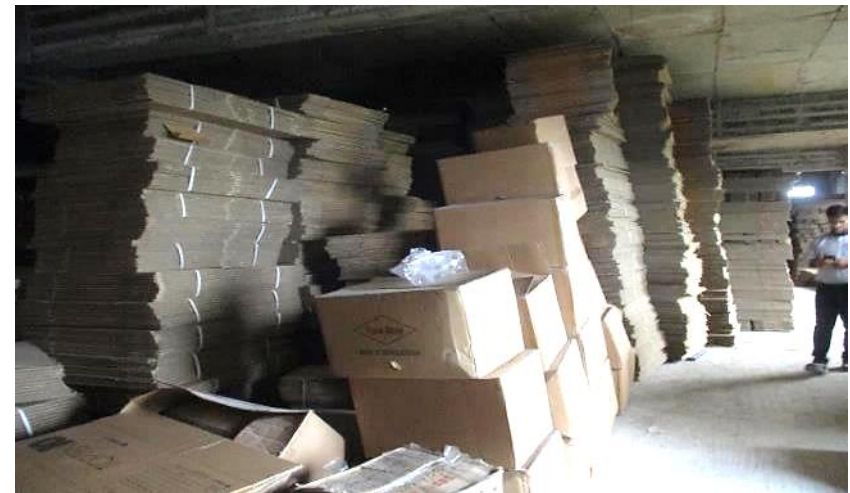
6 kPa loading on 7th floor

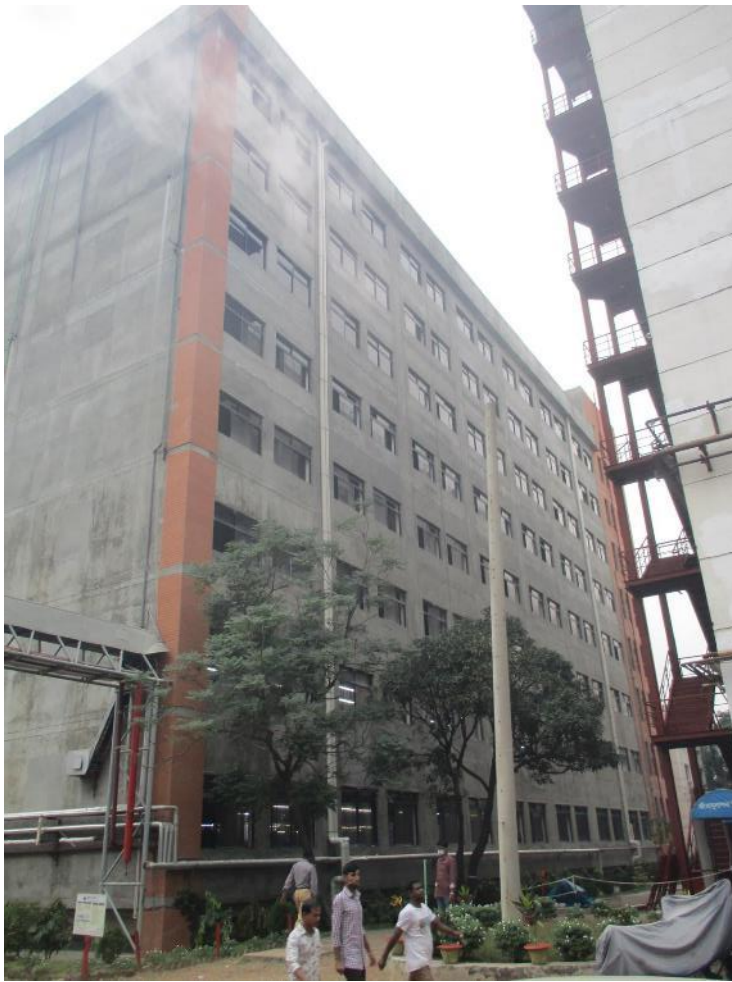
KFL building

As per BNBC, every building or structure designed shall have its design documents prepared in accordance with the provision of Section 1.9.1. The design document shall include a design report, and a set of structural drawings, which shall be prepared in compliance with section 1.9.1.1 and section 1.9.1.2 of part-6, BNBC. However, design report was not available during inspection. The building engineer is required to prepare a design report in compliance with BNBC.

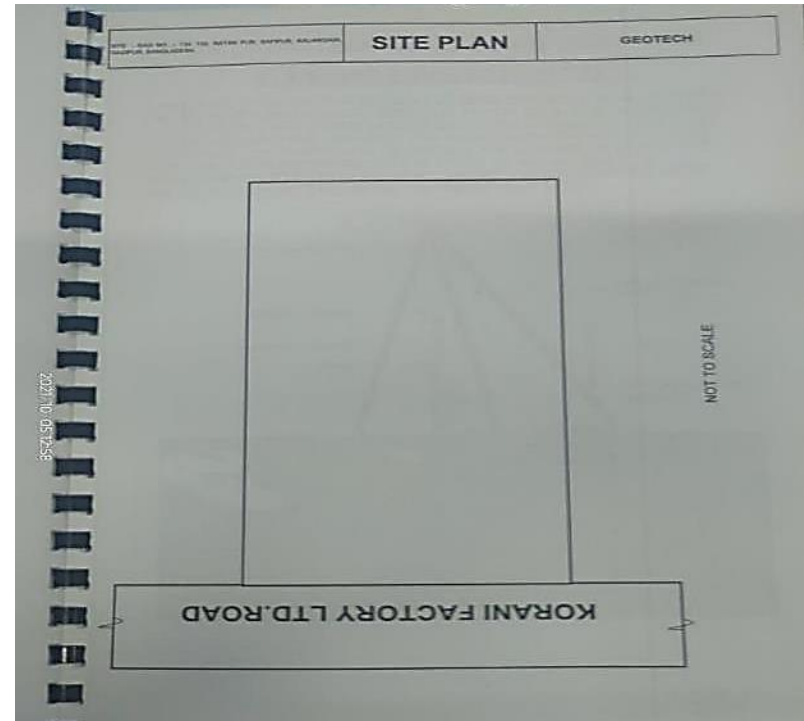
Inconsistency in material test report (soil and concrete)

Location of the building & bore hole locations are missing in the soil test report.

Conduct geotechnical investigation to close vicinity of the structure, determine actual soil bearing capacity and check the foundation adequacy. Maintain proper records of testing [Soil & concrete].

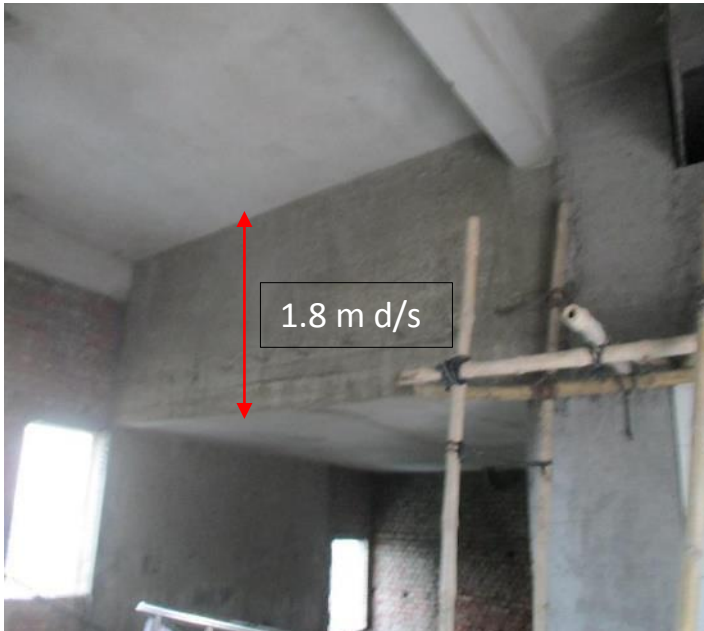
OHWT on the roof

Structural details of OHWT & parapet wall on the roof and retaining wall on the basement floor are not shown in the structural drawings. The building engineer is required to survey the structural components and produce accurate structural details.

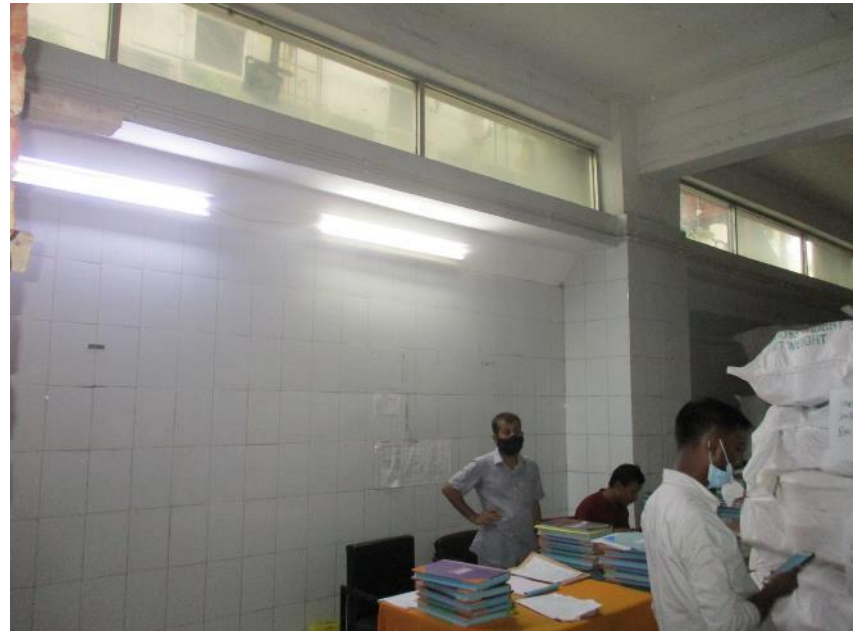
Retaining wall on the basement floor

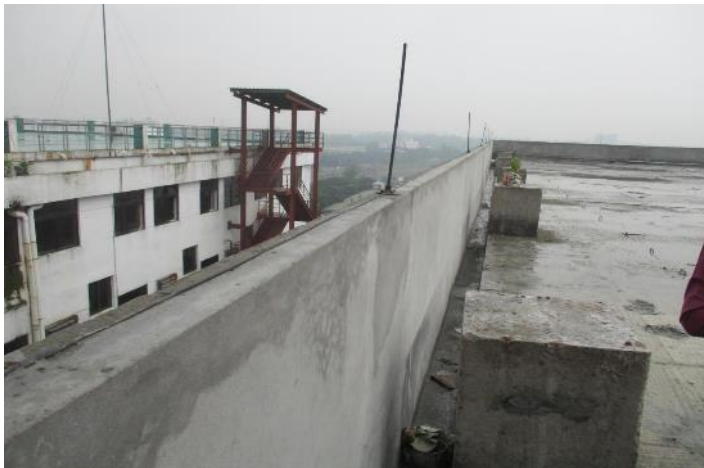
RC parapet on the roof

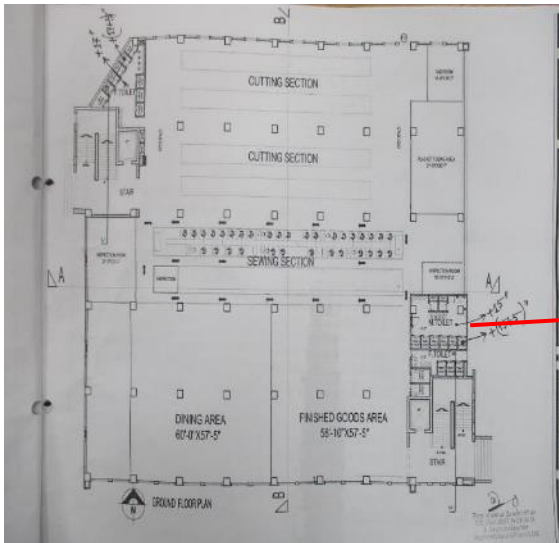
Floor layout plan (floor rise 375 mm all floor)

Floor rise, floor height, brick wall layout does not match with as-built conditions. The building engineer is required to survey the structure and produce accurate as-built drawings.

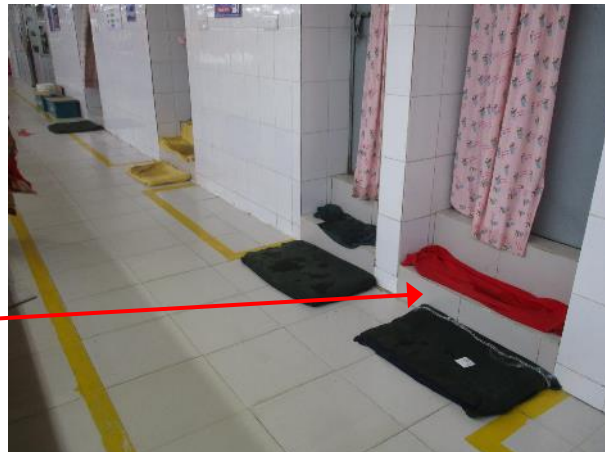
Approx. 450 mm floor rise on ground to 3rd floor and 200 mm on other floors

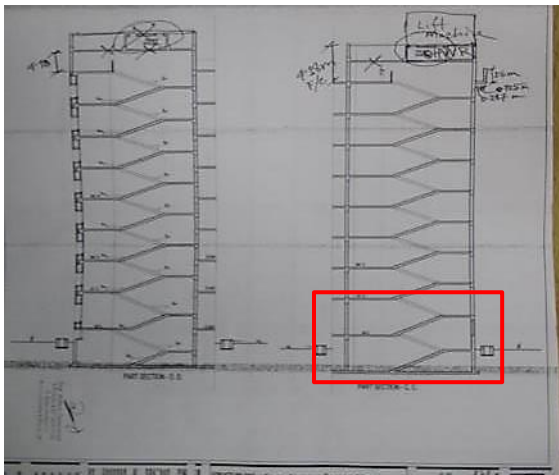
13'-8" floor height at basement & GF instead of 14'

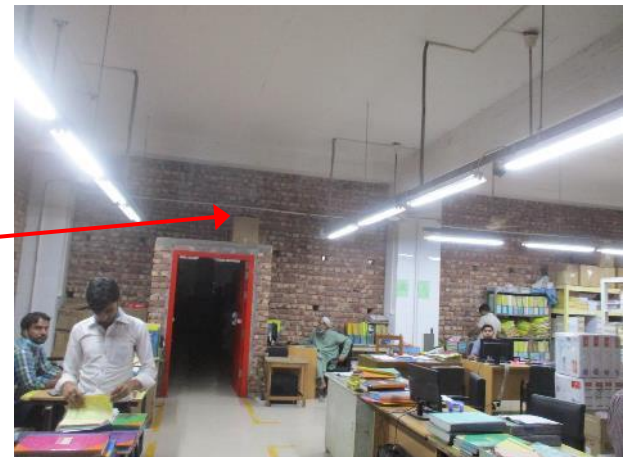
Brick walls on basement floor not shown in drawing

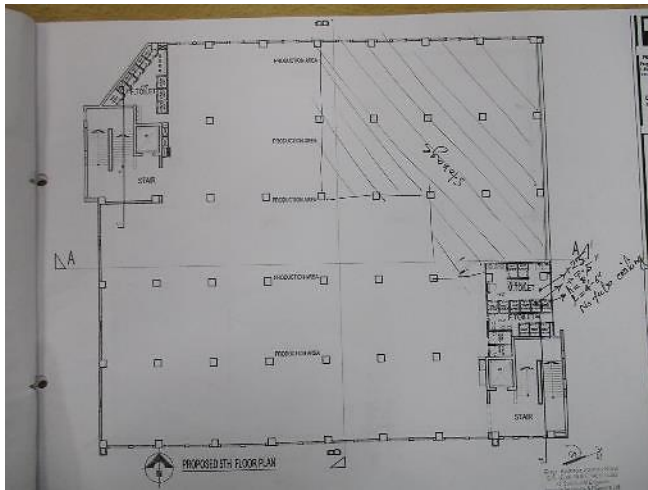
5th floor plan (production)

On the 5th and 7th floor storage was observed on production area. The building engineer is required to check the occupancies and update the floor live loading plan for all floors based on BNBC requirements and manage the floor loading accordingly.

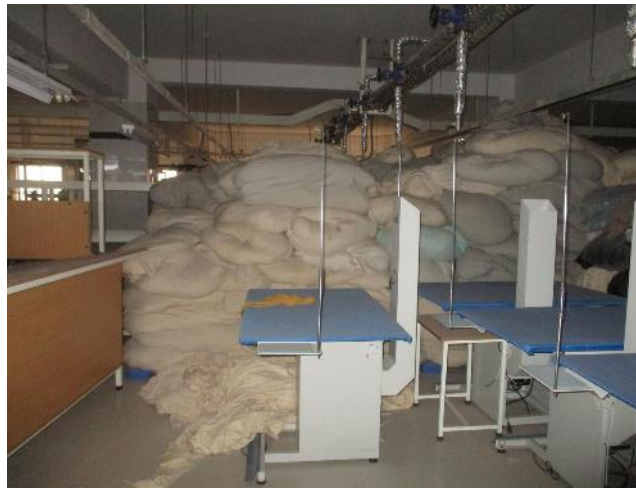
Storage on the 5th floor

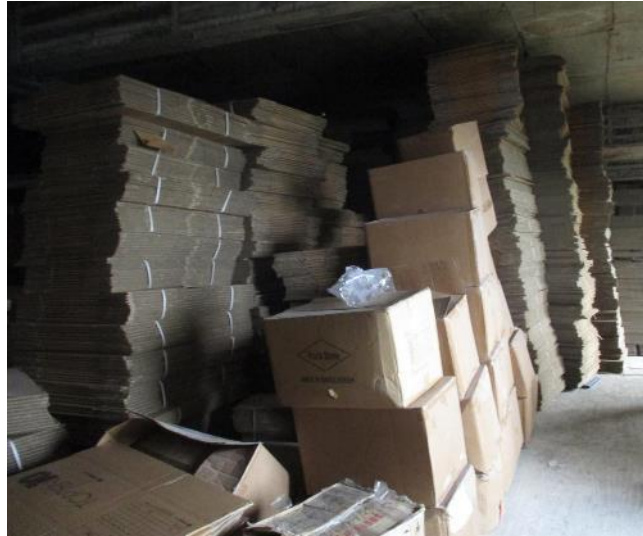
Storage on the 7th floor

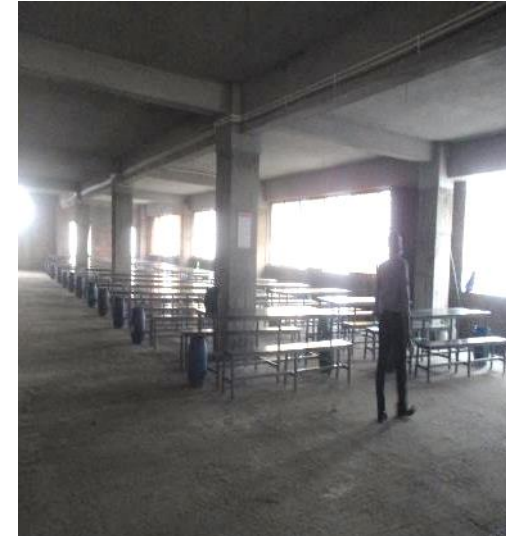
Dining on the 7th floor

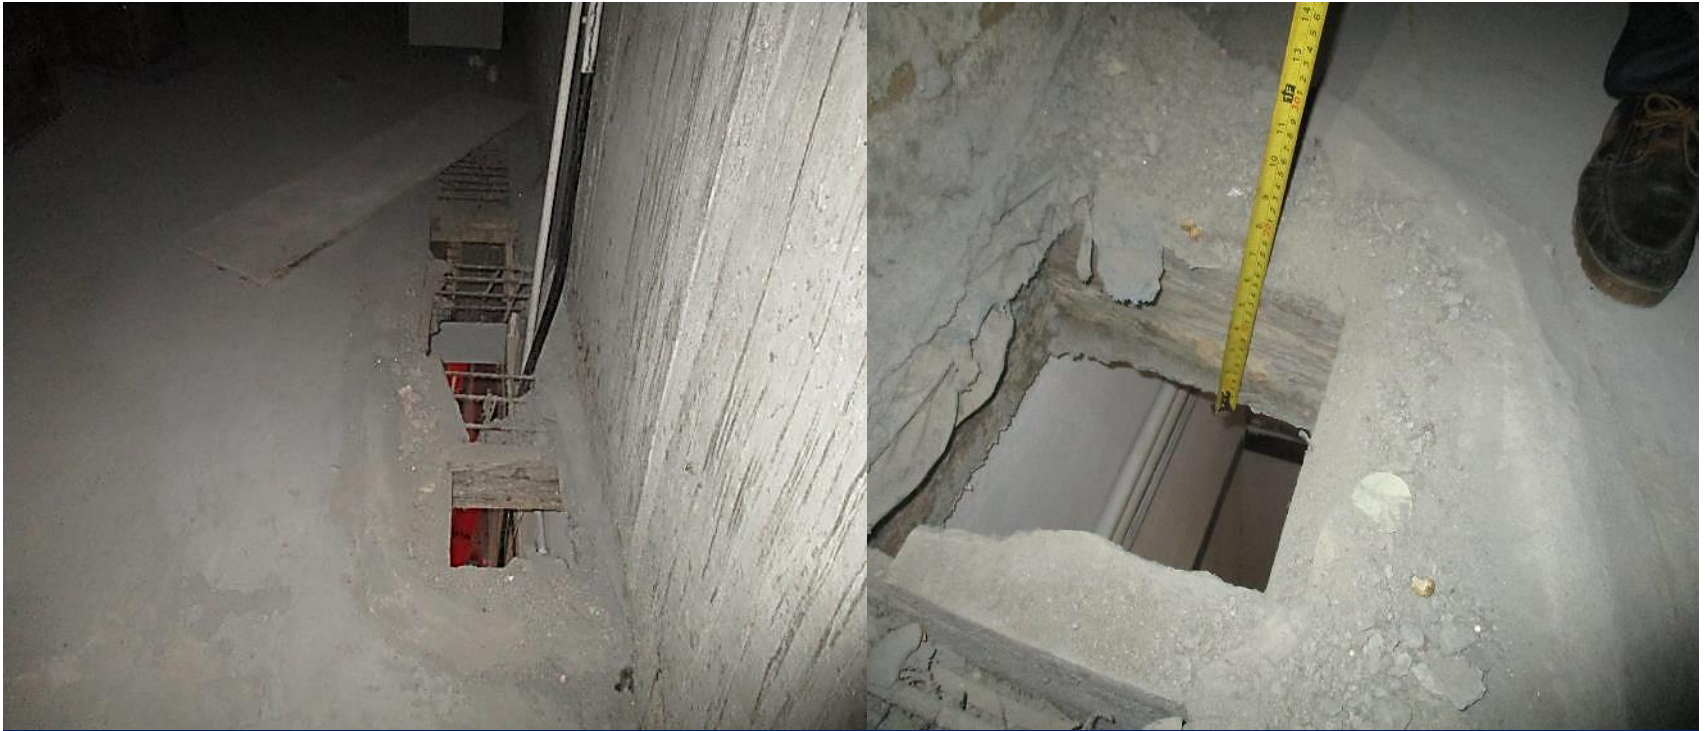
Slab opening has been observed at the edge of shear wall

The building engineer is required to check the slab capacity, diaphragm connections, deflection of the floor slabs and suggest proper actions accordingly.

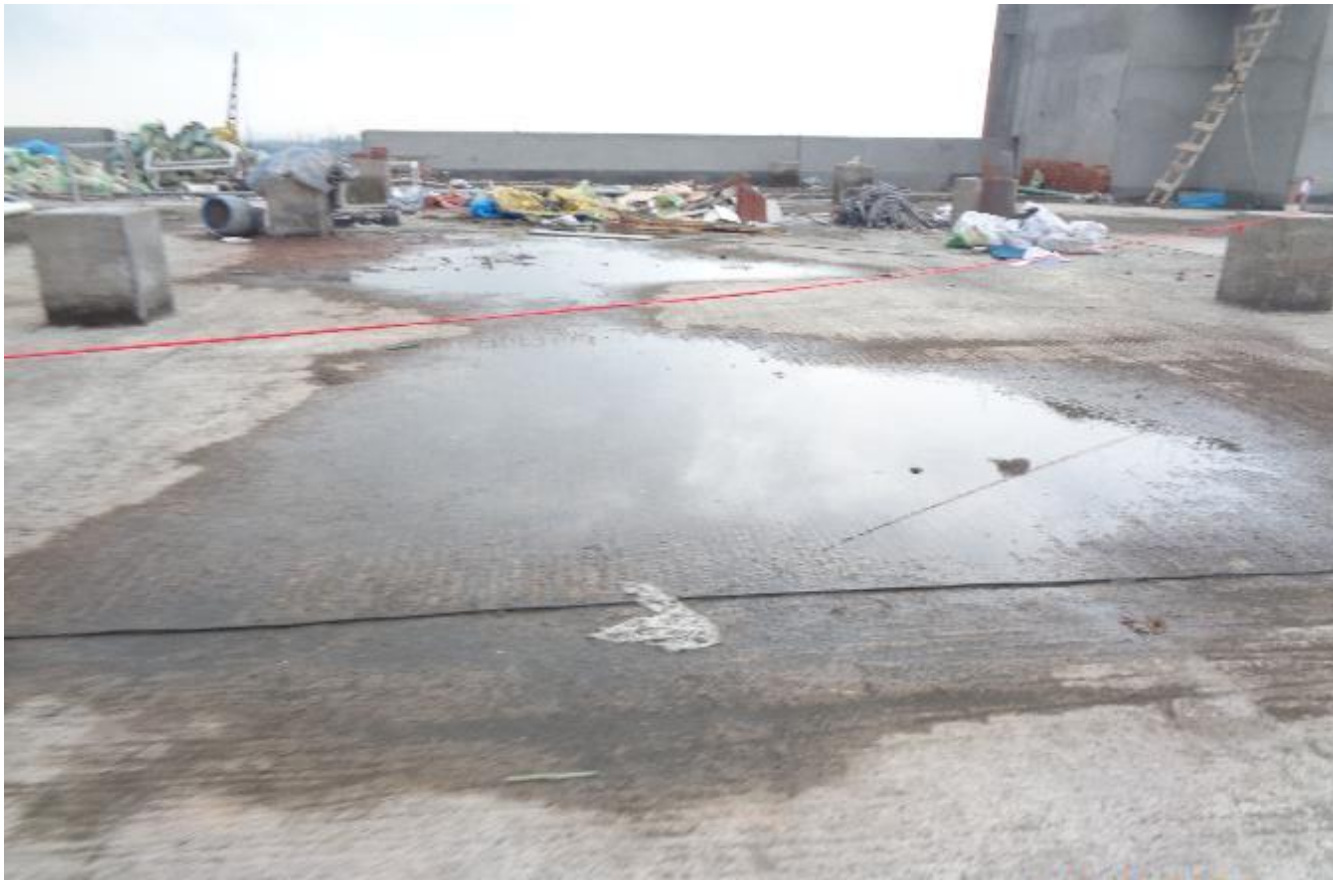
Stagnant water observed on roof

Develop proper drainage system on the roof with adequate slope or apply water proofing layer on the roof to resist water ingress into the slab.

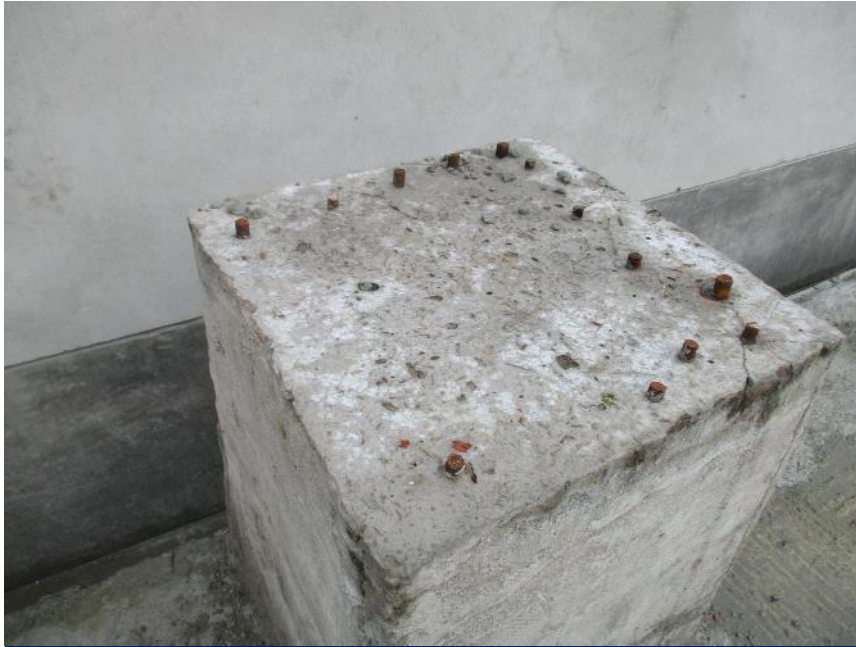
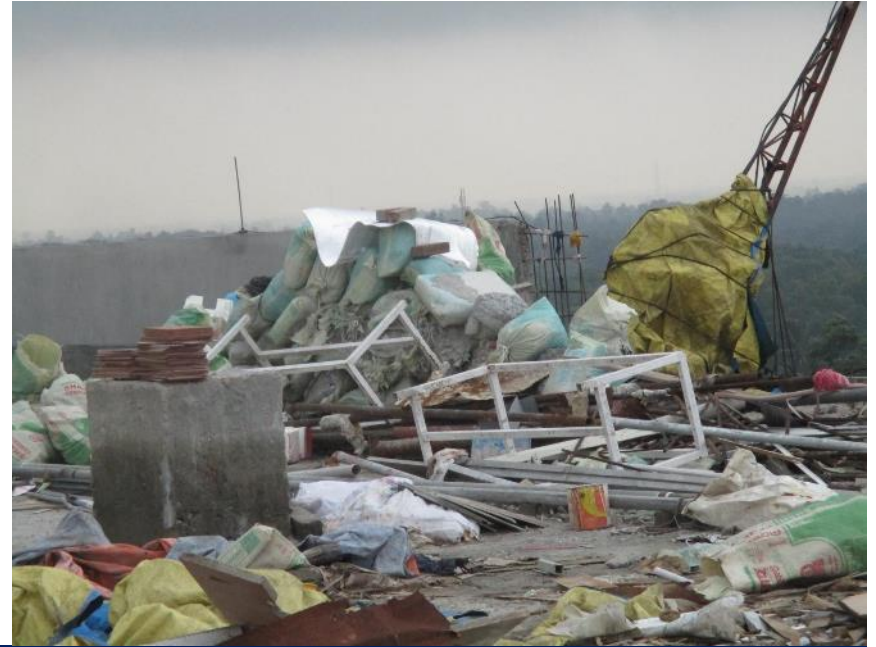
Expose rebar has not been covered properly & construction debris found on the roof

The factory is required to remove the corrosion from the rebar and cover the exposed rebars.
Also, remove the construction debris from the roof.

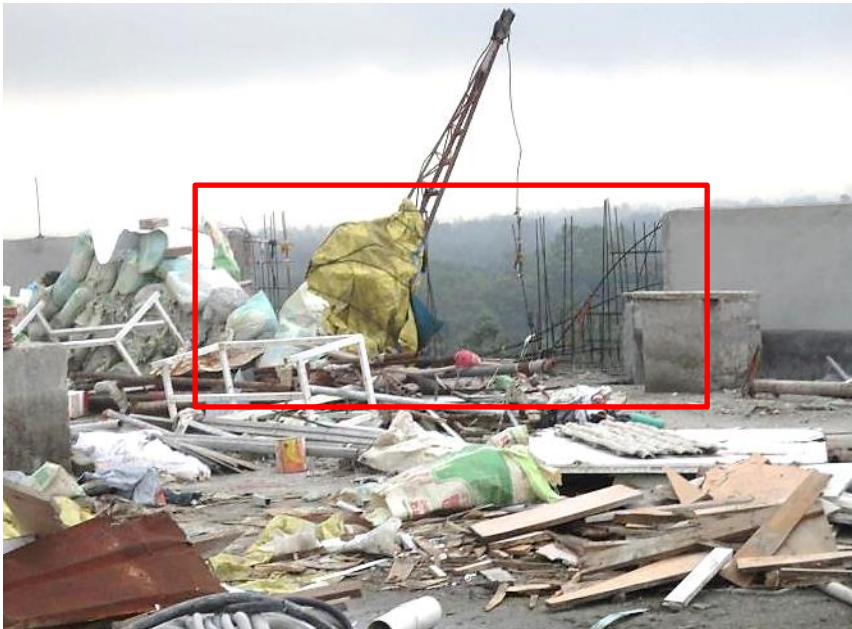
Roof parapet wall missing on the eastern side

The RC parapet wall is resting on the beam bottom cantilever slab. The factory is required to provide parapet wall to the eastern part of the roof. The building engineer is required to check the lateral stability of the parapet walls and check the capacity of below cantilever slabs.

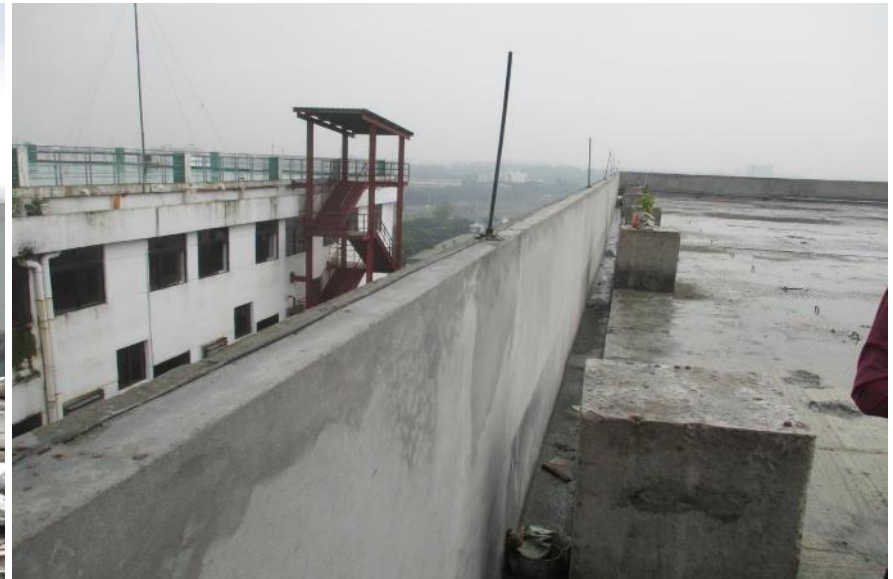
Free standing wall observed on the beam bottom cantilever slab.
