# Metro Knitting & Dyeing Mills Ltd (Factory-02) New Building

Charabag, Ashulia, Savar, Dhaka- 1341  
(23.883822, 90.310283)  
4th October 2021

## 1. Building-3 (Green Project) -(B+G+8)

# Observations

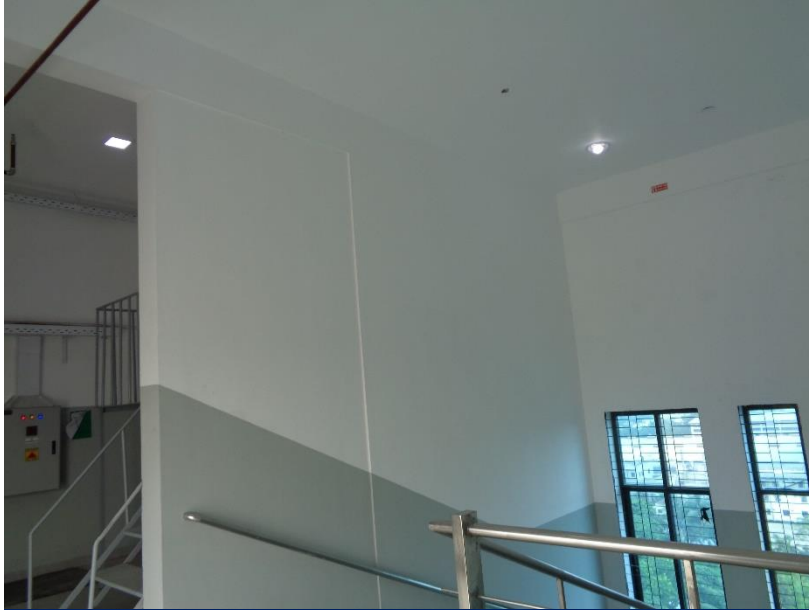
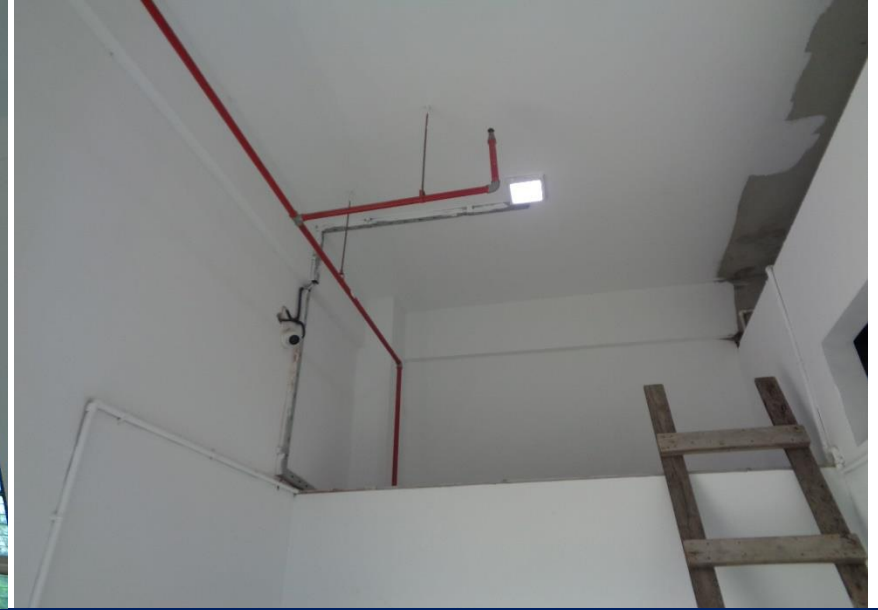
Beam & slab detail were not shown in as-built drawing for any of the staircases

Beam & slab detail were not shown in as-built drawing for any of the staircases. Factory engineer is required to update the as-built drawing showing details of all the structural elements.

| Item No. | Observation | Recommended Action Plan | Recommended Timeline |
|---|---|---|---|
| 03 | Missing information in as-built drawing (Building-3 (Green Project)) | Factory engineer is required to survey the structure and update as-built (architectural & structural) drawings. | 6-weeks |

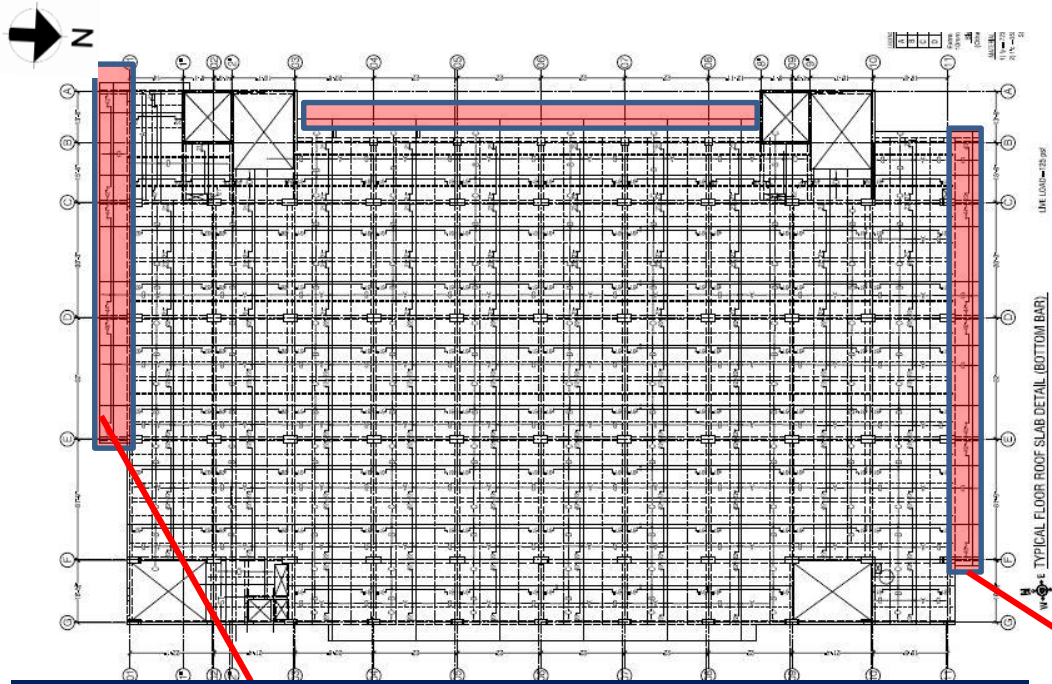
Cantilever dimension was not shown in as-built drawing. Factory engineer is required to update the as-built drawing showing dimension of all the structural elements.

Cantilever dimension was not shown in as-built drawing

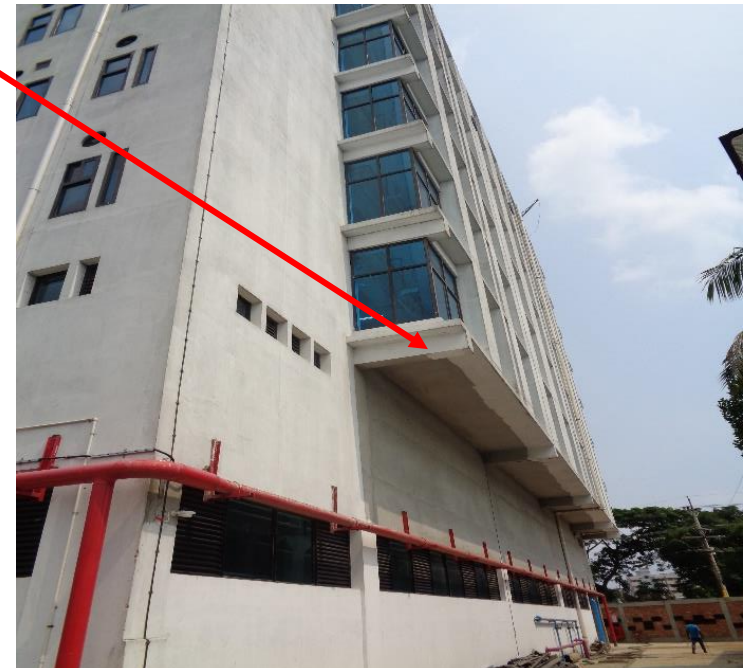
Cantilever at south side

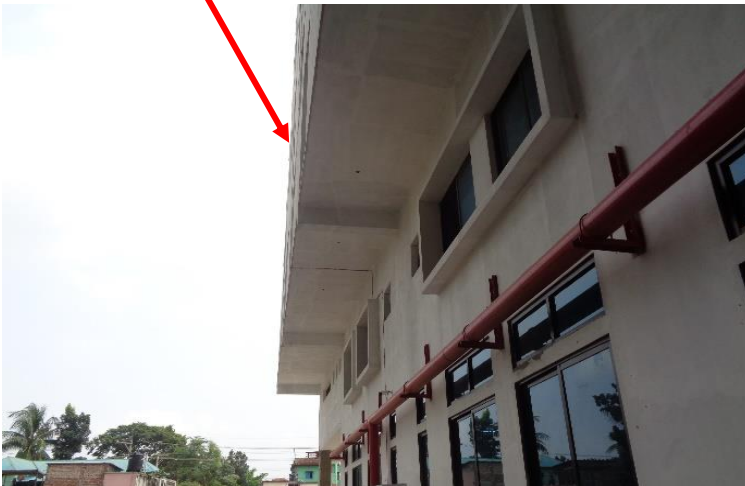
Cantilever north side

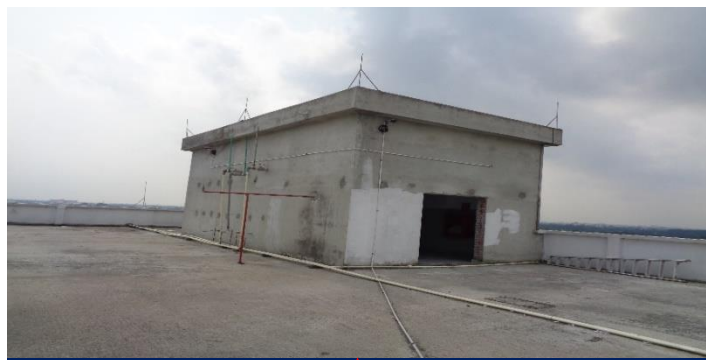
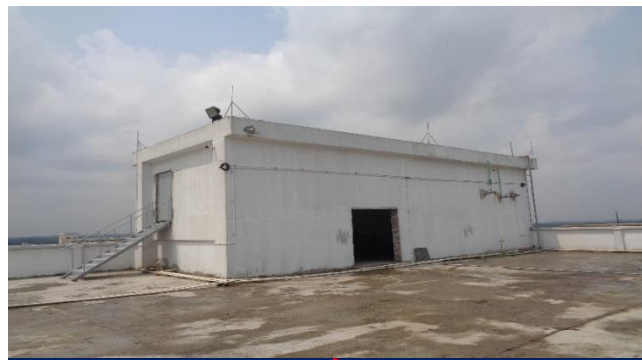
RC water tank

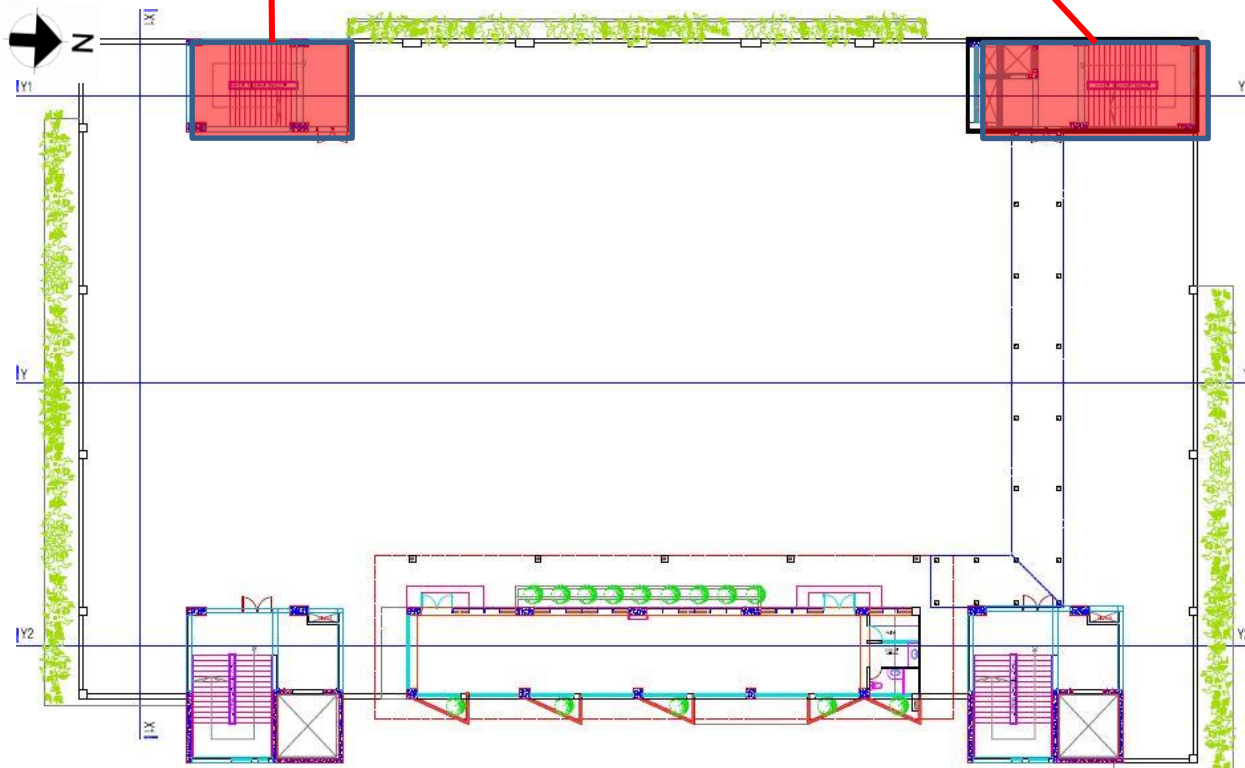
Roof layout

Over water tank location was not shown in archliberal drawing. Factory engineer is required to update the as-built drawing showing the water tanks.

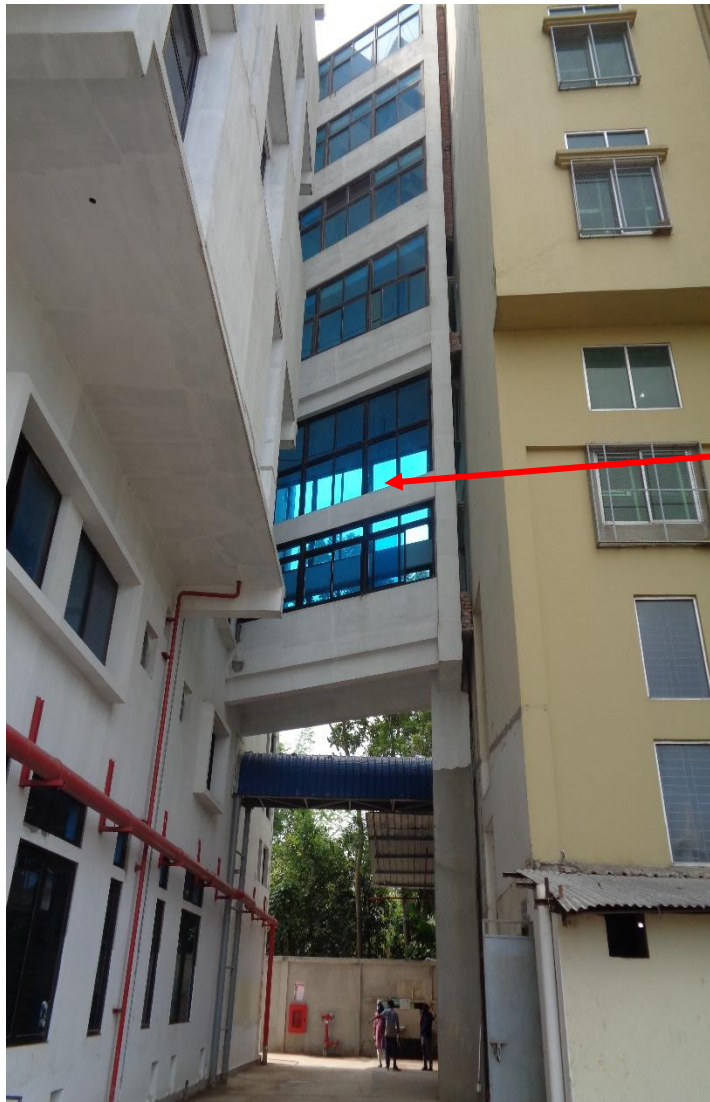
Extension at north side

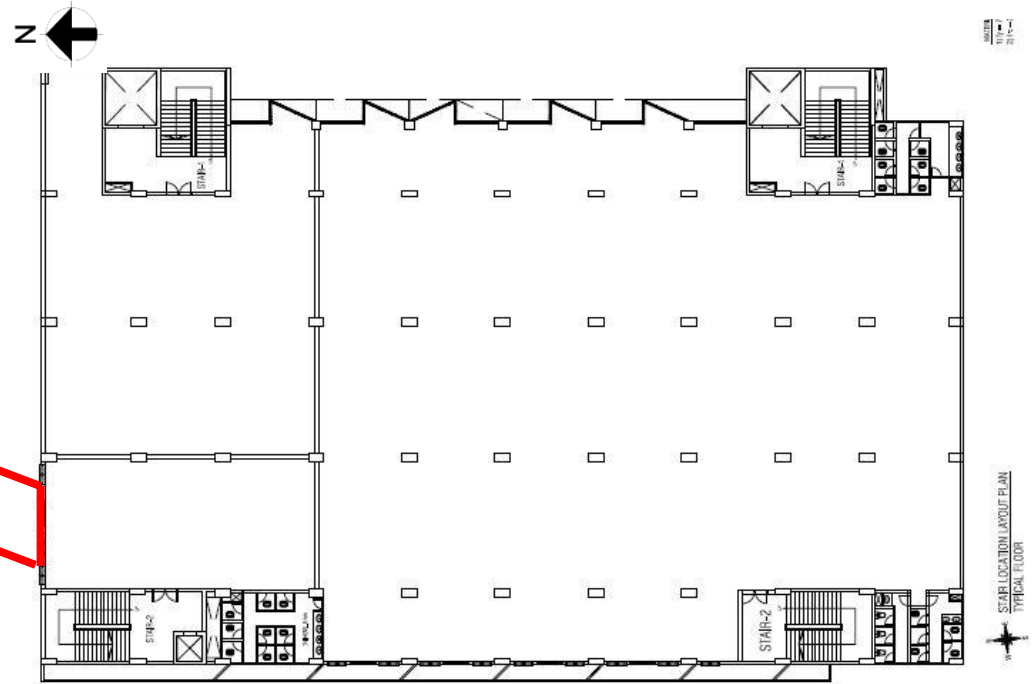
Extension at north side was not shown in archliberal drawing. Factory engineer is required to update the as-built drawing showing the extension.

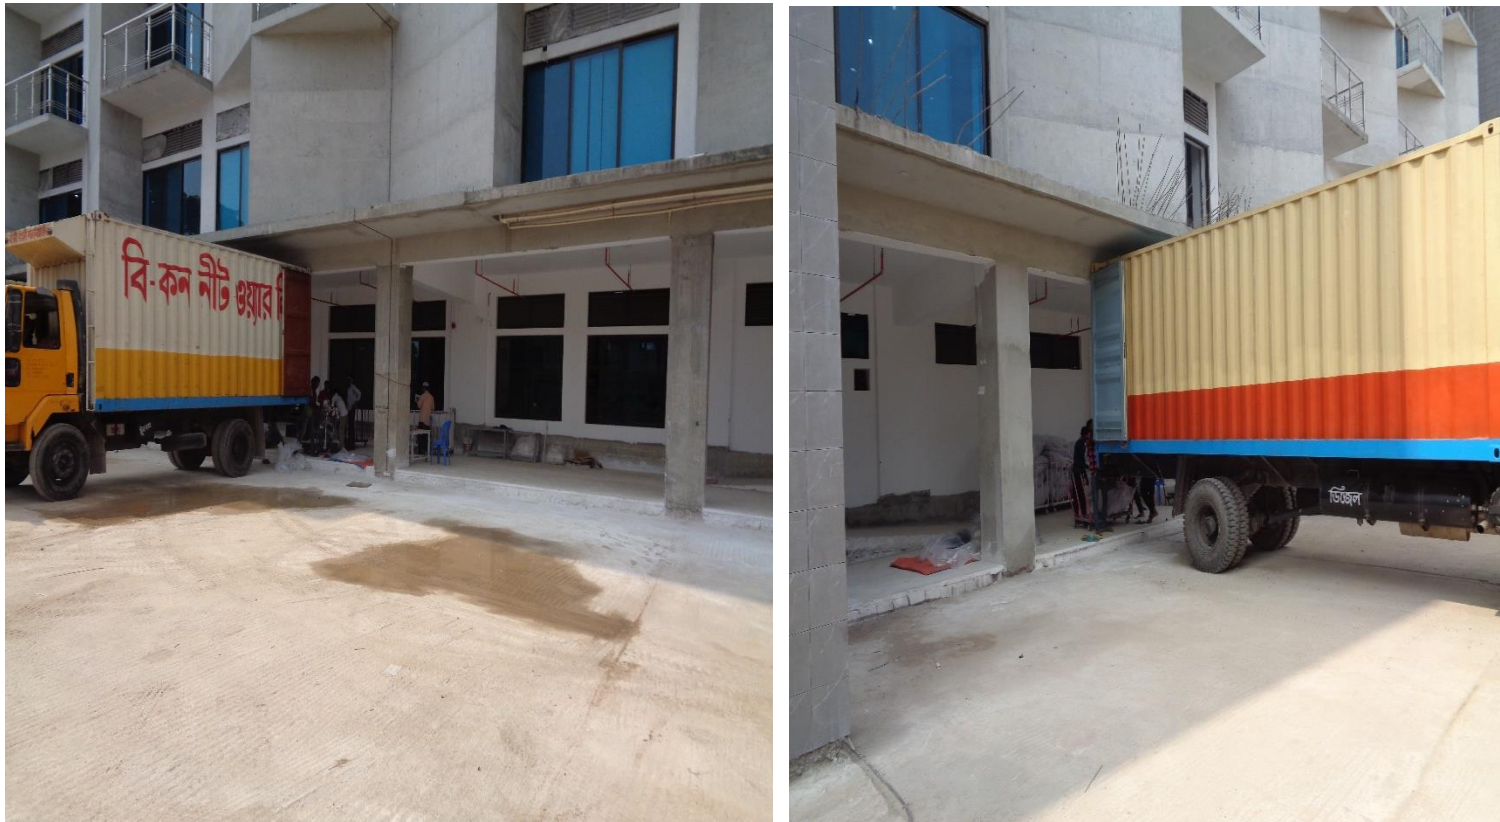
Columns prone to possible vehicle impact

Some columns were found exposed which are prone to possible vehicle impact. Factory is required to provide barrier around all the exposed columns to protect the columns from possible vehicle.

| Item No. | Observation | Recommended Action Plan | Recommended Timeline |
|---|---|---|---|
| 04 | Possible vehicle impact (Building-3 (Green Project)) | Factory is required to provide barrier around all the exposed columns to protect the columns from possible vehicle. | 6-weeks |

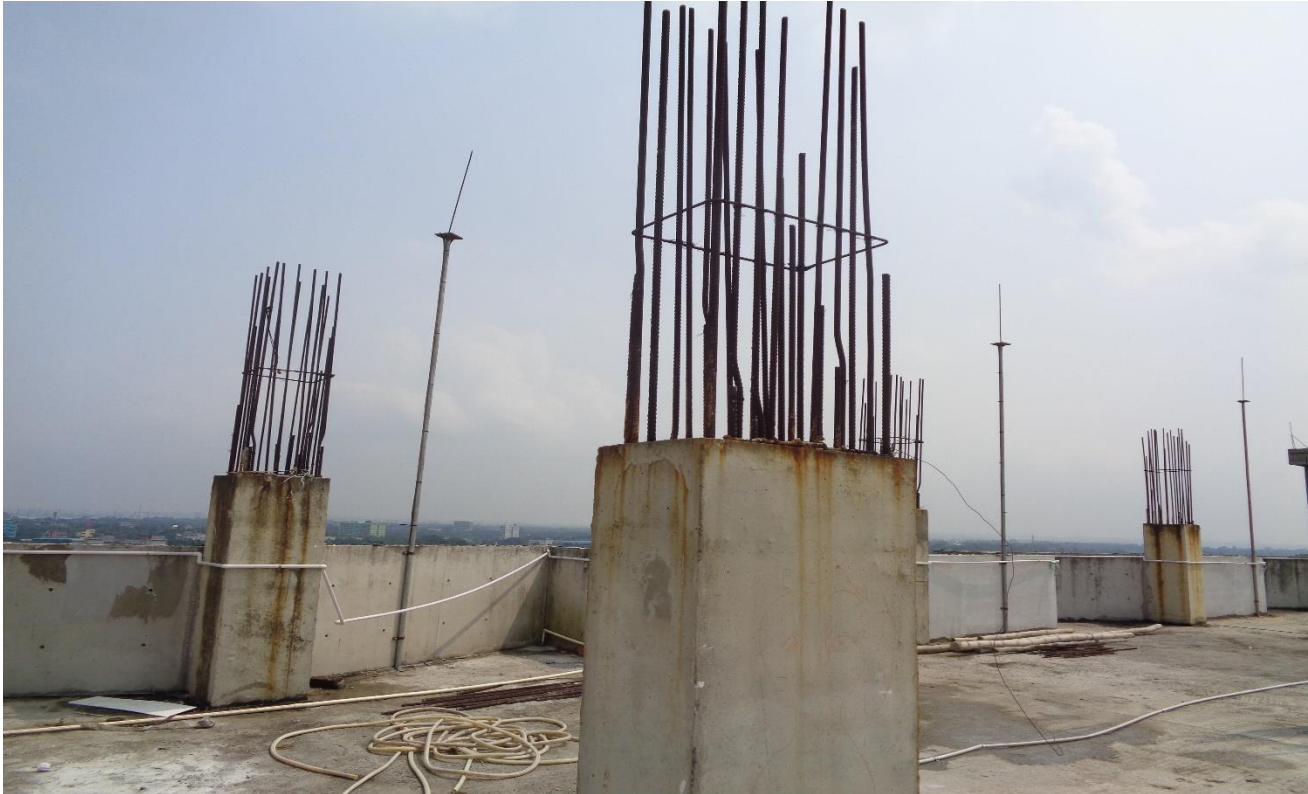
Exposed reinforcement left at roof level

Exposed reinforcement is left at roof level & staircase which was prone to corrosion. Factory is required to provide rust proof paint on exposed reinforcement to protect from corrosion.

| Item No. | Observation | Recommended Action Plan | Recommended Timeline |
|---|---|---|---|
| 05 | Exposed reinforcement left at roof level (Building-3 (Green Project)) | Factory is required to provide rust proof paint on exposed reinforcement to protect from corrosion. | 6-weeks |
