# INITIAL FIRE SAFETY INSPECTION REPORT

## Metro Knitting & Dyeing Mills Ltd. (Factory-02) New Building

**Inspected By: Nirmal Chandra Sinha and Nainin Nowrose**

**Date: 04 October 2021**

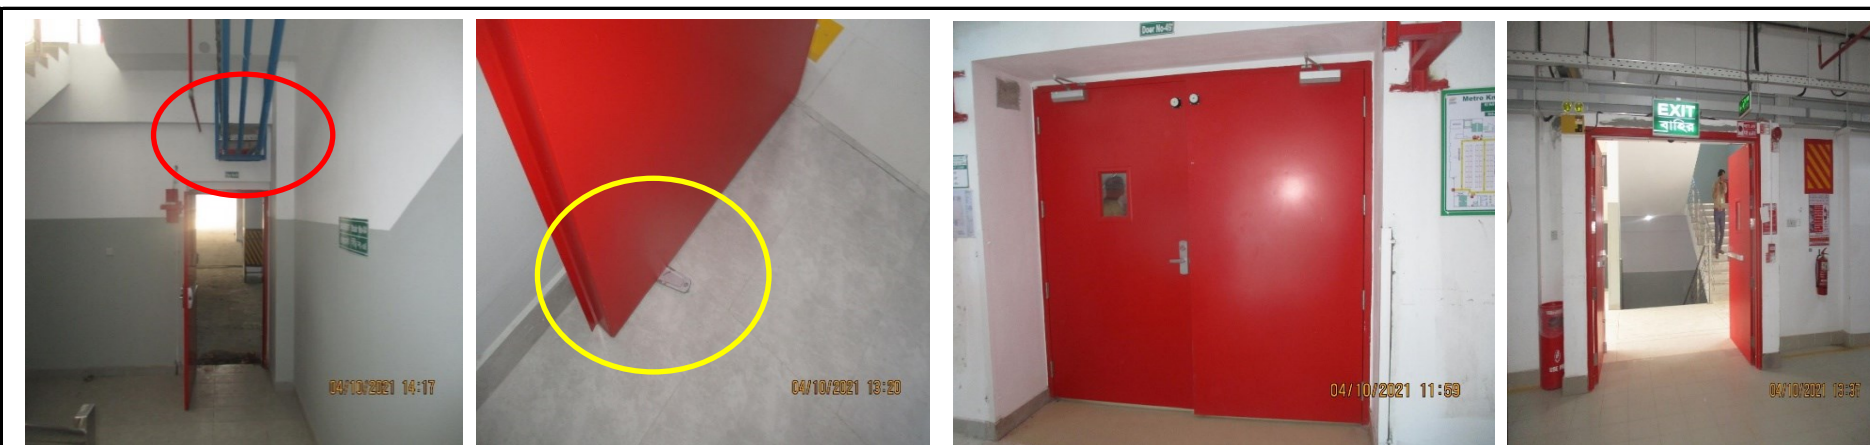
| Sl No. | Category | Findings | Required Action | Remediation Time Frame |
|---|---|---|---|---|
| 1 | Fire Rated Construction | The exit stairs are not separated from work areas and other spaces on each floor by fire-rated construction. During inspection it was observed that the factory has installed fire doors at exit. | <p>Submit installed fire rated door documents to the RSC for review. Provide minimum 1.5-hr fire rated doors for buildings that are 4 or more stories. Seal all unprotected openings to separate the exit stairs from work areas and other building spaces on all floor levels. Seal all penetrations and openings in exit stair enclosure walls to maintain the fire separation as per Accord standard 6.3.1.3. Ensure that the fire doors are self-closing and positive latching and that they are provided with fire exit (panic) hardware where serving production floors.</p> <p>If fire doors are required to be held open for functional reasons, provide automatic closing devices tied to the fire alarm system. Once fire doors are installed, every door in a stair enclosure serving more than 5 stories shall be provided with re-entry unless it meets ACCORD standard 6.8.3.1.</p> | Within 3 months |

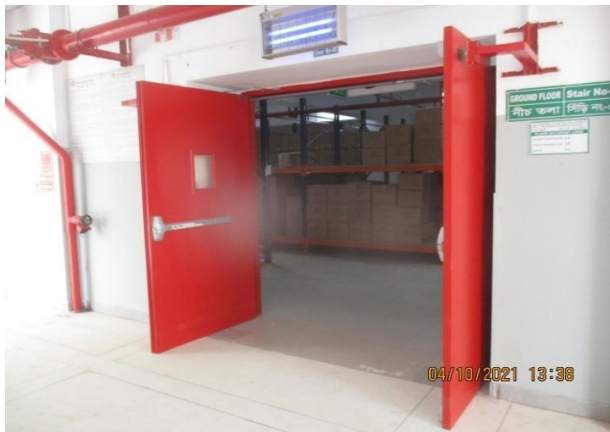
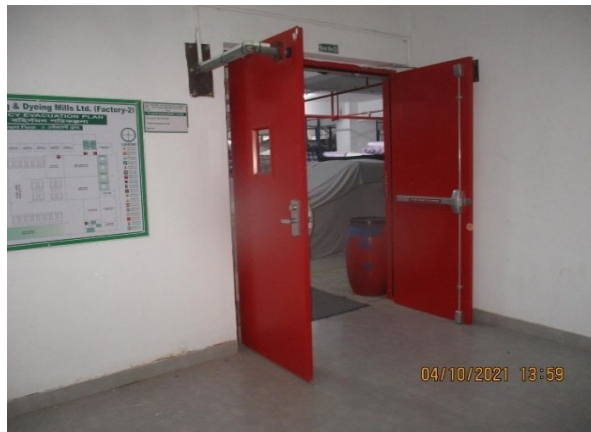
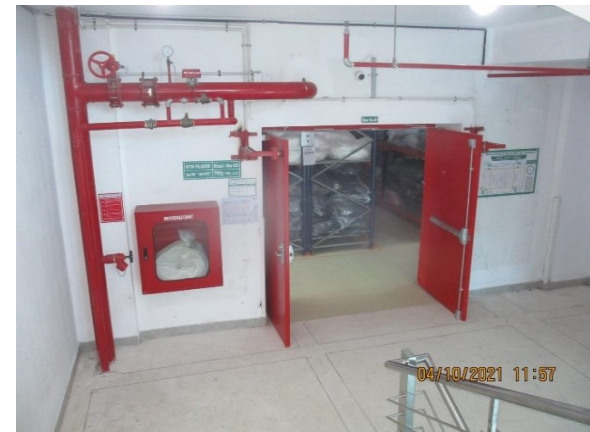
| 2 | Fire Rated Construction | Storage rooms (Basement, Ground floor and 8th floor) used for combustible storage are not separated by fire rated construction from exit stair enclosure and production area on several floors. | Rooms used for storage of combustible materials shall be separated from the surrounding occupancy with a minimum 1 hour construction. Store rooms directly discharge in exit stair enclosure shall be separated in accordance with the Accord standard 6.14.3. | Within 3 months |

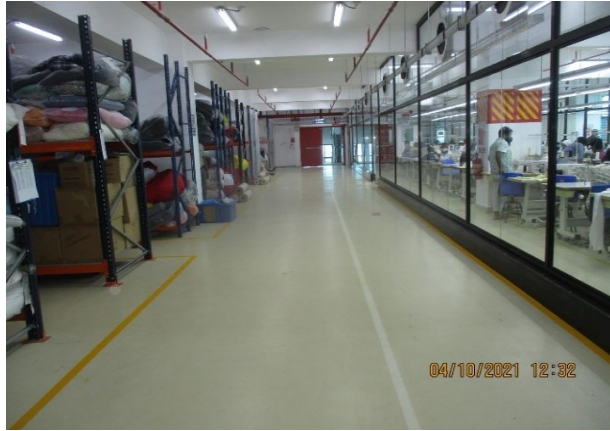
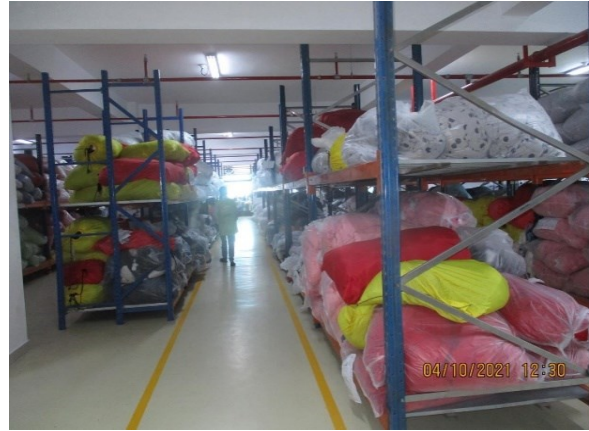
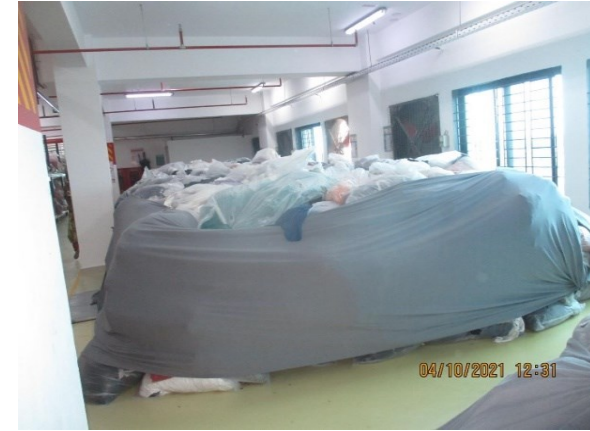
| 3 | Fire Rated Construction | <p>Areas used for combustible storage open to the factory are not separated by fire rated construction on several floors. Cutting input areas and Fabric for relaxation areas are not separated from the sample section on 7th floor.</p> | <p>Provide dedicated storage rooms separated by minimum 1-hr fire-rated construction. Where separate storage rooms are not feasible,</p> <p>provide defined storage areas and limit the storage arrangement as follows:</p> <ol style="list-style-type: none"> <li>1. General Condition: Maximum height of 2.4m and maximum area of 23m<sup>2</sup> (250 sq.ft).</li> <li>2. If sprinkler protected: maximum height of 3.66m and maximum area of 93m<sup>2</sup> (1000 sq.ft).</li> </ol> <p>Separate areas of unenclosed combustible storage by a minimum clear distance of 3m (10 ft).</p> | With 3 months |

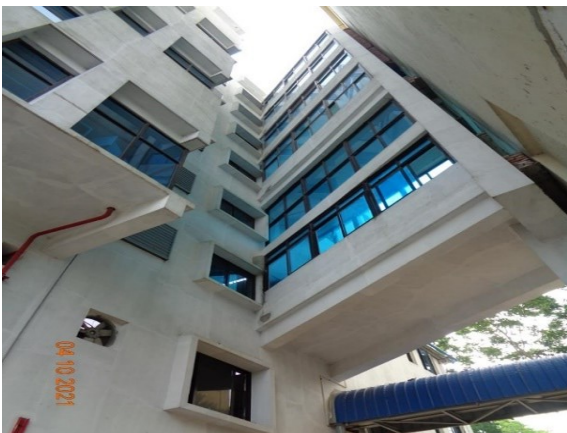
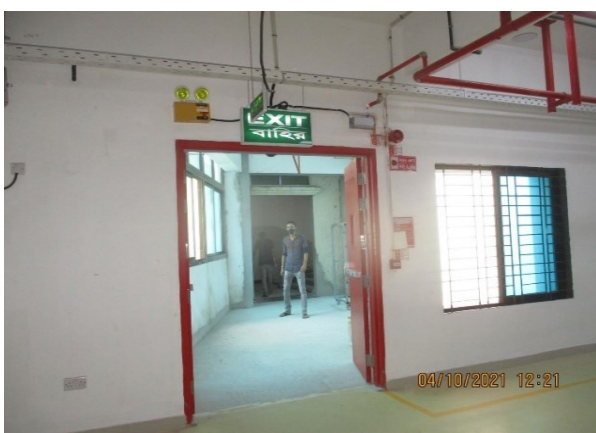
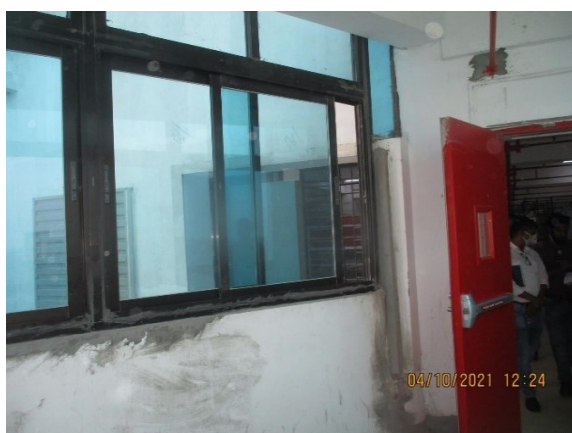
| 4 | Fire Rated Construction | Unsealed penetrations and openings are located in connecting bridge throughout the building which is directly connected to the building-1 exit stair-4 enclosure. | Seal all penetrations and openings in connecting bridge and exit stair enclosure walls to maintain the fire separation as per the standard. The rating of the exterior wall shall extend 3.05 m (10ft) beyond the ends of the stair structure. | Within 3 months |

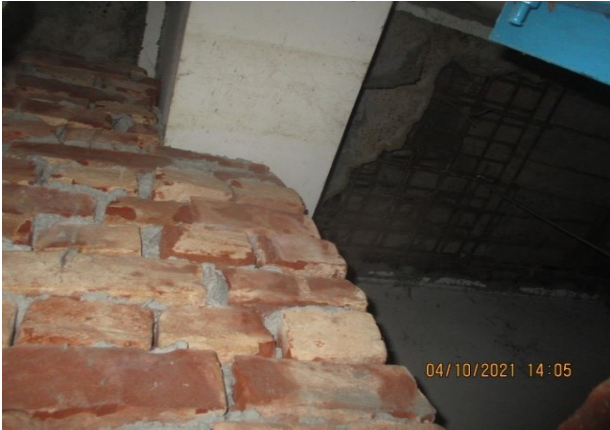
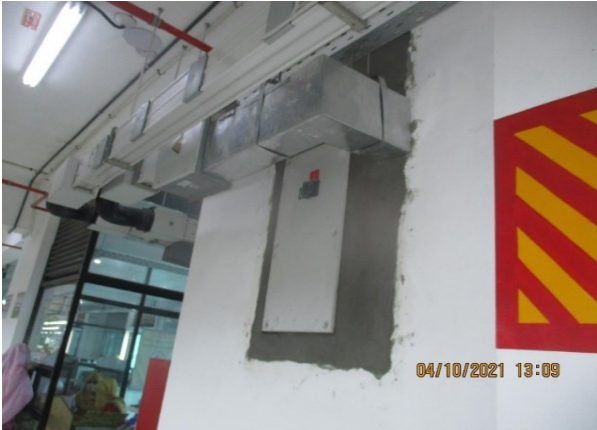
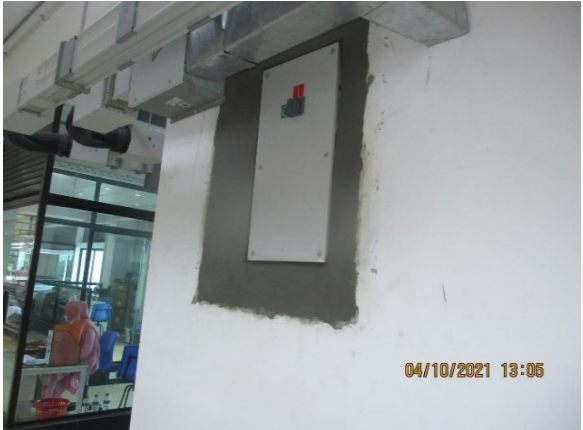
| 5 | Fire Rated Construction | Unsealed electrical cable and electrical (BBT) shafts are located in the fire-rated floor/ceiling assemblies on basement and others floor respectively. | Provide a minimum 2-hr fire rated shaft to separate the utility risers from each floor level and seal all penetrations in floor/ceiling assemblies to maintain the fire separation. | Within 3 months |

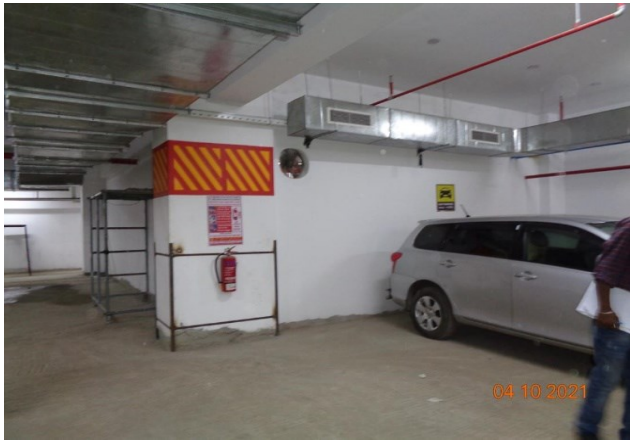
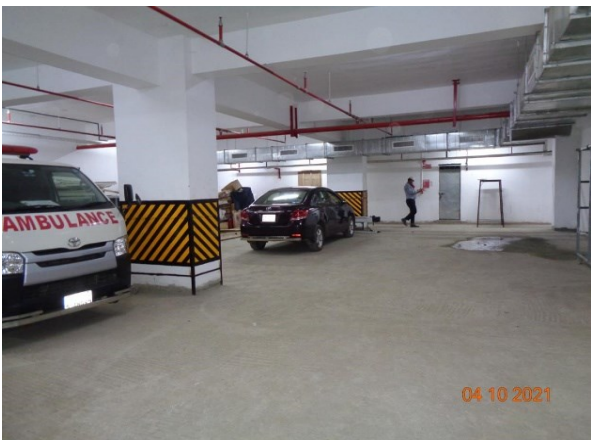
| 6 | Fire Rated Construction | Store rooms are not separated from car parking area and sewage treatment plant (STP) on basement. | Separate the store rooms by a minimum 2-hr fire-rated construction from parking areas and STP. Seal and/or protect all openings to maintain the required fire separations. | Within 3 months | | |

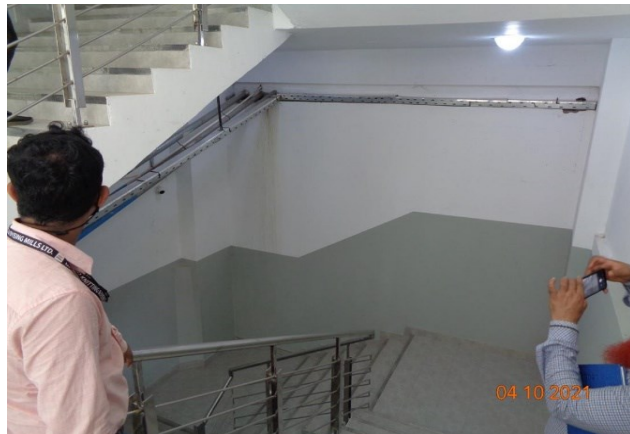
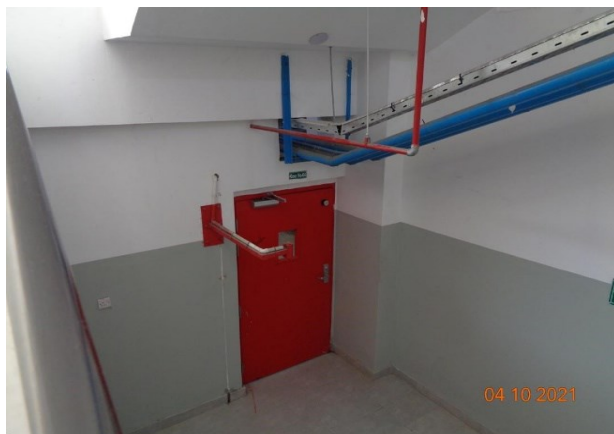
| 7 | Egress | <p>Electrical cable and water pipe passing through south-west exit stair enclosure on basement.</p> | <p>South-East exit stair enclosure on basement shall be separated from electrical cable and water pipe as per Accord standard 6.14.4.</p> | <p>Within 3 months</p> |

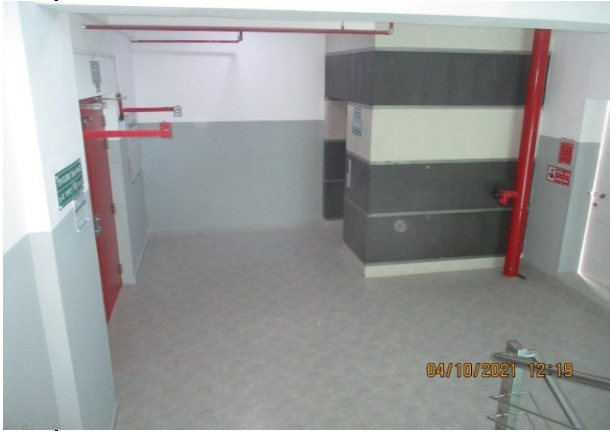
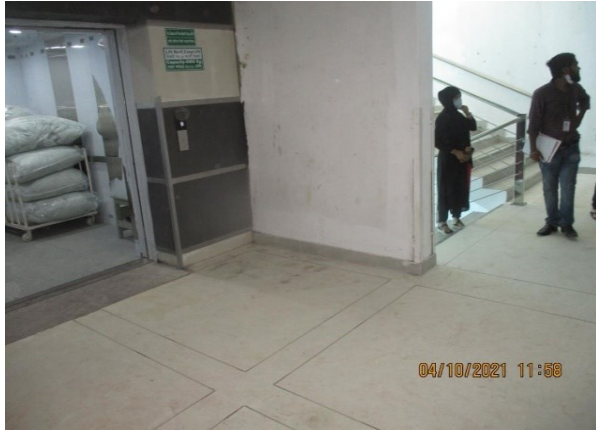
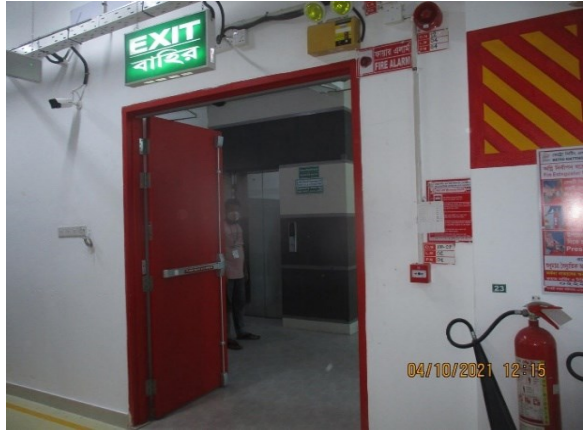
| 8 | Egress | Elevator/Lift shafts provided in North-East (Stair-1), North-West (Stair-3), South-East (Stair-2) exit stair enclosure. | Modify the elevator and stair enclosure arrangement in a way to satisfy Accord standard 6.14.3. Elevator shall not open into an exit enclosure. | Within 4 months | | | | | |

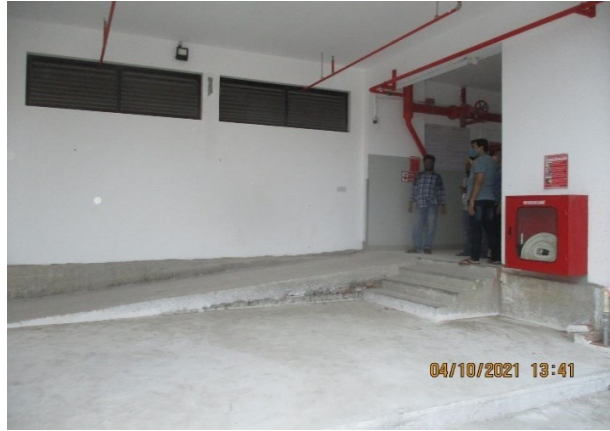
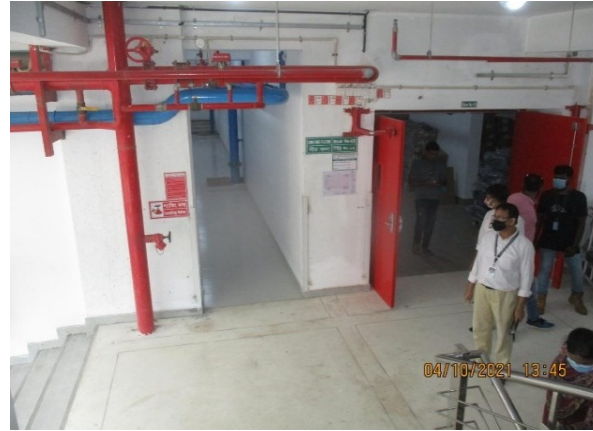
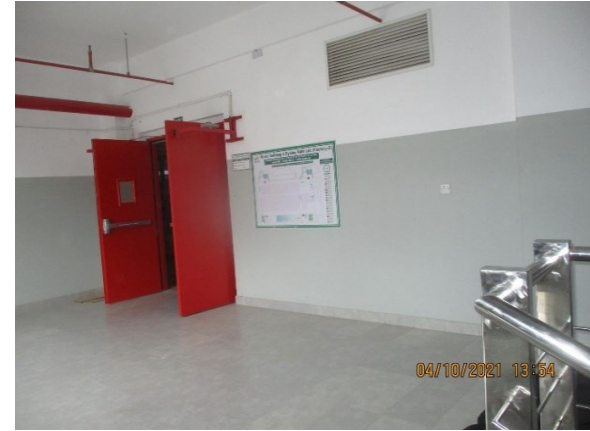
| 9 | Egress | North-East (Stair-1), South-East (Stair-2) and South-West (Stair-4) exit stairs discharge on ground floor of the building and not separated from the building interior of the building. | Modify stair to discharge directly outside or Provide 2- hr fire-rated exit passageway leading directly outside (vestibules to separate any storage areas). | Within 6 months |

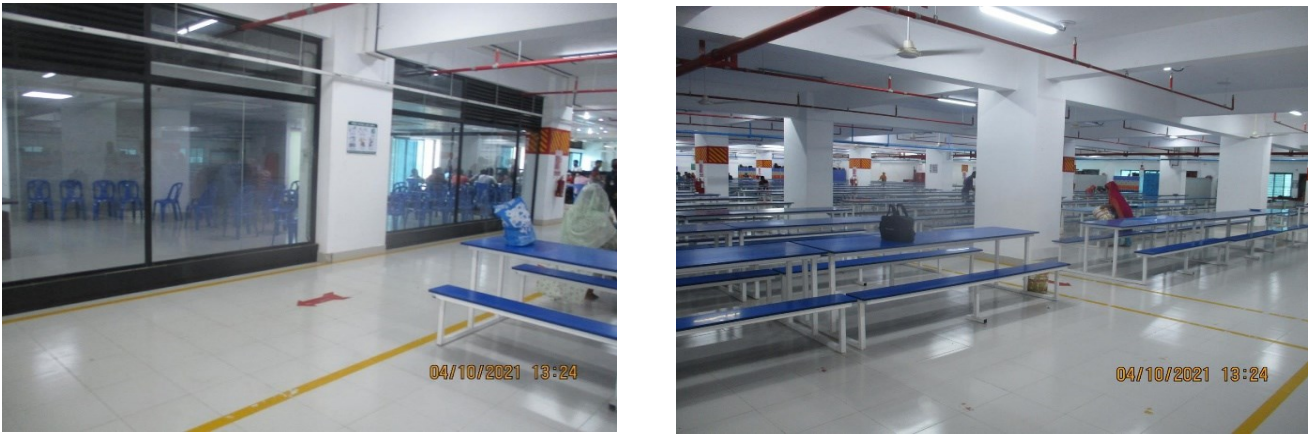
| 10 | Egress | Exit capacity (1476) is not adequate for the occupant load (1000) on the 1st floor in dining area. | Reduce occupant load / sitting arrangement to not more than available exit capacity (1000) on the 1st floor in training and dining area. | Within 7 days |

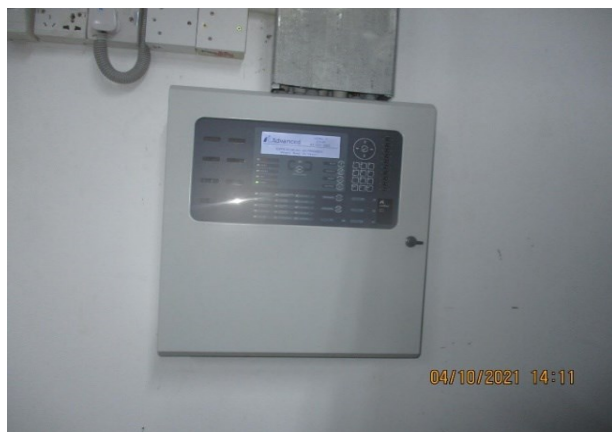
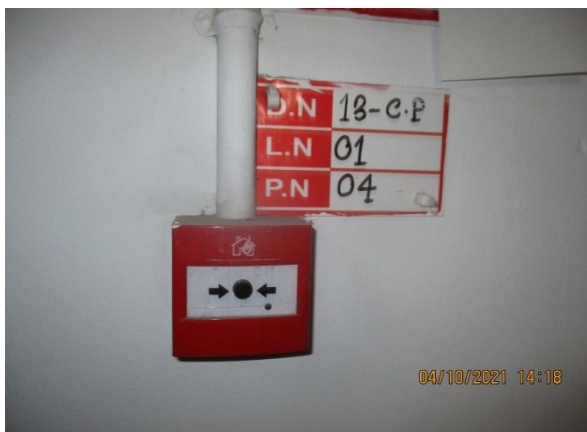
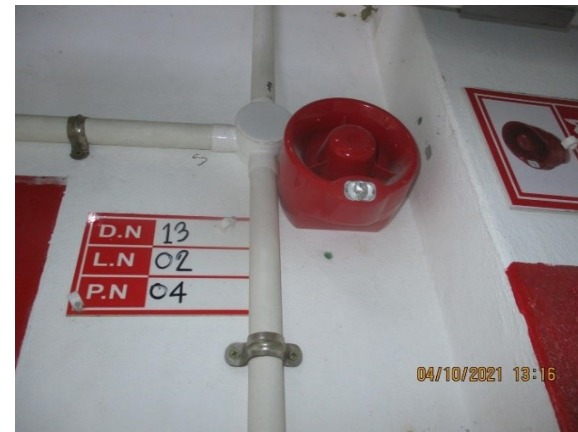
| 11 | Fire Detection & Alarm System | <p>An addressable <b>Advanced (MxPro)</b> brand fire alarm system has installed in the factory building premises. Fire detection system installation requires to detailed review to confirm compliance with NFPA 72 and Accord standard for all buildings in the factory premises.</p> | <p>Submit as-built drawings, testing records, equipment certification and other relevant documentation to the RSC for review and approval.</p> | <p>Design submission (Within 2 months),<br/>Modification within 4 months (if required)</p> |

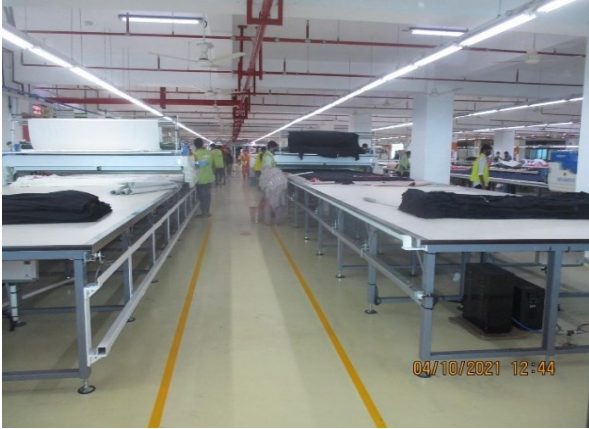
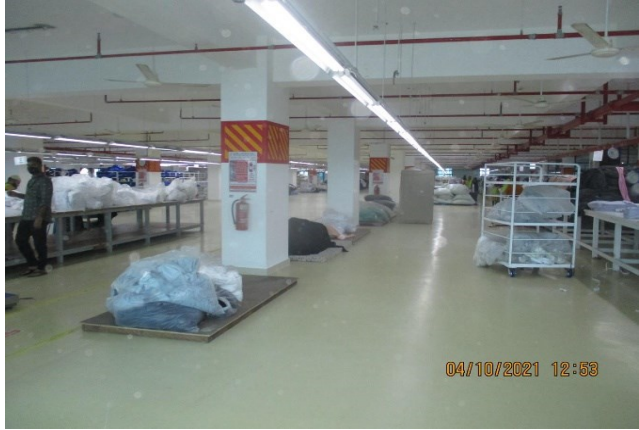
| 15 | Egress lighting | Directional signs are not provided where direction of the path of travel to an exit has changed. | Illuminated directional signs shall be provided where there is a change in the direction for the path of travel and the direction to an exit is not obvious. | Within 1 month |

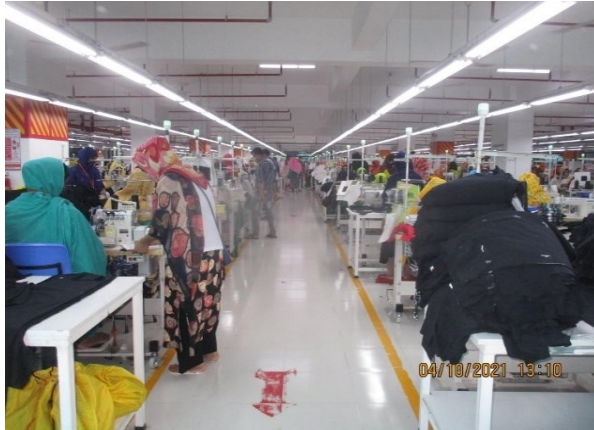
| 16 | Emergency Lighting | Based on the number and location of emergency lights observed, adequate illumination levels are not anticipated along egress routes. | Test the emergency lighting system on each floor and provide additional emergency fixtures to provide adequate illumination along the means of egress. Provide a minimum illumination of 10 lux at the floor level within exit stairs and exit discharge paths and minimum 2.5 lux along exit access aisles. | Within 3 months |
