# AKR Fashions Ltd. (New)

Tetuljhora, Jorpul Bus Stand, Rajfulbaria, Savar, Dhaka-1347.  
(23.80162, 90.26108)

5 December 2022

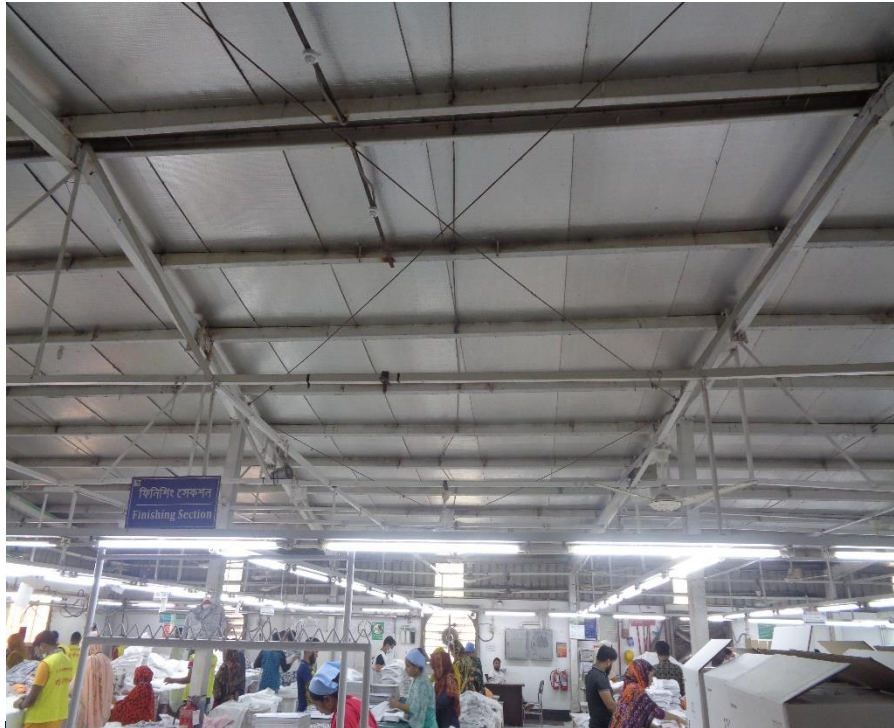
Roof bracing provided only

Roof bracing provided at some location, but no wall bracing provided. In addition, load transfer media/compression strut is not provided from frame to frame to transfer the lateral load therefore lateral stability system of the shed is apparently incomplete. Building engineer is required to check the lateral stability of the structure.

| Item No. | Observation | Recommended Action Plan | Recommended Timeline |
|---|---|---|---|
| 01 | Apparently incomplete lateral stability system (Production Shed) | Building engineer is required to check the lateral stability of the structure. | 6-weeks |
| 02 | Apparently incomplete lateral stability system (Production Shed) | Implement remediation work if required. | 6-months |

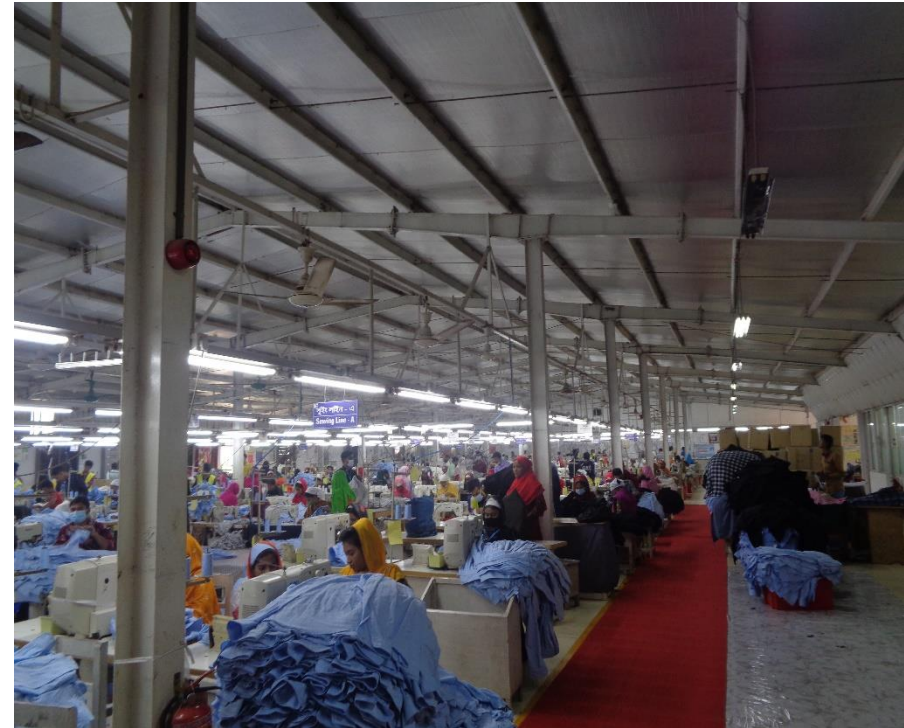
No load transfer media provided

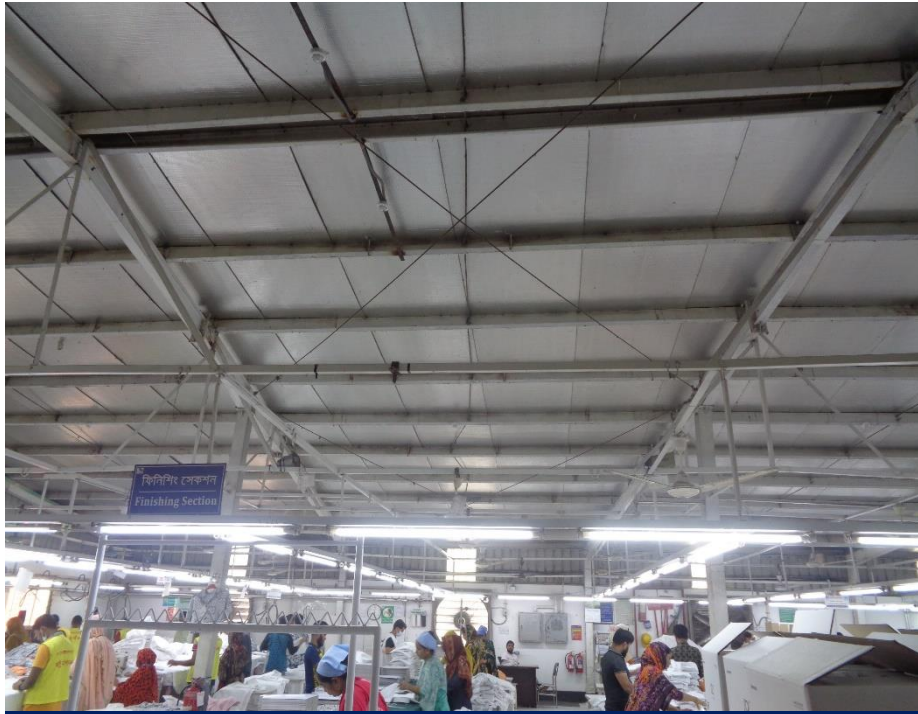
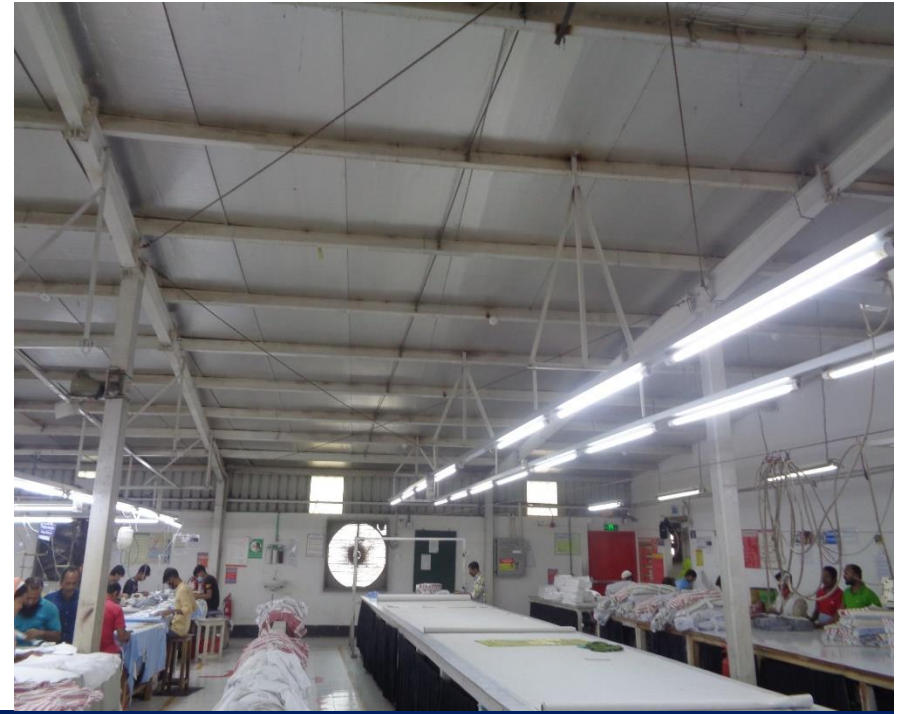
Loose roof bracing

Roof bracings were observed as loose at some locations. Factory is required to tighten all loose bracings.

| Item No. | Observation | Recommended Action Plan | Recommended Timeline |
|---|---|---|---|
| 03 | Loose roof bracing (Production Shed) | Building engineer is required to tighten all loose bracings. | 6-weeks |

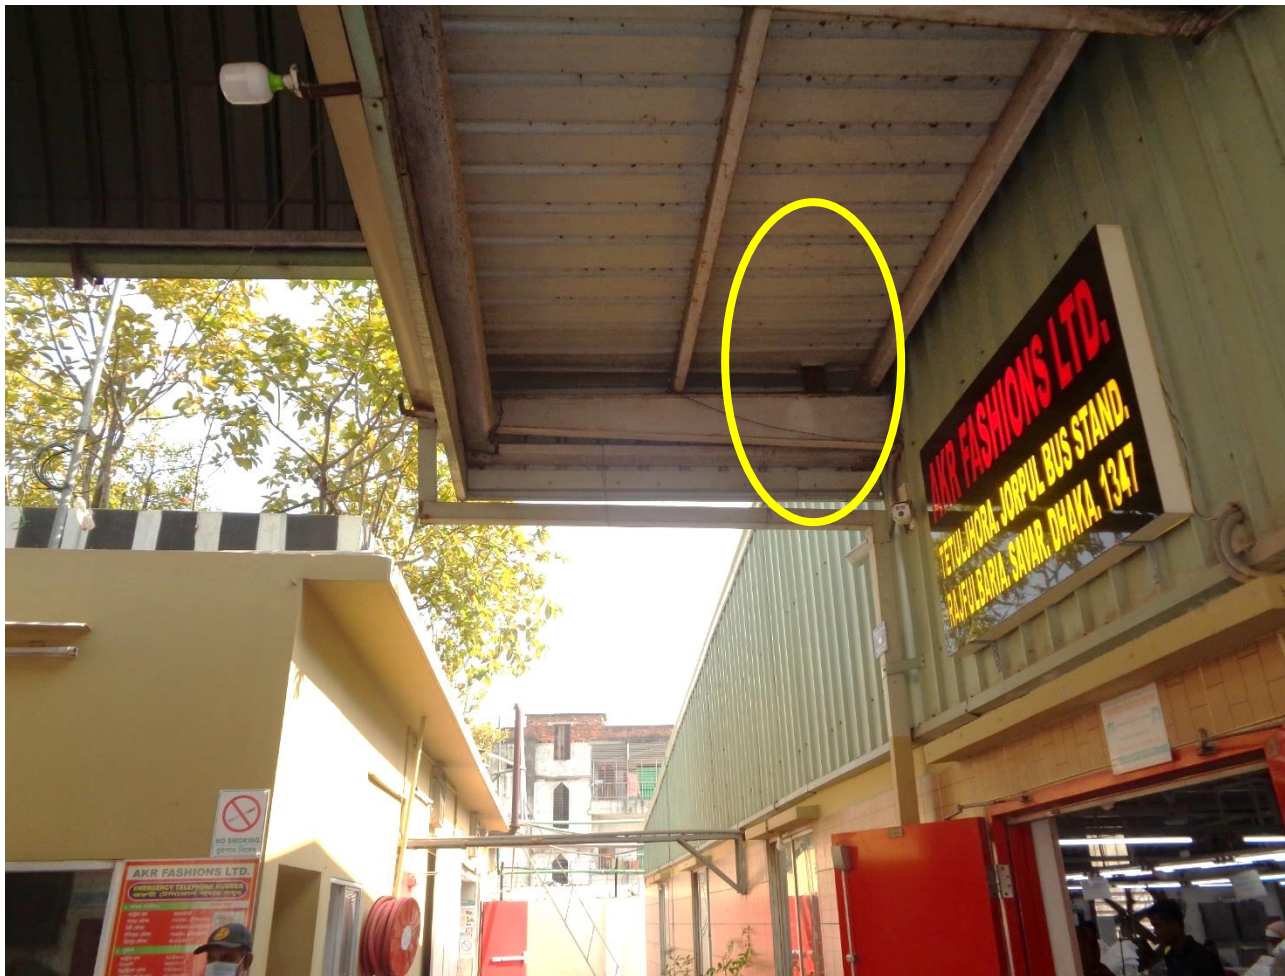
Additional vertical load on rafter of canopy coming from parking area (South-east corner)

Additional vertical load coming from parking area (South-east corner). Building engineer is required to review the adequacy of the rafter for additional vertical load coming from parking area

| Item No. | Observation | Recommended Action Plan | Recommended Timeline |
|---|---|---|---|
| 04 | Additional vertical load coming from parking area (Production Shed) | Building engineer is required to review the adequacy of the rafter for additional vertical load coming from parking area. | 6-weeks |
| 05 | Additional vertical load coming from parking area (Production Shed) | Implement remediation work where required. | 6-months |

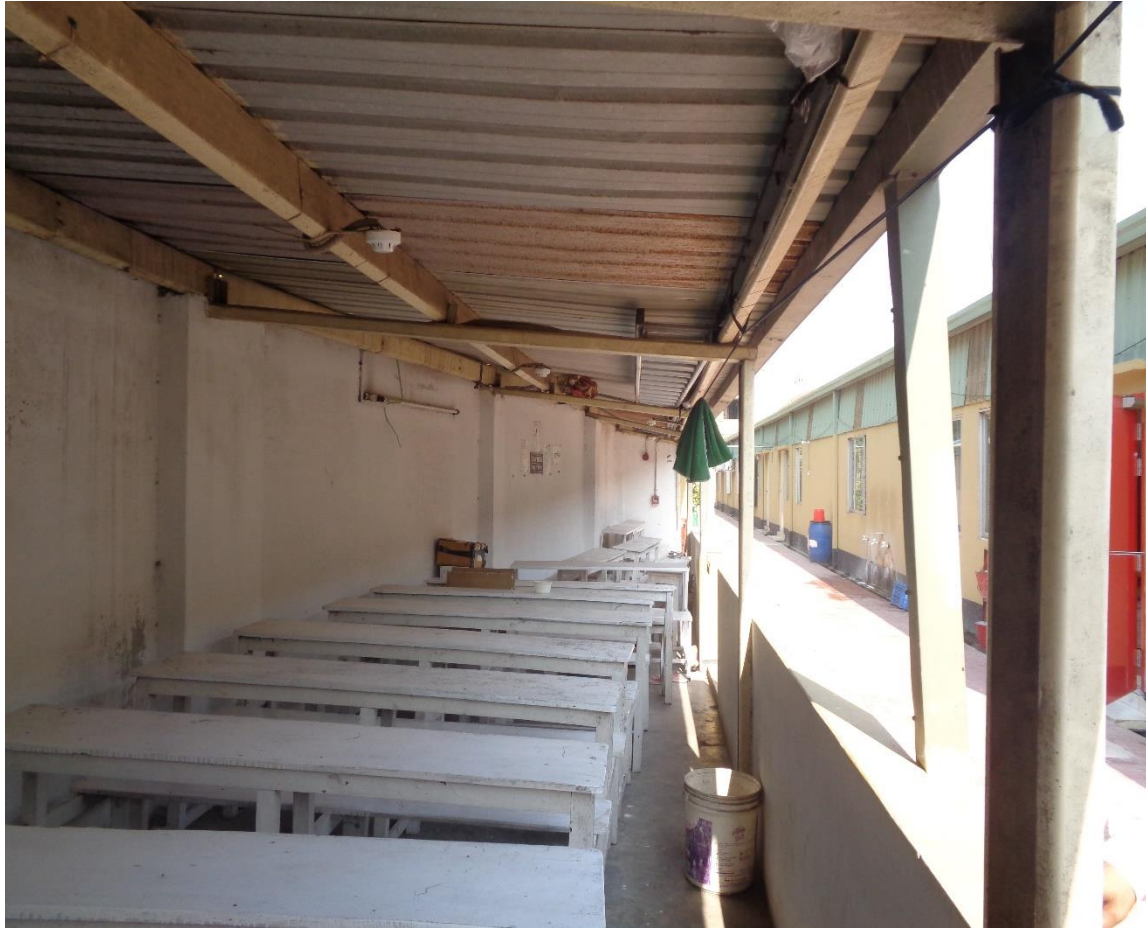
Dining Shed was appeared to be non engineered due to lack of apparent load path, poor connection and apparently inadequate member size. Building engineer is required to check the connection adequacy for uplift forces as part of EA otherwise replace the structure with a well-designed structure.

| Item No. | Observation | Recommended Action Plan | Recommended Timeline |
|---|---|---|---|
| 06 | Apparently non engineered shed (Dining Shed) | Building engineer is required to check the connection adequacy for uplift forces as part of EA otherwise replace the structure with a well-designed structure. | 6-weeks |
| 07 | Apparently non engineered shed (Dining Shed) | Implement remediation work where required. | 6-months |

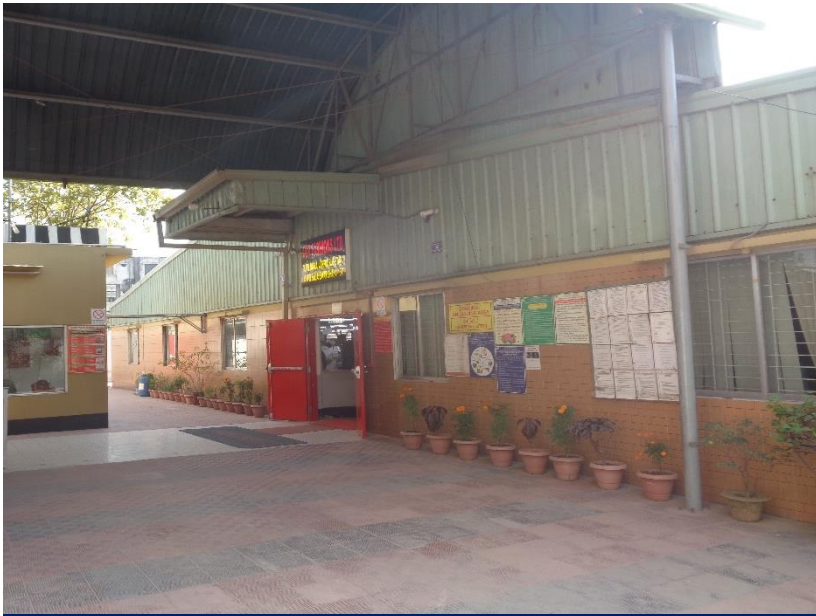
Production Shed

At the time of inspection, no approval drawing from local authority was available. Factory is required to seek approval from the local authority for all the structures within the factory premises.

| Item No. | Observation | Recommended Action Plan | Recommended Timeline |
|---|---|---|---|
| 08 | Missing approval drawing from local authority (All structures) | Building engineer is required to seek approval from the local authority for all the structures within the factory premises. | 6-months |
