Absolute Qualitywear Ltd.

Tek Kathora, Salna Bazar, Salna, Gazipur Sadar, Gazipur-1702.

18 December 2022

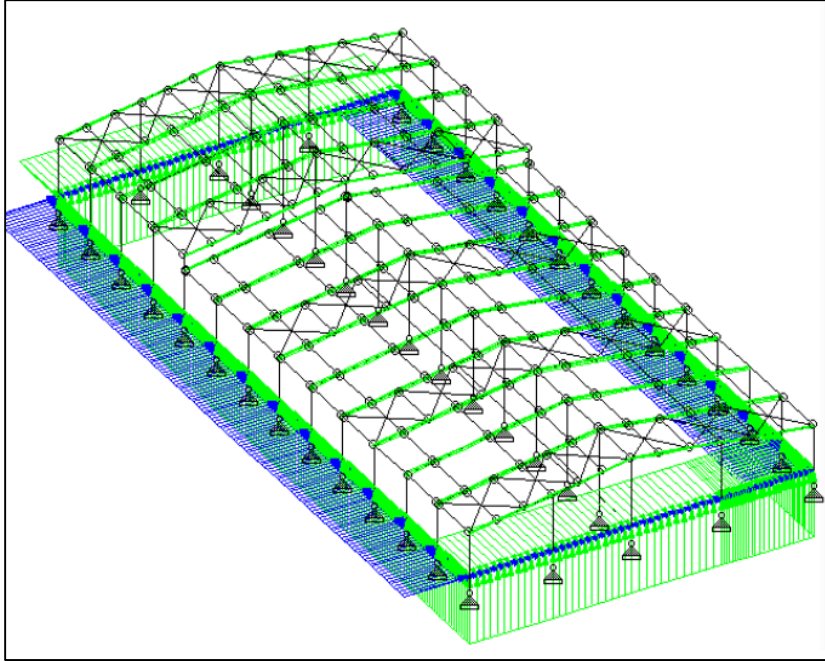
Discrepancy in lateral stability system between design report and on-site condition

In design report, continuous compression member was considered at ridge.

The building engineer is required to carry out Engineering Assessment (EA) to check the lateral stability system of the steel shed along the long direction.

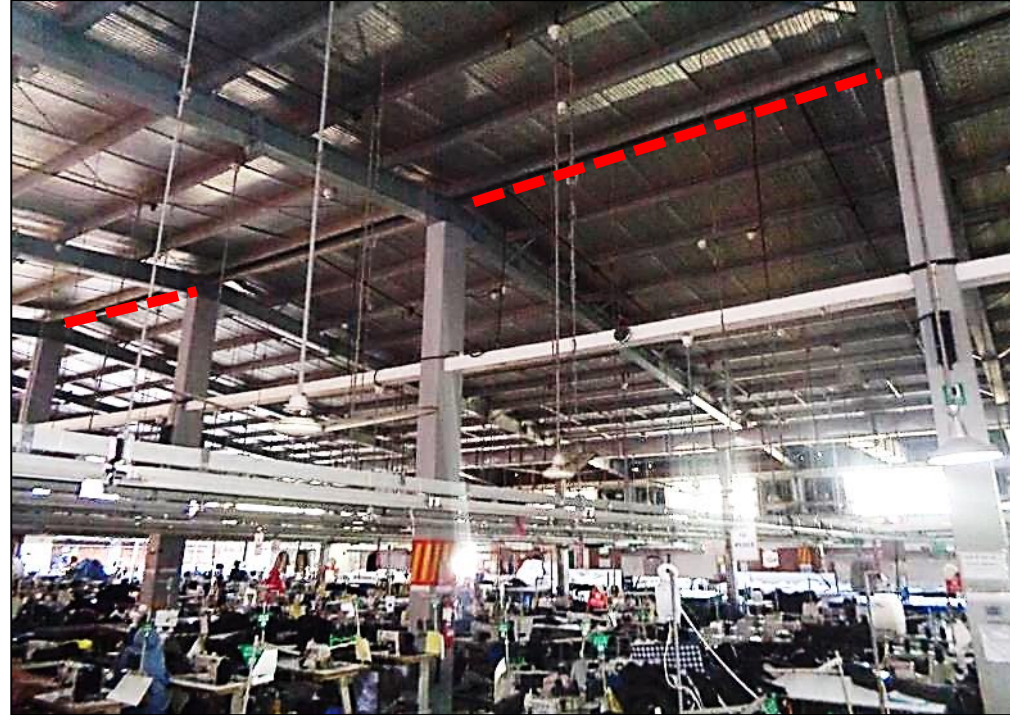
Absence of continuous compression member at ridge

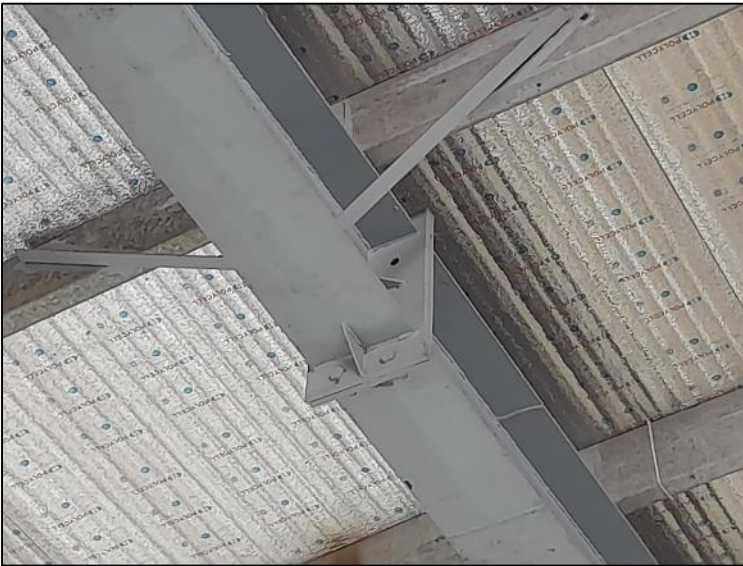
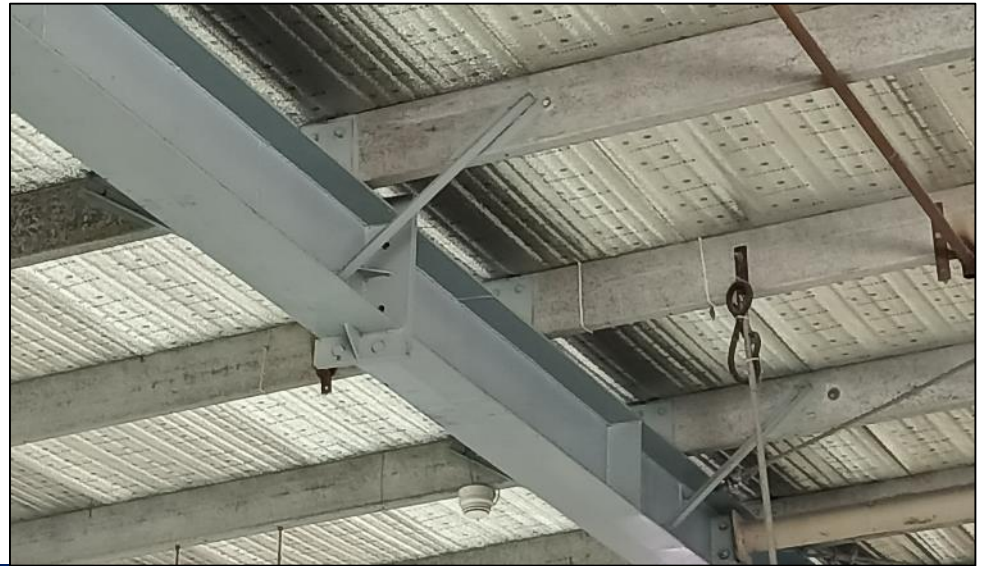
Bolt missing at several locations

Bolt missing and significant connection gap was observed at several locations.

Factory engineered is required to

- Install the missing bolt,
- Take proper measure to fill up connection gap.

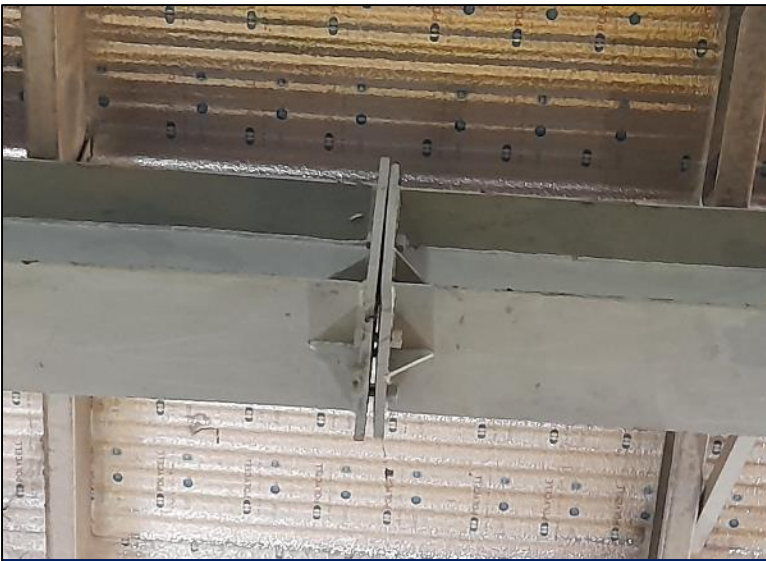
Significant connection gap

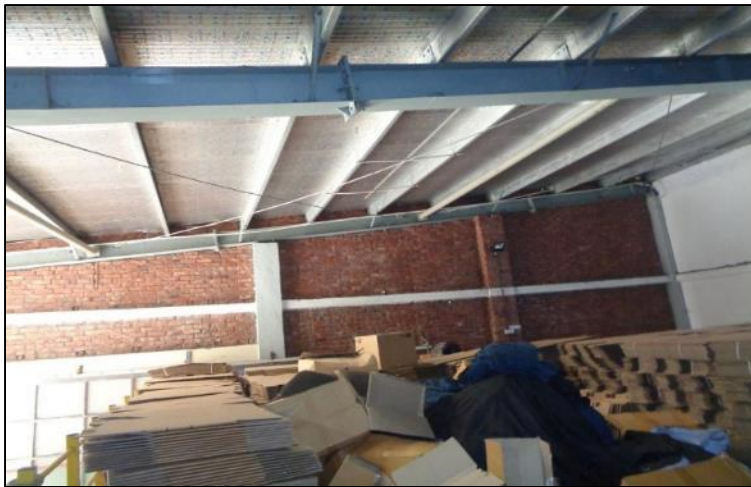
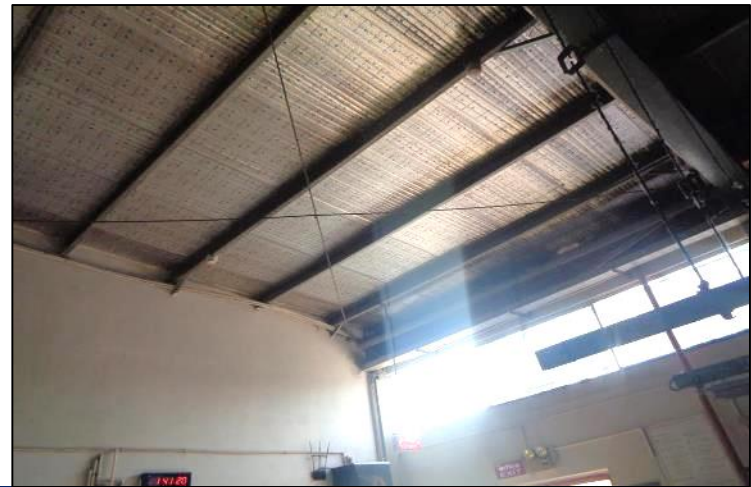
Loose cable bracing at several location

Loose cable bracing & inactive cable bracing were observed at several locations. The factory is required to tighten the loose bracing & free the load path of the inactive bracing properly.

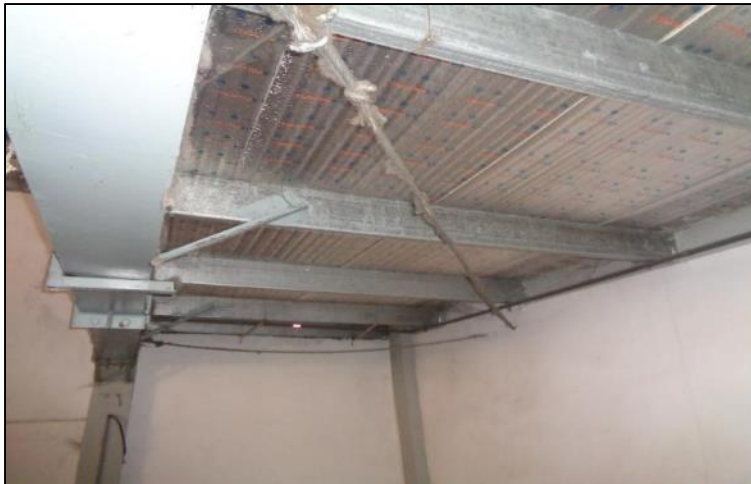
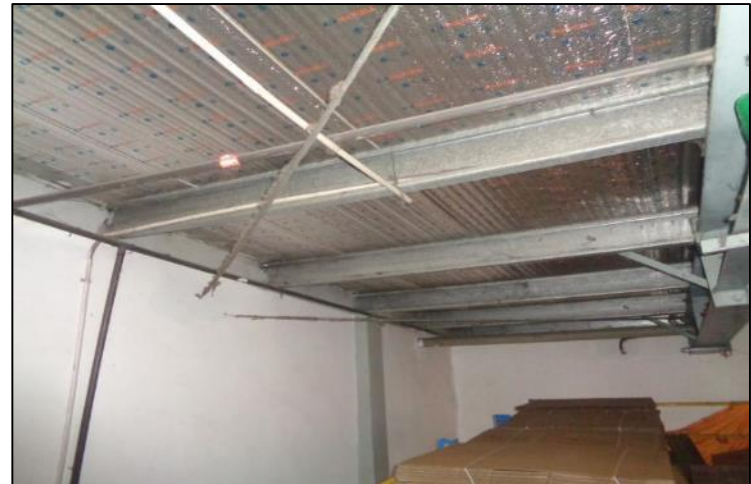
Inactive cable bracing (inserted in partition brick wall)

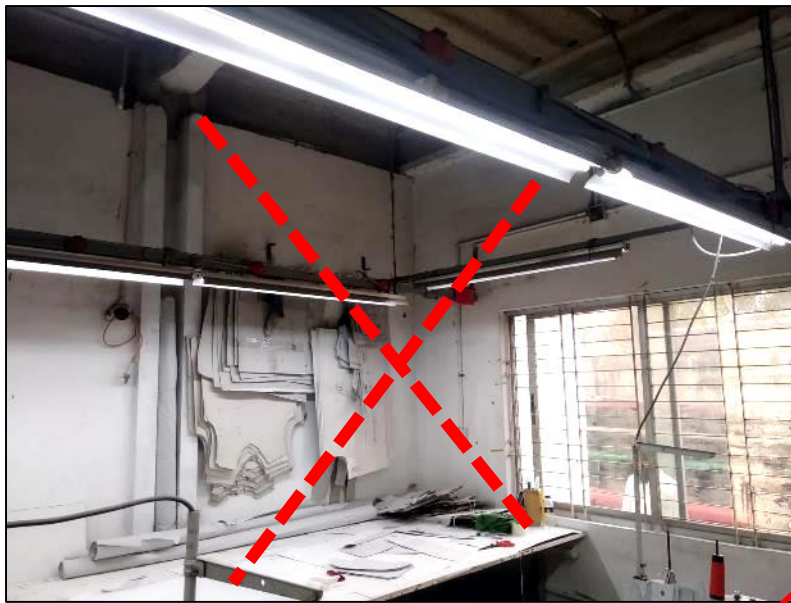
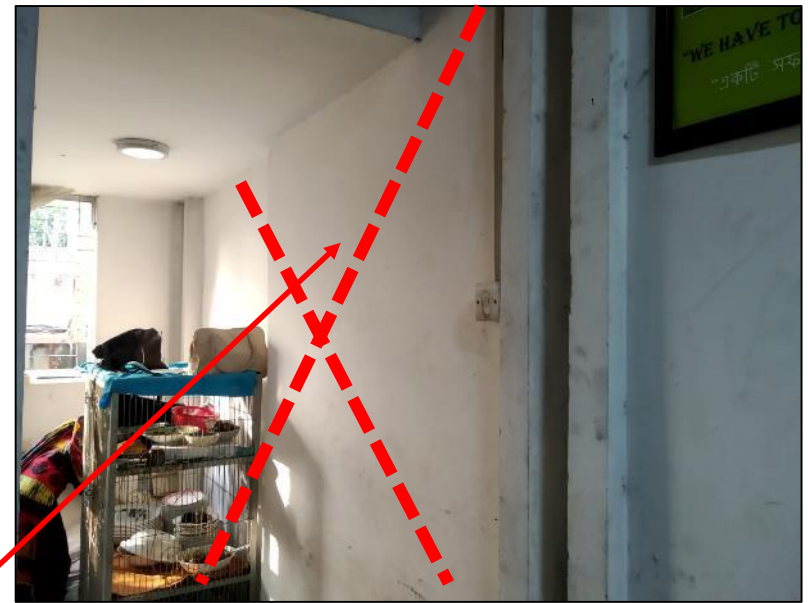
Vertical bracing found missing

Bracing was found missing at grid-E as per factory provided drawing. Factory is required to carry out the Engineering Assessment (EA) to check the lateral stability system against the lateral load.

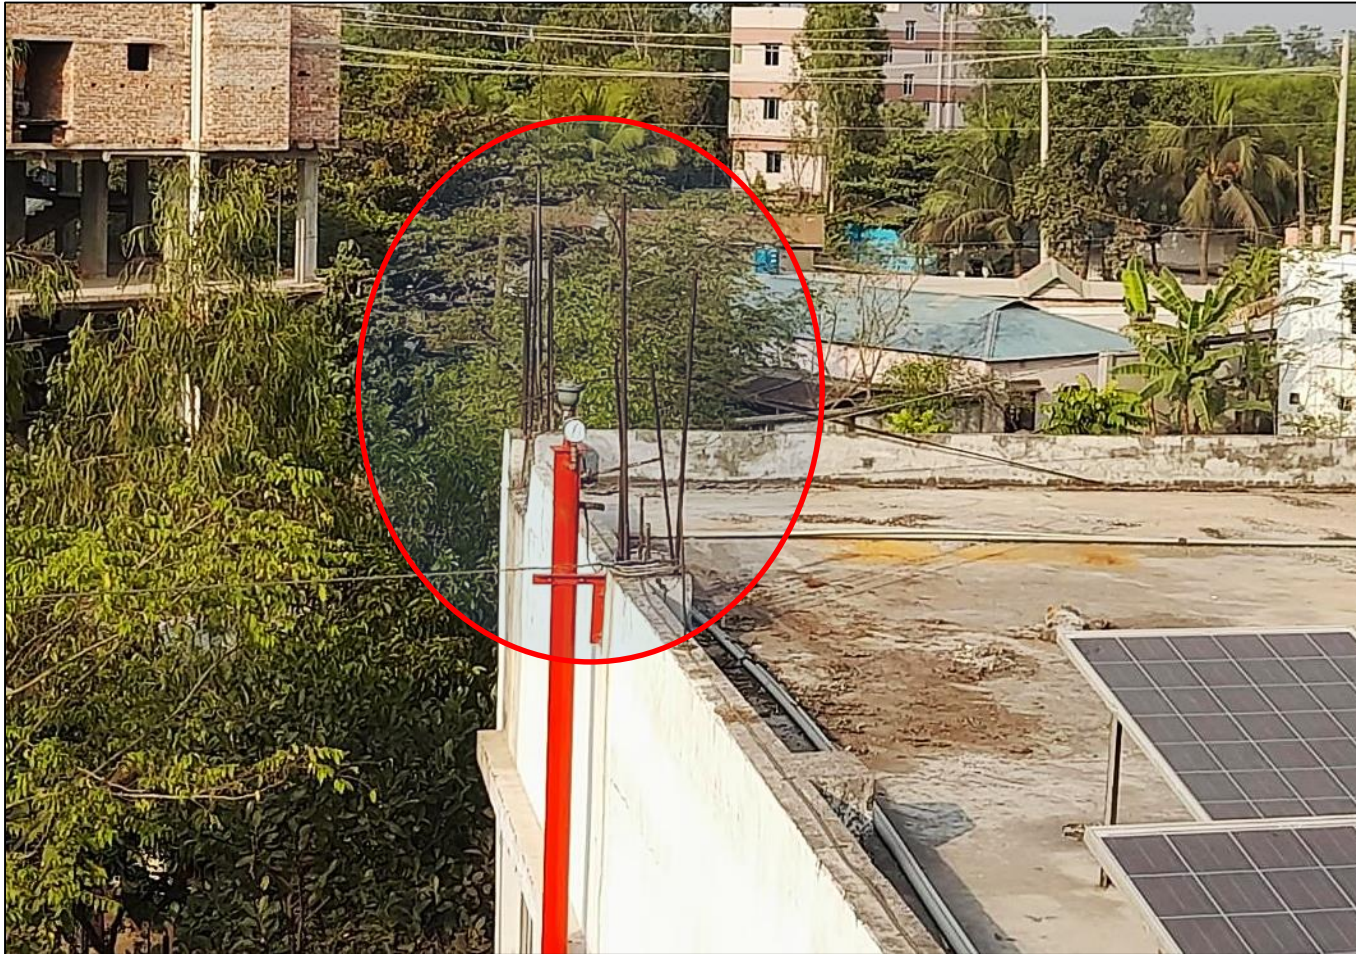
Corrosion at the exposed rebar of roof

Exposed rebar was observed at the roof of the utility building.

Factory is required to provide protective coating on the exposed rebar to protect from corrosion.
