Textown Ltd (Extension building)

Dewan Idris Road, Bara Rangamatia, Ashulia, Dhaka.
(23.911180, 90.301861)

23rd Sept 2020

Observations

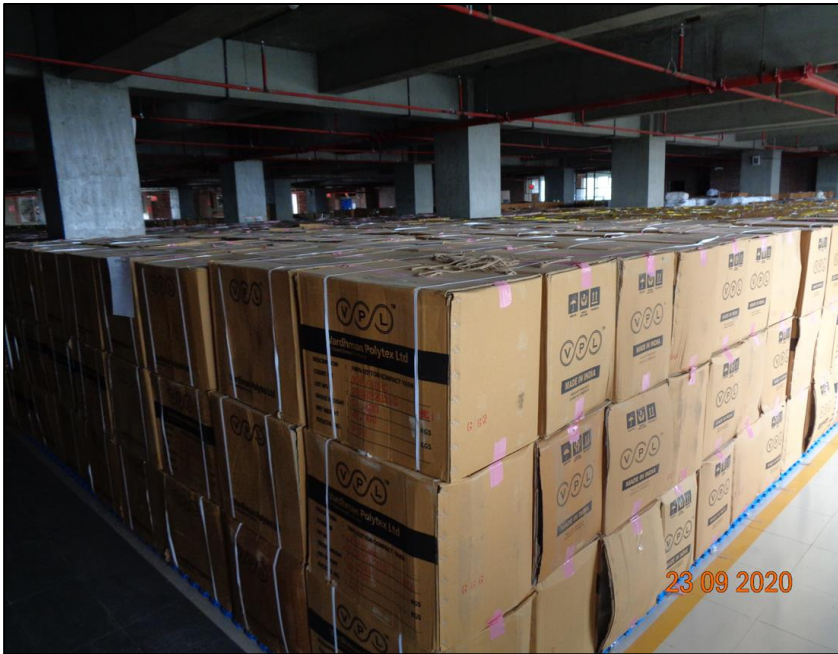
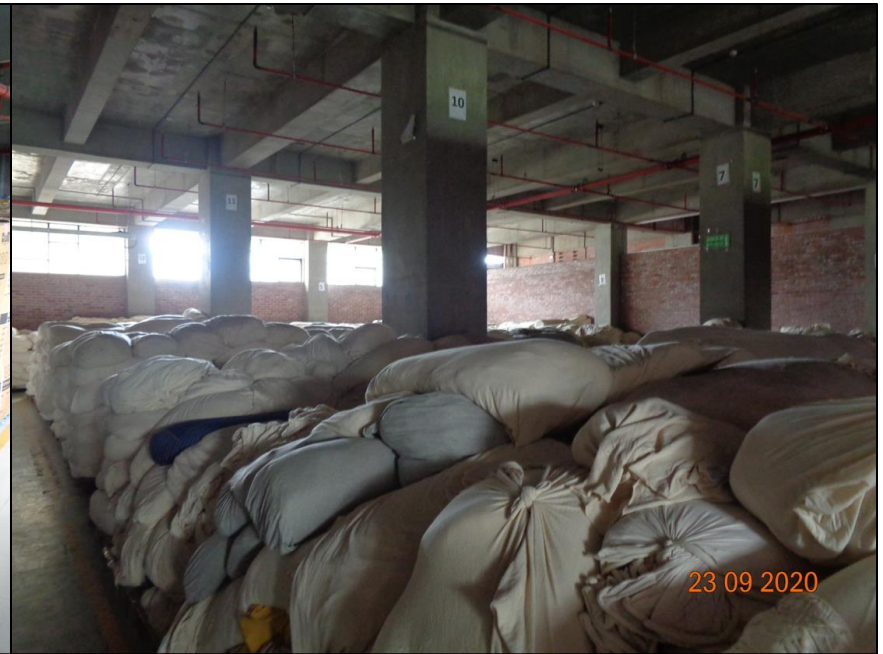
Floor loading

Variation of floor loading was found in the provided load plan for different floor levels, but the size & reinforcement of both beam & slab has been provided almost the same for all the floors level which should be addressed in the design report.

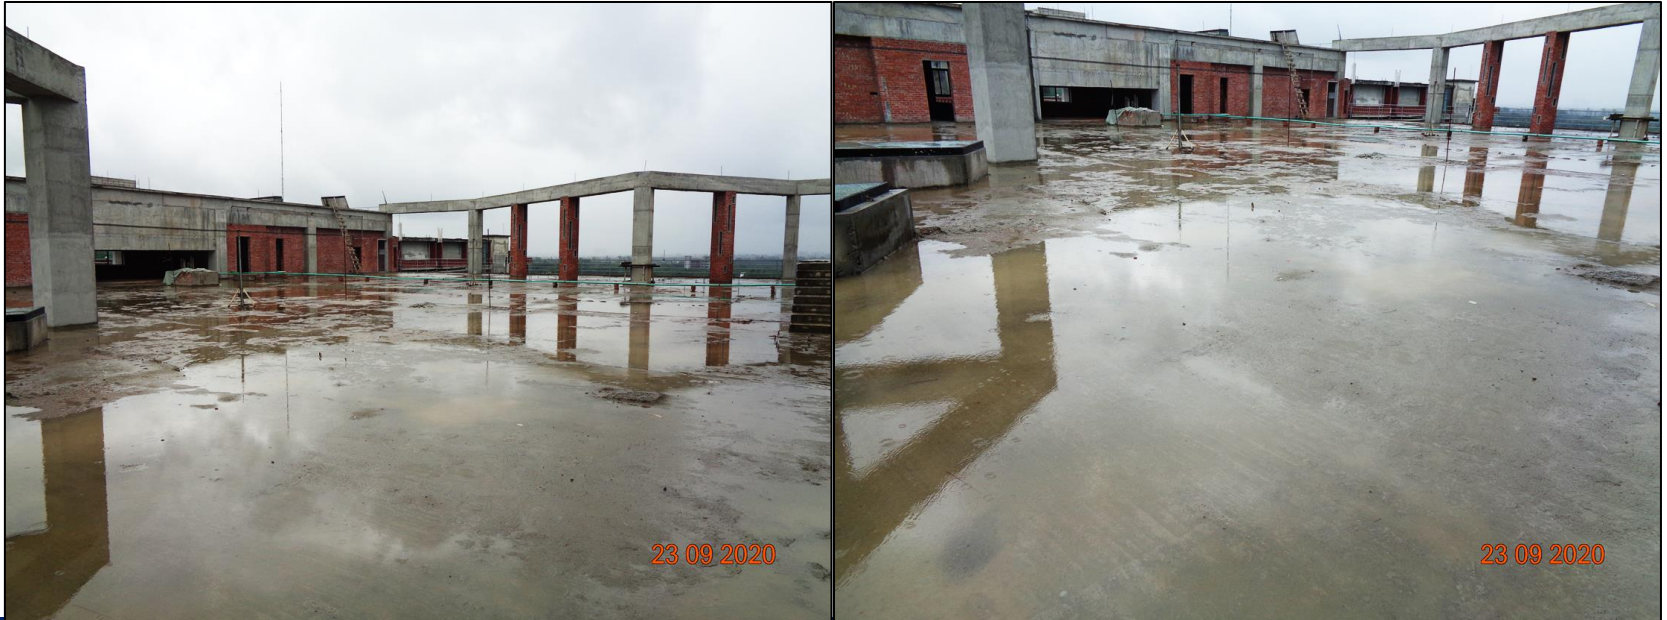
Lack of water proofing & water ponding

Water ponding and absence of water proofing layer.

Water ponding was found at roof due to lack of water proofing with proper slope. The factory engineer to apply proper water proofing layer with proper slope on the top of roof slab to resist water ponding.

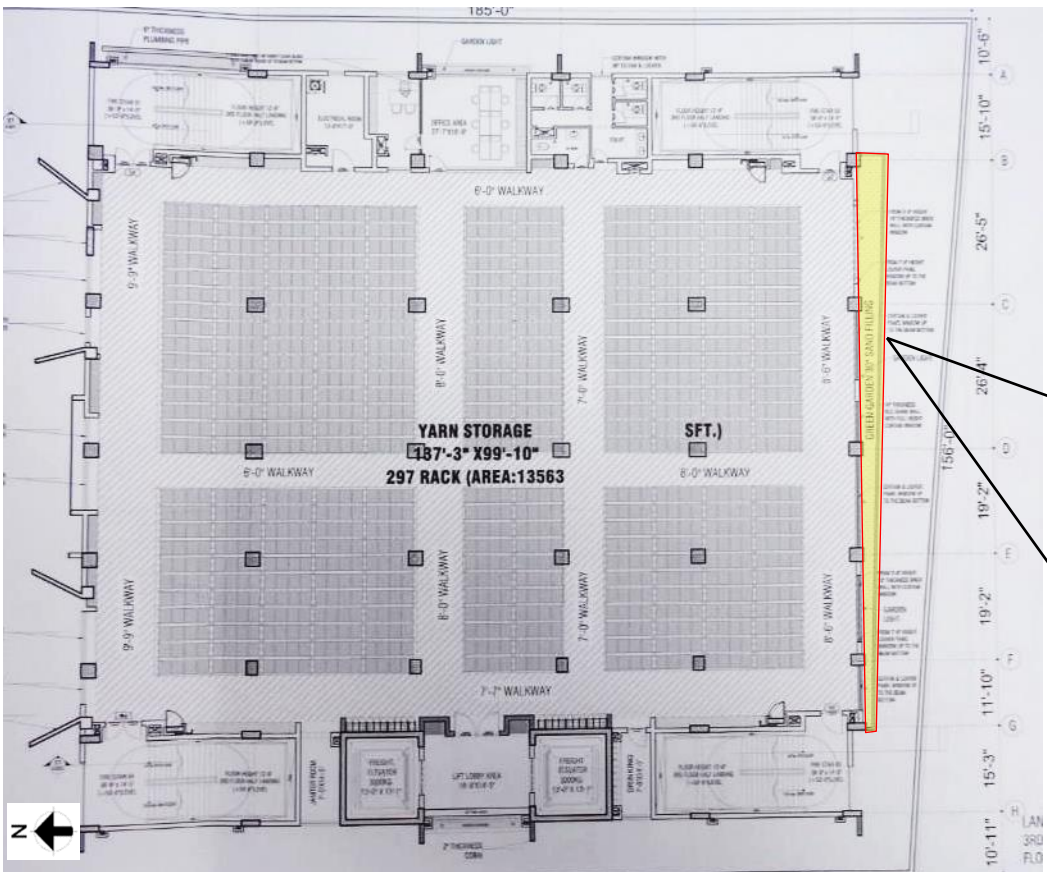
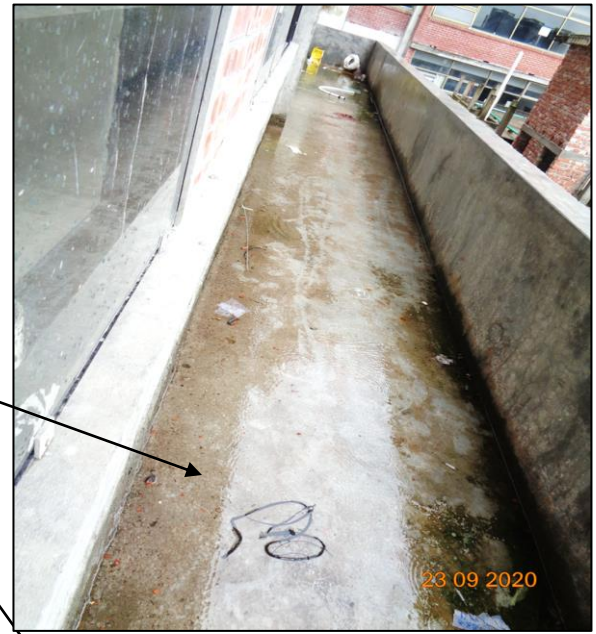
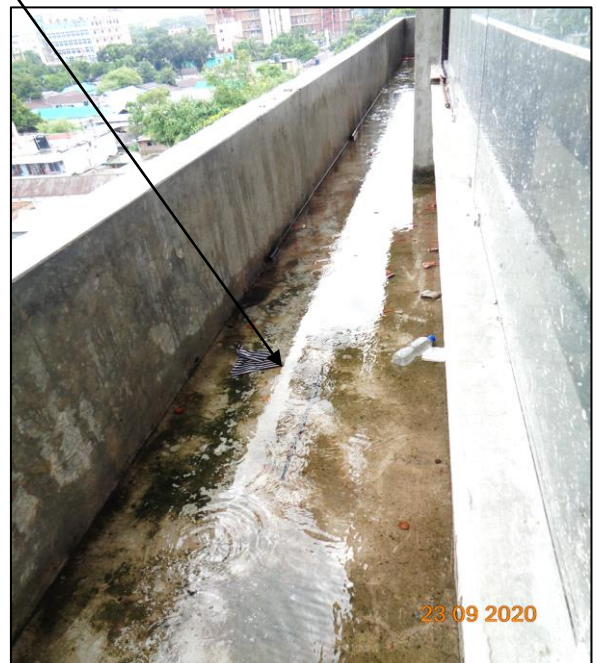
Water ponding at 3rd floor cantilever

Water ponding on cantilever of 3rd floor

Water ponding was found at 3rd floor cantilever portion due to lack of proper drainage system. The factory engineer to develop drainage system resist water ponding.

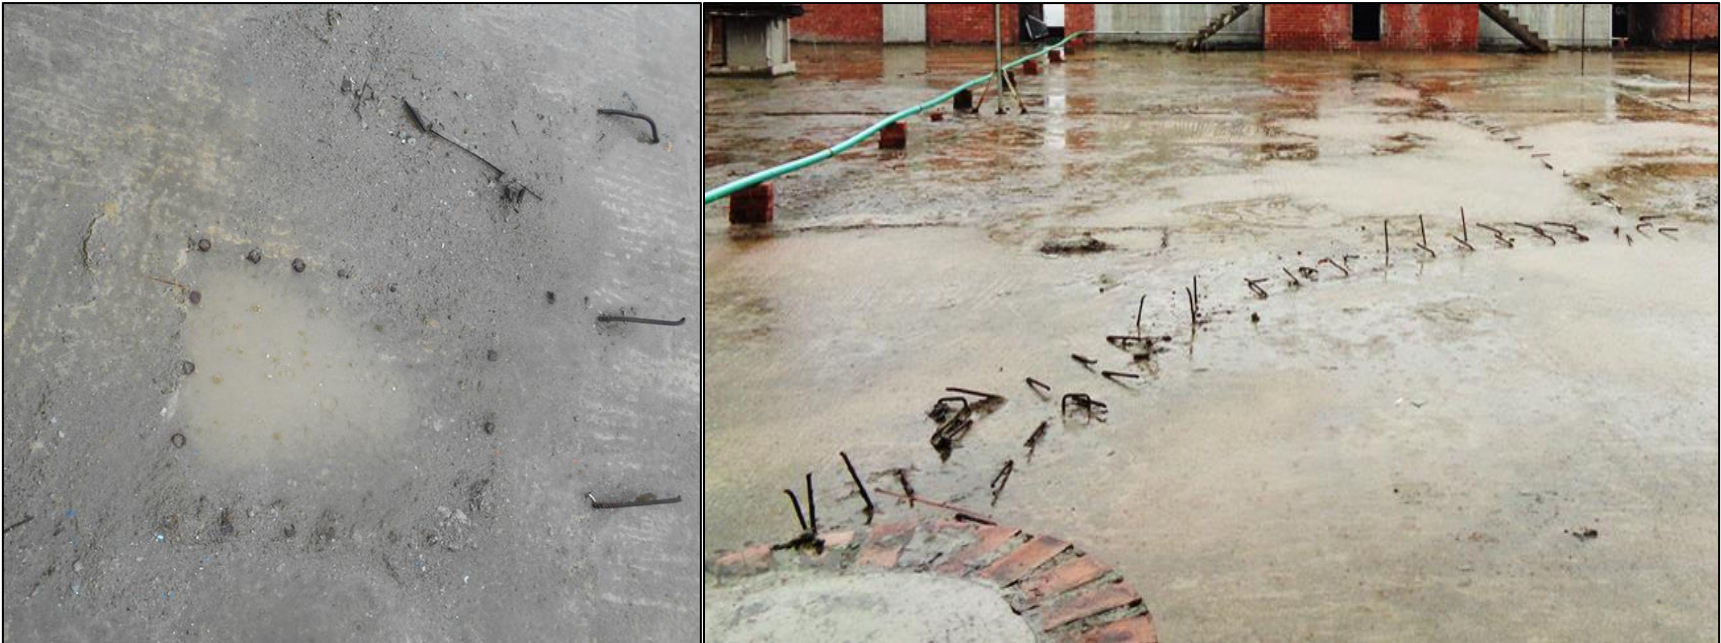
Exposed re-bar at roof

Exposed re-bar at roof.

Exposed re-bar was found at roof. The factory engineer is required to take necessary measures to prevent the corrosion in exposed re-bar.

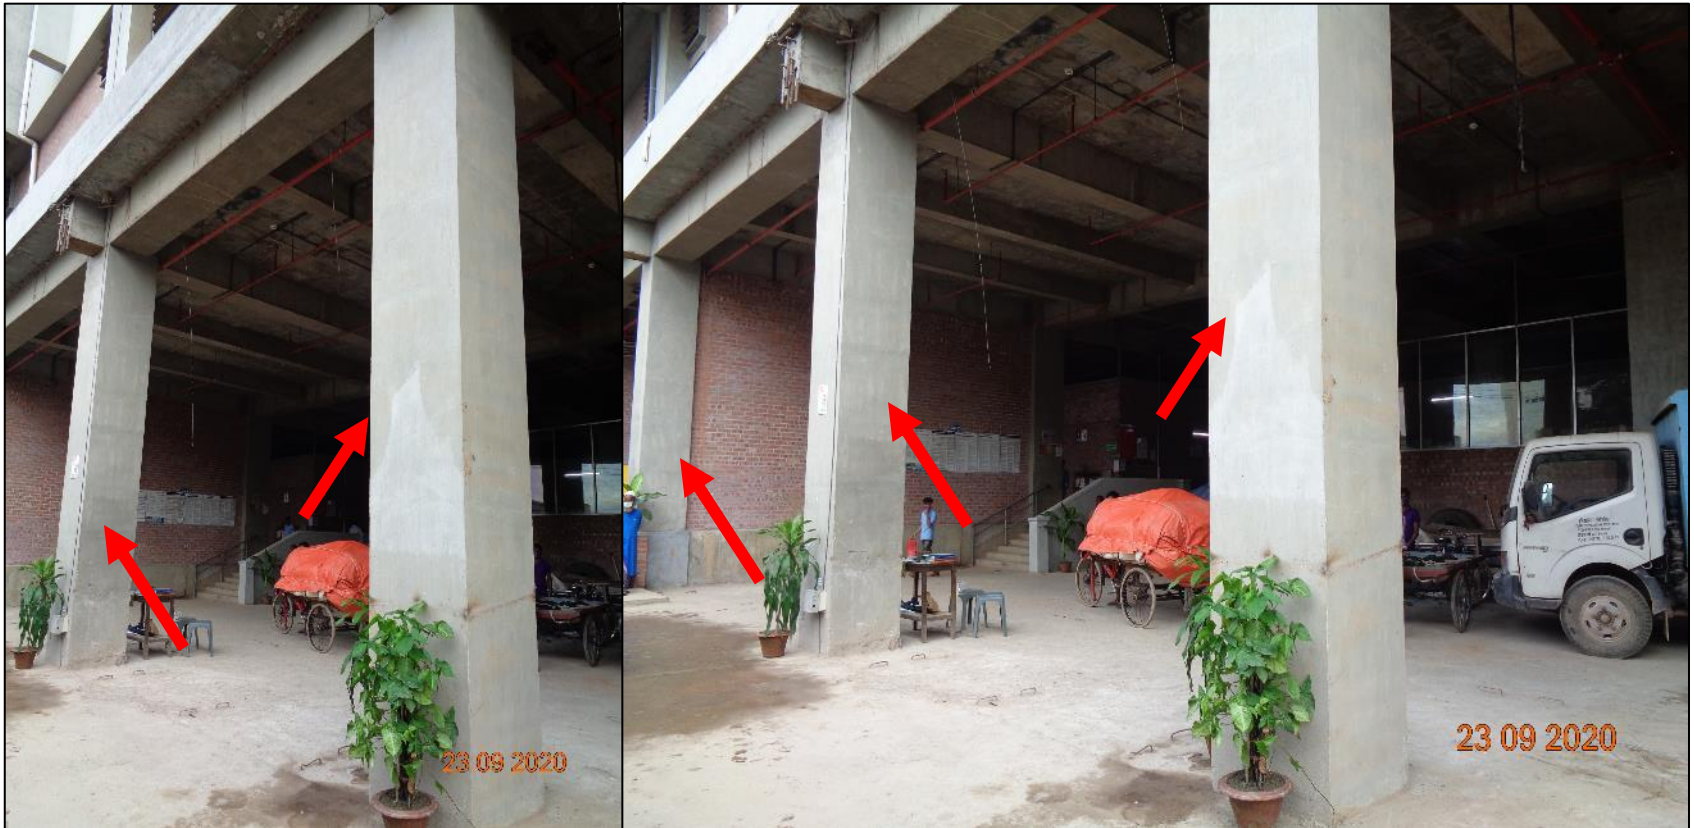
Column susceptible to vehicle impact

Susceptible to vehicle impact in column

Column was found adjacent of driveway of loading unloading platform. These column are susceptible to vehicle impact. The factory engineer is required to take necessary measures to prevent the vehicle impact by providing the barrier around the column
