# Cosmopolitan Industries PVT Ltd (Epic) New Shed

Khejurbagan, Baro Ashulia, Savar, Dhaka.

9th December 2020

# Building Information

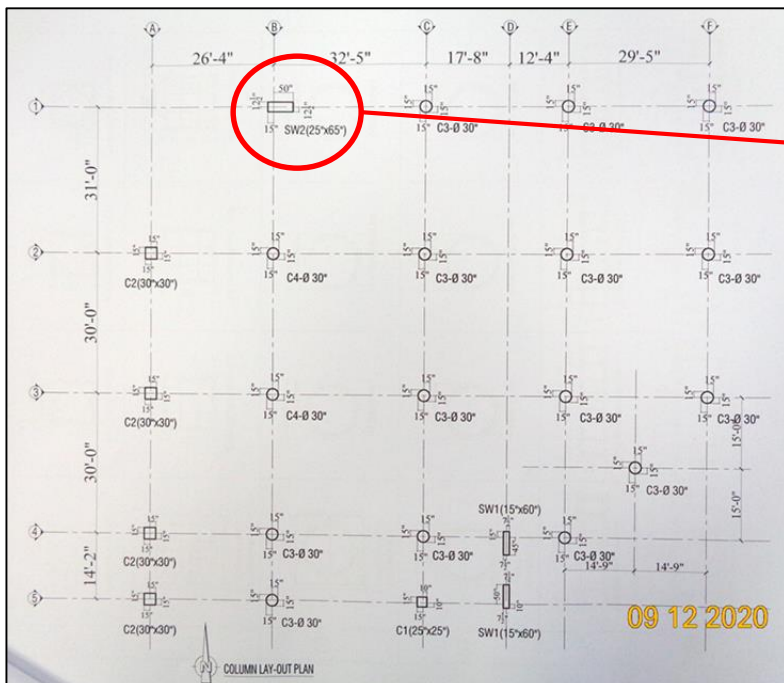
Column layout plan

Shear wall has been assigned at grid 1/B. The depth of the shear wall is 1625 mm and width is 625. So, the ratio of depth to width is 2.6. So, building engineer is required to provide the justification with proper reference for considering the member as shear wall instead of column.

As per BNBC every building or structure designed shall have its design documents prepared in accordance with the provision of Section 1.9.1. The design document shall include a design report, and a set of structural drawings, which shall be prepared in compliance with section 1.9.1.1 and section 1.9.1.2 as per BNBC. Factory engineer is required to revise the design documents and recheck the serviceability of the structure based on justification with proper reference.

| Item No. | Observation | Recommended Action Plan | Recommended Timeline |
|---|---|---|---|
| 1 | Design report needs to be revised | Factory engineer to revise the design report and prepare full set of drawings in compliance with section 1.9.1 as per BNBC | 6-weeks |

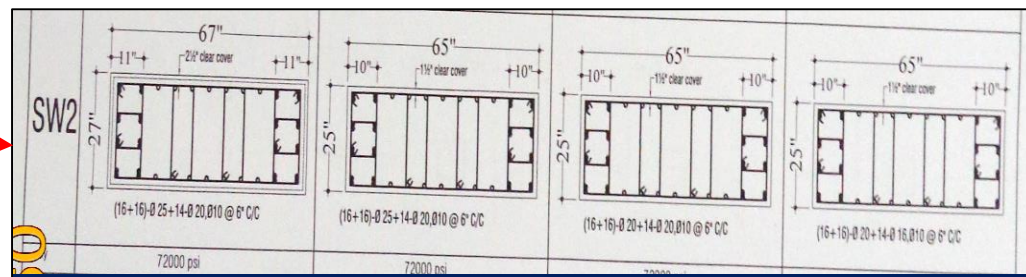
Column schedule – details of SW2

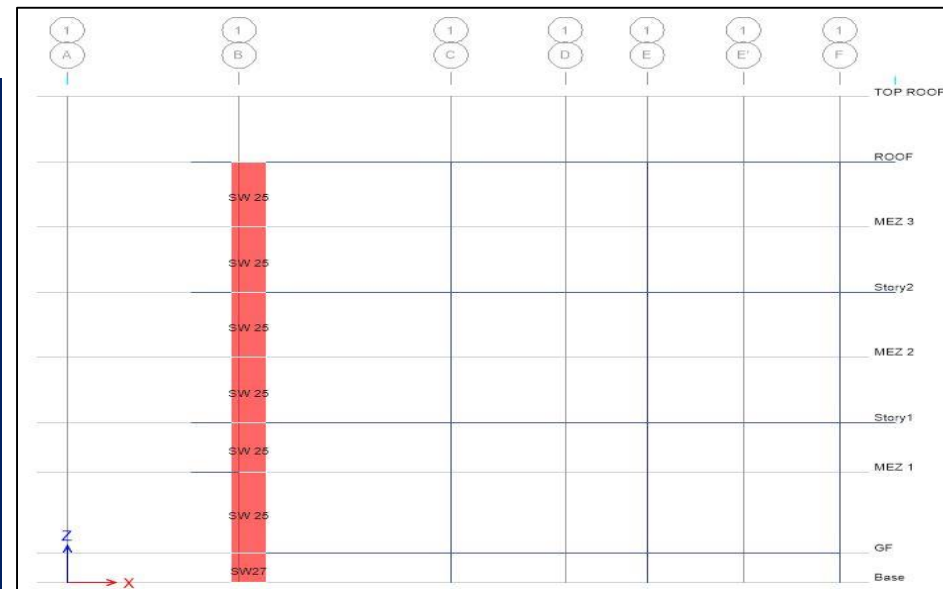
SW2 has been assigned as shear wall in FEA model

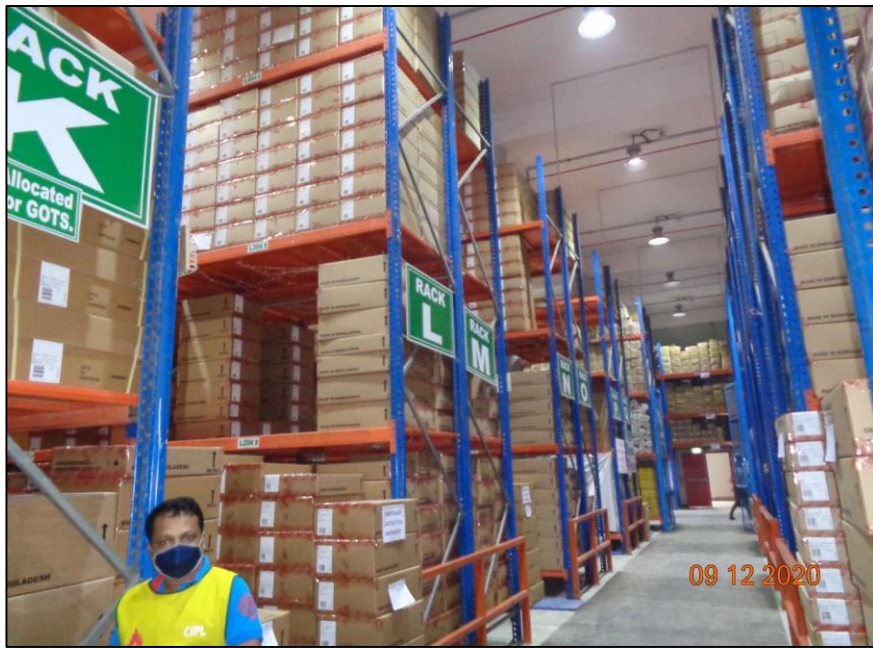
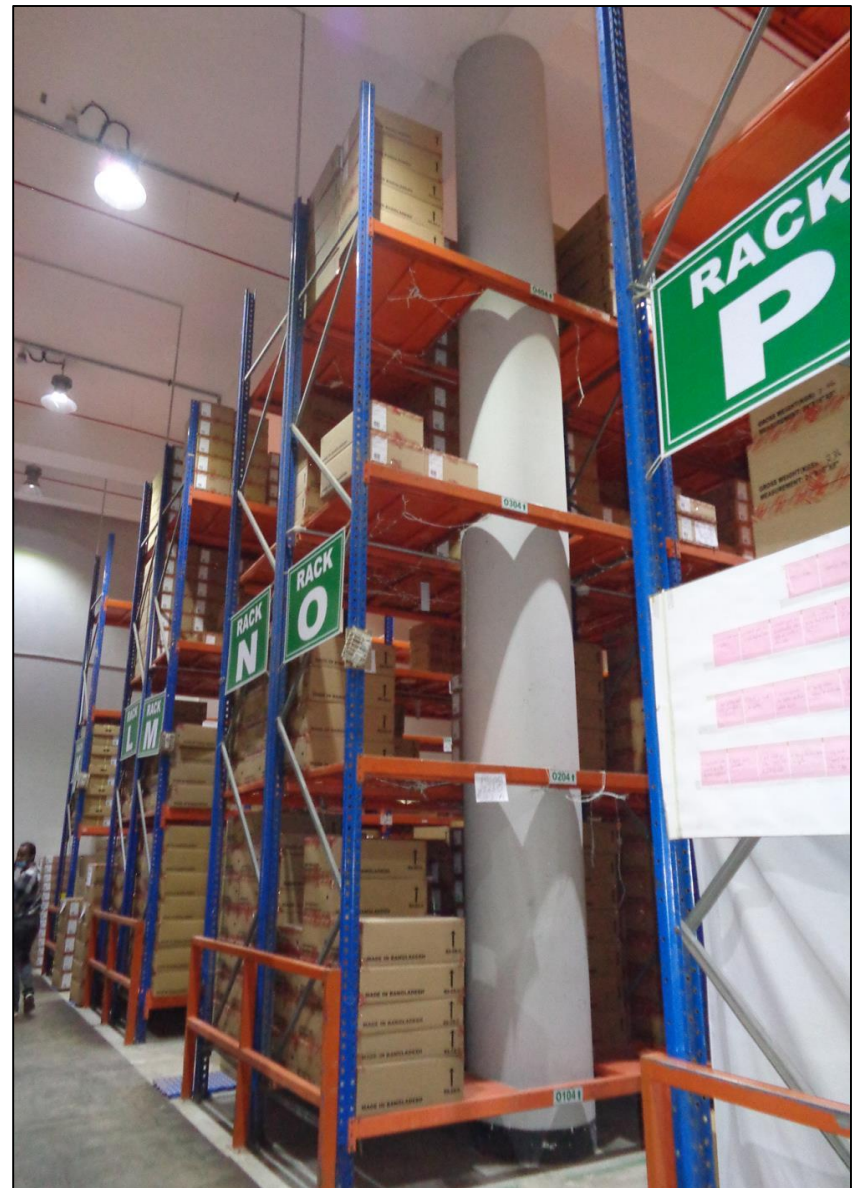
Storage was found resting on multi storied steel racks at both ground and first floor. The suspended floors are designed for 7 kPa and 12 kPa. But design specification or any adequacy check was not available to justify the capacity of the racks to carry the designed storage load. Factory engineer is required to carry out the adequacy check of the steel racks considering the heavy load resting on it.

Storage load resting on multi storied steel rack

| Item No. | Observation | Recommended Action Plan | Recommended Timeline |
|---|---|---|---|
| 2 | Design report needs to be revised | Factory engineer is required to carry out the adequacy check of the steel racks considering the heavy load resting on it. | 6-weeks |
| 3 | Design report needs to be revised | Verify and actively manage the prepared loading plan for all floor plates including the rack floors within the factory, considering floor, column and foundation capacity. | 6-weeks |

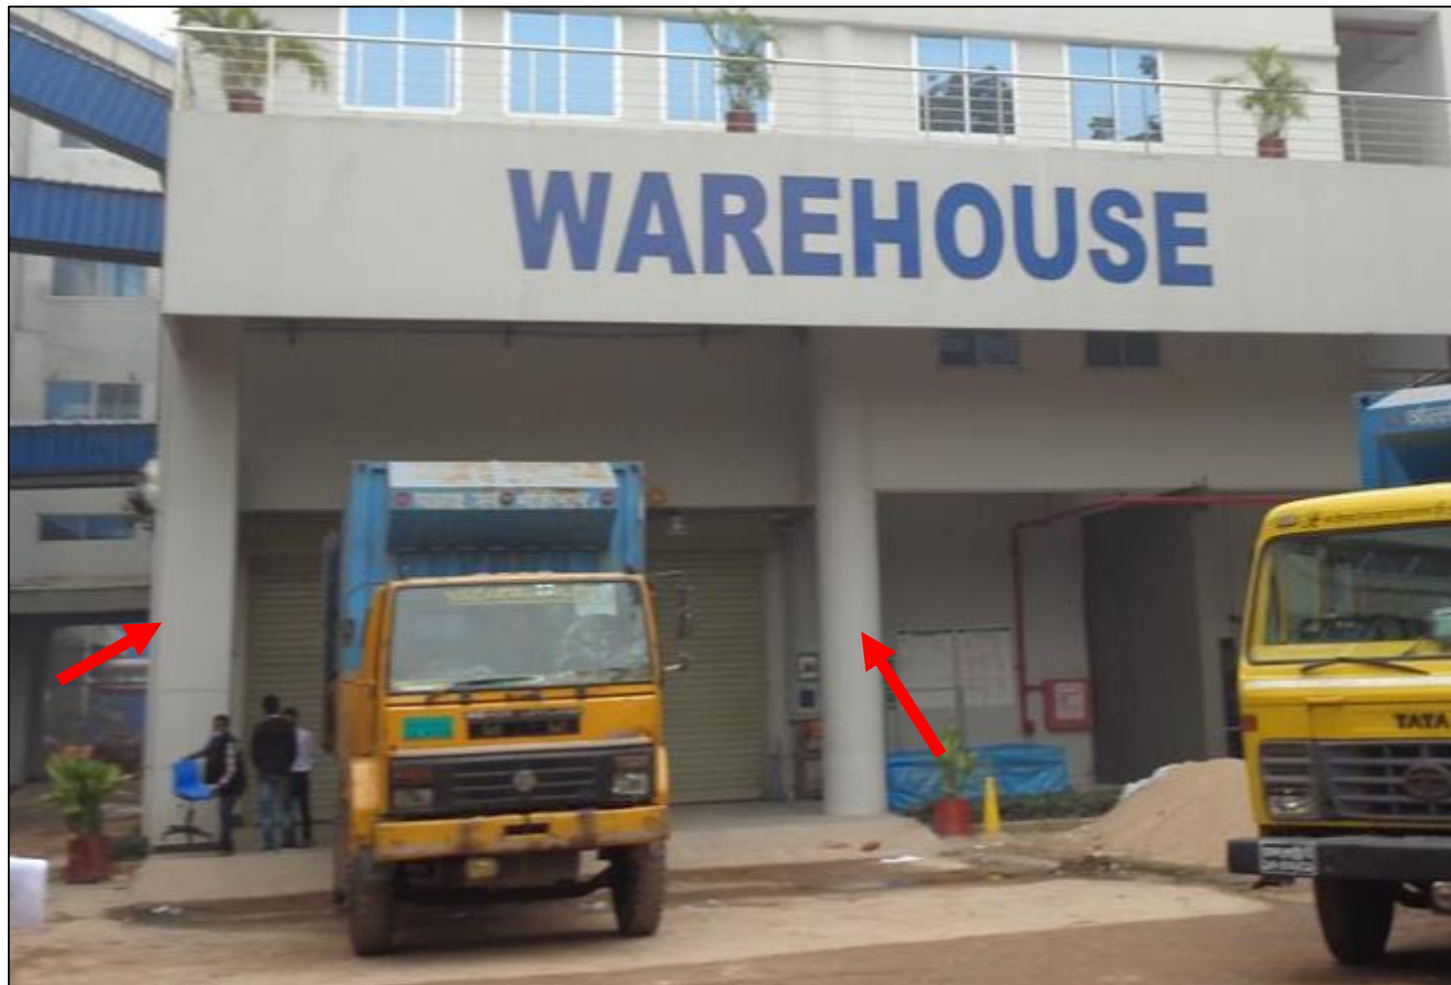
Column susceptible to vehicle impact

Columns were found adjacent of driveway of loading unloading platform. These column are susceptible to vehicle impact. The factory engineer is required to take necessary measures to prevent the vehicle impact by providing the barrier around the column

| Item No. | Observation | Recommended Action Plan | Recommended Timeline |
|---|---|---|---|
| 5 | Susceptive to vehicle impact in column | The factory is required to take necessary measures to prevent the vehicle impact by providing barrier around the column. | 6-months |

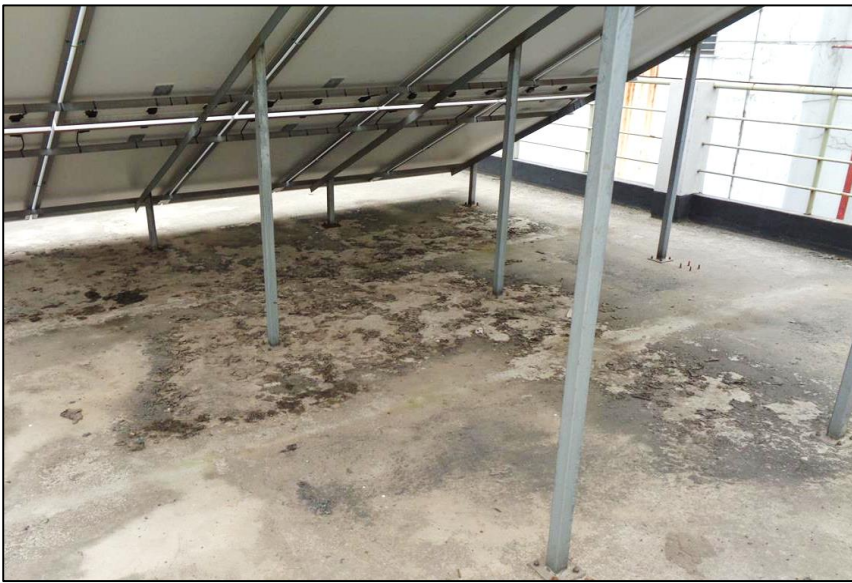
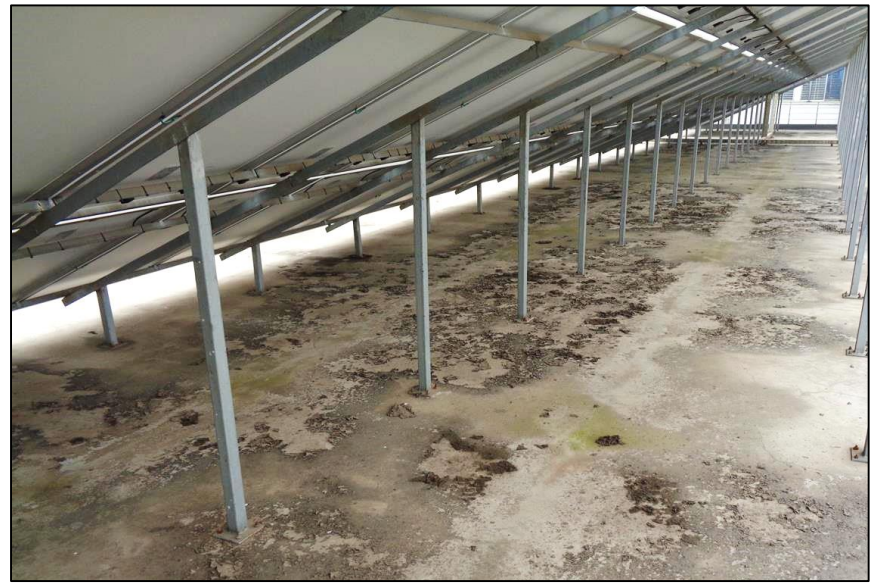
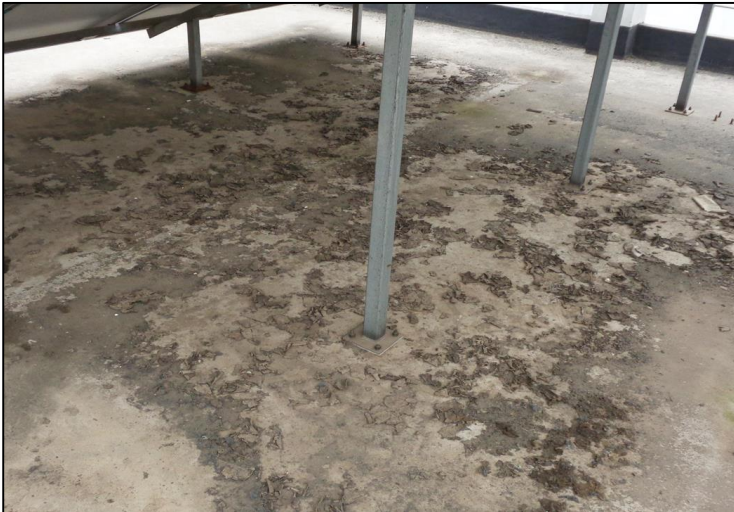
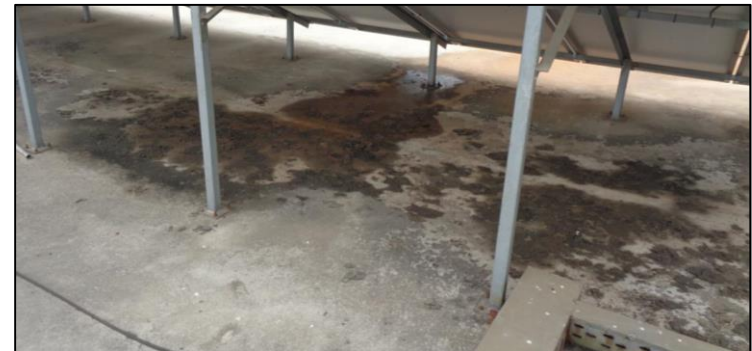
Signage of water ponding at roof

Signage of water ponding was found at roof due to construction of water proofing with improper slope. The factory engineer to improve drainage system with a proper slope on roof slab to prevent water ponding.

| Item No. | Observation | Recommended Action Plan | Recommended Timeline |
|---|---|---|---|
| 6 | Signage of water ponding at roof | The factory engineer to improve drainage system with a proper slope on roof slab to prevent water ponding. | 6-months |

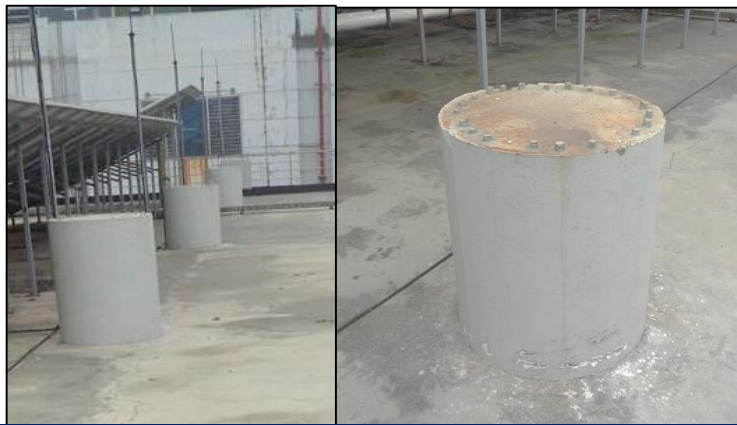
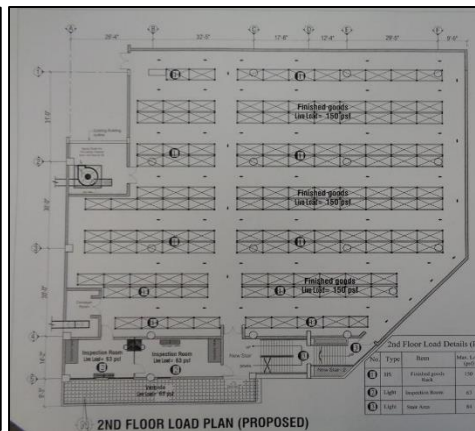
## Extended column re-bar at roof/2<sup>nd</sup> floor

The building permission layout is for 3 storied structure. Also, the design report of the structure was prepared for 3 storied structure. Till the date of this inspection, Building was constructed up-to two storied. So, there is a possibility of future vertical extension. But no Architectural & Structural drawing was found for the 3<sup>rd</sup> storey. Factory engineer is required to prepare full set of drawing & documents for the three storied structure prior to commencement of further extension work.

| Item No. | Observation | Recommended Action Plan | Recommended Timeline |
|---|---|---|---|
| 7 | Future Vertical Extension | Prior to vertical extension, factory engineer is required to produce Detailed Engineering Assessment(DEA) of the structure according to BNBC and submit to RSC for review. | 6-weeks |
| 8 | Future Vertical Extension | Carry out recommendation as outcome of the DEA. | 6-months |

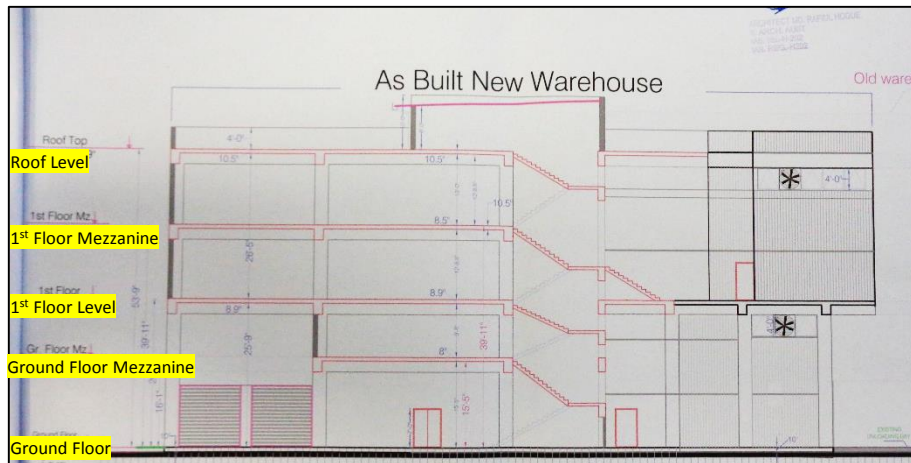
# Permit drawing for 3 storied from Union Porishod

2 storied building has been shown in drawing

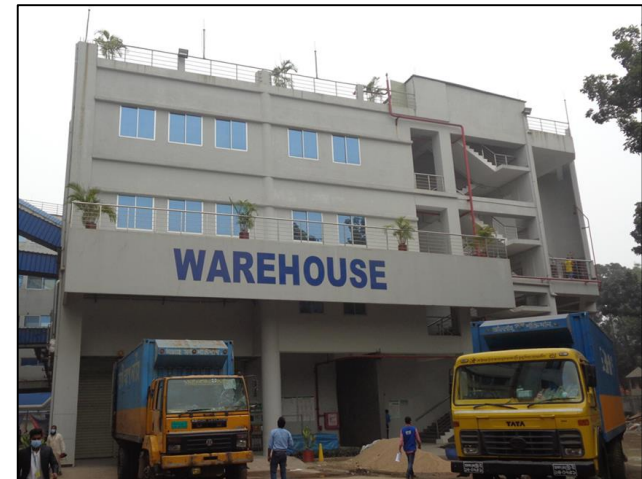
Building constructed up-to two storied
