# Anowara Knit Composite Ltd. (New Building 9 Dyeing)

Mulayed, Maona, Sreepur, Gazipur  
Co-ordinates: 24.228620, 90.407298  
16<sup>th</sup> November 2020

# Observations

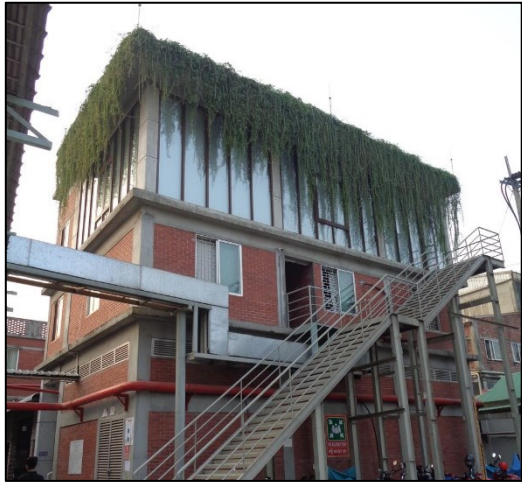
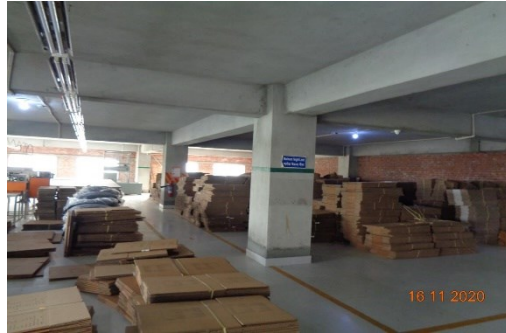
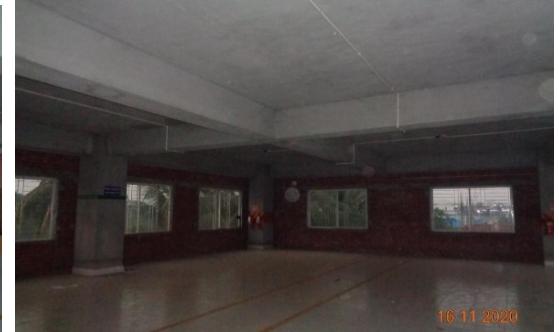
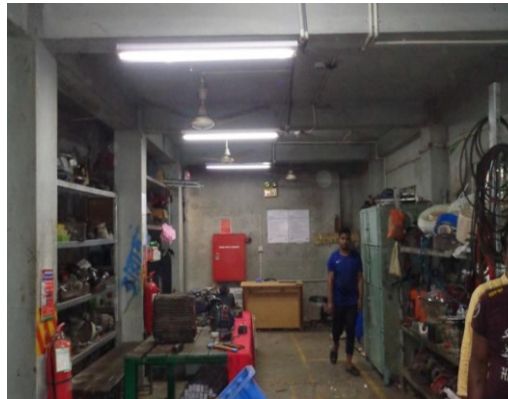
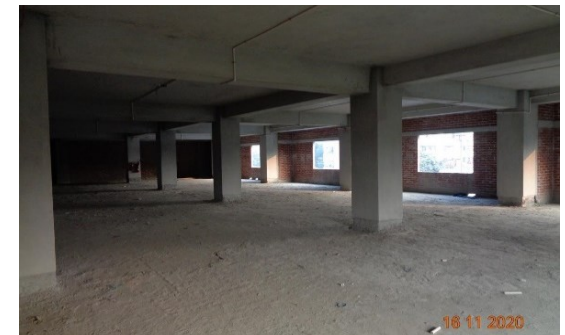
No design documents (structural assessment report) for any of these structures was available on site.

| Item No. | Observation | Recommended Action Plan | Recommended Timeline |
|---|---|---|---|
| 01 | Lack of Design documents.( All Buildings) | Factory engineer to survey the structure and prepare the design documents including a design report, and a set of structural drawings in compliance with section 1.9.1.1 and section 1.9.1.2 as per BNBC part 6 and submit to RSC for review. | 6-weeks |

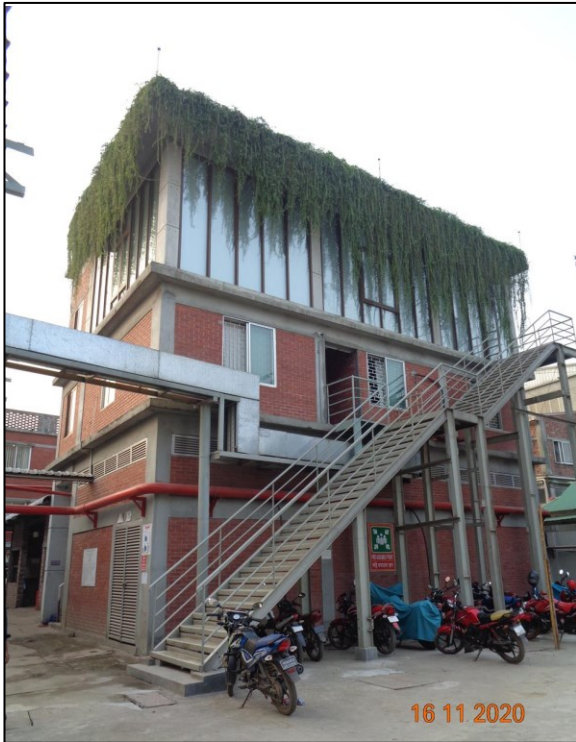
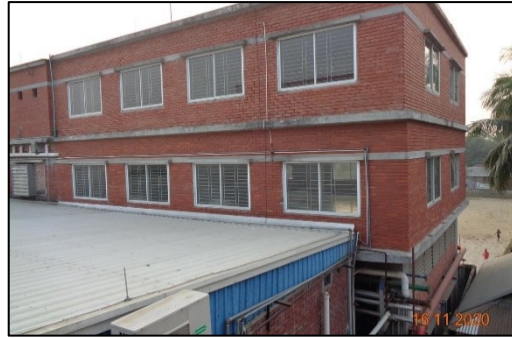
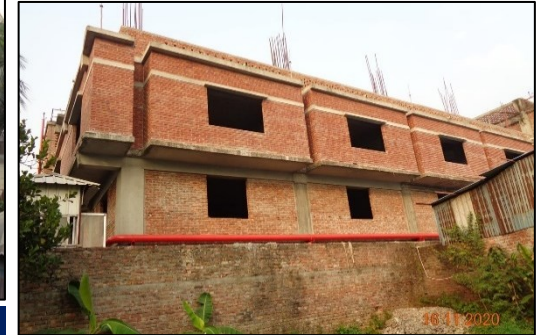
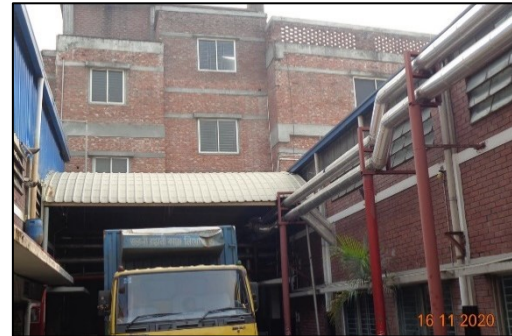
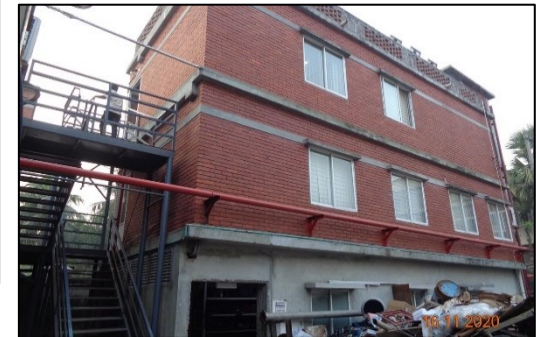
On site, no geotechnical investigation report was available for these structures.

| Item No. | Observation | Recommended Action Plan | Recommended Timeline |
|---|---|---|---|
| 05 | Lack of Geotechnical Investigation report (All Buildings) | Factory engineer is required to produce geotechnical investigation report for all the buildings as part of design report. | 6-weeks |

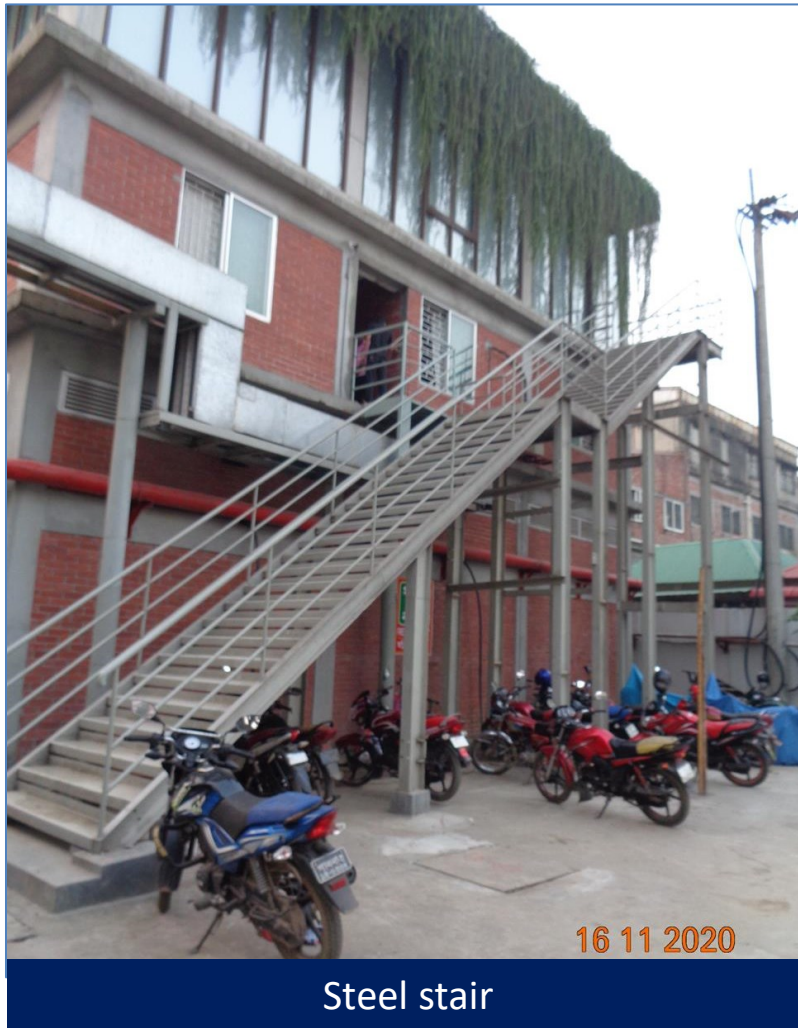
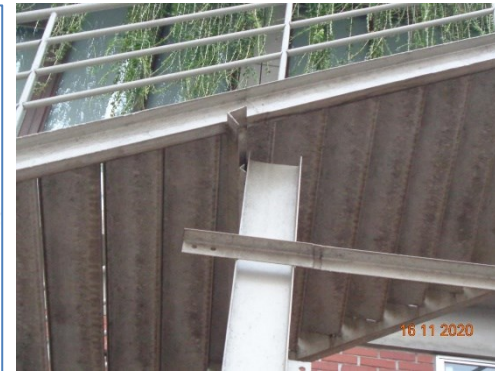
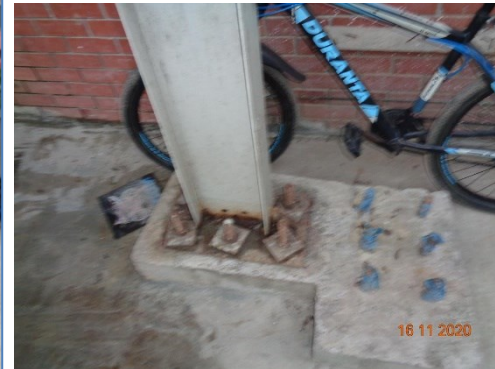
Steel stair

There is a steel stair adjacent to Building 10 (REB Building). Although as-built drawings for the stair was available but it lacks proper detailing of all the joints.

| Item No. | Observation | Recommended Action Plan | Recommended Timeline |
|---|---|---|---|
| 06 | Incomplete as-built drawings of external steel stair (Building 10 (REB Building)) | Factory engineer is required to produce accurate as built drawings of the external steel stair. | 6-weeks |

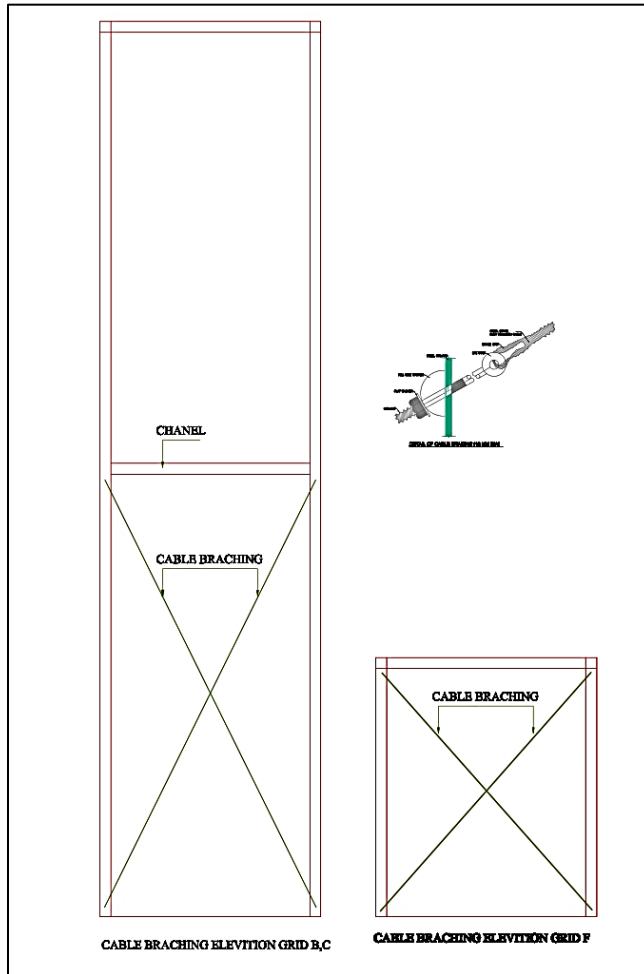
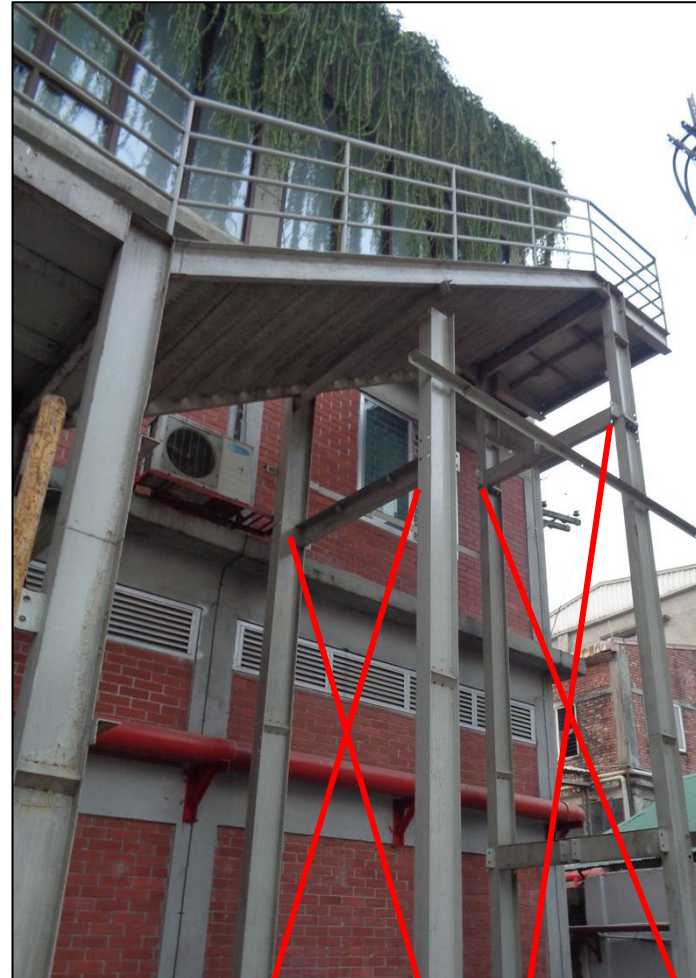
As built drawings show cable bracings along grid-B and grid-C but on site cable bracings were not found.

| Item No. | Observation | Recommended Action Plan | Recommended Timeline |
|---|---|---|---|
| 07 | Missing Cable bracings of external steel stair (Building 10 (REB Building)) | Factory Engineer is required to install the missing cable bracings. | 6-weeks |

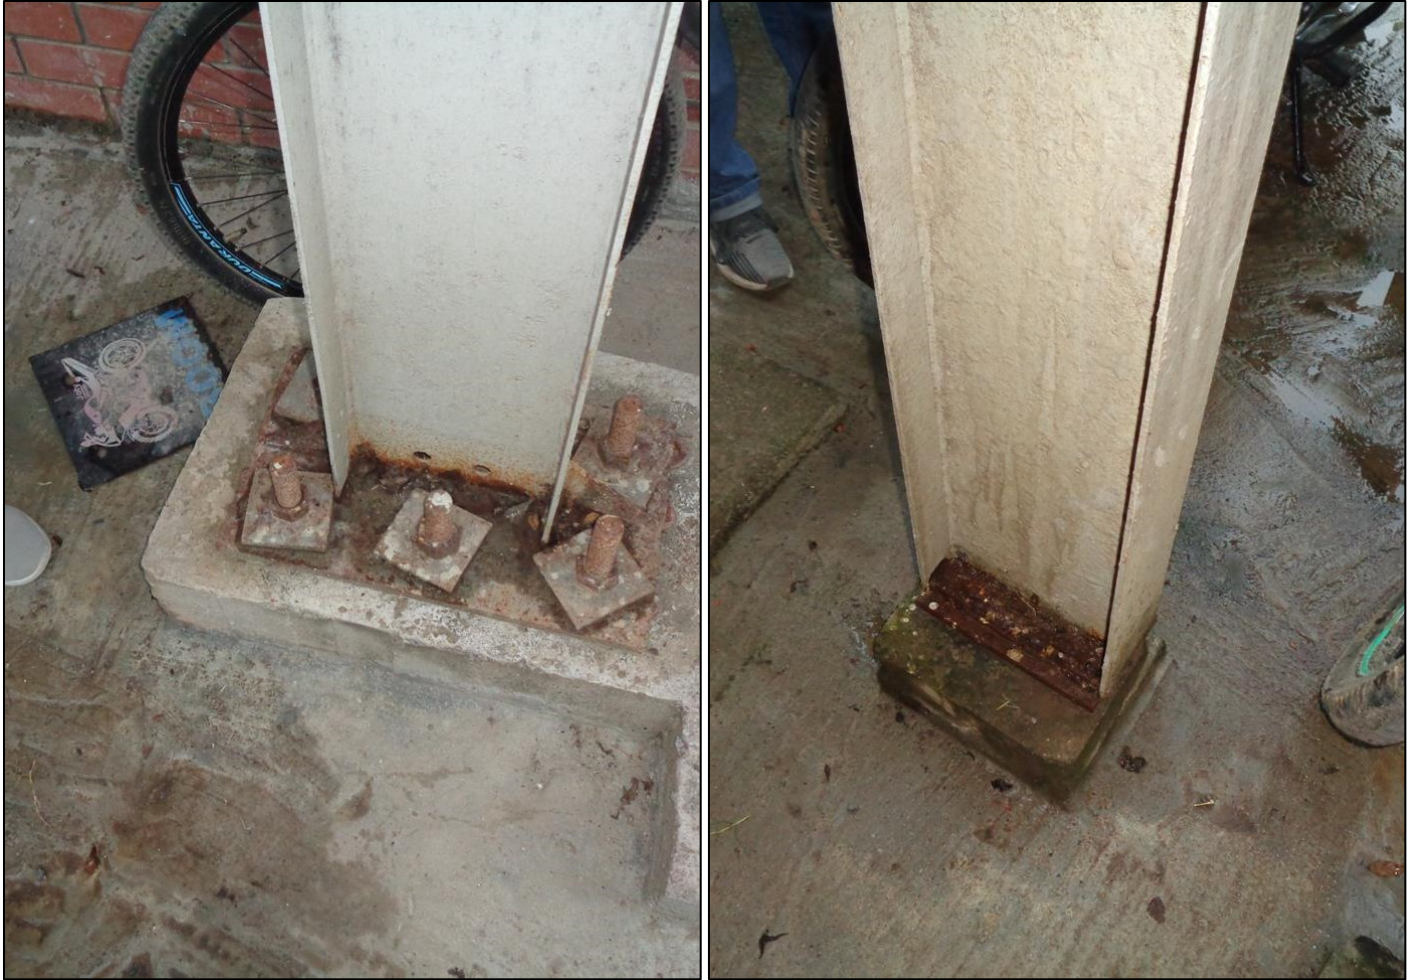
During inspection, corrosion in the steel stair columns was observed

| Item No. | Observation | Recommended Action Plan | Recommended Timeline |
|---|---|---|---|
| 08 | Corrosion in the steel stair columns. (Building 10 (REB Building)) | Factory Engineer is required to repair the corrosion and take preventive measures for reoccurrence. | 6-weeks |

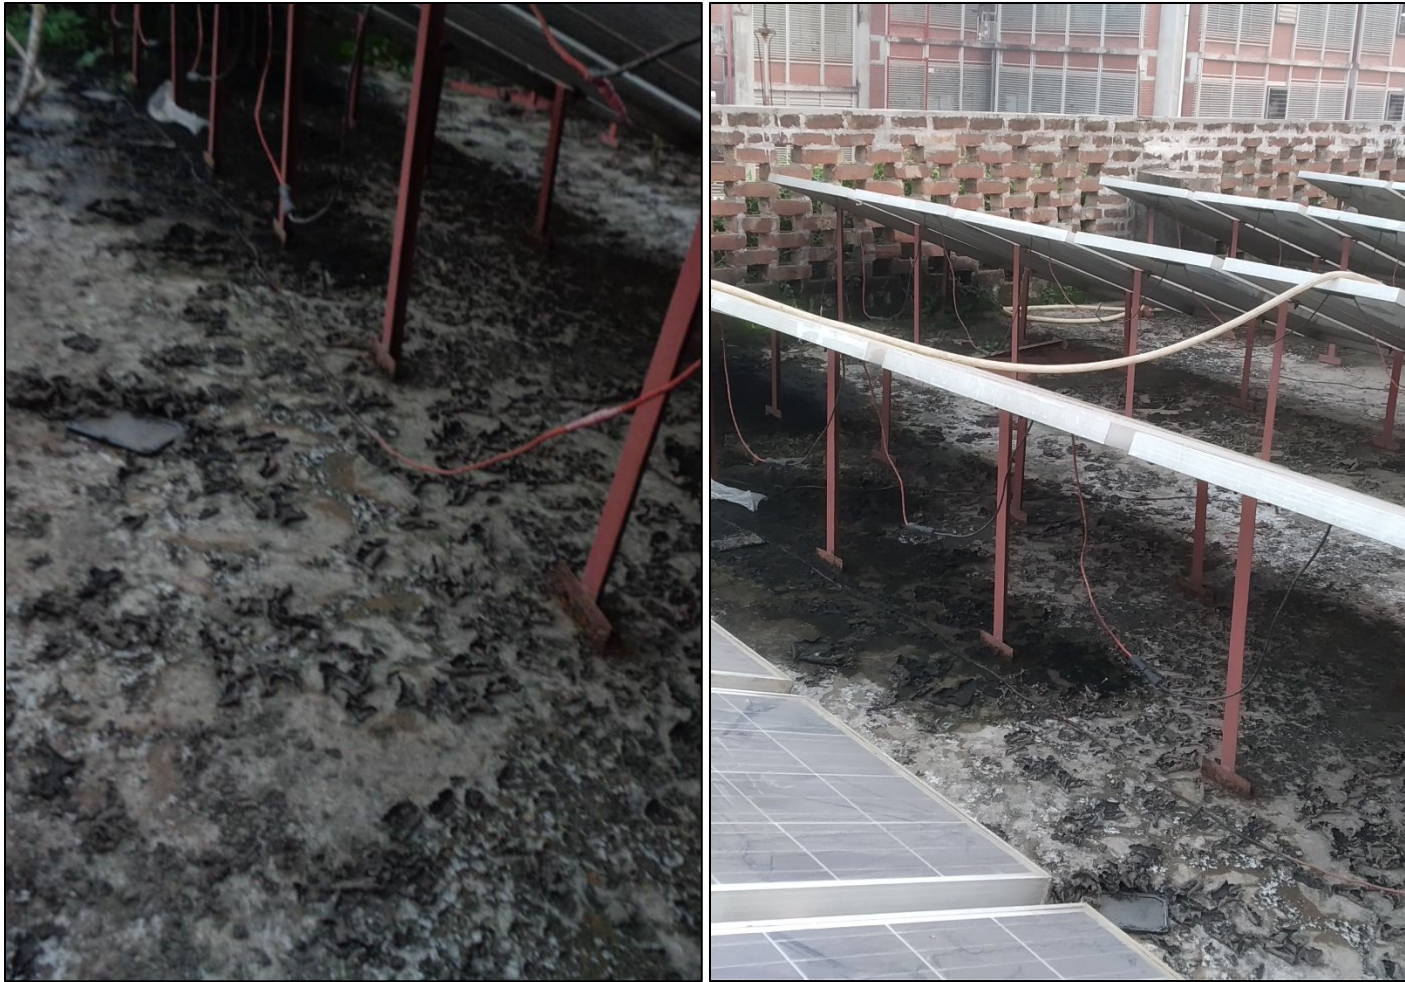
During inspection, signs of water ponding were observed on the roof.

| Item No. | Observation | Recommended Action Plan | Recommended Timeline |
|---|---|---|---|
| 09 | Water ponding on the roof (Building 10 (REB Building)) | Factory Engineer is required to provide adequate drainage to prevent water ponding. | 6-weeks |

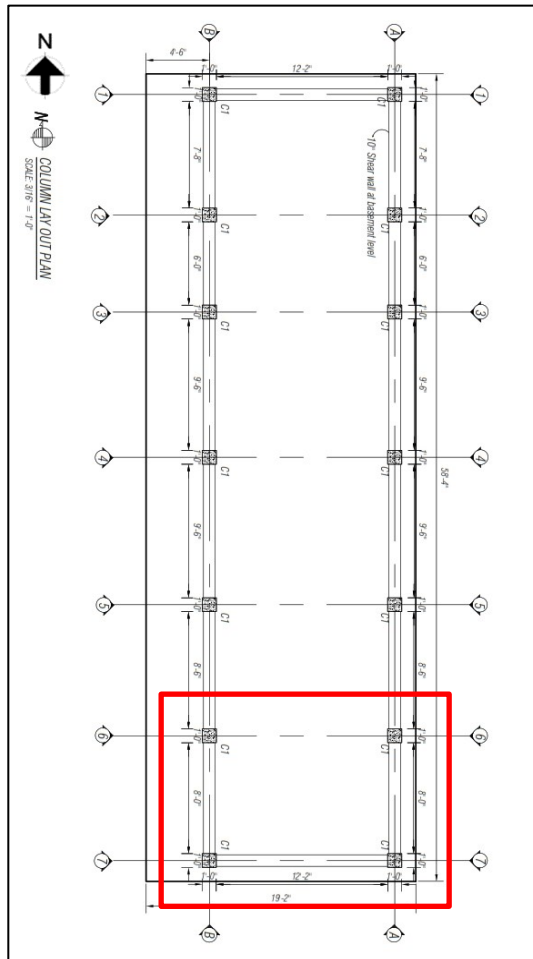
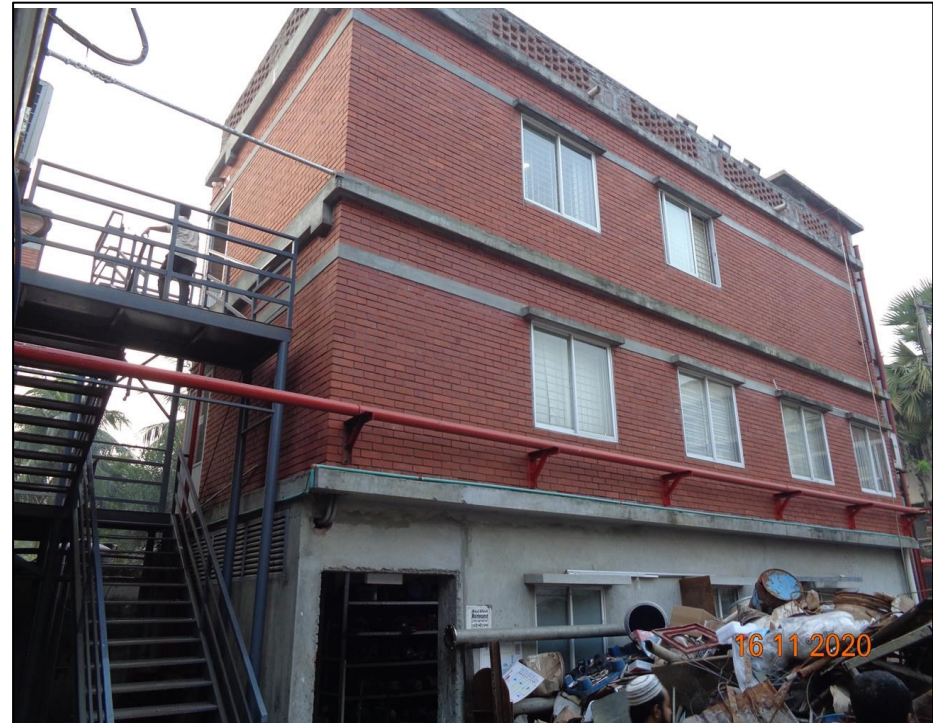
Building 11 (Lab Building) was found shorter in length along N-S direction. During inspection it was observed that span between gridline 6 and gridline 7 (marked in the layout) was not constructed.

| Item No. | Observation | Recommended Action Plan | Recommended Timeline |
|---|---|---|---|
| 10 | Mismatches in as built drawings. (Building 11 (Lab Building)) | Factory Engineer is required to survey the whole structure and produce accurate as built drawings as part of the design documents. | 6-weeks |

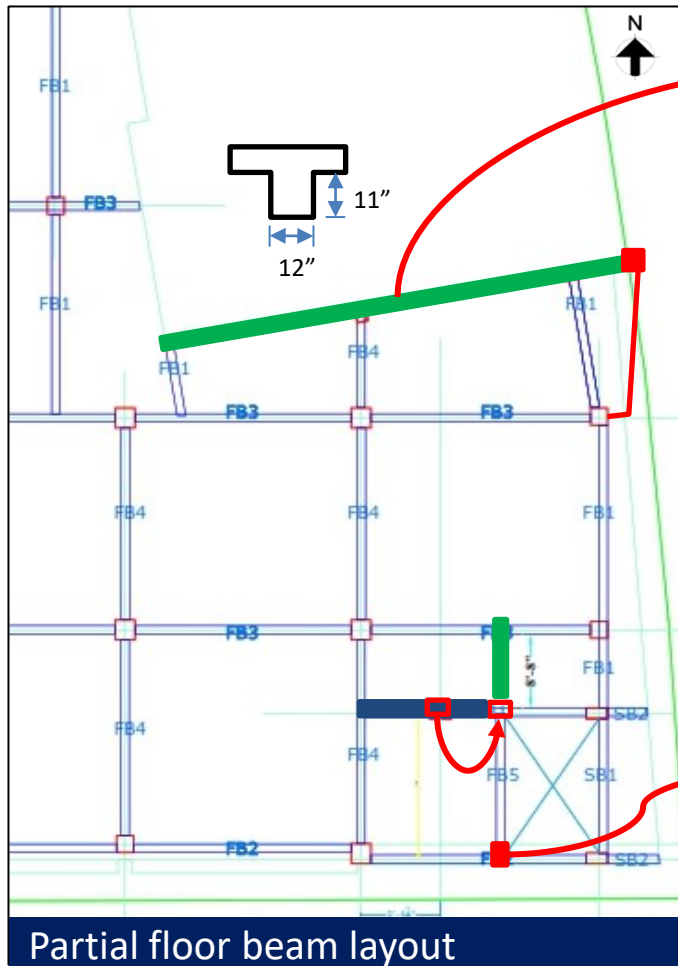
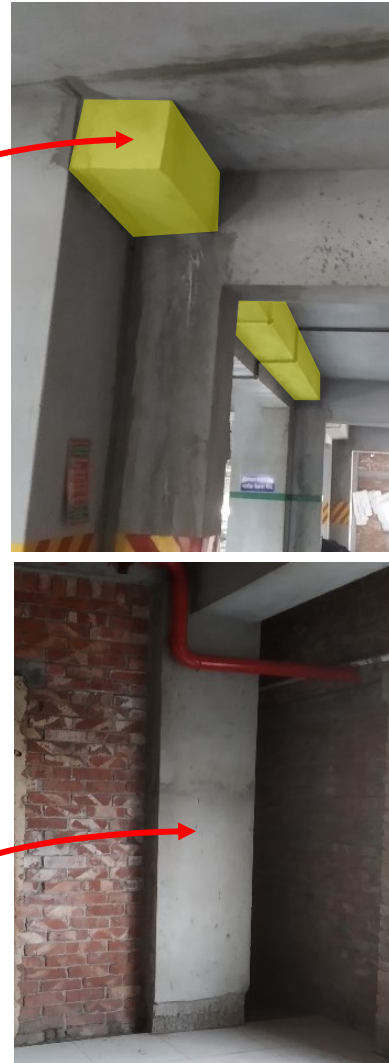
During inspection, two extra columns (marked red) were found which were not present in as built drawings. Also an undocumented beams (green marked) of size 12" x 11"(d/s) observed. Besides these a shift in column location found and beam in one location(marked blue) was not present. Above mentioned observations are shown in the floor beam layout plan.

| Item No. | Observation | Recommended Action Plan | Recommended Timeline |
|---|---|---|---|
| 11 | Mismatches in as built drawings. (Building 12 (Dyeing Extension-1)) | Factory Engineer is required to survey the whole structure and produce accurate as built drawings as part of the design documents. | 6-weeks |

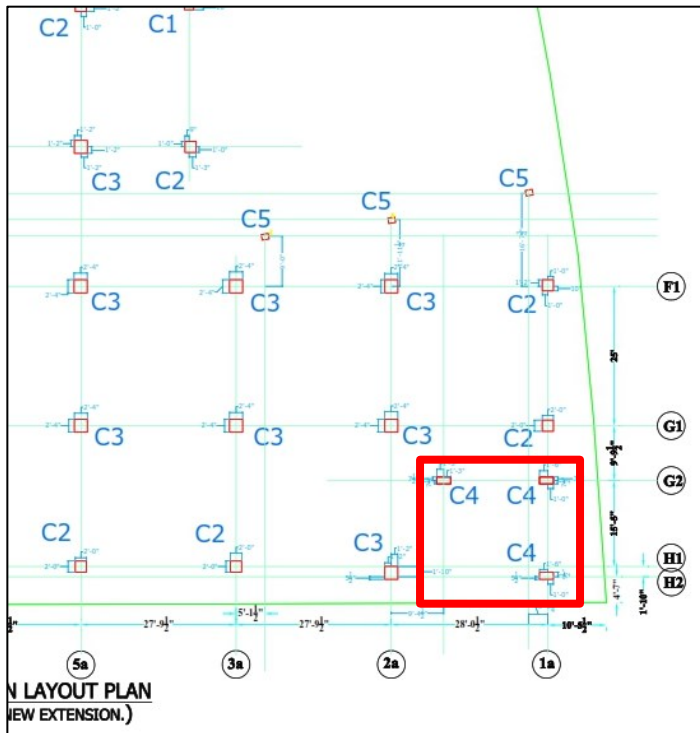
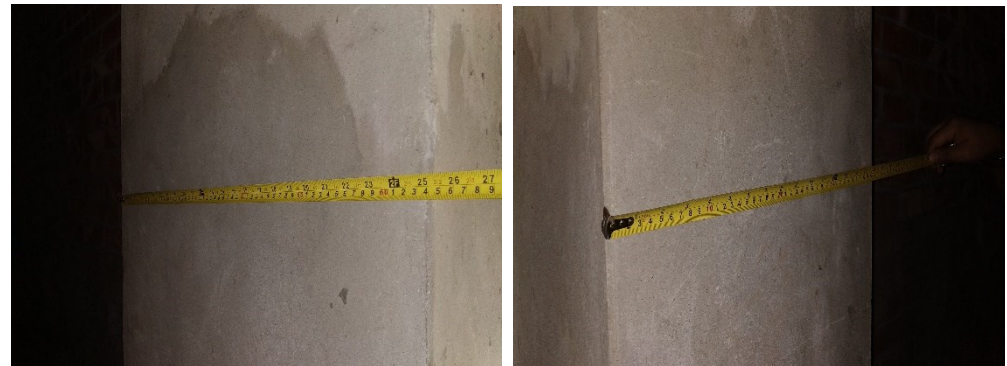
Column was measured to be 16" x 25"

As per column schedule, dimensions of C4 column should be 15" X 30" . But on site C4 columns were measured to be 16" X 25" with finishing.

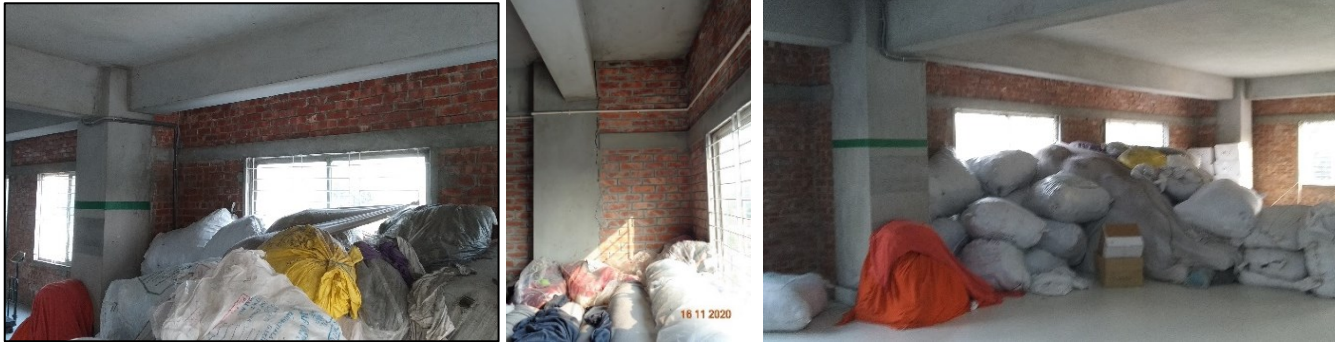
Loading in the cantilevered areas

The cantilevered areas in the 2<sup>nd</sup> floor were heavily loaded and cracks were observed in the walls and column connection.

| Item No. | Observation | Recommended Action Plan | Recommended Timeline |
|---|---|---|---|
| 12 | High loading in Cantilever Area. (Building 12 (Dyeing Extension-1)) | Factory Engineer is required to produce a check of the cantilevered area as part of the design documents. | 6-weeks |

| Item No. | Observation | Recommended Action Plan | Recommended Timeline |
|---|---|---|---|
| 13 | High loading in Cantilever Area.<br>(Building 12 (Dyeing Extension-1)) | Produce and maintain load plans for the cantilevered area considering assessment result. | 6-weeks |

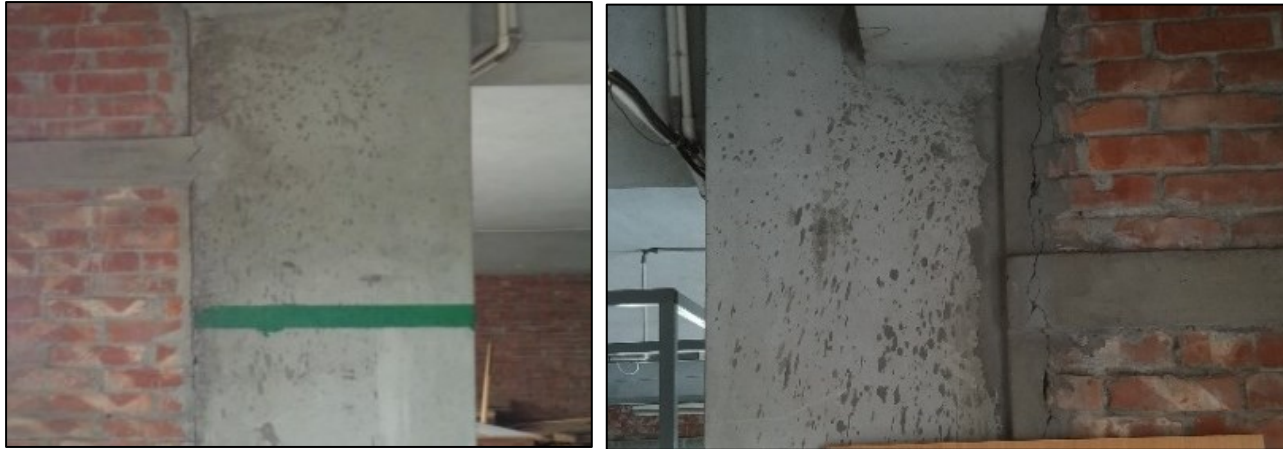
Cracks between columns and wall connection

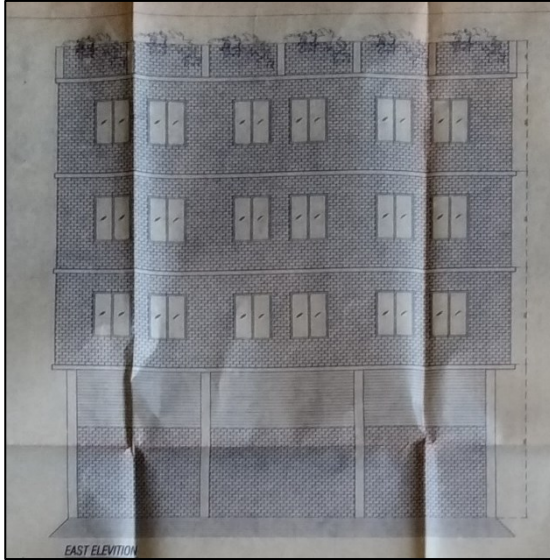
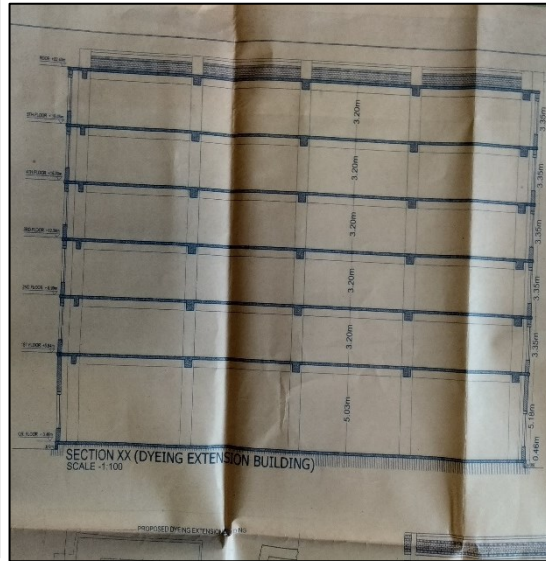
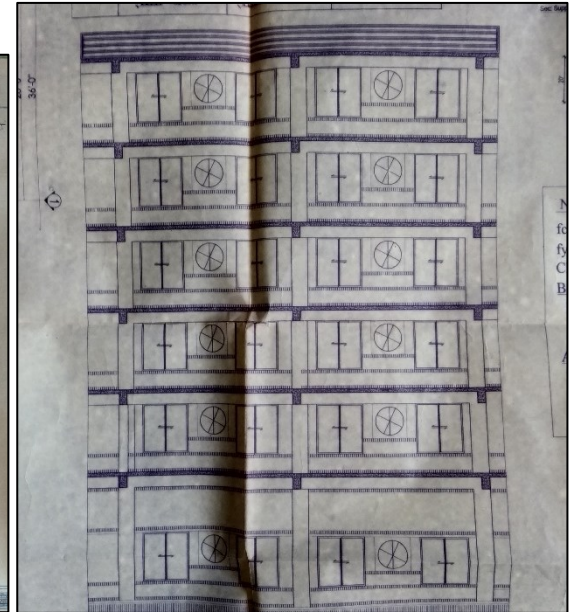
Building 10 (REB Building) permission application is for 4 storied structure, Building 12 (Dyeing Extension-1), Building 13 (Dyeing Extension-2) and Building 14 (Dyeing Extension-3) permission layout is for 6 storied structure. Till the date of this inspection, Building 10 (REB Building), Building 12 (Dyeing Extension-1), Building 14 (Dyeing Extension-3) were constructed upto three storeys and Building 13 (Dyeing Extension-2) was constructed upto two storeys. These buildings will be extended vertically in future.

| Item No. | Observation | Recommended Action Plan | Recommended Timeline |
|---|---|---|---|
| 14 | Future Vertical Extension (All Buildings (Except Building 11 (Lab Building))) | In case of future vertical extension factory engineer is required to produce Detailed Engineering Assessment(DEA) of the structure/structures according to BNBC and submit to RSC for review. | 6-weeks |
