# **FIRE SAFETY INSPECTION REPORT**

**ANOWARA KNIT COMPOSITE LTD.  
MULAYED, MAONA, SREEPUR, GAZIPUR**

**ACCORD**  
on Fire and Building Safety in Bangladesh

July 7, 2014

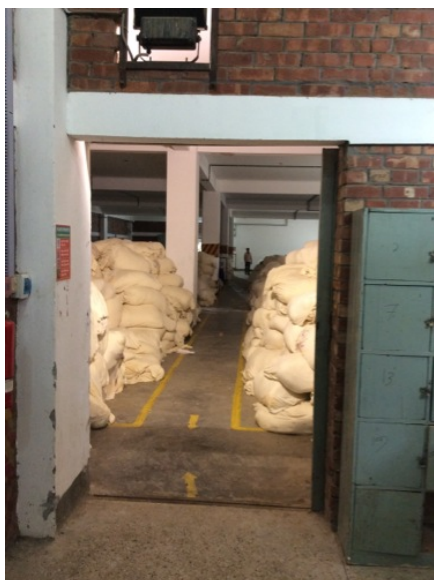
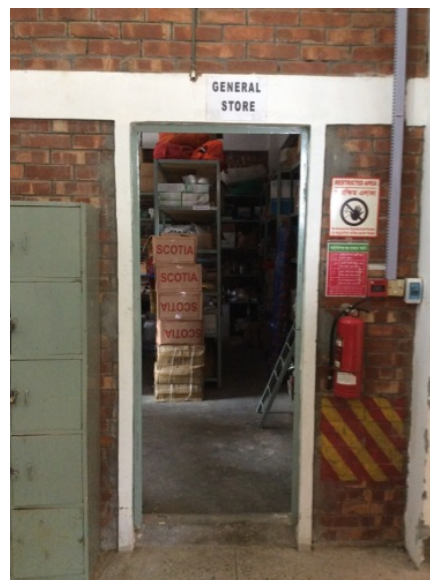
| F-1 | Fire Rated Construction | <p>Two (2) of the three (3) exits from the ground floor fabric batch storage room discharge to exit stairs.</p> <p>The ground floor general store also discharges to the northeast exit stair on the ground floor.</p> | <p>Provide 2-hr fire-rated vestibules where a storage room discharges to an exit stair. Provide a 1-hr fire rated door on the storage room side and a 1.5-hr fire rated door on the exit stair side.</p> <p>Keep the central fabric batch door. Only one (1) of the exit stair doors to the storage room can be sealed. The approximate max travel distance to the central door was measured to be 110 ft. (max allowable travel distance is 100 ft.).</p> <p>If the general store is unoccupied, seal door to northeast exit stair and provide access through fabric batch. If not, do the same but provide common vestibule to northeast exit stair, linking access to both fabric batch and general store. Seal access to the northwest exit stair from fabric batch.</p> | Within 3 months |

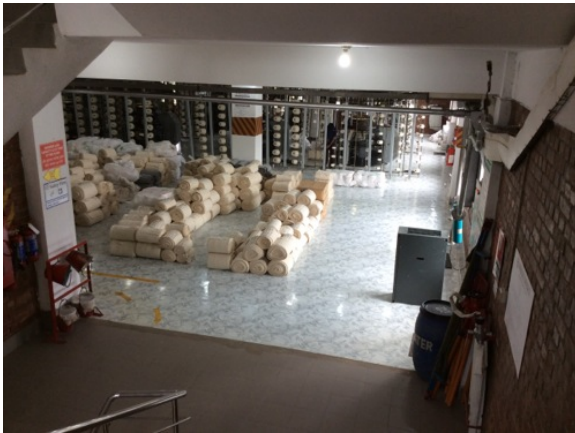
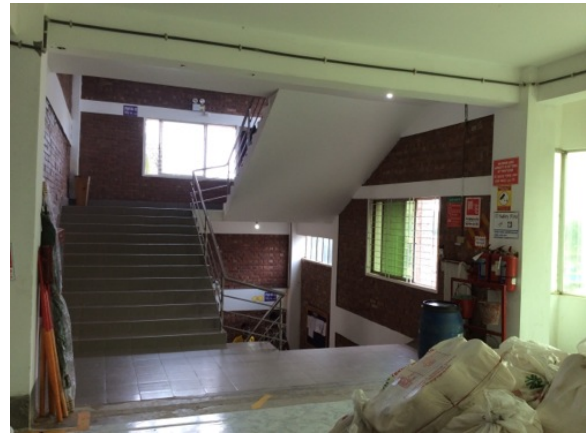
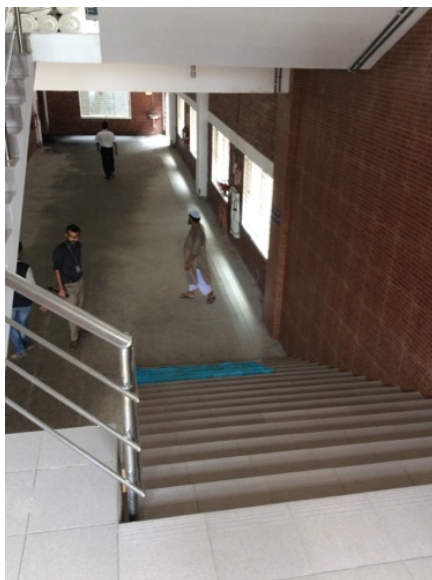
| F-2 | Fire Rated Construction | Both exit stairs were unenclosed on the first floor and the northwest exit stair was unenclosed on the ground floor. | Enclose all exit stairs with 2-hr fire-rated construction. | Within 3 months |

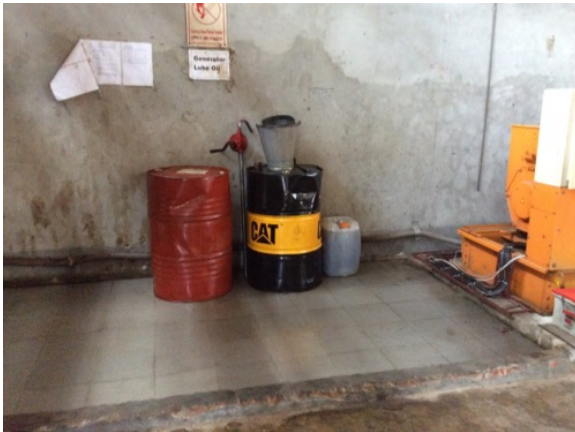
| F-3 | Fire Rated Construction | The diesel fuel storage area in the generator room is not separated by fire-rated construction and open to surrounding areas. | Separate the diesel fuel storage by a minimum 2-hr fire-rated construction. Seal and/or protected all openings to maintain the required fire separations. | Within 3 months |

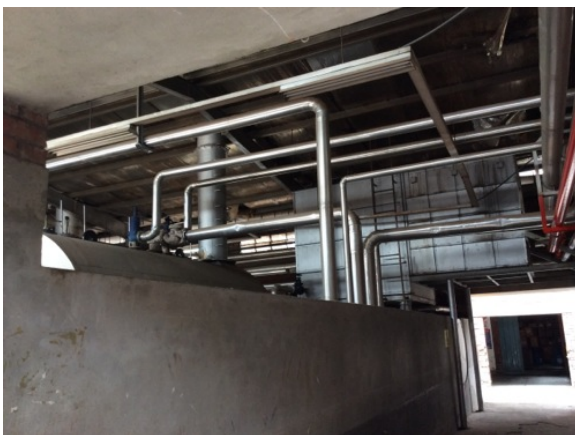
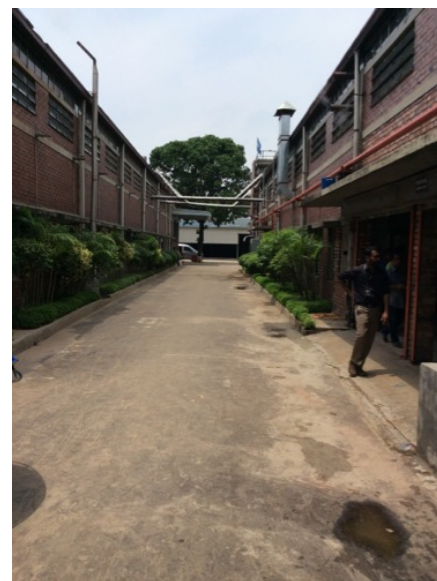
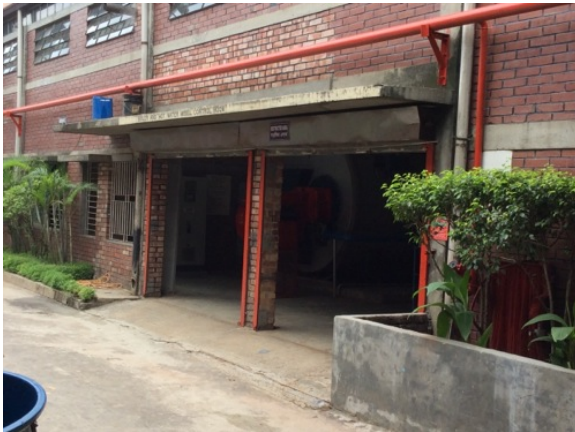
| F-4 | Fire Rated Construction | <p>The boiler/generator building is not separated by fire-rated construction due to openings, non-rated doors, and penetrations.</p> <p>The boilers and generators were not separated from each other.</p> | <p>Separate the boiler/generator building by a minimum 2-hr fire-rated construction. Seal and/or protected all openings to maintain the required fire separations.</p> <p>Separate the boilers and generators from each other by 2-hr fire rated construction.</p> | Within 3 months |

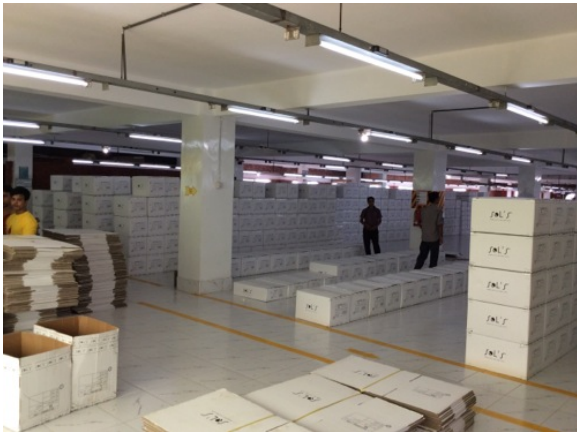
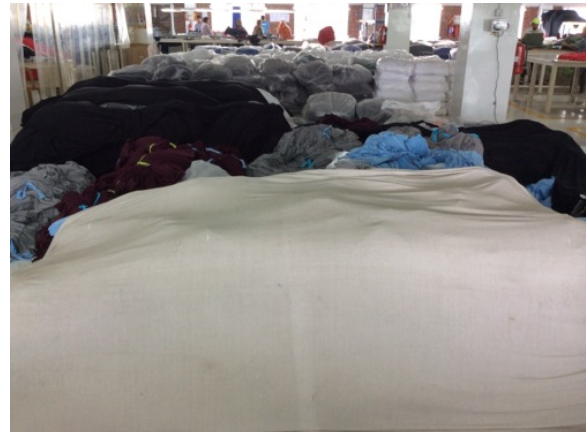
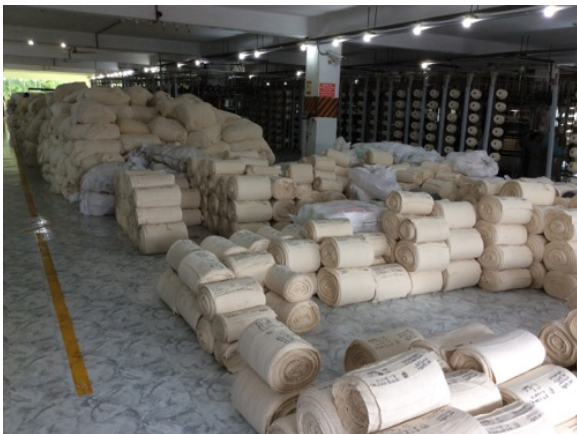
| F-5 | Fire Rated Construction | Areas used for combustible storage, open to the factory floor on the first, third, and fourth floors, are not separated by fire-rated construction. | <p>Provide dedicated storage rooms separated by minimum 1-hr fire-rated construction.</p> <p>Where separate storage rooms are not feasible, provide defined storage areas and limit the storage arrangement as follows:</p> <ul style="list-style-type: none"><li>- Maximum height of 2.4m and maximum area of 23m<sup>2</sup></li><li>- If sprinkler protected: maximum height of 3.66m and maximum area of 93m<sup>2</sup></li></ul> <p>Separate areas of unenclosed combustible storage by a minimum clear distance of 3m.</p> | Within 3 months |

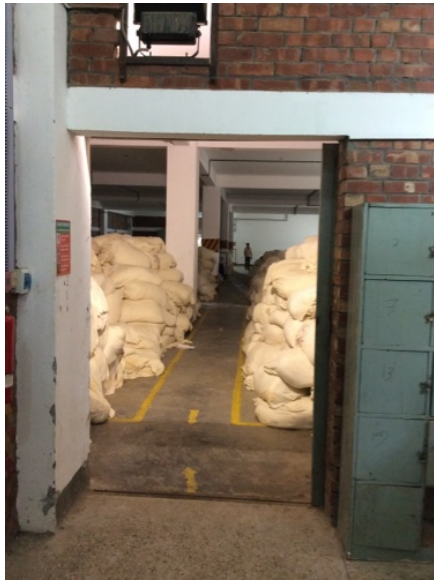
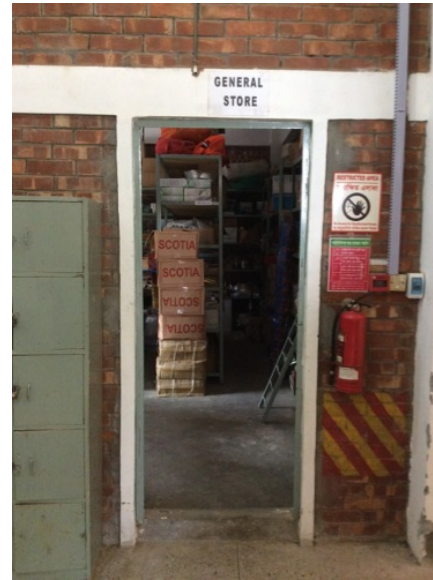
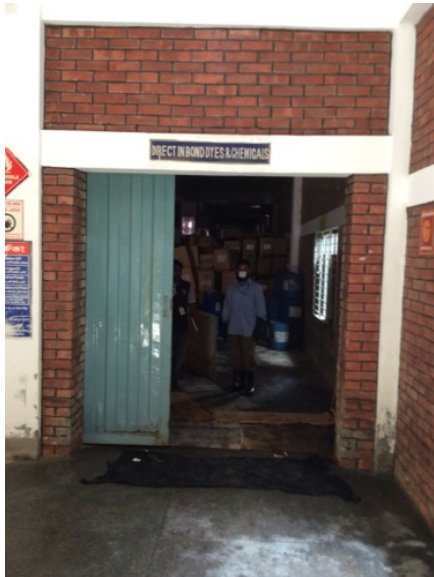
| F-6 | Fire Rated Construction | Rooms used for combustible storage on the ground (general store, fabric batch, and chemical warehouse) and second (store room) floors are not separated by fire-rated construction. | Provide dedicated storage rooms separated by minimum 1-hr fire-rated construction. | Within 3 months |

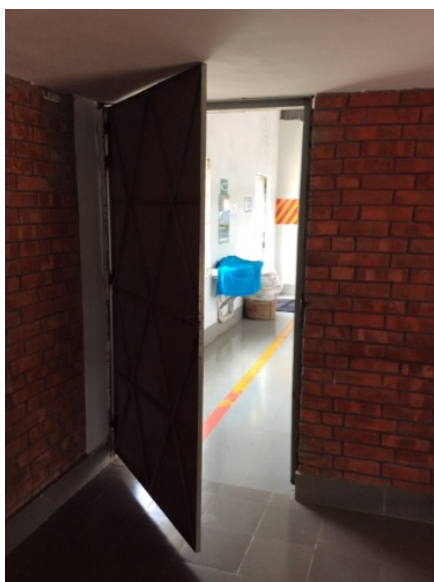
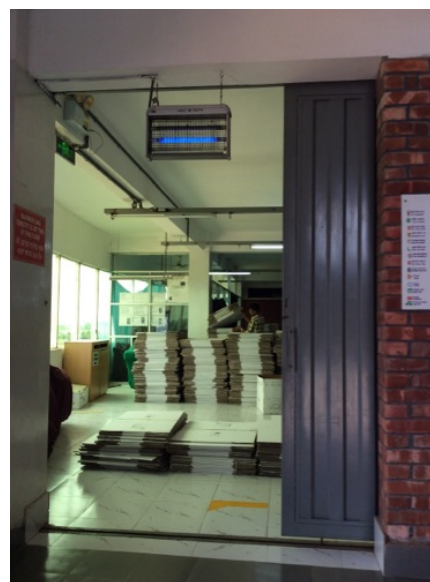
| F-7 | Fire Rated Construction | The exit stairs are not separated from work areas and other spaces on each floor by fire-rated construction. | Provide minimum 1.5-hr fire rated doors and seal all unprotected openings to separate the exit stairs from work areas and other building spaces on all floor levels. Ensure that the fire doors are self-closing and positive latching and that they are provided with fire exit (panic) hardware where serving production floors. | Within 3 months |

| | | | If fire doors are required to be held open for functional reasons, provide automatic-closing devices tied to the fire alarm system. | |

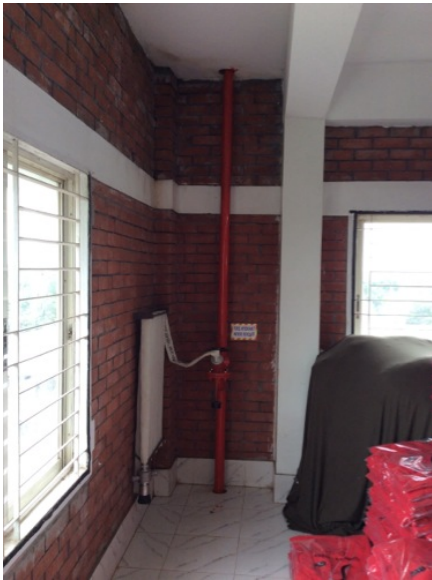
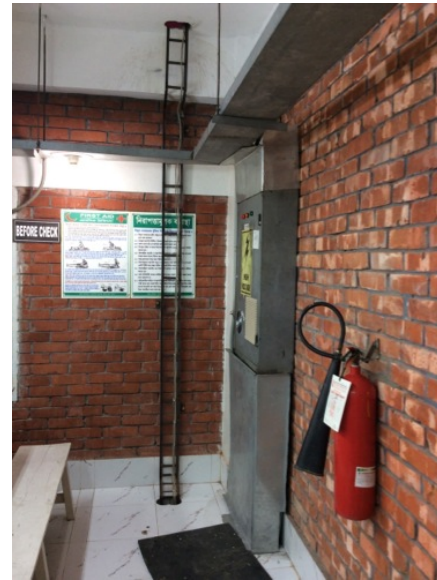
| F-8 | Fire Rated Construction | Unsealed penetrations and openings (two (2) hydrant pipes and two (2) electrical risers) are located in the fire-rated floor/ceiling assemblies on each floor. | Provide a minimum 2-hr fire-rated shaft to separate the electrical utility risers from each floor level.<br><br>Seal all hydrant piping penetrations and openings in floor/ceiling assemblies to maintain the fire separation. | Within 3 months |

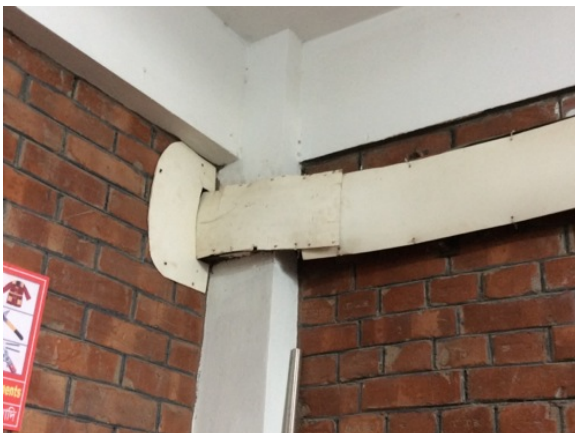
| F-9 | Fire Rated Construction | Unsealed penetrations and openings are located in the northwest exit stair enclosure on the second floor. Once the exit stair is enclosed on the first floor, the same penetration will be present. | Seal all penetrations and openings in exit stair enclosure walls to maintain the fire separation. | Within 3 months |

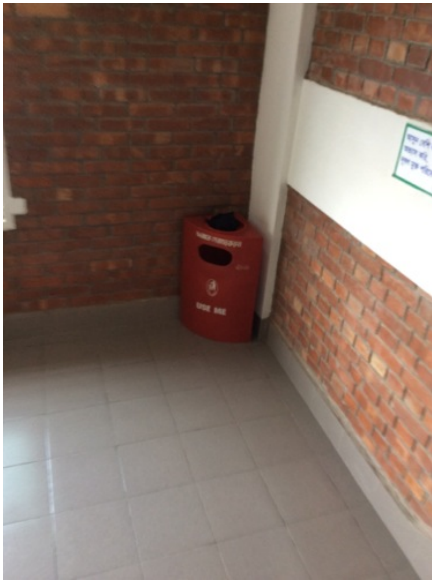
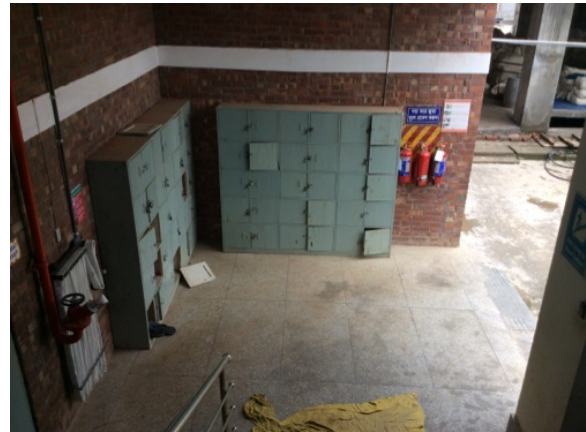
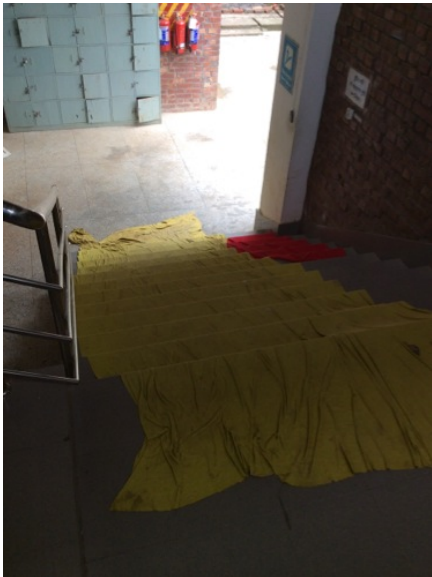
| F-10 | Egress | Storage was located in each exit stair on all floors. | Remove all storage from exit stairs and egress paths. | Immediate |

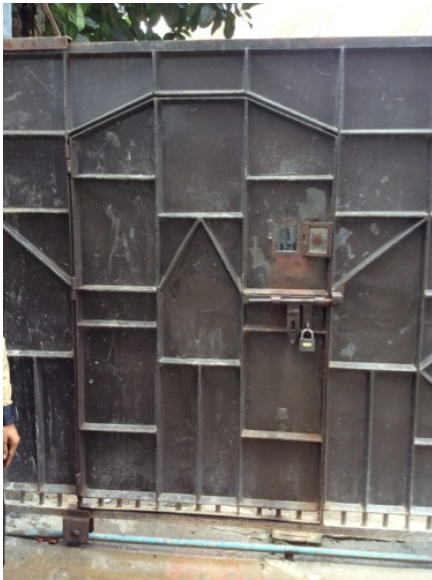
| F-11 | Egress | An egress door with locking features was provided along an exterior egress route. All gates/doors were open and unlocked during the inspection. | Remove locking features from all egress doors.<br><br>If locks are required for security reasons, utilize special door locking features complying with NFPA 101. | Immediate |

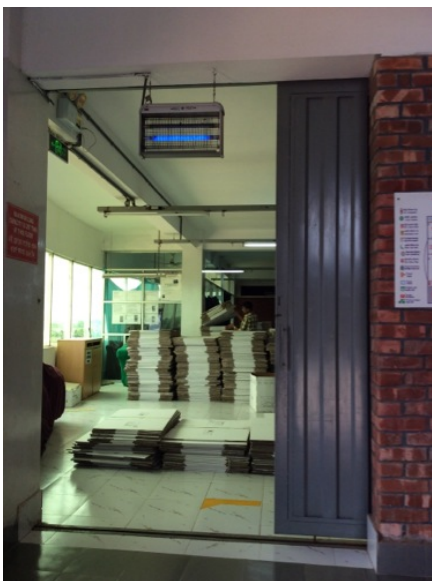
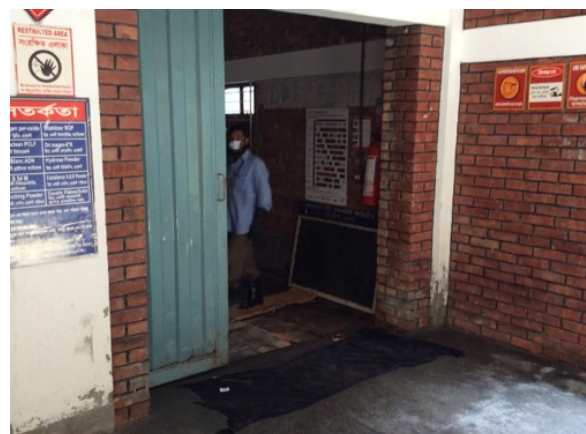
| F-12 | Egress | Sliding doors are provided at exit stairs and along egress routes. | Replace all sliding doors along the means of egress with side-hinged, swinging egress doors. | Within 1 month |

| | | | If locks are required for security reasons, utilize special door locking features complying with NFPA 101. | |

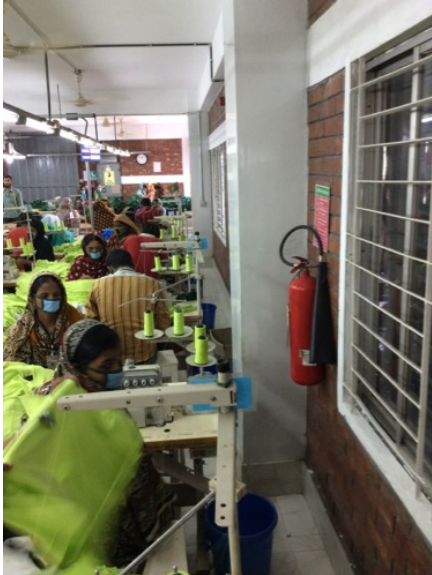
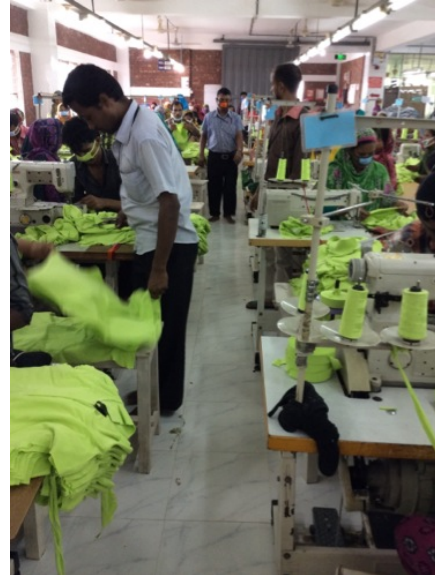
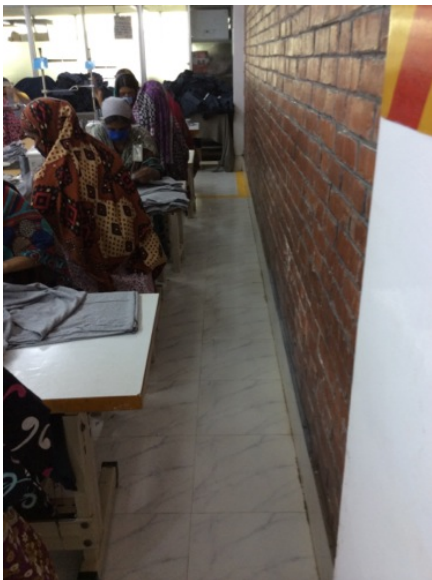
| F-13 | Egress | The width of egress aisles was less than 36-in. in several locations on the second floor. | Provide minimum aisle widths of 36-in. | Within 3 months |

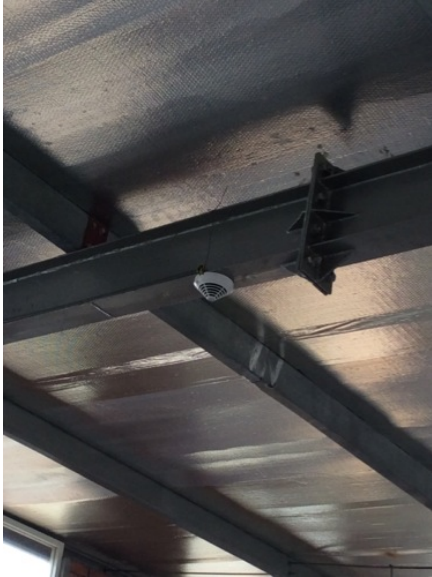
| F-15 | Fire Protection | Based off observations, the existing smoke detectors tied to the fire alarm were not installed correctly (on the bottom of electrical runners). | Based on ceiling configuration, provide additional detectors where needed, and install them in accordance with NFPA 72. | Within 3 months |

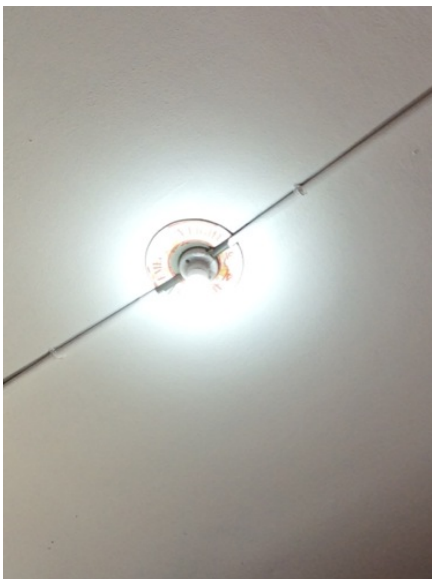
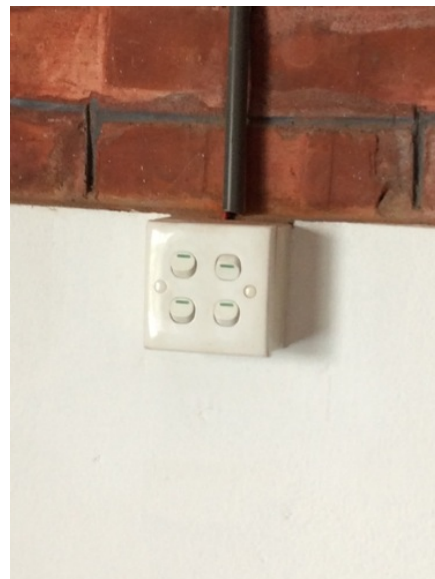
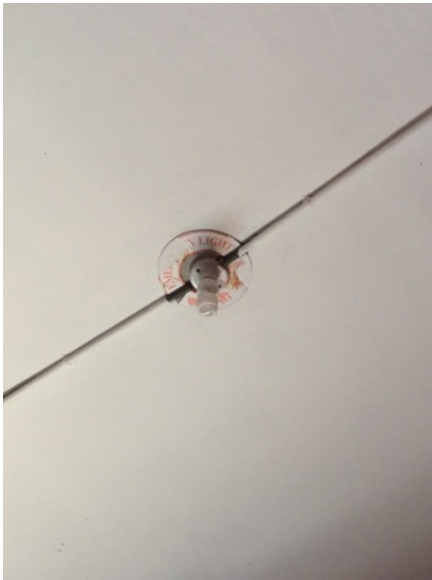
| F-16 | Egress Lighting | Manual on-off switch is provided for emergency lighting units. | Remove manual on/off switches from emergency lighting units to prevent them from being switched off. | Within 1 month |

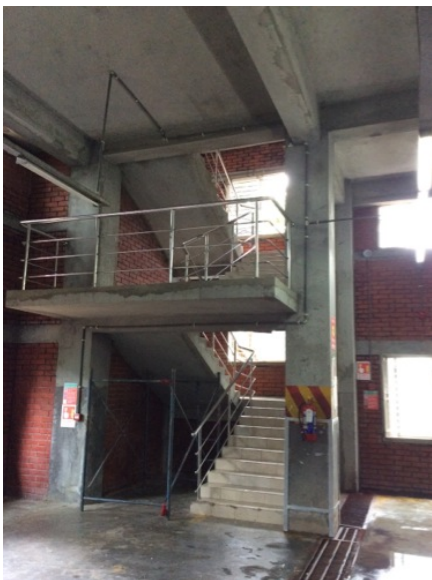
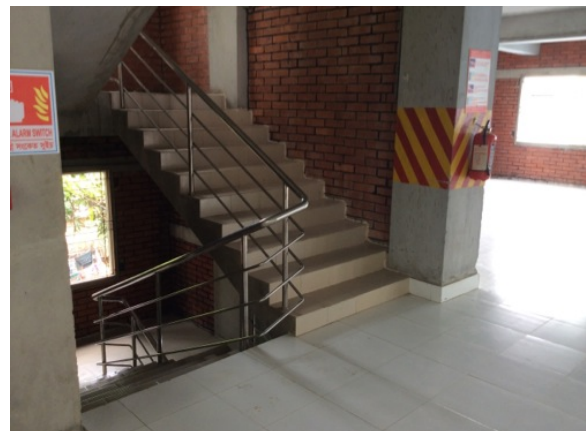
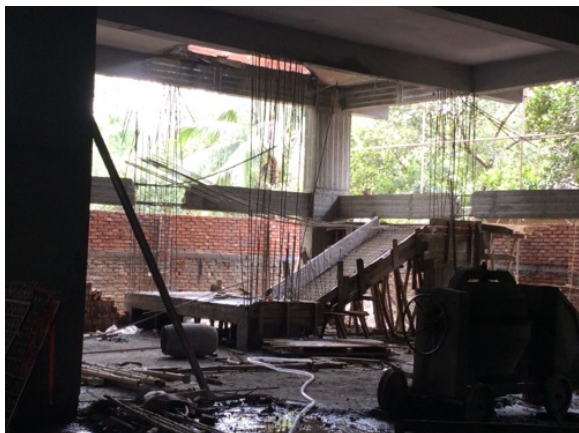
| F-1 | Fire Rated Construction | The northwest exit stair of Building 5 was unenclosed in fire-rated construction. | Enclose the northwest exit stair and all future exit stairs in 2-hr fire-rated construction on all floors. | Within 3 months |

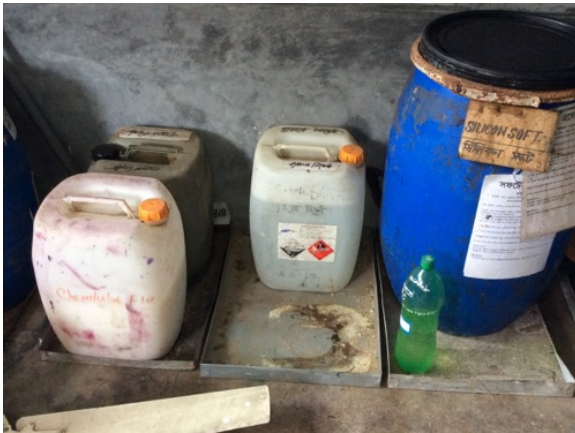
| F-2 | Fire Rated Construction | The flammable liquid storage area in Building 4 is not separated by fire-rated construction due to non-rated doors. | Separate the flammable liquid storage room by a minimum 2-hr fire-rated construction. Seal and/or protected all openings to maintain the required fire separations. | Within 3 months |

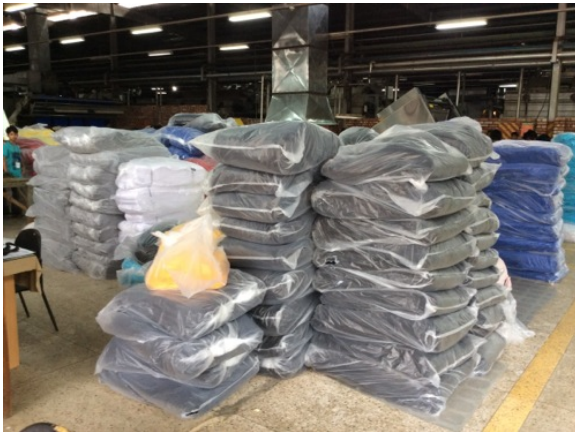
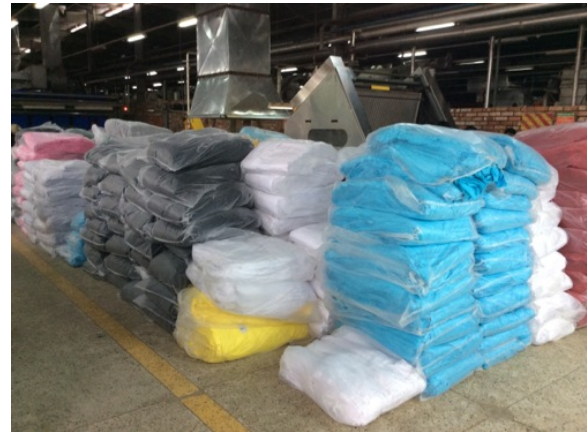
| F-3 | Fire Rated Construction | Areas used for combustible storage, open to the factory floor, are not separated by fire-rated construction. | <p>Provide dedicated storage rooms separated by minimum 1-hr fire-rated construction.</p> <p>Where separate storage rooms are not feasible, provide defined storage areas and limit the storage arrangement as follows:</p> <ul style="list-style-type: none"><li>- Maximum height of 2.4m and maximum area of 23m<sup>2</sup></li><li>- If sprinkler protected: maximum height of 3.66m and maximum area of 93m<sup>2</sup></li></ul> <p>Separate areas of unenclosed combustible storage by a minimum clear distance of 3m.</p> | Within 3 months |

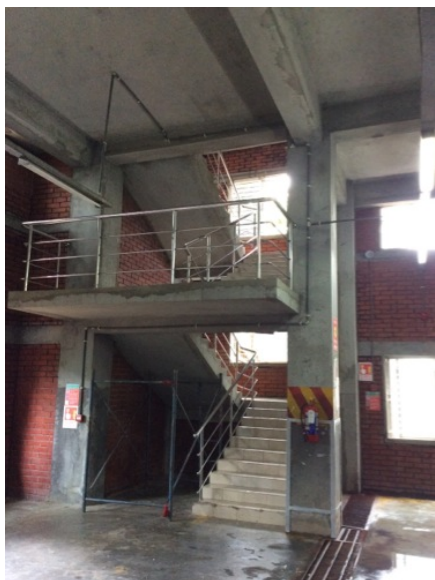
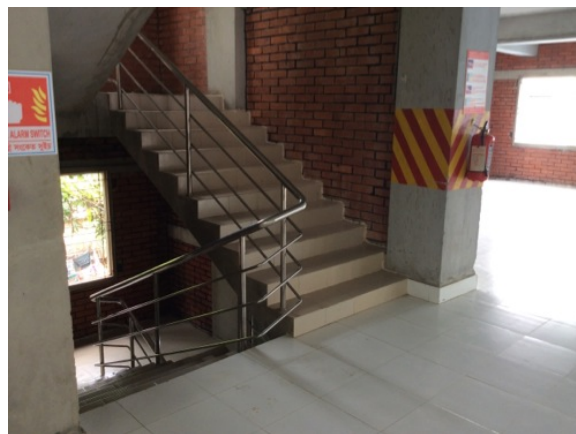
| F-4 | Fire Rated Construction | The exit stairs are not separated from work areas and other spaces on each floor by fire-rated construction. | Provide minimum 1.5-hr fire rated doors and seal all unprotected openings to separate the exit stairs from work areas and other building spaces on all floor levels. Ensure that the fire doors are self-closing and positive latching and that they are provided with fire exit (panic) hardware where serving production floors. | Within 3 months |

If fire doors are required to be held open for functional reasons, provide automatic-closing devices tied to the fire alarm system.

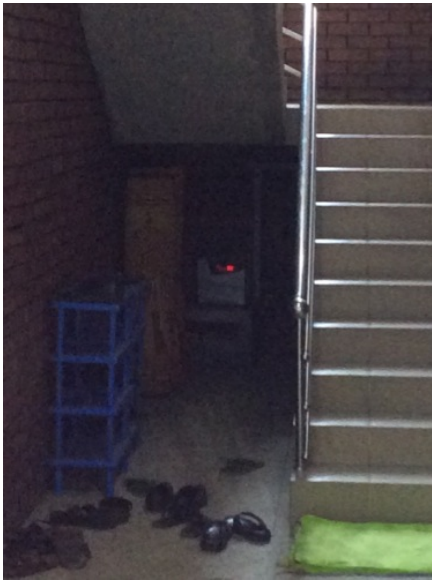
| F-5 | Egress | Storage was located in the northwest exit stair of Building 5. | Remove all storage from exit stairs and egress paths. | Immediate |

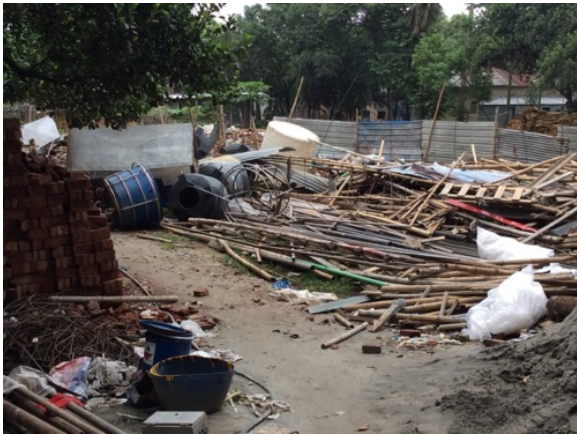
| F-6 | Egress | Storage was located in the egress path of the Building 5 southeast exit. | Keep egress paths and stairs clear of storage. | Immediate |

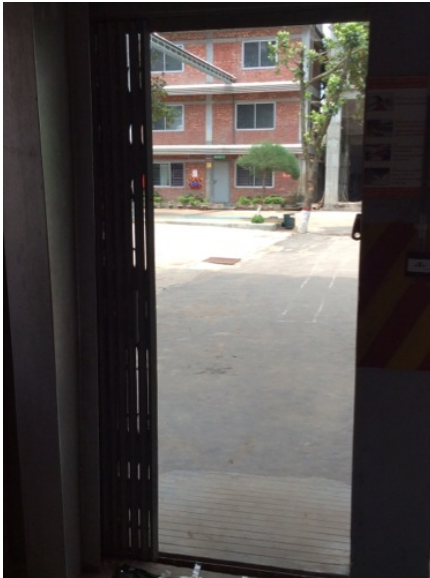
| F-7 | Egress | Collapsible gates are provided at building exits. | Replace all gates along the means of egress with side-hinged, swinging egress doors. | Within 1 month |

If locks are required for security reasons, utilize special door locking features complying with NFPA 101.

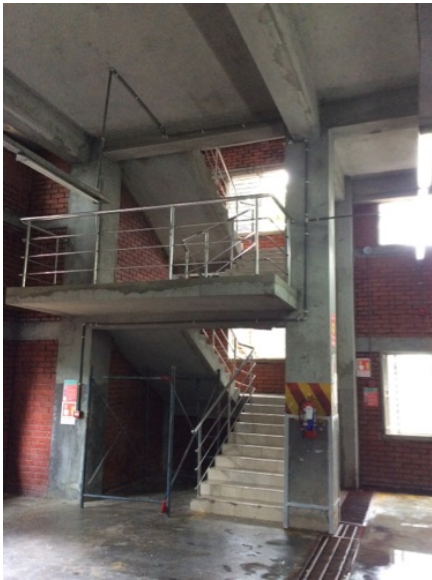
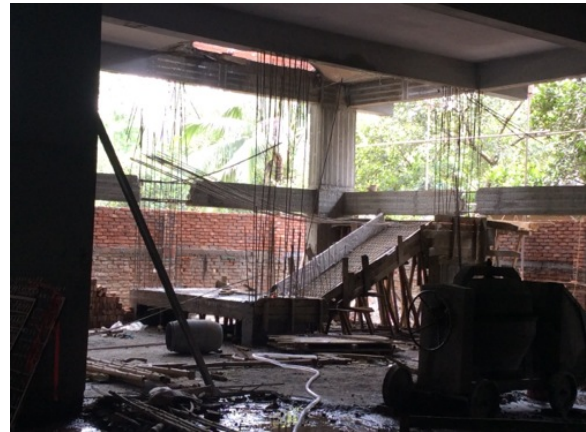
| F-8 | Egress | The Building 5 northwest exit stair discharged inside the building on the ground floor to production areas. It appeared as though the southwest Building 5 exit stair will do the same. | <p>Modify the exit stairs to discharge directly outside.</p> <p>Alternately, provide 2-hr fire-rated exit passageway leading directly outside (vestibules to separate any storage areas).</p> | Within 6 months |

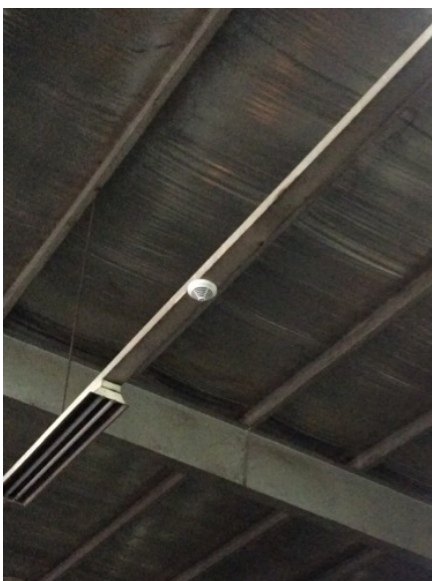
| F-10 | Fire Protection | Based off observations, the existing smoke detectors tied to the fire alarm were not installed correctly (on the bottom of electrical runners). | Based on ceiling configuration, provide additional detectors where needed, and install them in accordance with NFPA 72. | Within 6 months |
