# Fame Design Ltd. (New)

Lalpur, Fatullah, Narayangonj.  
(23.633857, 90.478877)

10<sup>th</sup> December 2020

# Observations

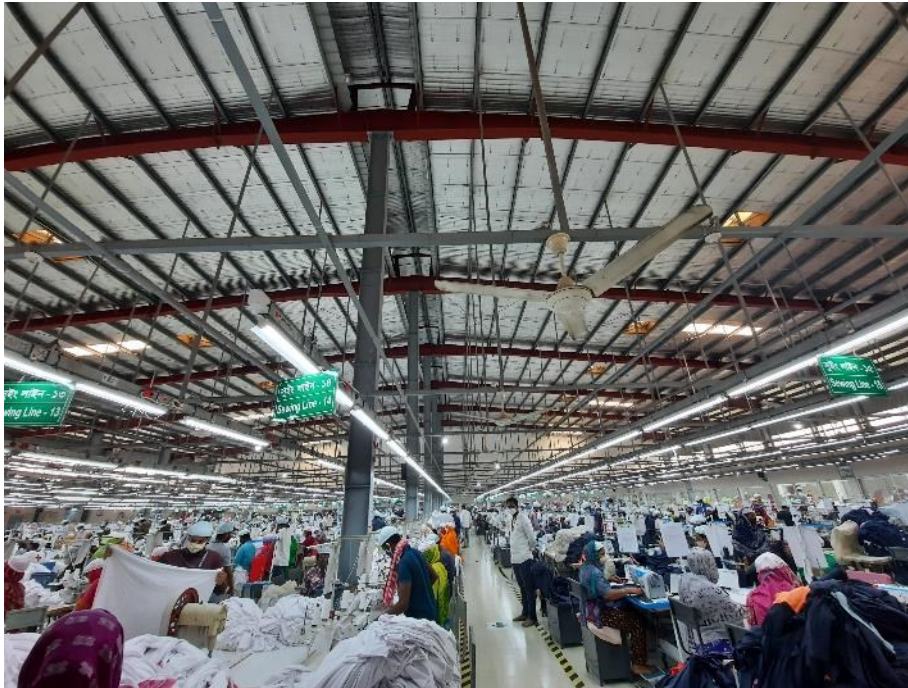
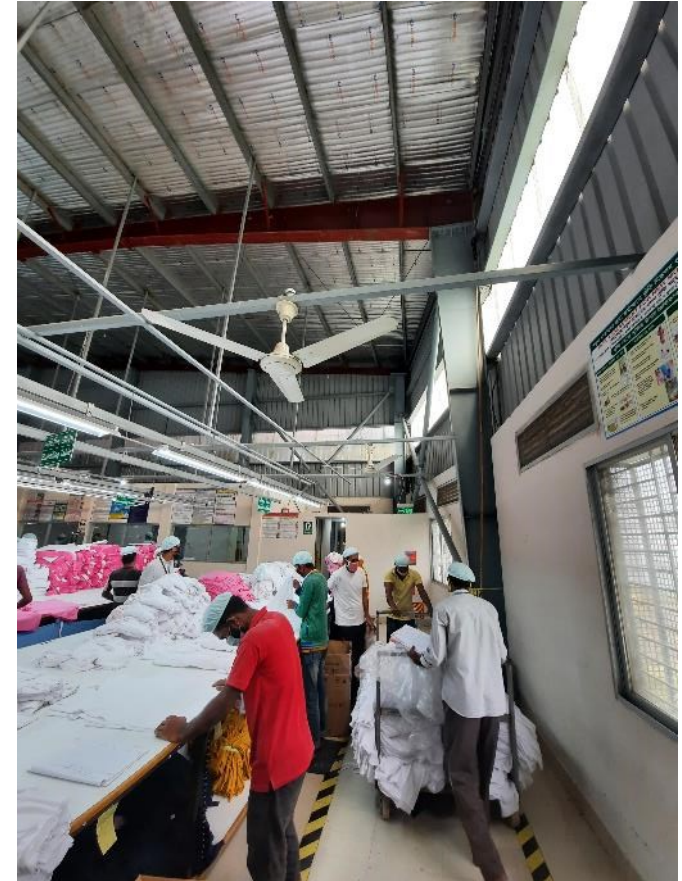
# **Absence of load transfer media in the long direction**

No compression strut/Load transfer media has been provided in the long direction. No design report was available on site. Building engineer is required to check the requirement of the any load transfer media in the long direction.

| Item No. | Observation | Recommended Action Plan | Recommended Timeline |
|---|---|---|---|
| 01 | Absence of load transfer media in the long direction (Production Building) | Building engineer is required to check the requirement of the any load transfer media in the long direction. | 6-weeks |
| 02 | Absence of load transfer media in the long direction (Production Building) | Building Engineer to prepare design report as per BNBC (part-6; Article 1.9.1) by reviewing design, loads and capacity of structural members. | 6-weeks |
| 03 | Absence of load transfer media in the long direction (Production Building) | Complete implementation of any remedial works deemed necessary by the Design Report. | 6-months |

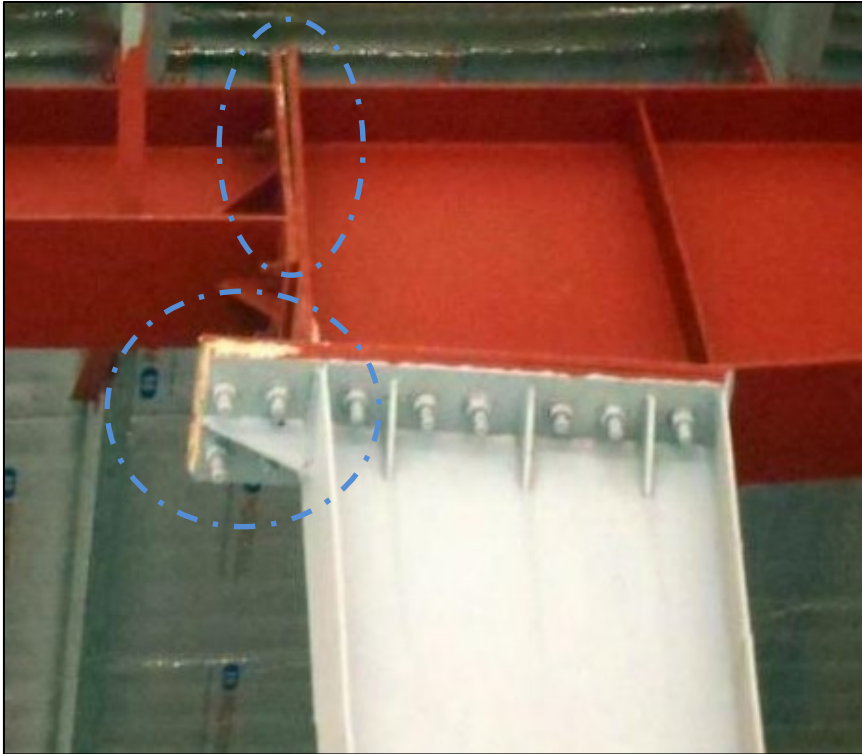
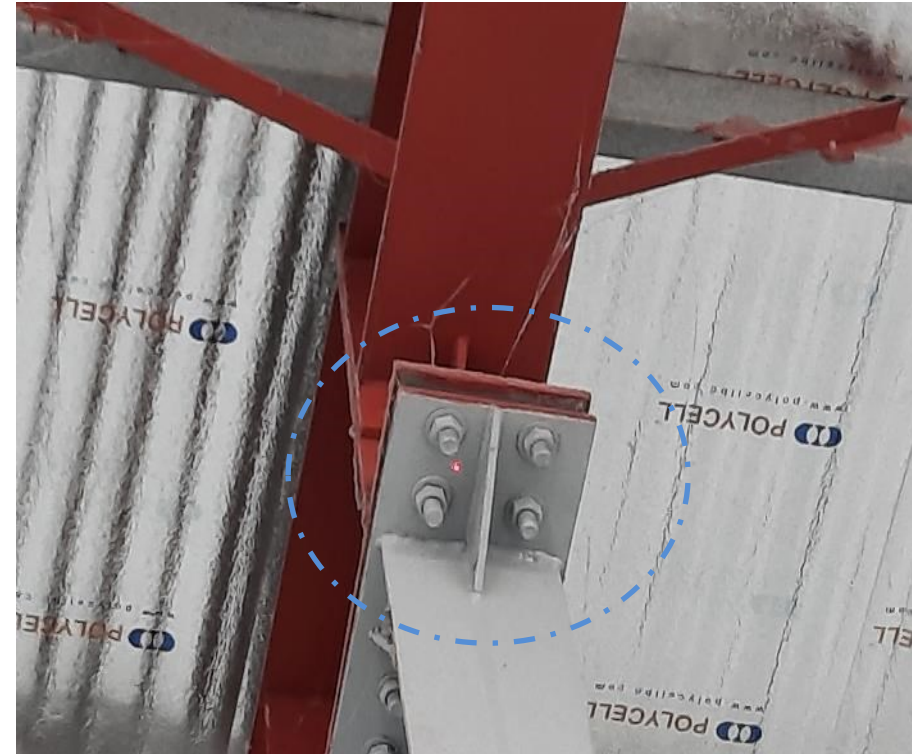
# Connection gap between rafter joints

Connection gap was found between connecting plates of the rafters and columns. Building engineer is required to seal the gaps between connecting plates with proper repair methodology.

| Item No. | Observation | Recommended Action Plan | Recommended Timeline |
|---|---|---|---|
| 04 | Connection gap between rafter joints. (Production Building) | Building engineer is required to seal the gaps between connecting plates with proper repair methodology. | 6-weeks |

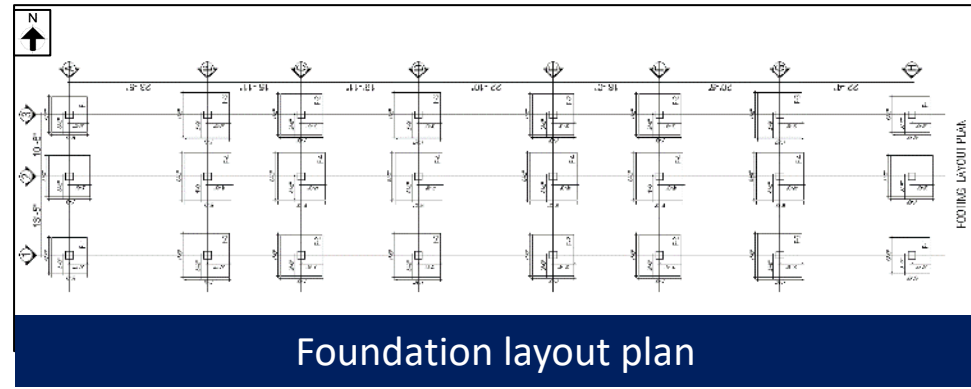
Foundation layout plan

**Footings are stressed above normal design limit.**

As per recommendation of geotechnical investigation report, the allowable bearing capacity is  $0.65 \text{ tsf}$  ( $7.1 \text{ ton/m}^2$ ) considering F.S 2.5.

Cursory calculation indicates that footing appears to be stressed above normal design limits considering the recommended soil bearing capacity in geotechnical report and footing sizes in drawing. Factory engineer is required to review the adequacy of footings and comply with BNBC.

| Item No. | Observation | Recommended Action Plan | Recommended Timeline |
|---|---|---|---|
| 05 | Footings are stressed above normal design limit (Utility Building) | Building engineer is required to review the adequacy of footings and comply with BNBC. | 6-weeks |
| 06 | Footings are stressed above normal design limit (Utility Building) | Building Engineer to prepare design report as per BNBC (part-6; Article 1.9.1) by reviewing design, loads and capacity of structural members. | 6-weeks |
| 07 | Footings are stressed above normal design limit (Utility Building) | Produce and actively manage a loading plan for all floor plates within the factory Building considering floor, column and foundation capacity. | 6-weeks |
| 08 | Footings are stressed above normal design limit (Utility Building) | Carryout remedial works where necessary. | 6-months |

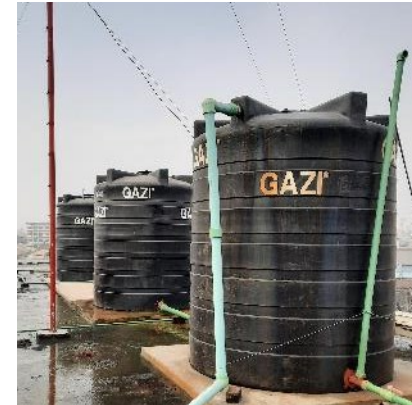
10000 liters water tank source of heavy loading

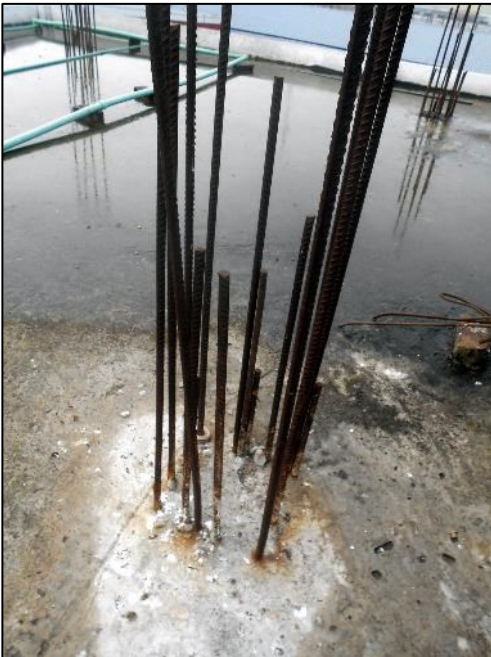
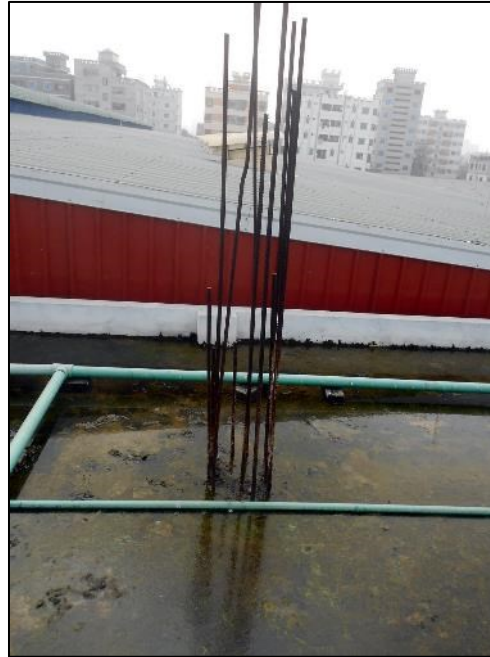
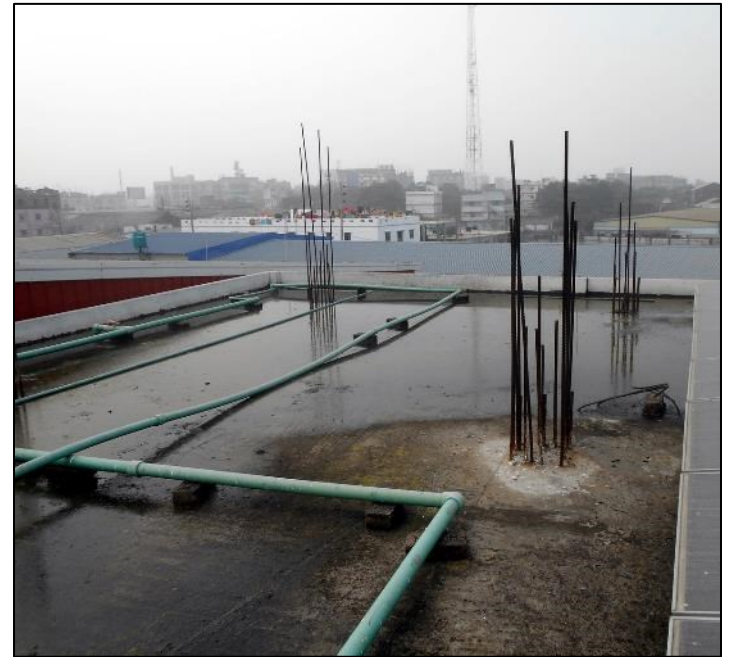
Exposed reinforcement at roof level

Exposed reinforcement found left at roof level. Building engineer is required to remove the exposed rebar otherwise provide rust proof paint to protect from corrosion.

| Item No. | Observation | Recommended Action Plan | Recommended Timeline |
|---|---|---|---|
| 09 | Exposed rebar at rooftop prone to corroded (Utility Building) | Building Engineer is required to remove the corrosions and take preventive measures. | 6-weeks |

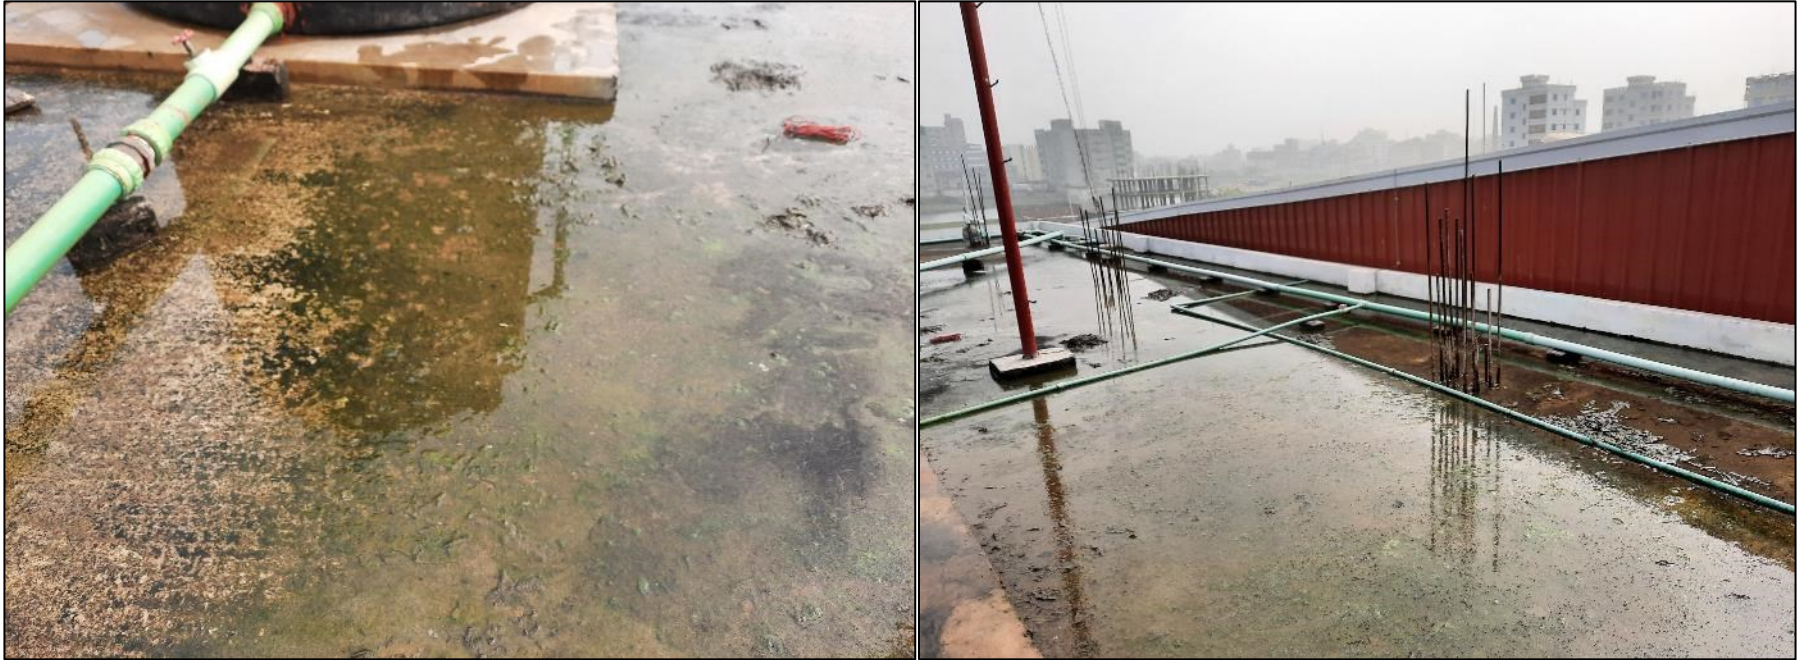
# **Water ponding & algae growth**

Water ponding & algae growth observed on the rooftop. Building engineer is required to improve the roof drainage system and provide water proofing.

| Item No. | Observation | Recommended Action Plan | Recommended Timeline |
|---|---|---|---|
| 10 | Water ponding & algae growth. (Utility Building) | Building engineer is required to improve the roof drainage system and apply water proofing. | 6-weeks |
