# KC Lingerie Ltd. (Unit-2)

57/1, Water Works Road, Godnail, Narayangong 1400.

23<sup>th</sup> February 2021

# Building Information

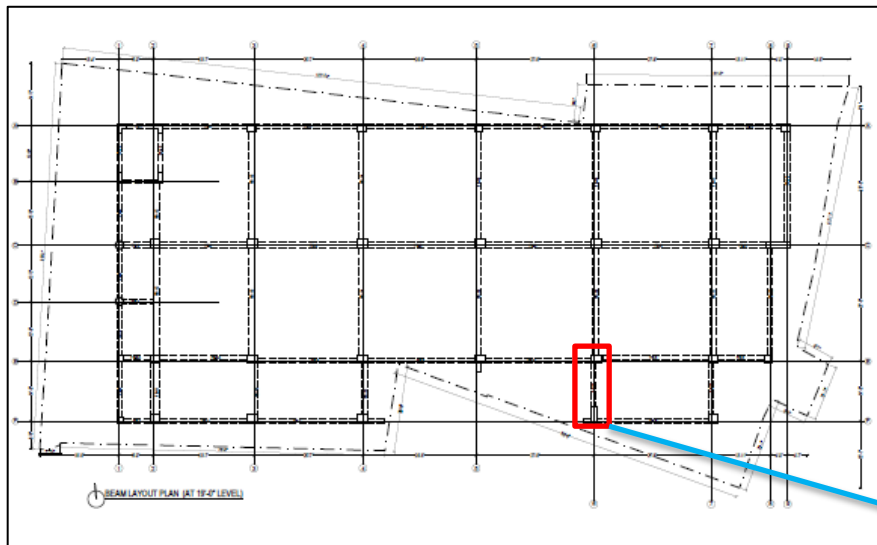
Beam layout plan

# **Discrepancies in as-built drawing with on-site condition**

Factory engineer is required to survey the whole structure and update the as-built drawing as per on-site condition.

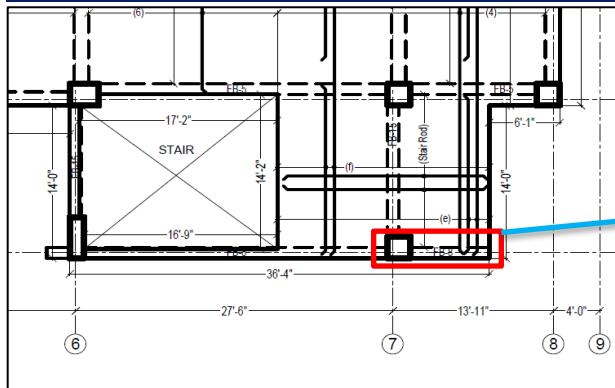
The d/s of floor beam FB-08 was found approx. 300 mm instead of 412.5 mm.

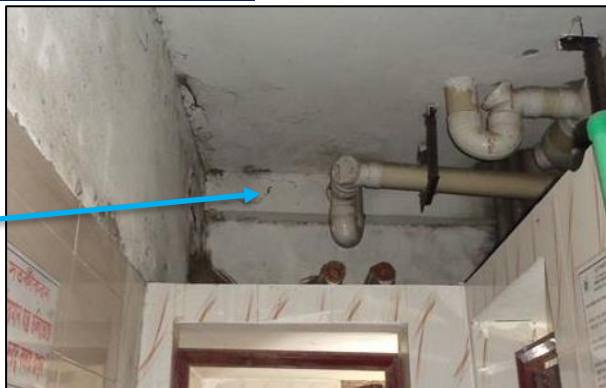
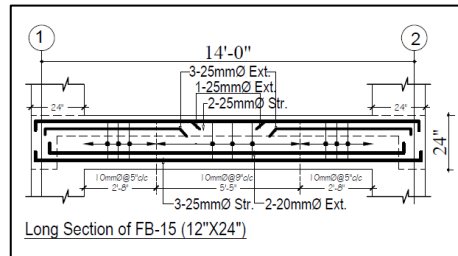
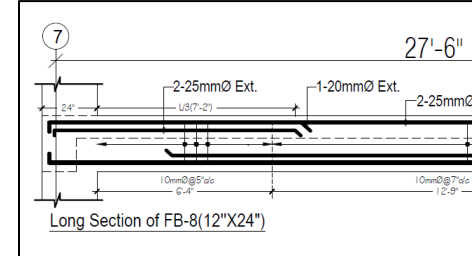
Sectional details of FB-15 and FB-08

The d/s of floor beam FB-15 was found 375 mm instead of 412.5 mm.

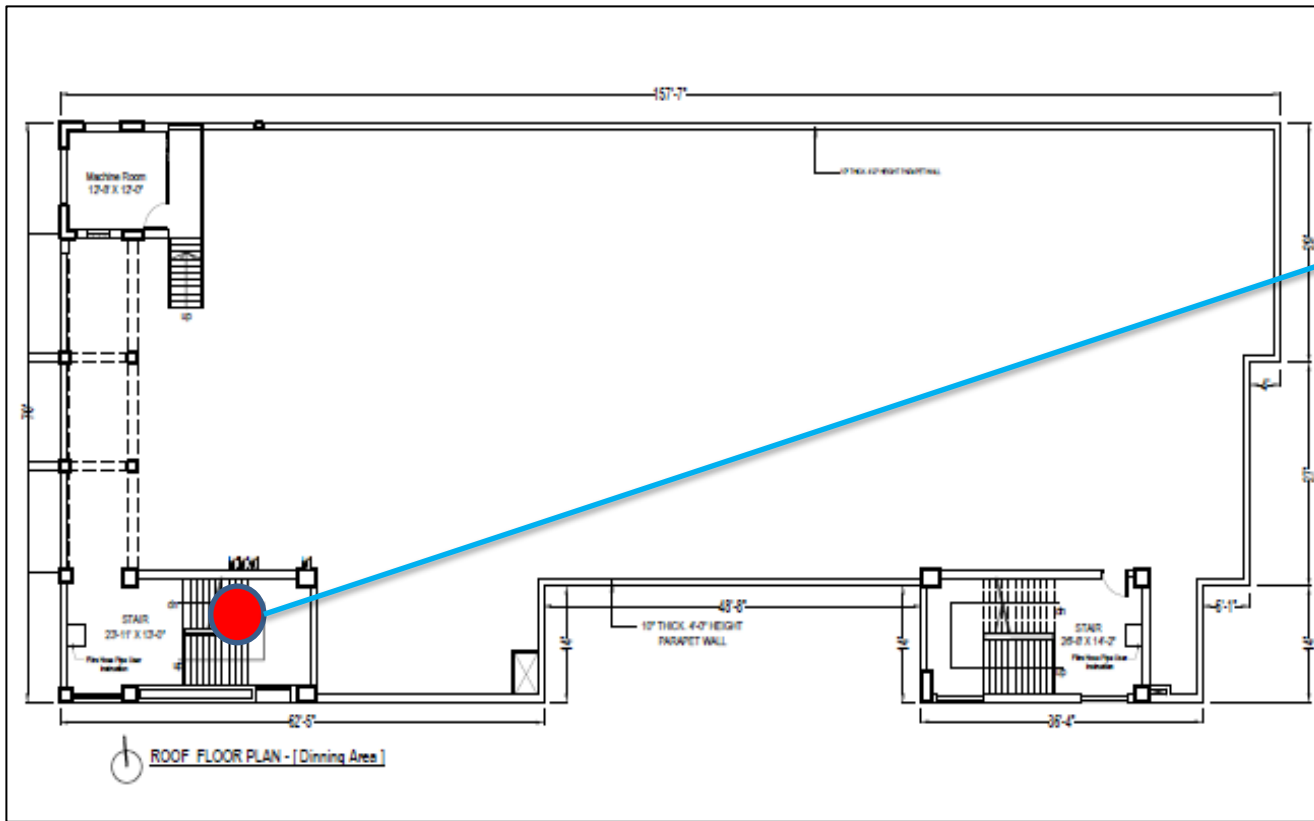
Roof layout plan

## **Undocumented plastic water tank at stair roof level**

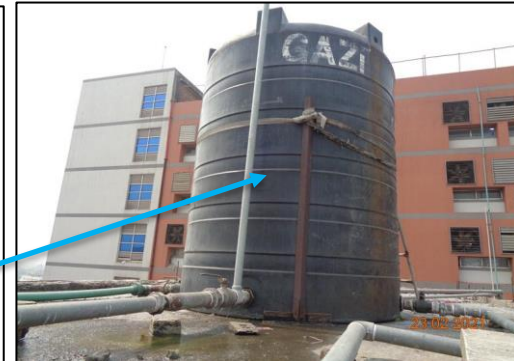
Undocumented water tank

An undocumented plastic water tank (5000 liter) was found at stair roof level. No drawing was available for this water tank. Factory engineer is required to survey the whole structure and update the as-built drawing as per on-site condition.

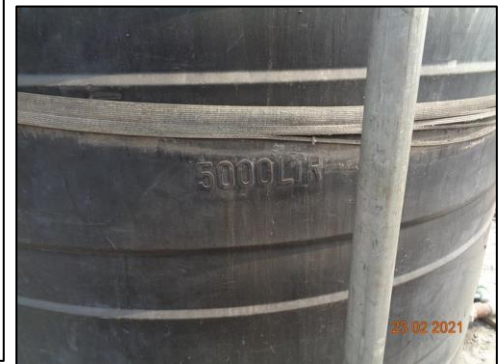
Capacity of water tank

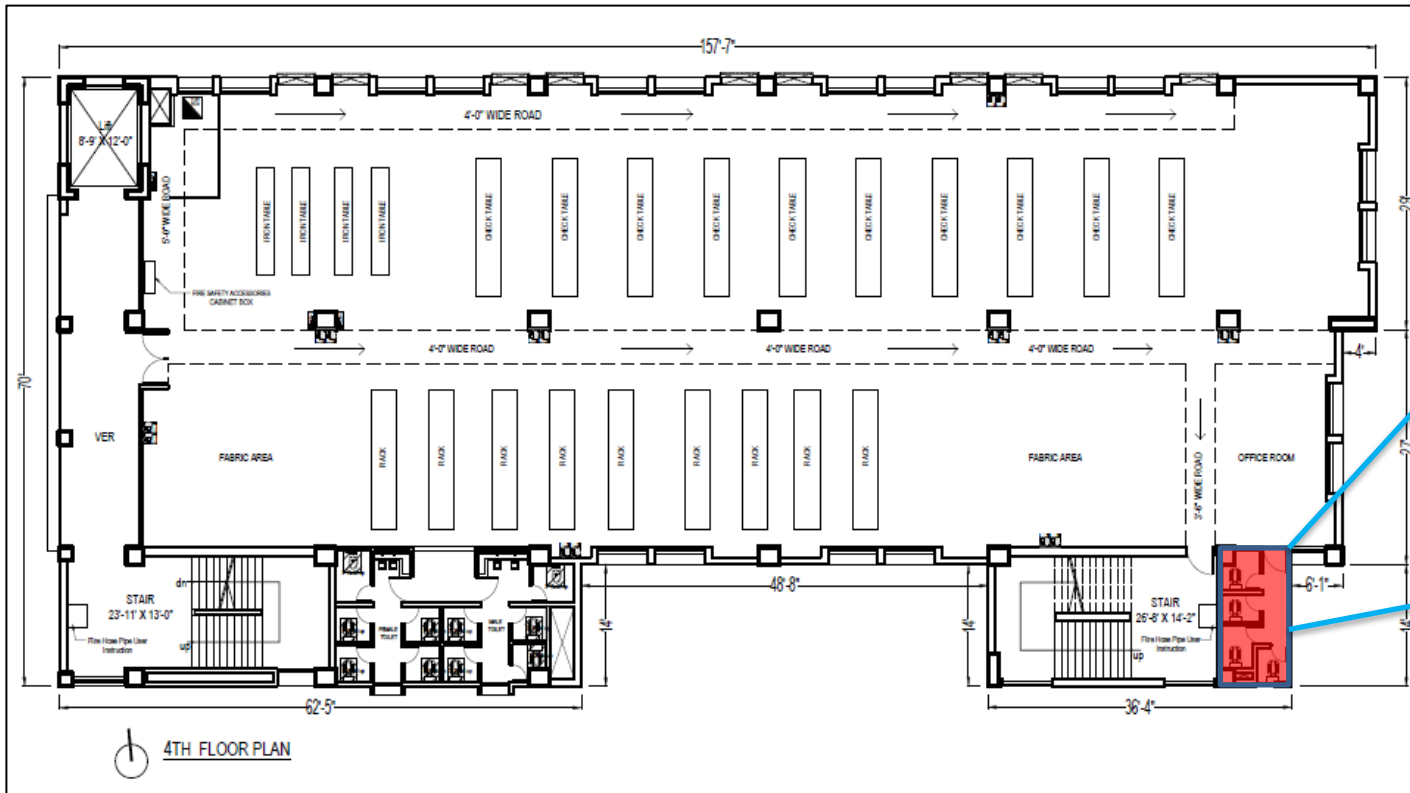
4<sup>th</sup> floor layout plan

**Toilet zone at south-east corner rest on cantilever**

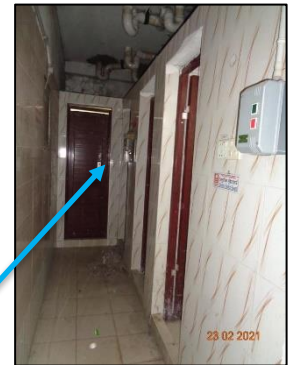
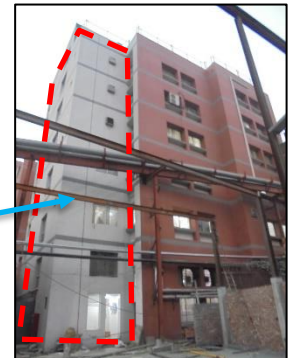
Cantilever toilet at south-east corner

A cantilever toilet was found at south-east corner of the building from ground floor to roof. Factory engineer is required to check the adequacy of the slab at cantilever portion.

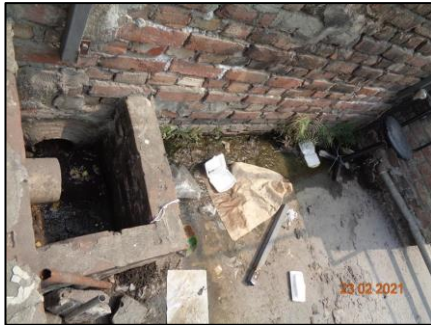
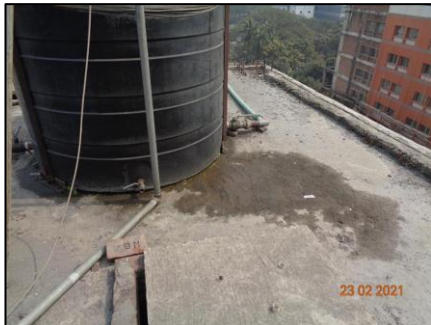
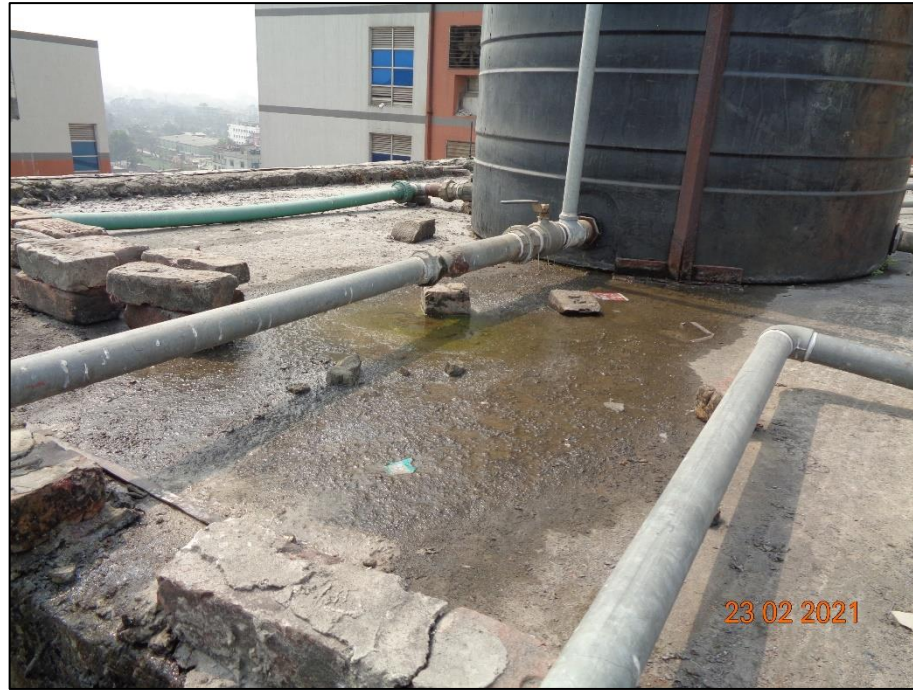
Water leakage at roof & stair roof

Due to leakage in the water supply line, water clogging was found at roof & stair roof. Factory engineer is required to take necessary measures to prevent the leakage in the water supply line. Also investigate the reason of leakage to verify if any damaged occurred due to the presence of the moisture in structural members.

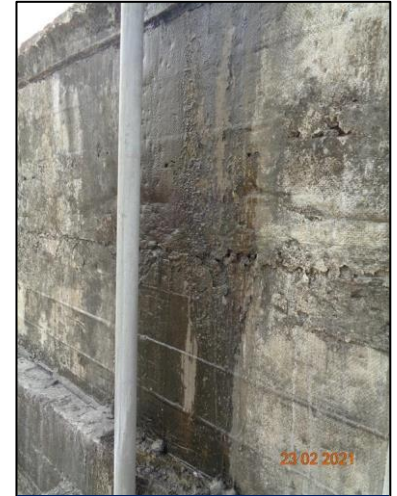
Water leakage in  
RC water tank

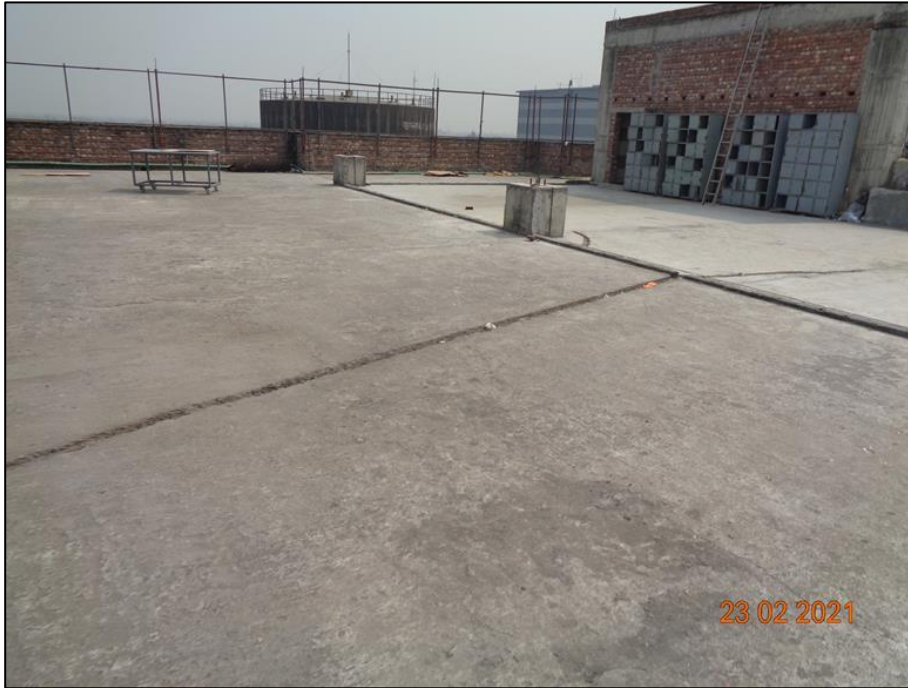
No water proofing layer

No water proofing layer was applied on roof. Moreover, drainage system was appeared to be improper. As a result, signage of water clogging was found on roof. Factory engineer is required to improve the drainage system & apply water proofing layer on roof.

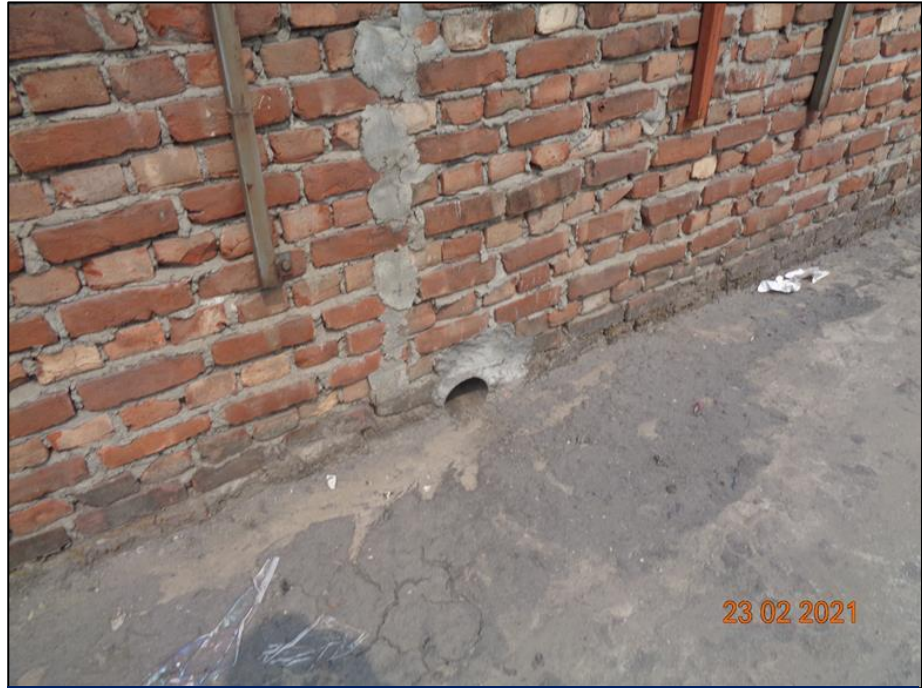
Signage of water clogging

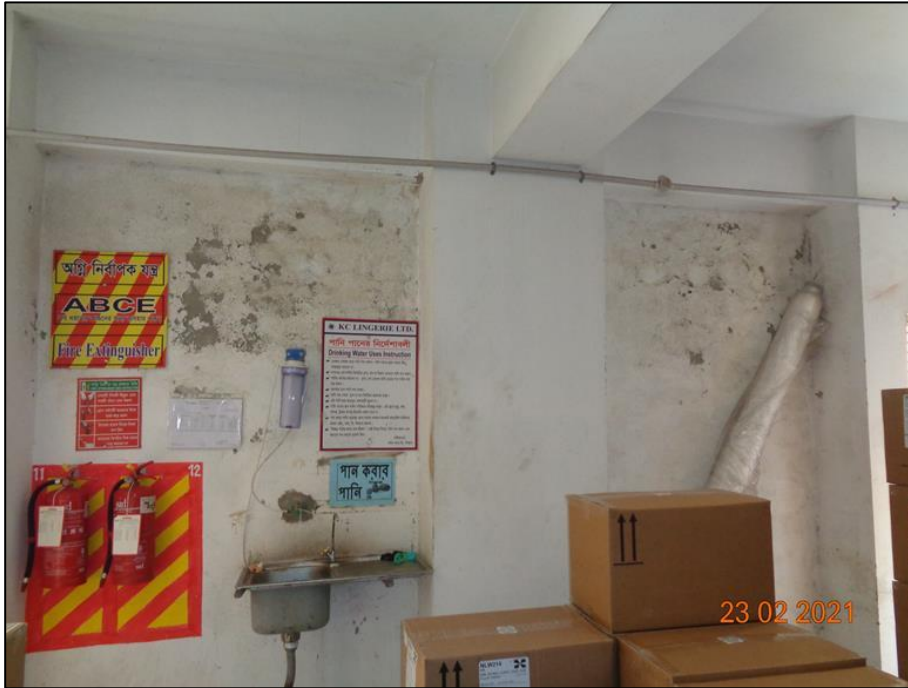
Dampness in periphery brick wall at 5<sup>th</sup> floor

Dampness was found in periphery brick wall at 5<sup>th</sup> floor and stair bottom slab from ground floor to roof. Factory engineer is required to investigate the reason of dampness and apply suitable method to repair dampness.

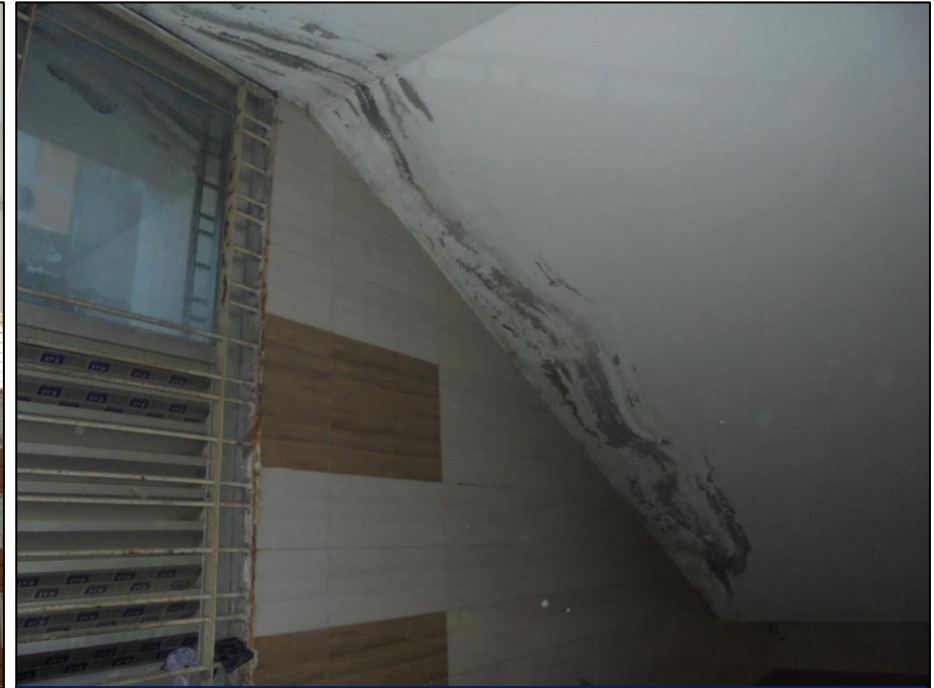
Dampness in stair bottom slab

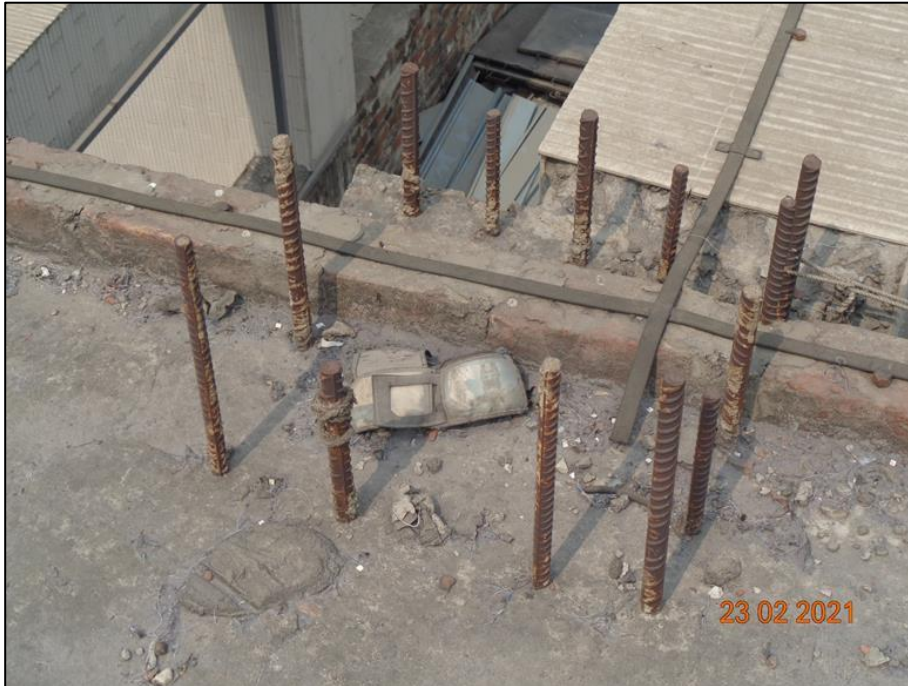
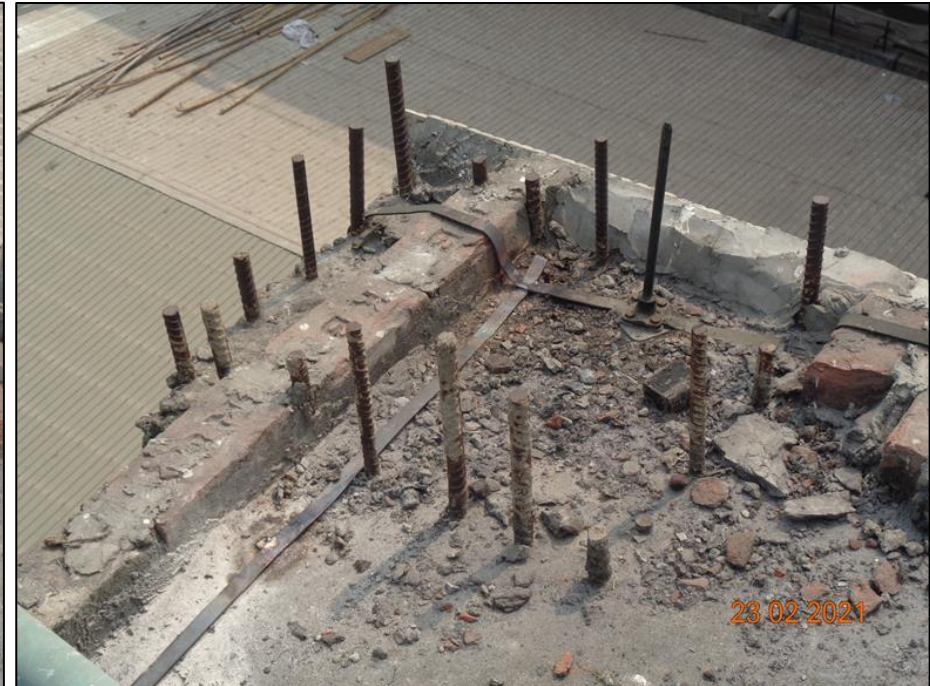
Exposed rebar at stair roof

Exposed rebar was found at stair roof. The exposed rebars are prone to be corroded. Factory engineer is required to provide rust proof paint to prevent future corrosion.

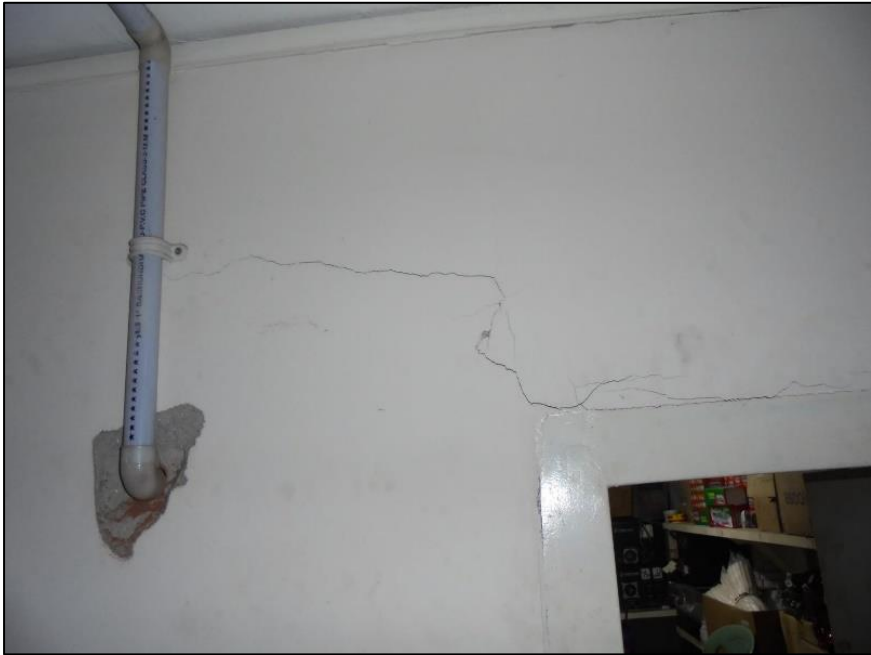
Crack in brick wall

Crack was found in several locations on brick wall. Factory engineer is required to investigate the cause of crack and repair the crack as per recommendation from investigation report.

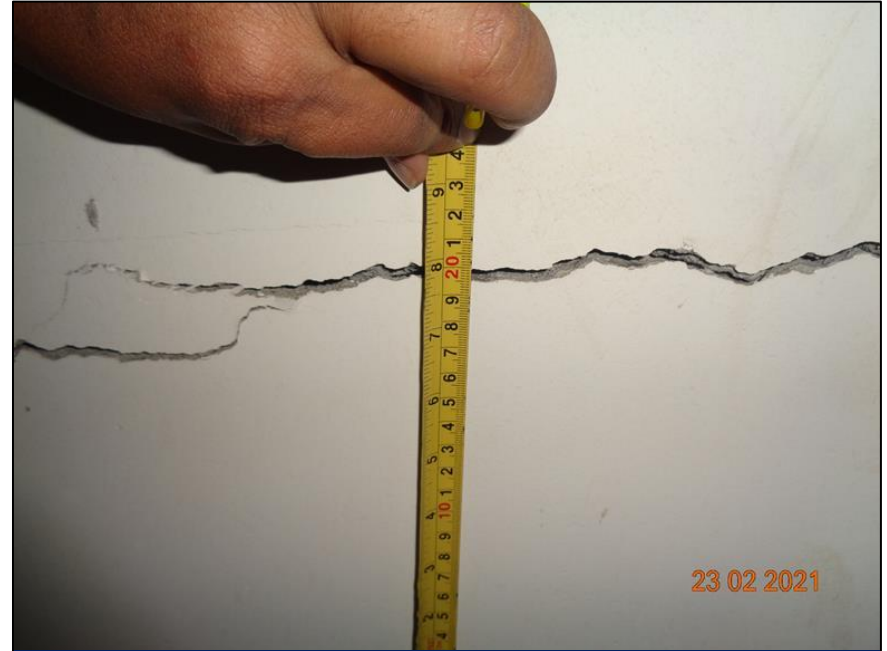
Thickness of crack

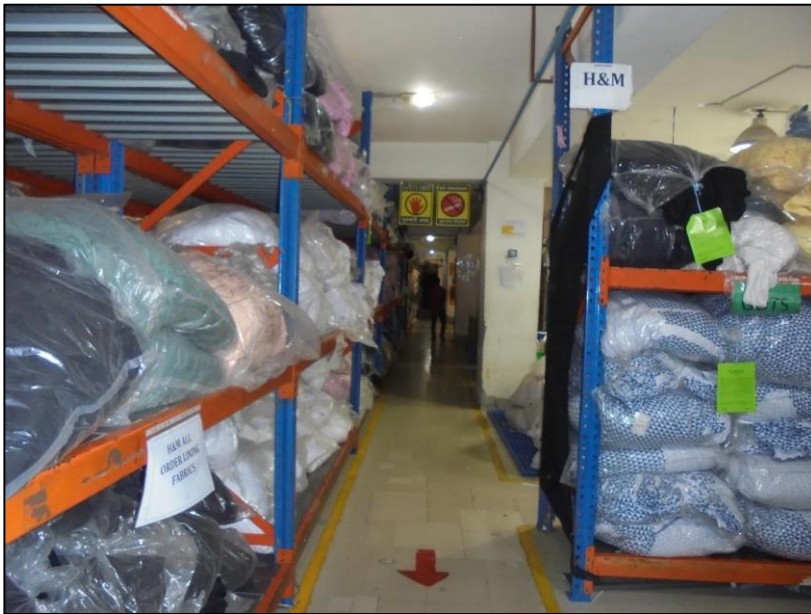
Storage rack

Storage racks in different floor were not anchored with floor. Factory engineer is required to anchor the storage racks with floor to avoid lateral instability.

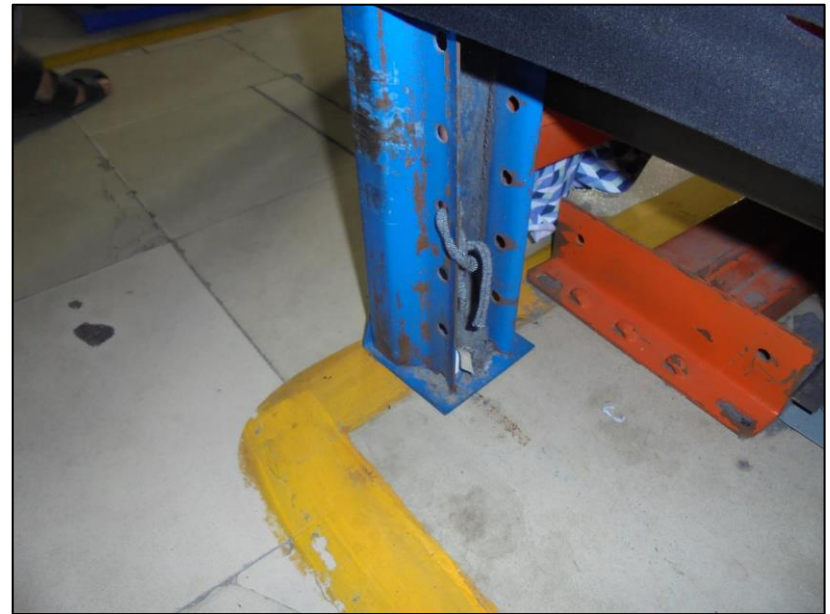
No anchoring with floor

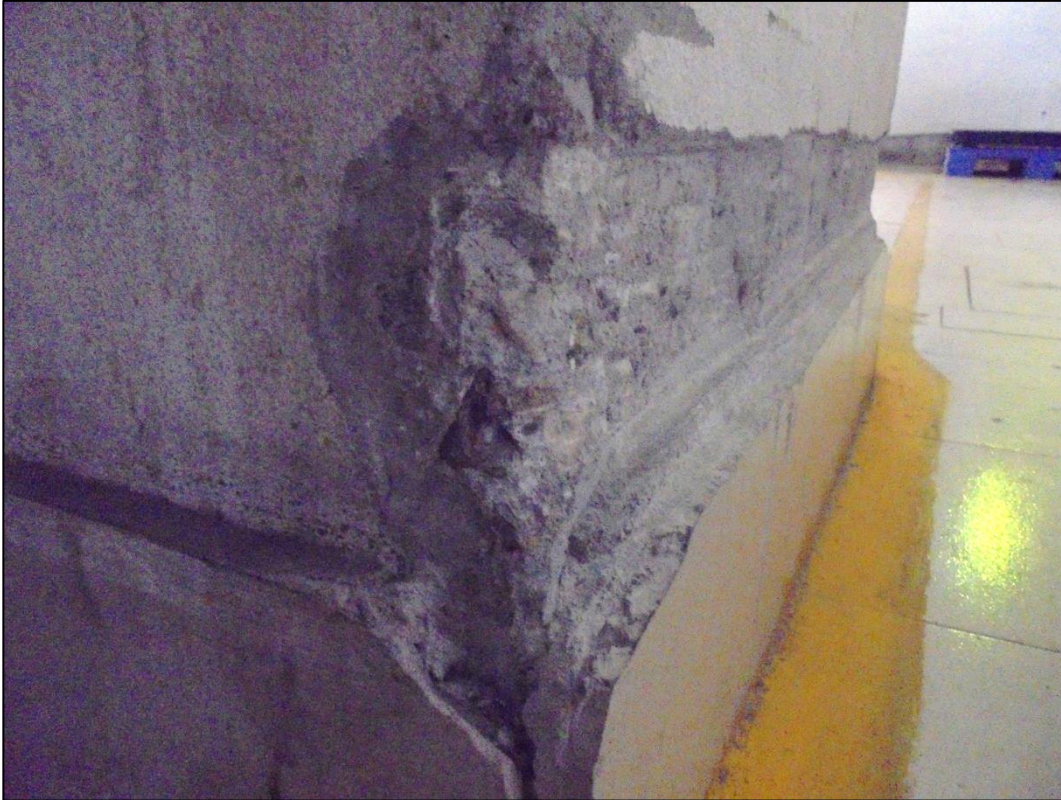
Damage column at 5<sup>th</sup> floor

Column at 5<sup>th</sup> floor storage area was found slightly damaged due to impact. Also ground floor column is susceptible to vehicle impact. Factory engineer is required to install column guard to prevent column from damage.

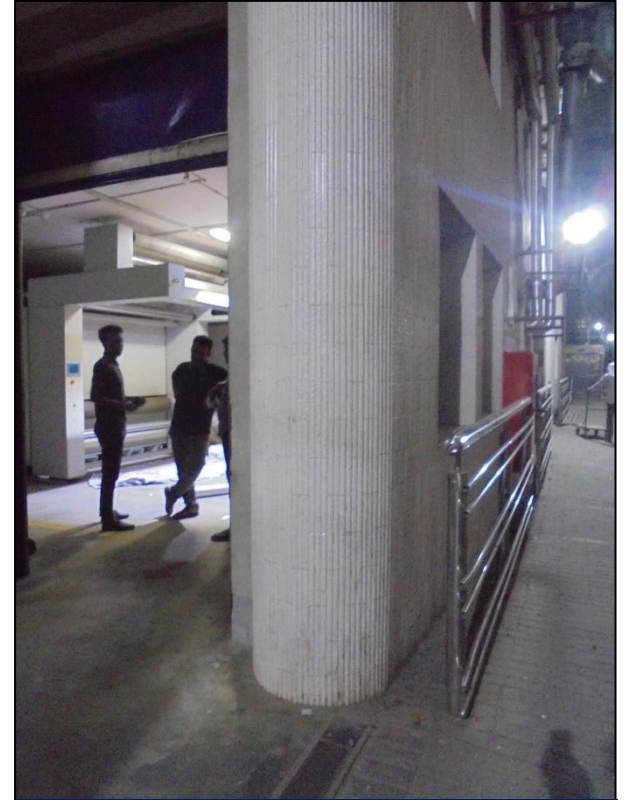
Column at ground floor
