# FASHION.COM LIMITED

25/2, Durgapur, Kathgora, Zirabo, Ashulia, Savar, Dhaka-1341.  
(23.907842, 90.301531)

01<sup>st</sup> Nov 2020

# Observations

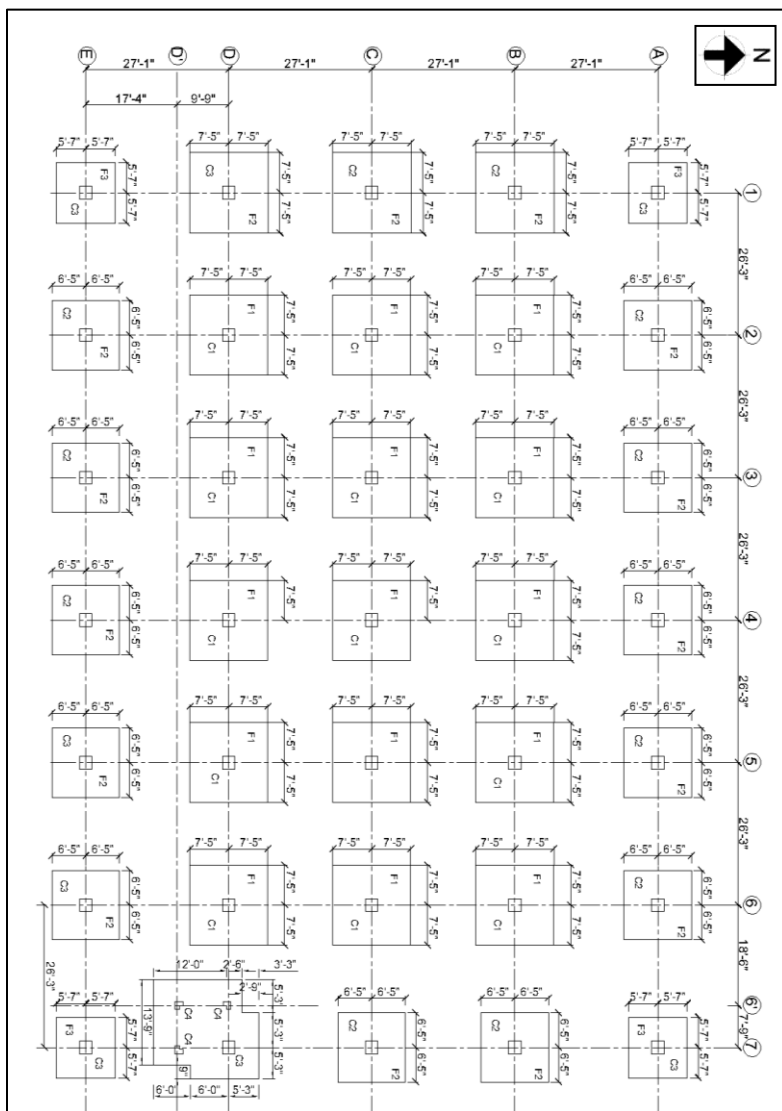
Foundation layout

**Punching stress of foundation exceeds normal  
design limit**

Cursory calculation indicates that, the punching capacity of the F2 foundation exceed normal design limit considering 3 kPa live load and provided material & soil test reports. Building Engineer to review design, loads and foundation stresses in compliance with section 1.9.1.2 of BNBC.

| Item No. | Observation | Recommended Action Plan | Recommended Timeline |
|---|---|---|---|
| 01 | Punching stress of foundation exceeds normal design limit (Production Building) | Building Engineer to review design, loads and foundation stresses as per BNBC (part-6; Article 1.9.1). | 6-weeks |

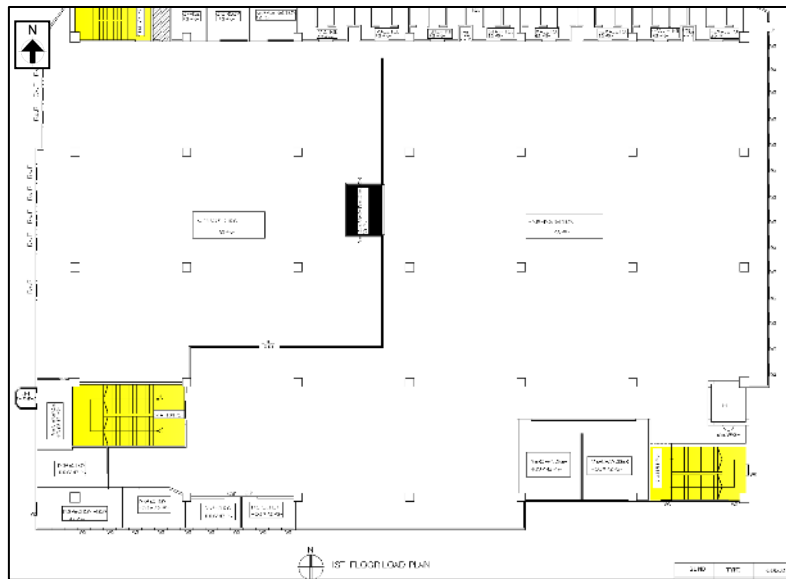
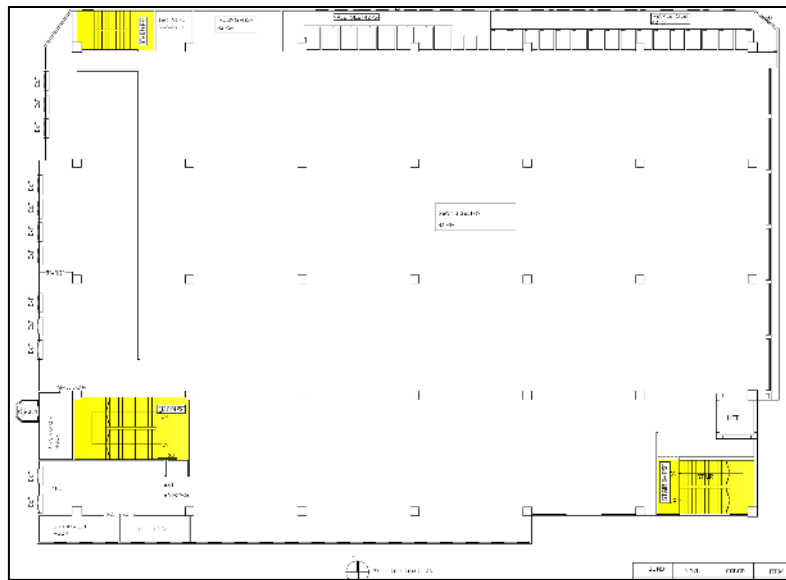
Load plan of 2<sup>nd</sup> , 3<sup>rd</sup> and 4<sup>th</sup> floor 2 kPa

The construction of the building was completed on 2017 but the load plan and design was developed considering 2 kPa for 2<sup>nd</sup>, 3<sup>rd</sup> and 4<sup>th</sup> floor and 3 kPa for 1<sup>st</sup> floor. Building engineer is required to revise the DEA report considering minimum floor live load (3kPa) as per BNBC (2006) load combination.

| Item No. | Observation | Recommended Action Plan | Recommended Timeline |
|---|---|---|---|
| 06 | DEA report need to be revised (Production Building) | Building Engineer to revise DEA report by reviewing design, loads and capacity of structural members & foundation. | 6-weeks |

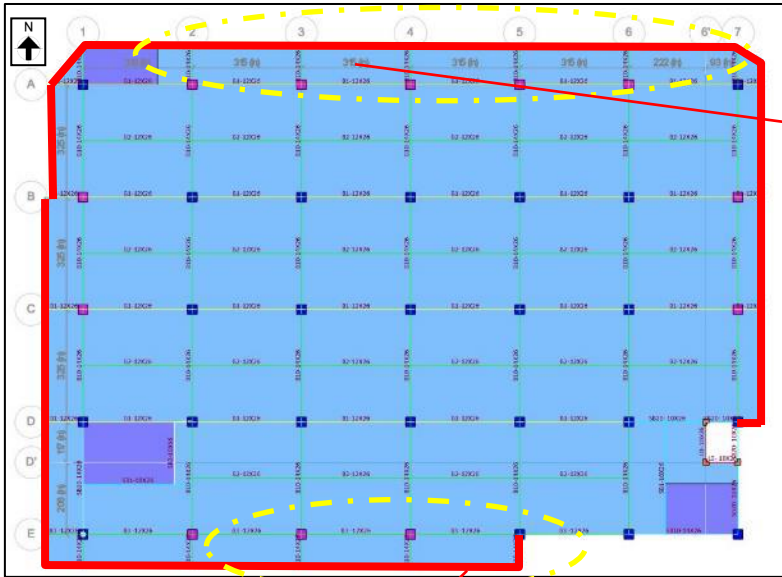
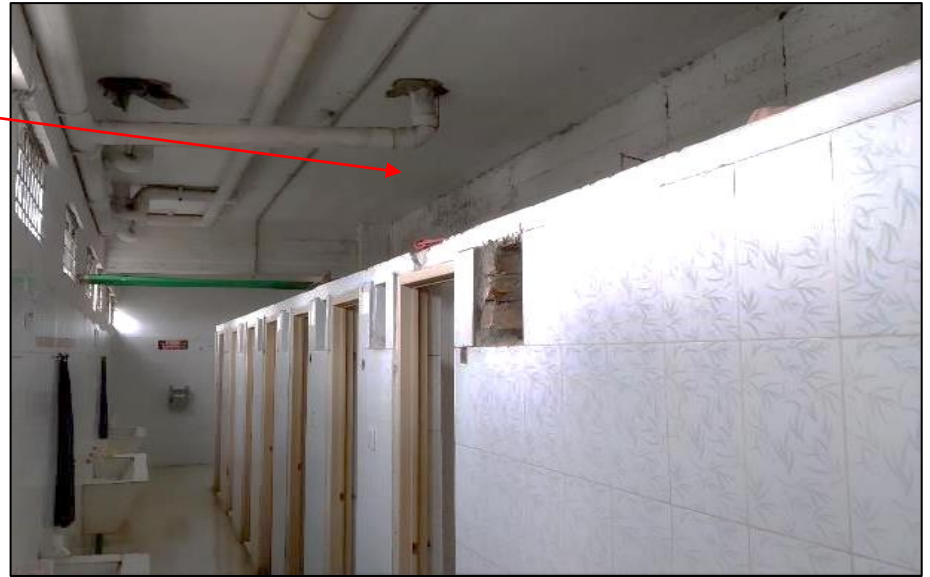
Edge beam on Toilet area

The edge beam was observed on the cantilever area as per the beam layout. This beam has not been addressed in both drawing or FEA model. But on the site, a continuous beam on the periphery was observed. The measured beam depth was 510 mm at ground floor. The drawing need to be revised along with DEA report.

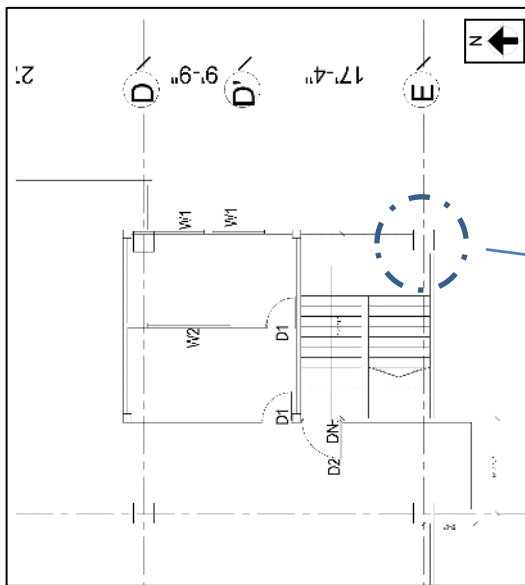
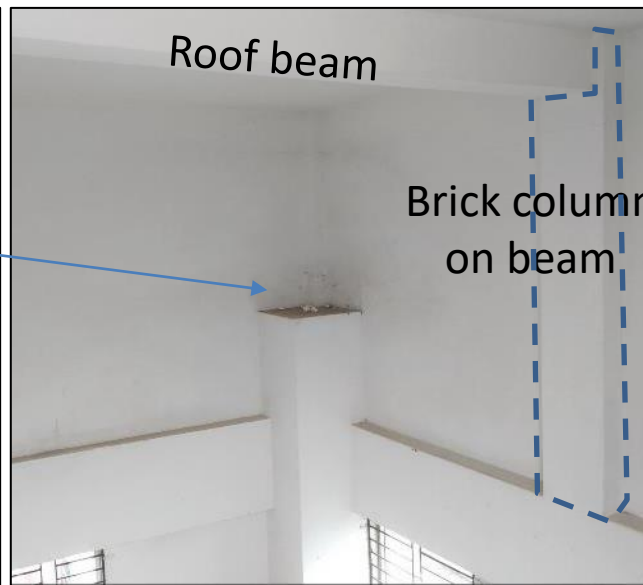
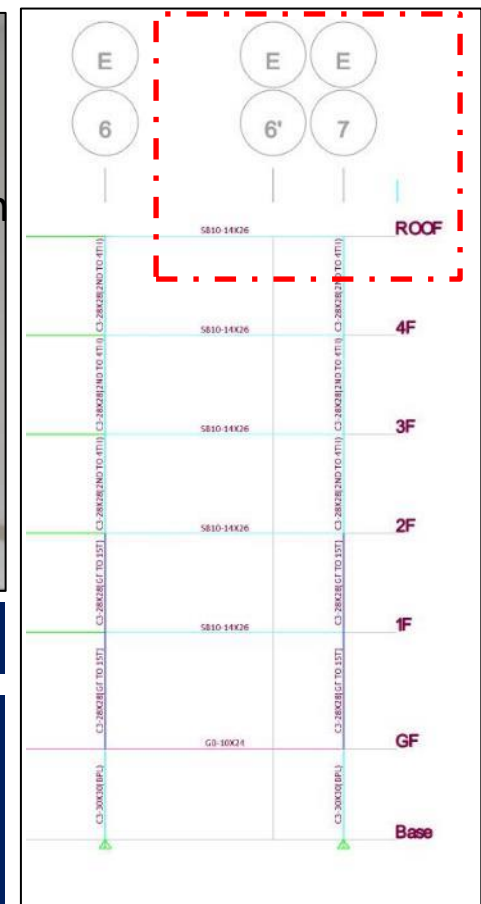
Column C3 (Grid E07) location on drawing and in site

As per architectural drawing, there are a garret on the east and west stair case. On the east stair case, the column does not reach up to the roof level. On the FEA model non of this garret area has been assigned. The roof slab and roof beam is seems to be supported by the masonry wall around. This system may rise the issue of lateral instability of the roof. Building engineer is required to address this issue and revise the DEA report along with the drawing.

Column C3 on FEA model, no section defined on the garret

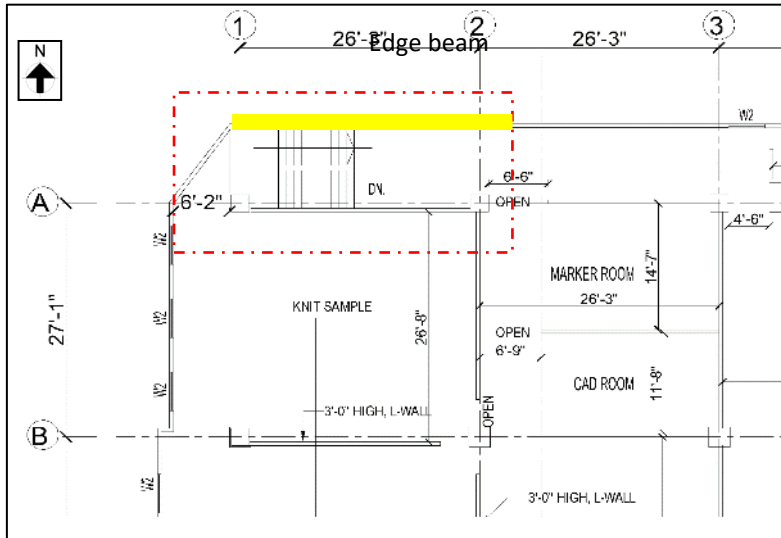
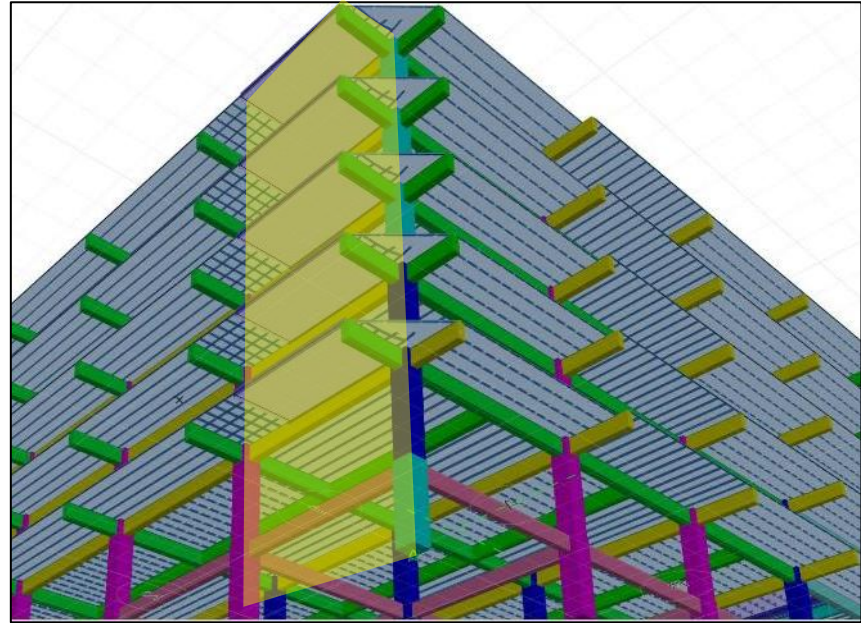
## Stair on north west direction

The highlighted area is the assigned stair on FEA model

The stair is fully resting on the beam and two columns on the west. There is an edge beam to support on the north side of the stair. There is no beam on the transverse direction either, to support the landing slab. Thus, the load path of the stair is not clear. Building engineer is to check the overall stability of the stair along with the DEA report.

| Item No. | Observation | Recommended Action Plan | Recommended Timeline |
|---|---|---|---|
| 10 | Verify Load Path of Stair at North West side (Production Building) | Building engineer to check the load path and overall stability of the mentioned stair along with the DEA report. | 6-weeks |

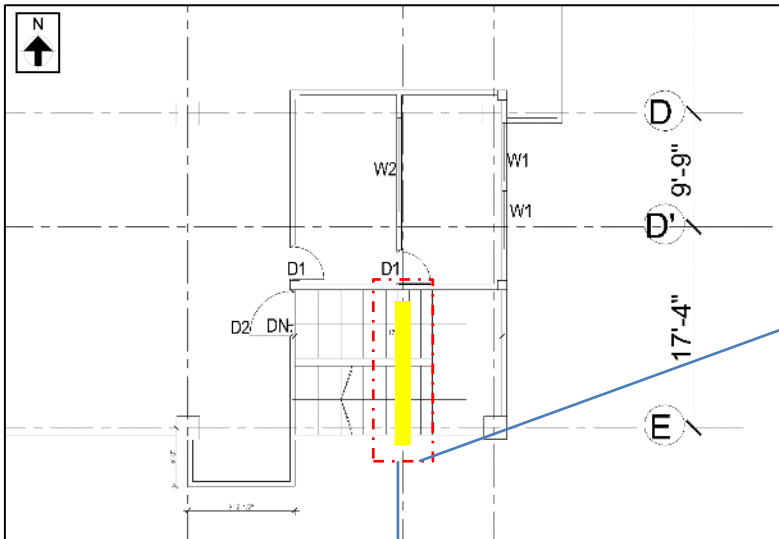
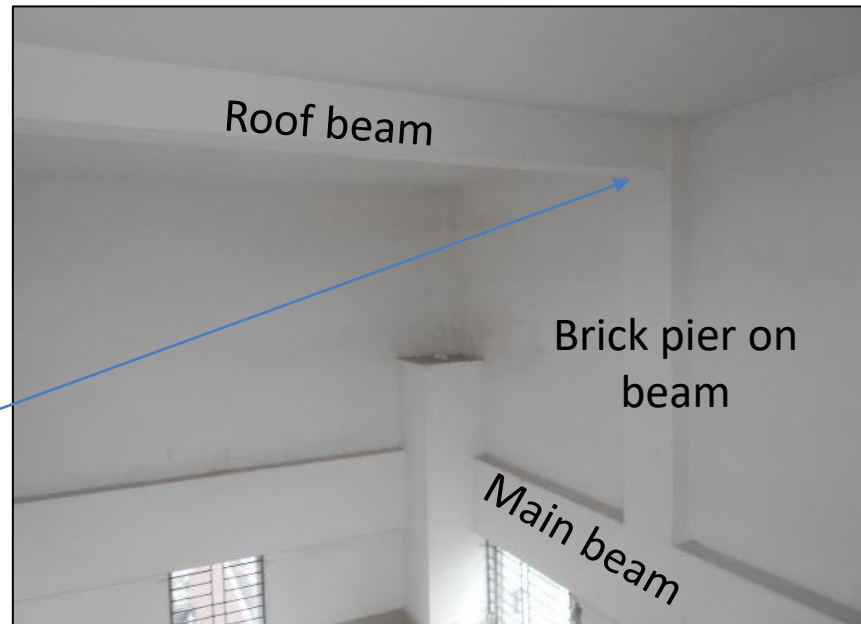
## Stair on south east direction

Roof beam is resting on brick pier which is resting on edge beam

Crack was observed near the support of the roof beam. The lateral stability of this roof beam along with the slab is unknown, as the beam-slab is resting on the periphery wall. Building engineer is required to investigate the crack as per part of DEA and suggest any remediation required.

| Item No. | Observation | Recommended Action Plan | Recommended Timeline |
|---|---|---|---|
| 12 | Appearance of Crack on Roof Beam (Production Building) | Building Engineer to investigate the cause of crack and continuous monitoring the status of the crack. | 6-weeks |
| 13 | Appearance of Crack on Roof Beam (Production Building) | Carry out any structural remedial works arising from review and investigation. | 6-months |

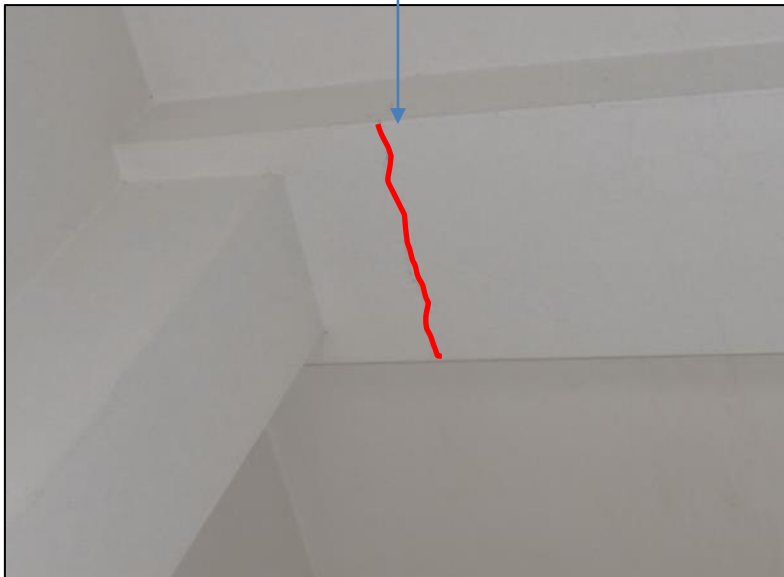
Crack on roof beam near the support

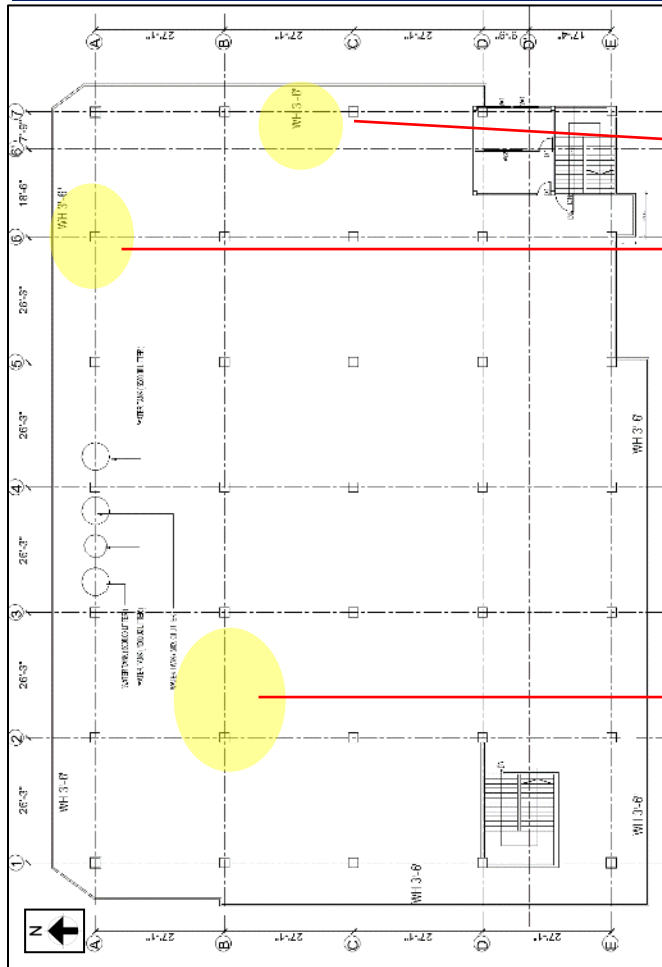
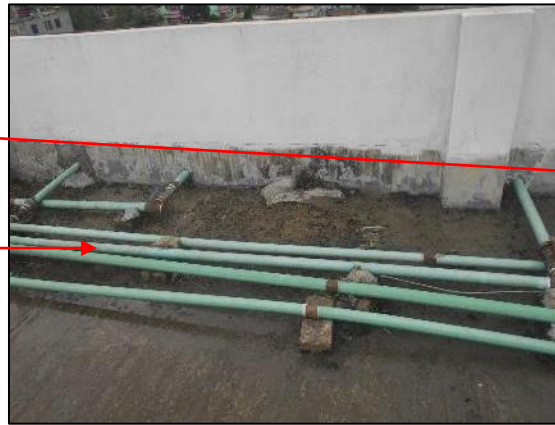
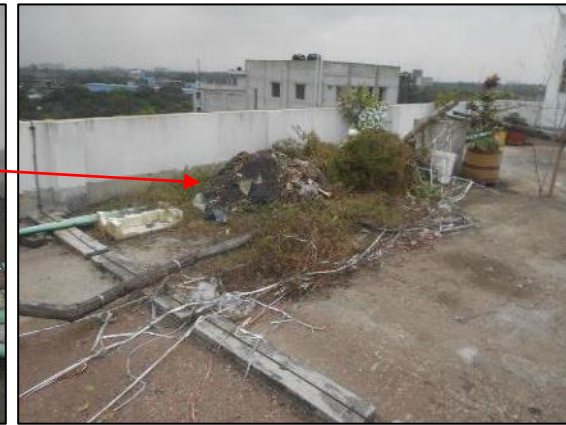
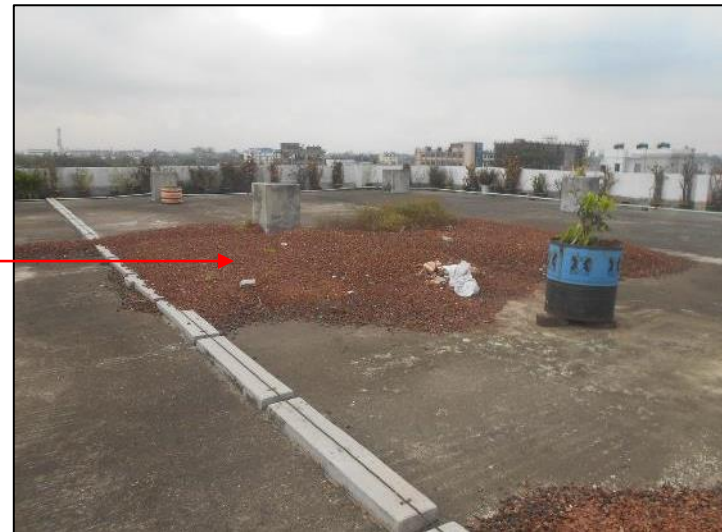
## Roof layout ( rubbish stacked area )

Rubbish was found on the different location of the roof slab. This stacking may deteriorate the structural integrity of the concrete of the slab by absorbing water in certain places. The drainage pipes were found on north and west direction only. Water stagnant was found on the north side. Building engineer is required to remove the rubbish materials from roof and develop proper drainage system.

| Item No. | Observation | Recommended Action Plan | Recommended Timeline |
|---|---|---|---|
| 14 | Roof slab susceptible to damage (Production Building) | Building Engineer to remove rubbish material from roof. | 6-months |

| Item No. | Observation | Recommended Action Plan | Recommended Timeline |
|---|---|---|---|
| 20 | Roof slab susceptible to damage (Production Building) | Building Engineer to develop a proper drainage system on roof as BNBC provision. | 6-weeks |

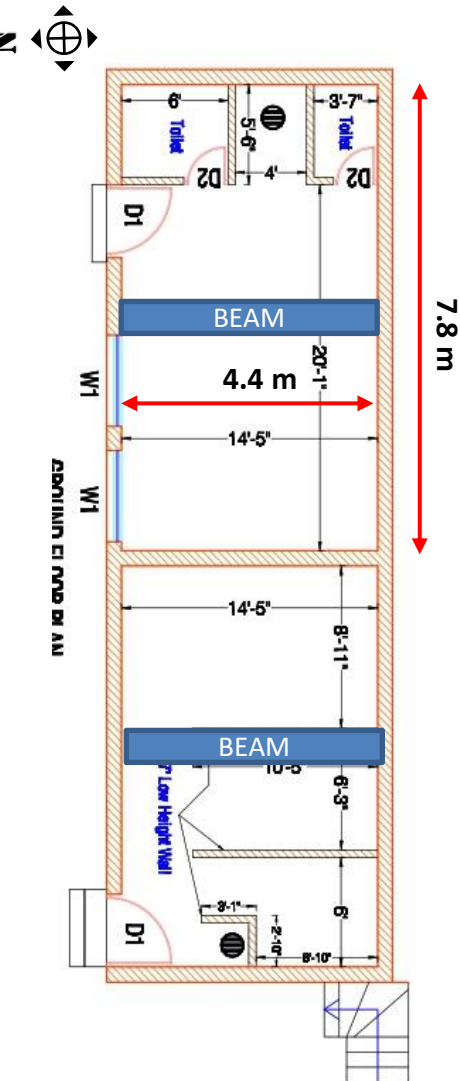
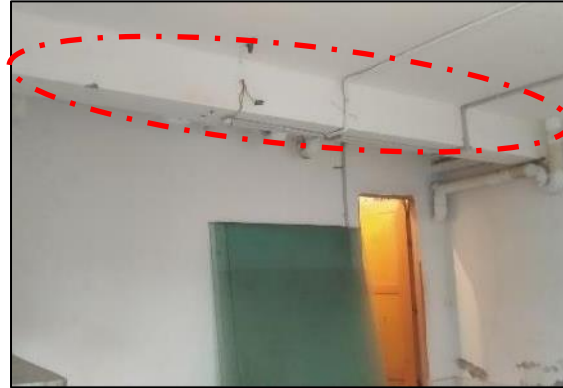
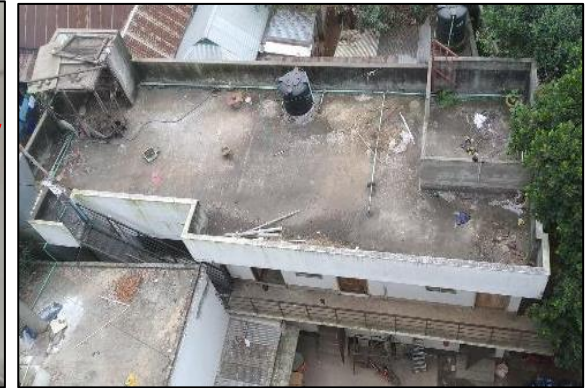
### Beam on mid span

The architectural drawing was available during inspection. The structural system of jhute building is, RC Beam slab supported on load bearing masonry wall which is resting on the concrete walls of underground water reservoir (UGWT). There are two beams found on the mid span of this building on both ground floor and 1<sup>st</sup> floor. There was no structural drawing to confirm the dimension and rebar of these beams, opening of the masonry load bearing walls and UGWT. Drawing to confirm the foundation system is also unavailable. There is a plastic water tank on the roof. No drawing found for the steel stair either. Building engineer is required to produce as-built documents and check overall stability against vertical and lateral loads as part of DEA.

| Item No. | Observation | Recommended Action Plan | Recommended Timeline |
|---|---|---|---|
| 21 | Lack of as-built document and verify overall stability (Jhute building) | Building Engineer to survey the structure and prepare accurate as-built (both architectural & structural) drawings. | 6-weeks |
| 22 | Lack of as-built document and verify overall stability (Jhute building) | Building engineer to carry out a Detail Engineering Assessment (DEA). | 6-weeks |

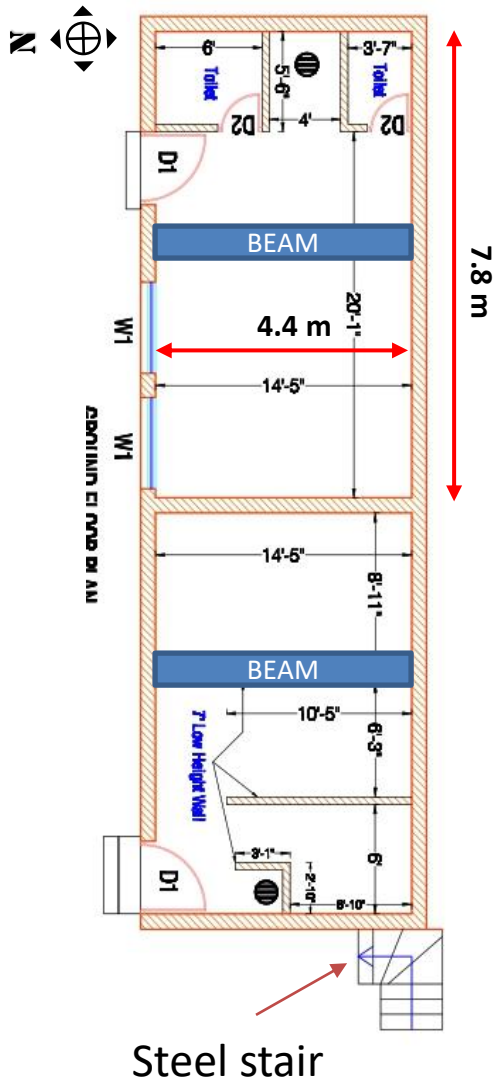
## Ground floor Floor plan

The stair on the west side is also poorly connected with the building wall with one side. Non engineering connection for the steel stair was found.

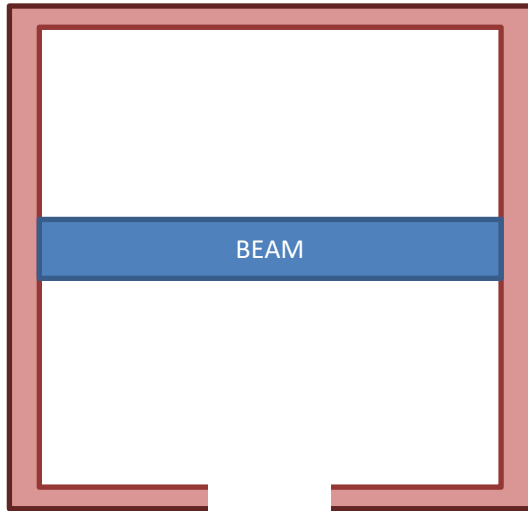
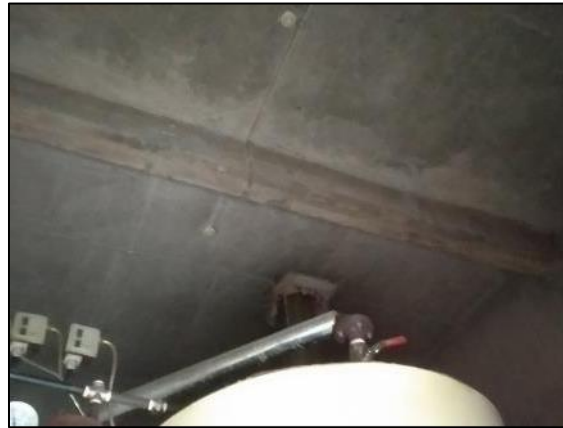
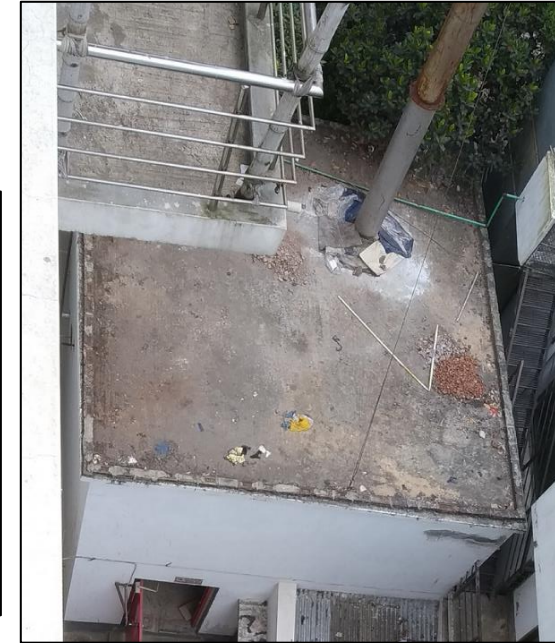
There were no credible as-built structural drawing or documents to review. This masonry structure with 5.36 height is totally resting on 250 mm brick wall. The Factory engineer is required to survey the structures and prepare as-built drawings.

| Item No. | Observation | Recommended Action Plan | Recommended Timeline |
|---|---|---|---|
| 28 | Lack of as-built document (Boiler Room) | Building Engineer to survey the structure and prepare accurate as-built (both architectural & structural) drawings. | 6-weeks |
