# Shad Fashion Ltd. (New Building)

Gorat, Ashulia, Savar, Dhaka  
(23.944135, 90.302859)  
22<sup>nd</sup> December 2020.

# Building Information

1. New Building. (G+2)

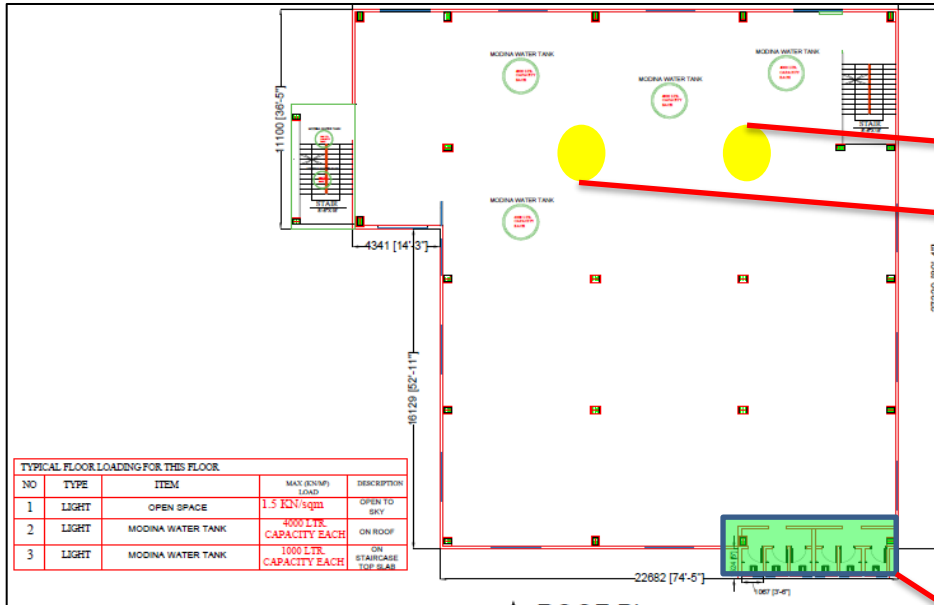
## 4000-liter water tank

There are 2 water tanks on roof top whose allowable capacity is 4000-liter. But 4 nos. 4000-liter water tanks have been shown in as-built drawing & also water tank position has not matched with as-built drawing. Moreover, 6 nos. of toilets has shown in as-built drawing, but that area is open to sky on site.

Factory engineer is required to survey the hole structures and prepare accurate as built drawings.

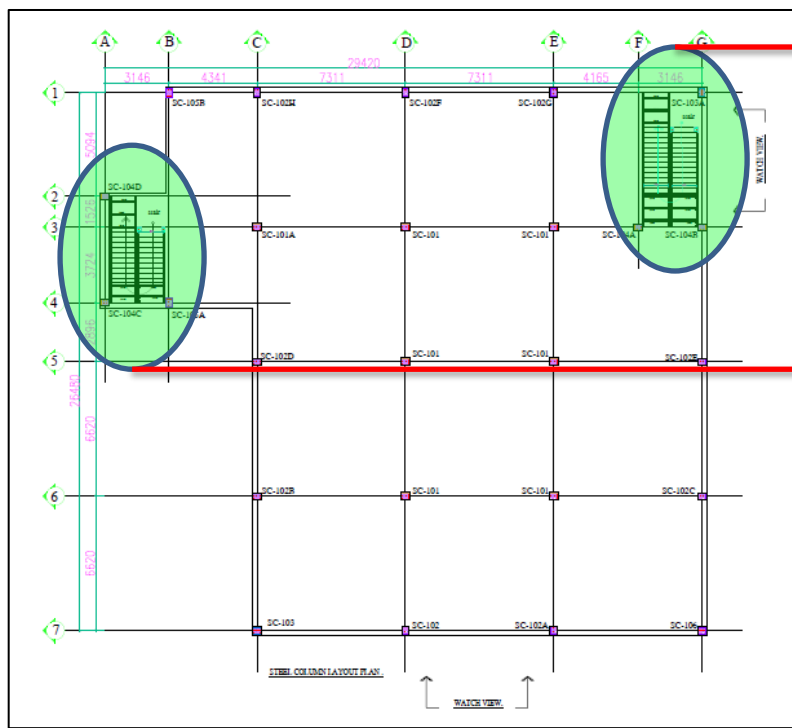
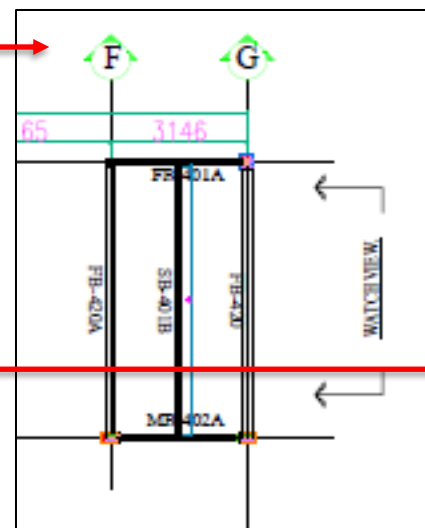
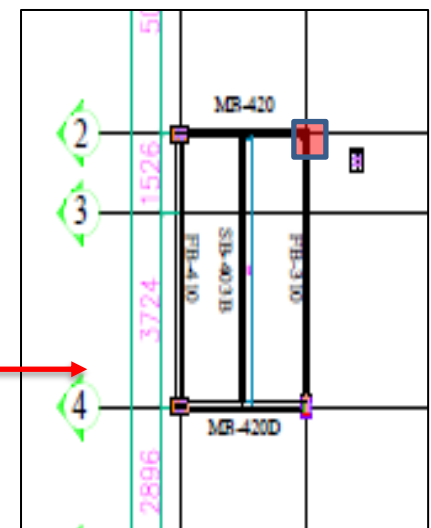
Stair top beam layout

The details of stair sub-beam (SB-401 B & SB-403 B) has not been shown in drawing. The layout of stair main-beam (MB-420 D & MB-402) were found different with grid section. Moreover, the flange thickness of (FB-420 & FB-310) was measured 5 mm but in as-built drawing thickness was shown 6 mm.

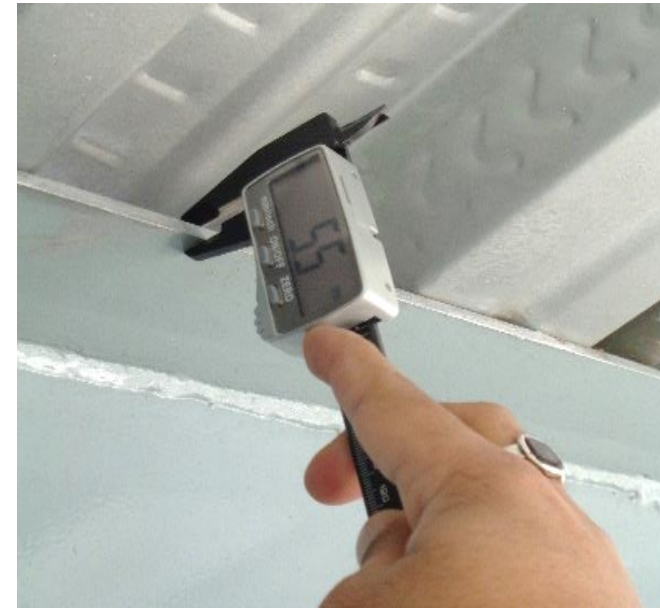
Flange thickness found 5mm

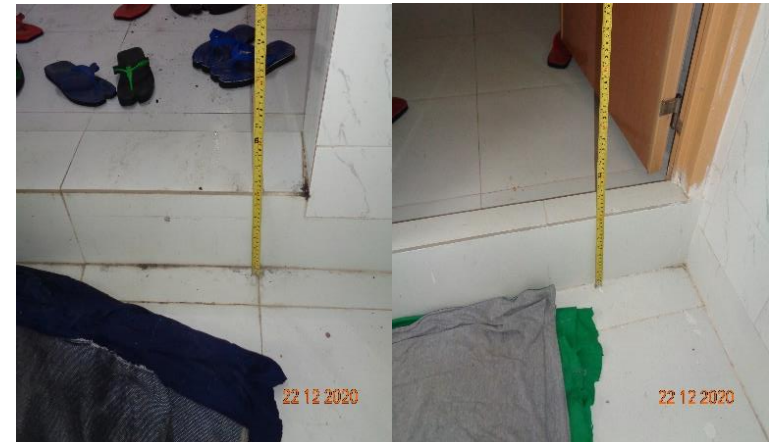
Floor Build-up was found at toilet zone area at site condition. Build-up height was measured approximately 200 mm. The information regarding build-up has not been shown in as-built drawing.

Build-up at toilet zone

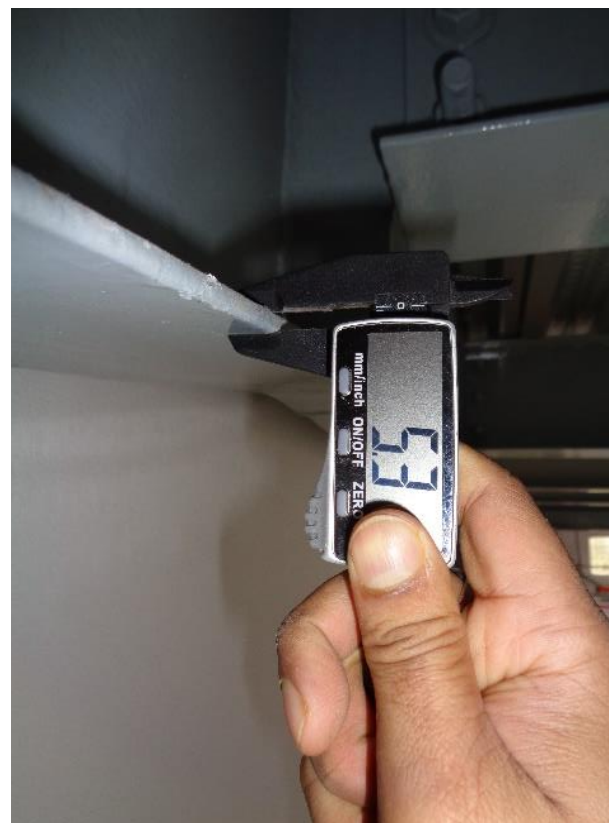
Flange thickness of primary floor beam MB-301G at grid-1 was found 5 mm on site instead of 6 mm. Also the flange thickness of beam MB-201B & MB-301B were found 5 mm in stead of 6 mm.

Flange thickness

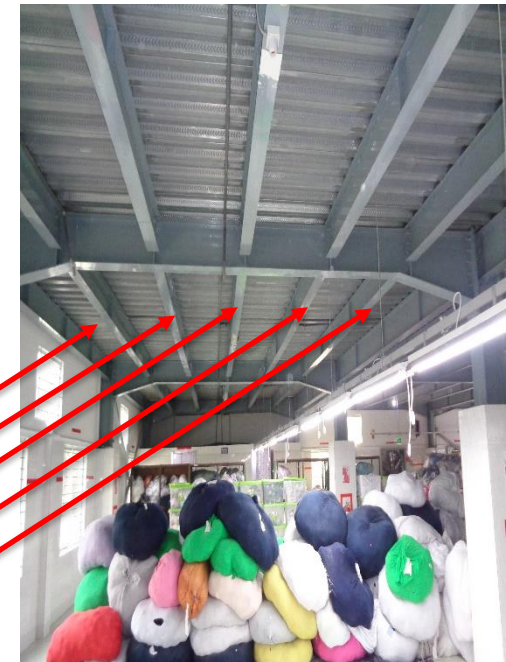
I-Joist (SB-301B) was found as W:275 mm; F: (150X5) mm on site

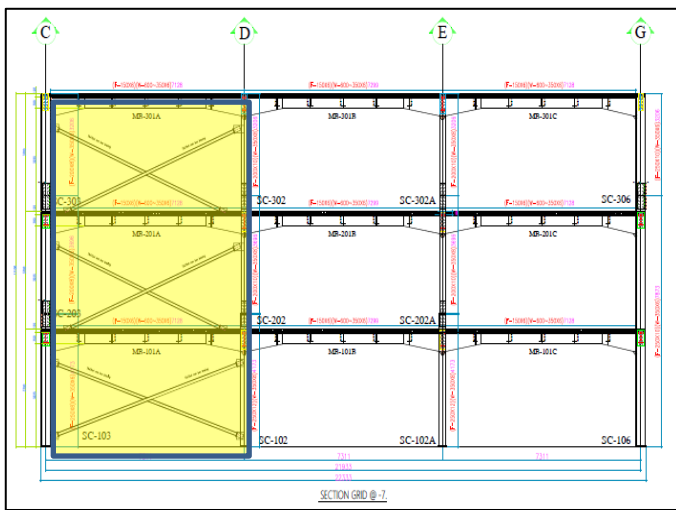
In as-built drawing the size of the bracing has been shown 75X75X4 mm (box section). But the Vertical bracing was measured 70X70 mm (box section) on site.

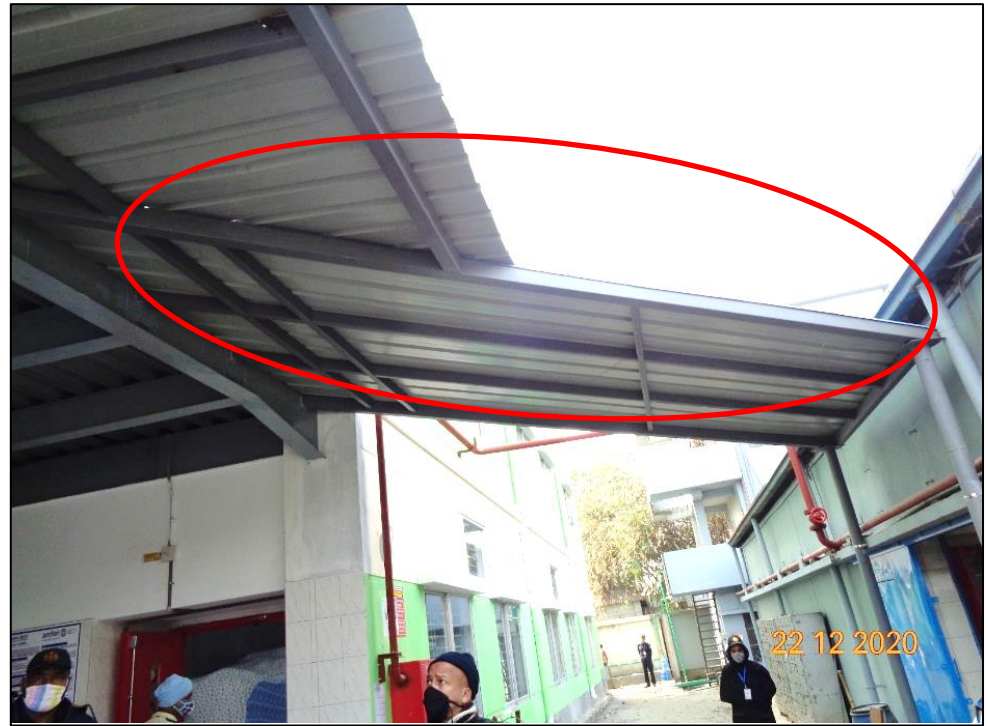
Undocumented Canopy at the entrance of the building which is connected by welding with the steel beam. No information has been provided regarding this canopy in the as-built drawing.

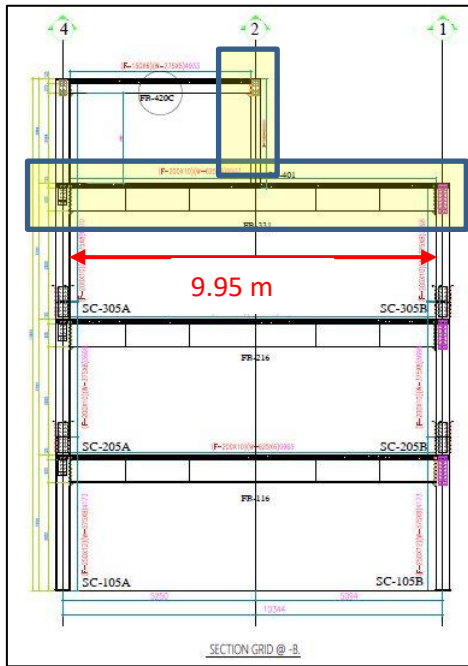
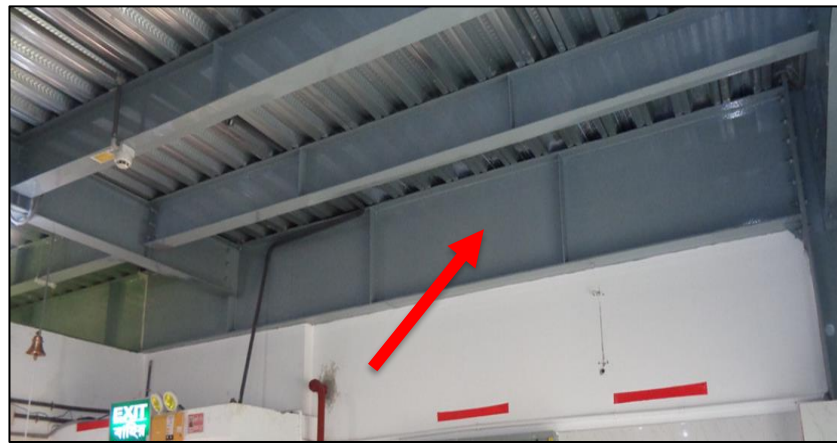
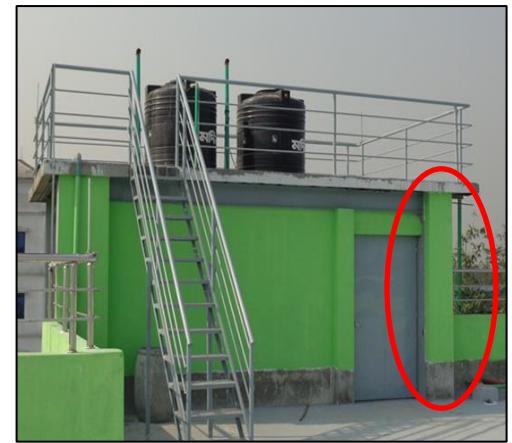
A beam (length 9.95m) is supporting a column of stair roof. And there are two plastic water tanks having 1000 L water capacity each. The adequacy (deflection capacity) check of the beam required to be incorporated in design report.

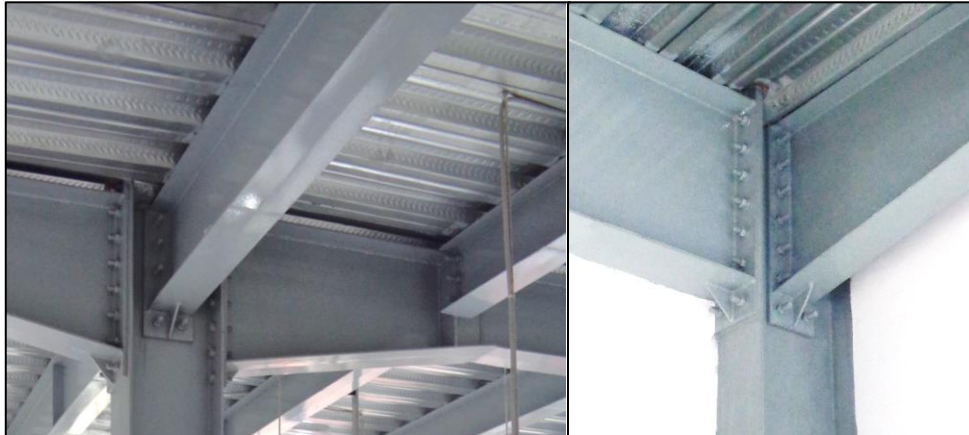
Adequacy for all type of connections is required to be incorporated in design report.

As per BNBC every building or structure designed shall have its design documents prepared in accordance with the provision of Section 1.9.1. The design document shall include a design report, and a set of structural drawings, which shall be prepared in compliance with section 1.9.1.1 and section 1.9.1.2 as per BNBC. Factory engineer is required to revise design report following BNBC requirements.

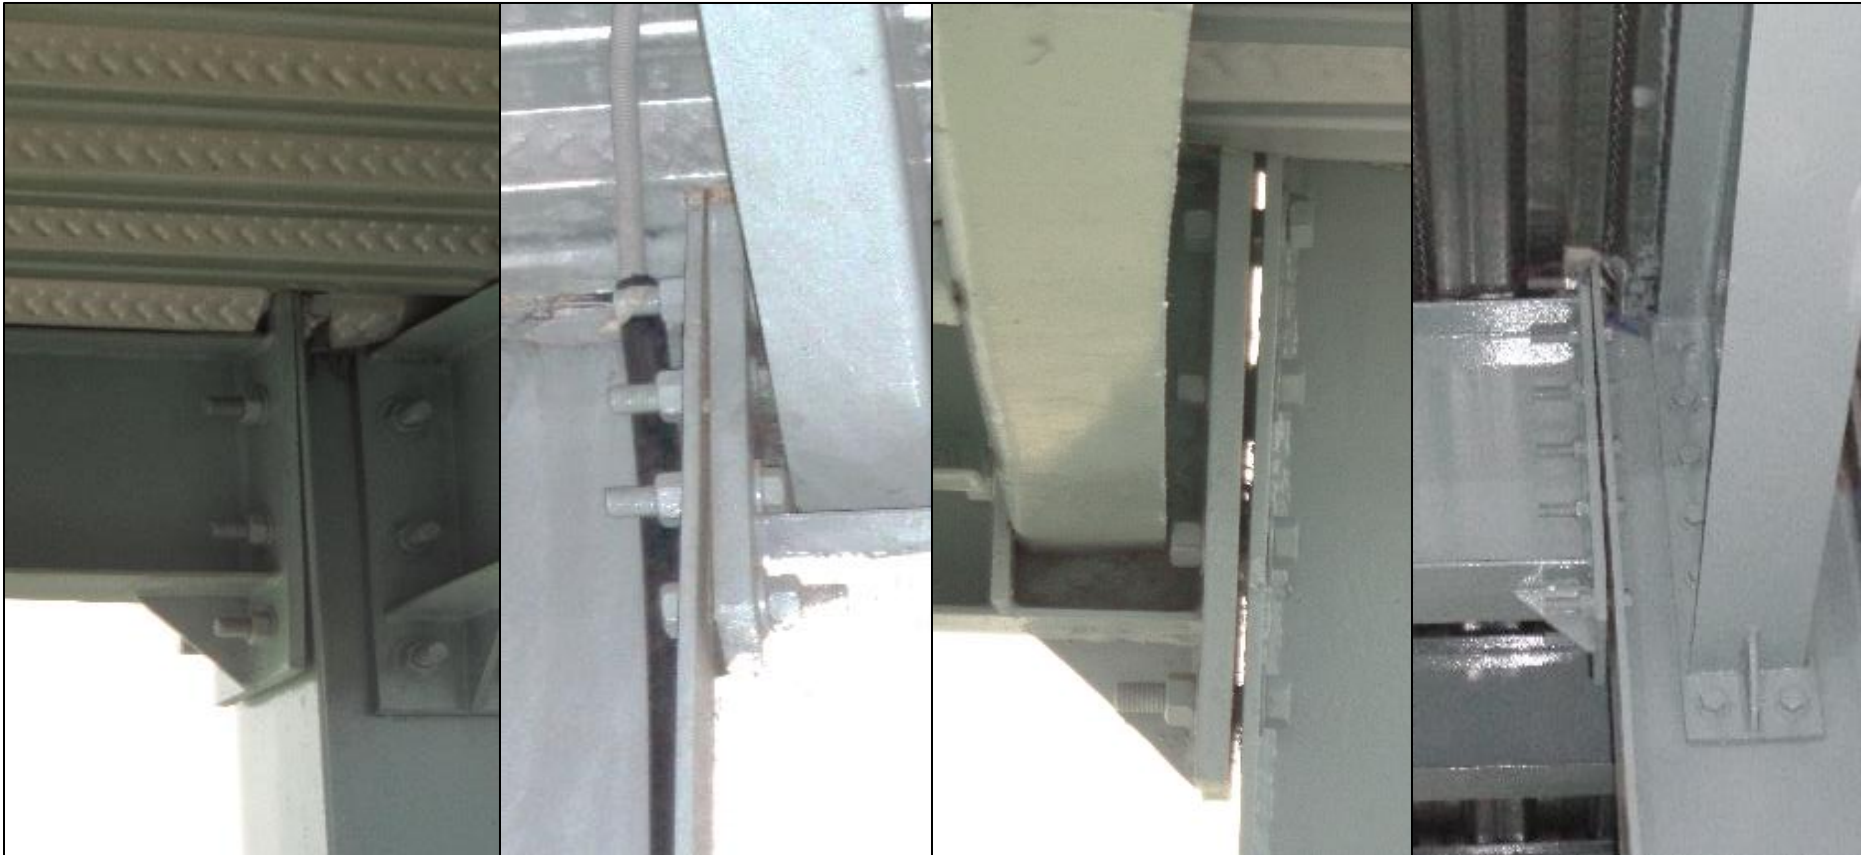
**Significant gap in connection**

Significant gaps in connection observed in beam-column joint at several location. Factory engineer is required to identify all the locations and carry out suitable remedial works for connection gap.

| Item No. | Observation | Recommended Action Plan | Recommended Timeline |
|---|---|---|---|
| 06 | Significant gap in connection. | Building Engineer is required to identify the locations and carryout suitable repair works for the connection gap. | 6-weeks |
